Microbat Culvert - Box Monitoring

2017 Annual Report

Pacific Highway Upgrade: Woolgoolga to Ballina

RE: Year 2 construction phase monitoring of microbat culverts and associated roost boxes at Woolgoolga to Halfway Creek (Section 1) Pacific Highway Upgrade.

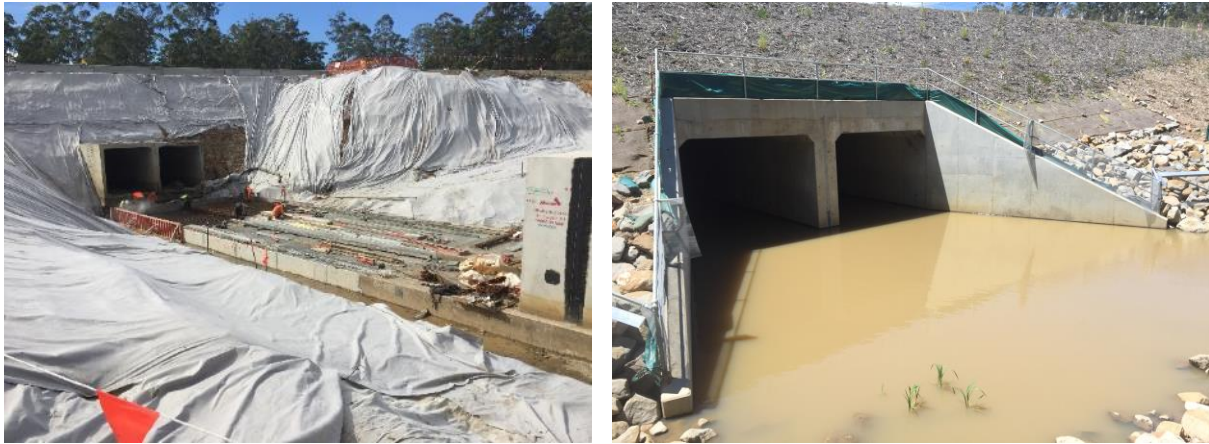
Plate 1: Western view of culvert #46 (Boney's Creek) during construction of the new culvert (17/5/2016) (L) and the same view of the completed culvert during the spring survey (26/10/17) (R).

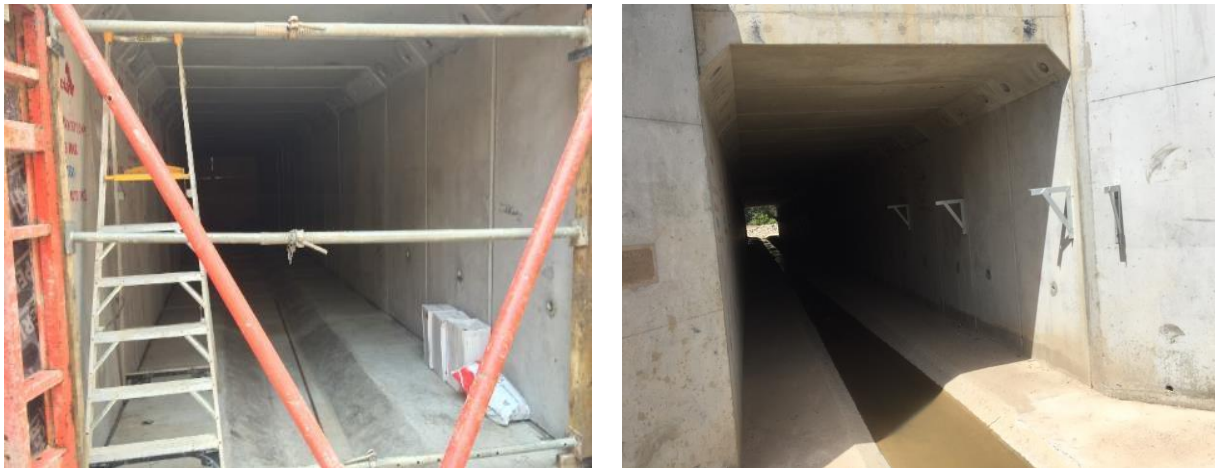
Plate 2: Western view of culvert #49 whilst under construction during autumn inspection (17/5/2017) (L) and 5 months later the complete culvert (26/10/17) (R)

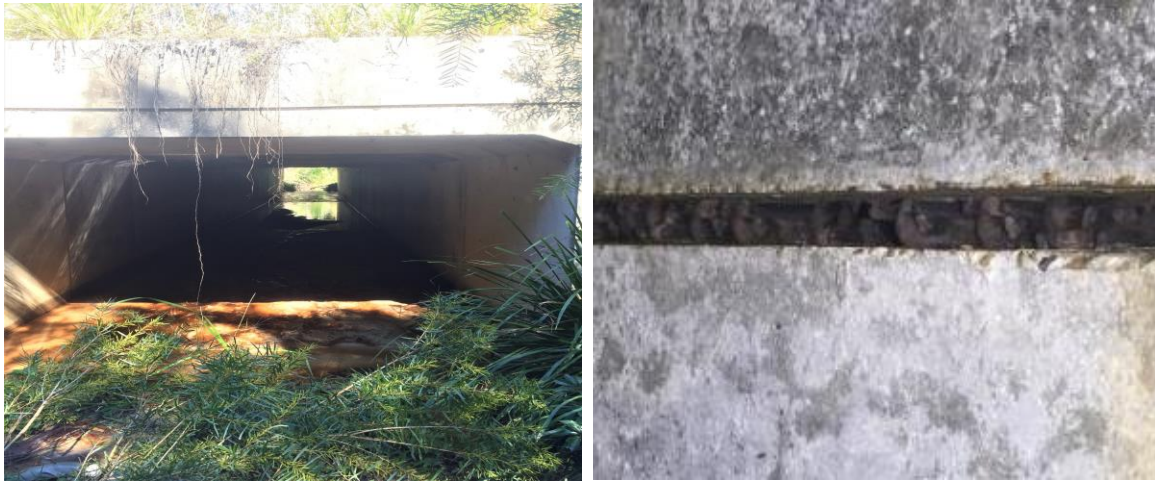
Triple-cell culvert #66 contained 85 little bent-wing bats and two eastern horseshoe bats (*Rhinolophus megaphyllus*) during the autumn inspection and approximately 420 little bent-wing bats, five eastern bent-wing bats and two eastern horseshoe bats were recorded during the winter inspection (Plate 3). No bats were recorded during the spring survey and three eastern horseshoe bats were present during the summer survey. Old scats were evident on the culvert floor during all but the autumn survey.

Plate 3: The middle cell of the non-excluded triple cell box culvert #66 (L). The culvert featured approximately 505 little bent-wing and five Eastern bent-wing bats during autumn and winter inspections (R).

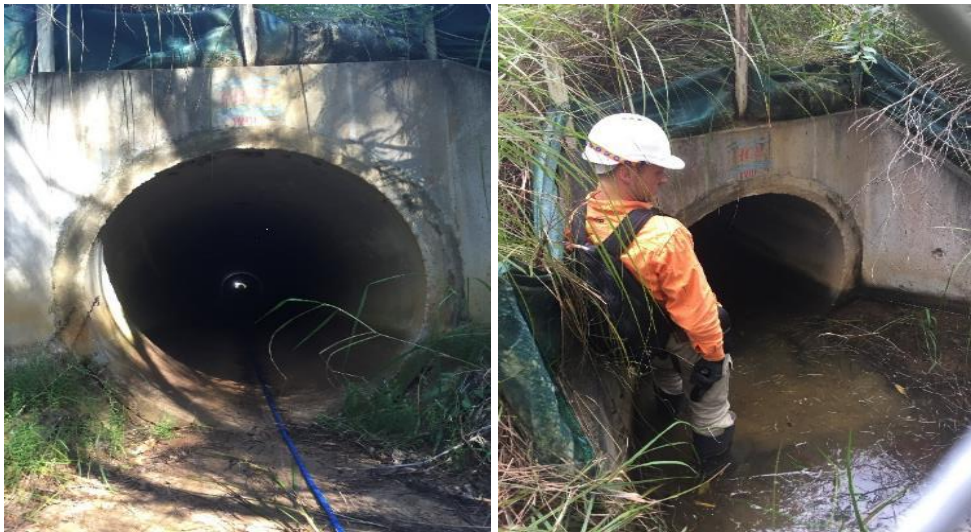
Drainage structure #67 (1200mm RC pipe) featured two Eastern horseshoe bats roosting during the summer survey and no bats on the remaining three inspections. Both individuals were hanging from the obvert near the center of the cell. Vegetation and mesh fencing obscure the entrances to this pipe.

Plate 4: Non-excluded RC pipe #67 featured two eastern horseshoe bats at the summer inspection (L). Approximately 50-300mm of water flowed through the pipe during winter (R).

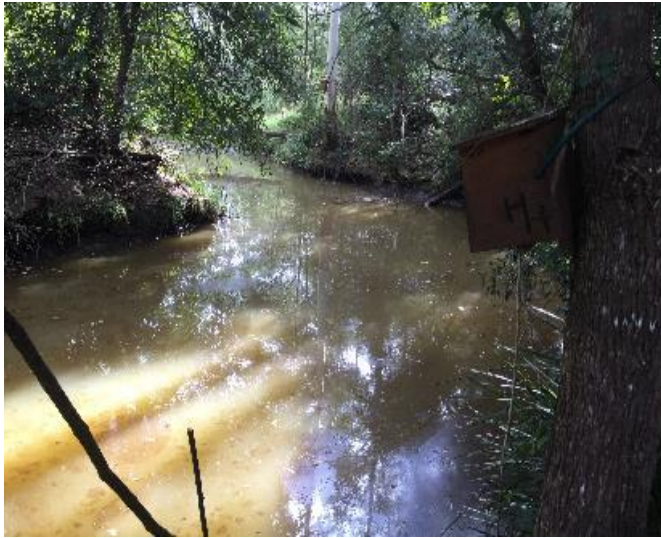
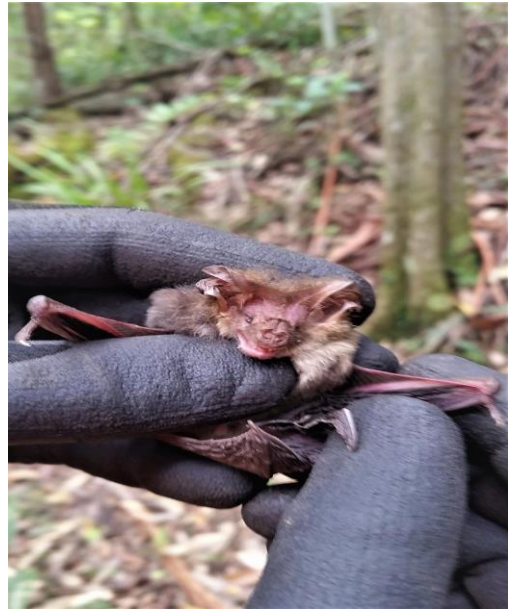
Three Gould’s long-eared bats (*Nyctophilus gouldi*) were recorded in two boxes during the summer 2017 inspection. One microbat was recorded roosting in a box on the east side of drainage structure #46, Boney’s Creek (Plate 4) during the spring inspection. The bat took flight upon inspection but was identified as a long-eared bat (*Nyctophilus spp.*). No bats were recorded in any of the other boxes during seasonal inspections. No evidence of breeding was recorded.

Roosting boxes were mostly in good condition though some minor deterioration was evident. At the time of the last summer inspection all boxes were still functional for their intended purpose.

Plate 4: Microbat roost boxes on the east side of structure #46 at Boney’s Creek. Gould’s long-eared bat recorded in box on west side of Boney’s Creek (R).

- The two adjacent habitat boxes utilised by long-eared bats should remain insitu to provide ongoing habitat for that species.
- The seven remaining bat boxes adjoining culvert #46 and two adjoining culvert #49 should be installed inside the respective culverts. Box distribution should be determined onsite. Boxes would be attached to culvert walls at ceiling level and positioned centrally where roosting conditions are optimal. Boxes would be installed so as to not impede water flow through the structure.
- 200mm wide strips of tiling grout or similar should be applied to the middle third of the obvert of each culvert around each join and roughened with a tiler's trowel or similar tool, as per the MMP.
- Monitoring of structures should be in accordance with the Microbat Management Plan.
