Sandpiper Ecological Surveys

1 February 2017

RE: Year 1 monitoring of microbat culverts and associated roost boxes at Woolgoolga to Halfway Creek (Section 1) Pacific Highway Upgrade.

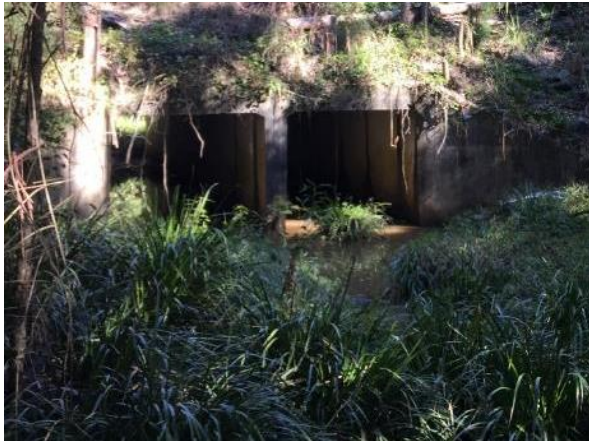
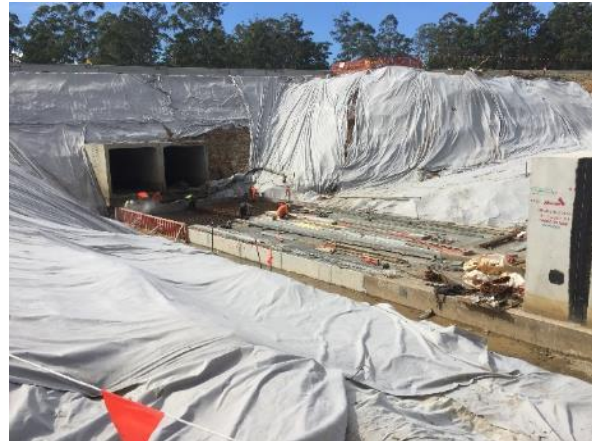
Exclusion material was largely retained in place during the inspection period and reinstalled on occasions where some detachment had occurred. Some remedial filling of an emergent gap between the headwall and end unit of the inlet and outlet of structure #46 was conducted during autumn and spring inspections. Whereas culvert #46 remained open during construction, the outlet of culvert #49 was blocked off prior to autumn inspection and at the inlet prior to the spring inspection (Plate 1 & 2). A temporary 750mm drainage pipe extended through the outlet blockage during this period. At the time of the spring inspection, new culverts had been constructed on the east and west side of #46 and the west side of #49 and construction was almost complete.

Plate 1: Western view of culvert #46 (Boney's Creek) at the time of exclusion (20/5/2015) (left) and 12 months later during construction of the new culvert (17/5/2016) (right).

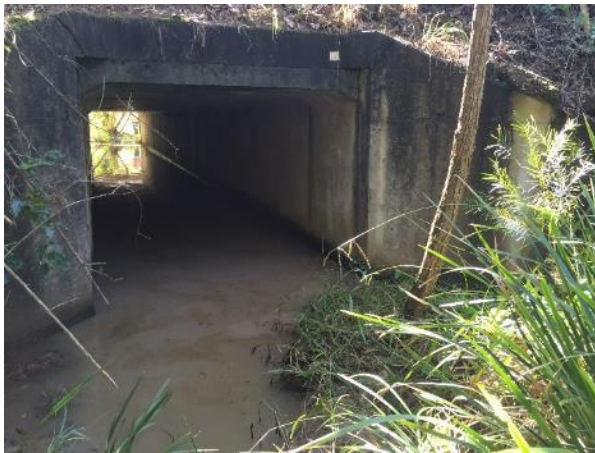
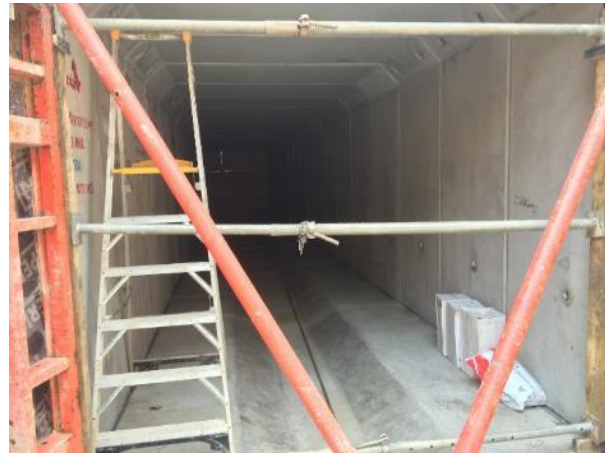
Plate 2: Western view of culvert #49 at the time of exclusion (20/5/2015) (left) and 12 months later during construction of the new culvert (17/5/2016) (right).

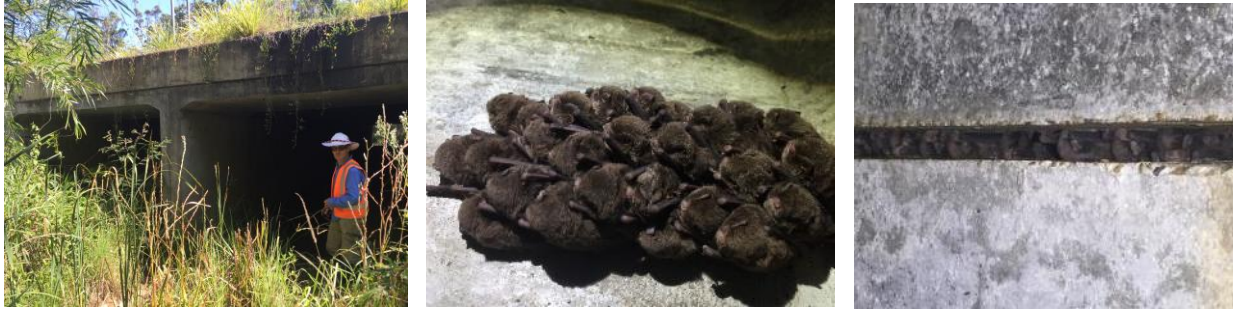
Both non-excluded (control) drainage structures featured microbats (Table 2). Triple-cell culvert #66 contained up to 500 little bentwing bats and eastern bentwing bats (*Miniopterus orianae*) during autumn and winter inspections (Plate 3). Drainage structure #67 (1200mm RC pipe) featured a single eastern horseshoe bat (*Rhinolophus megaphyllus*) during summer and autumn. On each occasion the individual was hanging from the obvert near the center of the cell.

Plate 3: Non-excluded triple cell box culvert #66 (left) featured up to 500 little bentwing and eastern bentwing bats during autumn and winter inspections (middle and right).

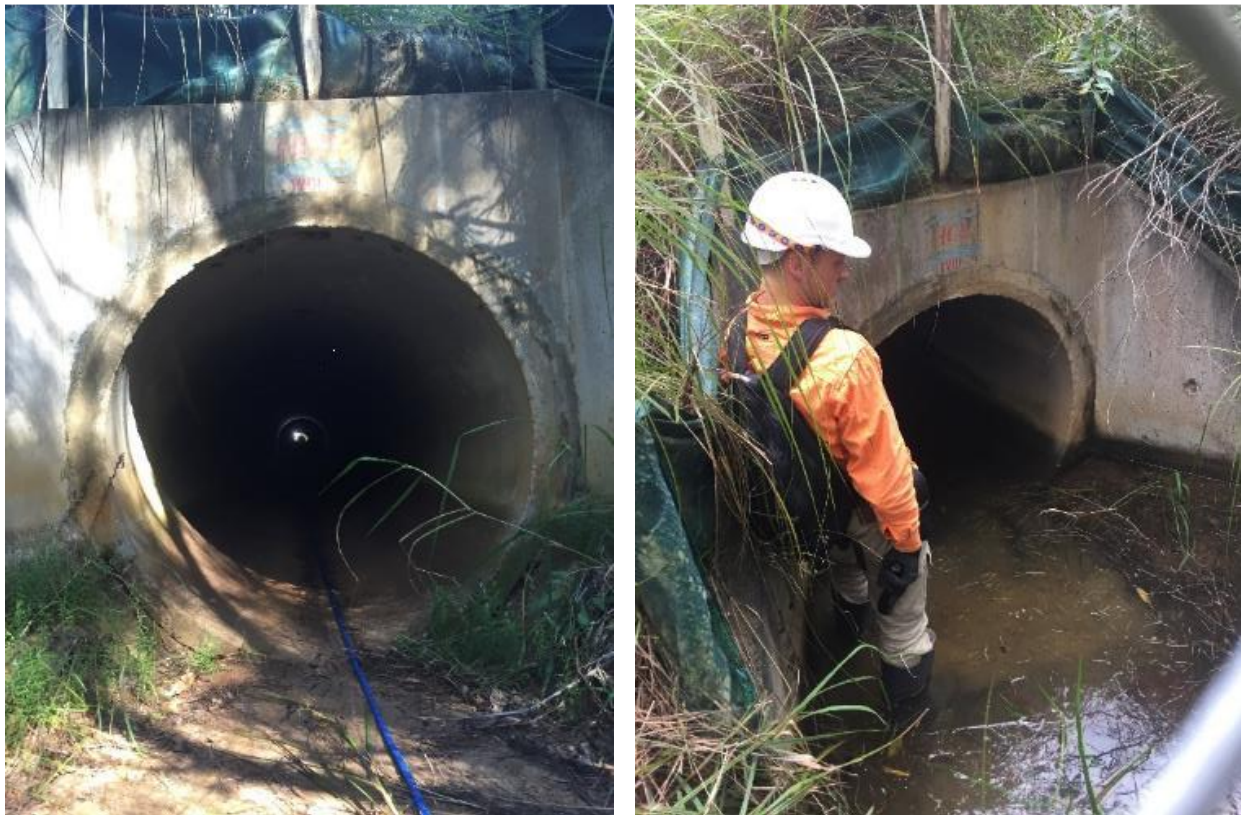
Plate 4: Non-excluded RC pipe #67 featured a single eastern horseshoe bat during summer and autumn (left). Approximately 400mm of water flowed through the pipe during winter (right).

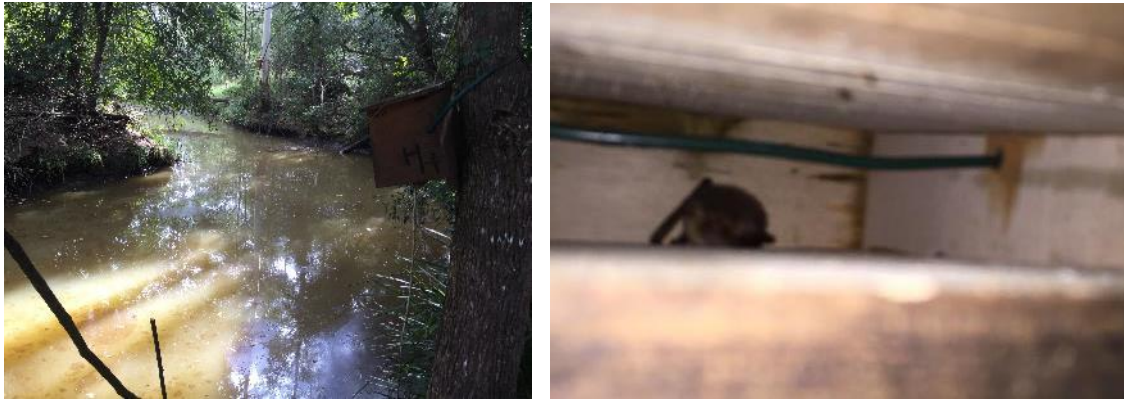
Microbats were detected during winter within two roosting boxes on the east side of drainage structure #46, Boney's Creek (Plate 4). Both boxes featured long-eared bats (probably Gould's long-eared bat *Nyctophilus gouldii*) with a total of six individuals recorded. No evidence of breeding was recorded.

Roosting boxes were mostly in good condition though some minor deterioration was evident. At the time of the final spring inspection, each of the three roost box sites featured one box displaying minor delamination of the ply side walls.

Plate 4: Microbat roost boxes on the east side of structure #46 at Boney's Creek (left) featured long-eared bats (probably Gould's long-eared bat *Nyctophilus gouldii*) during the winter inspection (right).
