GMC ENVIRONMENTAL CONSULTING

HW10 Pacific Highway Upgrade, Woolgoolga to Ballina – Koala Revegetation, Section 10

2018/19 Annual Inspection Report

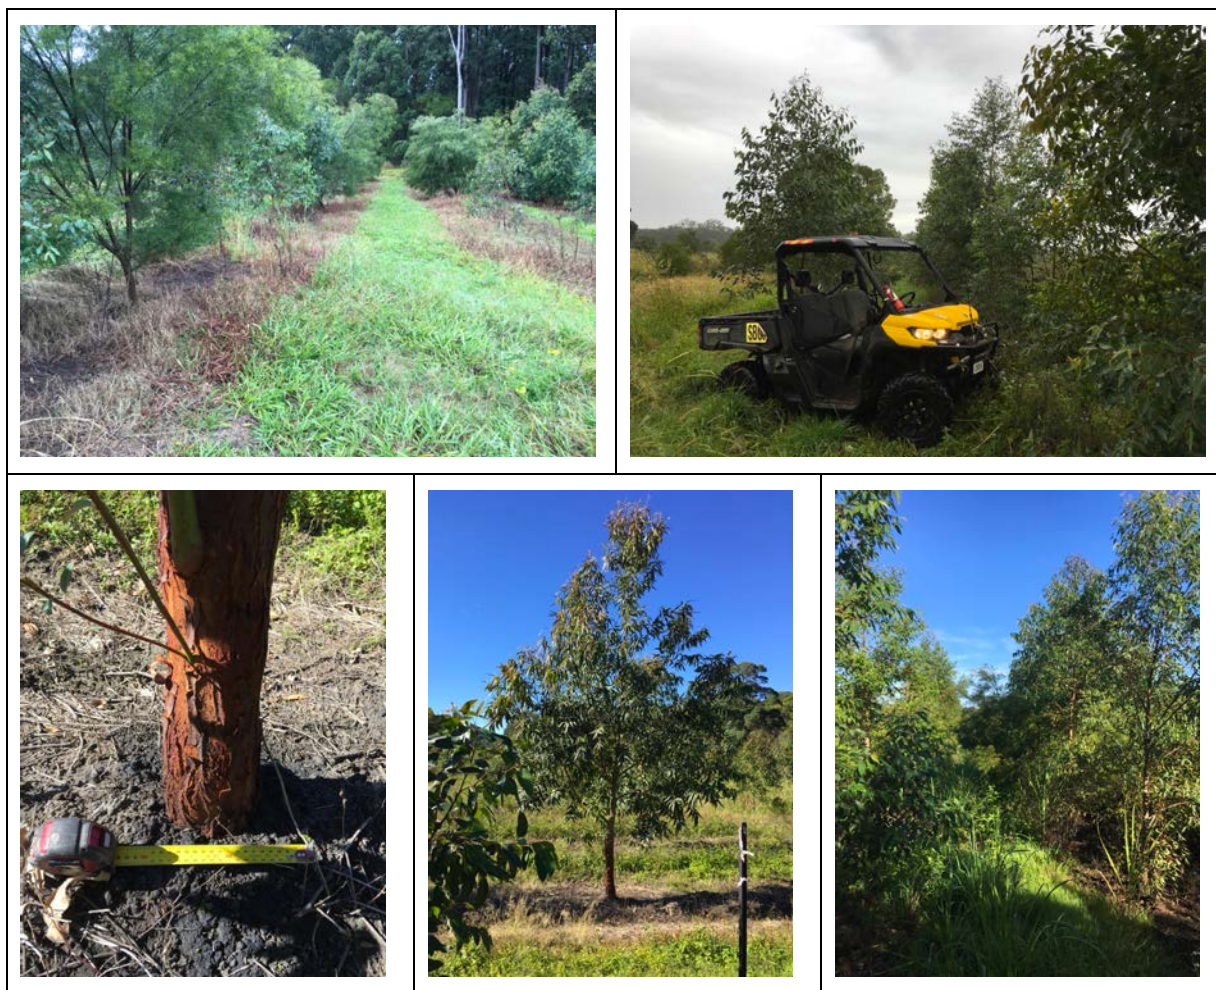
Figure 8. Tree Growth Across Project

Generally, plant survival across the whole project continues to be very good. The trees across most planting sites are growing very well with average heights ranging between 2m to 4m. The tallest tree observed and measured was approximately 6 metres in height. In most instances trees have double in size and in some instances tripled in size since the 2018 inspection. Observation during the annual inspection indicated there is a small amount of replacement planting required and the planned undertaking of these works is detailed in Section 6 of this report. Some of the best growth areas include Planting Areas 1, 6-8, 9, 10-15, and 19-20.

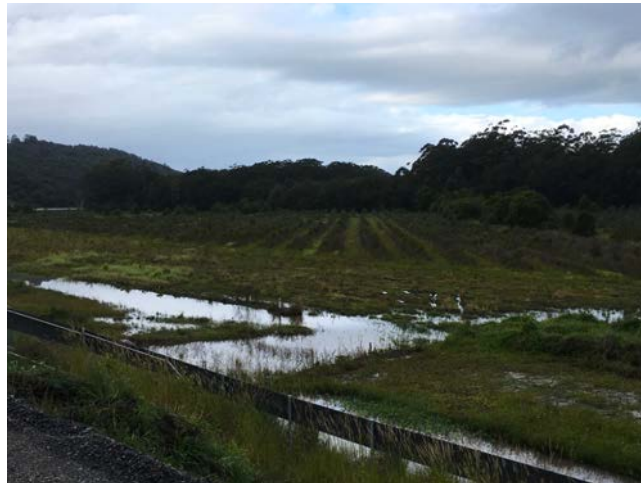
Soil saturation was observed to be a key feature in regard to plant growth and some species survival. A large portion of the project revegetation area is located in low lying areas that are subject to prolonged soil inundation/saturation. In these areas, project wide, it was observed that acacia survival was non-existent to below average. The acacia cover crop did not respond well to these wet soil conditions. Some eucalypts and Forest Oak also did not grow or survive well within these conditions or took a longer period of time to adjust. In planting areas with even a slight elevation that allowed soil drainage, the affected species especially the acacias are doing significantly better and demonstrated strong growth and survival.

Soil drainage has also shown to considerably affect tree growth. In lower lying zones, tree growth has been observed to be up to 50% slower than better draining areas. While growth was observed to be slower, tree establishment and survival is generally not affected.

Figure 9. Saturated Soil Area – PA13's

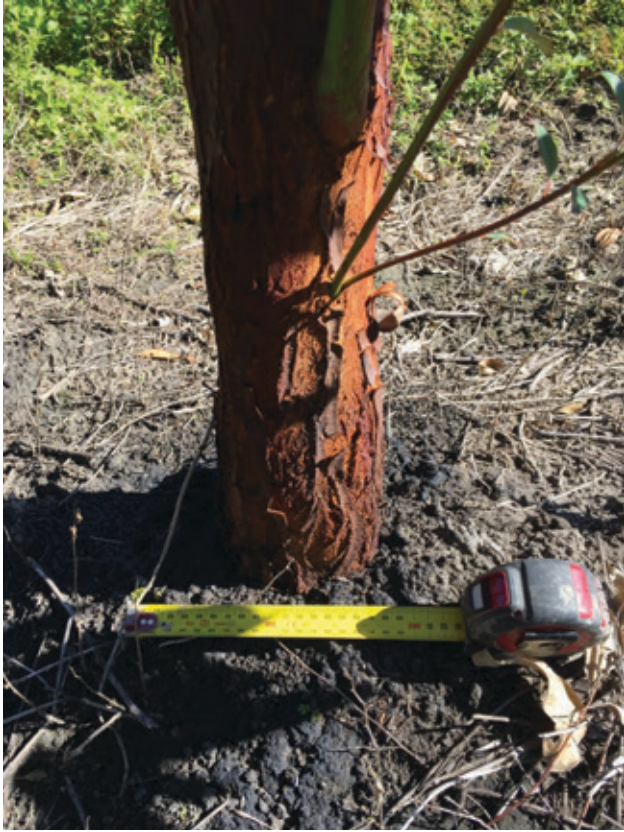
Good stem growth - PA19.1

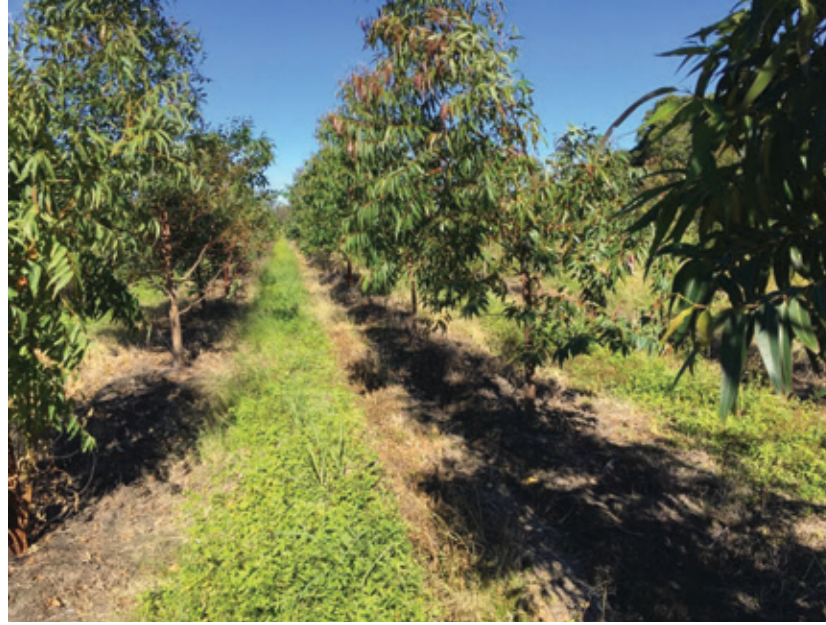
Good weed control - PA19.1

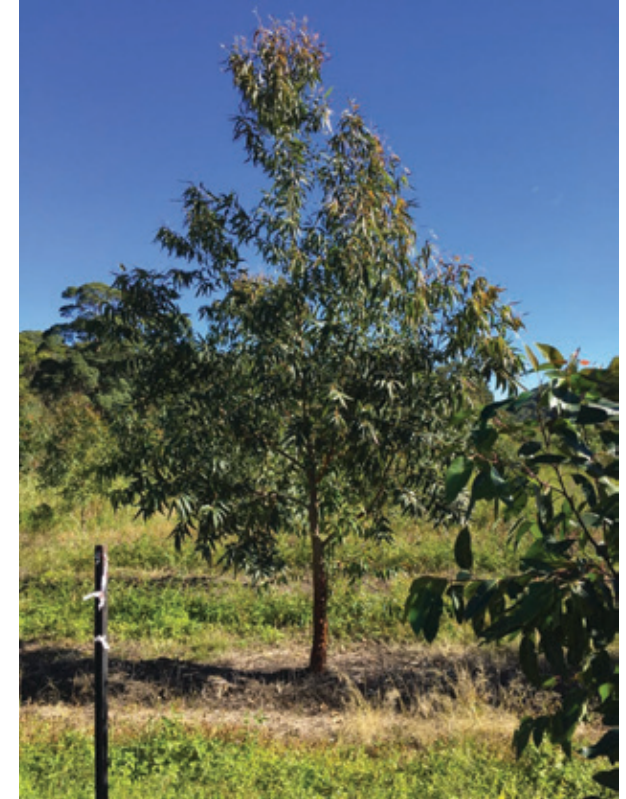
Good tree structure PA19.1

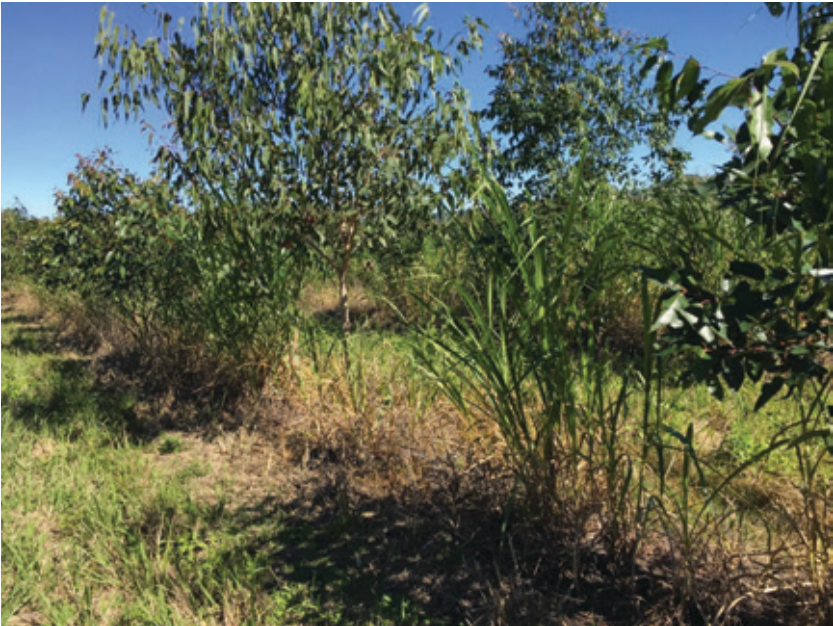
Volunteer sugar cane in PA19.5

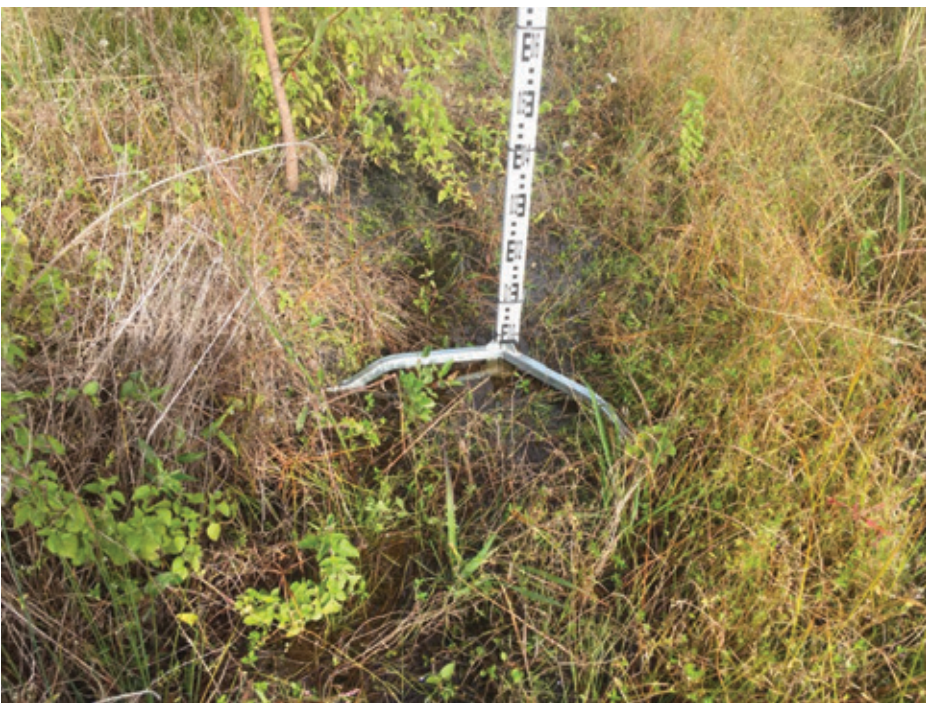
| Site 7 | | | | | | | | | |
|---|---|---|---|---|---|---|---|---|---|
| Comments: | Continuous wet to saturated soils in this area with water above ground level. Moisture levels restrict weed control activities but the trees in this area are now above grass height and are looking well established. The trees look very healthy and are growing well. With the high soil moisture levels the trees are about half the height at present compared to better draining areas. | | | | | | | | |

PA21.3 Saturated soils with water sitting above ground level across site

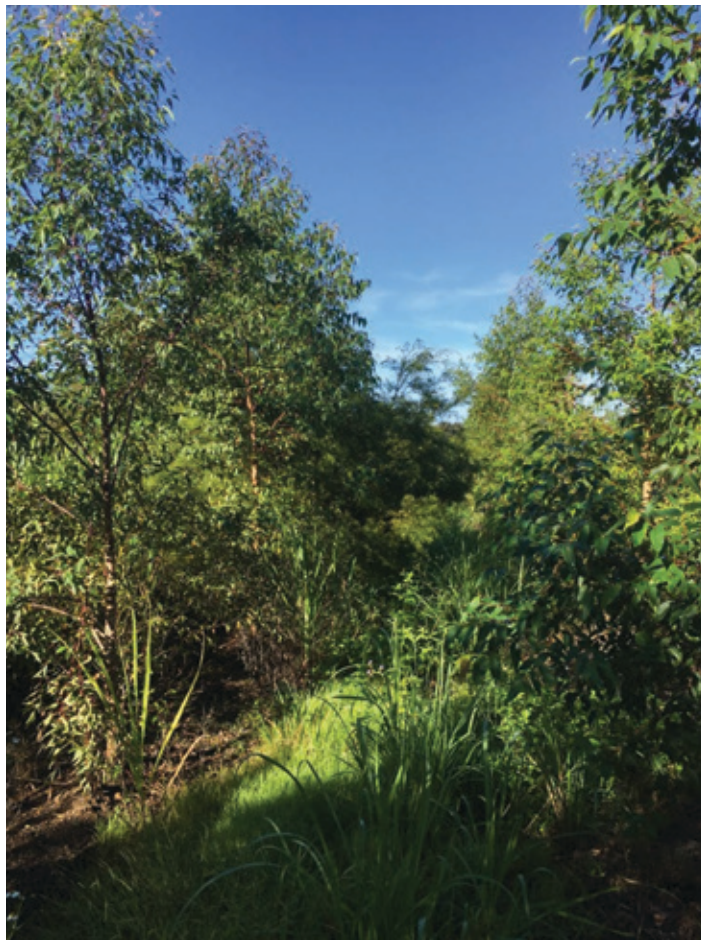
| Site 19 | | | | | | | | | |
|---|--|---|---|---|---|---|---|---|---|
| Comments: | Continued excellent growth rates with one tree measured at 6m. Elevated position has resulted in very fast growth rates and good establishment. Weed control effective with trees well above weed heights and now starting to form a forest canopy in places. | | | | | | | | |

PA10.3/4-11.4 Canopy starting to form

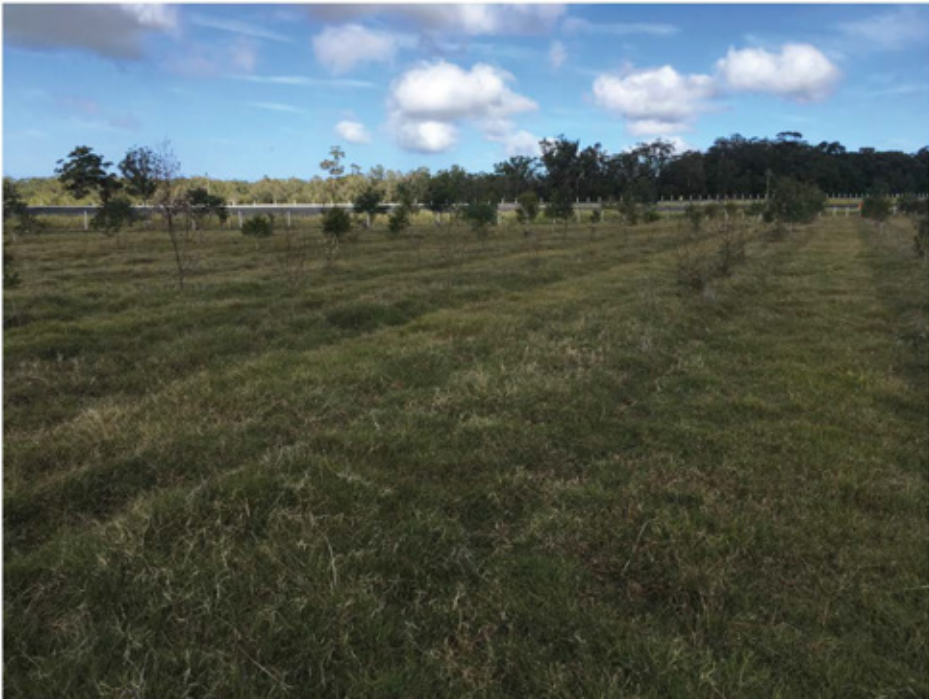
PA6.1 Plant losses from prolonged dry/hot period - Dec/Jan

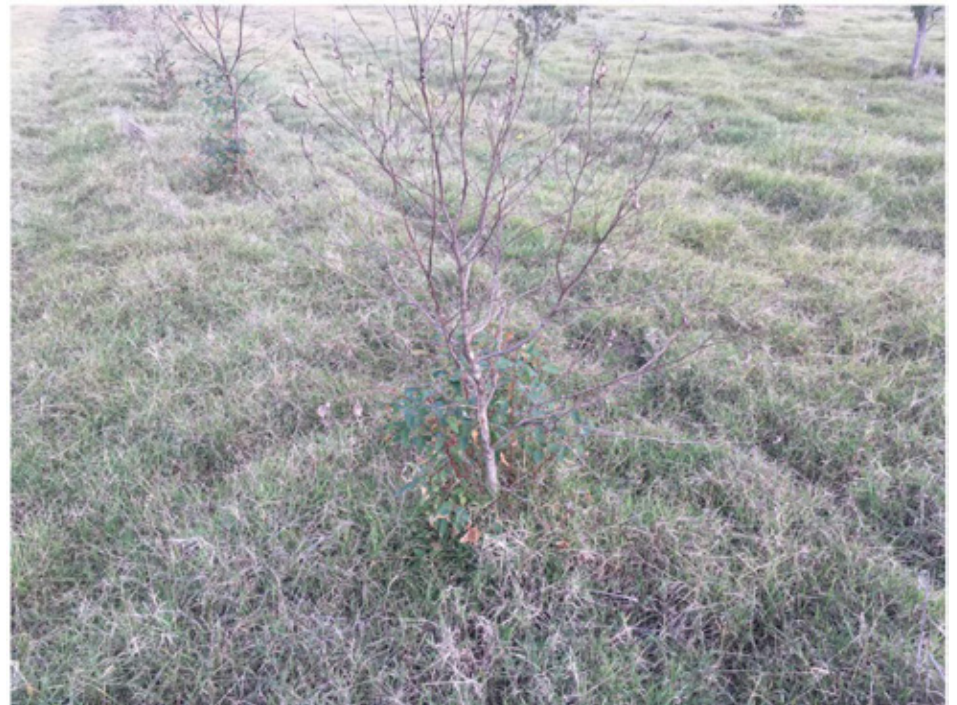
PA6.1 Plant recovery after dry/hot period
