# Woolgoolga to Ballina Pacific Highway upgrade

**Sections 3-11 Microbat Monitoring  
Annual Report 2018**

# W2B Sections 3 – 11 Microbat Management Plan 2018 Annual Monitoring Report

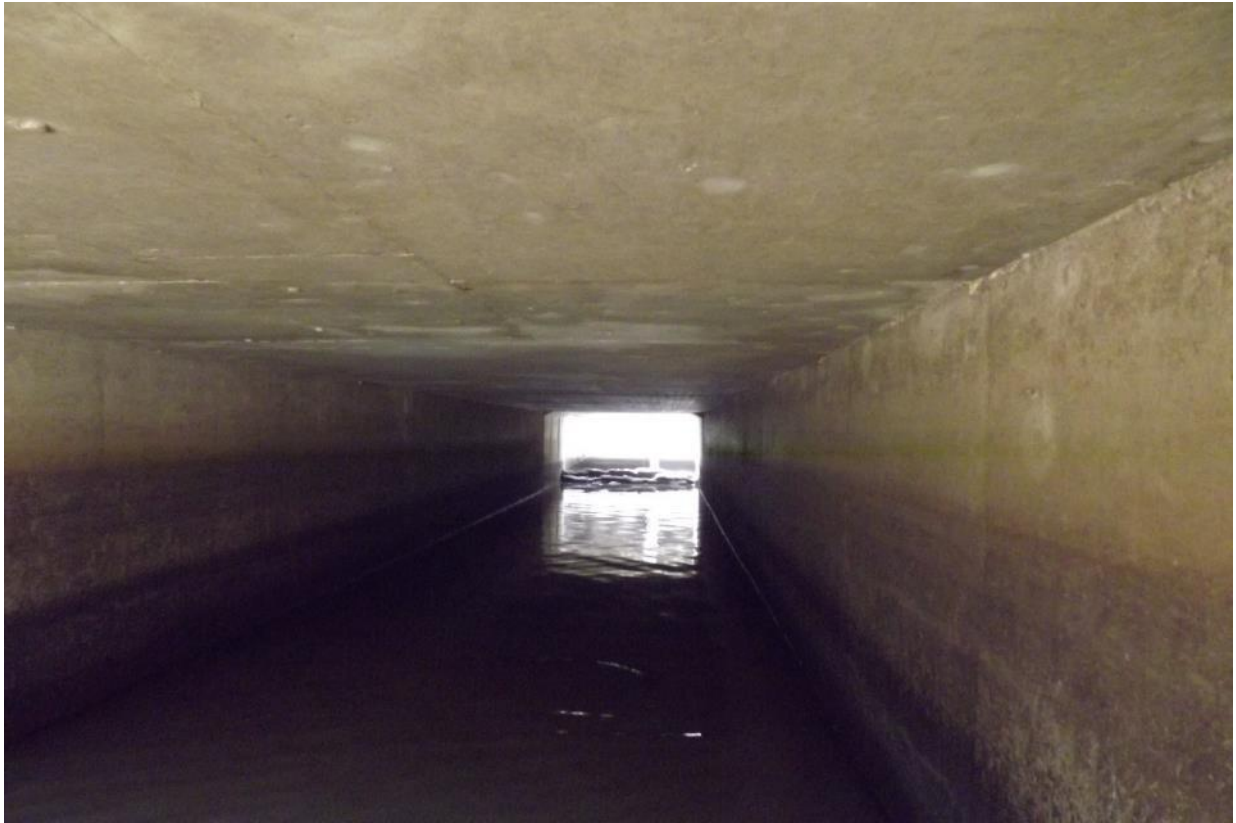
Oakey Creek culvert (Figure 11) contained a very small amount of shallow and exposed roosting habitat. The culvert contained deep (>1.5m) permanent water during all inspections and there were concerns over the practicality of installing and more importantly maintaining the integrity of exclusion devices. Due to these concerns and the relatively low risk of microbat habitation a decision was made to leave the Oakey Creek culvert open to microbats (ELA 2018b). This decision was made in consultation with EPA and a W2B environmental representative.

**Figure 11:** Looking east through Oakey Creek culvert, one of the impacted subject drainage structures along the W2B alignment showing current and previous high water levels (staining half way up culvert walls).

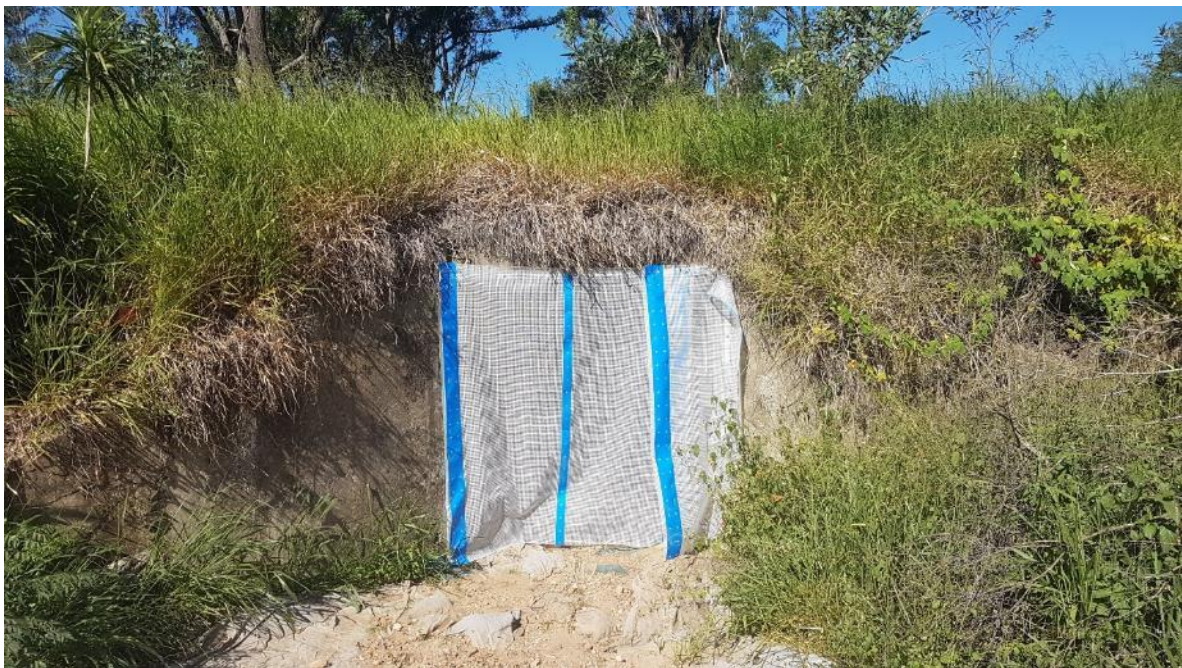
**Figure 14: External exclusion for microbats using heavy duty plastic sheeting across a culvert outlet, Devil's Pulpit tie in, Woolgoolga to Ballina Pacific Highway upgrade, May 2018.**

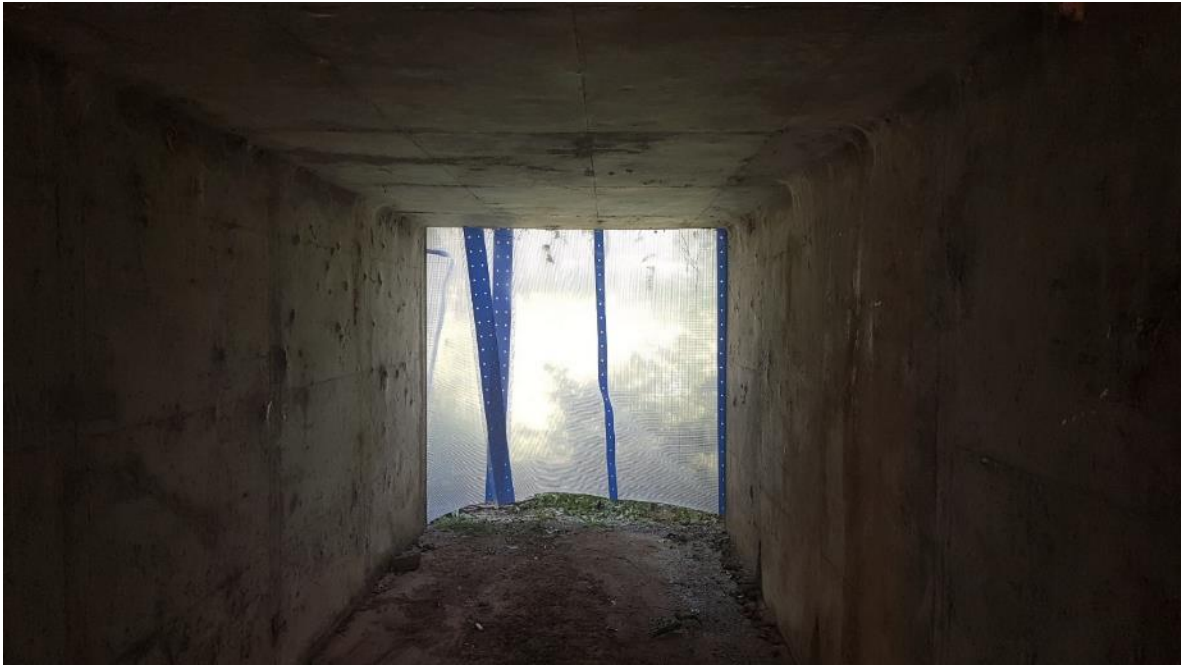
**Figure 15: Internal view of exclusion device for microbats using heavy duty plastic sheeting across a culvert outlet, Devil's Pulpit tie in, Woolgoolga to Ballina Pacific Highway upgrade, April 2018.**

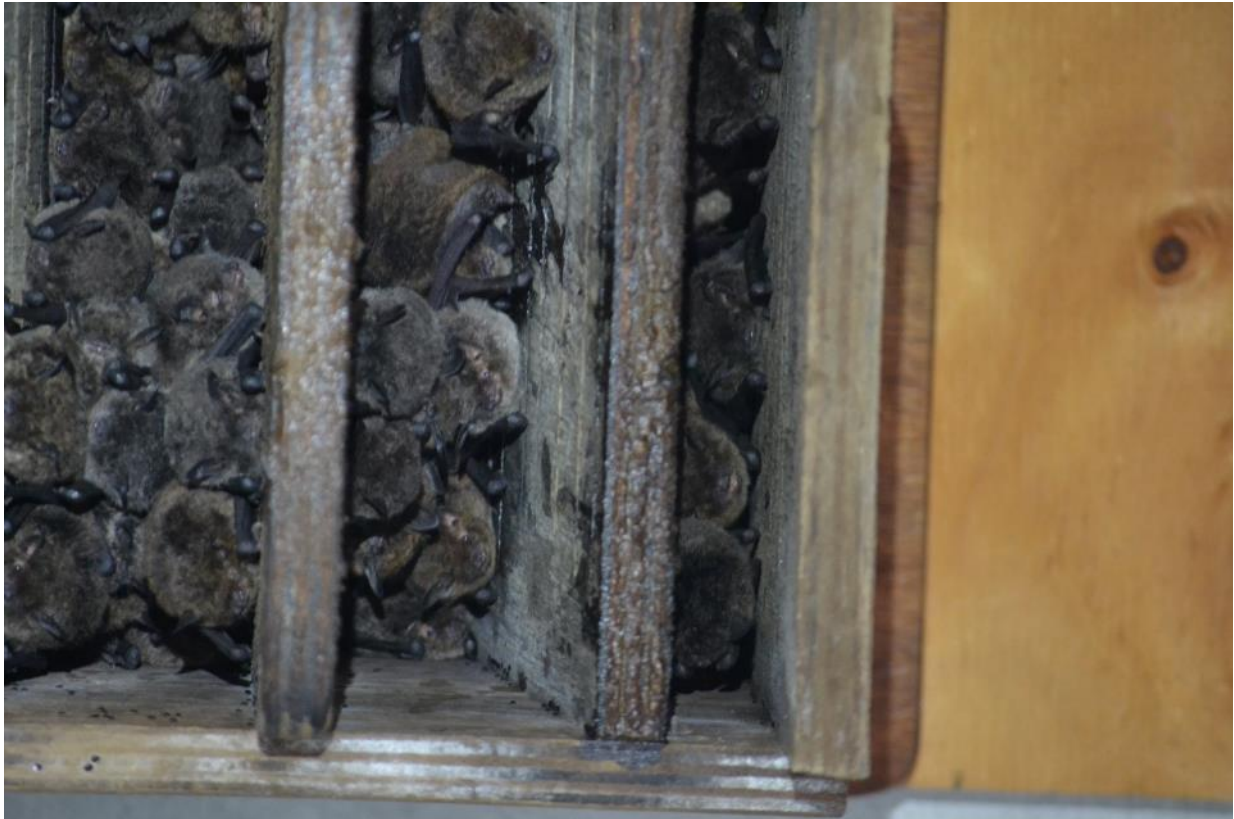
**Figure 17: One of the four bat boxes installed beneath Mororo Bridge full of Southern Myotis.**

The four boxes underneath Mororo Bridge (south) were also not installed as part of the W2B project. Mororo Bridge is a control site and any existing boxes attached to the bridge whether used or unused should remain where they were originally placed. Significant degradation of these boxes has been noted during monitoring inspections, with the timber permanently coated with excretions (guano and urine) from the bats. The boxes are often at capacity and the local population of Southern Myotis would benefit from installation of at least 6 new boxes of similar size or with a capacity to accommodate up to 500 Southern Myotis at this location.

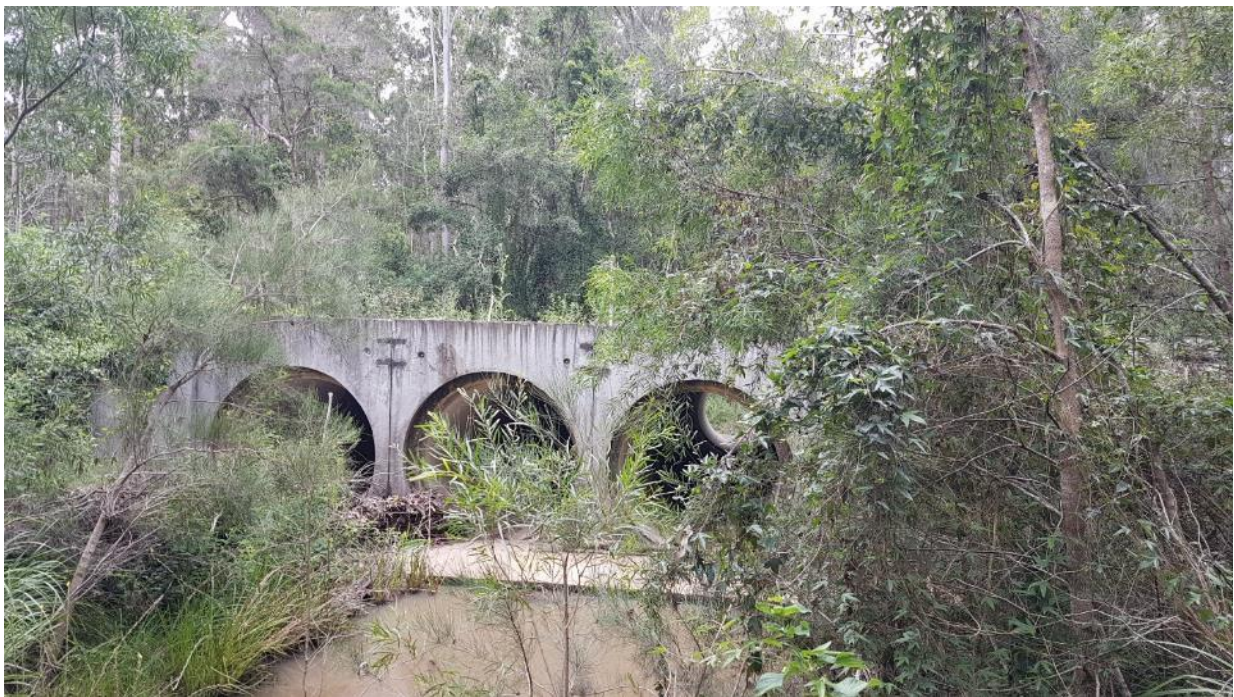
Similarly, the culvert at Pheasants Creek CH 35900 (Figure 20) was only partially excluded to microbats, with the internal holes and gaps sealed using expanding foam. This was due to the need to maintain a flyway for Southern Myotis along the creek line at this location whilst removing the chances of large breeding aggregations inhabiting the culvert prior to demolition. There was a small amount of guano recorded in the culvert during Sept 2018 inspections, but no further evidence of microbat usage recorded in Dec 2018.

**Figure 20: Glenugie Link Section 3A Pheasants Creek culvert, January 2018.**
