Construction Ecological Monitoring

Annual Report - Revision 1

March 2017

CMC Group

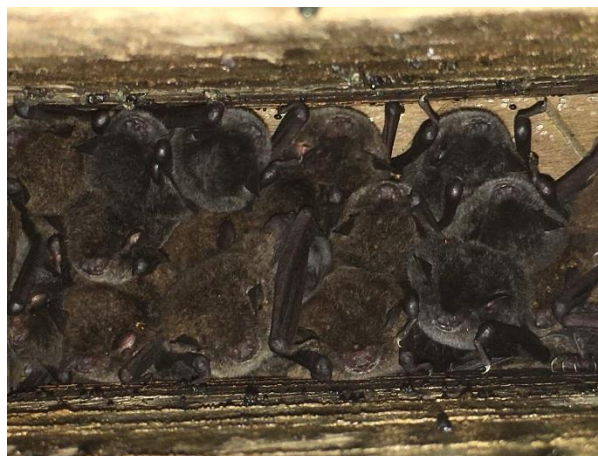
Plate 3 shows large-footed myotis found in the lattice nest box under the Halfway Creek Bridge.

Plate 3 Large-footed myotis in lattice nest box at existing Halfway Creek bridge

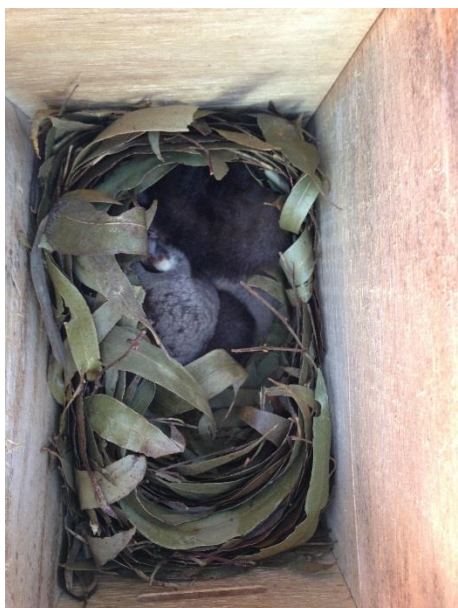
Plate 4 Two sugar gliders (Box#120, winter 2016)

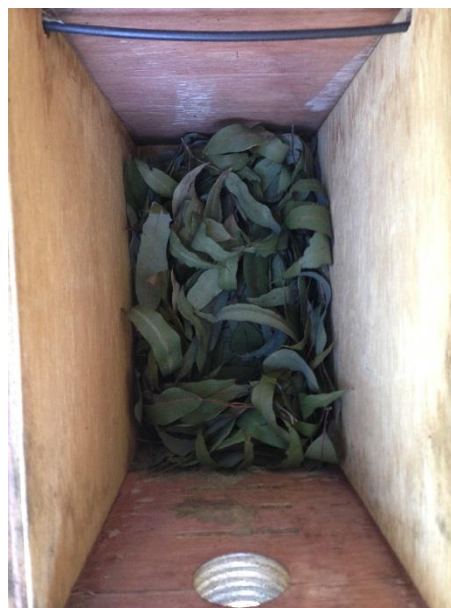
Plate 5 Evidence of occupancy example (Box #3, winter 2016)

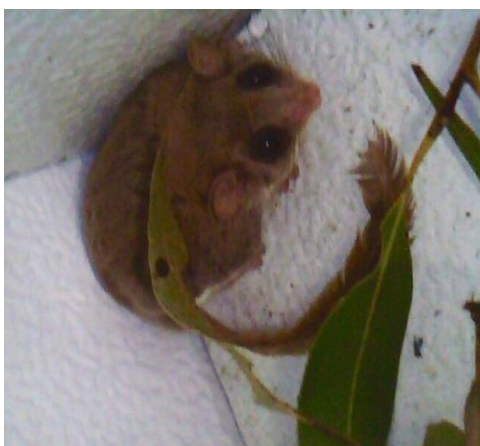
Plate 6 Feather-tail glider (summer 2016, in Aluminium/Polystyrene composite) (Box #94)

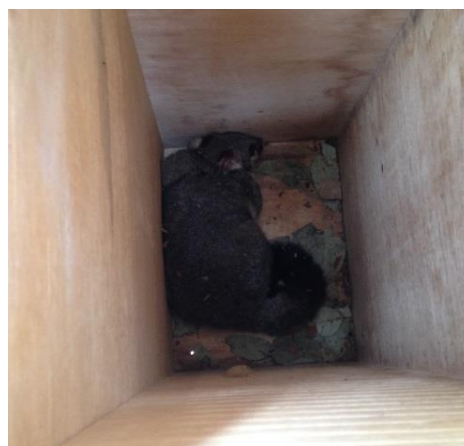
Plate 7 Common brushtail possum (Box#7, summer 2016).
