Threatened Species Management

Monitoring of Threatened Flora

Pacific Highway Upgrade: Woolgoolga to Ballina

Sections 1 & 2 – July 2016

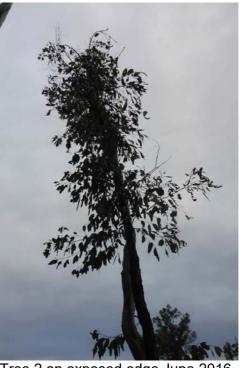
Tree 1, good recovery from fire June 2016

Tree 2 on exposed edge June 2016

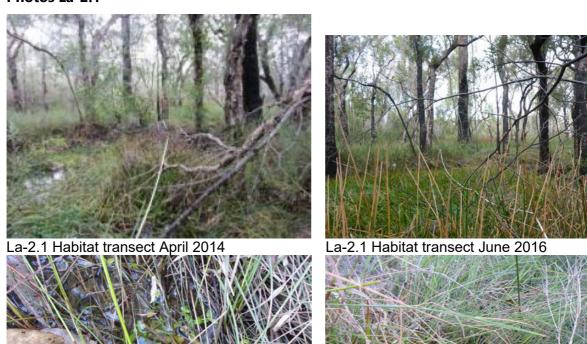
Photos La-2.1

La-2.1 Leaves of *Lindernia alsinoides* submerged, June 2016

Habitat of Lindernia alsinoides, June 2016
