Pacific Highway Upgrade - Nambucca Heads to Urunga Operational Phase
Threatened Flora Monitoring Year 1 Annual Report

Prepared for NSW Roads and Maritime Services
Peter Richards
December 2017

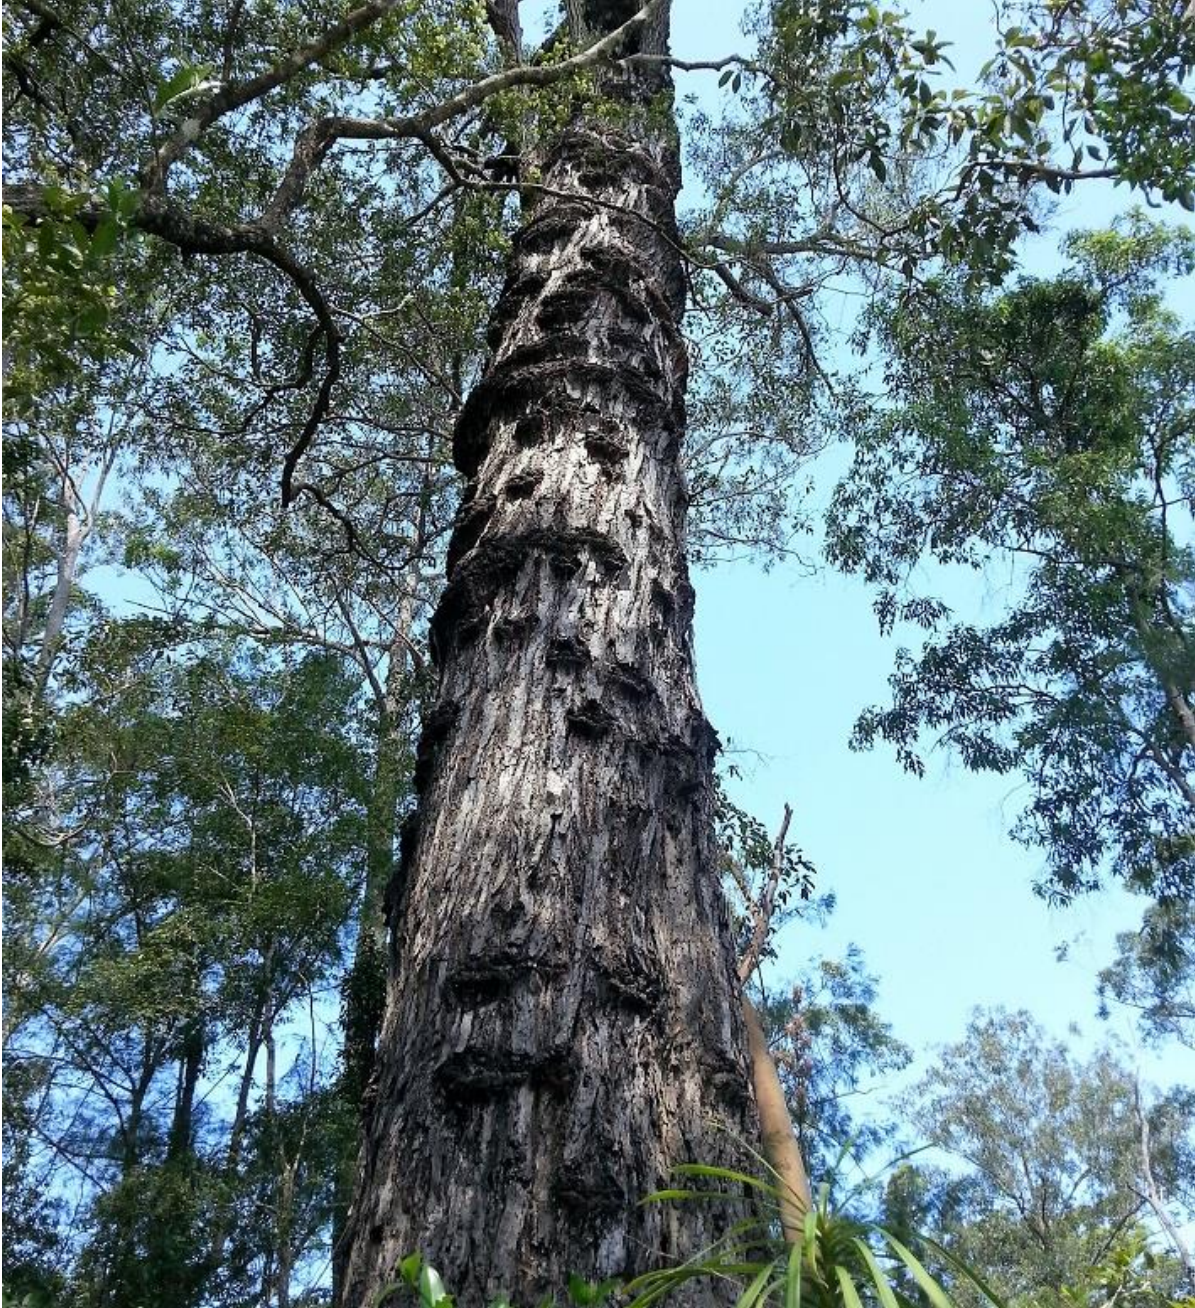
Figure 6: The very large, old Gully Ironbark opposite TA1. Note numerous old Yellow-bellied Glider feeding scars on the trunk.

The very large Gully Ironbark, which occurs on a drainage line in the NH2U road reserve directly opposite TA1, was observed to be in good health, with new growth on some limbs. As this specimen is a very old tree, the crown inevitably displays some signs of senescence (Figure 6).

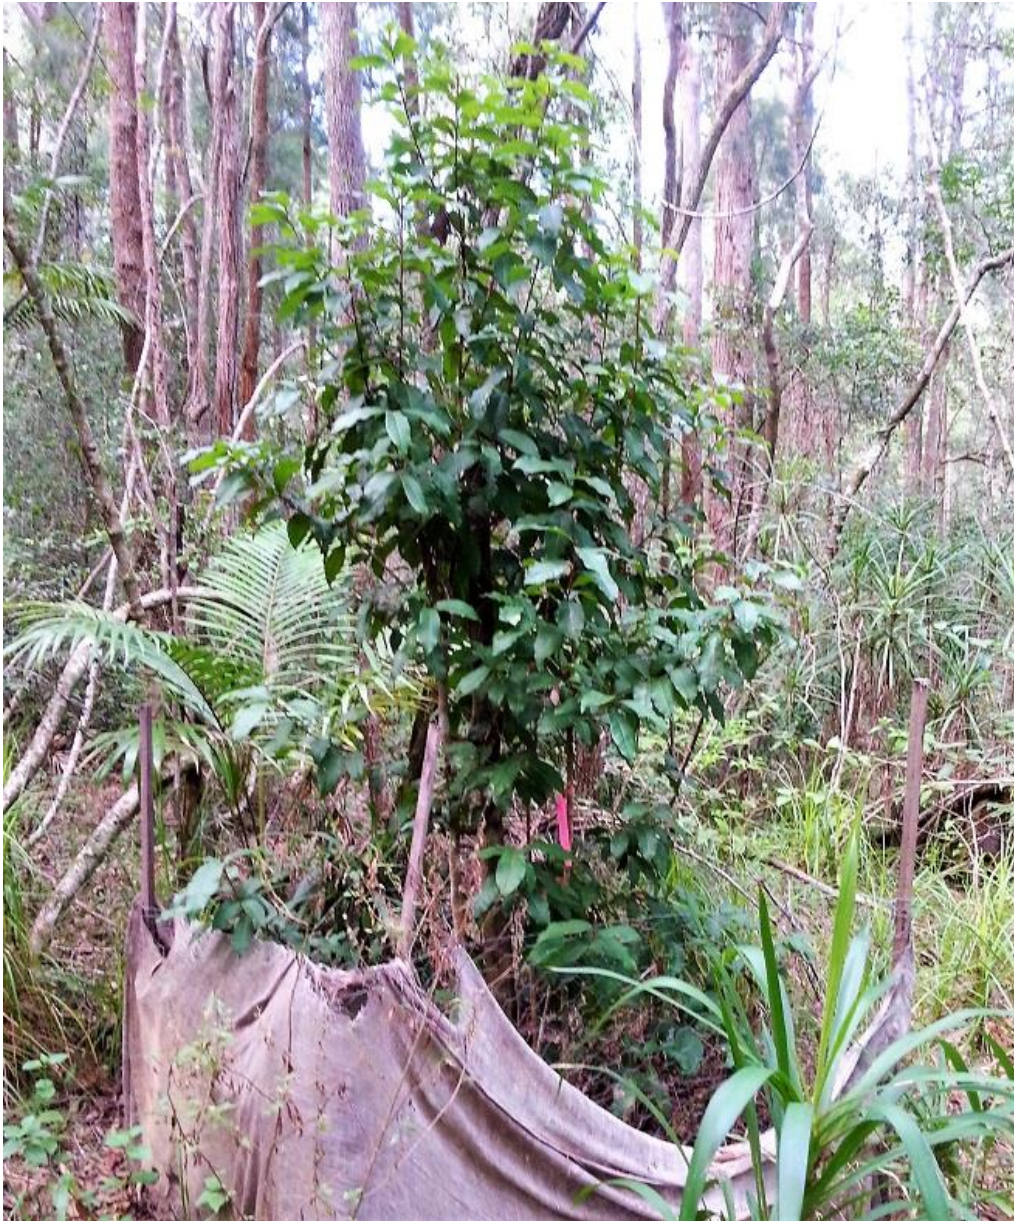
Figure 7: Rusty Plum transplanted tree No. 3 in good health with new growth.

The current survey revealed a survival rate of 67%. Plant 1 bore a healthy, basal stem shoot which had doubled in size from the previous survey in November 2016. Plant 2 appeared to be dead, and Plant 3 was in excellent health with a flush of new growth (Figure 7).
