# Woolgoolga to Ballina Pacific Highway upgrade

**Construction and Operational Monitoring of  
In-situ Threatened Flora Species (non-  
rainforest)**

Annual Report 2018

Project No: IA136900  
Document Title: In-situ Threatened Flora (non-rainforest flora) Annual Monitoring Report 2018  
Document No.: Final  
Revision: v.2  
Date: 15 November 2019  
Client Name: Roads and Maritime Services  
Client No: IA136900  
Project Manager: Chris Thomson  
Author: Jonathan Carr  
File Name: J:\IE\Projects\04\_Eastern\IA136900\21 Deliverables\02 Plants\_in-situ\2018\IA136900\_W2B\_flora\_annual\_report\_2018\_Draft\_04 09 2019.docx

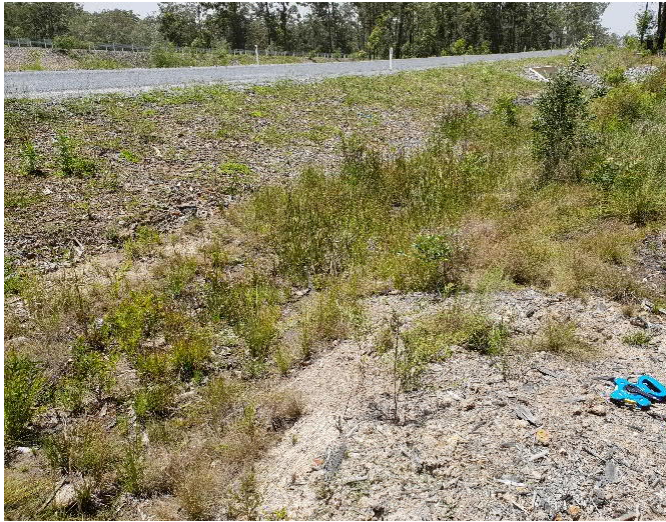
An additional two sites were established for new populations appearing within or nearby existing sites. Numerous plants were observed (>50 individuals) at new in-situ site La-1.3a (chainage:6700) along a roadside drainage at Simmons Flat Road (refer to Photograph 1). Three plants were observed within Elt-2.1 at new in-situ site La-2.2 (chainage:14700).

Photograph 1: New *Lindernia alsinoides* sub-population at new site La-1.3a along roadside drainage (Simmons Flat Road) adjacent to old Site La-1.3.

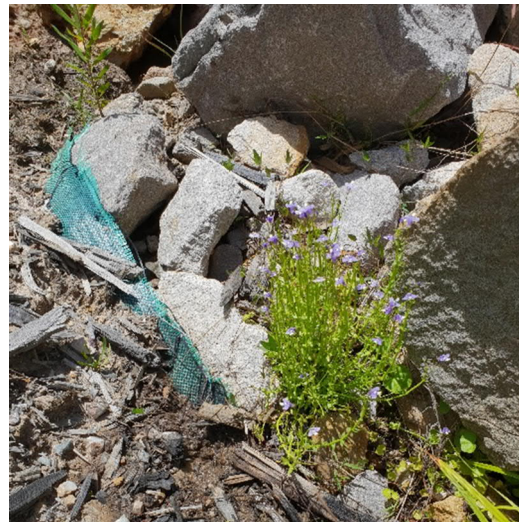
New individuals were also observed along completed portions of section 1 (Corindi Beach) on seepage zones and on edge of constructed sedimentation basin near site La-1.2.

Photograph 2: New *Lindernia alsinoides* observed on edge of constructed sedimentation pond on rocky substrate near site La-1.2

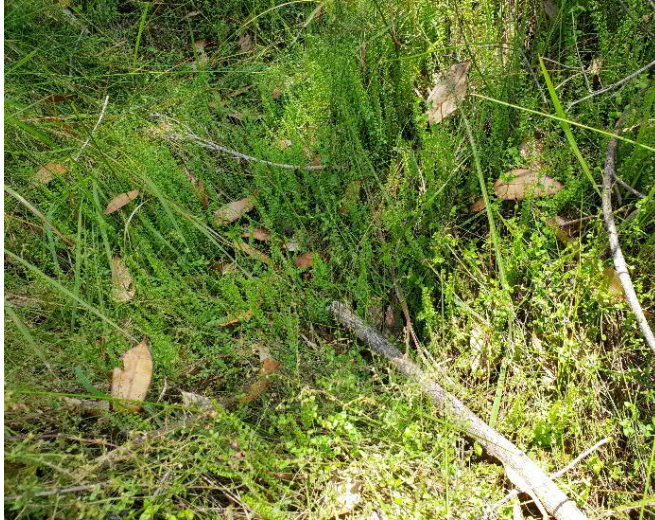
Photograph 3: *Lindsaea incisa* dominating groundcover with area of occupancy (50 m2) in site Li-2.2

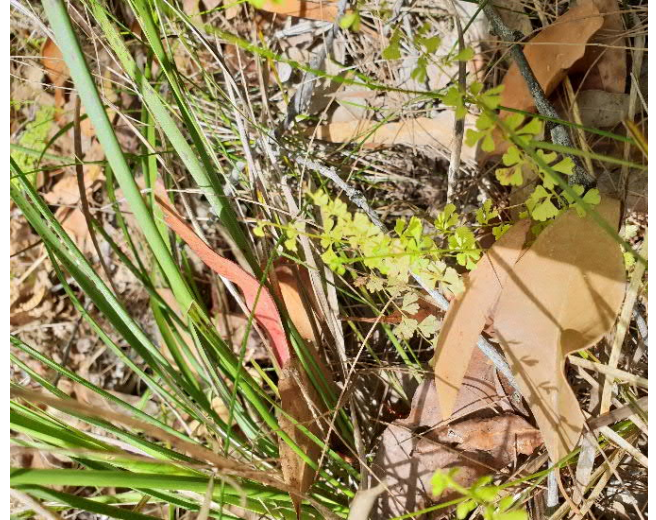
Photograph 4: Minor dieback of *Lindsaea incisa* observed in site Li-1.1

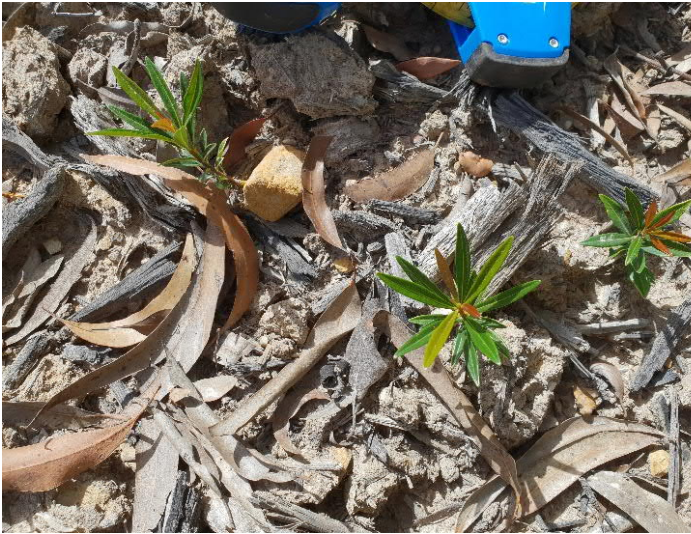
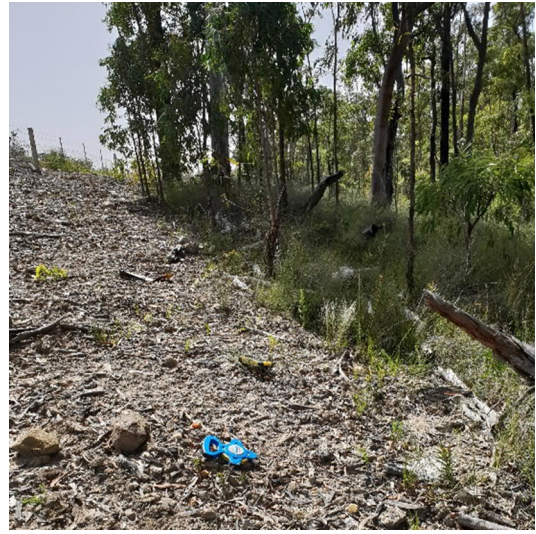
Photograph 5: Quassia sp. Moonee Creek seedlings growing in mulch adjacent to Qm-2.2

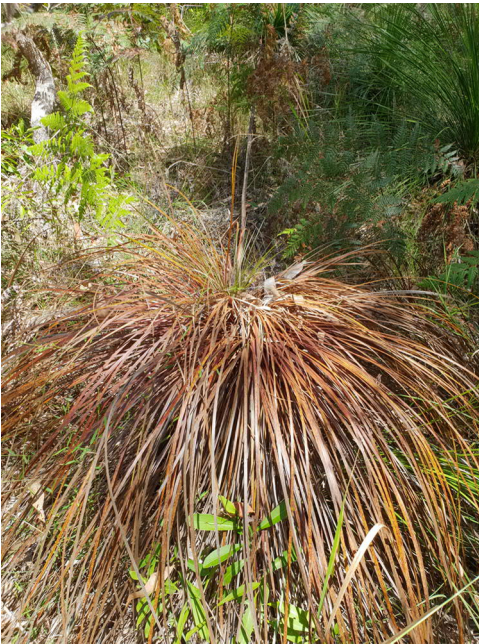
Photograph 7: Xanthorrhoea sp. dieback at in-situ site Ar-3.7 in November 2018.

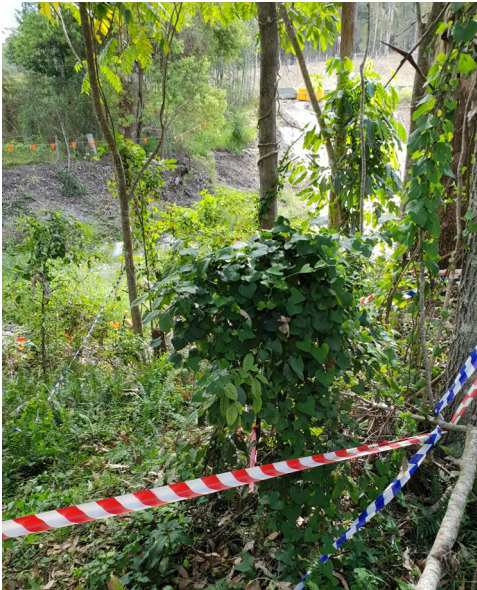
Photograph 8: *E. muelleri* subsp. *bracteata* at in-situ site Emb-4.1 showing *Aristolochia elegans* weed climber smothering shrub in November 2018.

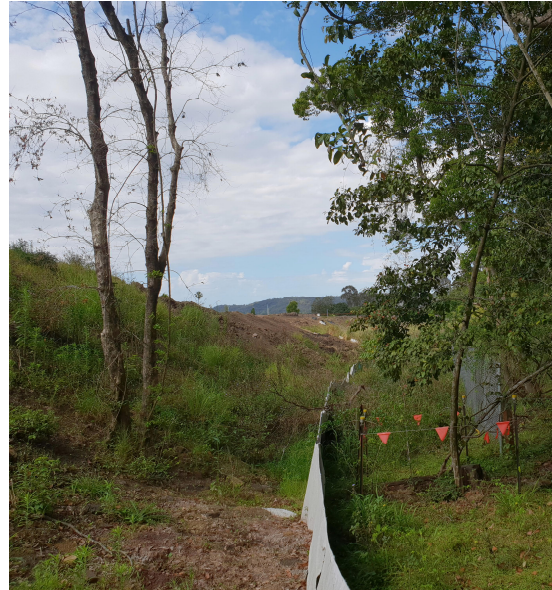
Photograph 9: *E. muelleri* subsp. *bracteata* at in-situ site Emb-4.2 adjacent to new embankment.

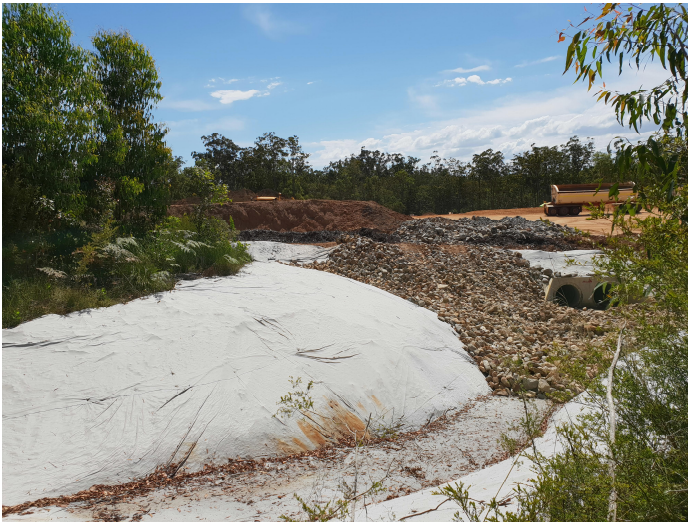
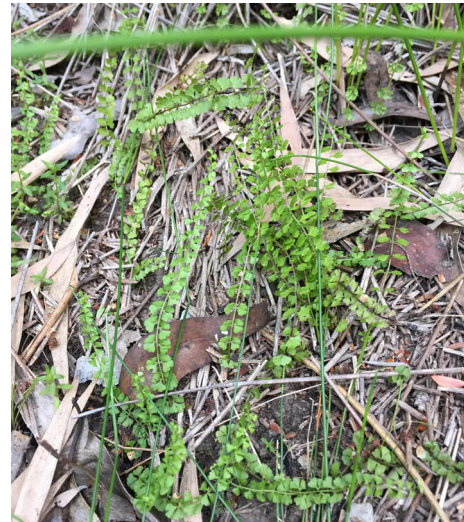
Photograph 10: Year 2 construction in-situ Site Li-3.1 showing cleared habitat and geofabric for drainage line and natural vegetation regeneration on edges (November 2018)

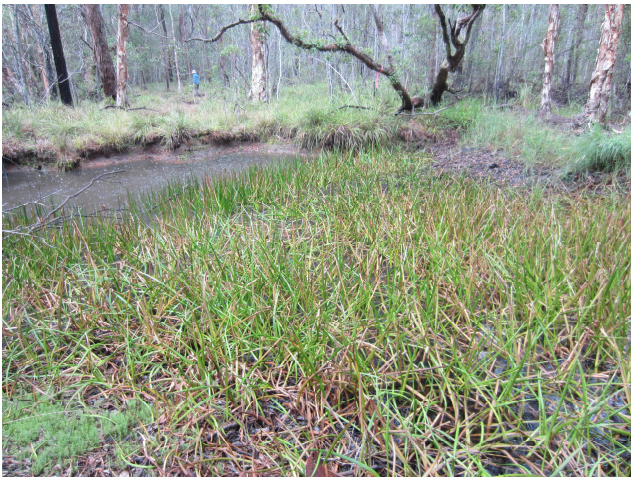
Photograph 12: Pre-construction phase at in-situ site Mt-7.2 showing healthy population of *M. triglochinoxides* (May 2014)

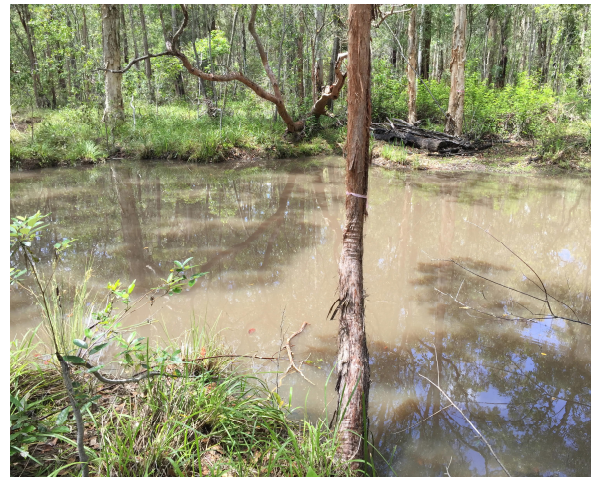
Photograph 13: Year 1 construction phase at in-situ site Mt-7.2 showing major decline of *M. triglochinoxides* population (November 2017)

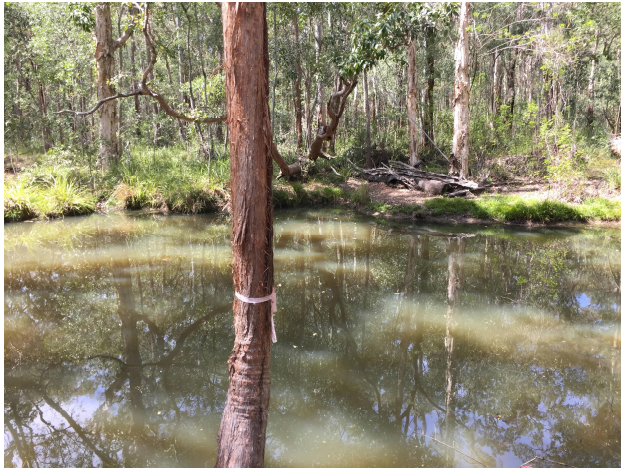
Photograph 14: Year 2 construction phase at in-situ site Mt-7.2 showing no recovery of *M. triglochinoxides* core population (October 2018)

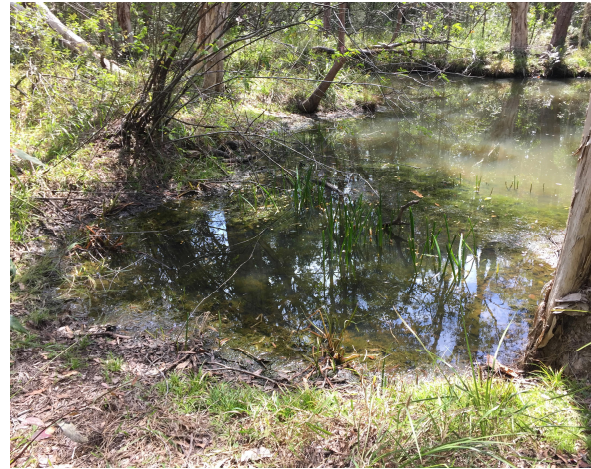
Photograph 15: Year 2 construction phase at in-situ site Mt-7.2 showing recovery of *M. triglochinoxides* on edge of pond (October 2018)

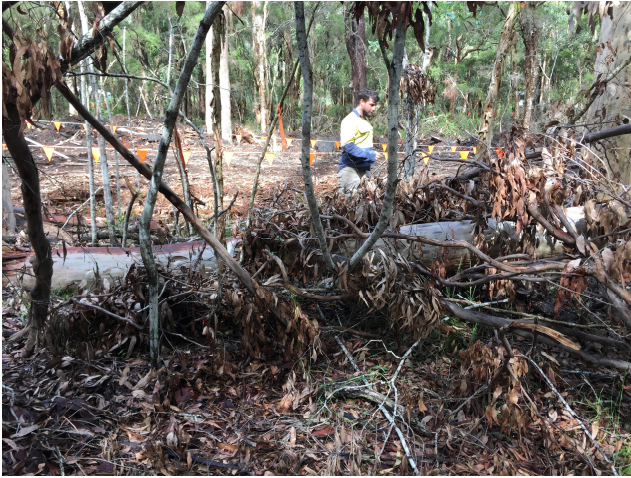
Photograph 16: In-situ site Mi-7.1 showing fallen tree trunk with damaged *Melaleuca irbyana* shrubs underneath within project boundary (April 2018)

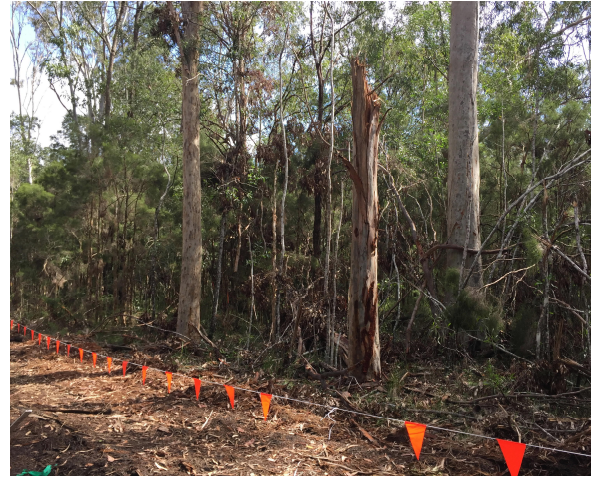
Photograph 17: In-situ site Mi-7.1 showing remains of broken tree within project boundary (April 2018)

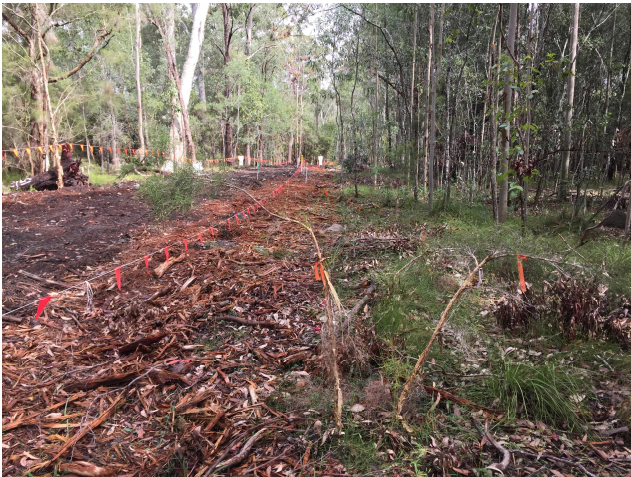
Photograph 18: Year 2 construction phase at in-situ site Mi-7.2 showing flagged and damaged *Melaleuca irbyana* shrubs outside the project boundary (April 2018)

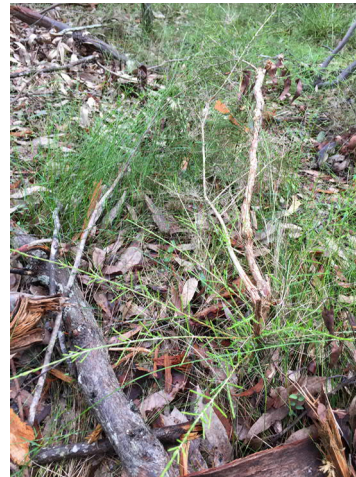
Photograph 19: Damaged *Melaleuca irbyana* shrub with broken stem at in-situ site Mi-7.2 outside the project boundary (April 2018)
