**Green-leaved Rose Walnut Rehabilitation Plan – W2B Project,
Section 4. Annual Monitoring Report (July 2020 – August 2021)**

3/9/2021

Introduction

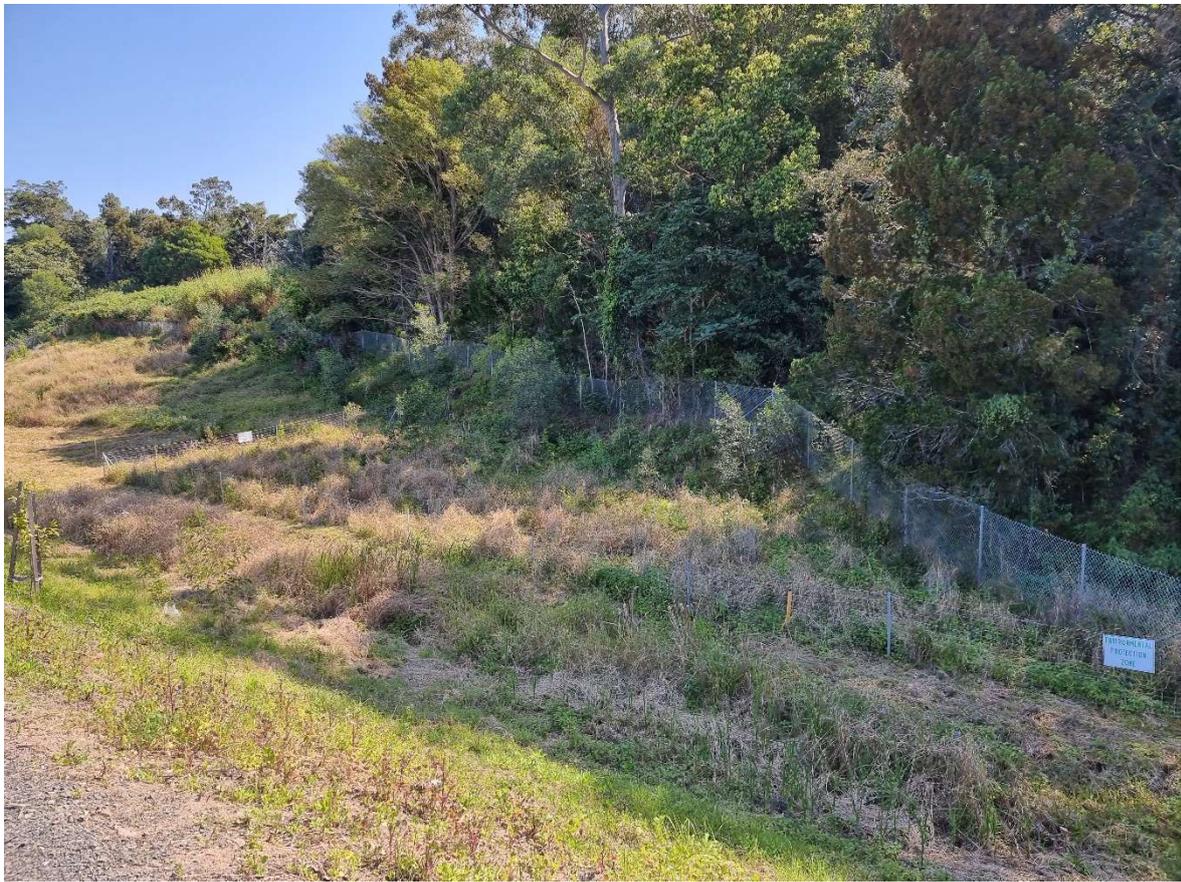
The survival rate was 100% after six months (to August 2021) and all plants had produced new growth (Table 1). One plant was defoliated by insects after planting but has produced vigorous new leaf growth.

Plate 1: Translocation receipt site for RGRW adjacent to the Maclean interchange. Twelve RGRW were planted near the tall fence on the uphill side of the side.

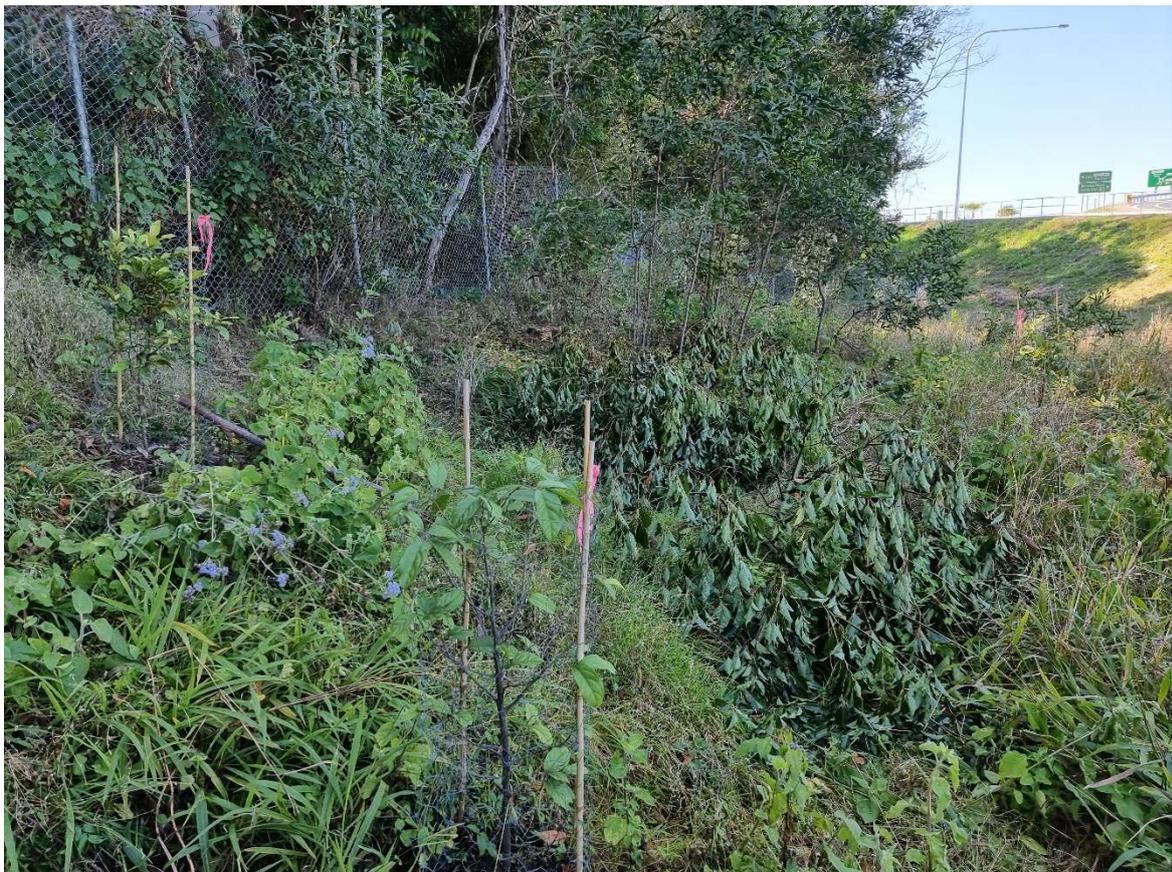
Plate 2: Two RGRW inside wire tree guards and Camphor Laurel removal behind. Highway embankment in the background. The original tree was located in back corner below embankment.

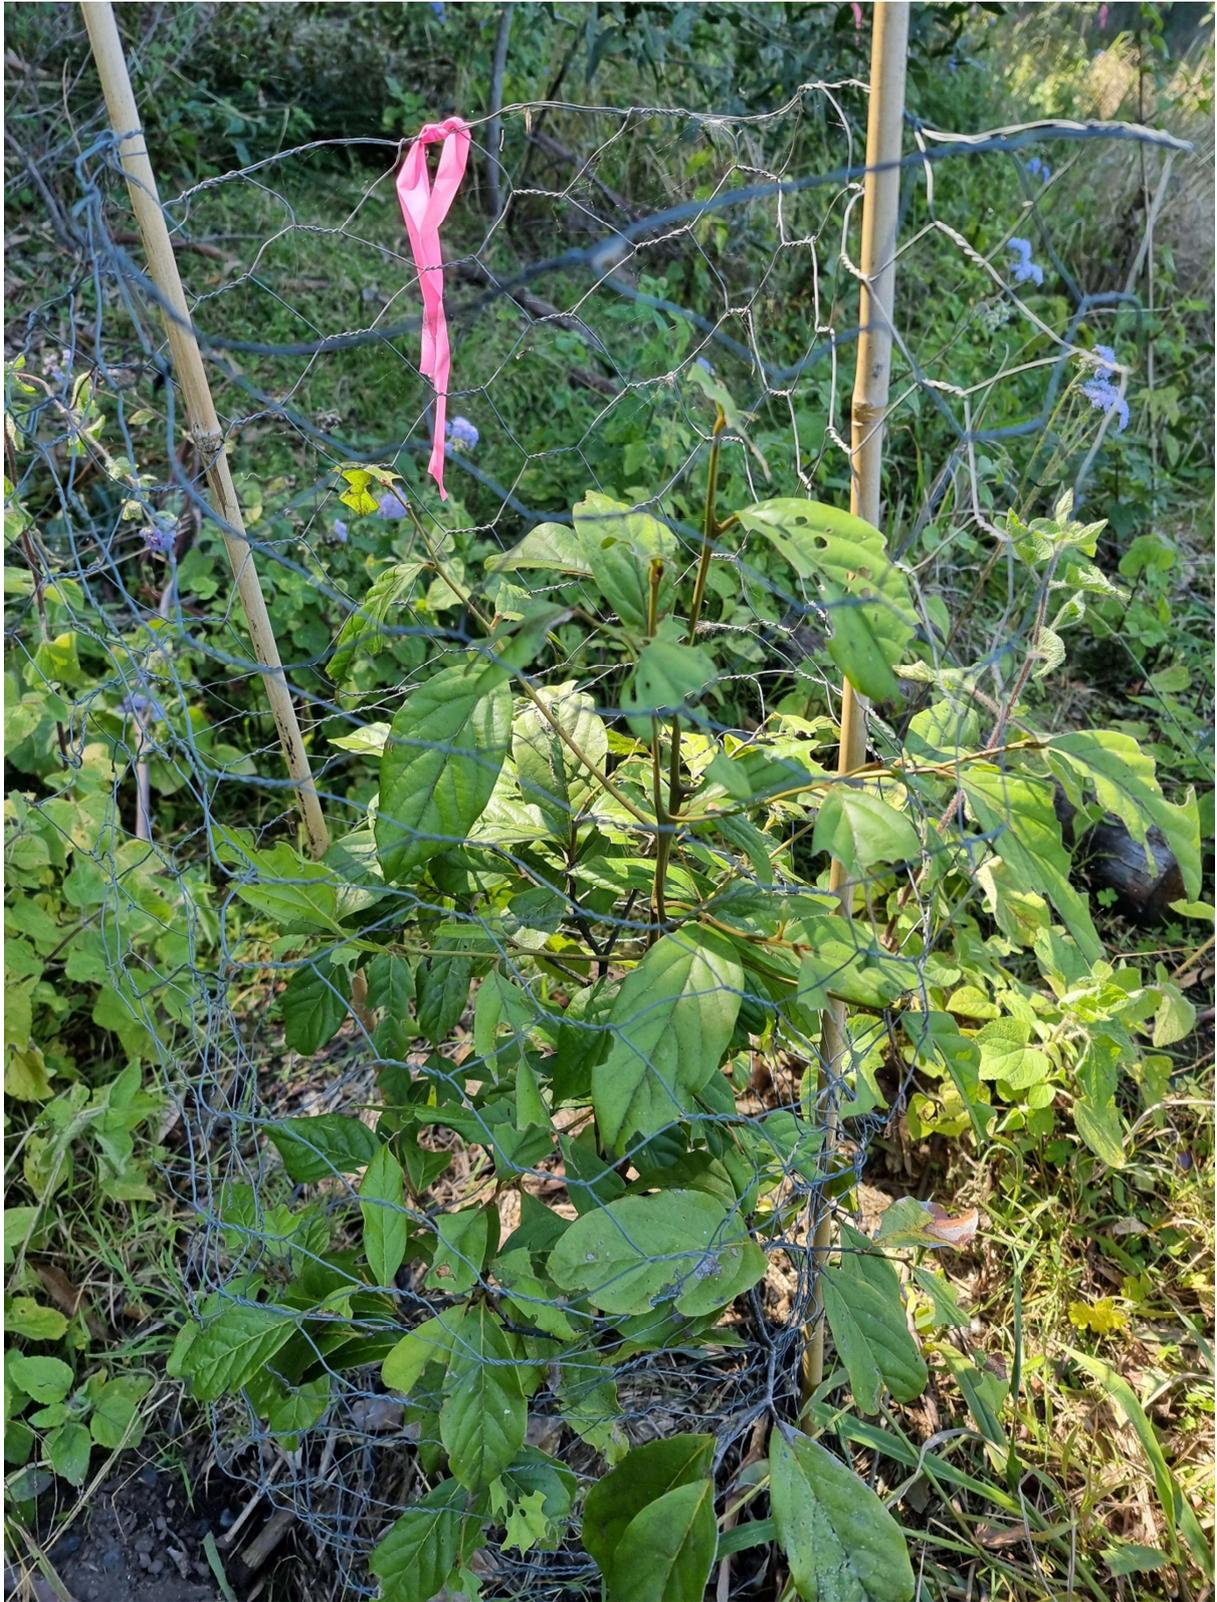
Plate 3: A RGRW inside a chicken wire tree guard showing healthy leaf condition 6 month after planting out.

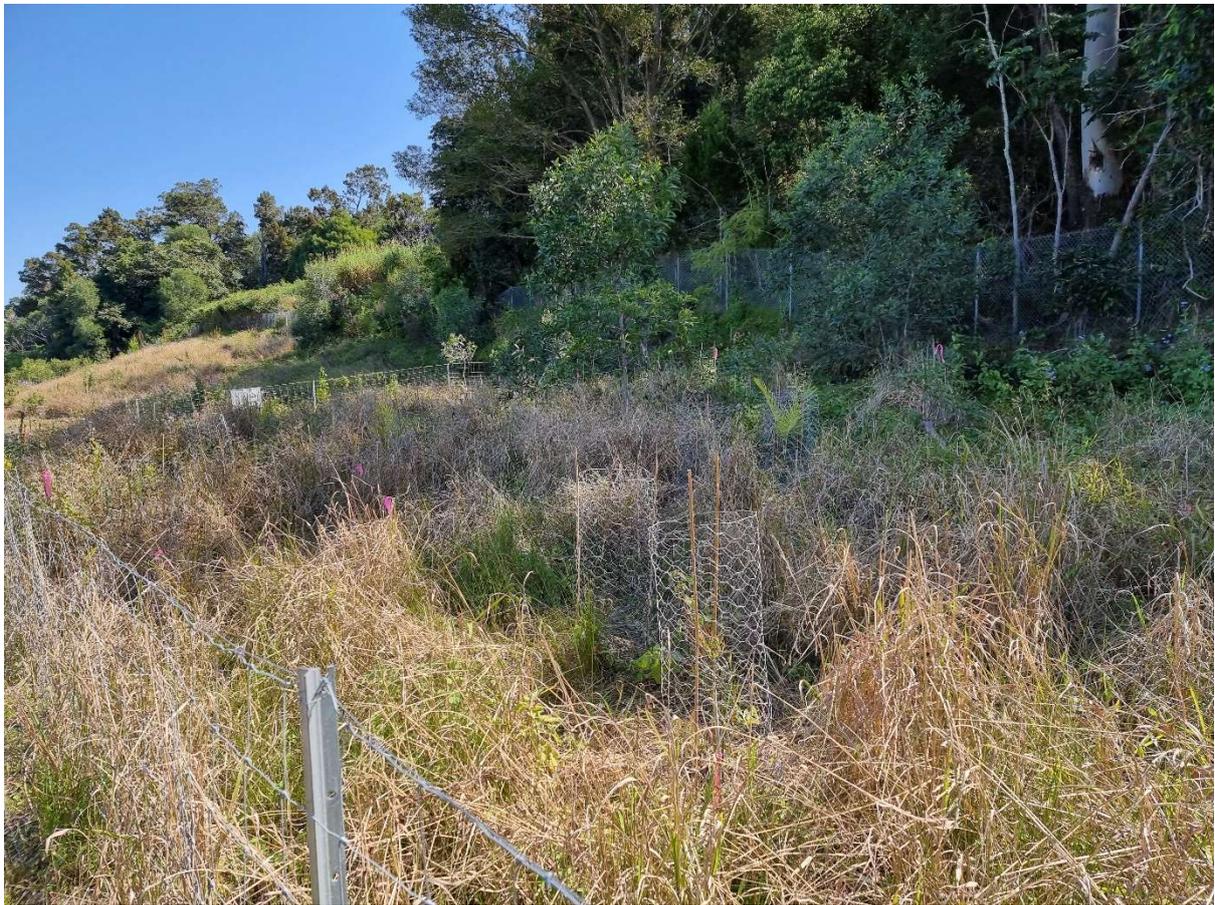
Plate 4: RGRW translocation site at the Maclean interchange. The open grassy area has been planted with *Acacia melanoxylon*, Bangalow Palm and Bottlebrush Tree to provide shelter for RGRWs. Most have tree guards to prevent wallaby grazing (active at site).

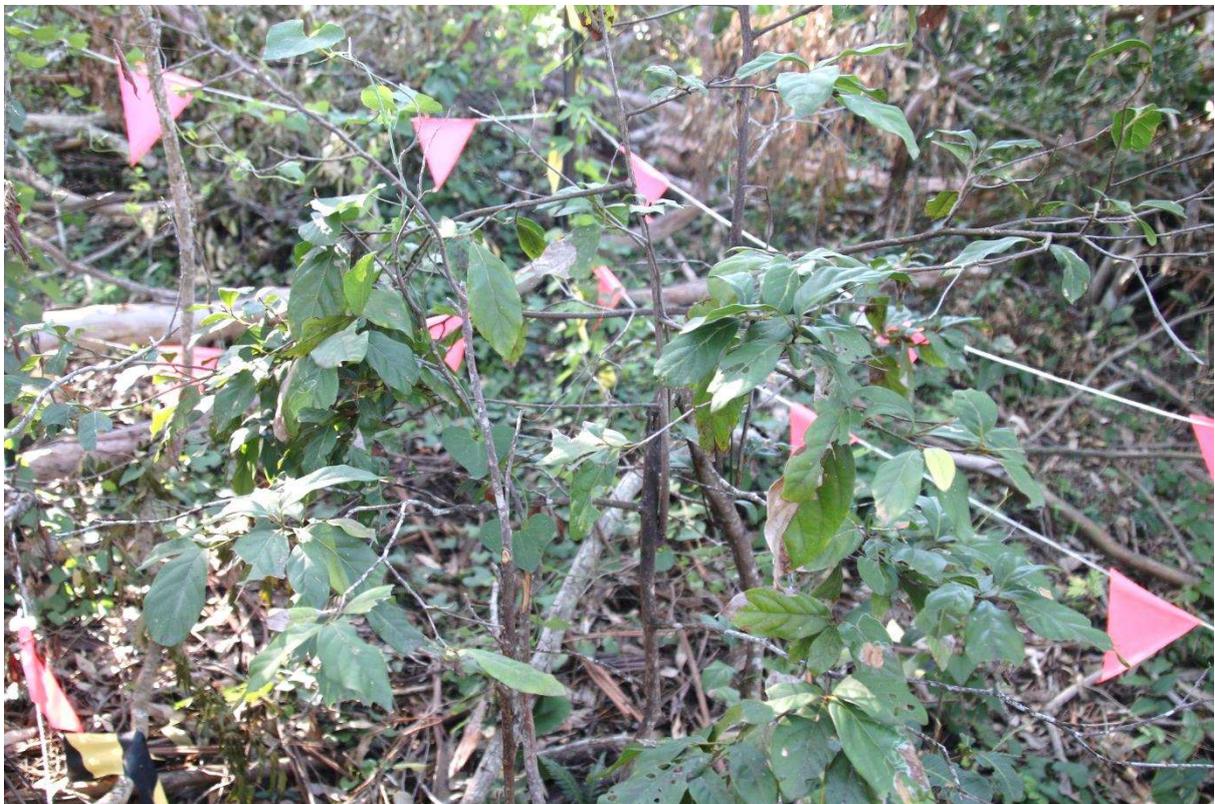
A dense infestation of the exotic vine Dutchmans Pipe (*Aristolochia elegans*) at the site threatens to smother the RGRW sapling. Weed control carried out by Ecos Environmental involved spraying Dutchmans Pipe with glyphosate and metsulfuron (Brush-off). The cut-and-paint method was not applied as the copious white sap exuded by cut stems of this species is reported to be toxic and a serious health hazard.

Weed control work has been carried out for 2 years but the site is still infested with Dutchmans Pipe, which covers a large area. The RGRW remains in reasonably good health and has put on some growth since management began.

Plate 5: In situ (naturally occurring) RGRW sapling in the road reserve north of the Maclean Interchange.

Action	2021-2022 (Year 4)
Maintenance	
Management Zone 1 <ul style="list-style-type: none"> Water RGRW during any long dry spell – most likely between Oct-Jan. Control grass and weed growth around plantings 	Oct & March (two site visits)
Management Zone 2 <ul style="list-style-type: none"> Spray Dutchmans Pipe 	Oct & March (two site visits)
Annual Monitoring and Report	JulyAugust
