Pacific Highway Upgrade Nambucca Heads to Urunga Operational Phase

Threatened Flora Monitoring Annual Report Year 4 – 2020/21

Transport for NSW | 09 February 2021 | Final Report

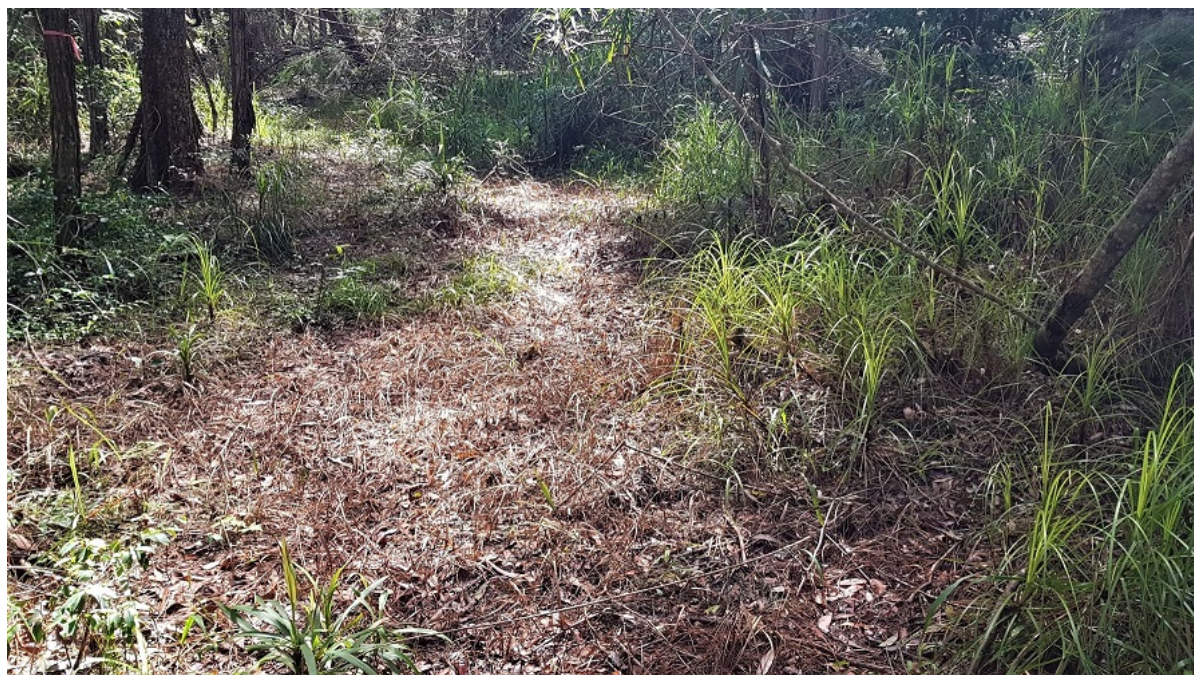
An inspection of the treatment area on 3rd January 2021 revealed significant reduction in weed cover and minimal impact upon native recruitment into the site (Figure 6).

Figure 6: Post-treatment image taken 3rd Jan 2021 of area treated for Broad-leaved Paspalum 25th Nov 2020.

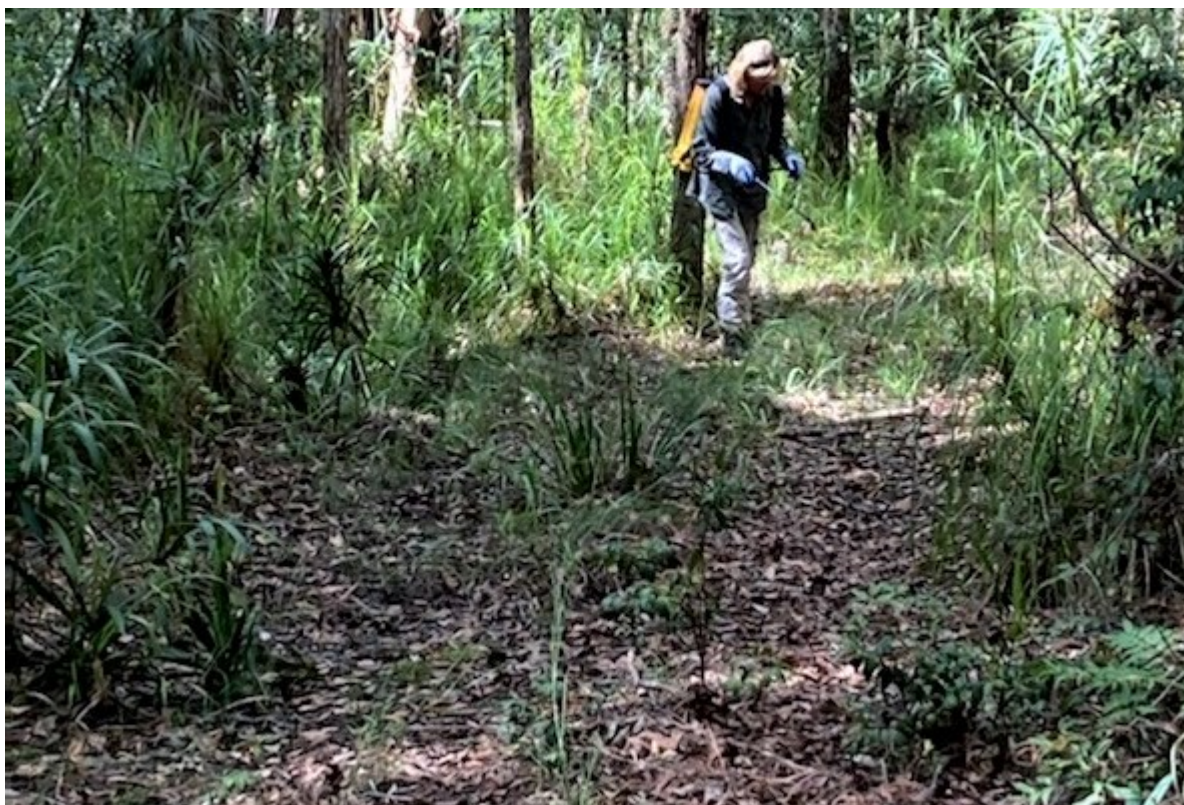
The follow-up weed treatment was undertaken at the site on 22nd January 2021, after being delayed by wet weather. Inspection of treated areas at the time of follow-up show complete removal of Lantana from treated areas and almost complete removal of adult and seedling Broad-leaved Paspalum (Figure 7; Figure 8).

Figure 7: Follow-up treatment of seedling Broad-leaved Paspalum 22nd Jan 2021

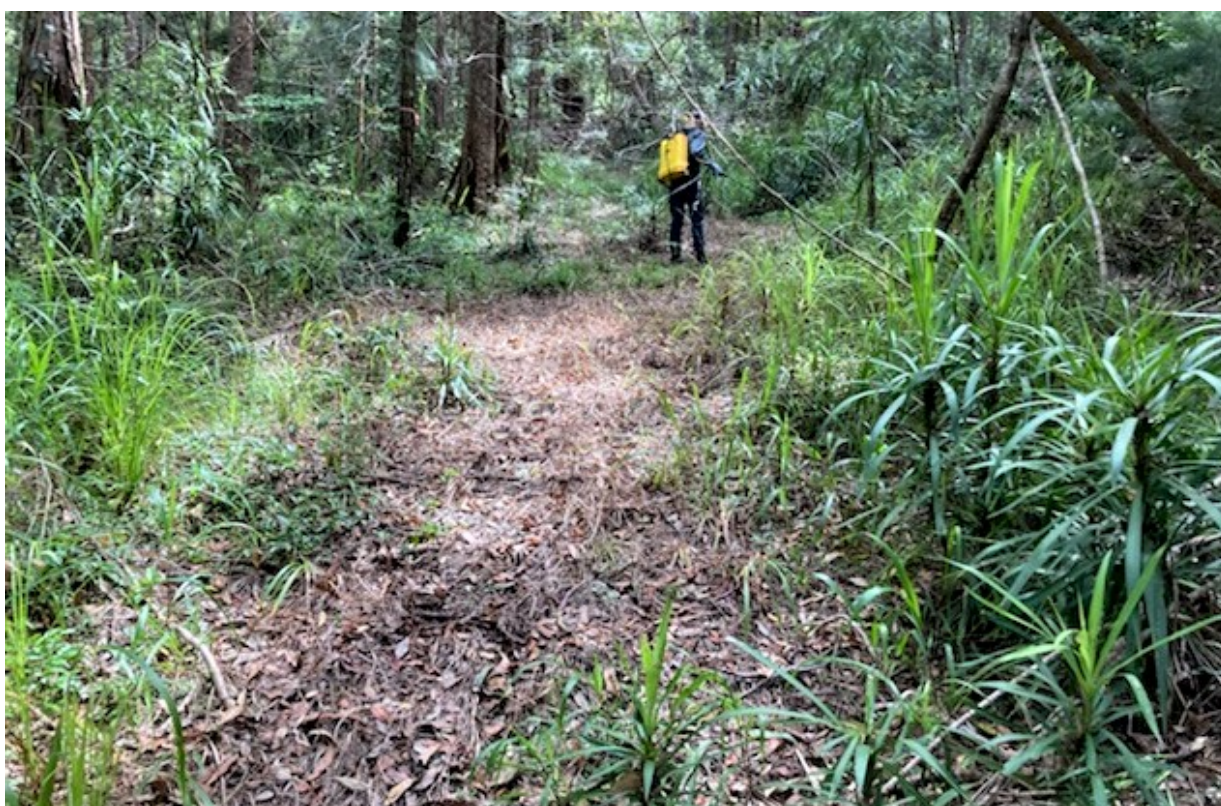
Figure 8: Follow-up weed treatment, TA1, 22nd Jan 2021

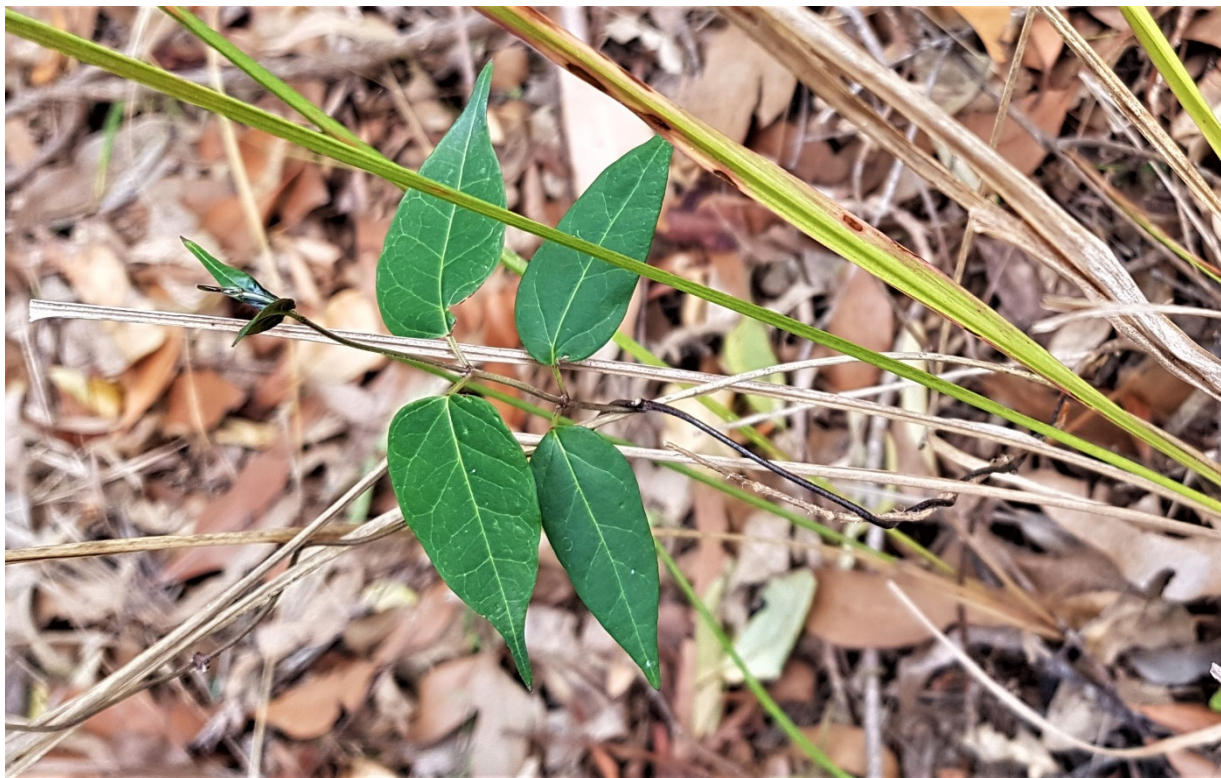
Appendix 1 provides full details of the results of the NH2U Year 4 monitoring of *in situ* Slender Marsdenia. Of the five *in situ* Slender Marsdenia plants being monitored, one (ML119) has now been recorded as died back for four consecutive years. Of the remaining sites, the plants near Martells Road (2010-1 and 2010-3) supported healthy plants, with a condition class of 3. Plants at site UTW3 remained in only fair condition, whilst plants at site UTW4 (Figure 9), had declined in condition.

Figure 9: *In situ* Slender Marsdenia UTW4 in Jan 2021.

Slender Marsdenia currently meets 2 of 3 performance indicators for *in situ* flora. There was a decline in condition of some plants resulting in a median condition class of 2. This is probably a result of the past three seasons of hot dry weather having a significant impact, in particular, on the plants UTW3 and UTW4, which occur on a much drier site than is typical for Slender Marsdenia.

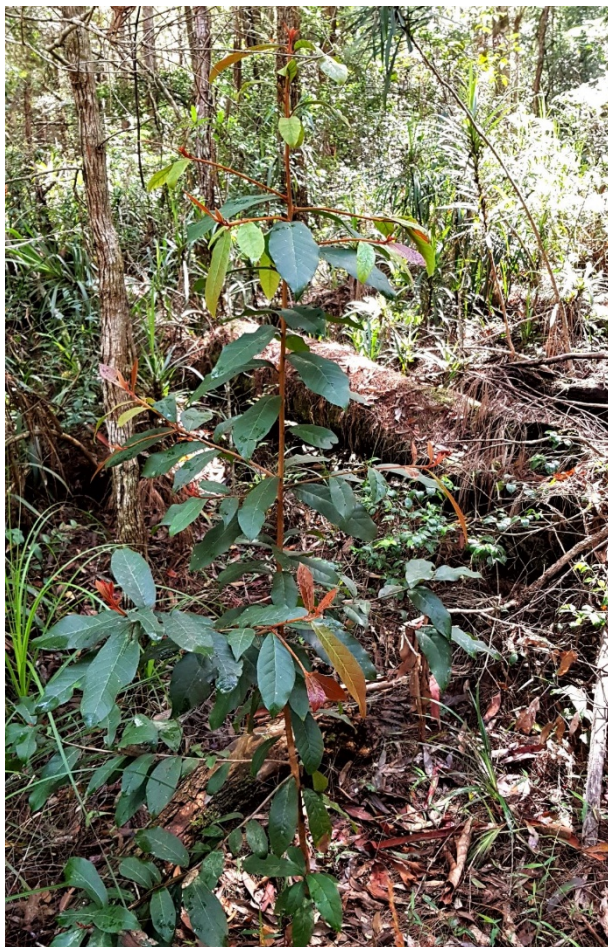
Two small Rusty Plum trees (4-8m high) were transplanted into Sector E in TA1. One tree had split and was separated into two pieces (plants 1 and 2) before planting. The other tree (plant 3) was pruned back to remove most of the branch system before being transplanted. Plant 2 died in 2017. The current survey revealed no losses since the previous survey, with a survival rate of 67%. Plant 1 bore a healthy, basal stem shoot which had almost doubled in height since the previous survey (Figure 10). Plant 3 was in excellent health, with flowering observed on this plant for the first time since translocation.

Figure 10: Rusty Plum transplanted tree No. 1 in excellent health with new growth.

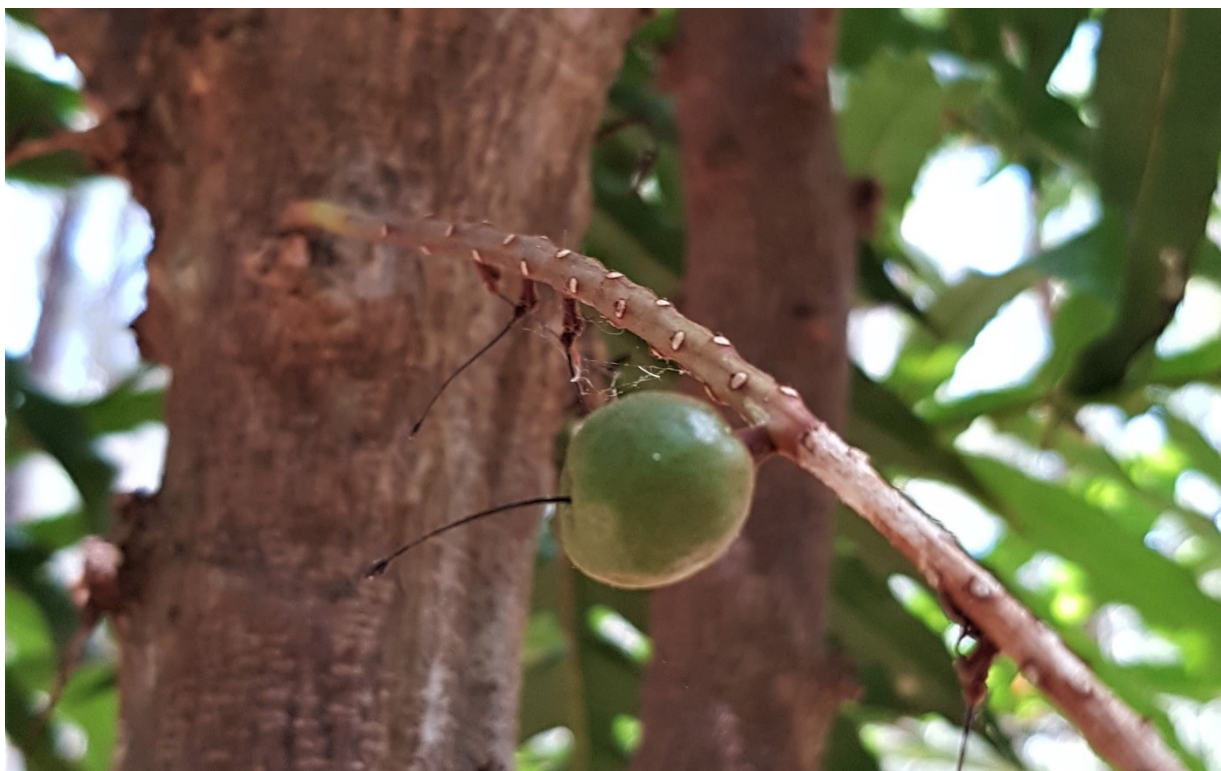
A single Red Bopple Nut tree was transplanted to Sector H in TA1. The tree was recorded in excellent condition during the current survey. Flowering had occurred, with several developing fruits observed (Figure 11).

Figure 11: One of several immature fruits observed on Red Bopple Nut transplant in TA1 Nov 2021

The single translocated Red Bopple Nut tree is in excellent condition, flowering and sparse fruiting occurring in spring 2020. It is expected that this specimen will meet ongoing performance criteria.
