W2B Sections 3 – 11 Microbat Management Plan
2019/20 Annual Monitoring Report

Pacific Complete

Project Name	W2B S3 – 11 Microbat Management Plan 2019 Annual Monitoring Report
Project Number	5728
Project Manager	Alicia Scanlon
Prepared by	Alicia Scanlon, Skye O’Brien, Samantha Patch and Liz Brown
Reviewed by	Frank Lemckert, Sophie Powrie
Approved by	Andrew Walsh
Status	Final
Version Number	2
Last saved on	15 March 2022

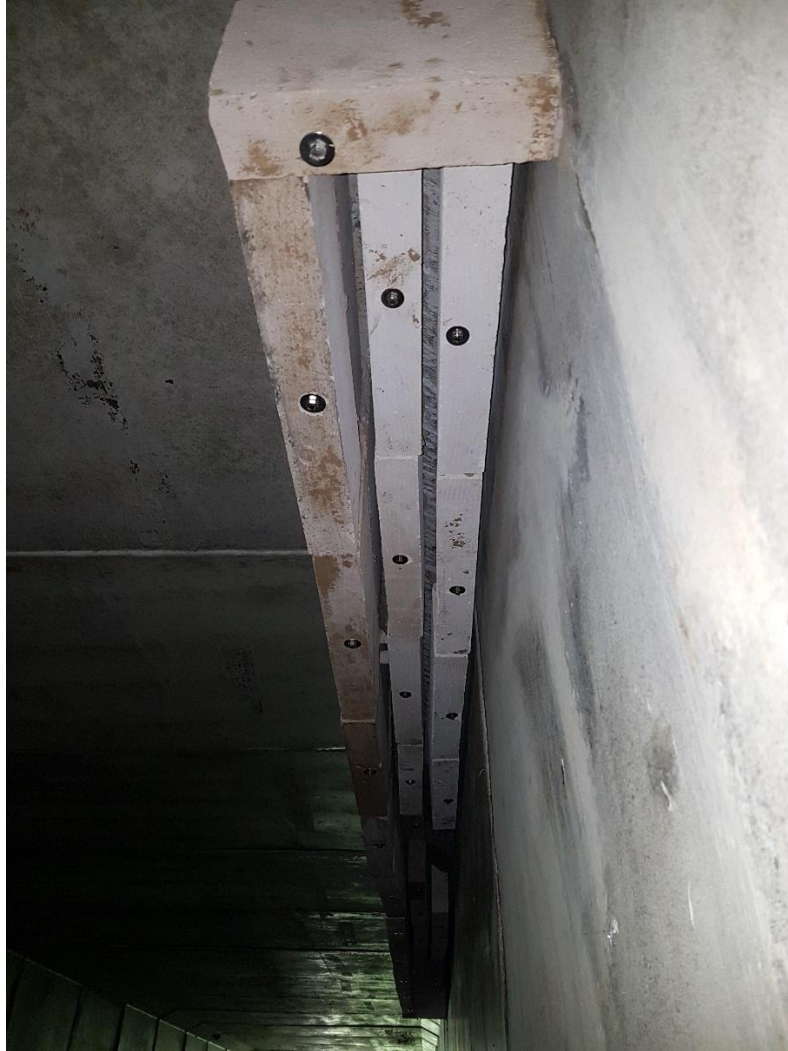
Plate 1: Prototype Hebel box designed to accommodate up to 2,000 Bent-winged Bats, installed in a box culvert at Glenugie CH 31400, March 2019.

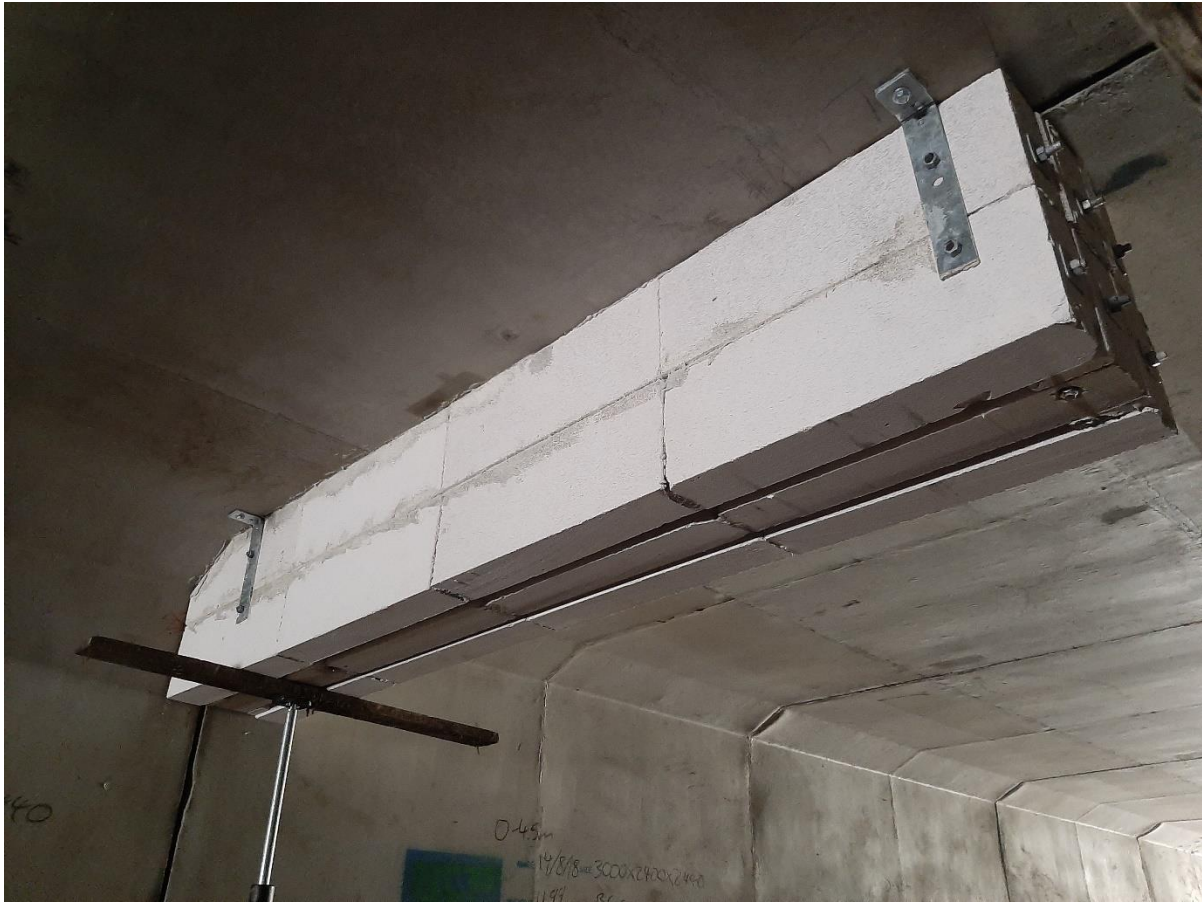
Plate 4: Large style double chambered Bent-winged Bat box constructed from Hebel blocks with capacity to accommodate hundreds of Bent-winged Bats installed in a box culvert beneath the Pacific Highway at Greenhill (CH 76400) in June 2021.

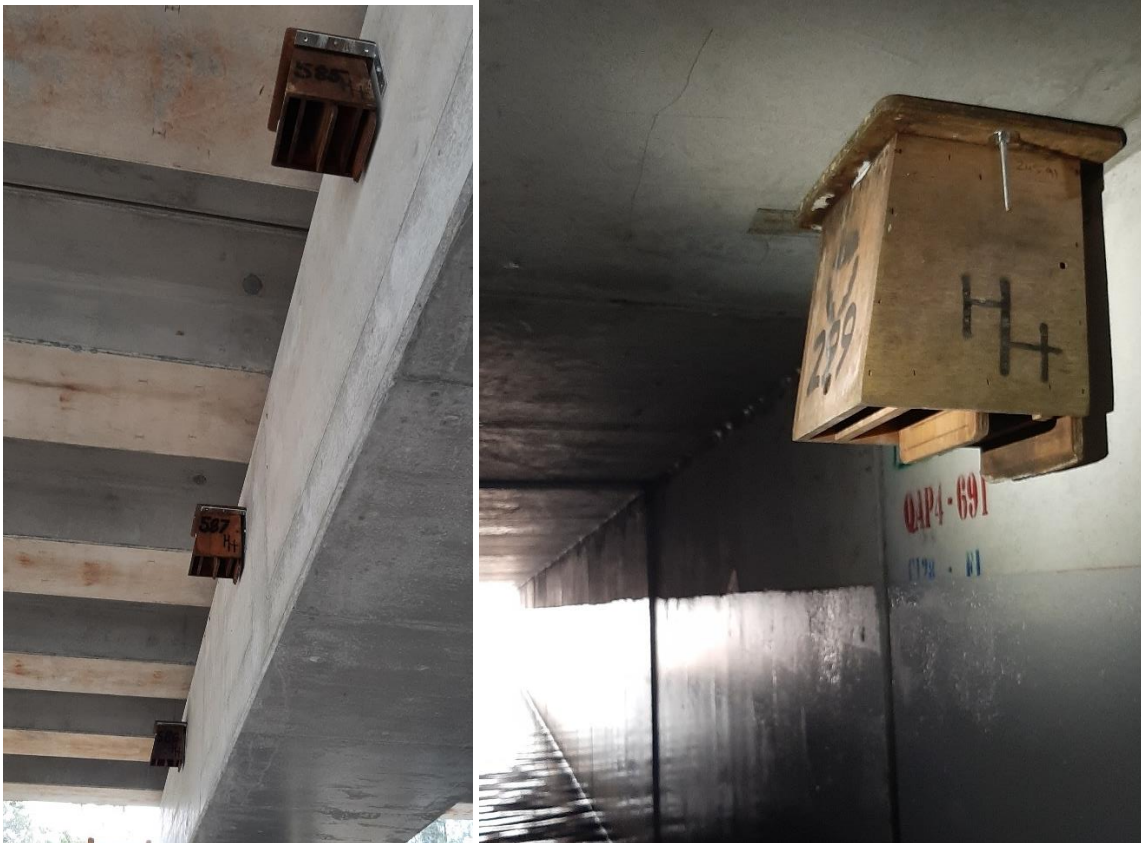
In addition, some newly built structures at impact sites required additional permanent habitat augmentation in the form of relocated bat boxes. This was either because there was no roosting habitat available in the newly built structure (Oakey Creek) or because the boxes had not been used and a more suitable site for box installation was created with the newly built structure. Where boxes have been relocated into new structures those sites are now treated as permanent bat habitat locations. None of the three bat boxes installed along Pheasants Creek had been used regularly by bats and these boxes were installed beneath the new Pheasants Creek Bridge (CH 36379, Figure 1) in June 2021 where the creek is more open and permanent (Plate 5). The bat box installed in a tree along Oakey Creek to the west of the highway alignment was never used and was installed in the newly built culvert at CH 122266 in June 2021 because it did not contain any roosting habitat (Plate 5).

Plate 5: Re-located bat boxes at Pheasants Creek Bridge, Glenugie (LHS) and Oakey Creek culvert, New Italy (RHS) on the Pacific Highway.

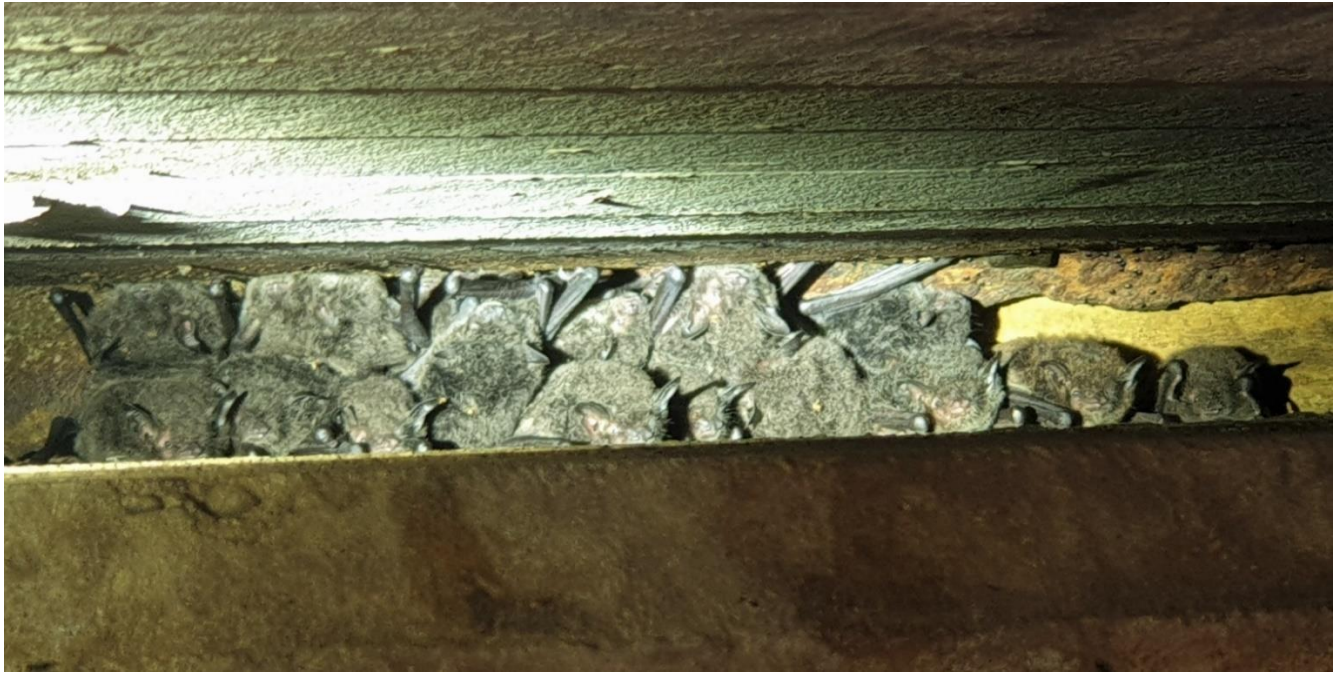
Plate 6: Cluster of 18+ Southern Myotis recorded at Tabbimoble Creek Bridge, January 2020.

Tabbimoble Creek Bridge was used by Southern Myotis as a breeding site during the summer of 2018, and this situation was potentially repeated with the observation of 18+ Southern Myotis present in January 2020 (Plate 6). Low numbers of records of Southern Myotis at either of the Tabbimoble Bridge sites were recorded during March 2019 (6 bats), July 2019 (5 bats) and August 2020 (2 bats) which is a similar pattern to results for Southern Myotis recorded at these locations prior to commencement of works.

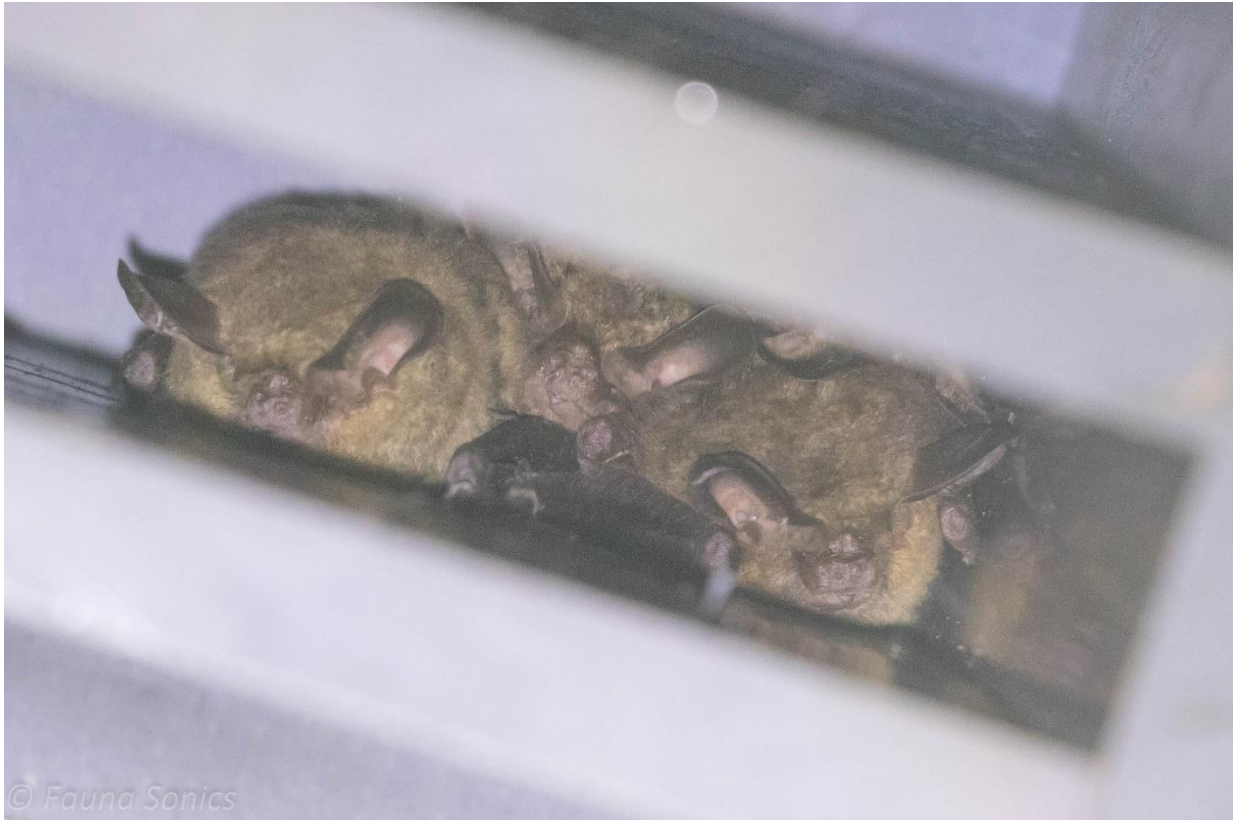
The occurrence of Eastern Long-eared Bat in a box is notable, because outside of the W2B project, there are few recorded instances of this threatened species roosting within a bat box. During the August 2020 monitoring event, twelve Eastern Long-eared Bats (vulnerable) were recorded in boxes along Tabbimoble Creek in Section 6 (Table 6). This is the same location where this species has been recorded using boxes multiple times during previous monitoring events. During March 2019 it was not possible to identify the *Nyctophilus* spp. present in a box to species level because of the restricted view of bats in the box, so there is potential for two other *Nyctophilus* spp. to have been present; *N. geoffroyi* (Lesser Long-eared Bat) or *N. gouldi* (Gould's Long-eared Bat), neither of which is listed as a threatened species.

Plate 7: Four *Nyctophilus bifax* (Eastern Long-eared Bat) recorded in a Cyplas bat box along Tabbimoble Creek, August 2020.

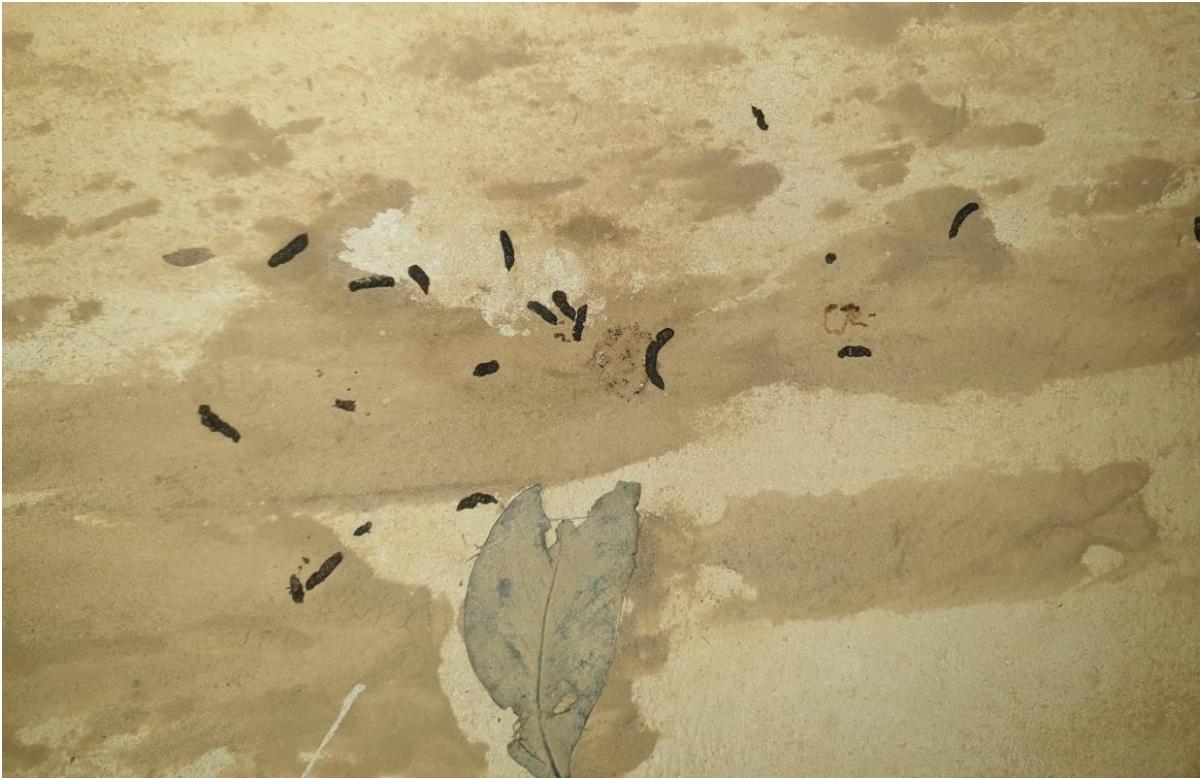
The results for Saltwater Creek culvert during the 2019-20 monitoring period indicate greater use of this culvert by bats than has been recorded at any time in the past. Fresh guano was recorded on two occasions (March 2019, January-February 2020) indicating recent occupation by microbats (Table 8). This was followed by 12 Little Bent-winged Bats recorded during July 2019 and one Little Bent-winged Bat recorded during October 2019. A small amount of fresh guano (Plate 8) along with a large pile of old guano (Plate 9) and one dead Little Bent-winged Bat was recorded during the January-February 2020 inspections. There was on old pile of guano but no bats present in August 2020.

Plate 8: Fresh bat guano at control site at Saltwater Creek (Section 10), January 2020.

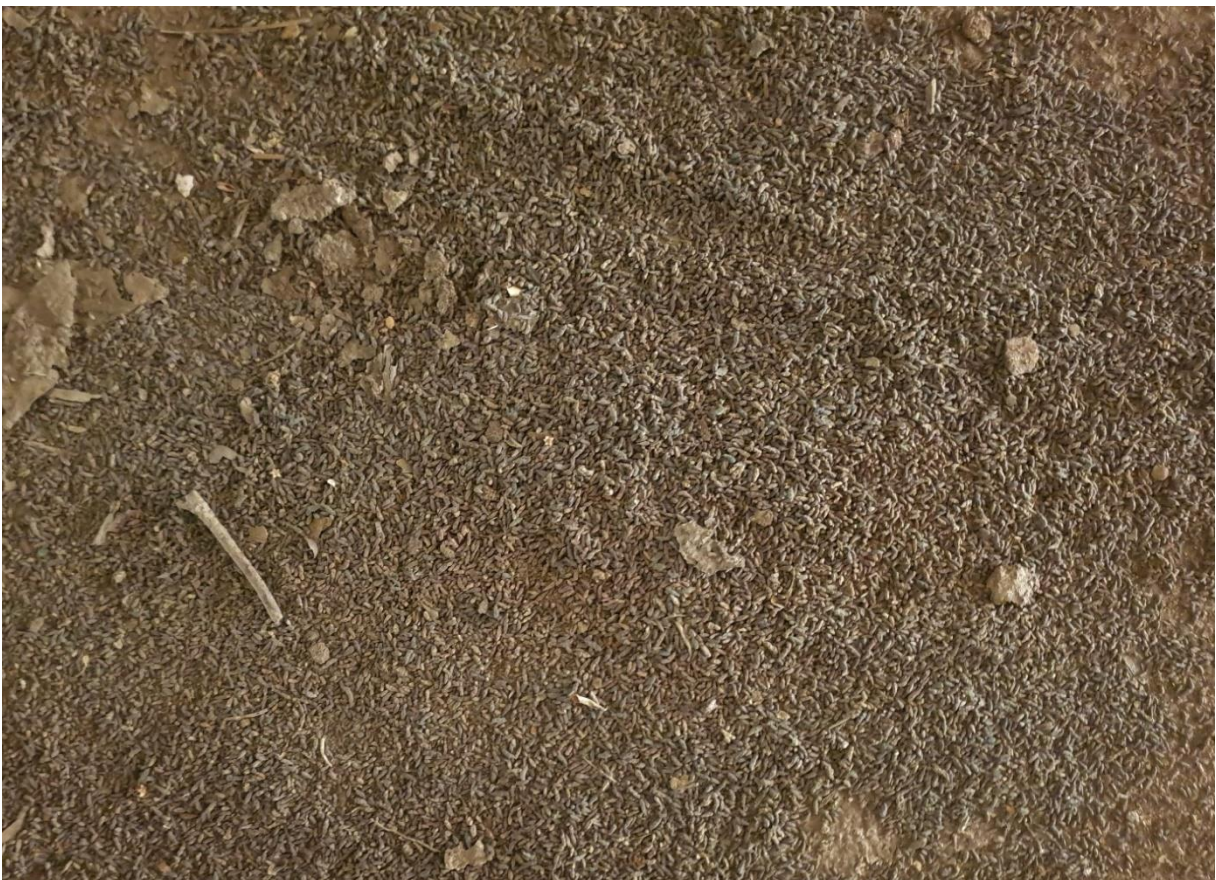
Plate 9: Mass area of old bat guano at control site at Saltwater Creek (Section 10), January 2020.

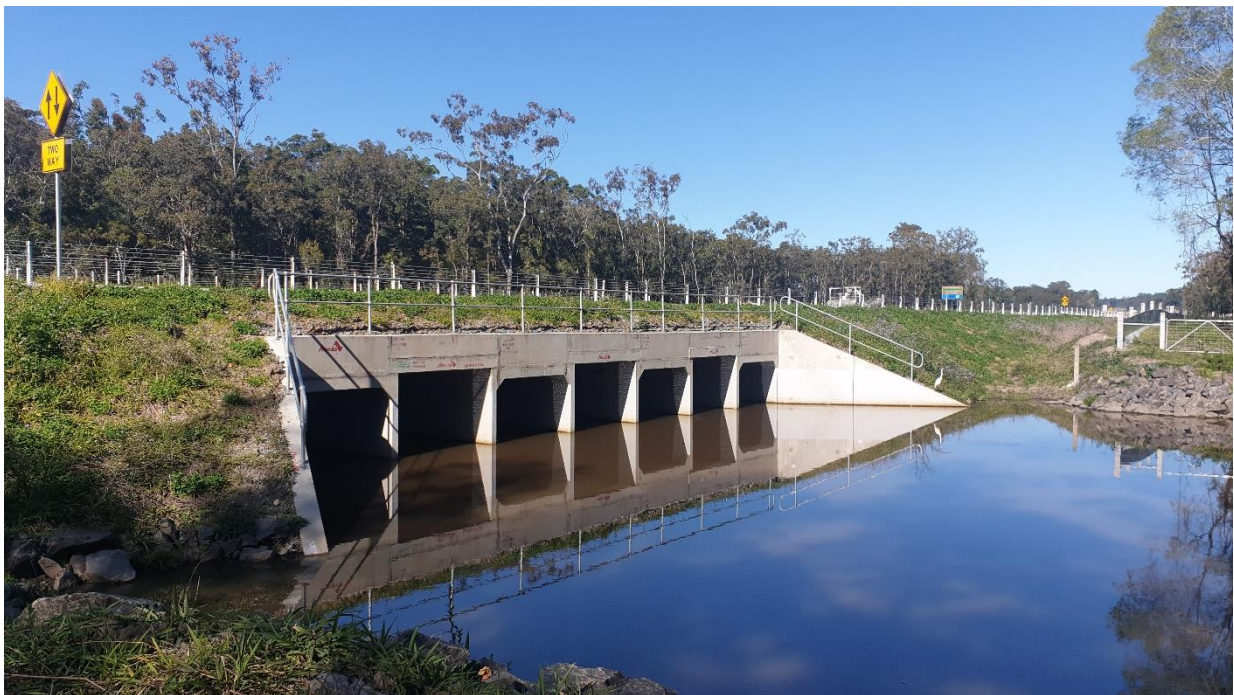
At the end of the 2019-20 monitoring period only one of the 13 impacted structures scheduled to be removed had not been excluded; the Oakey Creek culvert at CH 122280. There were no microbats observed at Oakey Flat # 3, Oakey Creek culvert (Section 7) during inspections conducted in March, July or October 2019 or January-February 2020. Owing to the lack of evidence of microbat occupation at Oakey Creek throughout the monitoring period, and given the practical difficulties in securing exclusion devices, it was decided the Oakey Creek culvert would remain open. New culverts were constructed at Oakey Creek (Section 7) during 2020 and the old culvert was demolished following a pre-clearing inspection for microbats during the last quarter of 2020 (Plate 10). The compensatory bat box that was installed in a tree along Oakey Creek adjacent to the original culvert was installed in the new structure in June 2021, never having been used in its former location in a tree along Oakey Creek (Plate 5).

Plate 10: New Oakey Creek culvert, August 2020.

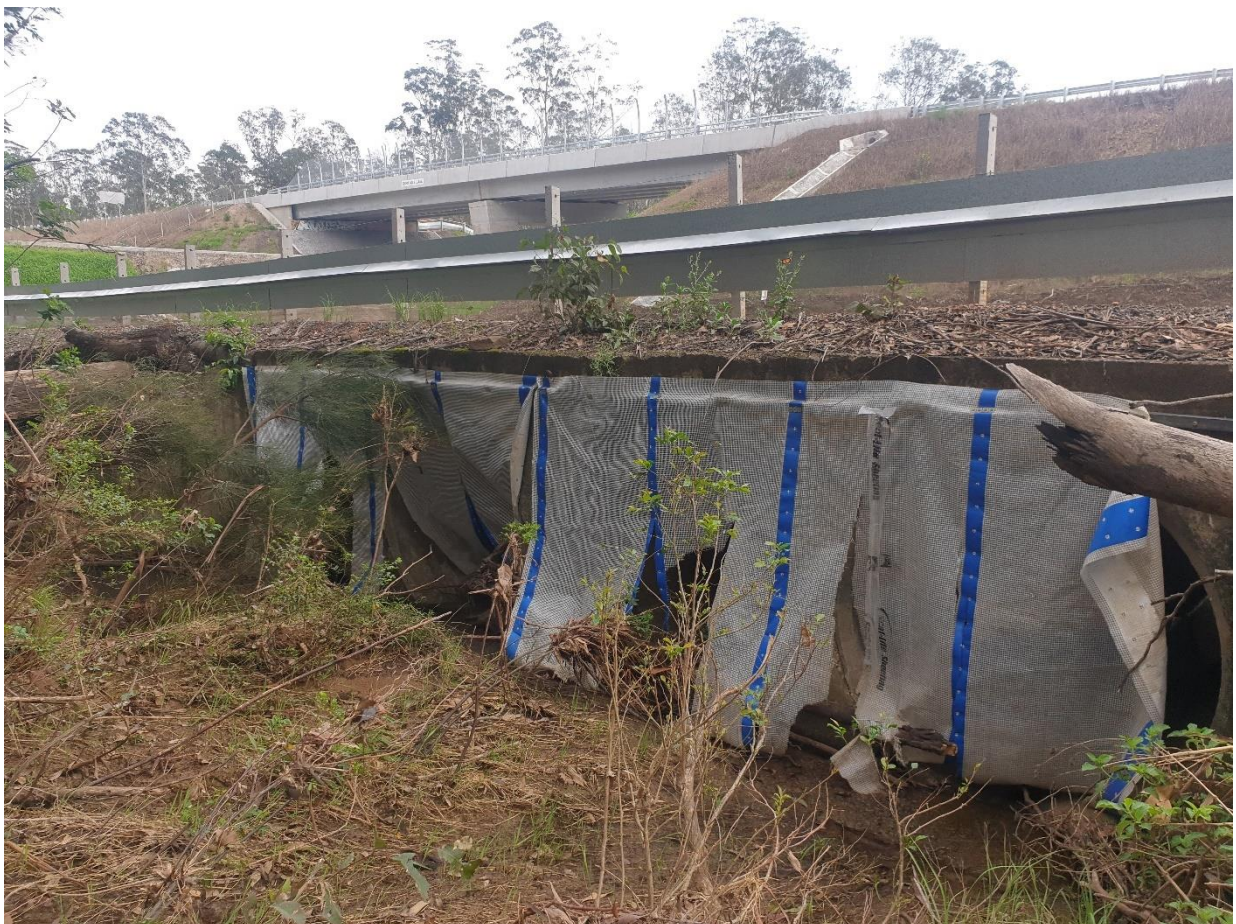
Plate 11: The original Picaninny Creek culvert showing exclusions still semi-intact following flooding in January 2020.

It is important that all efforts be made to re-establish a maternity colony of Southern Myotis in the vicinity of Pheasants Creek and Picaninny Creek. Given the original Picaninny Creek culvert remains, it may be possible to re-habilitate this culvert to allow Southern Myotis to roost within it. Currently it has expanding foam applied within all lift holes and expansion joints. It is recommended that this be removed from the original roosting sites in lifting holes in cells 2 and 3 of the culvert in such a way that promotes and facilitates uptake by Southern Myotis. Continued monitoring of the bat boxes installed beneath Pheasants Creek Bridge and the new Pheasants Creek culvert are required to monitor the situation. It is suggested that this be reviewed following summer 2022 monitoring. If there has been no establishment of a maternity colony of Southern Myotis in the vicinity of Pheasants Creek and Picaninny Creek, continued monitoring is likely to be required.

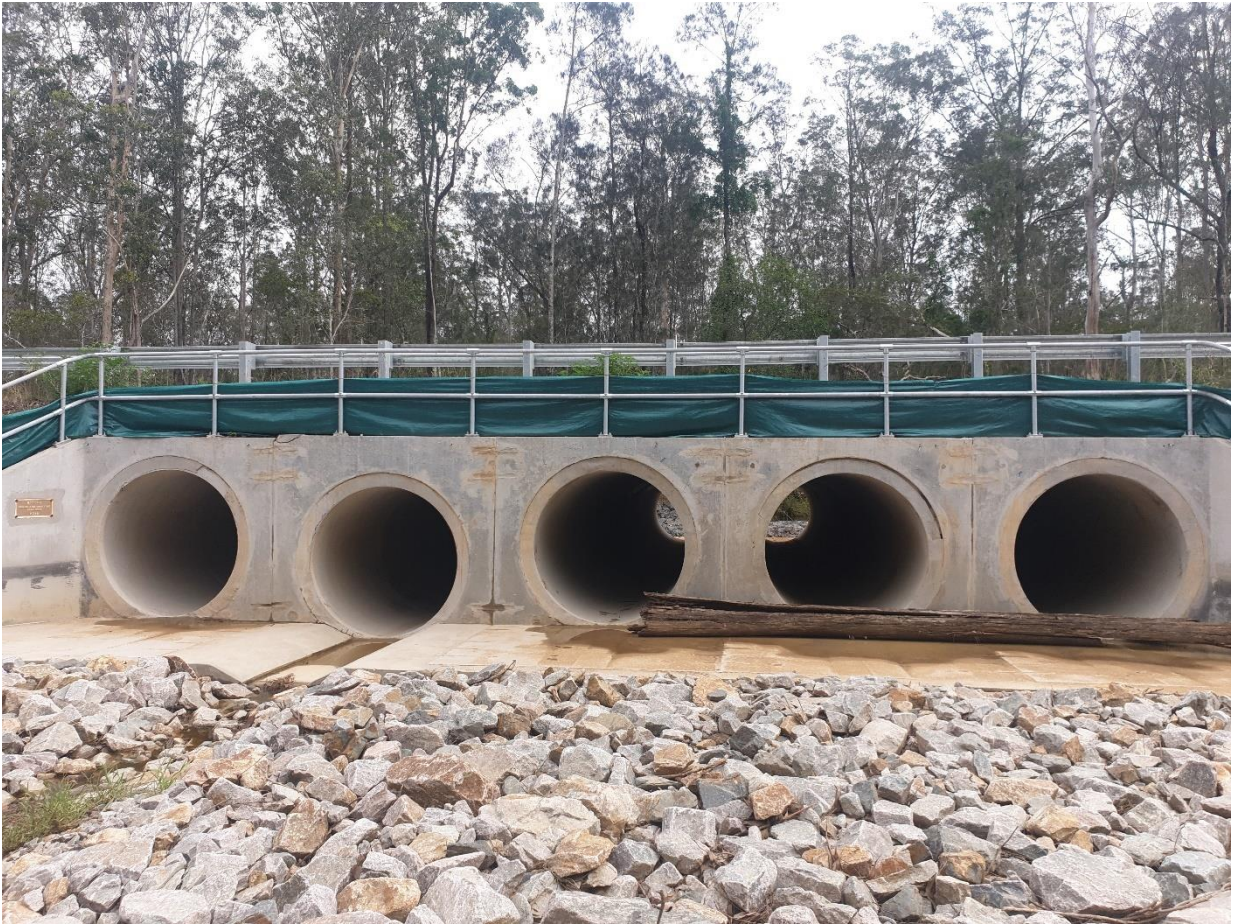
The new Pheasants Creek culvert is a 5 cell RCPC, with all lift holes left unfilled and uncapped and maximum joint gaps in many of the expansion joints. The permanent habitat audit and recent monitoring inspections (2019-2020), as well as opportunistic inspections undertaken in early 2021 has found that the habitat available within the new Pheasants Creek culvert allows for small groupings of around 10 and potentially up to 20 Southern Myotis to roost communally. The combined requirement for newly constructed structures at Pheasants Creek and Picaninny Creek was for a capacity of up to 100 Southern Myotis (2 x original maximum occupancy) .

The original Pheasants Creek culvert hosted small aggregations of Southern Myotis prior to construction, with two maternity colonies present in the adjacent Picaninny culvert. There have been occasional observations of Southern Myotis utilising the new Pheasants Creek culvert, with 2 Southern Myotis present in March 2019, 5 Little Bent-winged Bats and 1 Southern Myotis present in July 2019, 1 Southern Myotis present in October 2019, and light guano accumulations on the base of the culvert in most cells beneath most lift holes, including bat bug casings within many lift holes during most inspections.

Plate 12: Newly installed culverts at Pheasants Creek, Eight Mile Lane, Glenugie Link, Section 3A, October 2019.

If no evidence of use of the boxes, or of a maternity colony of Southern Myotis established within Pheasants Creek culvert during summer 2021/22 monitoring, adjustments may need to be made to the original Picaninny Creek culvert which was retained, and further summer monitoring undertaken. It is suggested that the expanding foam / exclusion material be removed from as much of the roosting habitat (lifting holes in culvert cells 2 and 3) in the original Picaninny Creek culvert as soon as possible to allow for Southern Myotis to move through the culvert cells, locate potential habitat and roost within it. There have been changes to the environment outside the original Picaninny Creek culvert which may reduce its suitability as a roosting and breeding habitat location for Southern Myotis in the short to medium term. These changes include the removal of vegetation surrounding the culvert, landform and

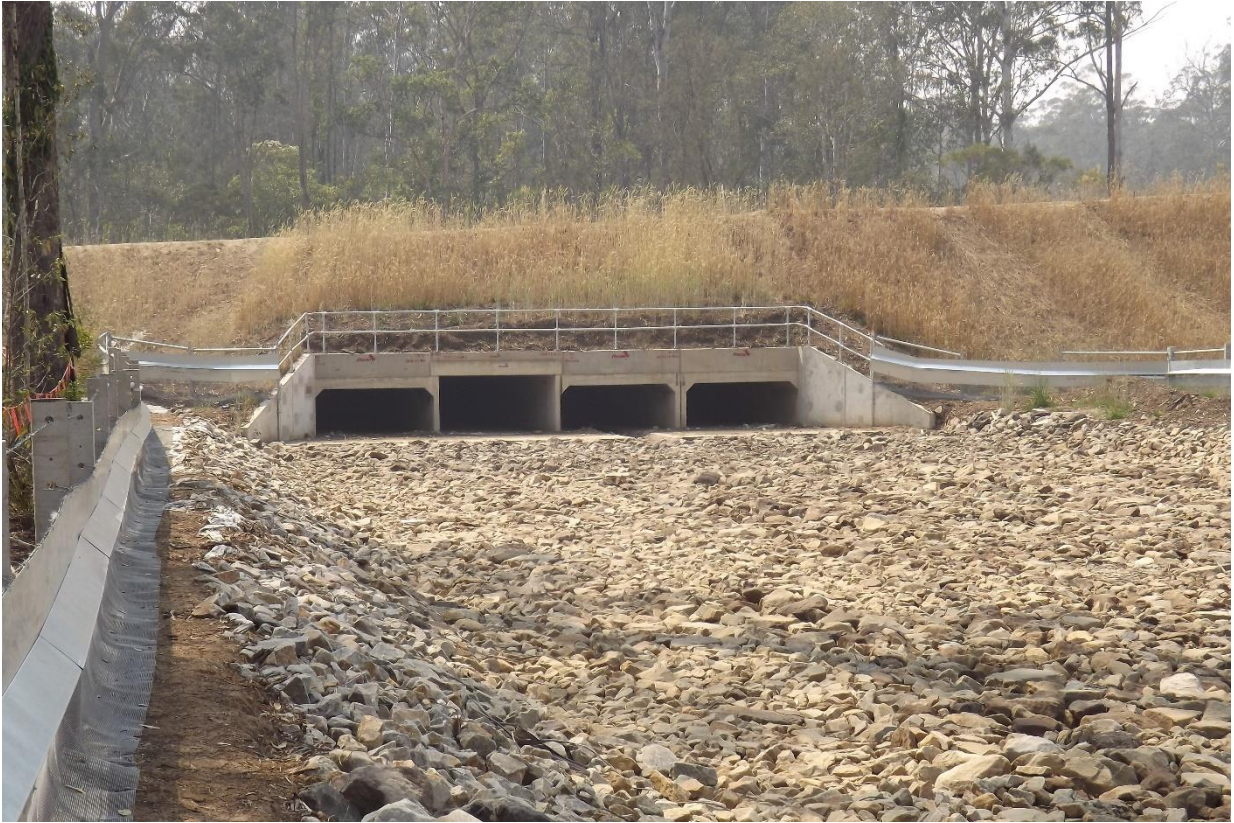
The new Picaninny Creek culvert is a longer but lower box culvert that runs under Eight Mile Lane. Although it is used by bats as evidenced by light guano beneath some expansion joints during the October 2019 inspection, the low height of this culvert makes it unlikely to be used by Southern Myotis. The guano present was representative of *Rhinolophus megaphyllus* (Eastern Horseshoe Bat) guano.

Plate 13: Newly installed culverts at Picaninny Creek, Eight Mile Lane, Glenugie Link, Section 3A, October 2019.

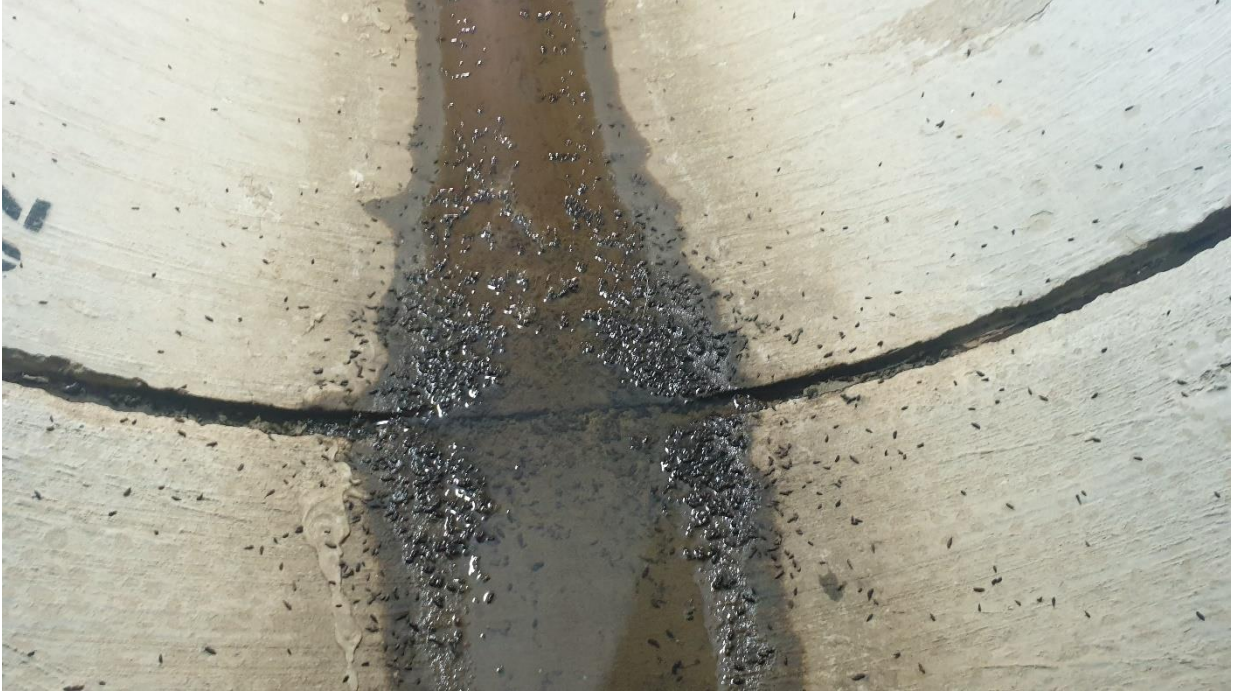
There were no microbats recorded in the culverts at Maclean Cut by ELA during the 2019/20 monitoring period, however there was evidence of small to moderately sized aggregations having been present between monitoring events in the form of guano piles beneath most exclusion joins and bat bug casings around several of the lift holes of the two main culverts suitable as microbat roosting habitat at CH 82030 and CH 82330 (Plate 14 and Plate 15). The permanent habitat audit however found that the capacity of microbat habitat available in the new culverts was at most two hundred bats. The original culverts at Maclean cut contained up to 300 bats and new structures were required to contain habitat for up to 650 bats to allow for expansion of the colony and errors associated with minimal monitoring of the culverts prior to preparation of the MMP.

Plate 14: Microbat guano beneath an expansion joint of one of the new Maclean cut culverts, August 2020.

These findings led to the requirement for additional permanent habitat for Bent-winged Bats to be installed within a suitable nearby structure. Investigations of culverts located between Maclean cut and Green hills were undertaken during the first quarter 2021 (Table 6 and Table 10). The nearest suitable structure was a box culvert at Green hill CH 76450 and a Bent-winged Bat Box constructed from Hebel blocks was installed within this culvert in June 2021 (Plate 4). During inspections of this culvert in February 2021, it was noted that there were several widened expansion gaps and evidence in the form of guano that small numbers of bats had roosted at the site previously. A small cluster of eight Little Bent-winged Bats were present in one of the widened expansion joints during installation of the Bent-

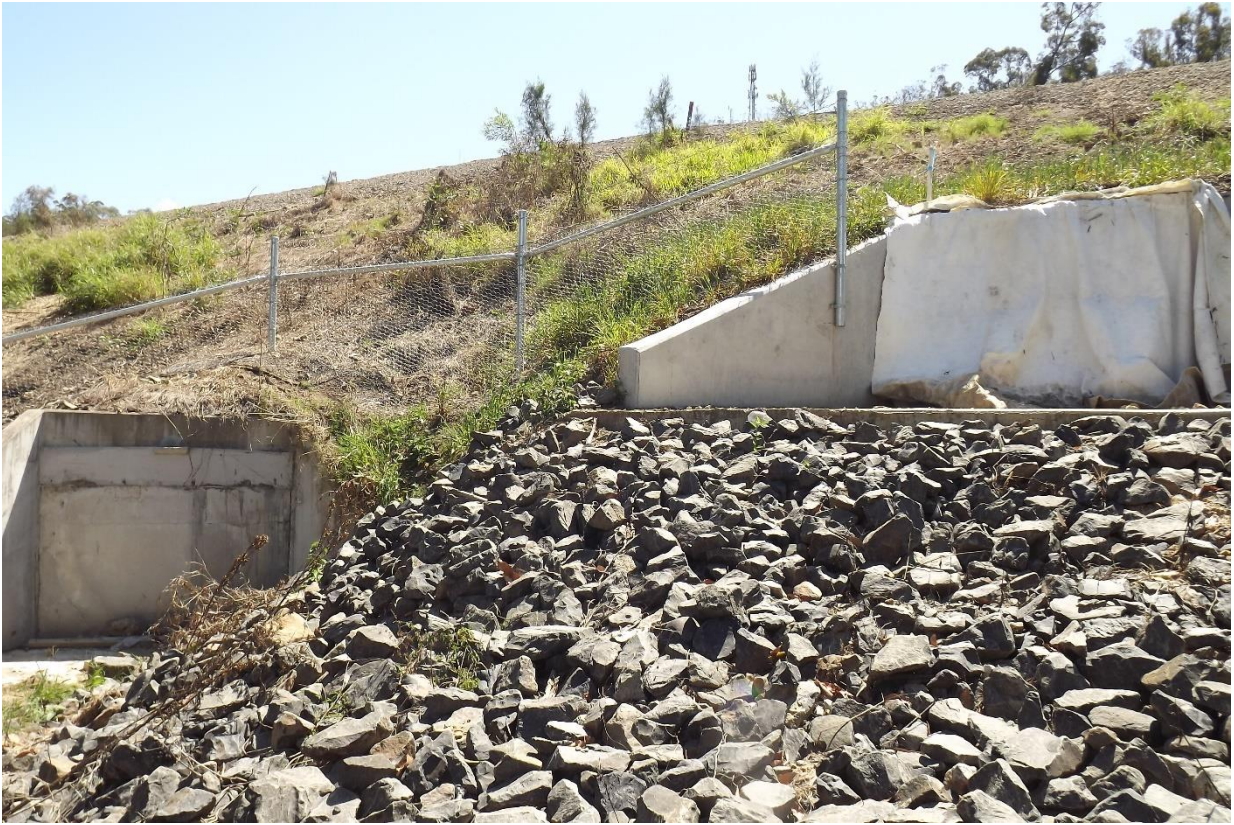
The results of the permanent microbat roosting habitat audit found that the new culverts at Maclean cut (CH 82030 and CH 82330) did not have the required capacity to accommodate up to 650 Bent-winged Bats and none of the boxes installed in trees had been used. As a result, one additional box was required to be installed post construction that would provide suitable compensatory permanent roosting habitat for up to 650 Bent-winged Bats (2 x the original maximum number of Bent-winged Bats recorded at Maclean cut to allow for growth of the colony). A larger style Bent-winged Bat box was installed approximately 5.5 km south in a box culvert at Greenhill (CH 76400) to augment the existing culvert in June 2021 (Plate 4, Figure 2). A small cluster of Little Bent-winged Bats (8) were recorded roosting within an expansion joint in the box culvert at Greenhill during the installation of the Bent-winged Bat box in June 2021. There was no other structure within the W2B project boundary suitable as a roost site for Bent-winged Bats and capable of hosting the larger style Bent-winged Bat box at Maclean cut or closer than the box culvert at Greenhill.

Plate 15: Original box culvert (now sealed, lower LHS) and newly constructed culvert (upper, RHS) at Maclean cut, October 2019.

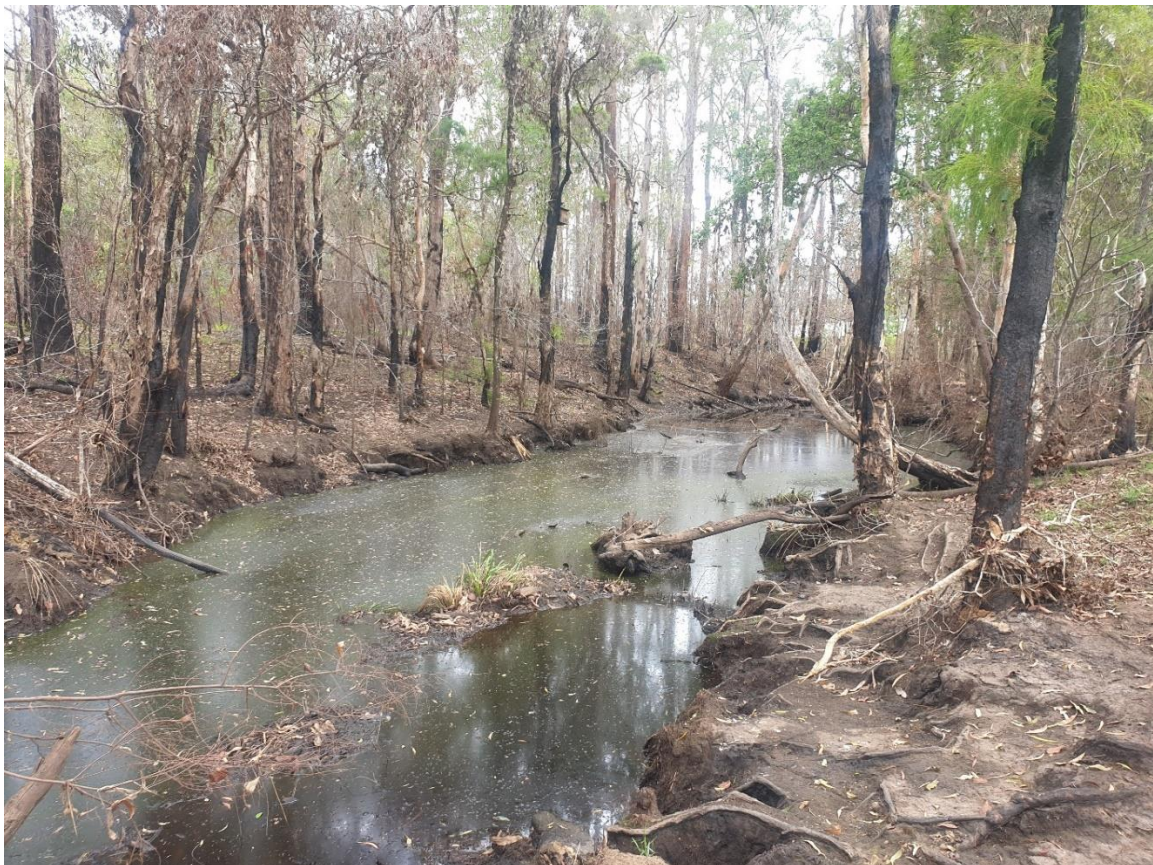
Bushfires affected Sections 6, 7, 8, 9 and 10 of the subject area in 2019-20. The wider Tabbimoble Creek area (Plate 16) was impacted by bushfire in 2019-20. A bat box was lost to fire (Plate 17), while a further four boxes were scorched but remained functional. We do not consider it necessary to replace the box that was lost as these boxes were temporary replacement habitat, permanent habitat being available within the adjacent Tabbimoble Creek Bridges.

Plate 16: Burnt section of Tabbimoble Creek showing a tree-mounted bat box (upper central portion of image), 2020.

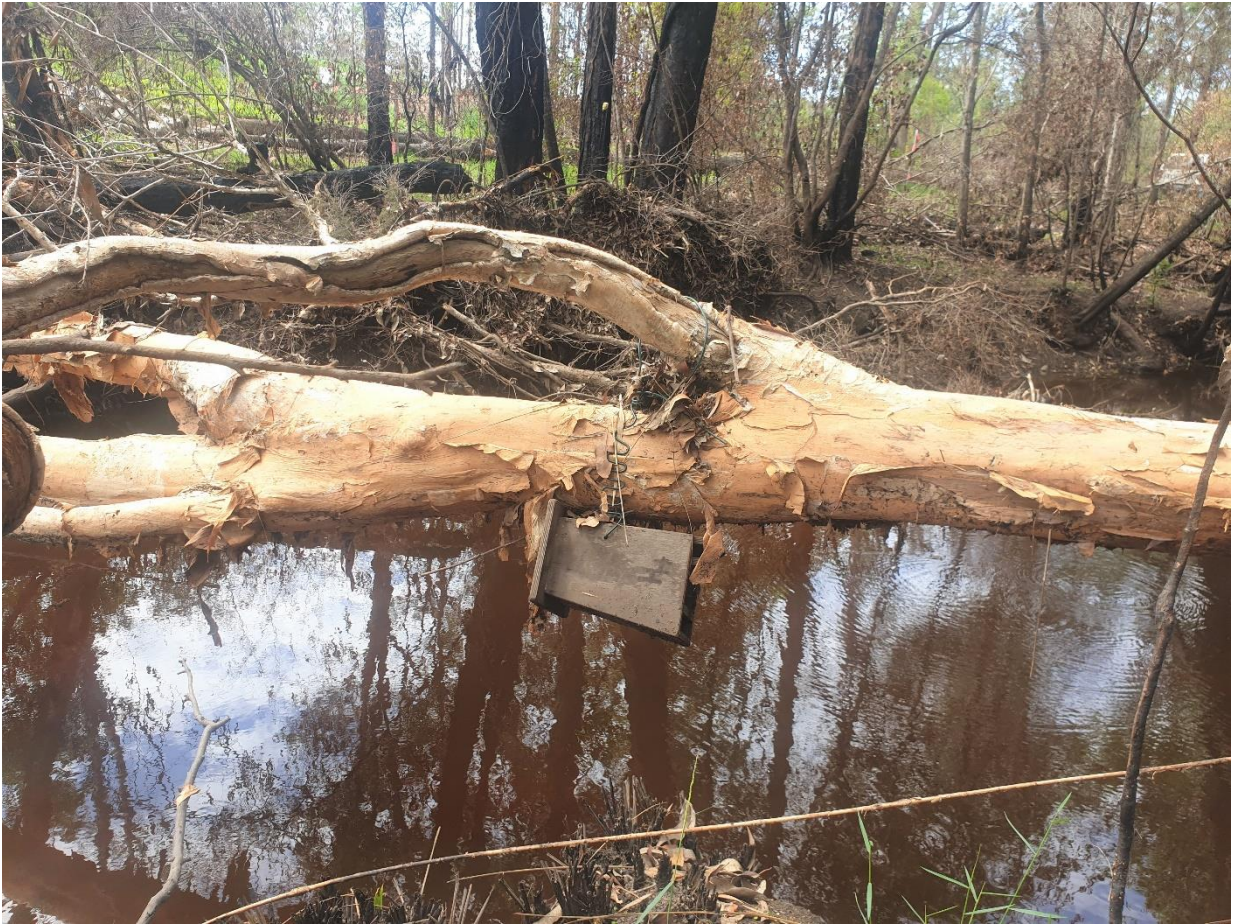
Plate 17: Burnt section of Tabbimoble Creek showing a fallen tree mounted bat box across the creek line, January 2020.
