Woolgoolga to Ballina Pacific Highway upgrade

**Operational Monitoring of In-situ
Threatened Flora Species (non-rainforest)**

Annual Report 2021

Transport for NSW

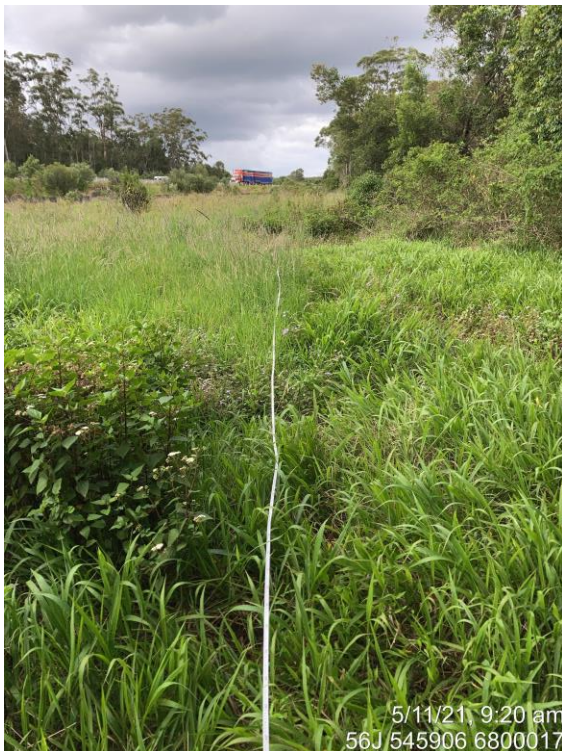
Competition with other plants continues to be a threat to *A.hispidus* and the wetter conditions in 2021 has cause increase in cover of some weeds. This is primarily by exotic species such as *Ageratum houstonianum*, *Paspalum dialatatum*, *Commelina benghalensis*, *Senecio madagascariensis*, *Verbena littoralis* and *Ambrosia artemisiifolia* forming dense groundcover (refer **Photograph 3.1 and 3.2**). This is particularly evident at sites Ah-8.1, Ah-10.3, Ah-10.4, Ah-10.6 and Ah-C10.1, where it appears *A.hispidus* plants are being out-competed. Similarly, this is also happening at Ah-C10.1 with the native grass *Leersia hexandra*. *A.hispidus* appears to prefer small clearings and disturbed sites that have been slashed or grazed and this is a consequence of strong competition with native and exotic greases and weeds which share this favoured moist low-lying habitat. This problem may be exacerbated by the removal of cattle from these properties, which have been previously managed through grazing. Cattle removal has occurred in some locations during the construction period. **Table 3-1** shows the change in weed cover and number of weed species for all sites over all monitoring periods. This impact is not project related.

Photograph 3.1: Plot Ah10.4 Exotic species (*Paspalum*) dominating the plot and outcompeting *Arthraxon hispidus*.

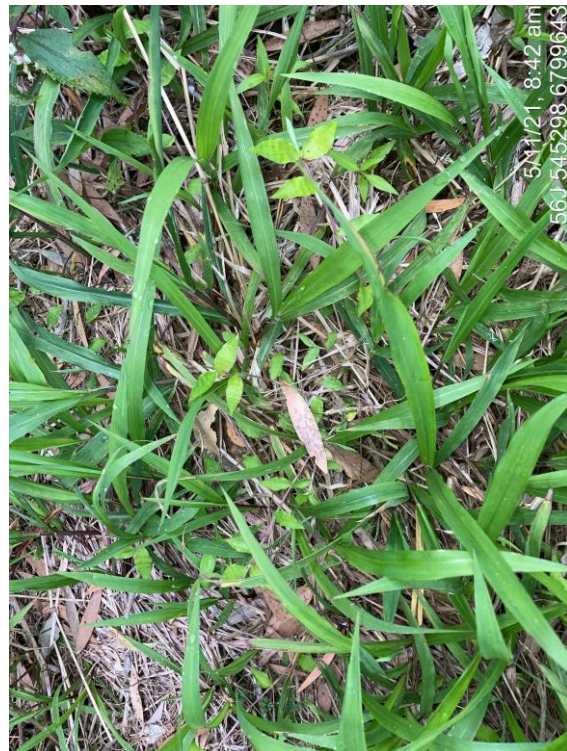
Photograph 3.2: *Arthraxon hispidus* continuing to grow in spaces amongst *Paspalum* (Ah-10.4). This situation was observed at a number of impact and control sites.

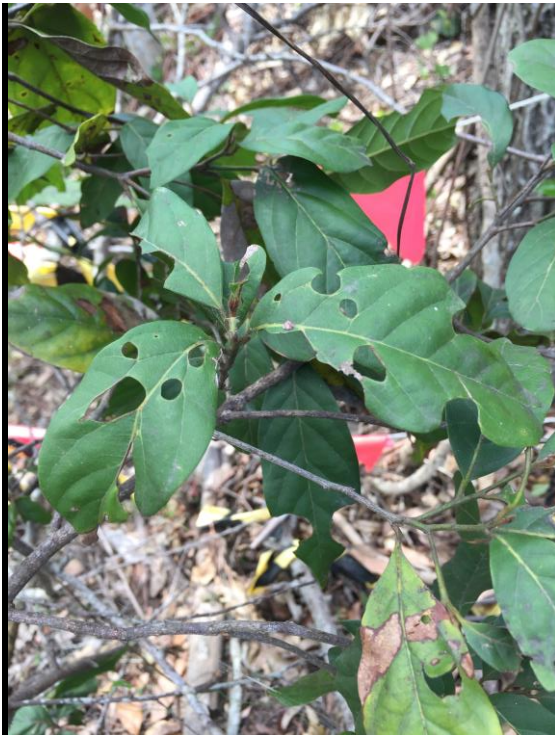
Emb-4.1 (chainage: 81700) was inspected on 20 October 2021. The single individual *E. muelleri* subsp. *bracteata* at site Emb-4.1 remains in good health and has improved in the last 12 months (refer **Photographs 3-3 and 3-4**). Insect activity and browsing on leaves in 2021 was minimal and consisted of only 1% of the leaves present. Leaf insect damage has been noted since the start of the program but hasn't caused detrimental harm to plant, however this has diminished significantly in 2021. New shoots were observed at the top of *E. muelleri* subsp. *bracteata* in 2021.

Photograph 3-3: *E. muelleri* subsp. *bracteata* at in-situ site Emb-4.1 showing insect browsing on older leaves

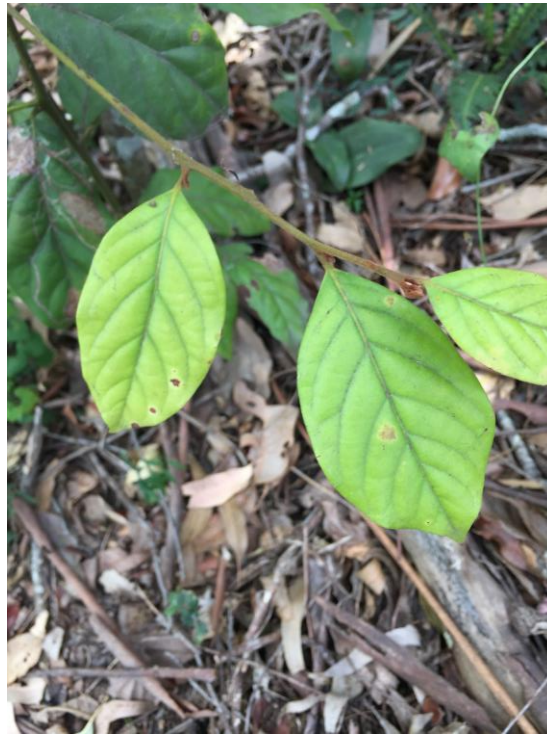
Photograph 3-4: New growth on *E.muelleri* subsp *bracteata*.

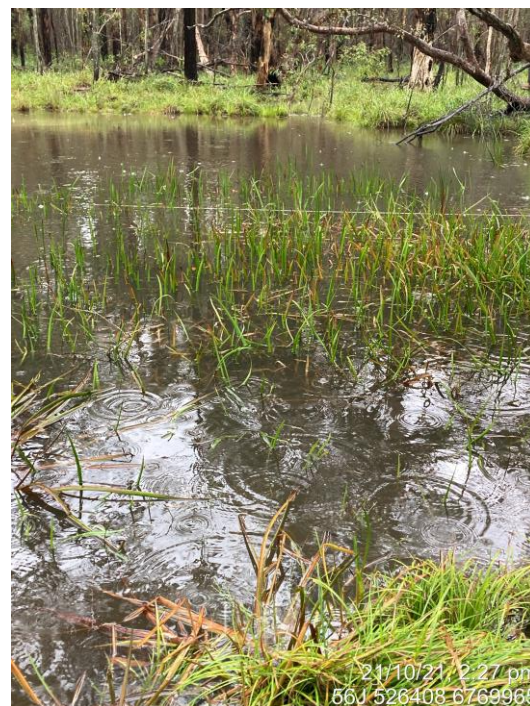
Photograph 3-6: Year 2 operational phase at in-situ site Mt-7.2 showing gradual recovery of *M. triglochinooides* core population (October 2021)

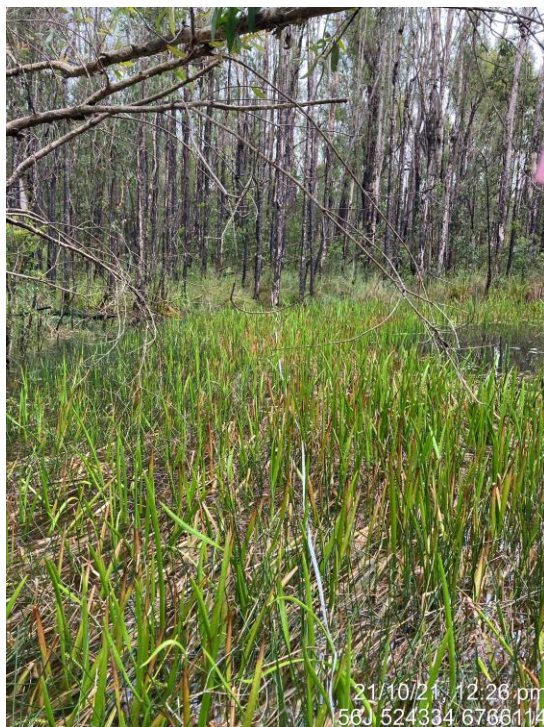
The cover of *M. triglochinosides* at the in-situ site Mt-7.1 decreased from 12 % to 4.5 % percent cover from 2019 to 2020 (associated with drought and fire period), however has increased up to 38 % of the plot by 2021 due to pond filling and large increase in area of available habitat, good post-fire recovery. This is related to a large hot fire which passed through the habitat in November 2019 and plant abundance declined for next 12 months. There was evidence of plants at the edge of the pond being burnt. Two years post fire, many new recruits were observed in 2021 with plants having expanded into the new shallow water showing good recovery. Around 10% of the plants present still display burnt tips indicating stress during drought and fire but have survived. No weeds were present in the pond, with *M. triglochinosides* dominating the plot along with the presence of *Philydrum lanuginosum* (refer **Photograph 3-7**).

Photograph 3-7: Year 2 operational phase at in-situ site Mt-7.1 showing good recover following hot fire in November 2019 which burnt through Tabbimoble State Forest.

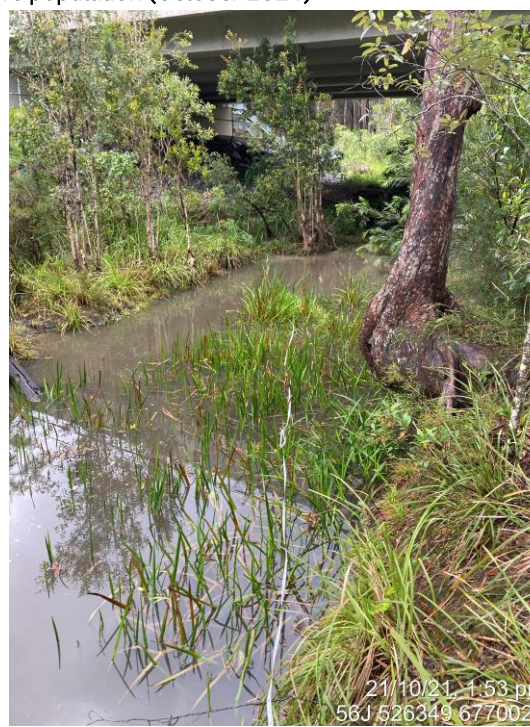
The mean percent cover of *M. triglochinosides* at in-situ site Mt-7.3 has changed temporally during the monitoring program. This site is directly within the corridor. The mean cover was at 80% in the baseline survey and remained similar at 86% during year 1 construction and 100 % in year 2. In year 3, works associated with bridge construction reduced the cover to 56% in 2019 and to 22% in 2020 with significant shading over the plots. In spring 2021 the site was showing evidence of good recovery, and plants have spread to the east and west of the bridge in areas not previously occupied, although absent below the bridge, which is expected. The cover is now at 50% (refer **Photograph 3-8**). These plants are located in the approved construction corridor.

Photograph 3-8: Year 2 operational phase at in-situ site Mt-7.3 showing population adjacent to bridge in background

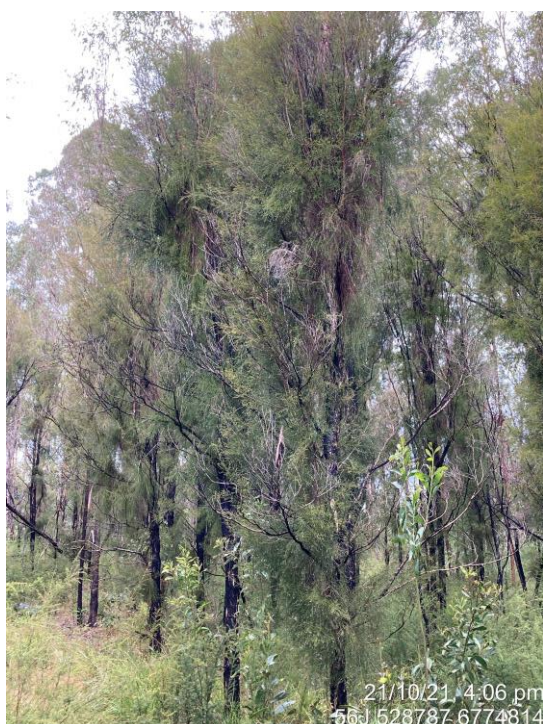
The abundance of *M. irbyana* at in-situ site Mi-7.1 (chainage: 120800) during the 2021 surveys confirmed 39 trees of which 27 were mature and 12 were resprouting in the easement. This site was observed as still recovering from fire with signs of dead trunks on older trees and new shoots sprouting from the base and burnt trunks (refer **Photograph 3-9**). Likewise, young trees in the easement were showing signs of regrowth from roots which had been previously slashed.

Photograph 3-9: *Melaleuca irbyana* in year 2 operational phase survey (October 2021) at in-situ site Mi-7.1 New growth after fire.

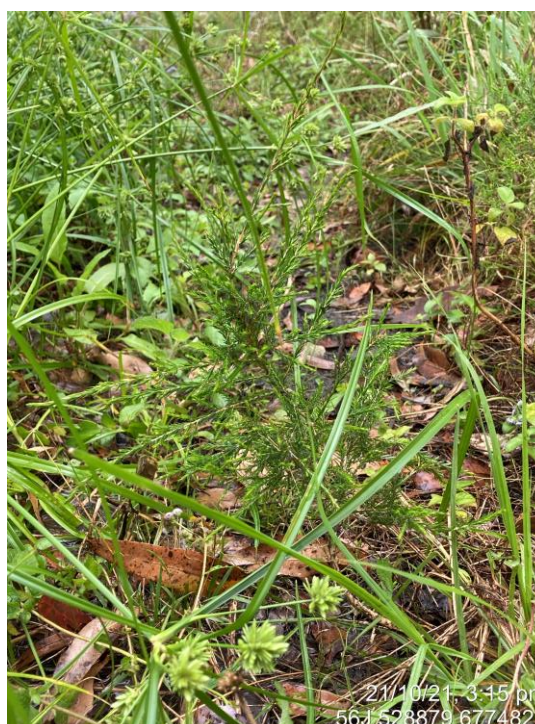
Similarly, the abundance of *M. irbyana* at in-situ site Mi-7.2 (chainage: 120900) during the 2021 surveys confirmed 33 trees of which 10 were mature and still recovering from fire, and 23 were immature located on the gas easement where these were previously slashed and have resprouted. These trees have increased in height now being up to 1 m taller in comparison to 2021. No signs of recruitment from seed were noted, however regeneration from fire is occurring (refer **Photograph 3-10**).

Photograph 3-10: Good post-fire recruitment of *M. irbyana* was noted in 2020 and 2021 impact and control plots demonstrating the species resilience to fire.

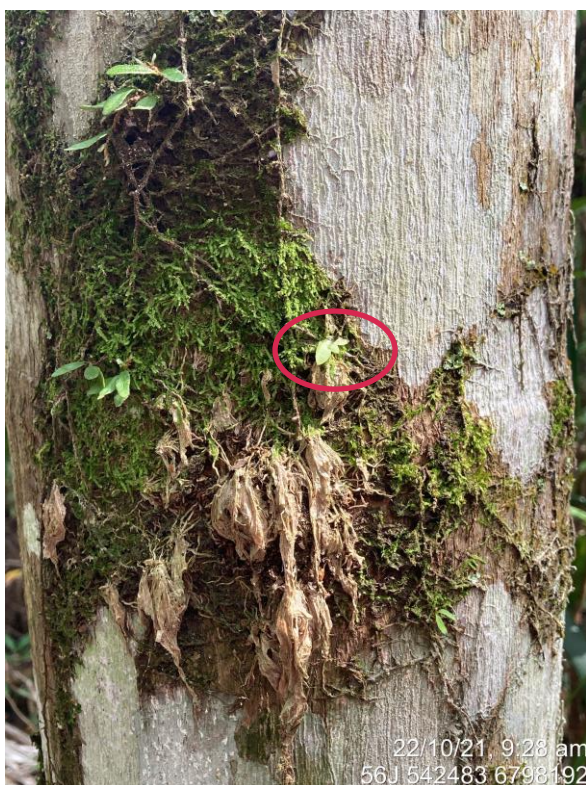
There have been slight variations in *O. titania* plant numbers and plant condition status at the impact site. While it is difficult to quantify there appear around 7-10 less individuals than previous construction and operation surveys and some of the remaining plants appear in poor condition due to desiccation, with some plant leaves browning and others having dead plant material (refer **Photograph 3-11**). This impact may be related to the below average rainfall in proceeding months to the 2021 survey, however plants at the control site are located >100 m further east away from the forest edge and are in healthy condition, where no desiccation was noted, and this suggests that the edge effect along forest clearing has indirectly contributed to the noted impacts. Plants at the control site were in very healthy condition, and some were found with sprouting flower spike and setting seed.

Photograph 3-11: *Oberonia titania* on edge of forest clearing at in-situ site Ot-10.1 (facing west) showing desiccation, likely from greater exposure to increased sunlight and dry conditions. Remaining shoot shown in circle. There has been no net loss at this stage

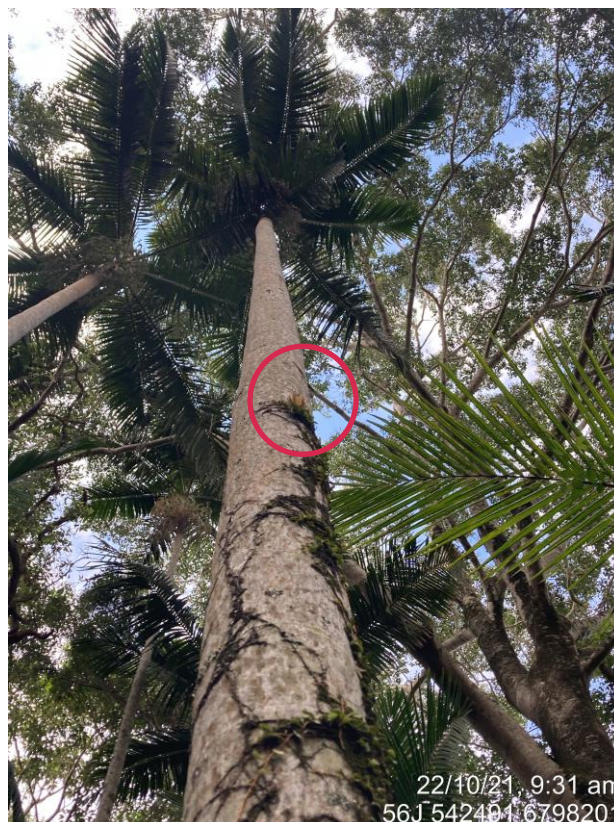
Photograph 3-12: *Oberonia titania* new plant located on same tree 5m from ground facing north away from forest edge is healthy

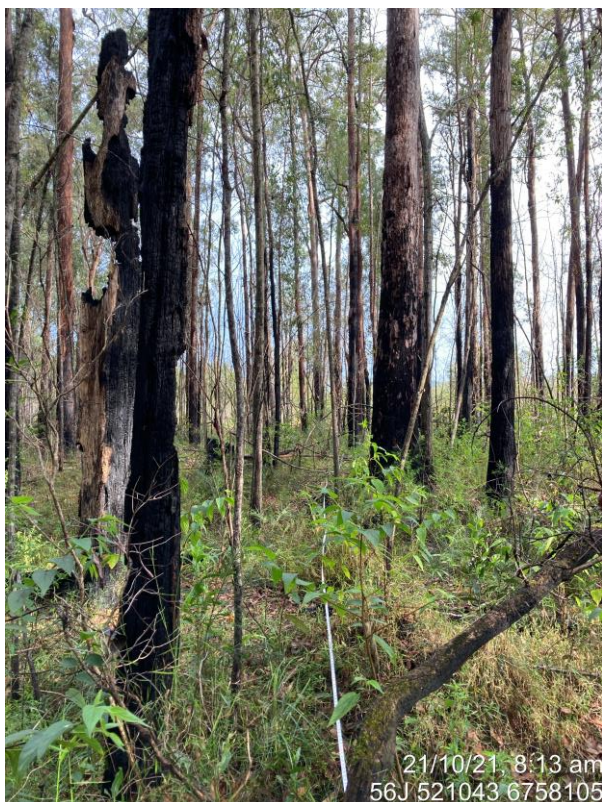
Photograph 3-13. *Prostanthera cineolifera* impact site in 2021 showing recovery after fire

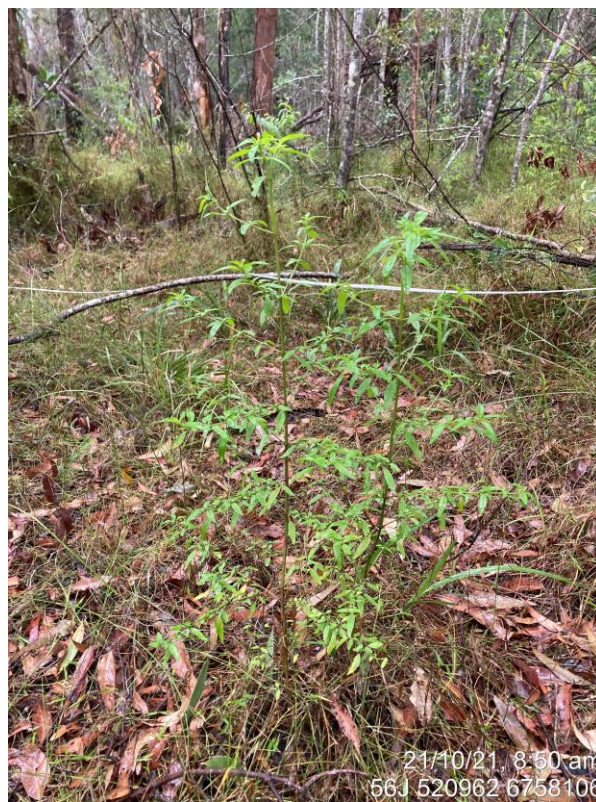
Photograph 3-13 new *Prostanthera cineolifera* individual sprouted after the 2019 fire
