# Warrell Creek to Nambucca Heads Landscape Rehabilitation Monitoring Operational Phase Annual Report 2022/2023

ECOS Environmental Pty Ltd

14/9/2023

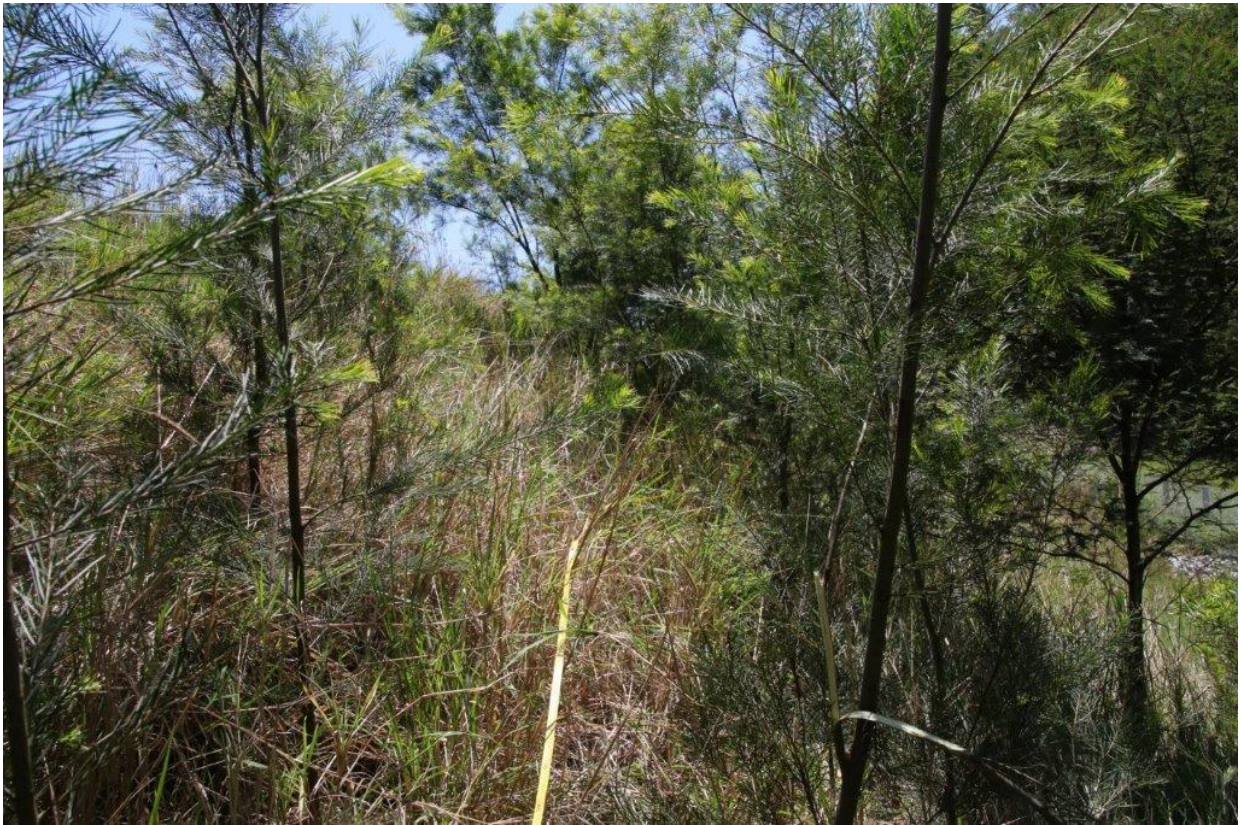
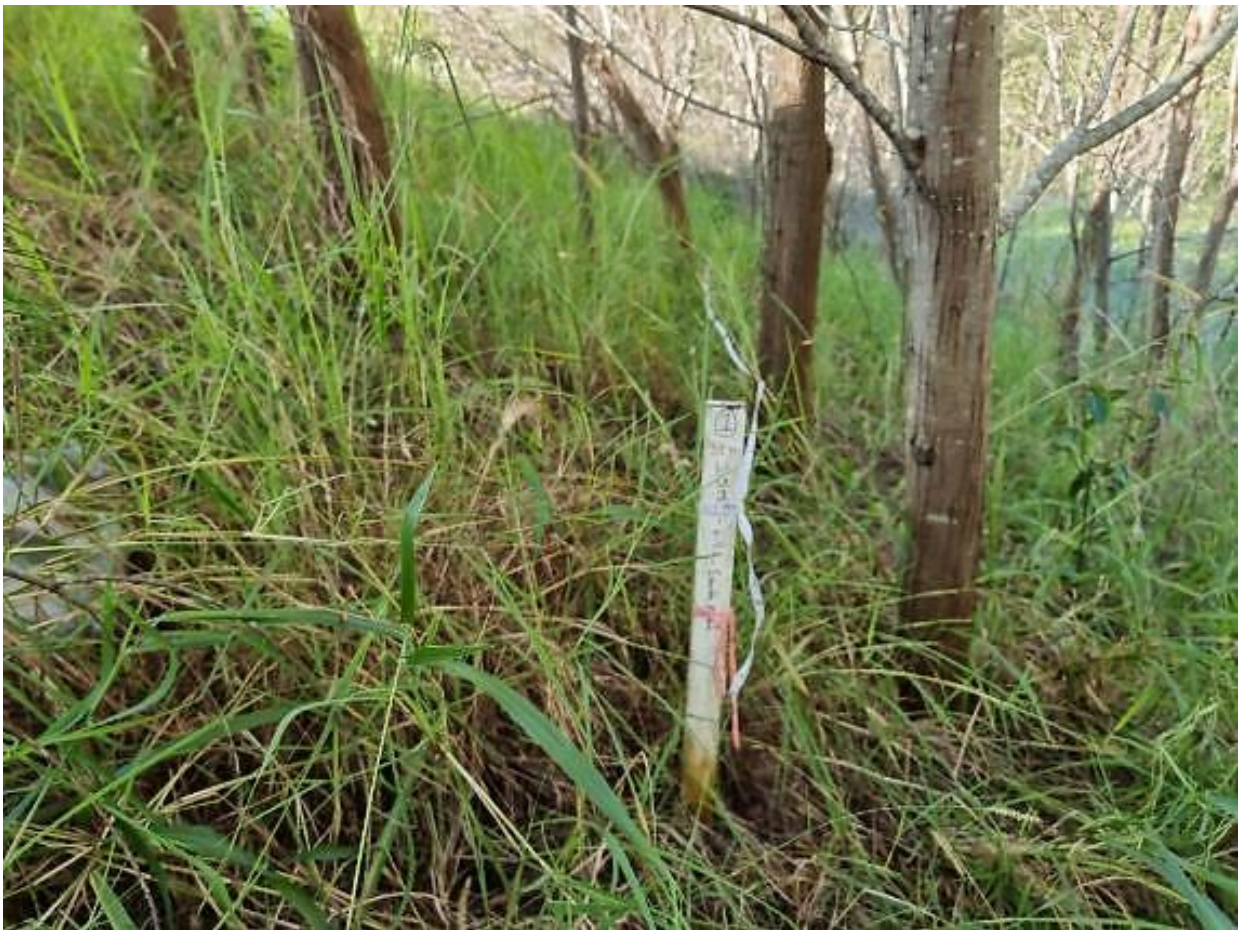
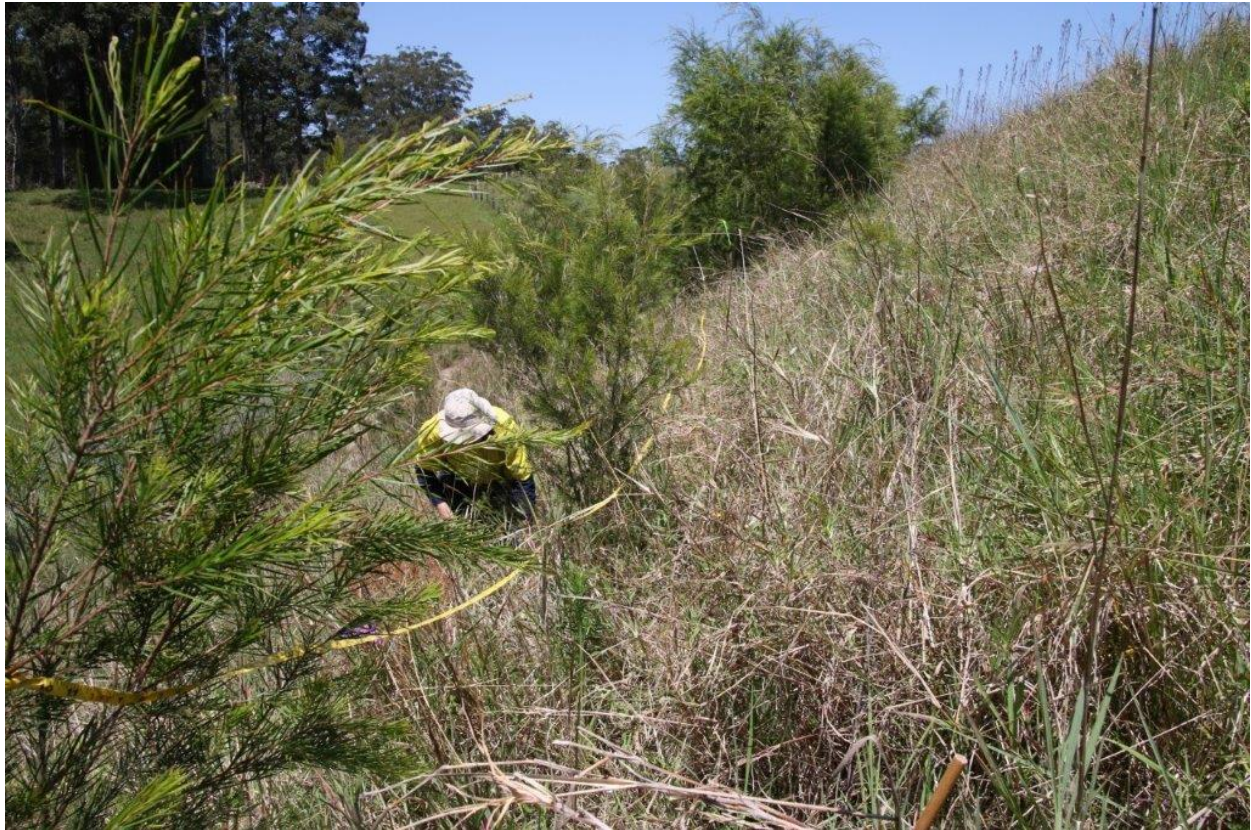
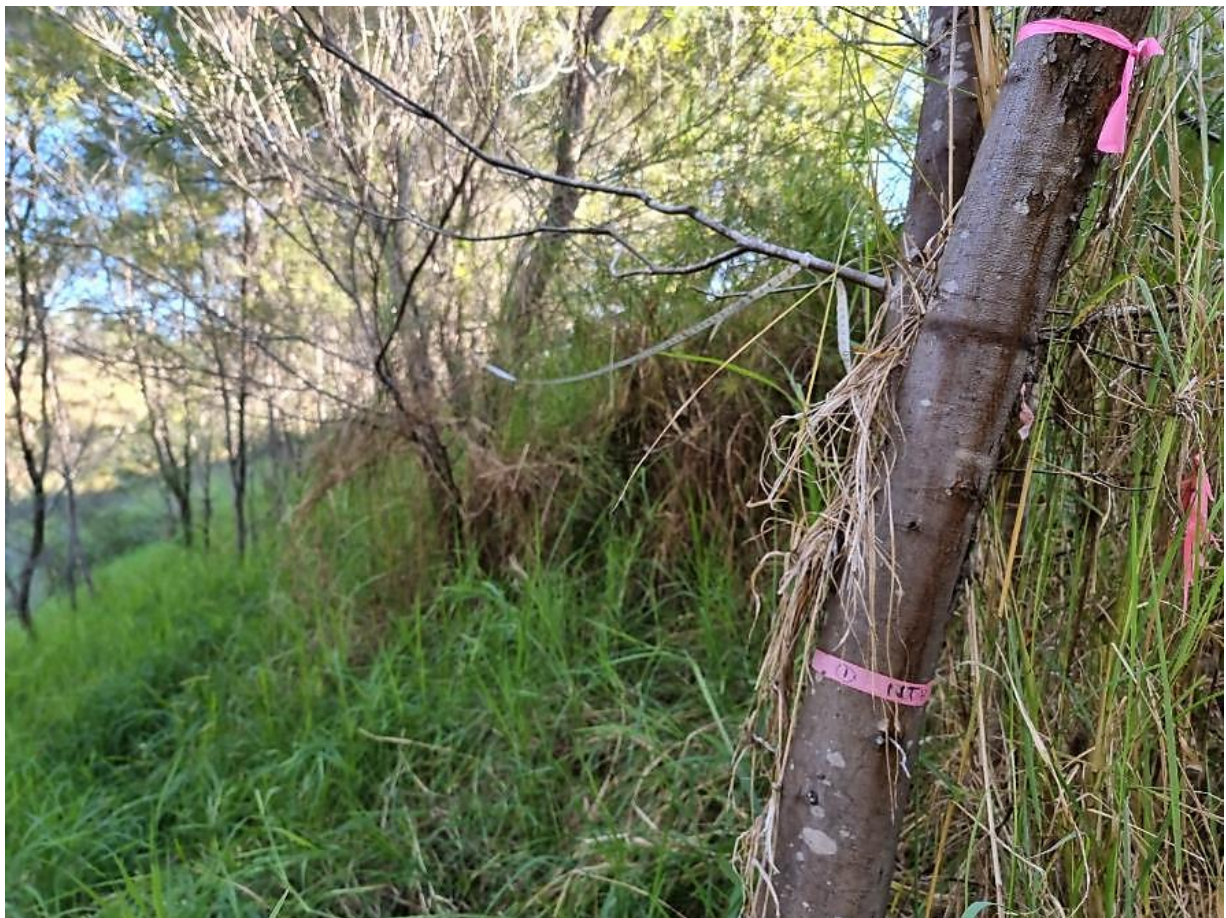
**Spring 2018 - Site 1 southern end**

2018 – sparse shrubland 2-3 m high, canopy crown cover 30-50%, dense *Setaria* understory 1.5-2 m tall.

2023 – tall closed shrubland, 6-7 m high, canopy crown cover 90%, over moderately dense *Setaria* 1.5-2 m high

Dominance of *Setaria* due most likely to *Setaria* seed in salvaged topsoil spread onto the fill batter, sourced from, or next to, grazing land.

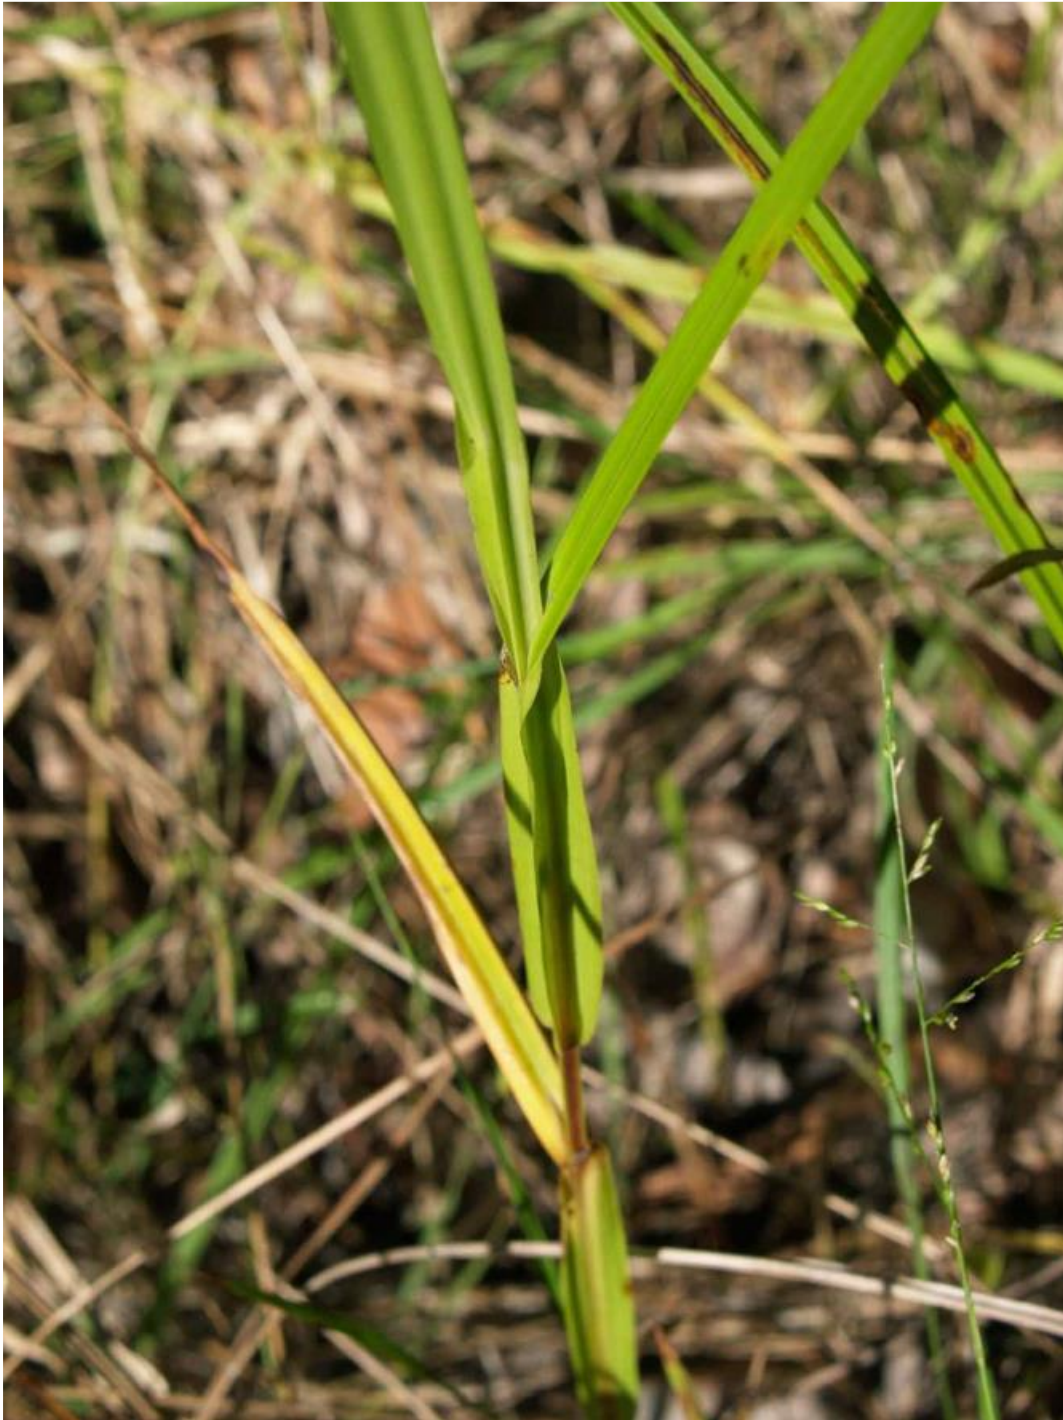
**Site 6 – *Scleria levis* (Winged Sedge).** Site 6 near Macksville represents a new southern limit for this species according to Virtual Herbarium [avh.chah.org.au/](http://avh.chah.org.au/). The previous most southerly record is from Boambee (Coffs Harbour)

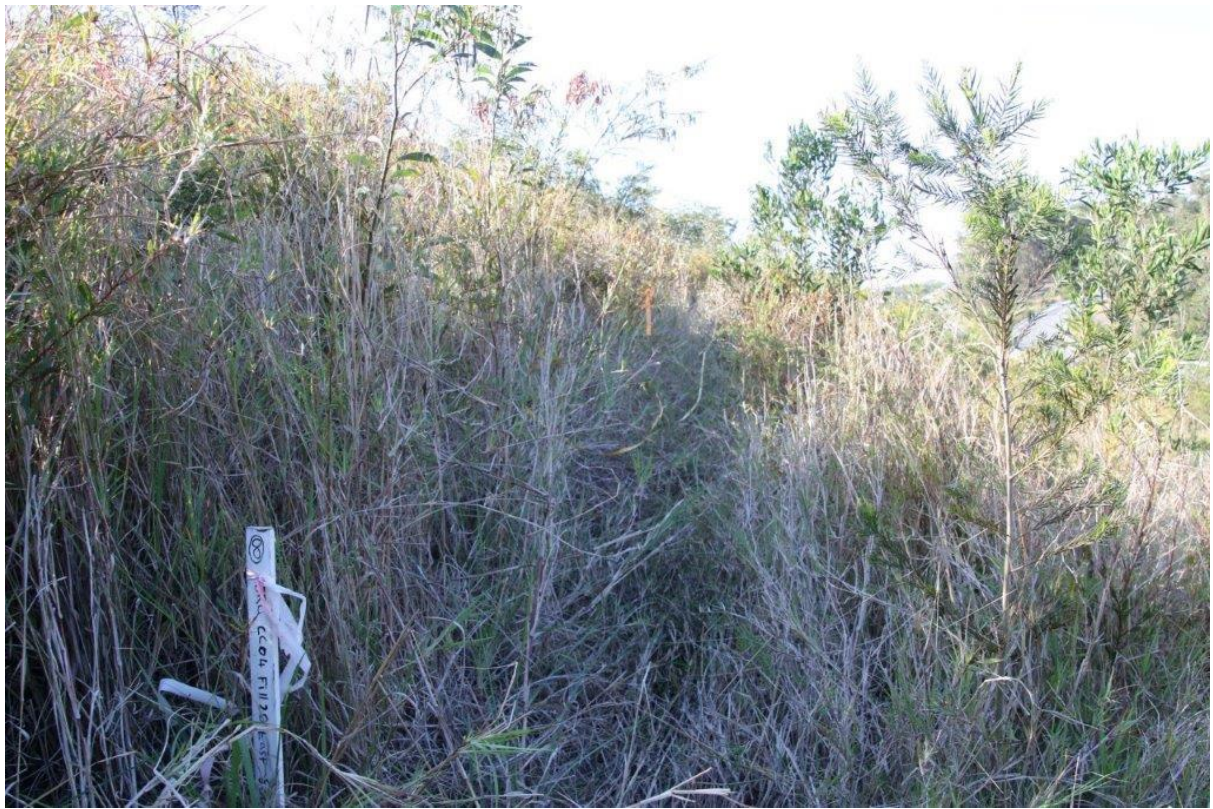
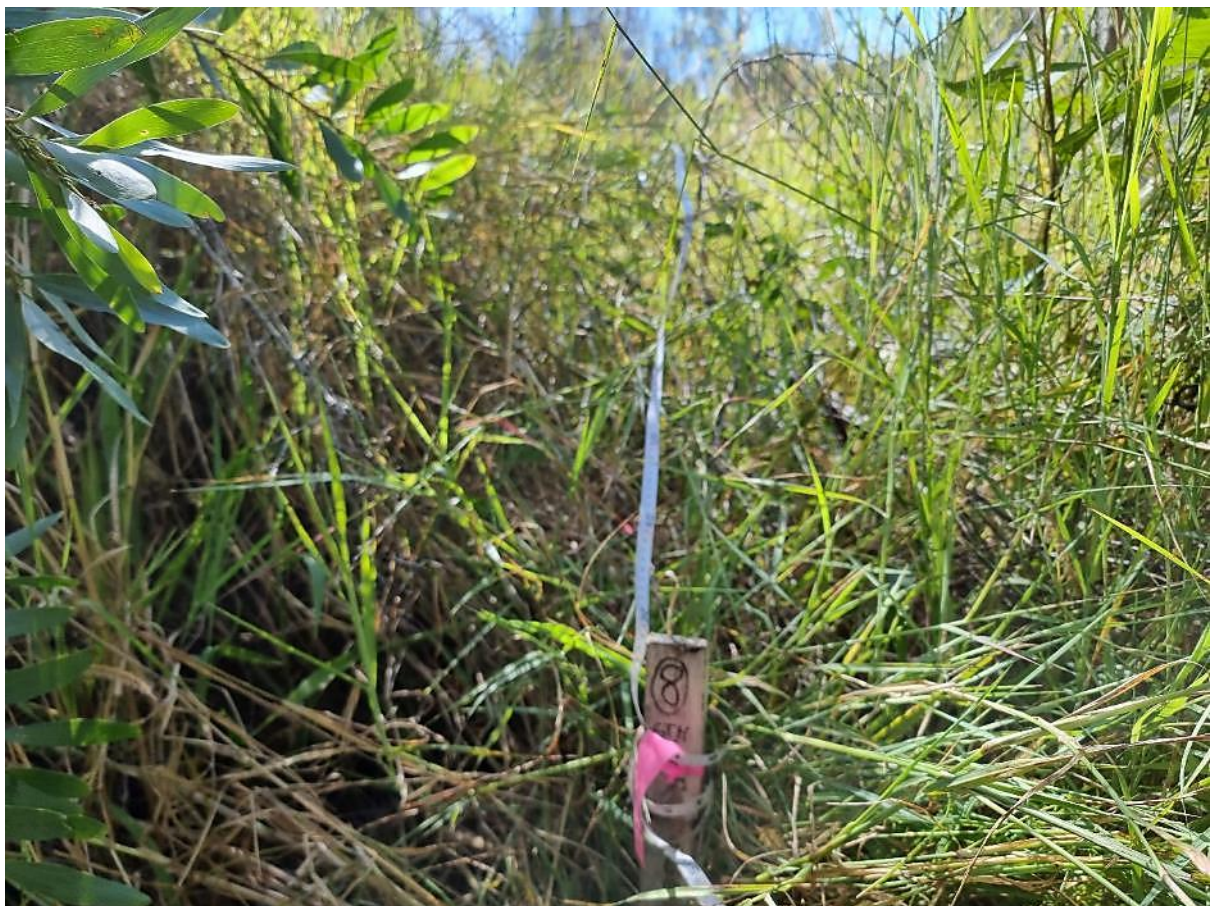
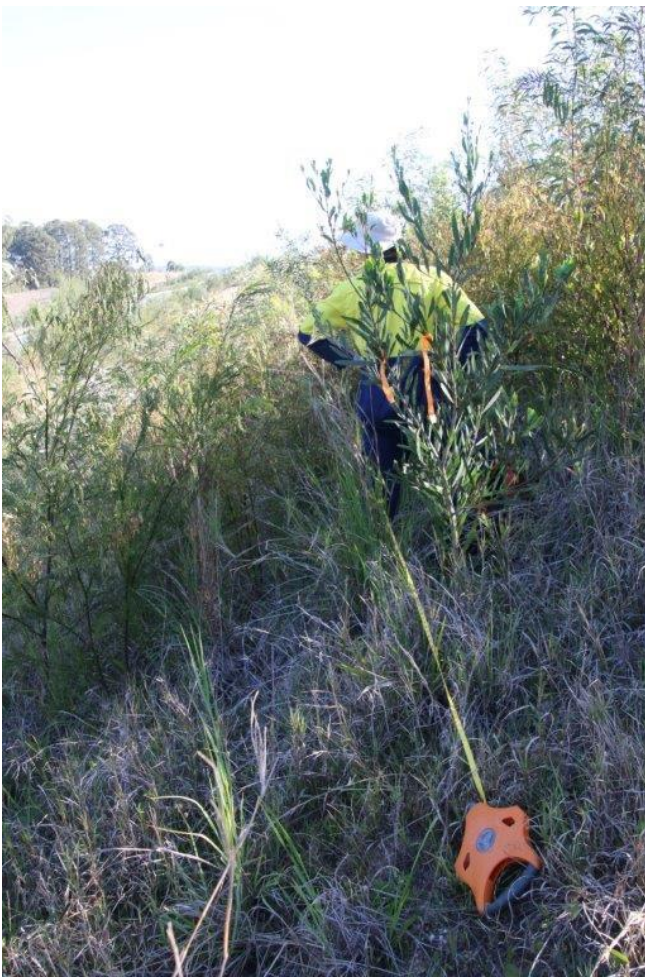
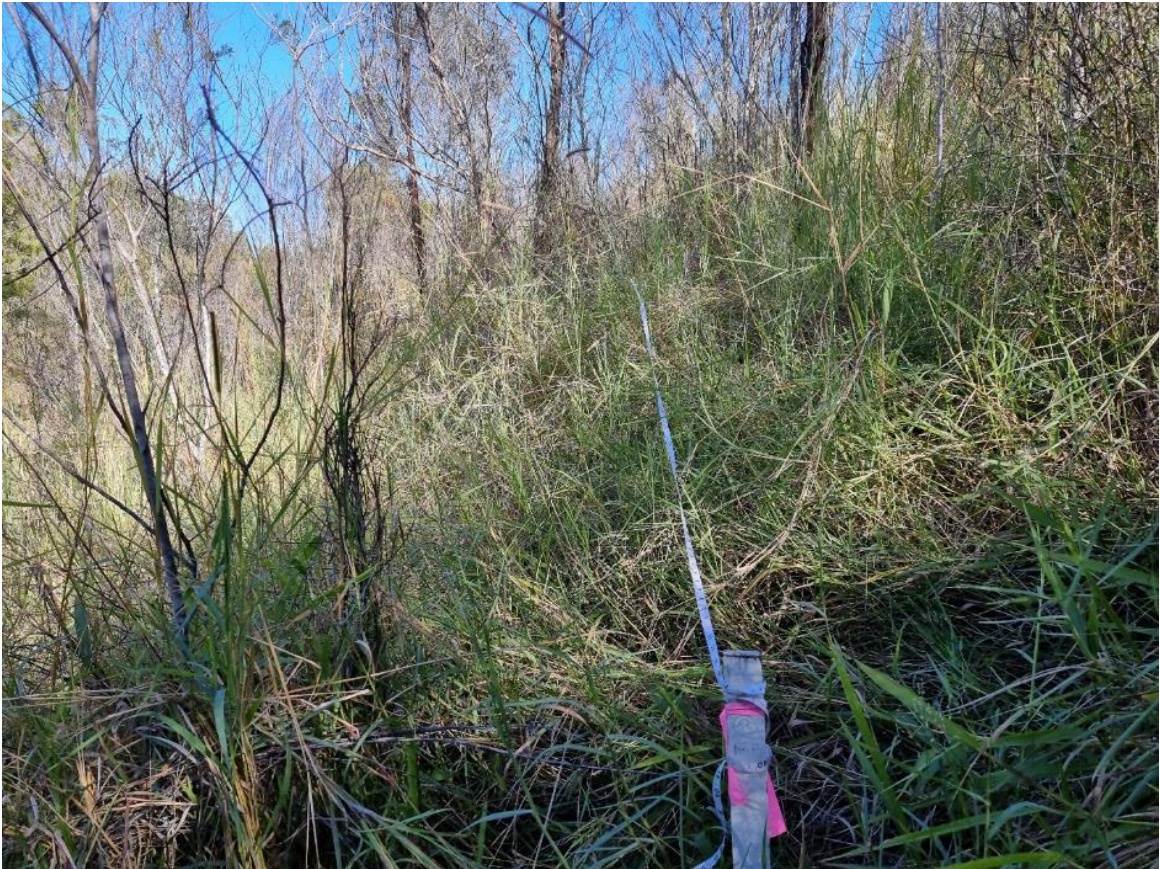
**Spring 2018 - Site 8 southern end**

This Bushland Reconstruction site was effective in establishing vegetation cover, but largely failed in establishing native (bushland) species. Even Acacia's failed to establish well and exotic grasses dominate the plot including *Setaria*, Broad-leaved *Paspalum* and a *Panicum* sp. These species were probably present in the soil seedbank spread on the batter. The topsoil may have come from a marginal forest area adjoining pasture.

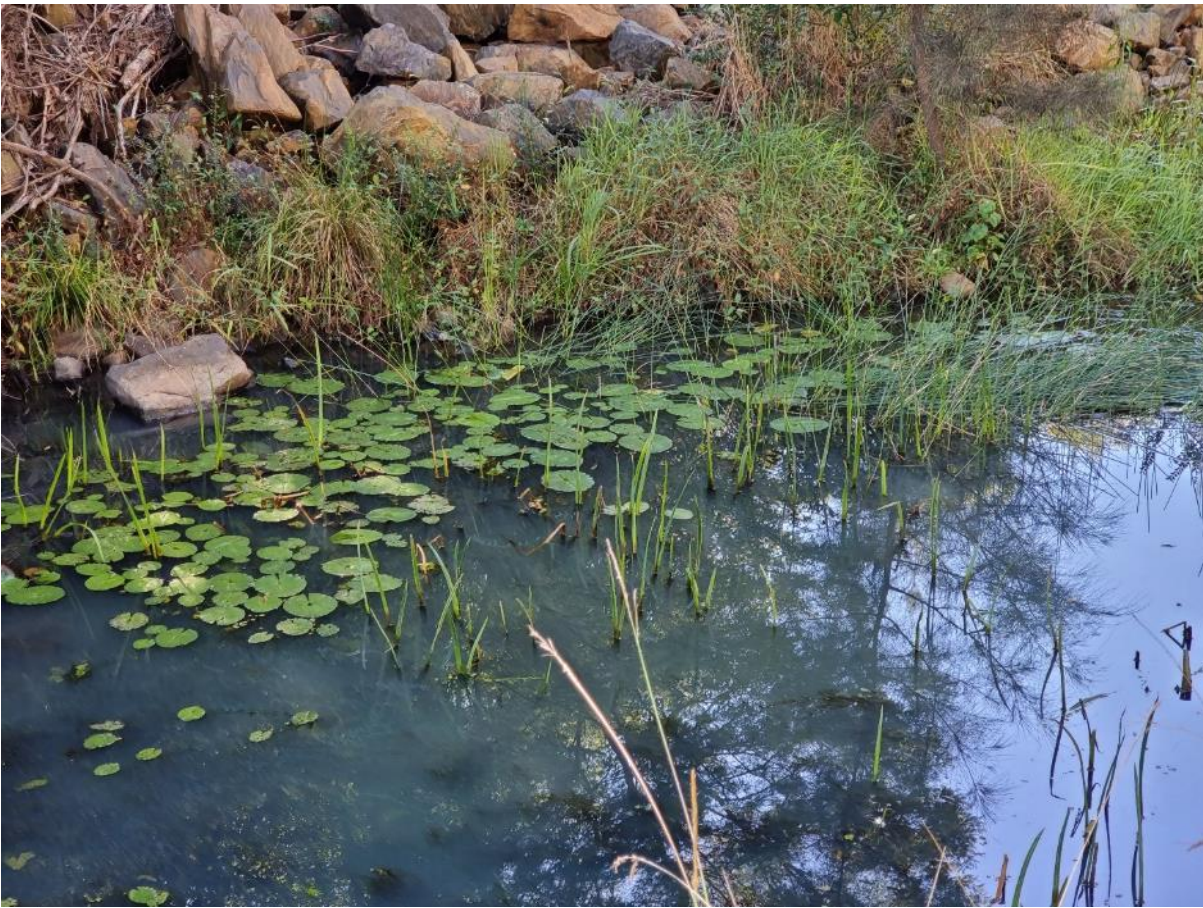
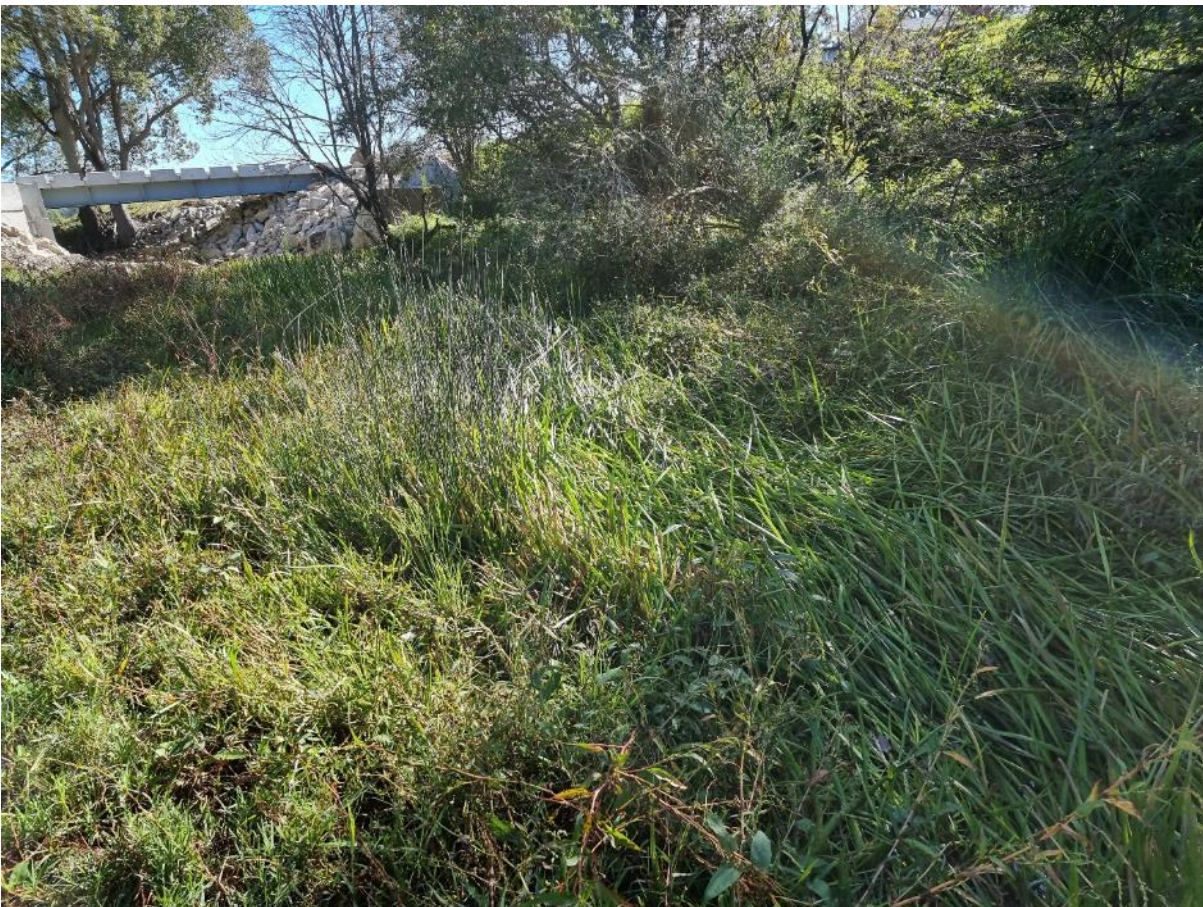
**Site 10**, *Maundia triglochinos* (emergent aquatic plant with narrow, upright, sword shaped leaf), Autumn 2023. Lower photo includes in situ *Maundia* found 50 m downstream of the above photo under the new 4-lane twin bridge (i.e. not the one in photograph).

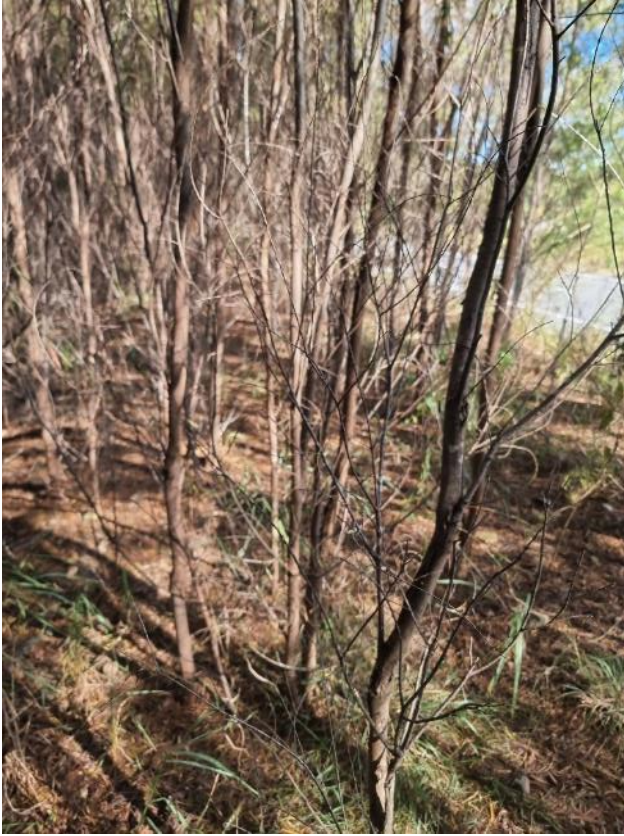
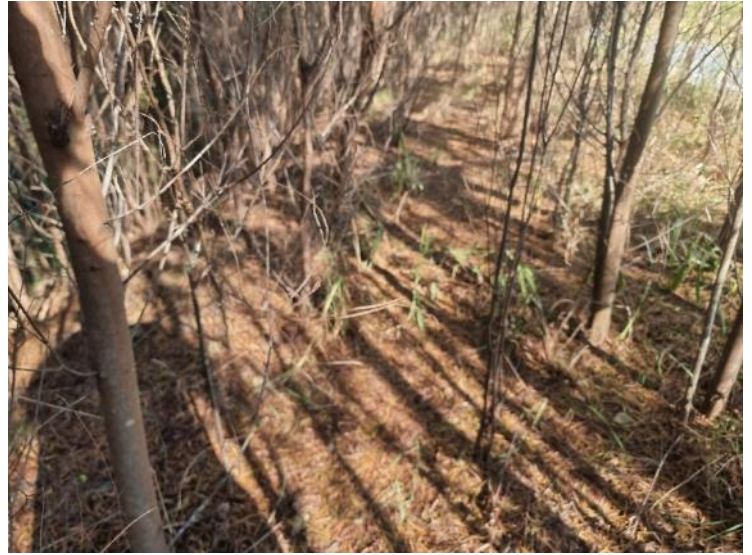
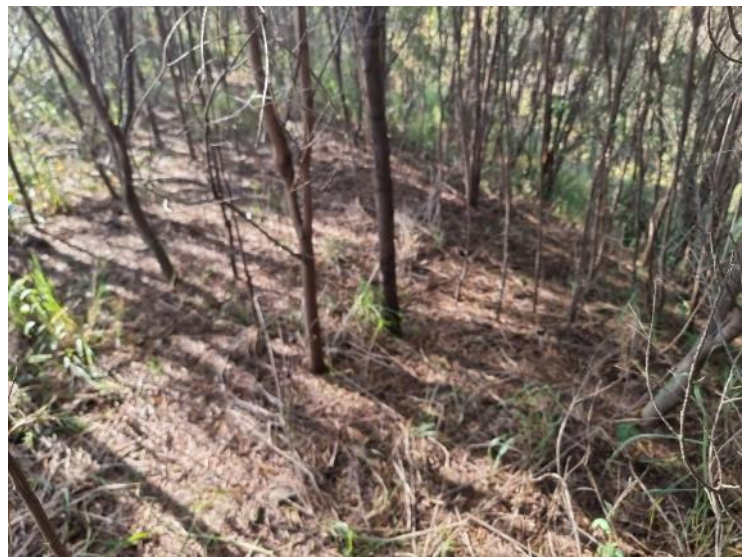
Embankment between streamline and highway adjacent to Plot 11. Dense *Acacia fimbriata*, five years old, has suppressed *Setaria sphacelata*. Bottom of photo on lower right shows sparse *Setaria* under *Acacia* near slope base compared to dense *Setaria* on Site 11 in the open (see photos above). The ground is covered by brown *Acacia* leaf litter. *Acacia* density > one per 4 m<sup>2</sup>.
