**Operational Phase Monitoring of Threatened Flora
Translocations, In-situ Threatened Plants and Slender Marsdenia and Woolls'
Tylophora Habitat Condition on the Warrell Creek to Nambucca Heads Highway
Project – Year 5 (2022)**

Prepared by:

ECOS Environmental Pty Ltd

14/4/2023

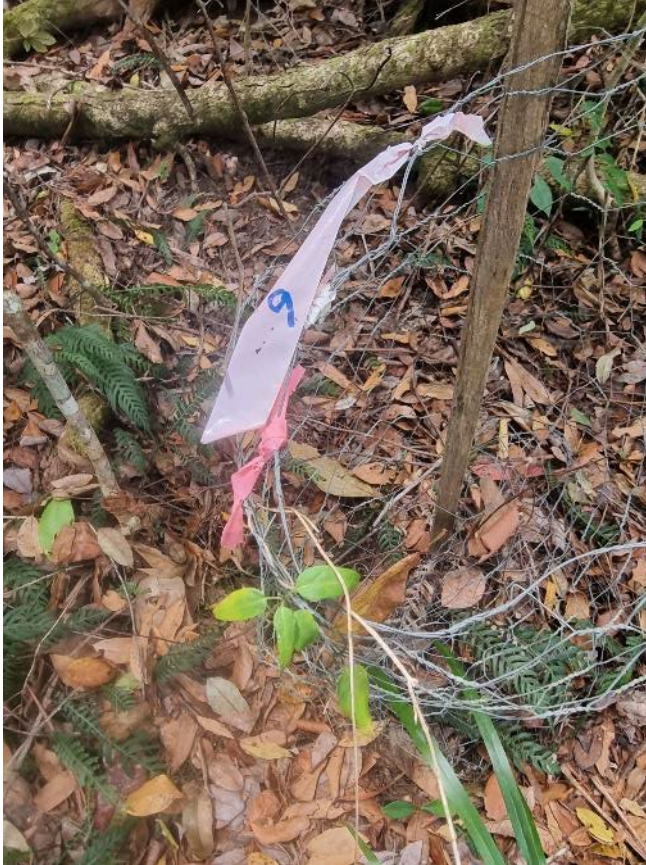
Plate 1: Recipient Site 8a, plant no. 9, growing on wire tree guard, 6 leaves yellow-green, stem dying back.

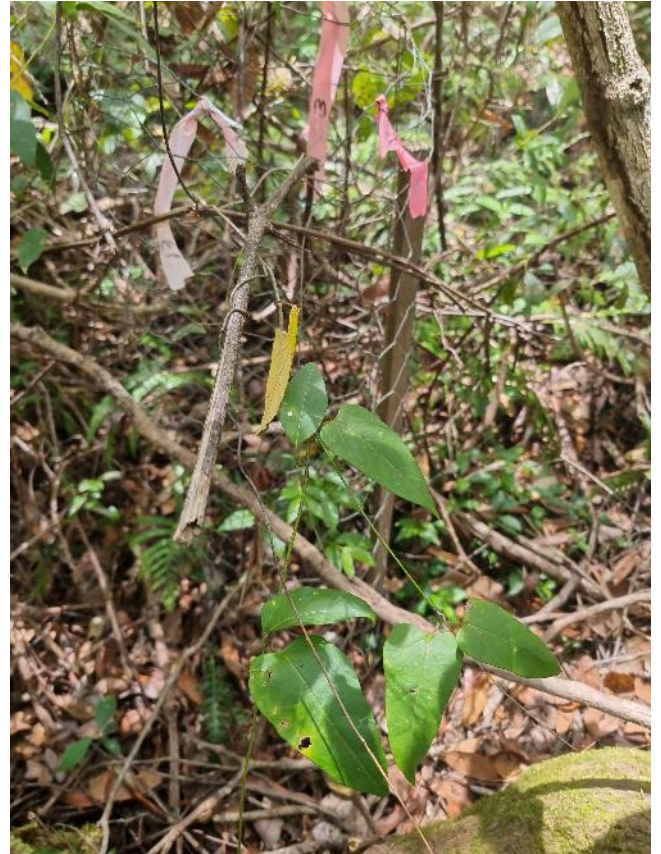
Plate 2: Recipient Site 8a, plant no. 13, tall, healthy stem 3.2 m in height.

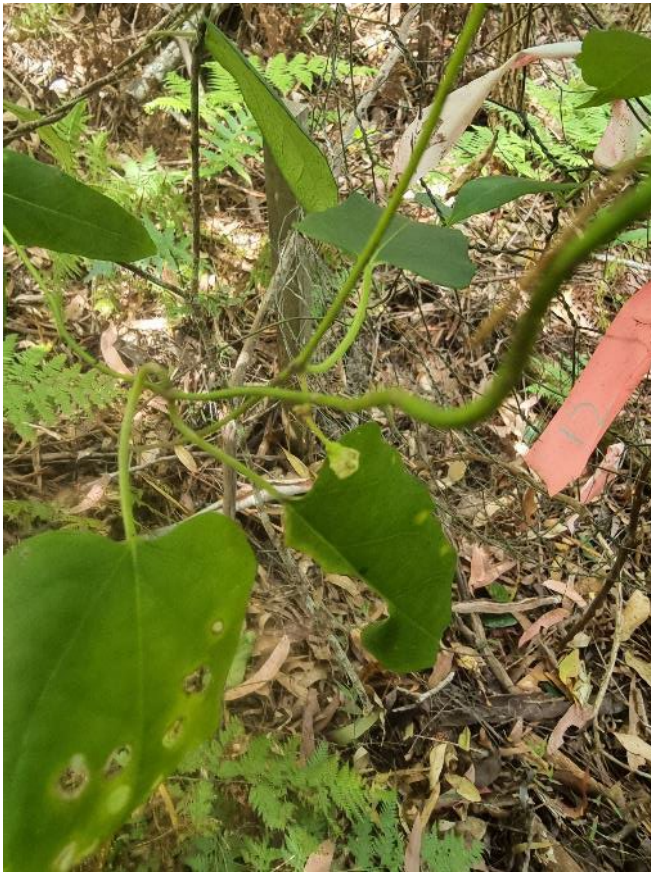
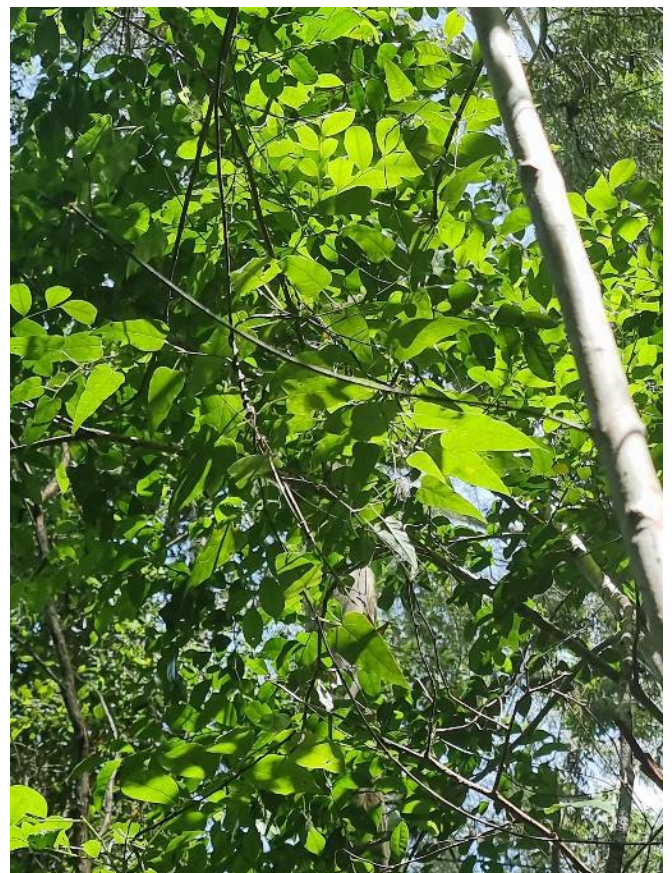
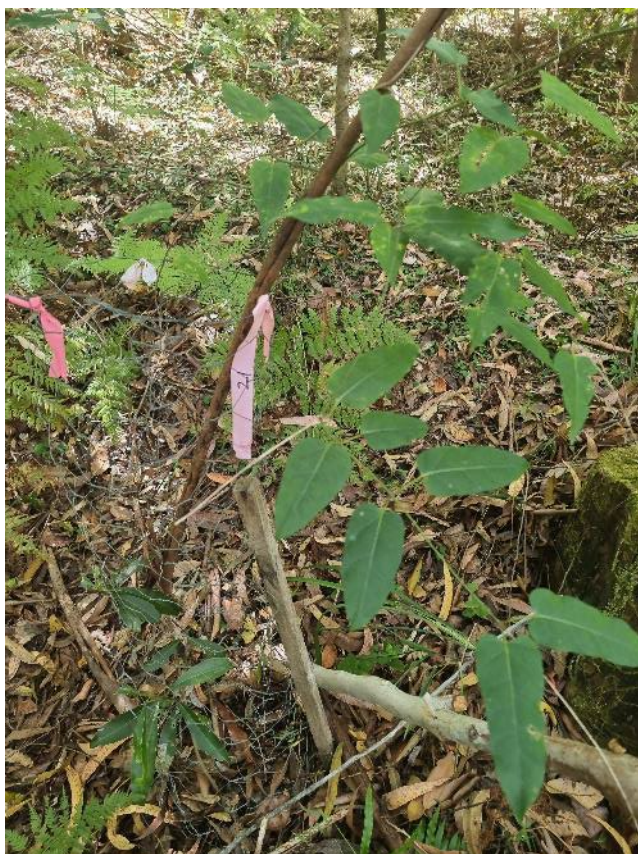
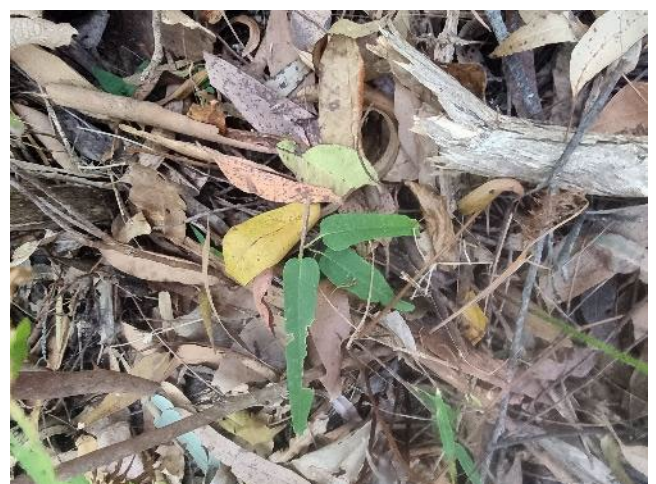
Plate 3: Top left. Recipient Site 8c, plant no. 12, flowering.

Plate 4: Top right. Recipient Site 8c, plant no. 20, tall plant, many leaves, in forest mid-stratum, flowering.

Plate 6: Bottom right. Recipient Site 8c, small plant 10 cm high.

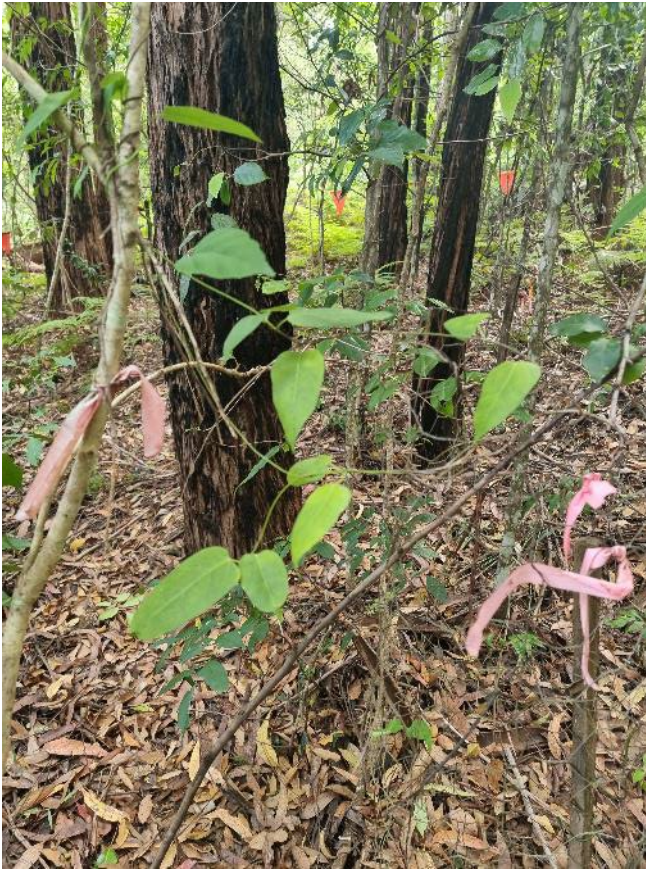
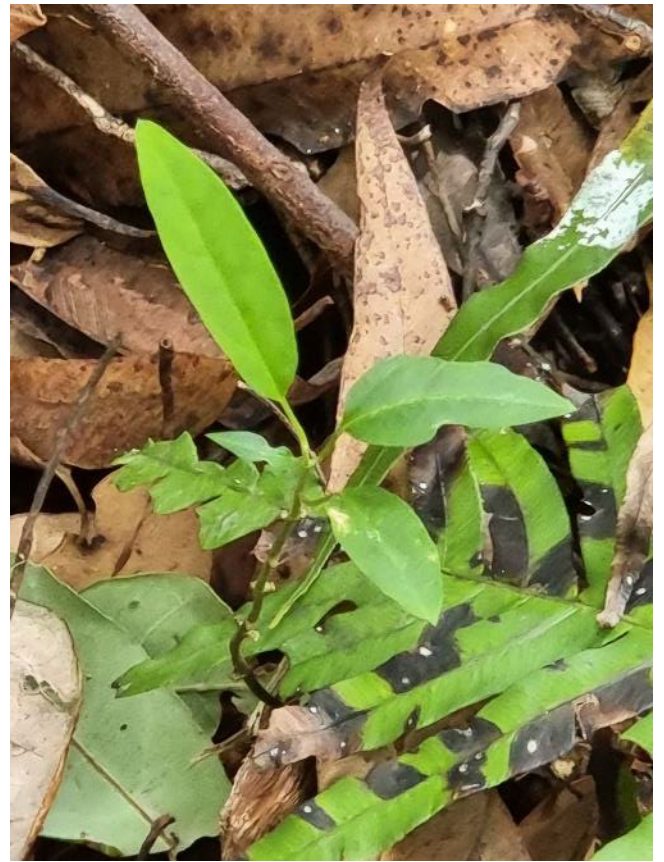
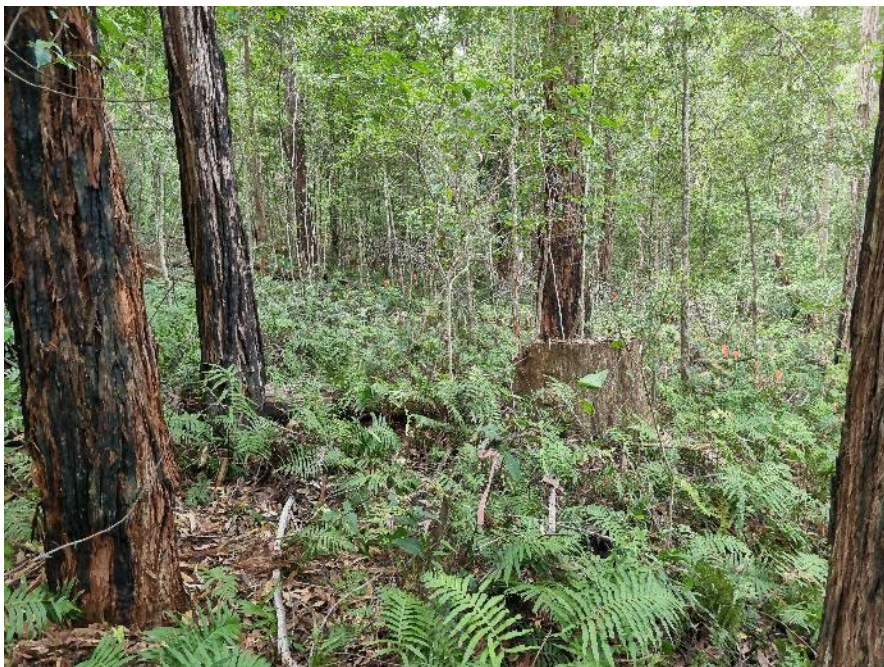
Plate 7: Top left. Recipient Site 7b no. 3, healthy, tall.

Plate 8: Top right. Recipient Site 7b no. 32, small plant 20 cm high, healthy.

Plate 9: Bottom left. Recipient Site 7b, view of habitat showing shady understory with dense ground layer of Gristle Fern (*Blechnum cartilagineum*).

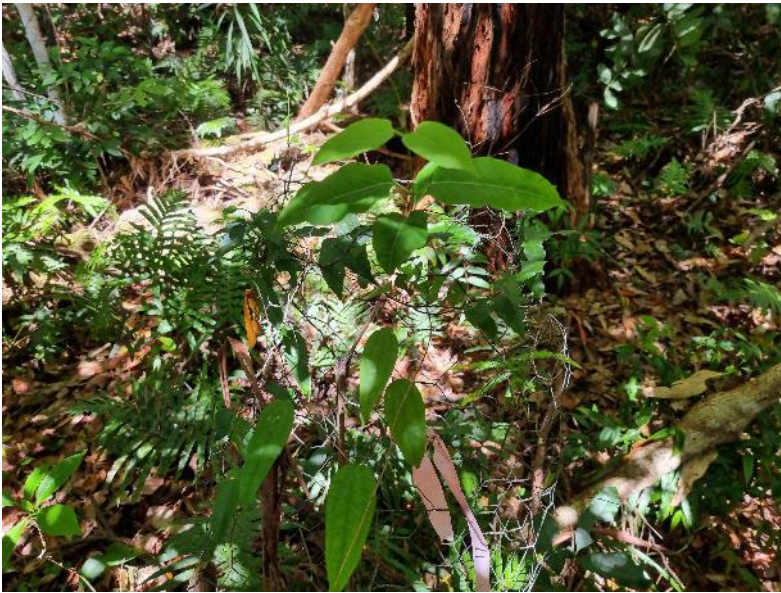
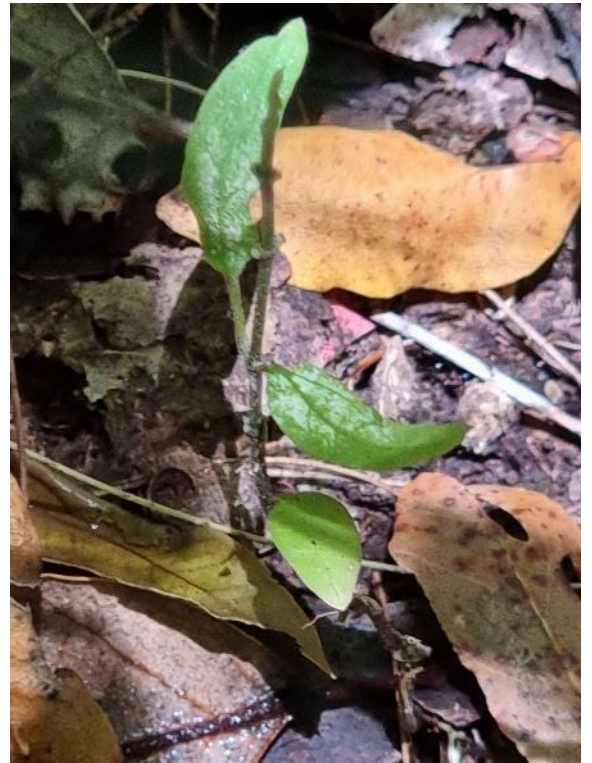
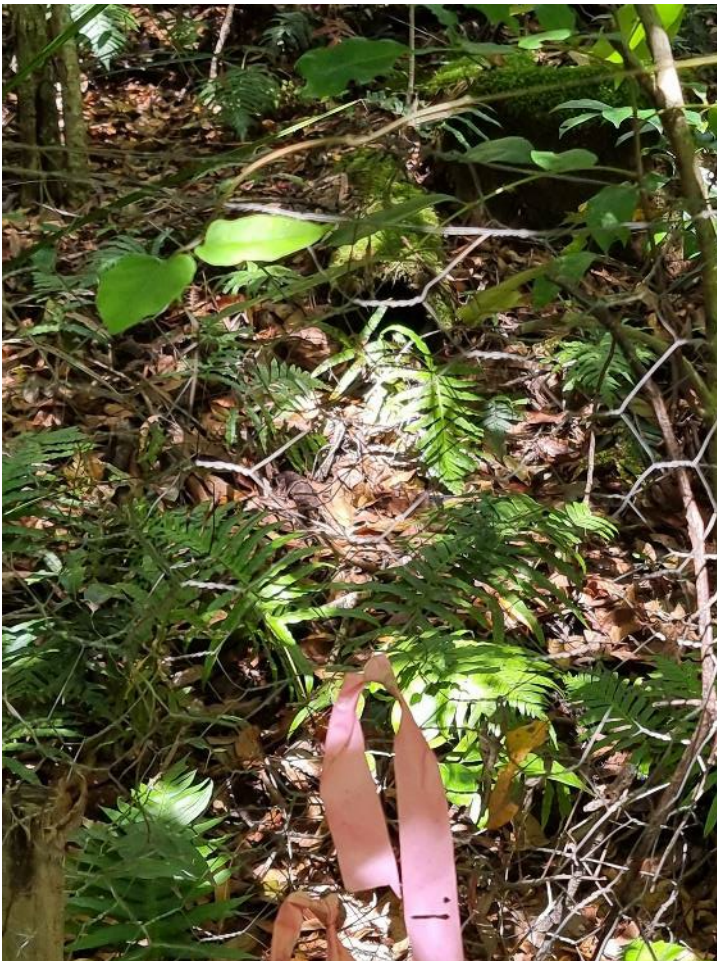
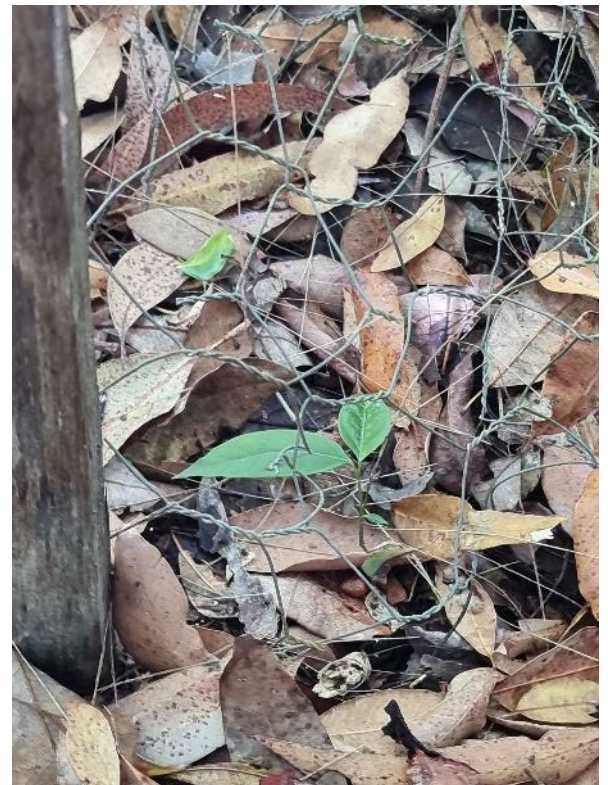
Plates 10 and 11: Recipient Site 5a. Top left plant no. 11, healthy tall. Top right plant no. 2, a small shoot. Bottom left plant no. 1, tall with few leaves. Bottom right plant no. 13, small plant with two leaves after eight years (this may be a recent shoot, but the plant hasn't grown any higher in eight years).

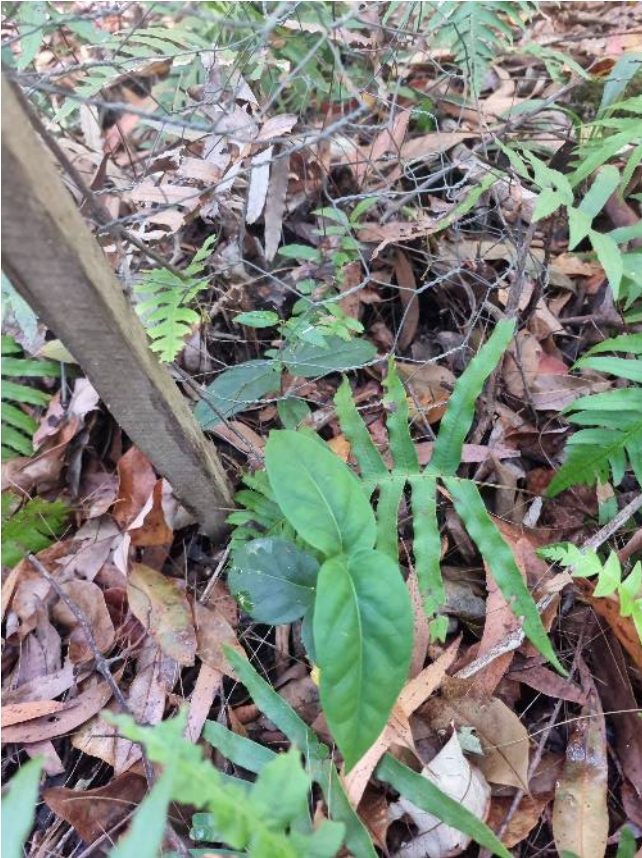
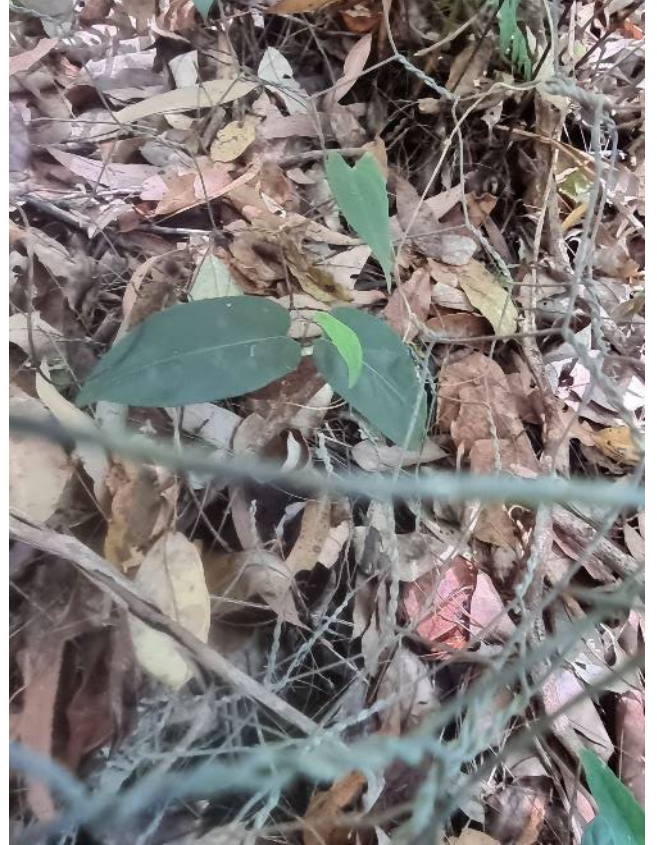
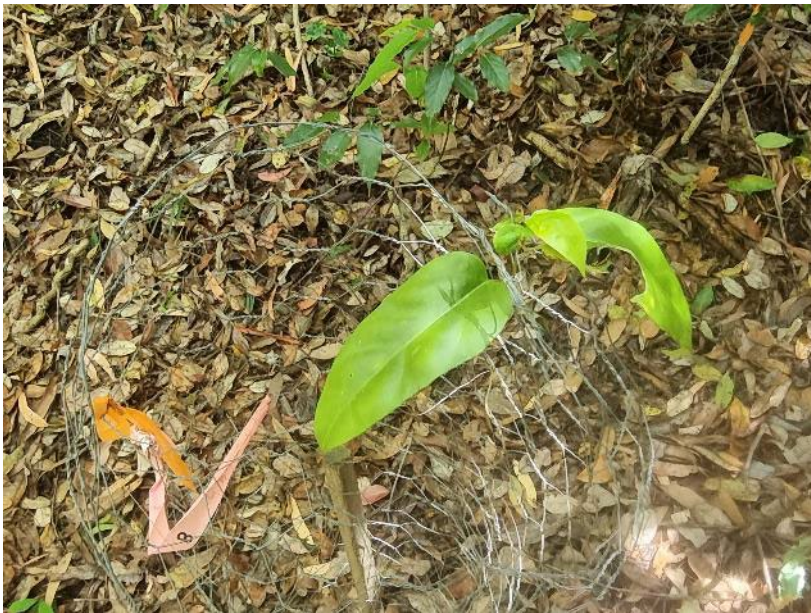
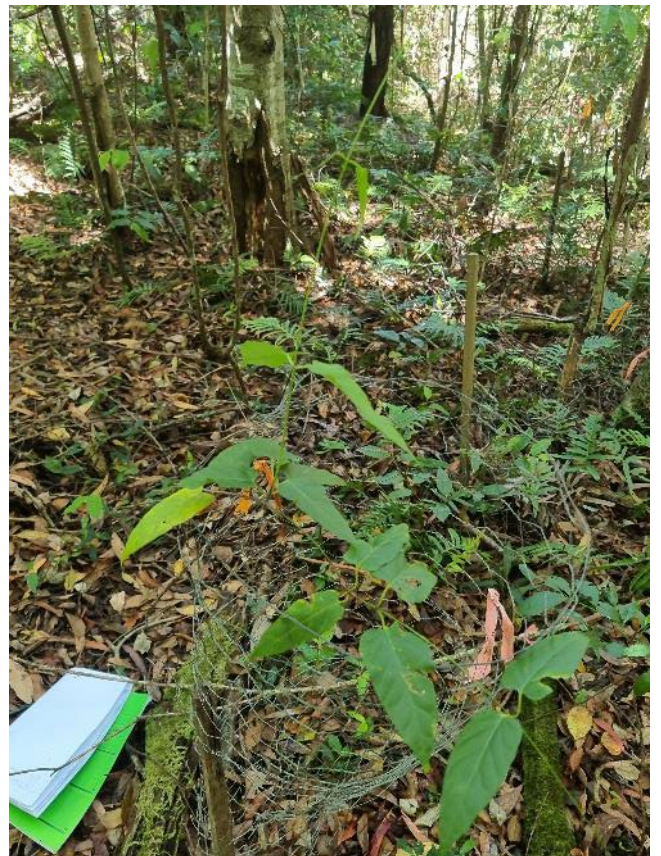
Plates 12 and 13: Recipient Site 5b. Approximately half the Marsdenia's translocated to this site turned out to be Large-flowered Marsdenia (*M. liisae*), a rare species, but not listed as threatened. It has larger leaves than *M. longiloba*. Three photos are *M. liisae*, bottom right is *M. longiloba*, plant no. 14.

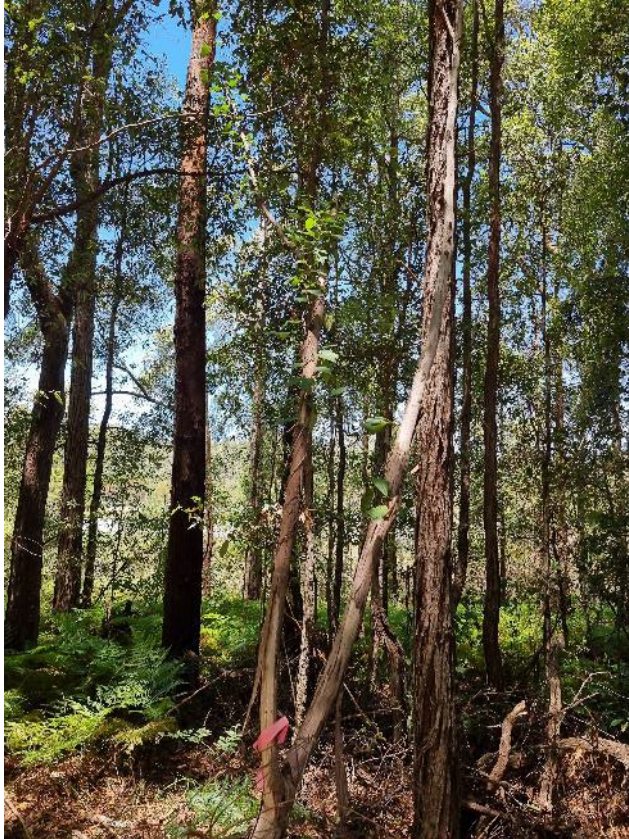
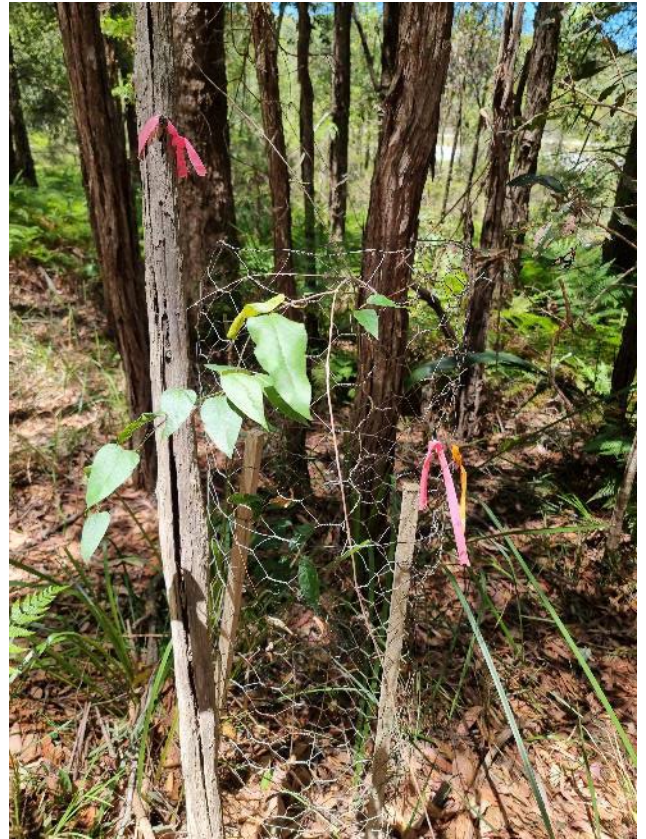
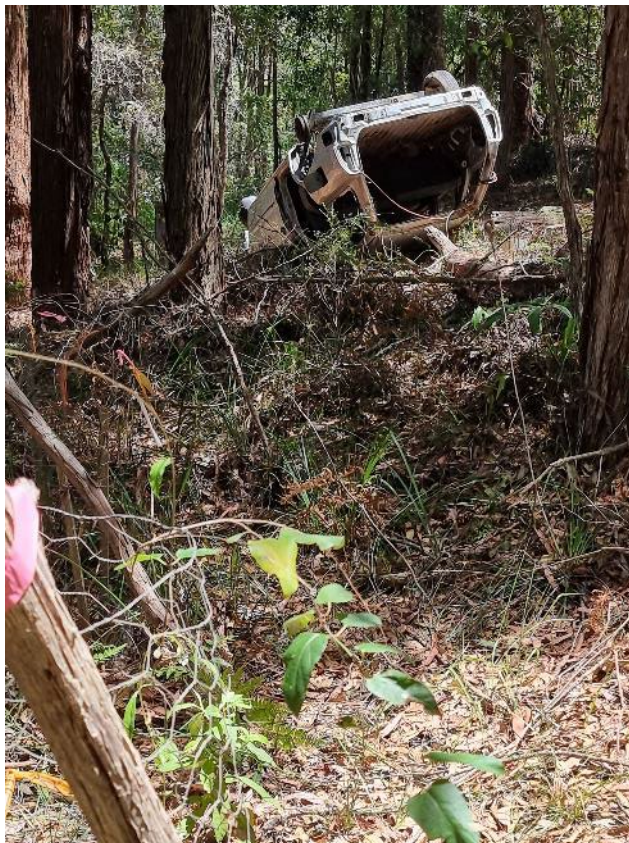
Plates 14 to 16: Recipient site 3.

Top left – plant no. 2 about 5 metres high with the assistance of a dead sapling placed for it to climb up into young trees.

Bottom left – this dumped car and other rubbish have been removed, but there is no sign identifying the site as a Threatened Flora Translocation Area, increasing the risk of this happening again.

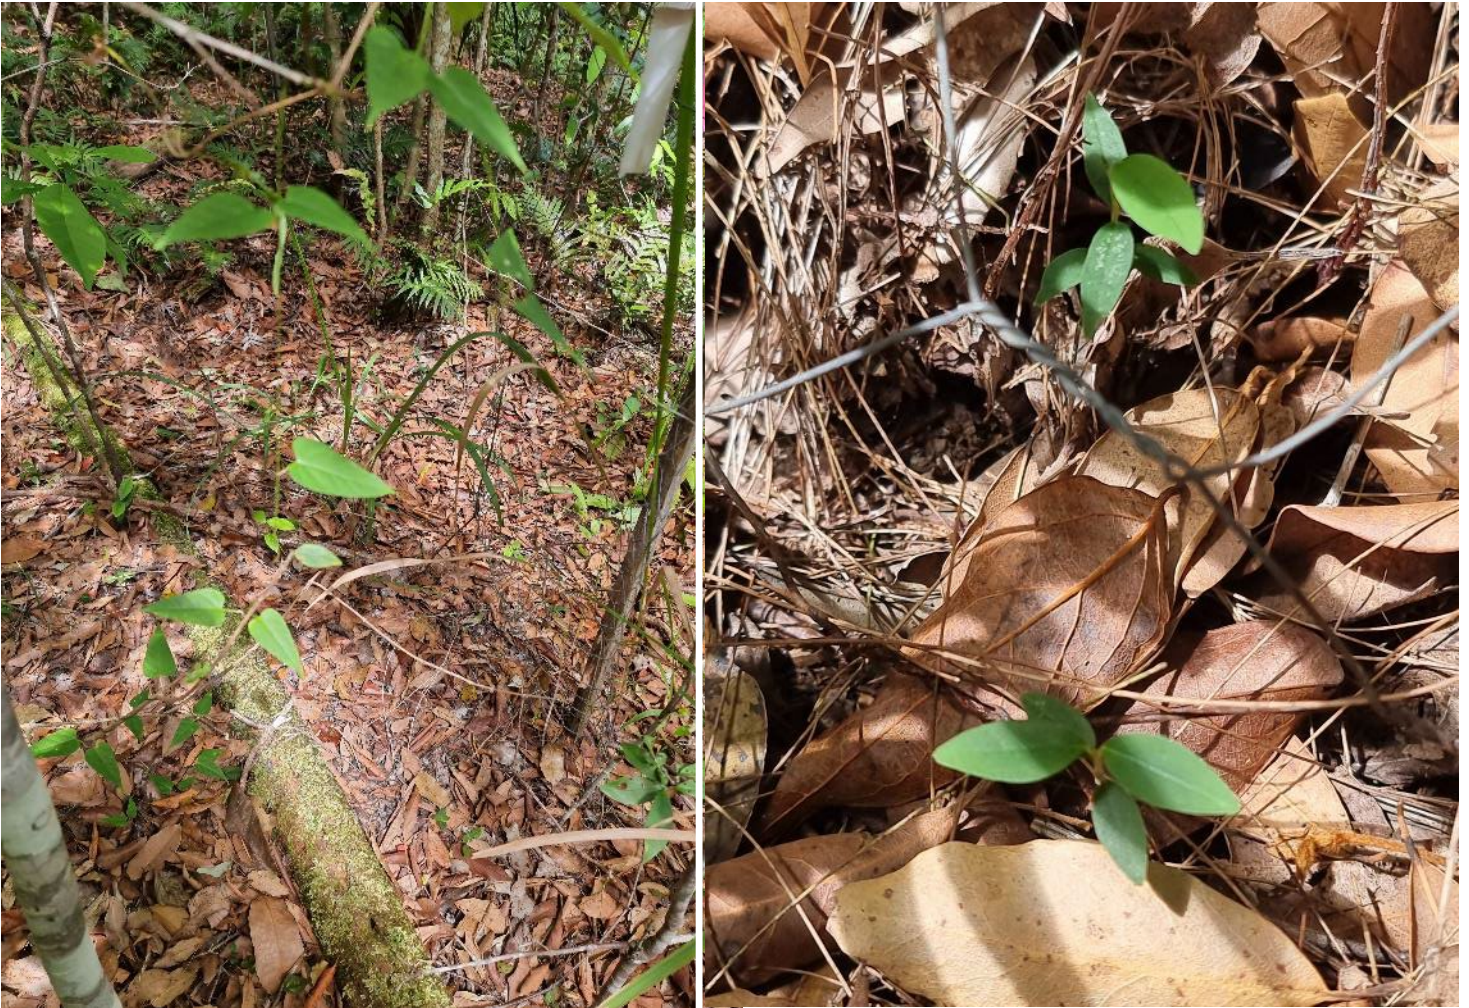
Plate 17 and 18: Recipient Site 1. Left - plant no. 19 about 80 cm high. Right - plant no. 14 consisting of two small shoots that shot from roots underground in the last 12 months.

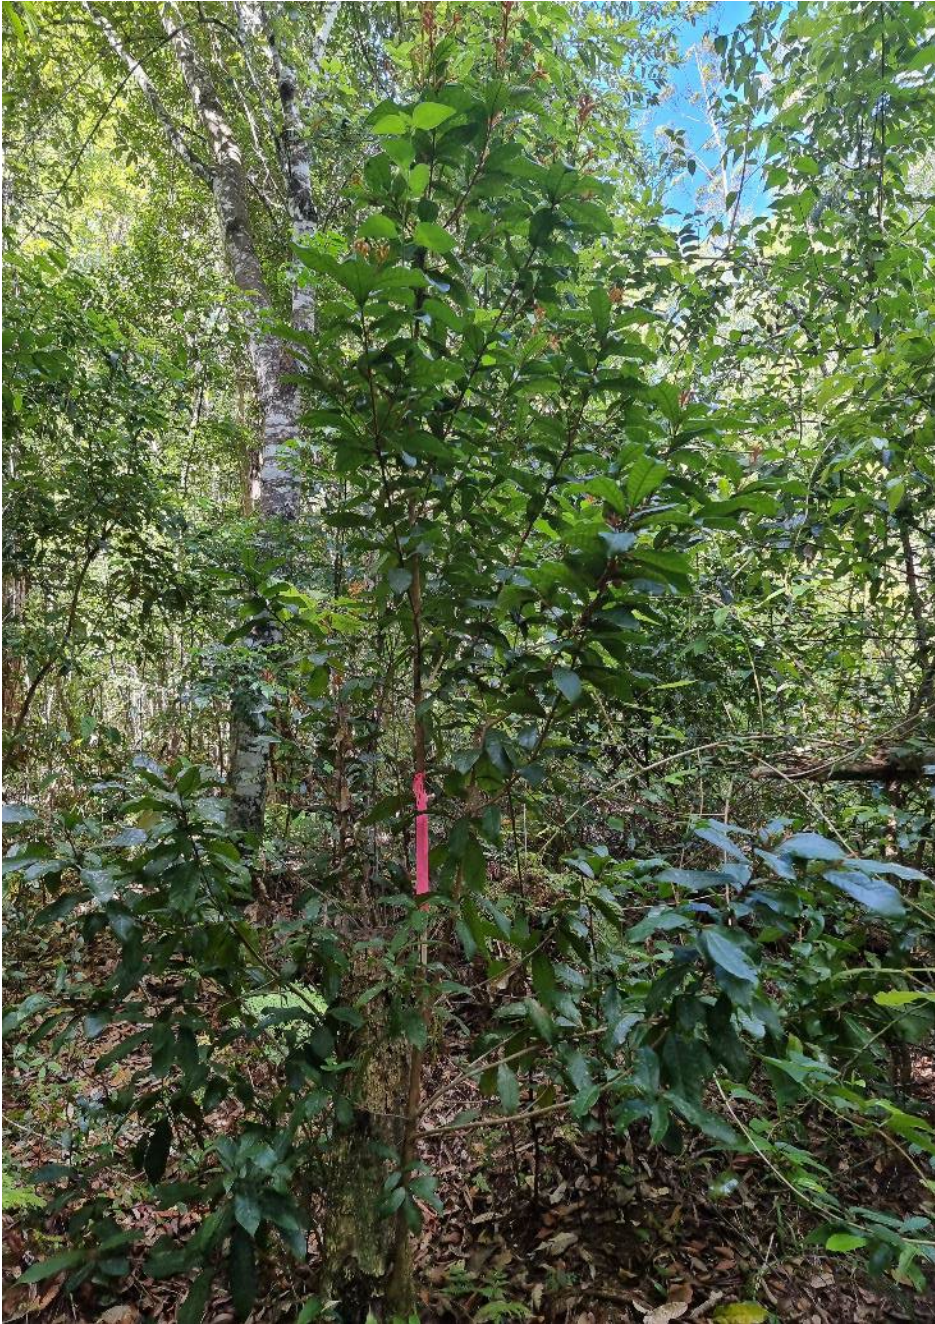
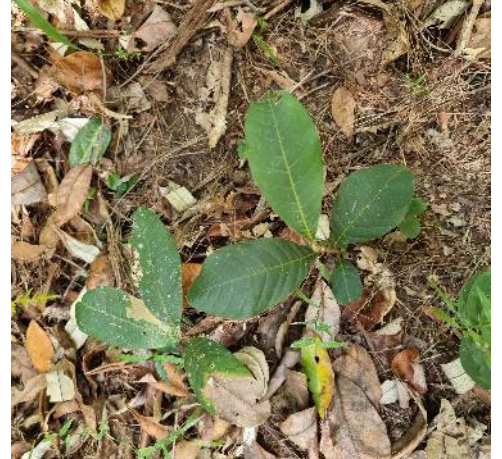
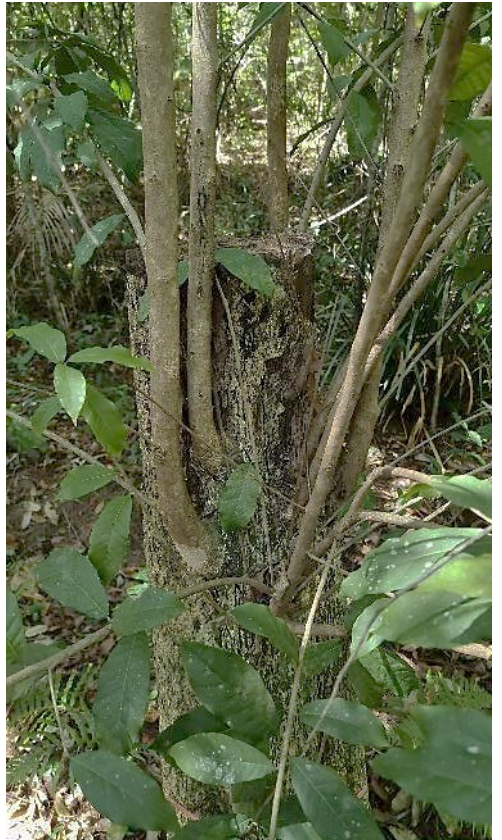
Plates 19 to 21: Left – transplanted Rusty Plum after eight years has regrown from stump of bare rooted tree.

Top right – seedling recruited from one of the transplanted trees two years ago, still surviving, growing very slowly.

Bottom right – transplanted Rusty Plum, multiple coppice stems have shot from a stump about 0.7 m high

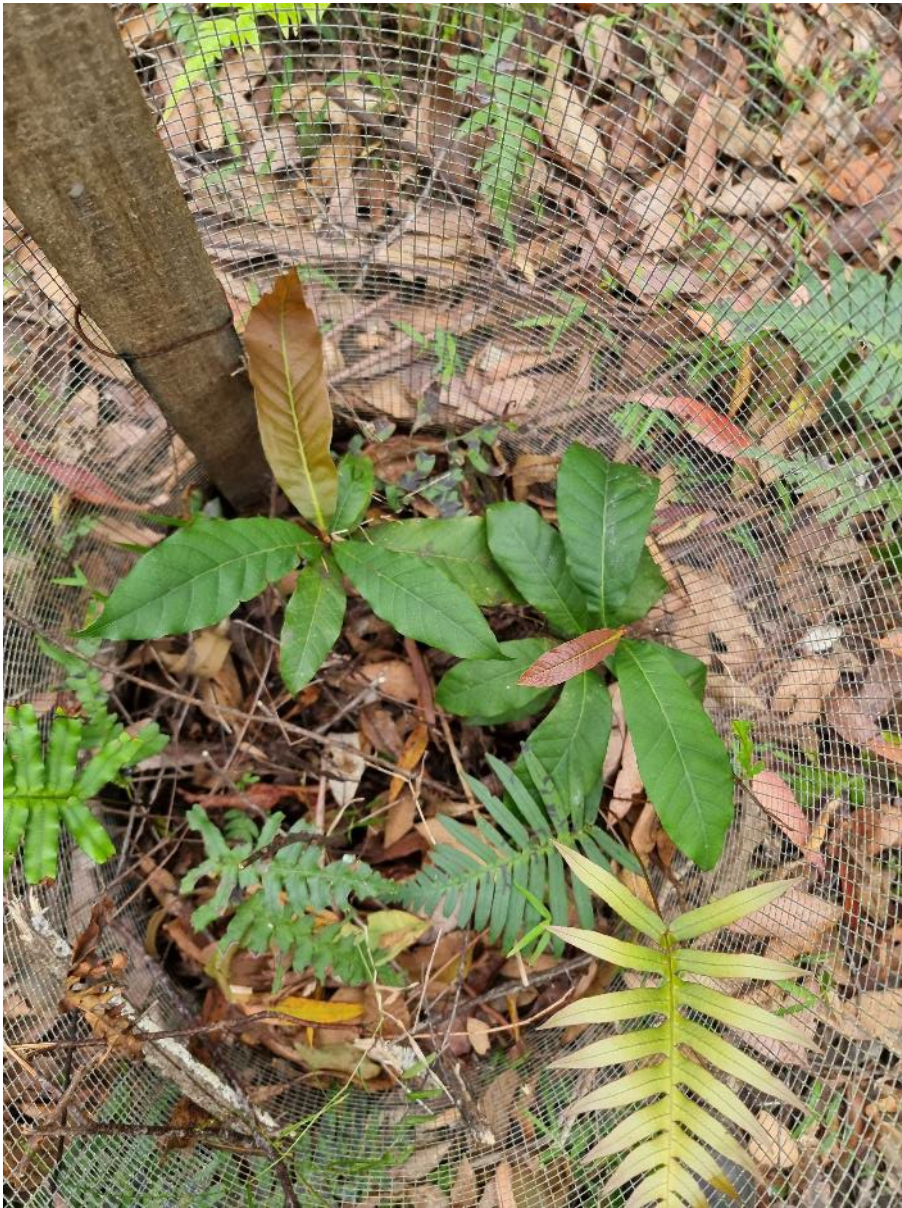
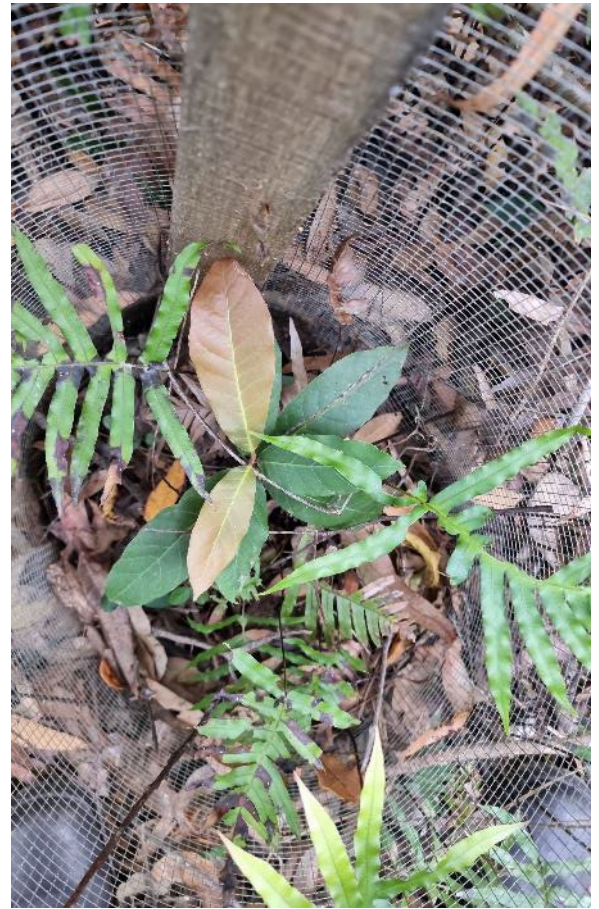
22and 23: Recipient Site 7a. Rusty Plum translocated by direct seeding locally collected seed into protective wire mesh cylinders. Three seeds were placed in each cylinder. After five years, two seedlings survive in one cylinder and one in the other. The seedlings are about 25 cm high and healthy, but slow growing. .

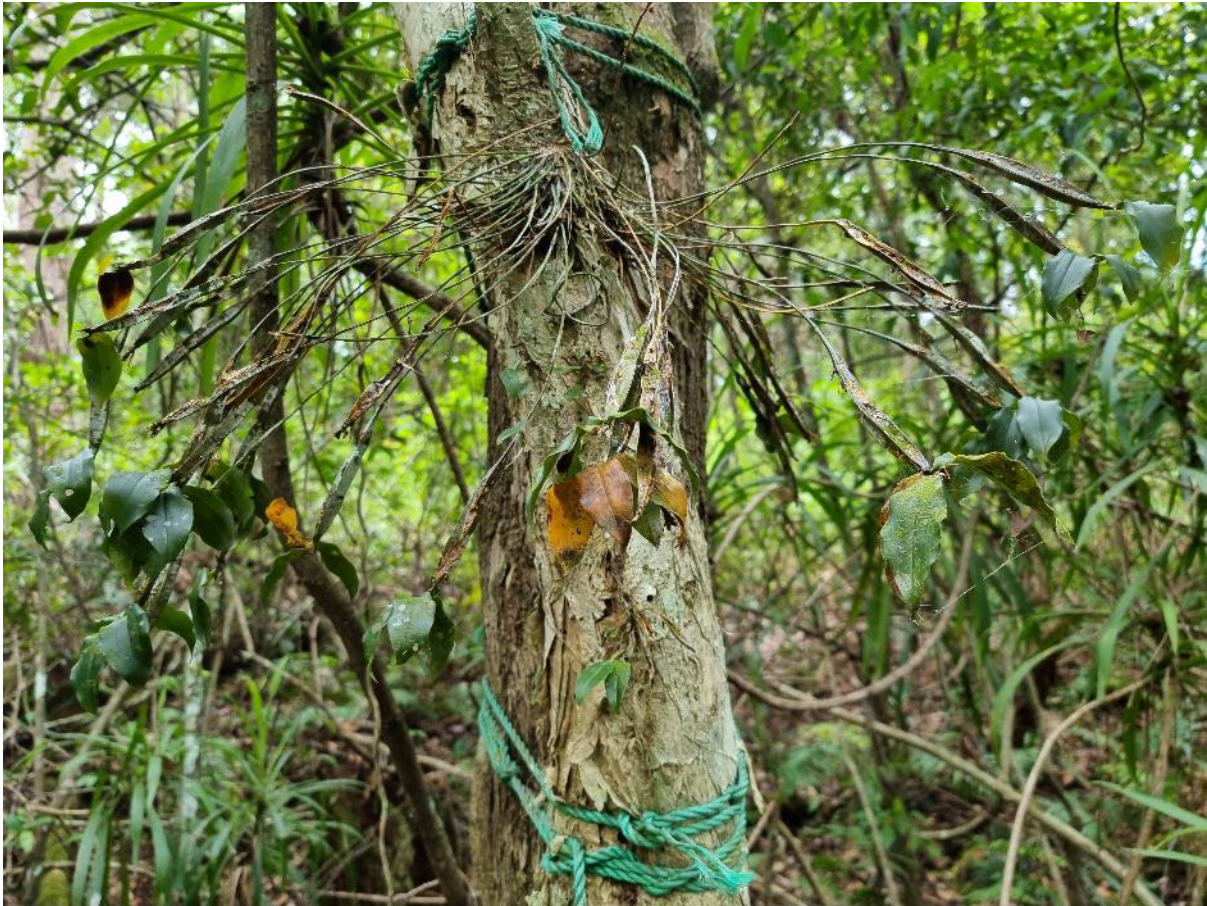
The orchid clumps declined in size (number of pseudobulbs) between 2020 and 2022. As observed with the in-situ plants, pseudo-bulbs were being grazed, stripping off the surface green tissue layer and hollowed out, probably by an insect or mollusc. A few new pseudobulb shoots were present in 2021 and 2022, compared to many in previous years. Decline may have been due solely to the grazer, or the branch substrate may have been supplying less nutrient. More than half the pseudobulbs in each clump flowered in 2022, so they must still be in reasonable condition, despite grazing.

Plate 24: Translocated Spider Orchid (*Dendrobium melaleucaphyllum*) in Recipient Site 7b. The clump of orchid pseudobulbs was moved attached to the small paperbark branch it was growing on and tied onto the tree trunk behind. The number of pseudobulbs or orchid stems has decreased by half since being moved, but remaining pseudobulbs are still in fair condition. The pseudobulbs have flowered in spring every year since being moved (as indicated by dried up flower spikes) but no seed pods formed, probably due to absence of an insect pollinator. Two orchid clumps were translocated, the second with fewer pseudobulbs than this one.

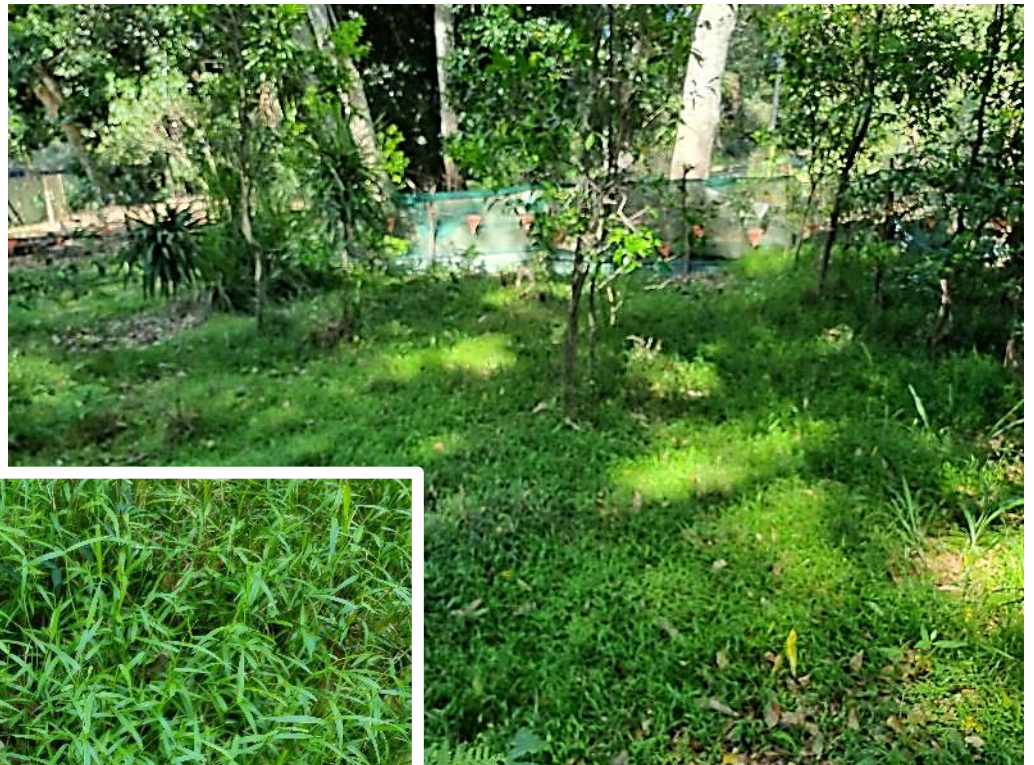
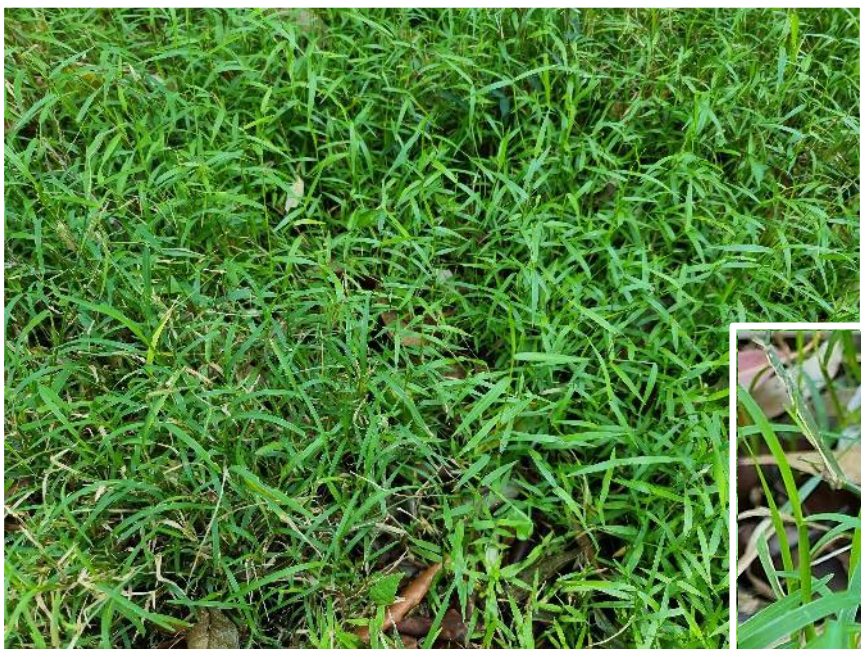
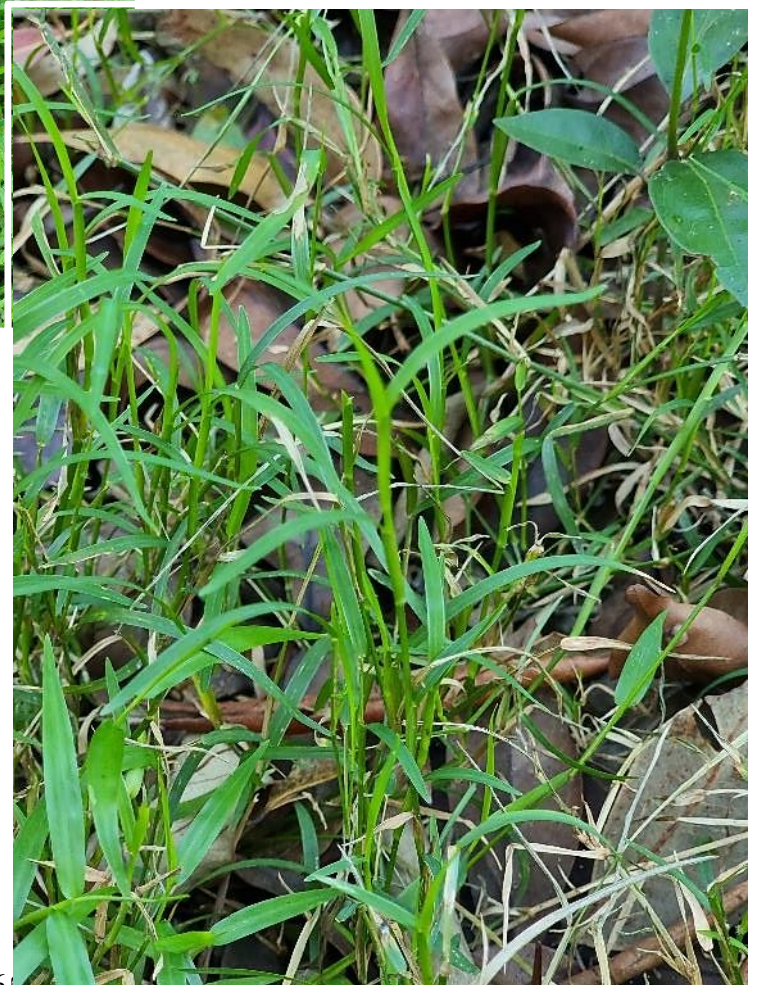
Plates 25 to 27: Floyds Grass Recipient Site 9a

Top – southeast end of Recipient Site 9a with dense *Ottochloa gracillima* (a native mat forming grass) suppressing Floyds Grass

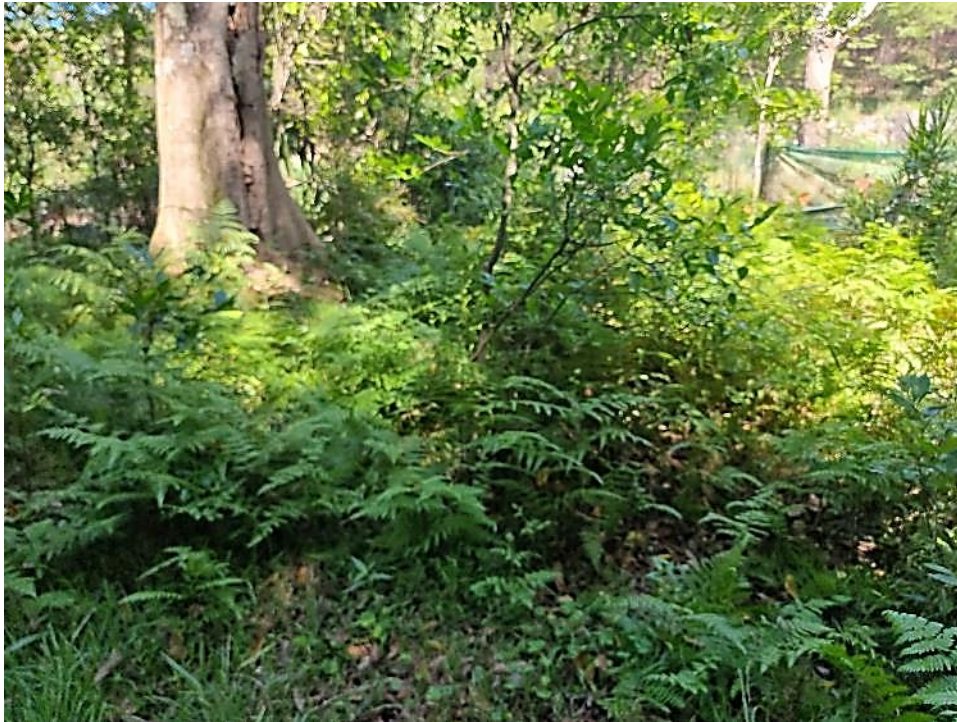
Plate 28: Recipient Site 9a. Another plant displacing Floyds Grass since last year is the native ground fern *Hypolepis muelleri* (Harsh Ground Fern), which overops and smothers Floyds Grass.

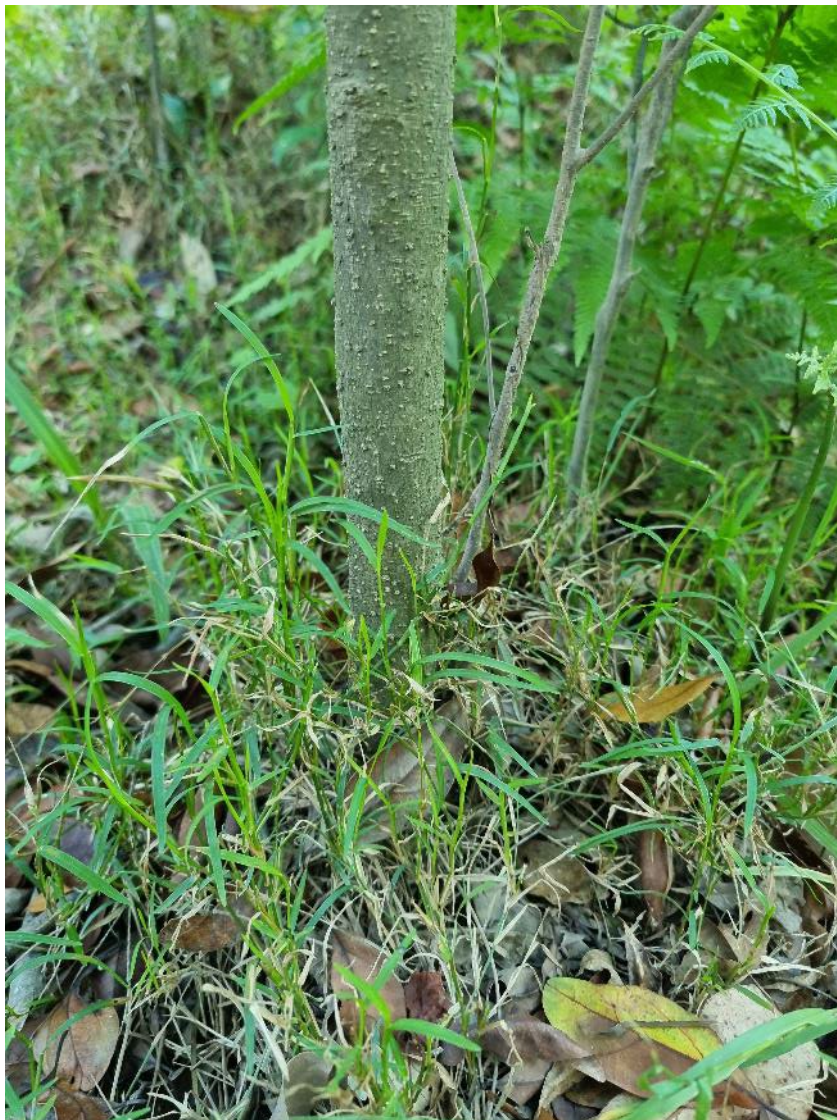
Plate 29: Recipient Site 9a.
Floyds Grass tries to escape smothering *Ottochloa* and Harsh Ground Fern by using the stems of small woody plants for support to climb above them, seen here.
