**Operational Phase Monitoring of Threatened Flora
Translocations, In-situ Threatened Plants and Slender Marsdenia and Woolls'
Tylophora Habitat Condition on the Warrell Creek to Nambucca Heads Highway
Project – Year 5 (2022)**

Prepared by:

ECOS Environmental Pty Ltd

14/4/2023

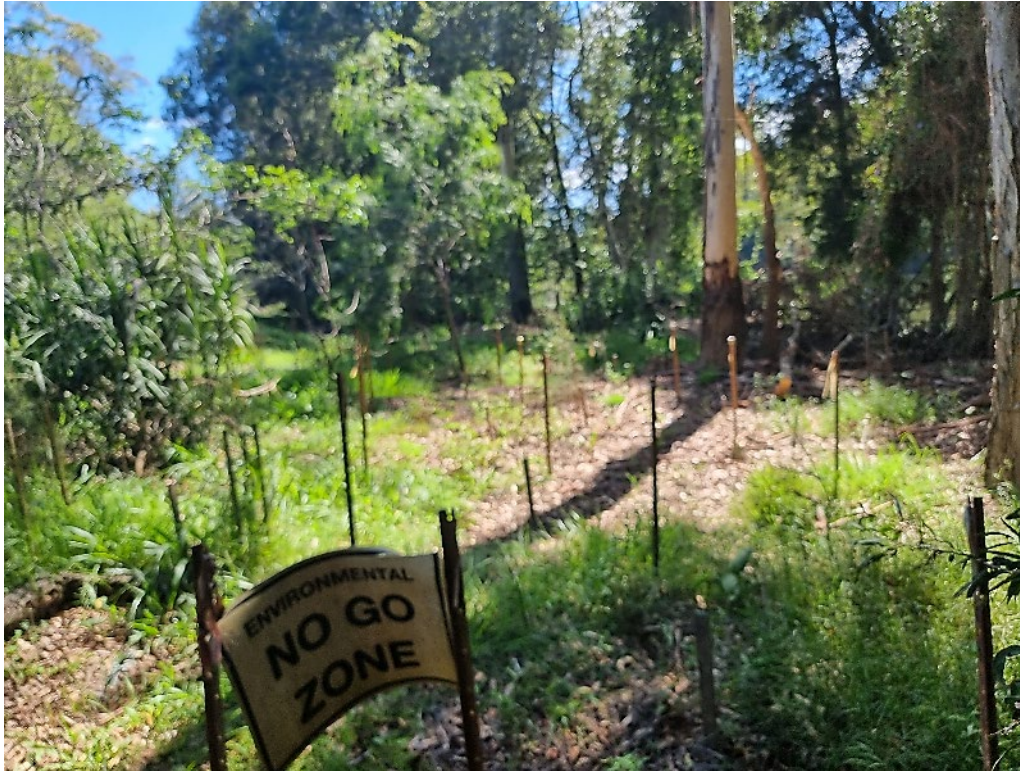
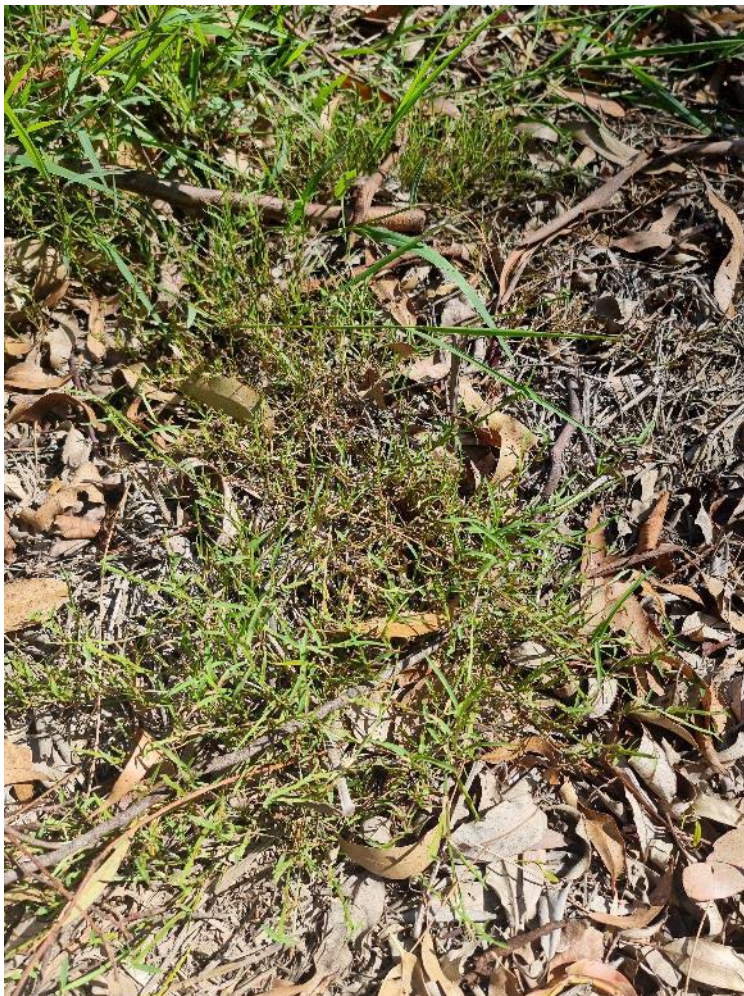
Plate 30 and 31: Recipient Site 9b

Top – After weeding Site 9b has a low cover-abundance of exotic Broad-leaved Paspalum but small amounts of remaining Floyd Grass shows little response.

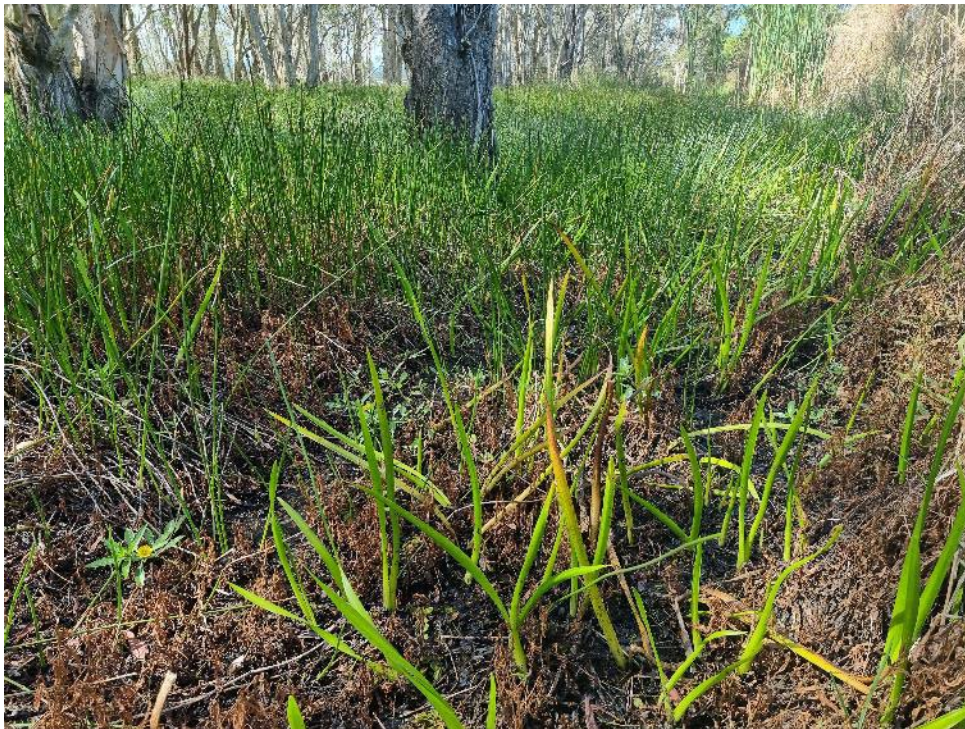
Plate 32: Maundia in-situ site on Nambucca floodplain next to highway at Macksville, Maundia regrew rapidly after the drought ended in early 2020.

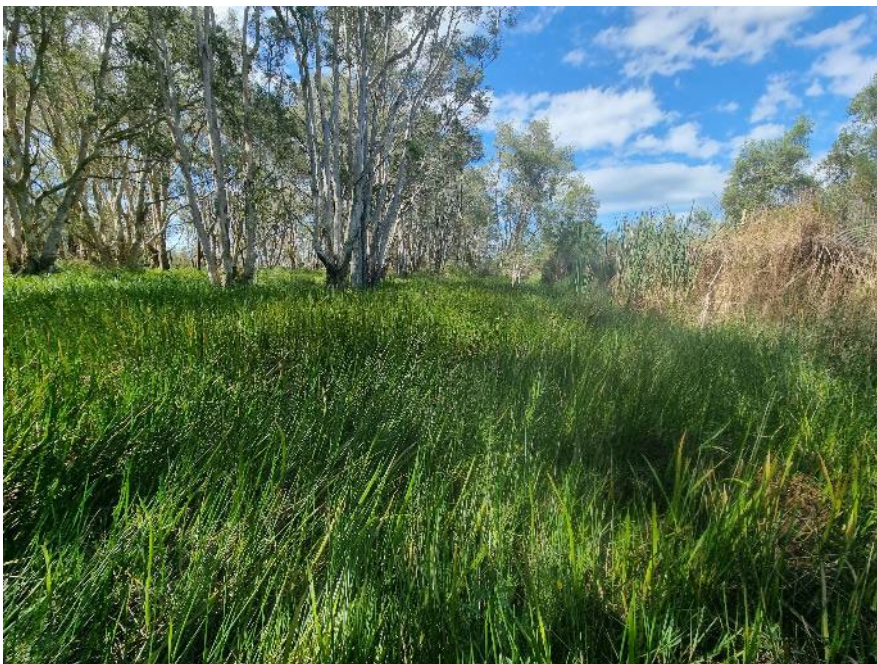
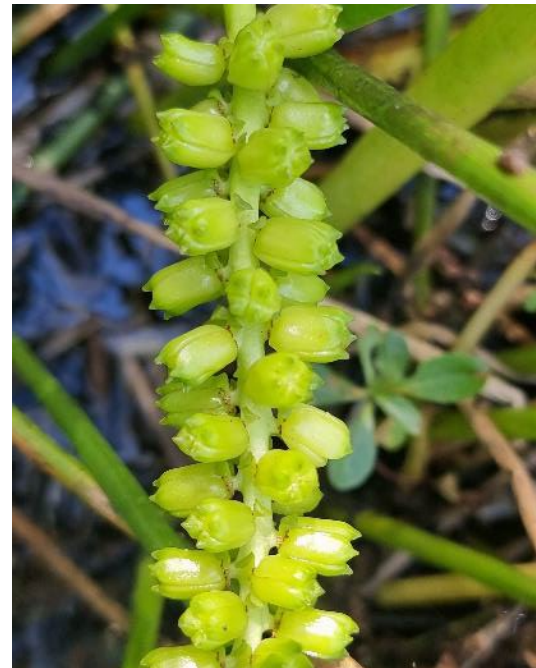
Plates 33 and 34: Left - Maundia growing in open paperbark swamp, sprayed grass on fauna fence and highway on right hand side. Right – spike of Maundia seed capsules ripening December 2022.

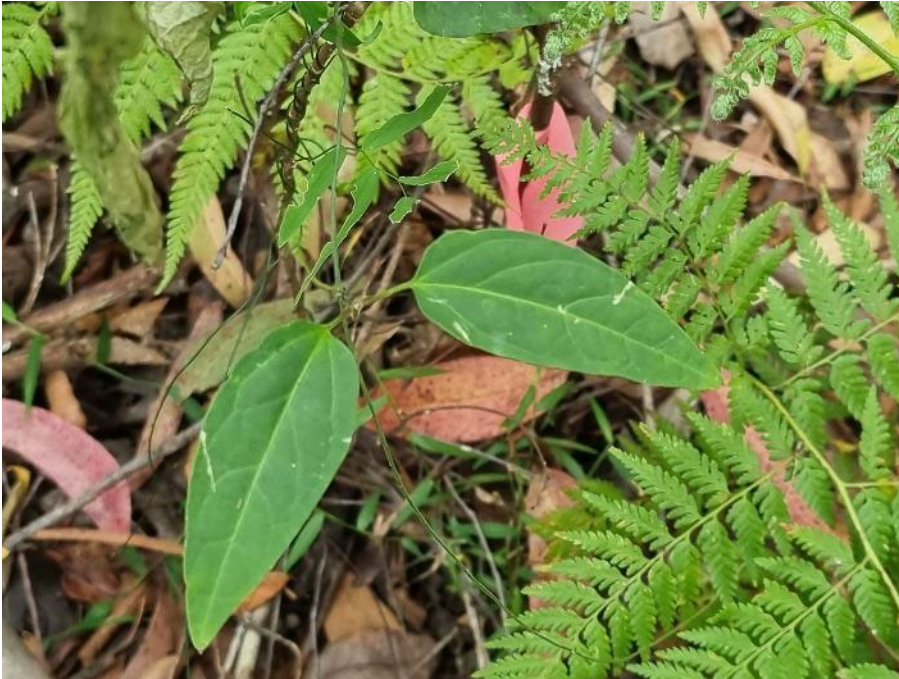
Plates 35 and 36: Slender Marsdenia no. 132 off Old Coast Road next to the highway.

This small patch of stems has maintained similar height for eight years. The plant in the photo to the right grew about 1.5 m high then died back to the ground. The small plant above had grown where the previous stem had died back so is probably from the same plant's root system.

These stem dynamics are similar to those observed in the translocated plants.

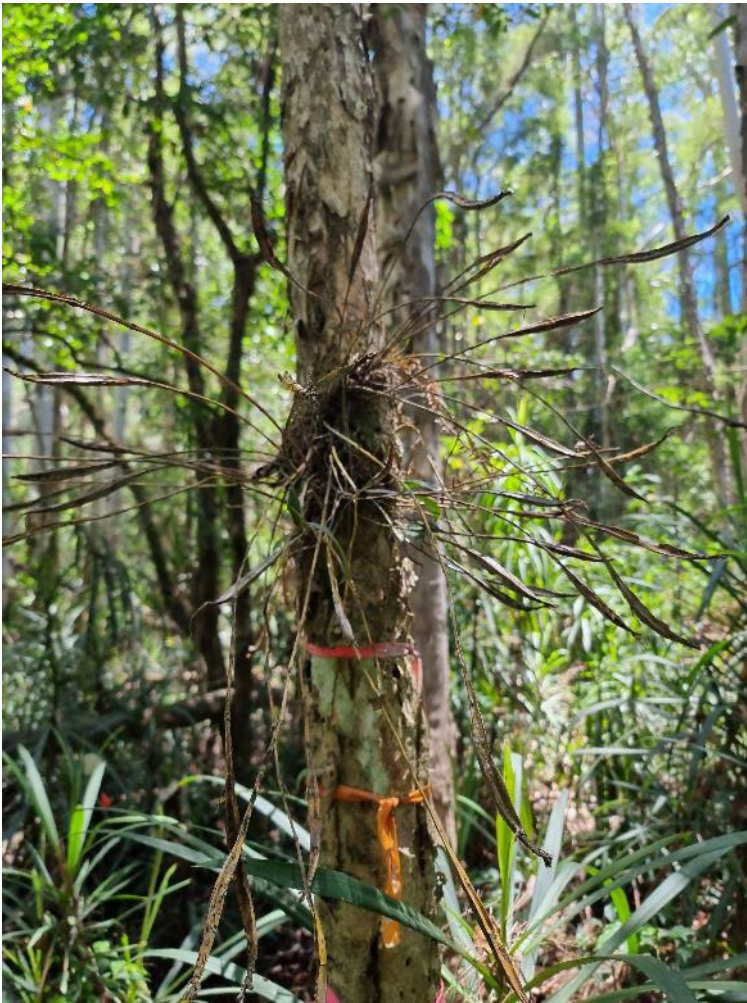
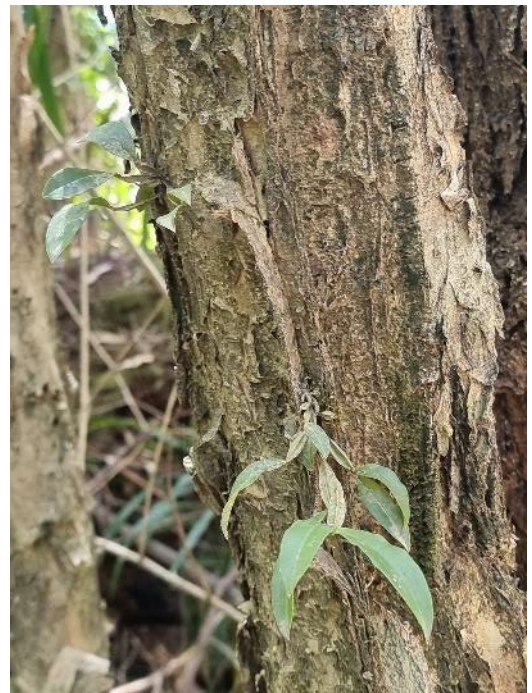
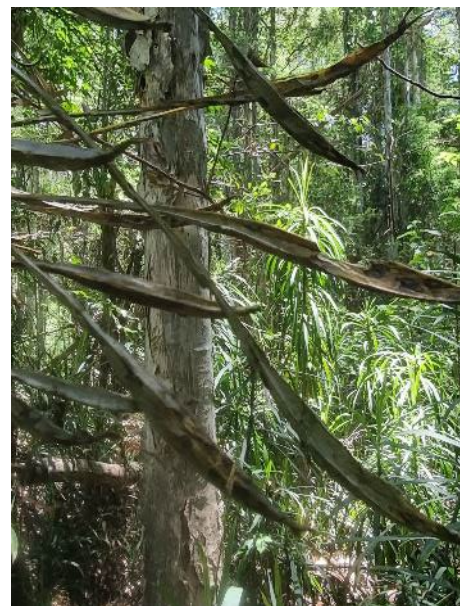
Plates 37 to 39: Top left – in situ orchid clump growing low down on a *Melaleuca stypheloides* trunk, the same situation as the translocated clump above.

Top right – small orchid recruits growing on the trunk below the main clump above. Unless these are vegetative shoots from the orchid's roots on the tree bark, they must be seedlings, indicating a pollinator was present during flowering and a pod formed. As no pods have been recorded in eight years, the seed event was probably 10 years ago or more, indicating the seedlings grow very slowly.

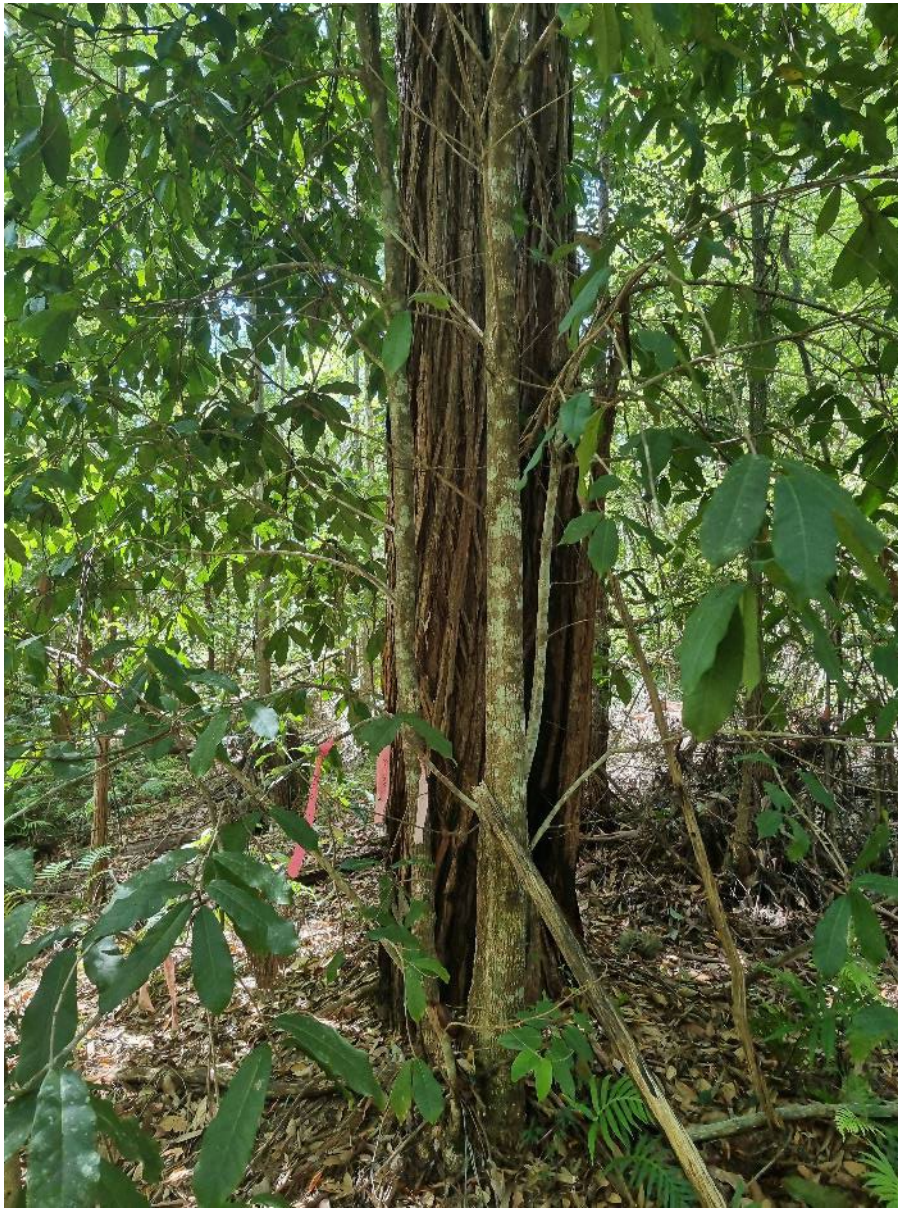
Plate 40: In situ Rusty Plum growing close to a turpentine with stringy bark behind, near Recipient Site 1

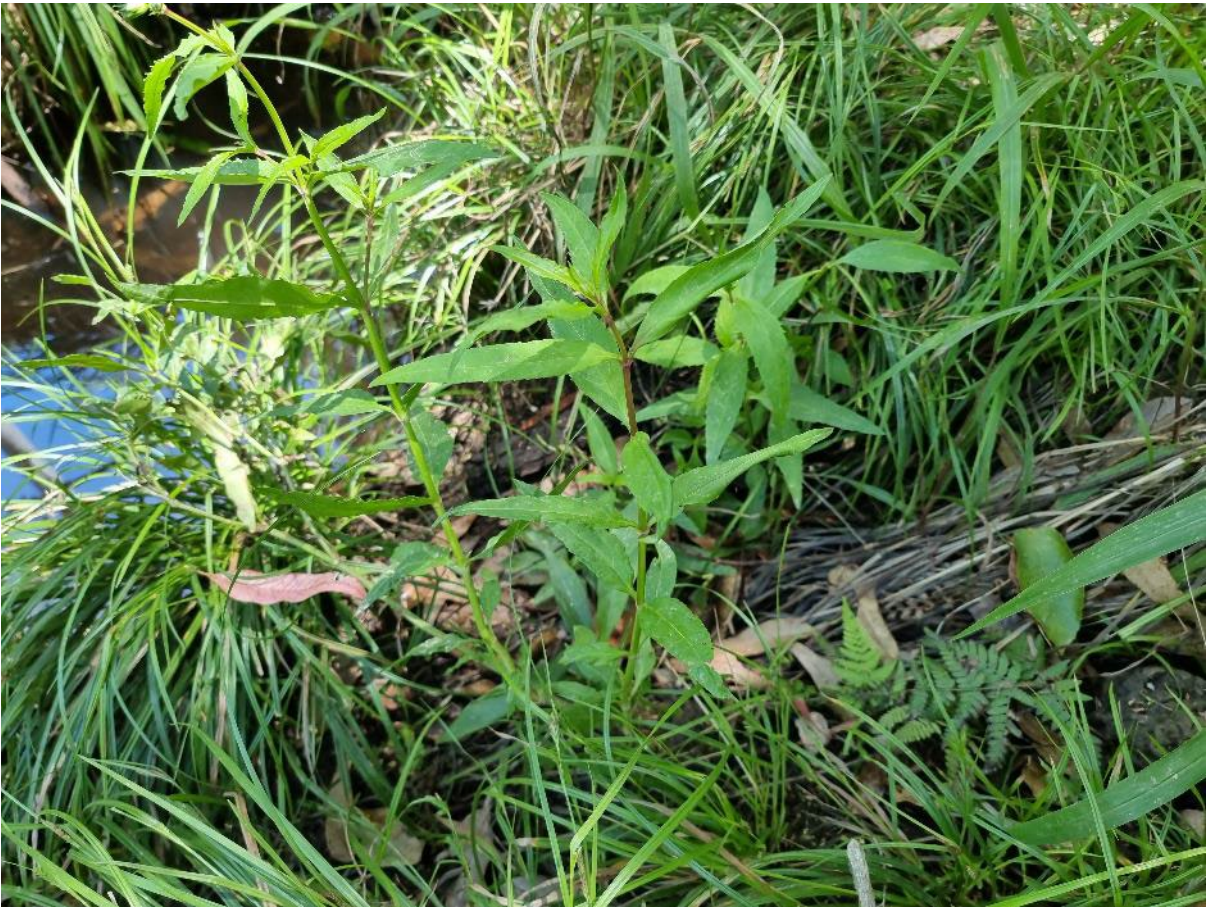
Plates 41 and 42. In situ Koala Bells growing on small creek bank next to Old Coast Rd.

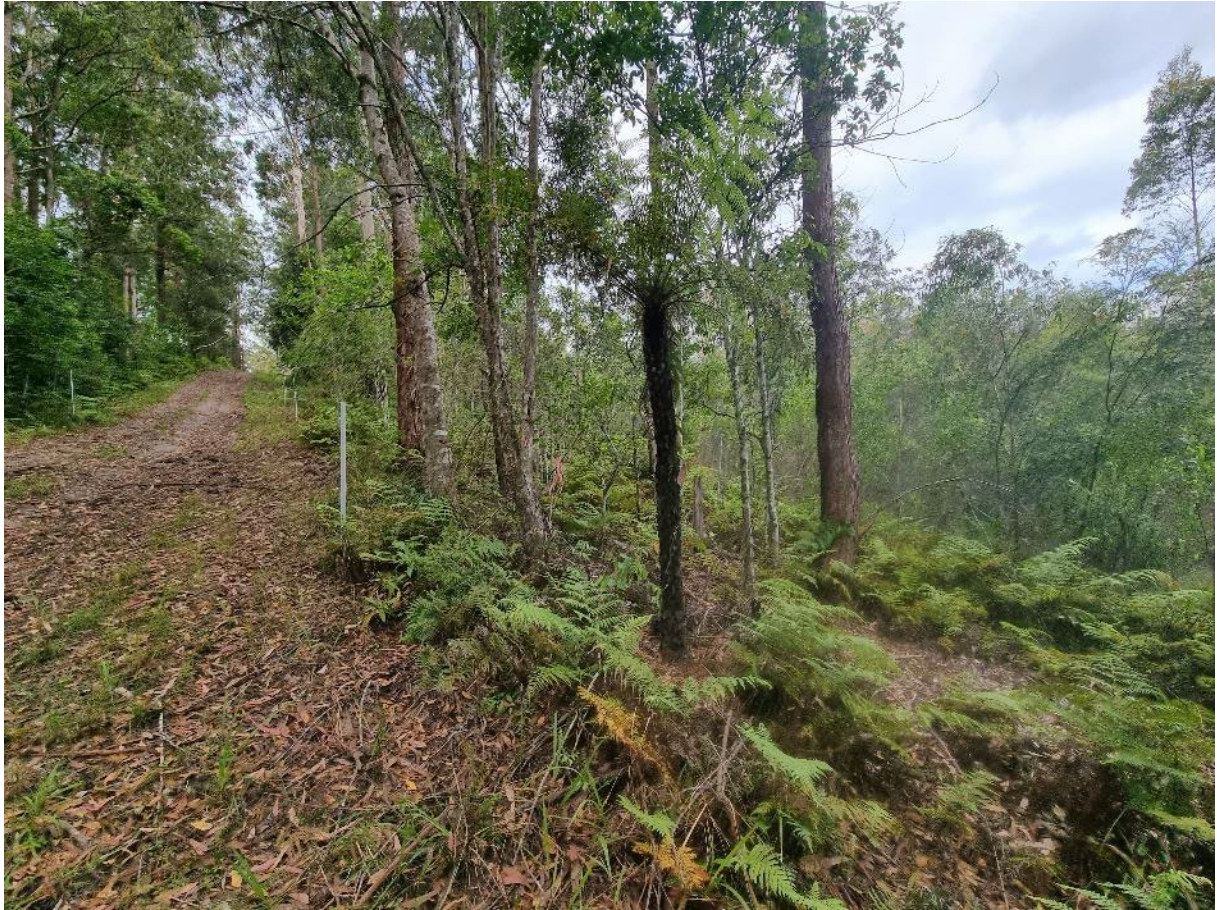
Plate 43: Habitat Condition Plot No. 7. Habitat in good condition, no exotic plants present.

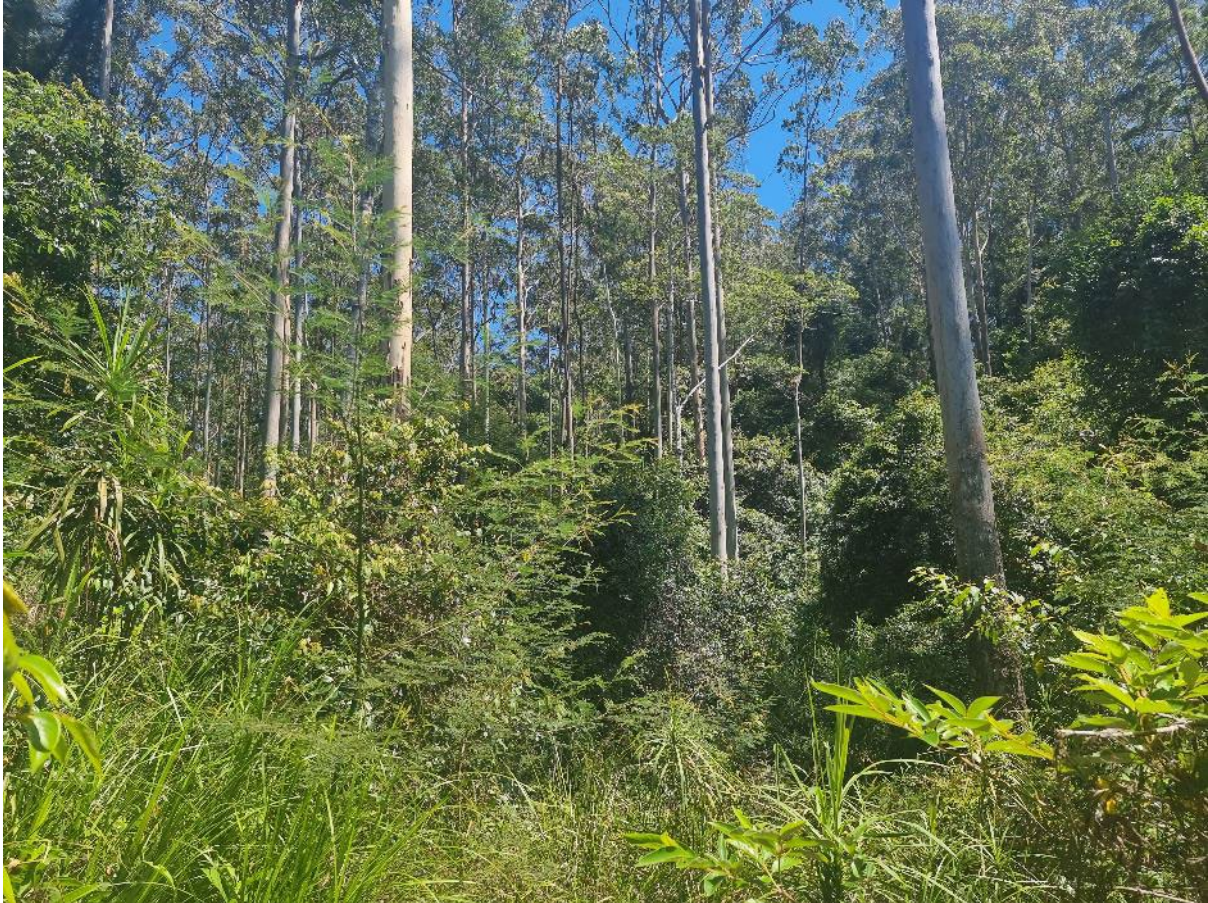
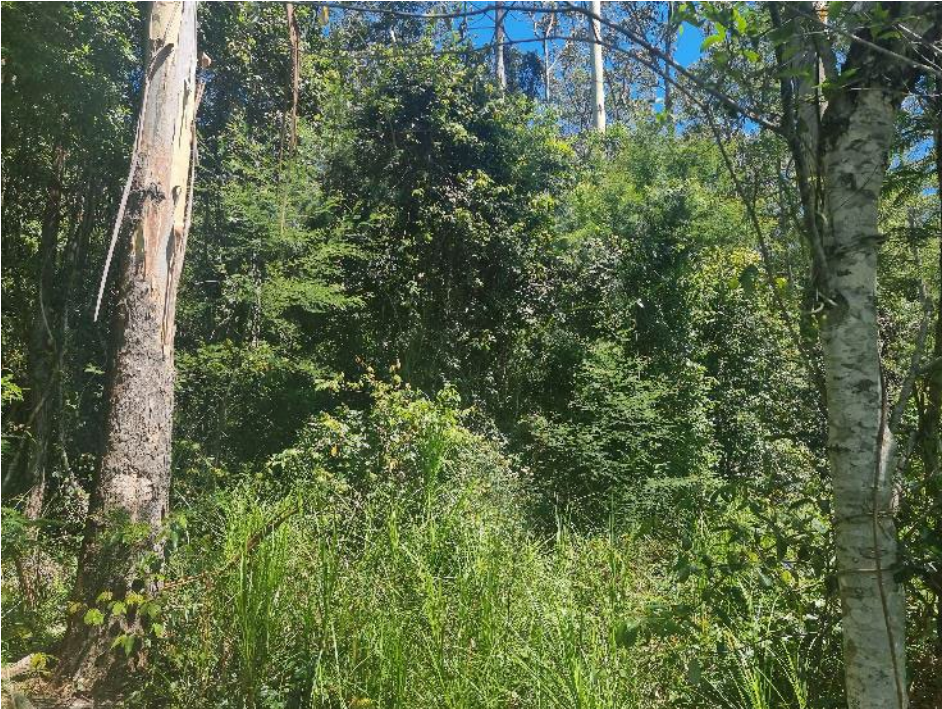
Plate 45 and 46: Habitat Condition Plots No. 5 and 6. Habitat in good condition, healthy native regrowth on forest edge, few exotics, minor Lantana.

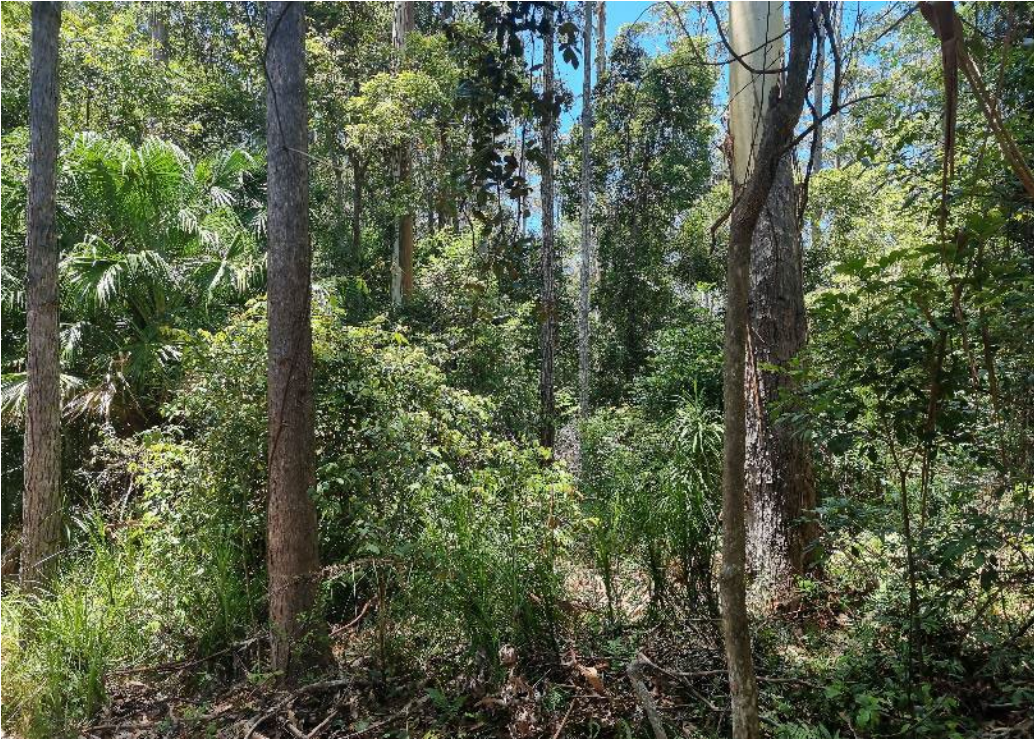
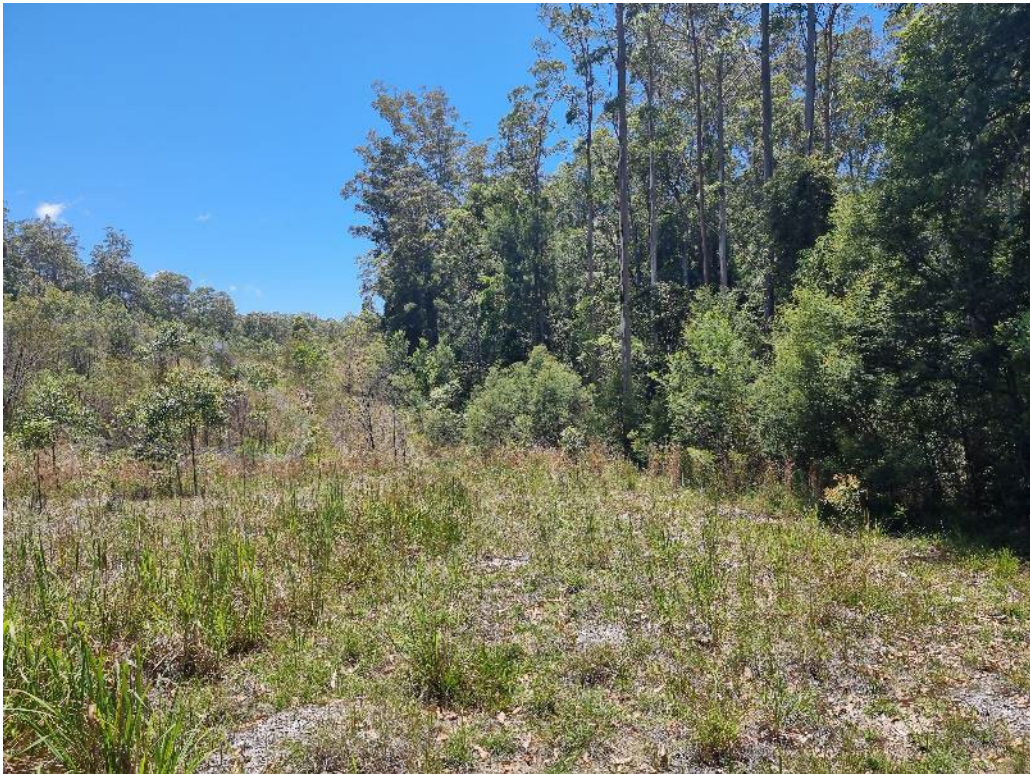
Plates 47 and 48: Habitat Condition Plot No.10. Habitat in good condition, healthy native regrowth on forest edge, no exotics inside forest, outside forest on cleared edge minor exotic grasses and weeds.

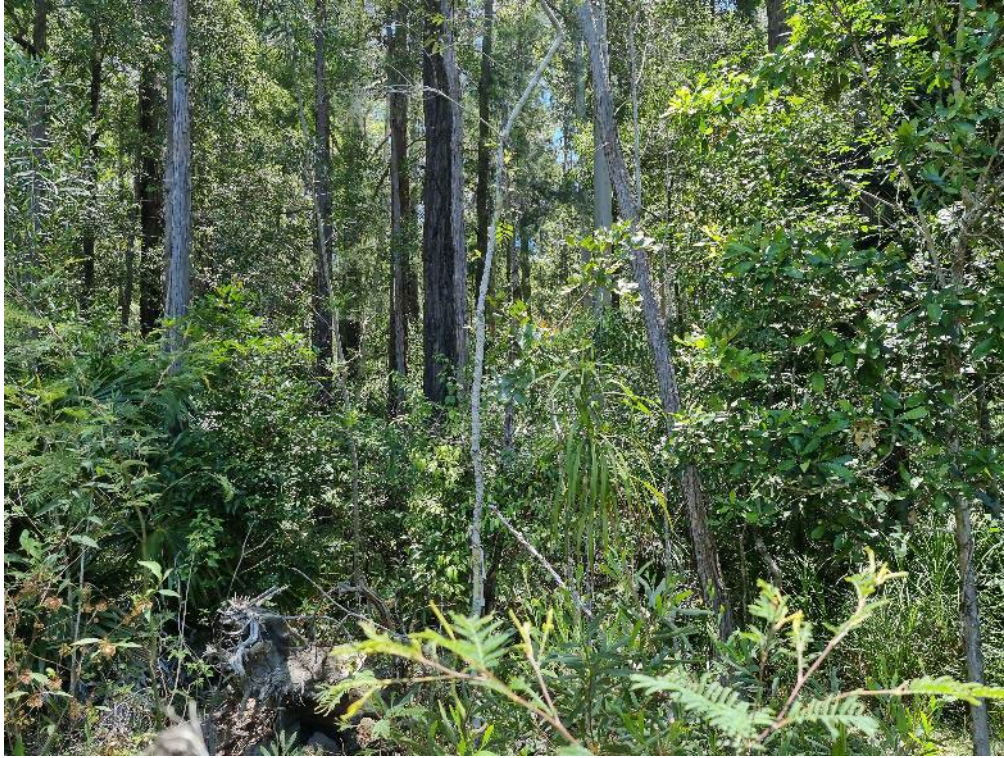
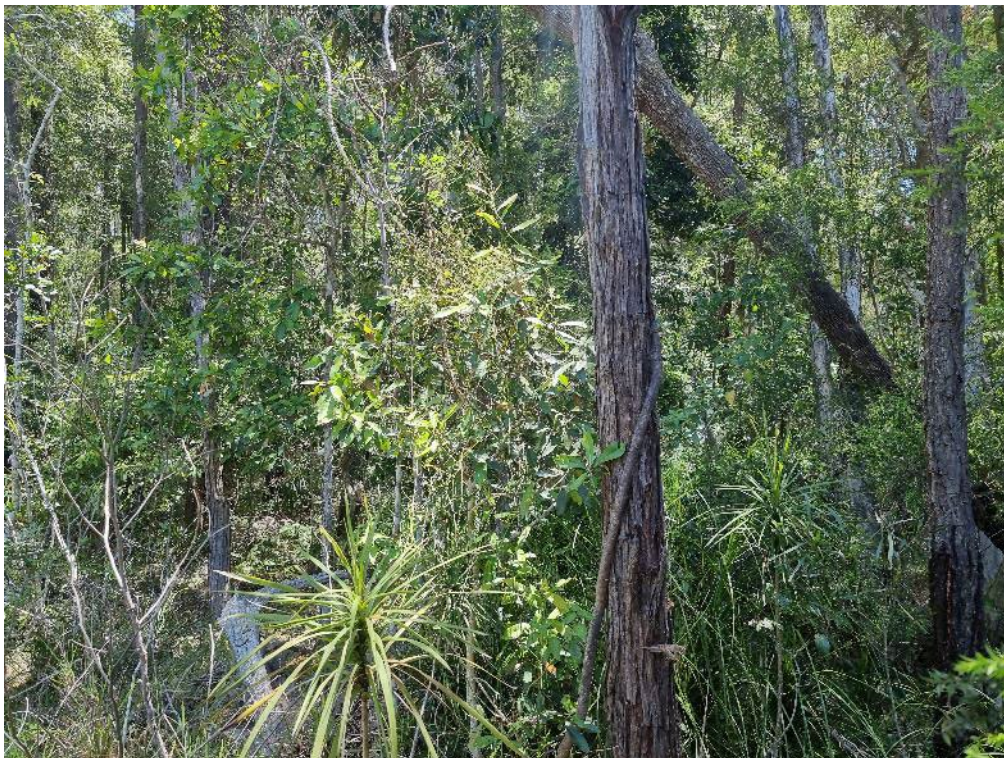
Plates 49 and 50: Habitat Condition Plot No.9. Habitat in good condition, healthy native regrowth on forest edge, no exotics inside forest.
