Appendix G

Field Mapping Photo Interpretation

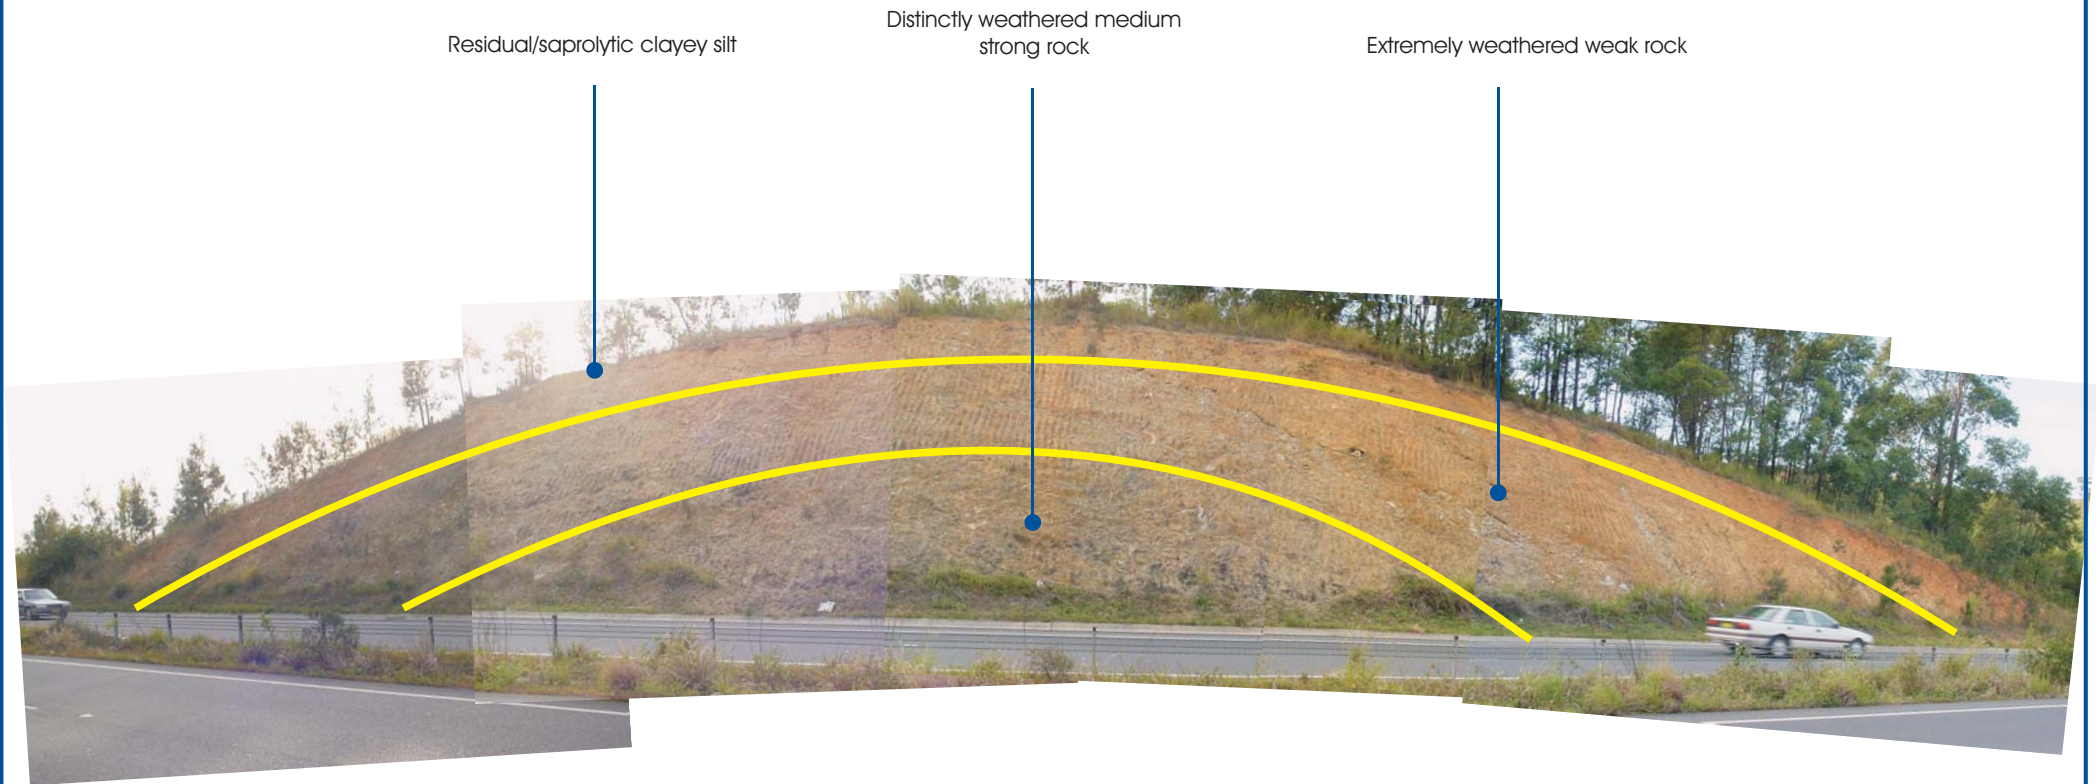
Siltstone/Greywacke: Weathering grades evenly from red, orange residual/saprolitic clayey silt to distinctly weathered, dark grey medium strong rock. Joints extremely to very closely spaced, typically closed but occasionally in-filled.

- * Slope angle of cutting 48° , slope direction 258°
- * No major erosion or slope failures evident
- * Dominant joints, dip/direction, 9/233, 84/88, 86/52, 85/292, 25/245, 35/295

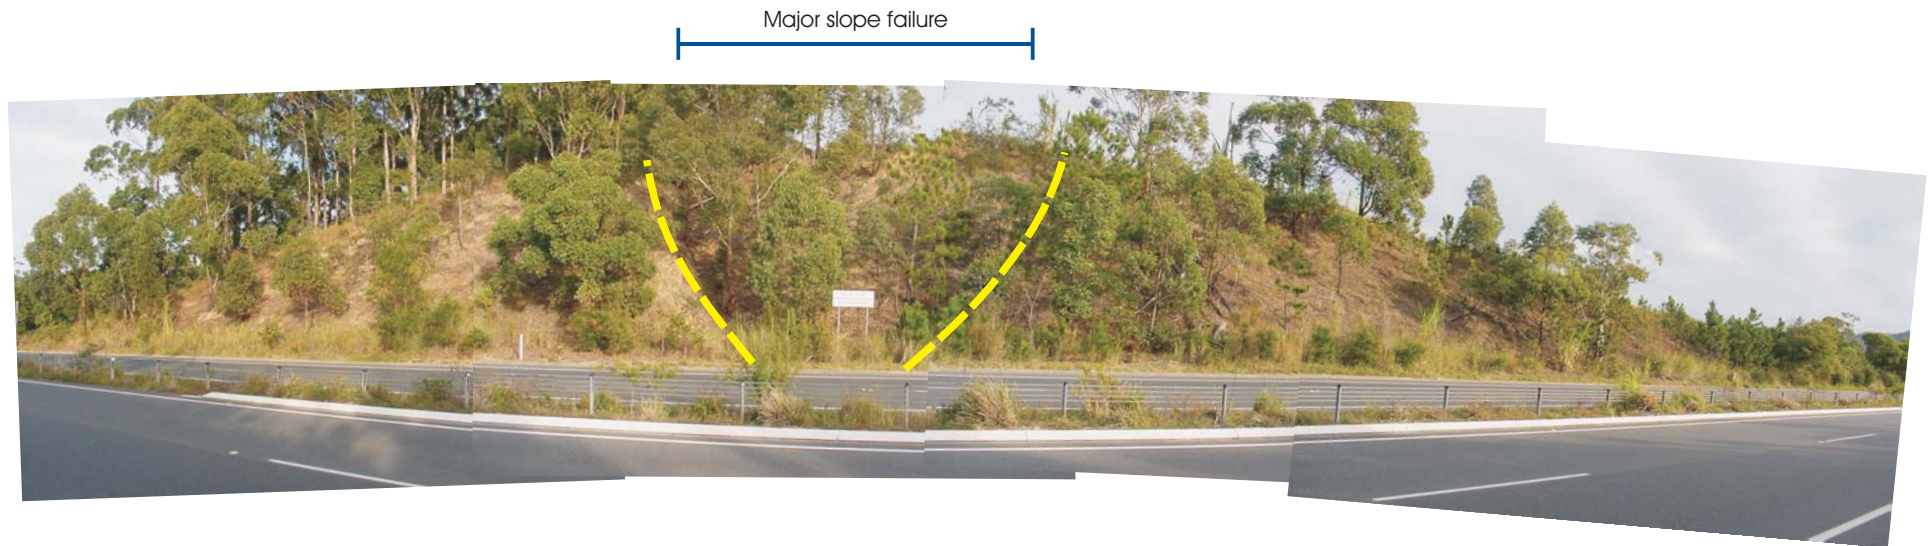
Siltstone/Greywacke: Grey, fine grained, weak, extremely to distinctly weathered rock, joints extremely to moderately closely spaced.

- * Thin soil cover (<1.0m)
- * Slope angle at cutting 45° , slope direction 90°
- * Major slumping type failure evident in centre of cutting
- * Dominant joint, dip/direction 59/110 (50mm spacing)

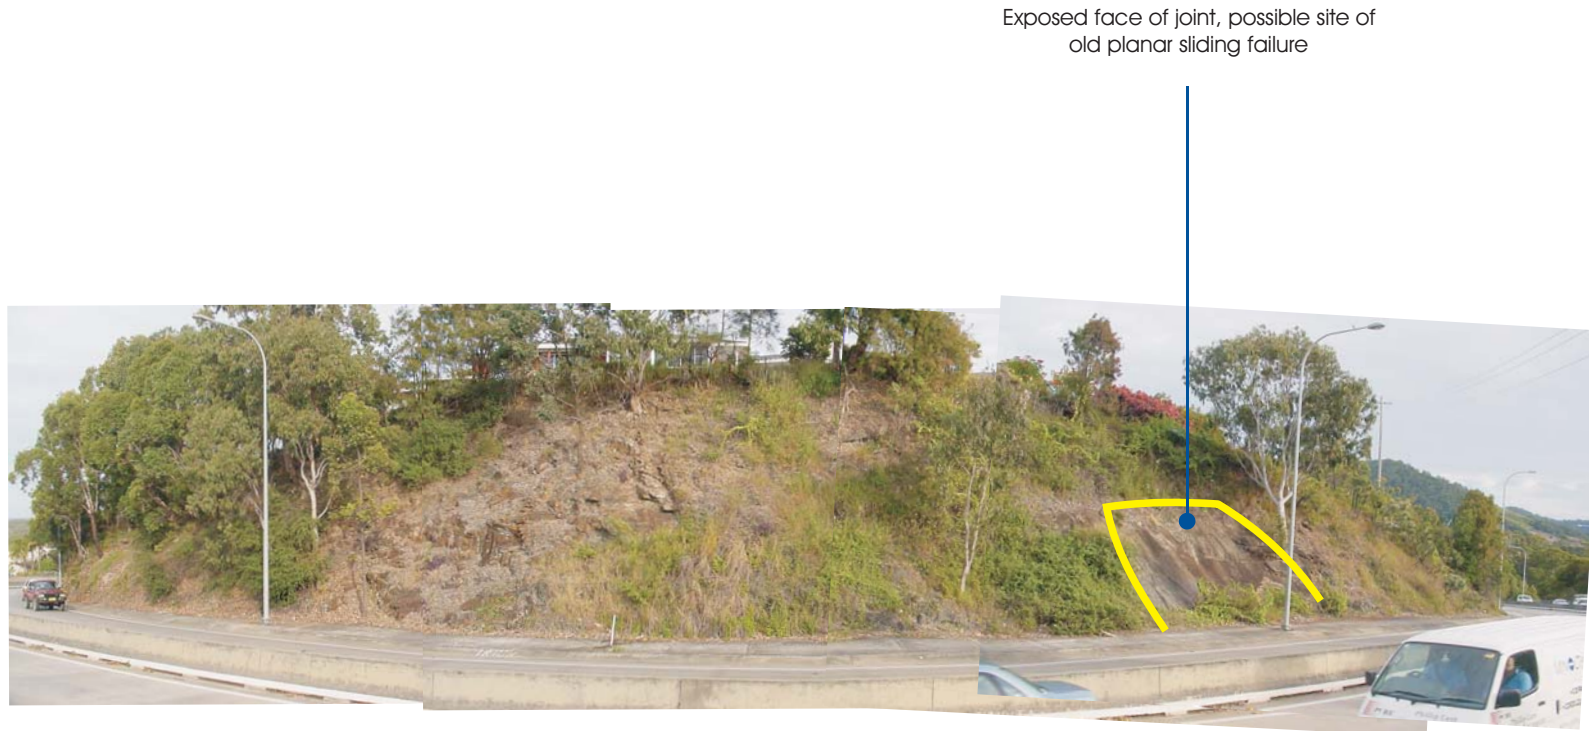
Argillite: Grey speckled white, distinctly to slightly weathered, medium strong to very strong rock, moderately closely spaced joints.

- * Slope angle at cutting 50° , cutting on 90° bend in road
- * Numerous joints at approximately 45° seen day lighting in face
- * Dominant joints, dip/direction, 75/70, 28/34, 40/65, 80/130, typical joint spacing 100-200mm

$\pm 30^\circ$ joint noted dipping towards
railwayline ie. south

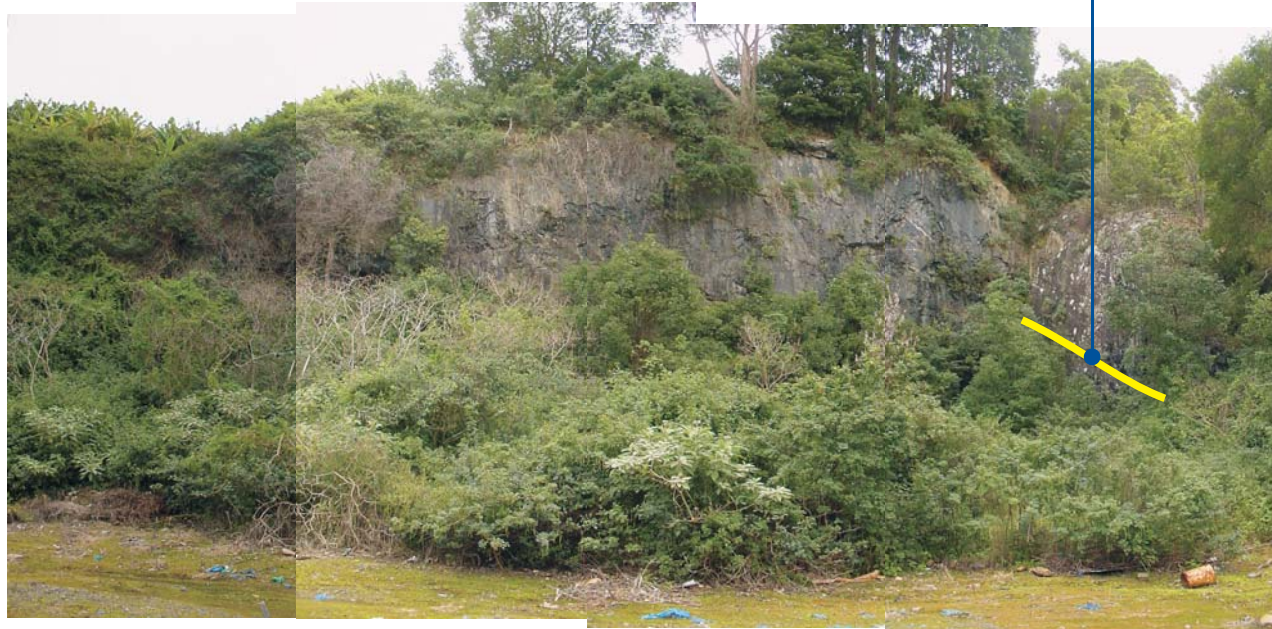
Argillite: Dark grey speckled white, slightly weathered, very strong rock with moderately spaced joints.

- * Abandoned Quarry - dense vegetation at base prevented access to face
- * Slope angle at face - vertical
- * Not possible to accurately measure joints, but 30° joint set noted striking approximately south

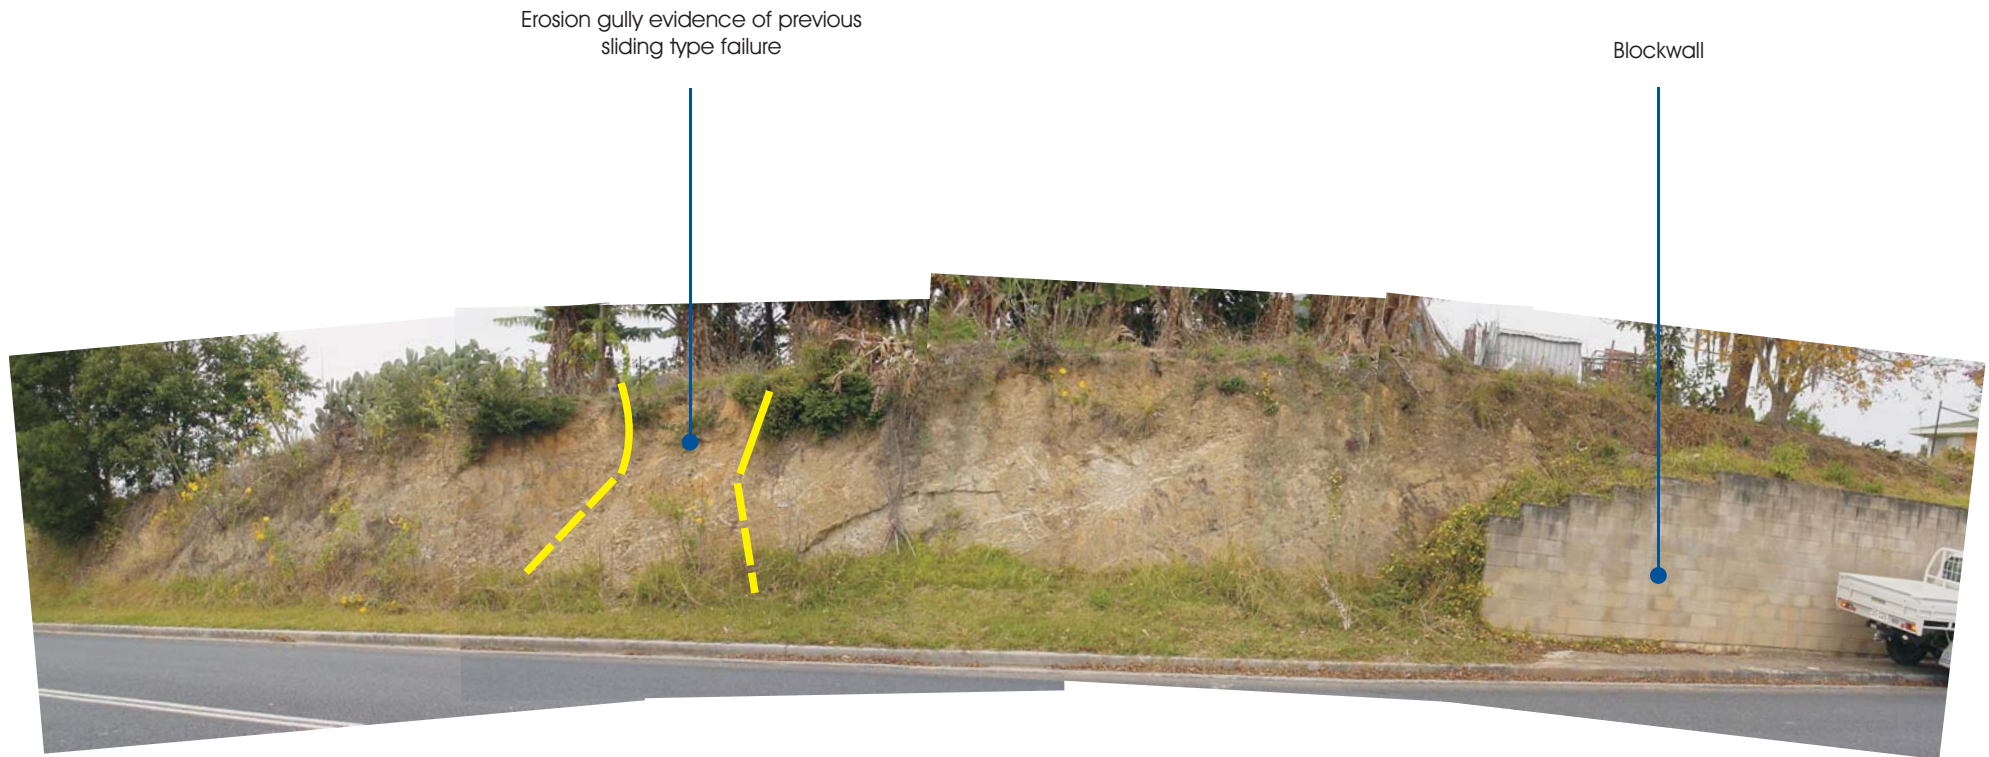
Weathered Argillite/siltstone: light grey stained orange brown, extremely weathered, extremely to very weak rock with very to moderately closely spaced joints.

- * Slope angle at cutting 75° , slope direction 182°
- * Severe erosion of face and evidence of old sliding failure
- * Netting placed over face to reduce erosion and encourage plant growth has been unsuccessful
- * Dominant joints, dip/direction, 29/56 (20mm spacing) 61/324, 84/184, (100-200mm spacing)

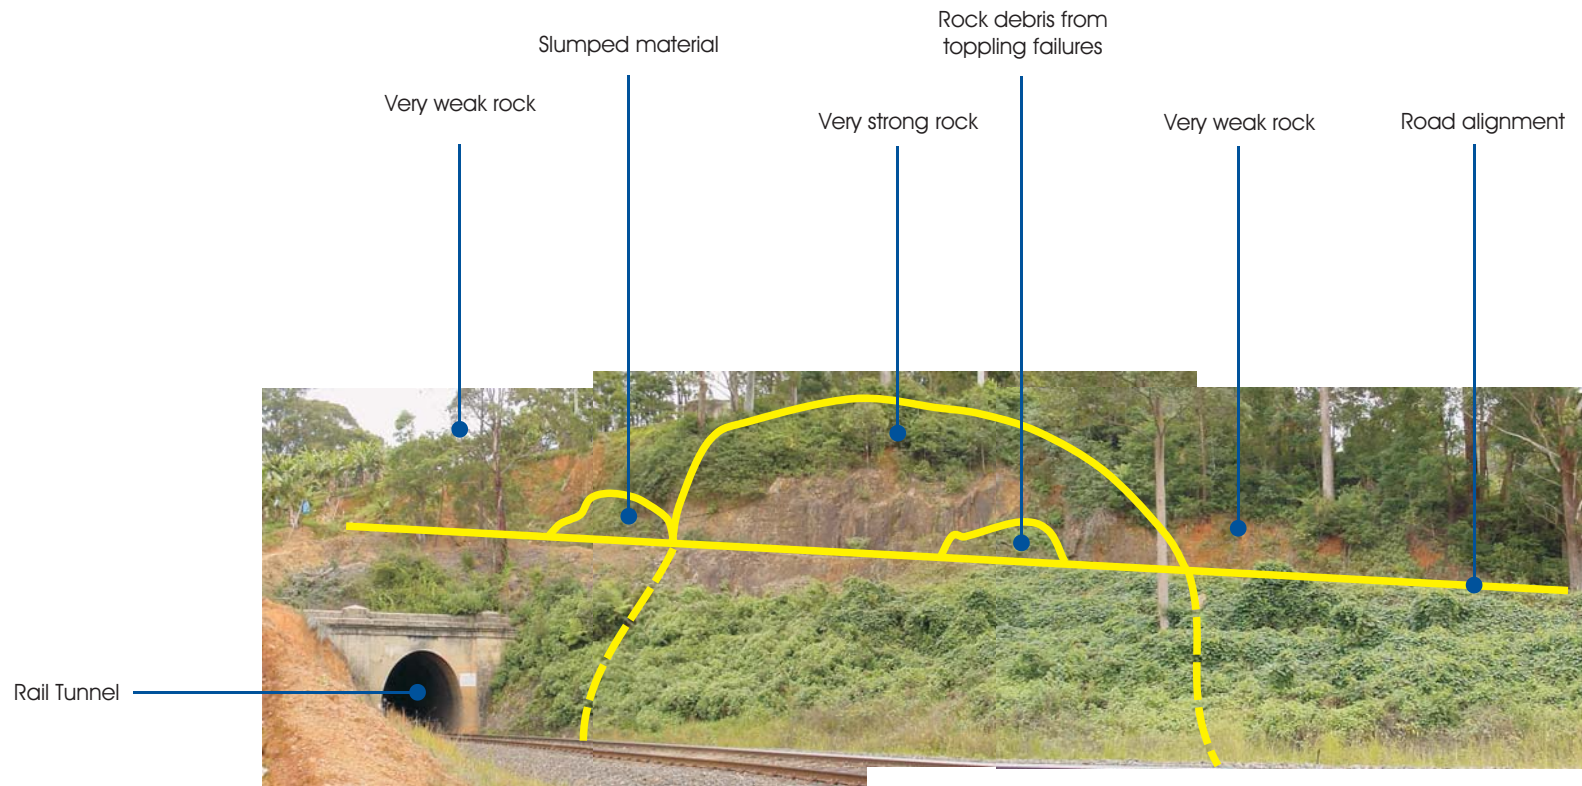
Argillite: Highly variable weathering from extremely weathered, orange and red, very weak rock that crumbles in hand to silt, to very strong, grey stained red and black on defects, distinctly weathered rock.

- * Slope angle of cutting 84° , slope direction 133°
- * Evidence of slump type failures in very weak rock and toppling failures in strong rock
- * Dominant joints in strong rock, dip/direction, $12/275$, $84/133$, $85/223$

Minor rockfalls

Deeply weathered, highly fractured gullies
approximately 500mm wide

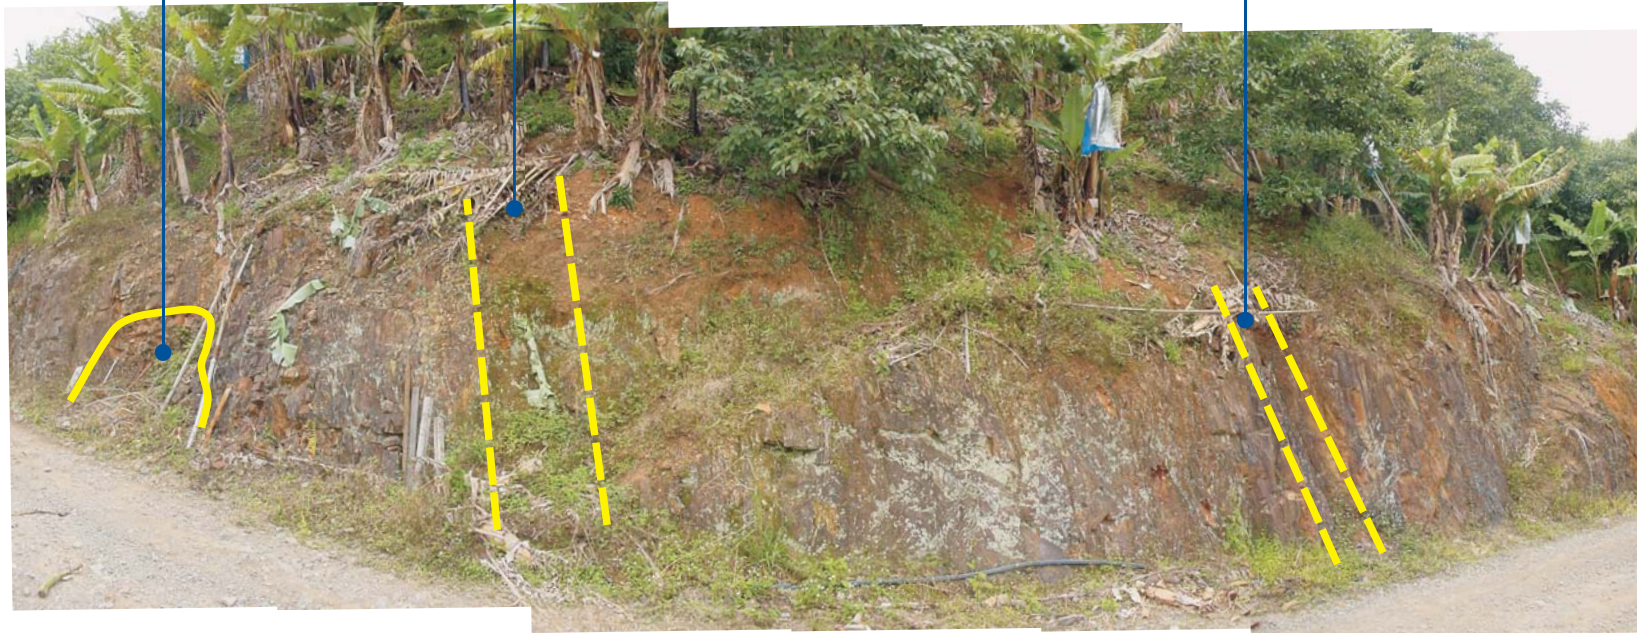
Argillite: Dark grey, distinctly weathered, very strong, extremely to moderately closely spaced defects, but with occasional 500mm wide, near vertical extremely weathered gullies/bands.

- * Slope angle of cutting 65° , slope direction 65°
- * Dominant joints, dip/direction, 25/72, 65/252, 75/326, 90/230

Slumped material

Old wedge type failure

Eroded gully

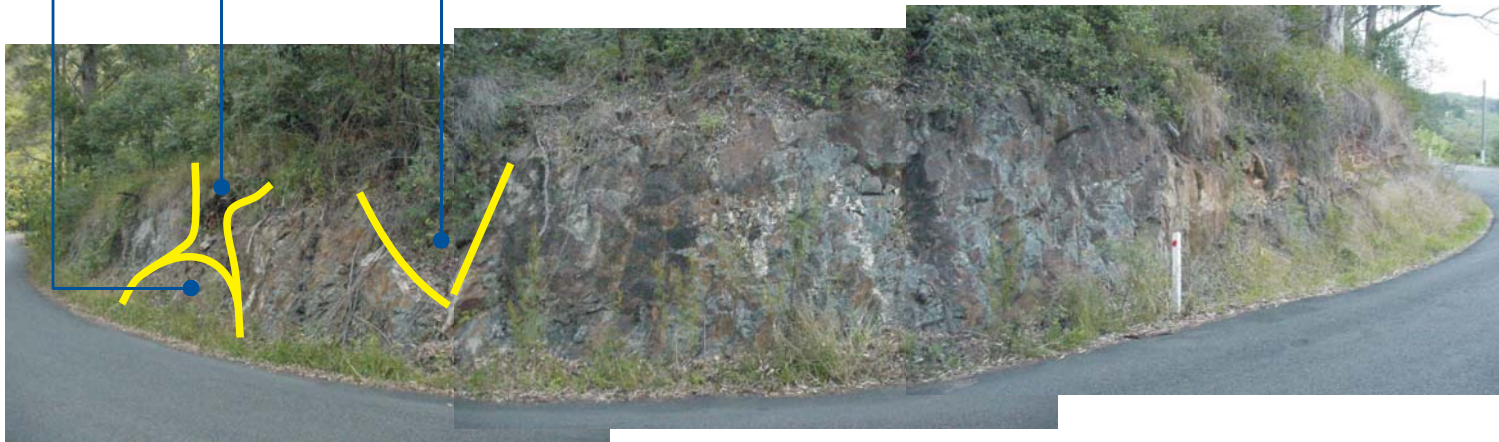
Argillite: Blue grey stained white on healed joints, distinctly weathered, medium to very strong rock with moderately closely spaced defects.

- * Slope angle of cutting 60° , slope direction 0- 90°
- * Colluvial slope above cut face consists of cobbles and boulders in a silty clay matrix
- * Dominant joints, dip/direction 40/80, 37/352, 65/88, (spacing 100-400mm), 38/85

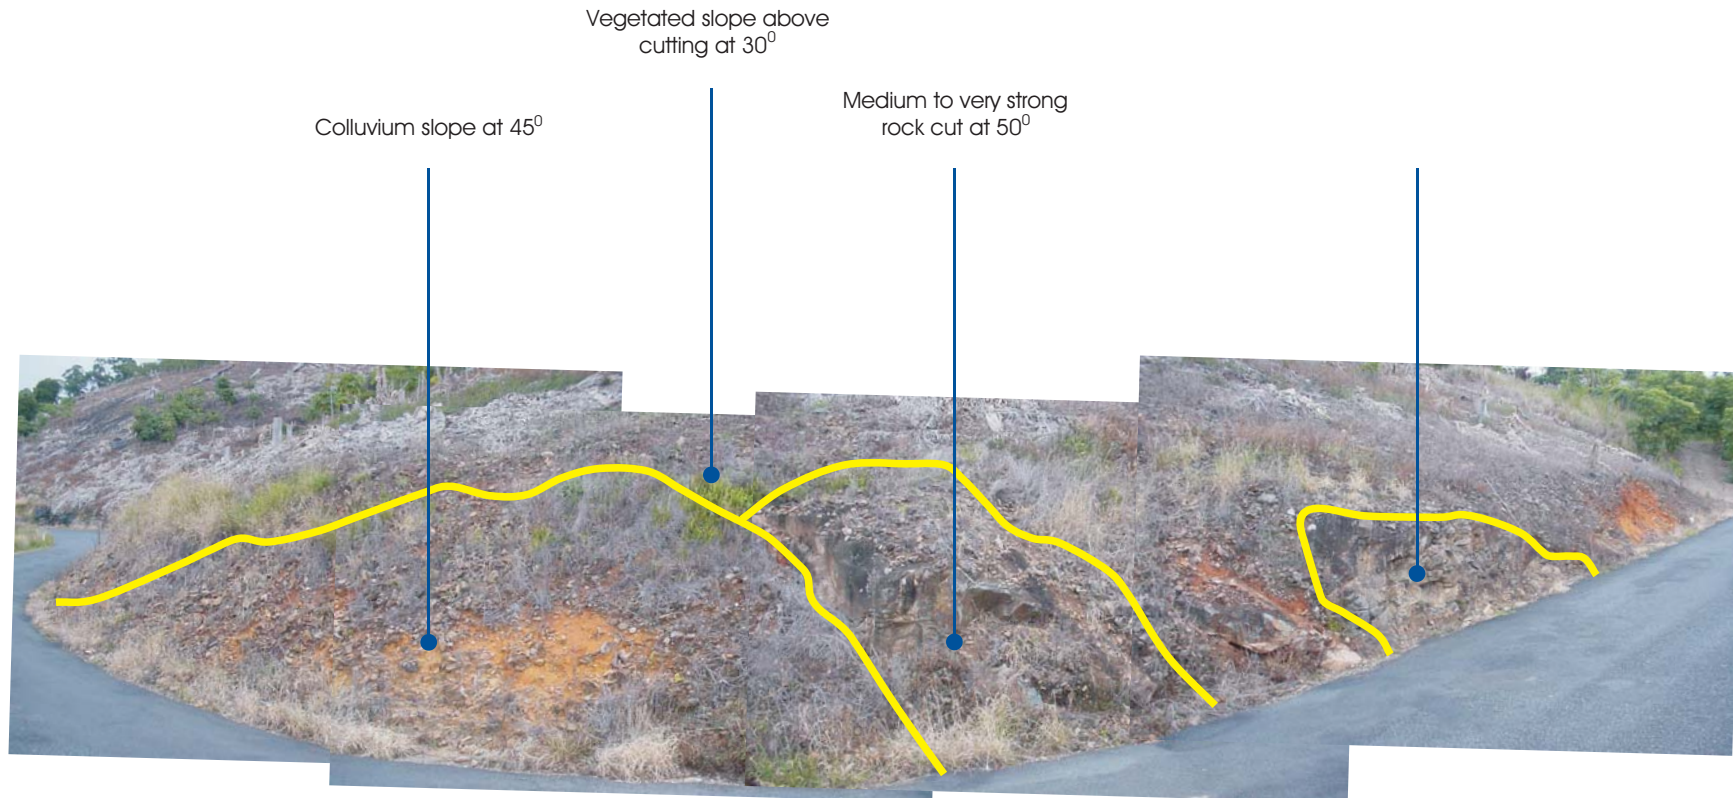
Colluvium and lithic sandstone: Colluvium consists of loose cobbles in a silty clay matrix, lithic sandstone is blue grey, coarse grained, distinctly weathered, medium to very strong rock with moderately closely spaced defects.

- * Slope angle of cutting as noted on photograph
- * Silty matrix of colluvium appears erodible
- * Dominant joints in sandstone, dip/direction 42/182, 75/102, 35/180

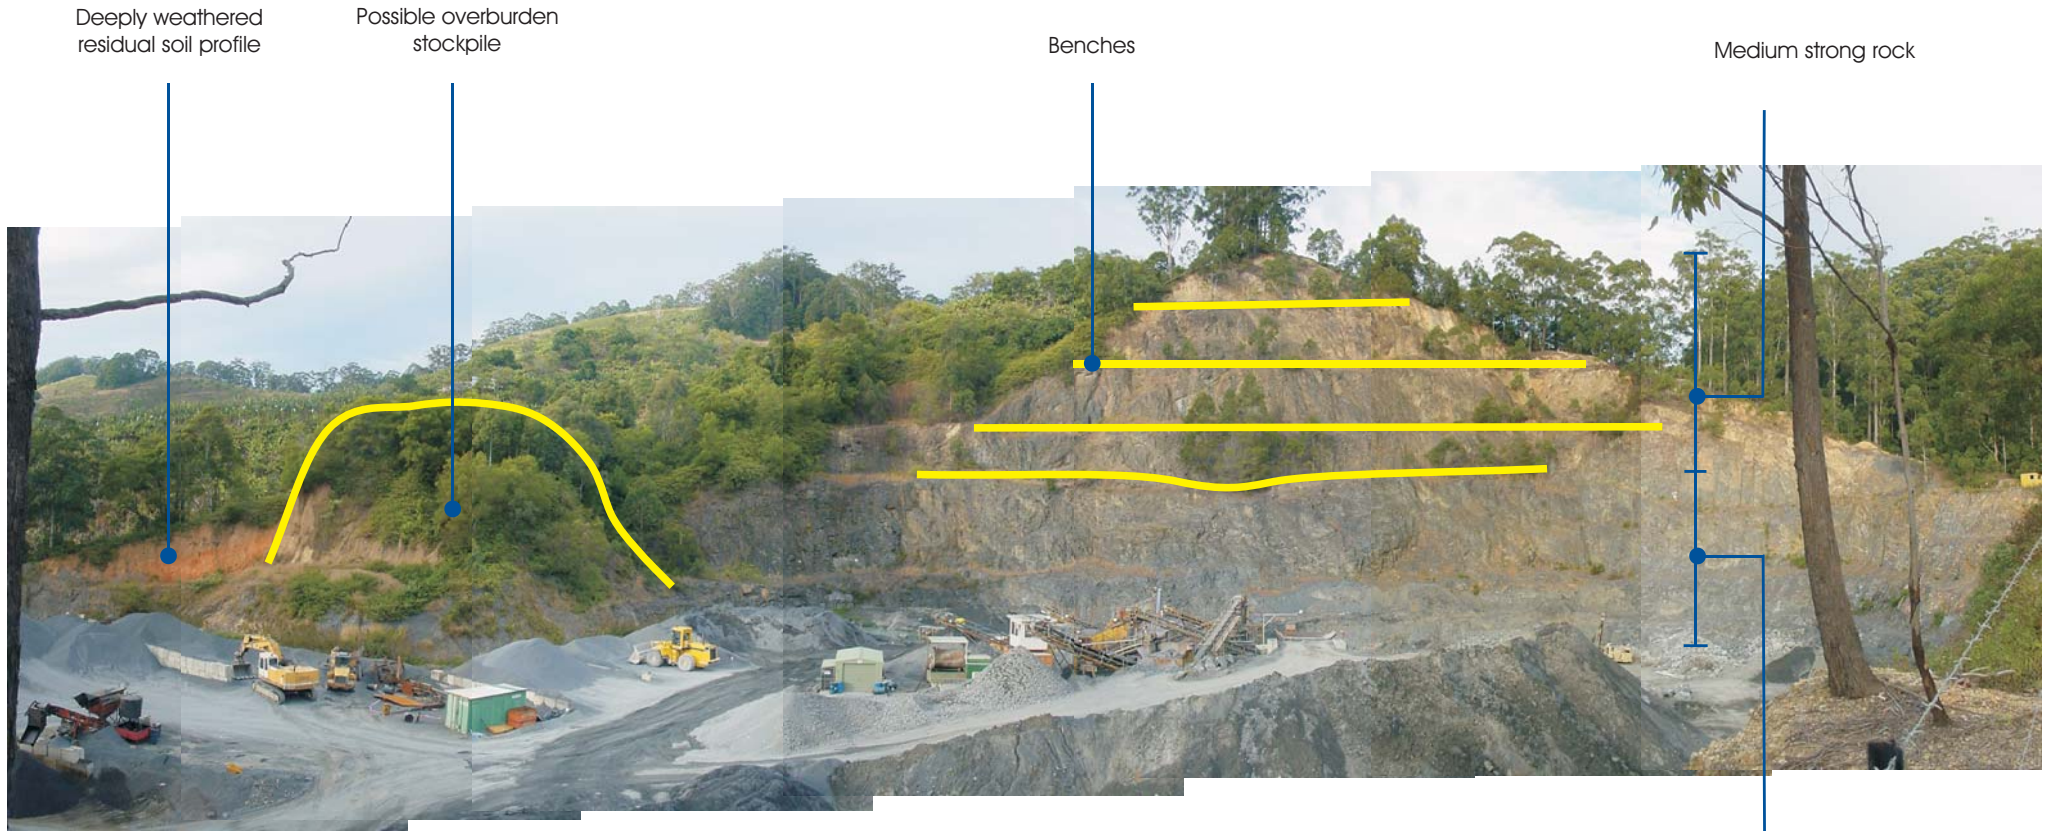
REDHILL QUARRY

Argillite: Dark blue grey at base of quarry grading to light brown at top of face, distinctly to slightly weathered, medium to very strong rock, very closely to moderately closely spaced defects.

- * Not possible to approach face as quarry closed at time of site visit
- * Quarry operated by Boral
- * Quarry reveals potential for shallow hard rock on ridgelines with more deeply weathered profile at base of slopes.

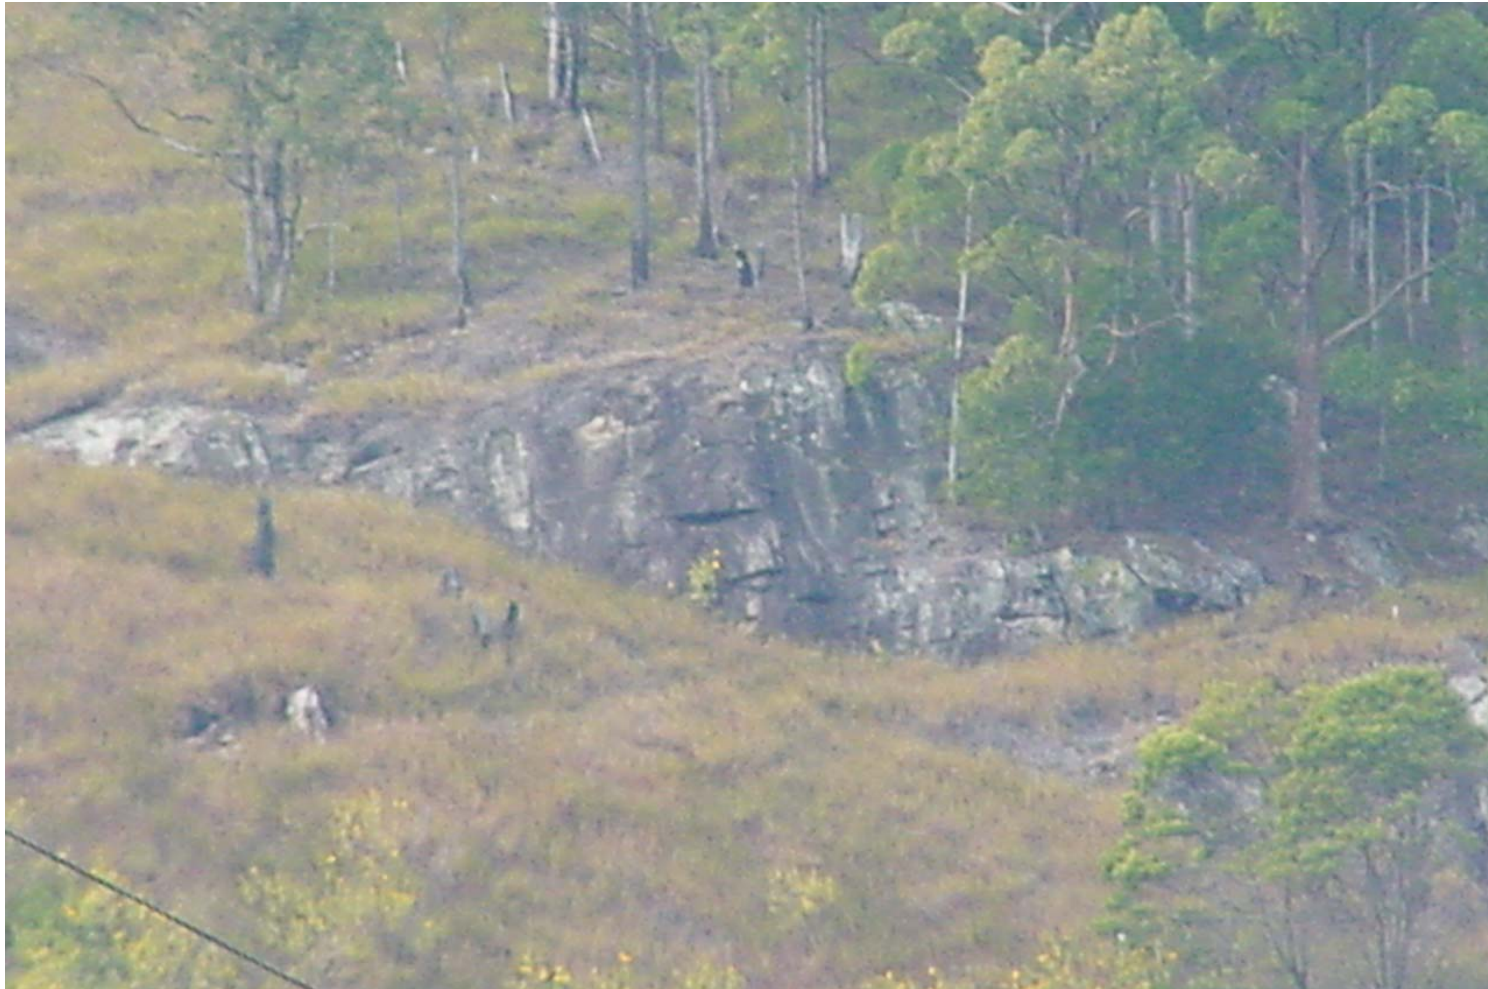
- * Natural rock outcrop noted on north face of Roberts Hill
- * Outcrop on private property, not possible to access area, photo taken from Coramba Road
- * Appears to be blue/grey hard rock argillite

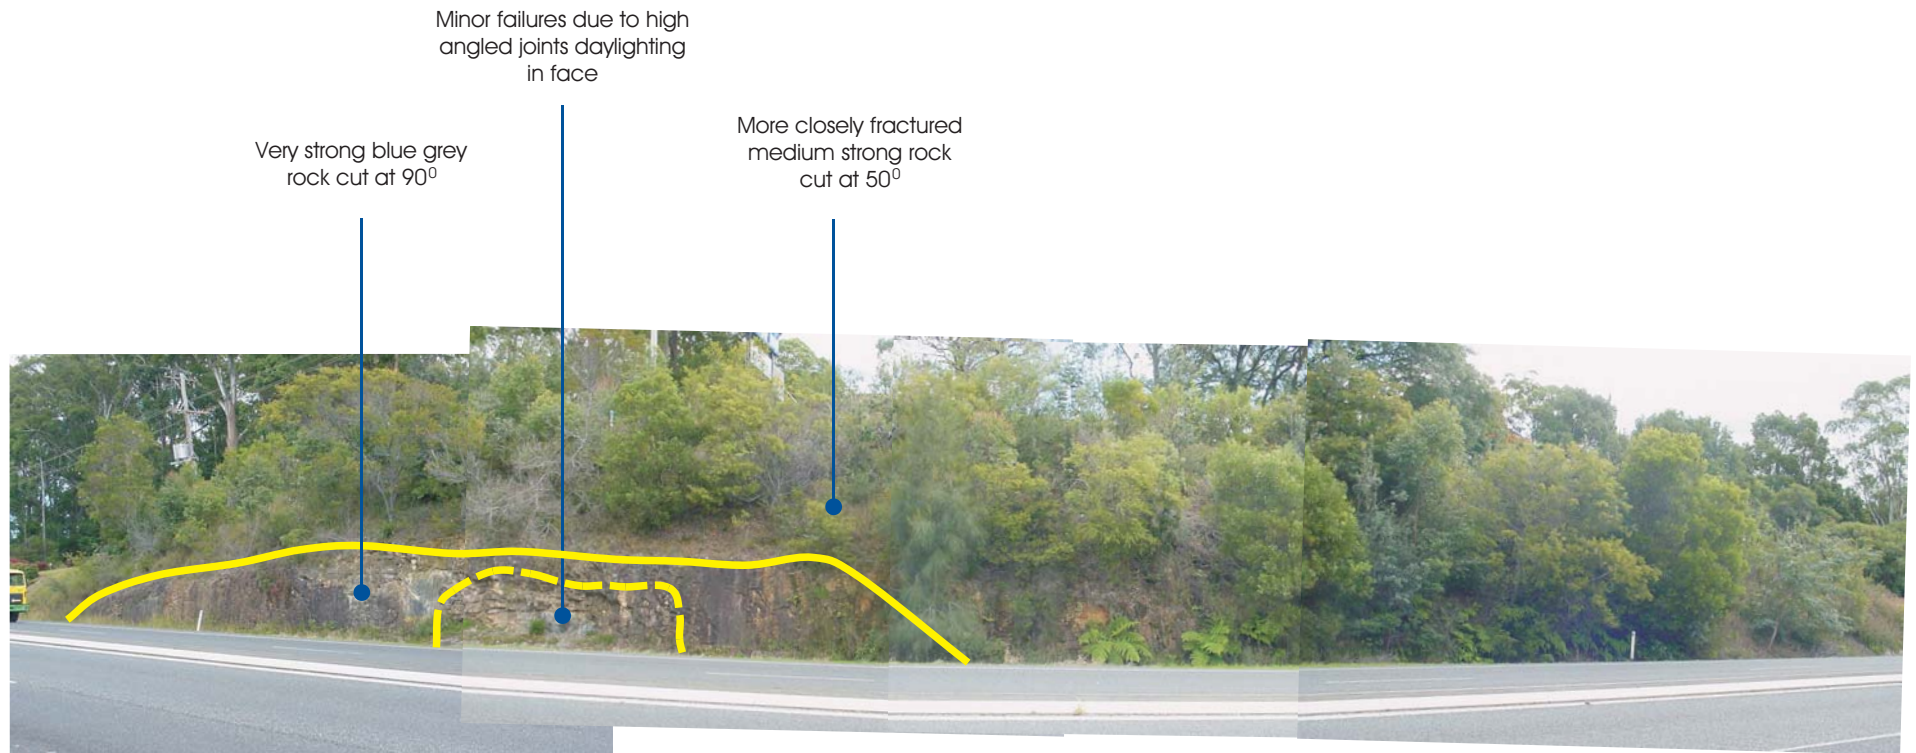
Argillite: Blue grey, stained red brown in upper portion of cutting, distinctly to slightly weathered, medium to very strong rock, silicified, moderately closely jointed.

- * Slope angle of face 90° - 50° , slope direction 120°
- * 20mm Quartz seam noted in face
- * Minor failures noted where high angled joints, daylight in face
- * Dominant joints, dip/direction, 20/168, 82/114 (spacing 50-100mm), 88/32

Clayey silt slump failures
and erosion evident

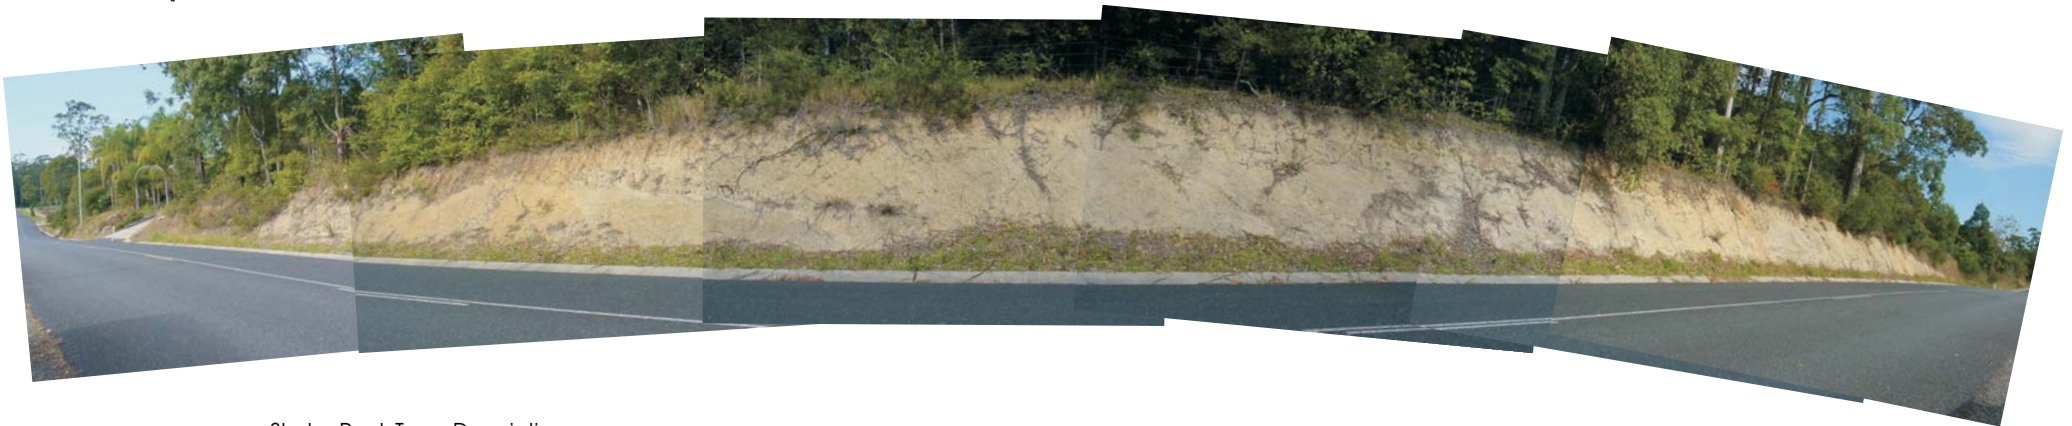
Weathered Argillite/Siltstone: Yellow brown, extremely weathered, extremely weak rock, breaks down to silt in hand or under light hammer blows, fragmented.

- * Slope angle of cutting 50°, slope direction 0°
- * Major slumping and erosion evident in residual clayey silt at end of cutting
- * Dominant joints dip/direction 11/208, 85/18 (numerous other high angled defects noted striking in many directions)

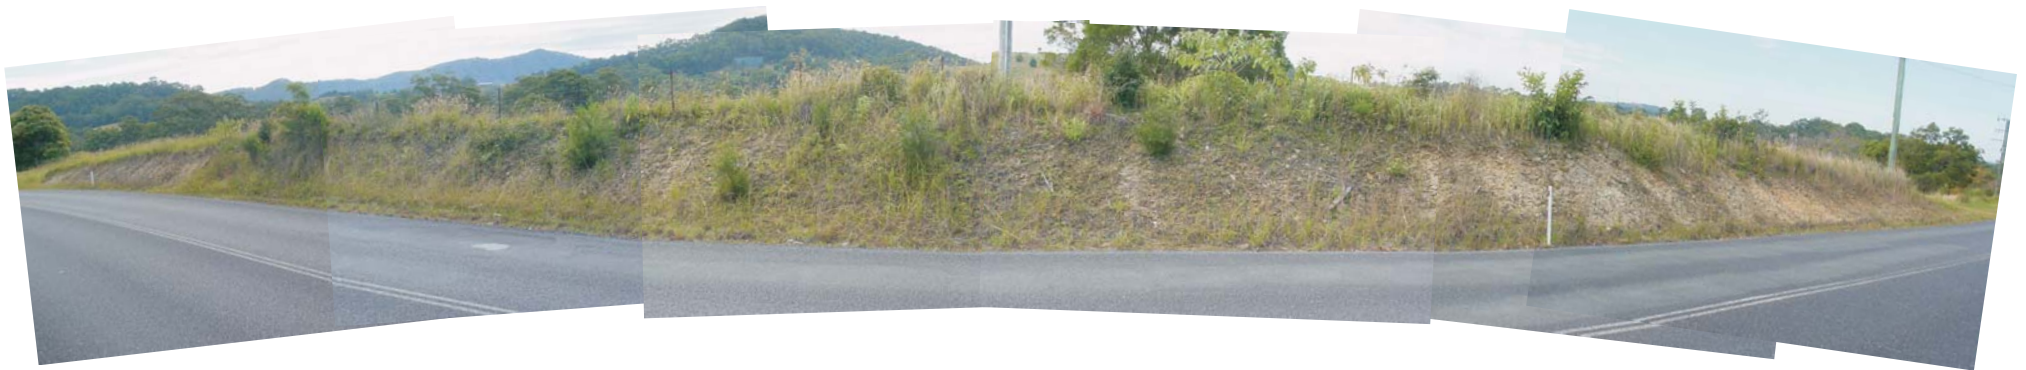
Weathered Argillite/Siltstone: Yellow brown, extremely to distinctly weathered, weak to medium strong rock with extremely closely spaced defects.

- * Slope angle at cutting 35°, slope directions 25°
- * Generally rock is broken up into 20mm blocks that are loose and in-filled with silt between blocks.
- * In some areas towards the base of the cut the material becomes more closely packed, with less silt infilling, but remains fragmented

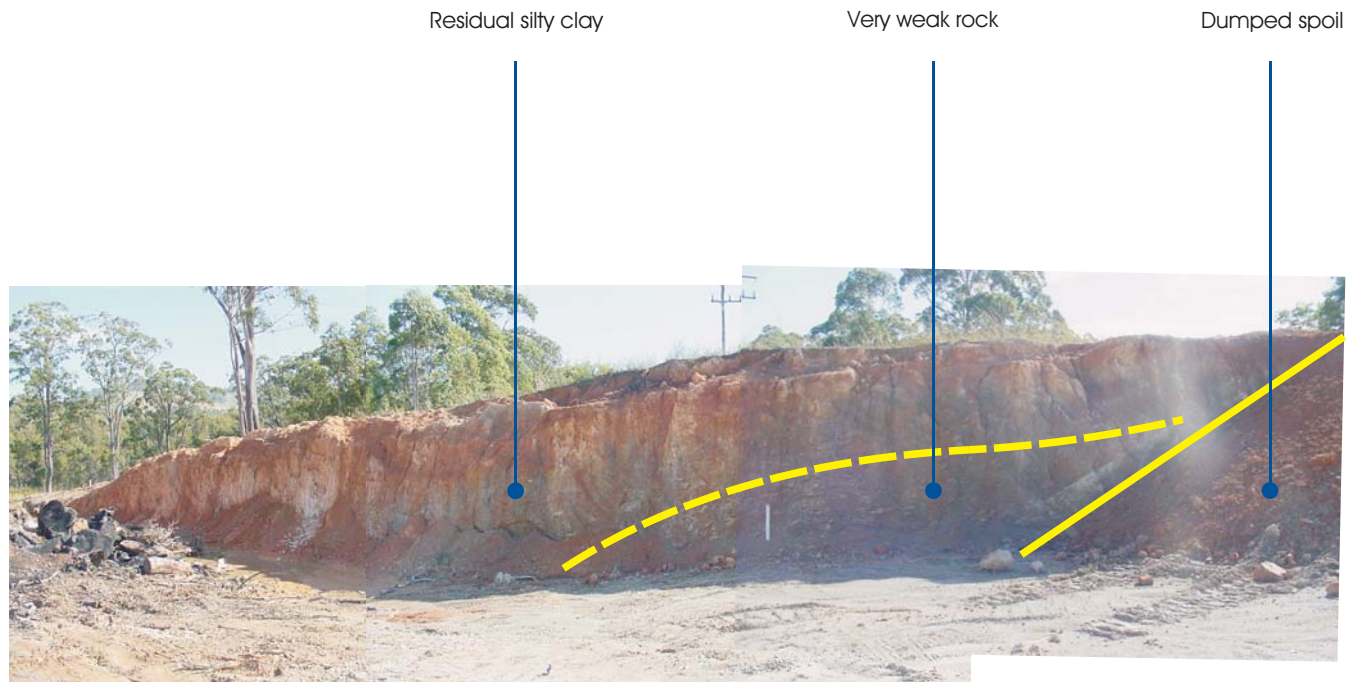
Very weak rock: Weathered Argillite: light grey and white, silicified, stained red and orange on defects, extremely weathered, defects very closely spaced.

Residual silty clay: Red and white, medium to low plasticity

- * Face cut vertical
- * Section of bulk earthworks for industrial area
- * Spoil heaps of crushed hard rock in other areas of the site indicate hard rock argillite was also encountered during the bulk earthworks operations.

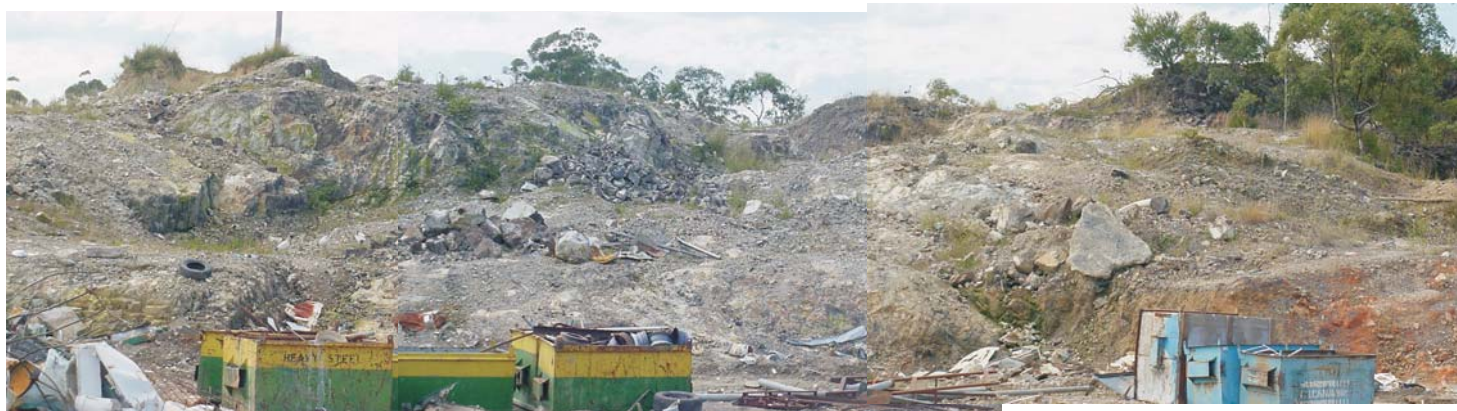
COFFS HARBOUR WASTE DISPOSAL SITE

Argillite: Dark blue, highly silicified, distinctly to slightly weathered very strong rock, defects moderately closely spaced.

- * Probably site of abandoned quarry, now forms part of waste disposal site.
- * Dominant joints, dip/direction, 35/170, 80/284, 85/206
- * Joint spacing typically 100-300mm

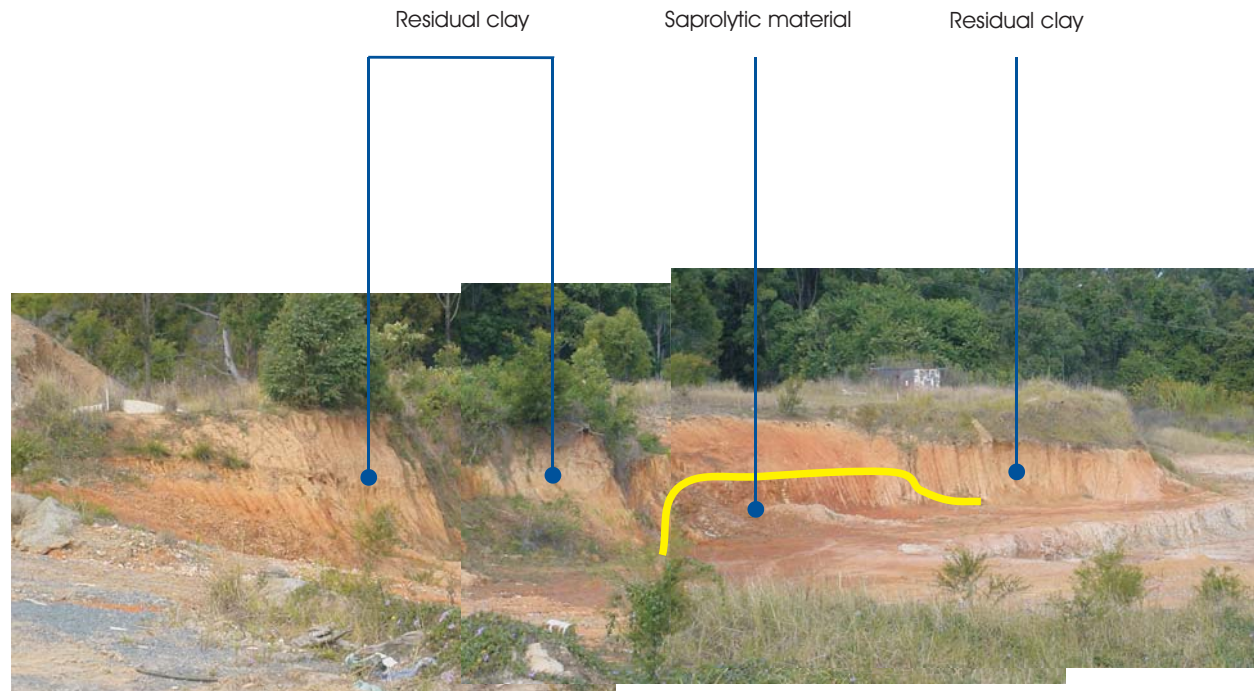
COFFS HARBOUR WASTE DISPOSAL SITE

Residual clay: Red and grey, medium plasticity, moist, stiff tending to saprophytic / very weak rock.

- * Area within waste disposal site
- * Occasional quartz band noted in residual and saprophytic material
- * Major erosion can be seen in cut faces of residual clay
