# **ENVIRONMENTAL COMPLIANCE REPORT 3**

Frederickton to Eungai  
Pacific Highway Project

MARCH 2015

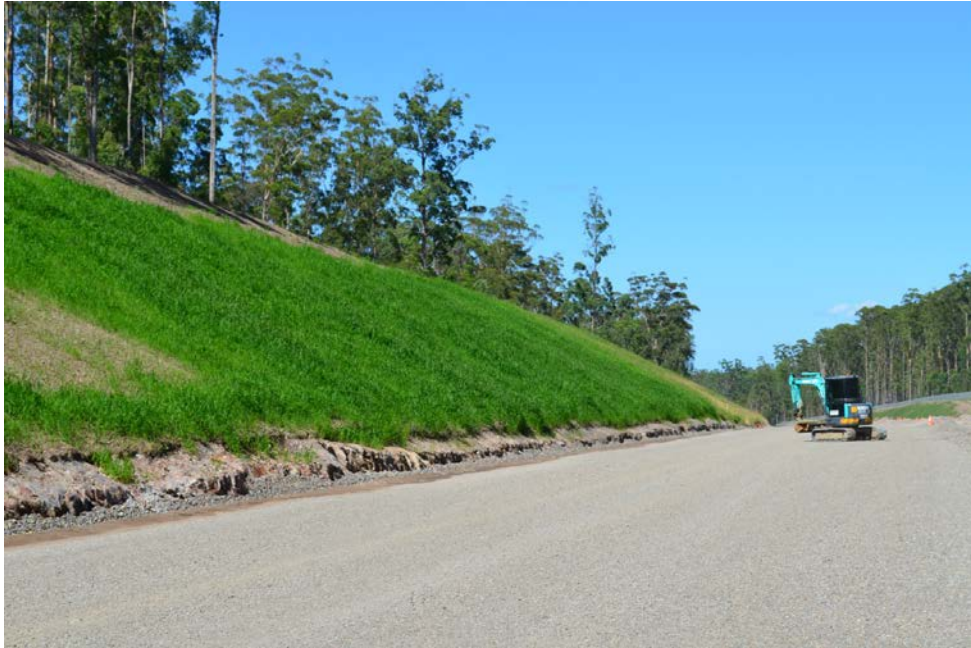
**Germination of cover crop on cut batter**

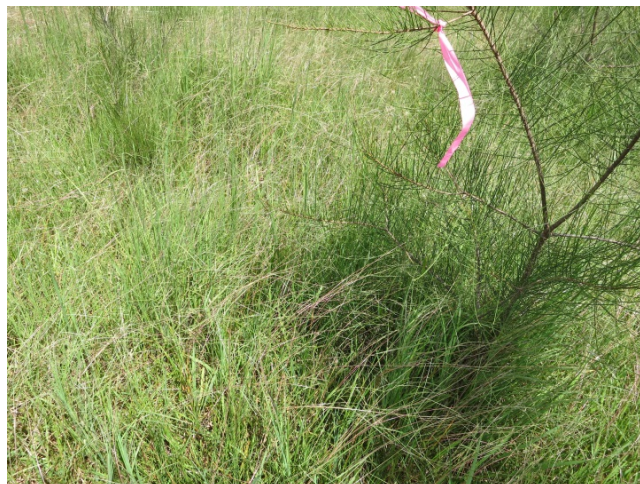
Hairy Joint grass was found in small clumps (generally about 30cm<sup>2</sup>), containing only one or two individuals. Hairy Joint grass was mainly found scattered across exotic pastures.

Showing typical dominance of exotic grass in which Hairy Joint Grass grows.

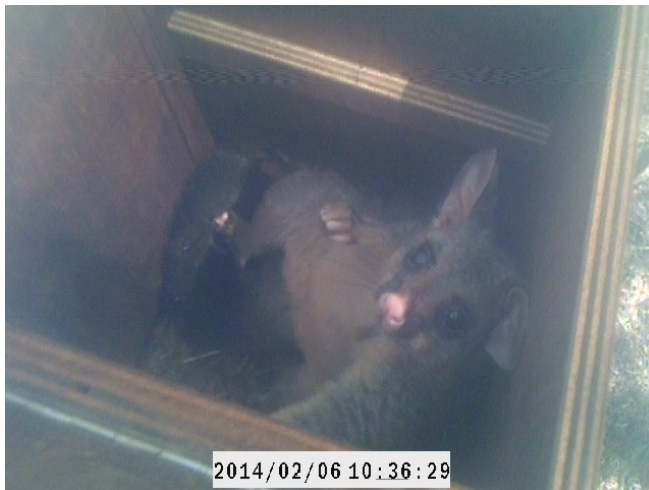
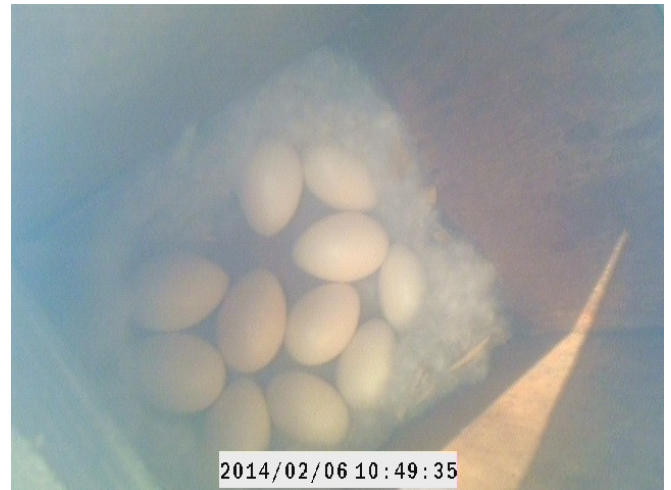
## Examples of fauna utilising nest boxes.

Clockwise from top right: Brush-tailed possum, Northern Mallard nest, Lace Monitor and Antechinus.

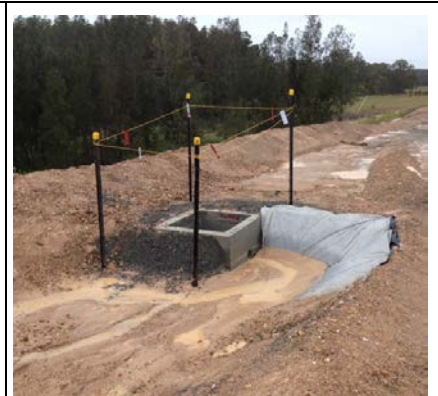
### Key Pits

There has been a major focus site wide on identifying and maximising the use of 'key pits' (longitudinal drainage) so as to direct site water runoff into nearby construction sediment basins. The project Soil Conservationist has advised Foreman and support staff on specific pits to target for site runoff, site Environmental staff have ran a number of workshops educating site personnel on key pit terminology and practices, and the result is maximum runoff to basins with lower transfer of silt into drainage infrastructure and basin(s).

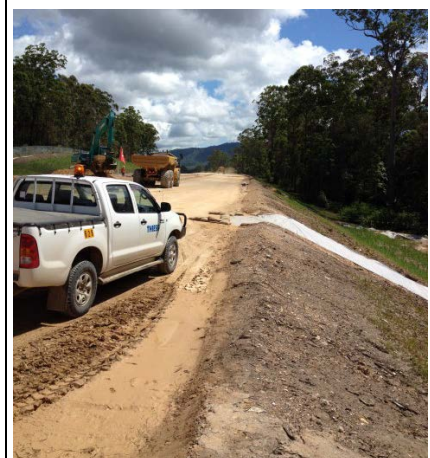
### Strengthening of batter chutes to construction basins

Batter chutes are designed take site runoff from the project formation down a fill batter and into the basin. A number of chutes failed in recent rainfall events within this reporting period and resulted in scouring to the batter and additional silt deposits within the receiving basin(s).

A project review identified a number of possible contributors to failures such as not properly keying the fabric in at the top of the chutes, incorrect placement of sand bags around the inlet to the chute, width of chutes, and type of fabric to line the chute.

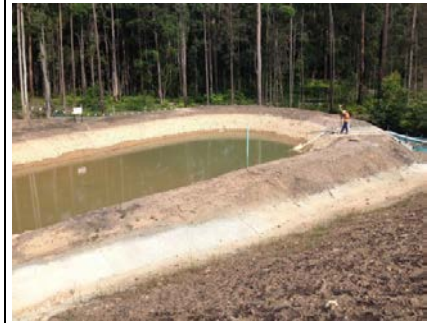
**Mid project basin review**

A recent internal audit of all basins was undertaken that included signage, fencing, condition of syphons and spears, dewater and desilt marker heights, and whether basins required desilting. As a result of the audit new signage has been installed, a number of basins have been desilted and further basins are planned to be desilted over coming weeks, and additional syphons have been installed to reduce pumping requirements.

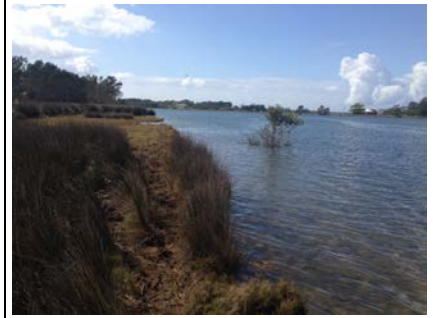
**North Coast Highway Clearing and River Restoration Project**

Thiess have donated and transported tree stumps / root balls, timber pins and rock from the Project to the Office of Environment and Heritage's North Coast Highway Clearing and River Restoration Project. The materials will be used to construct rock fillets for bank restoration on the Macleay River. Provide enhanced fish habitat and improved bank conditions.
