CONSTRUCTION COMPLIANCE REPORT 4

Frederickton to Eungai
Pacific Highway Project

OCTOBER 2015

File name	F2E-00G-RPT-ENV-049-02
Report name	Construction Compliance Report 4, Frederickton to Eungai Pacific Highway Project. 4 March to 3 September 2015
Document version	02 – Final incorporating RMS review comments
Revision issue date	7 October 2015

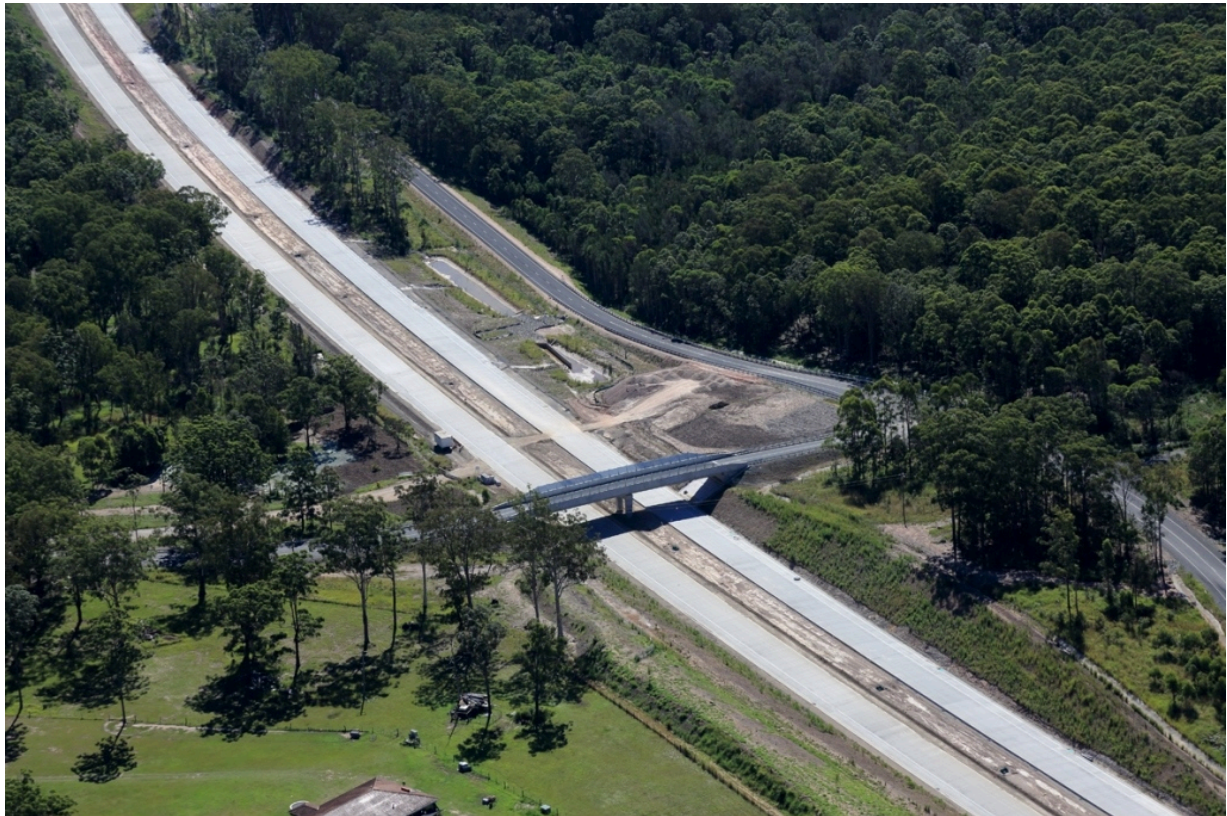
Bridge 2 Open to traffic

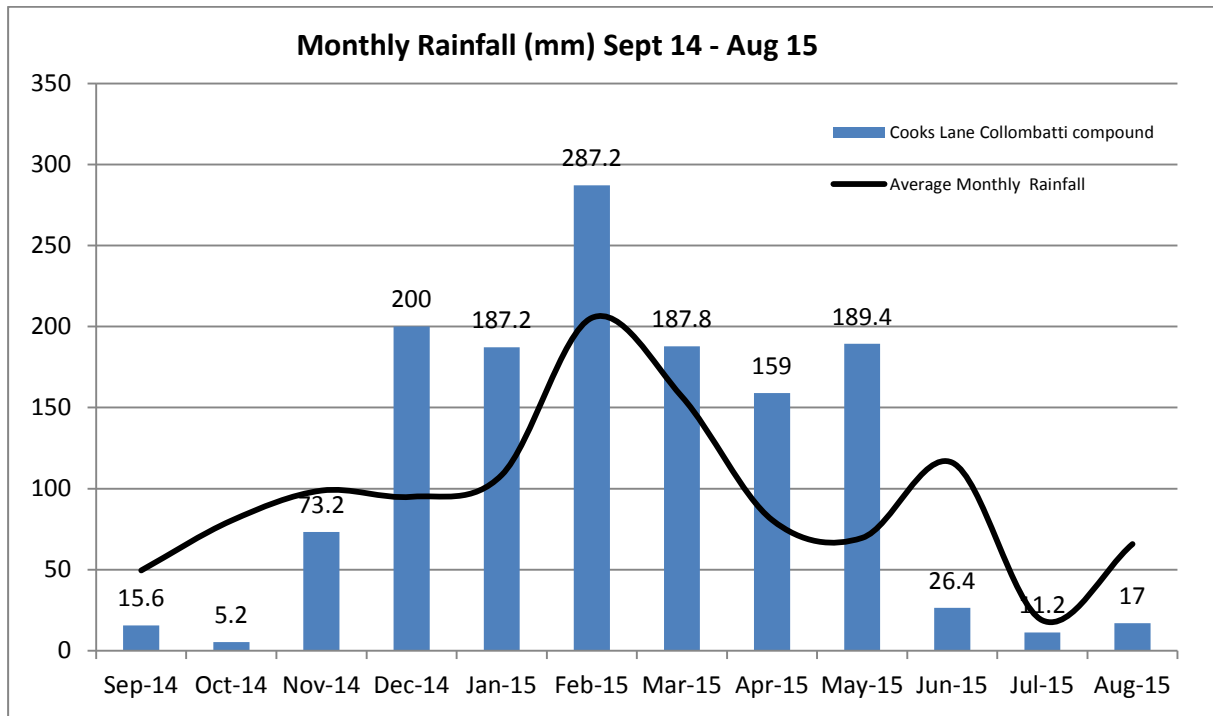
Figure 4-1 Monthly Rainfall at Cooks Lane (central) compound

Month	Northern Eungai compound	Cooks Lane Collombatti (central) compound	Southern Frederickton Compound	Average Rainfall from BoMs Collombatti weather station
March	136.4	187.8	172.0	156.7
April	167.8	159.0	125.0	80.7
May	219.0	189.4	127.6	69.6
June	24.8	26.4	13.8	116.0
July	20.2	11.2	13.6	18.7
August	25.2	17.0	16.8	65.8
TOTAL	593.4	590.8	468.8	507.5

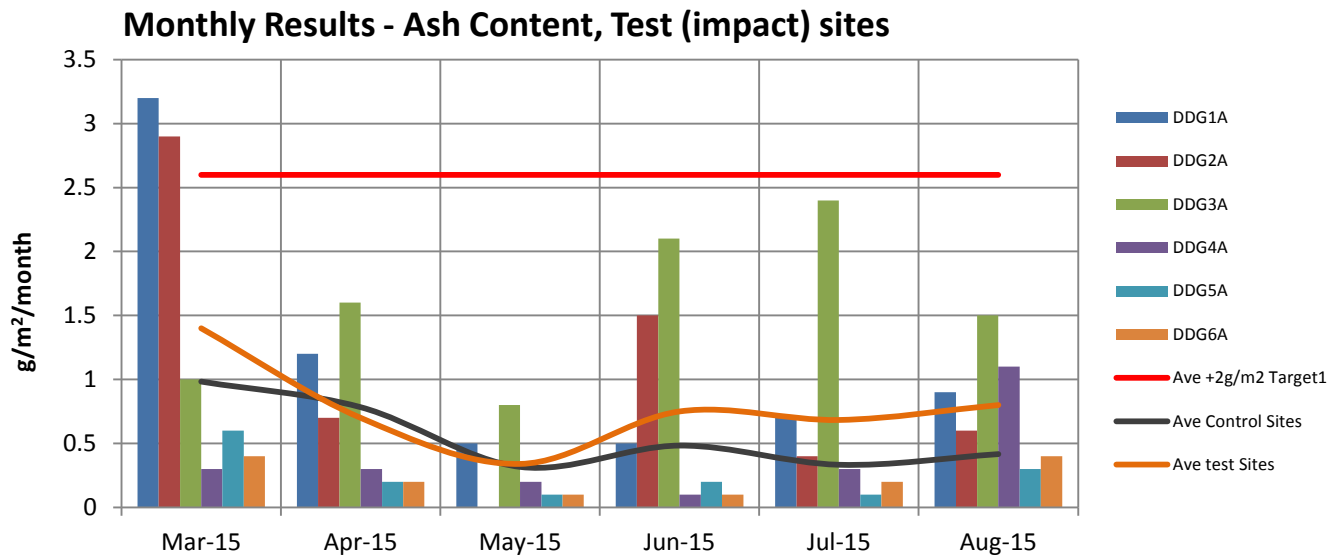
Figure 4-2 Monthly Ash Content

Dust deposition levels were maintained below the 2.6 g/m²/month target (for ash) at all test sites with the exception of DDG1A and DDG2A in March 2015 (refer to **Figure 2**). This exceedance was minor and the average monthly ash content target of 4 g/m²/month was not exceeded. Refer to Appendix 4 for full air quality monitoring results including both ash and insoluble solids.

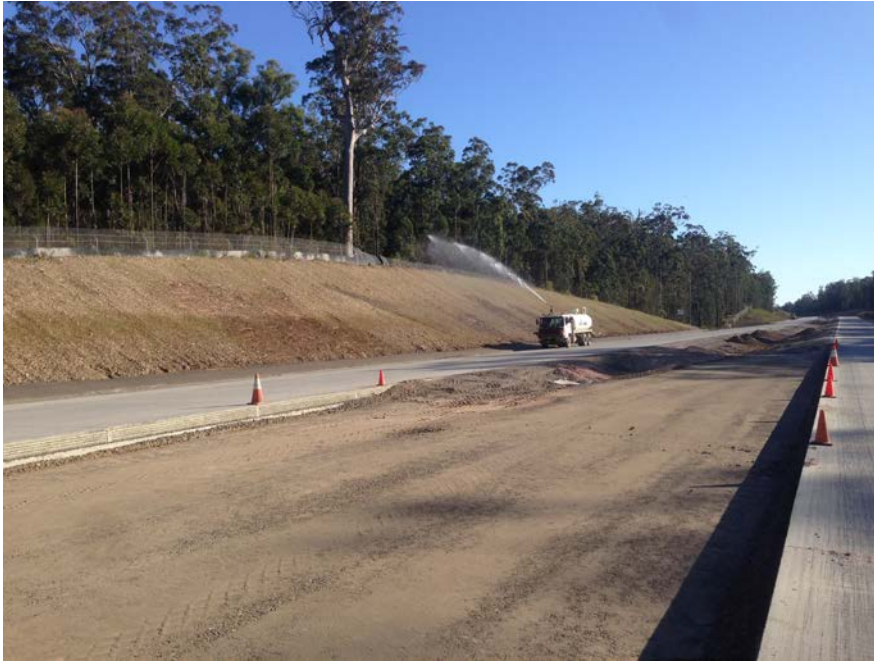
- Frequent use of water carts.
- Compacting high traffic areas and haul routes within the site.
- Reuse of asphalt millings from the redundant Pacific Highway on temporary haul roads
- Bitumen spray-seal of earthworks prior to paving.
- Reduced speed limits and restricted use of some machinery in high wind conditions.
- Stabilising stockpiles and exposed areas with sterile cover crop and native seed species when inactive for long periods (greater than two weeks).
- Early progress on final landscape/stabilisation works (hydro-mulching).
- Watering of rehabilitated and landscape areas to assist in establishing cover crop (see photo).

Watering of rehabilitated cut batters to assist in the establishment of cover crop

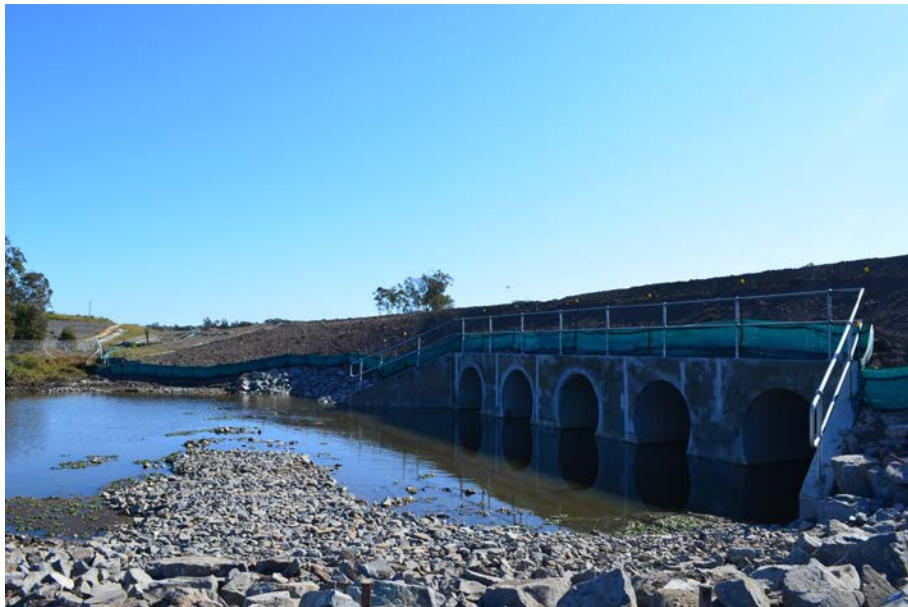
Downstream surface water quality (NTU - turbidity) exceeded the upstream water quality in the unnamed creek North of Frederickton during the August sampling event. Works at this location during the reporting period involved the construction of a culvert structure. These works required the unnamed creek to be blocked with sheet piles and the construction of temporary rock work platforms. These controls were removed in late July and the disturbed areas were rehabilitated which is likely to have contributed to the elevated turbidity (see Photo below). The flow in the creek at this time was very low.

Cross drainage culverts at the unnamed drainage line north of Frederickton

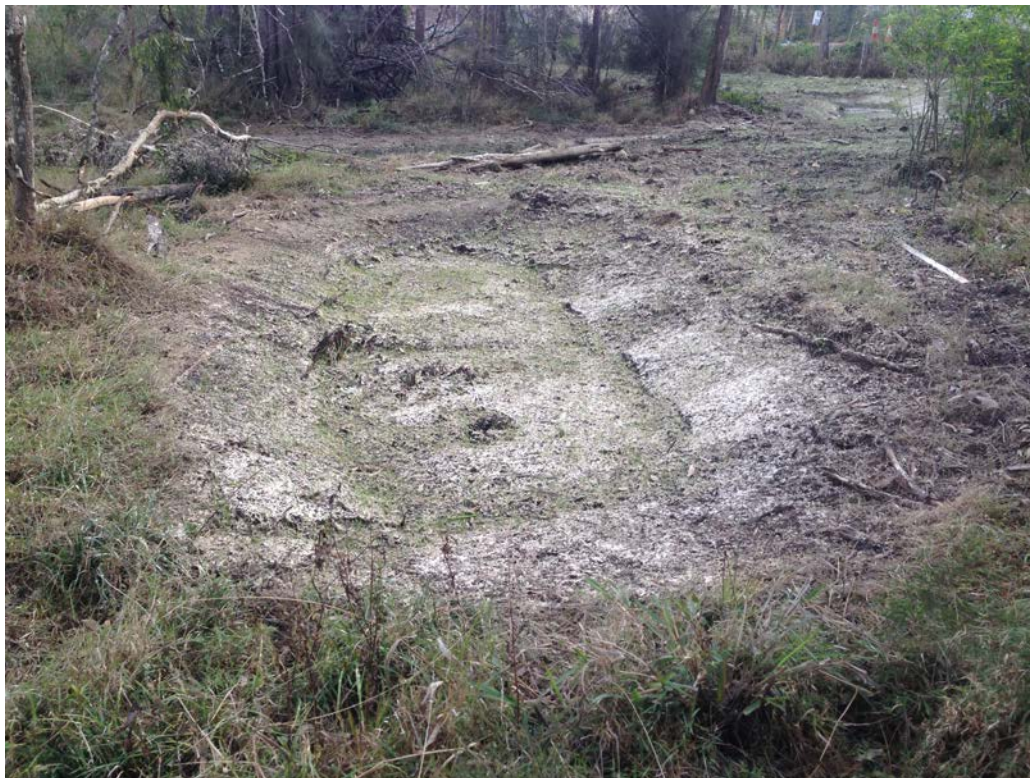
Four ponds were constructed at chainage 22500 – 22700 in *in situ* soil (there is not a temporary basins available at this location). Only four ponds as opposed to the five nominated in the Ecological Monitoring Program were constructed due to a lack of suitable cleared area. This reduction has been supported by Brian Tolhurst from the EPA.

Green-thighed Frog Pond at chainage 22500 – 22700

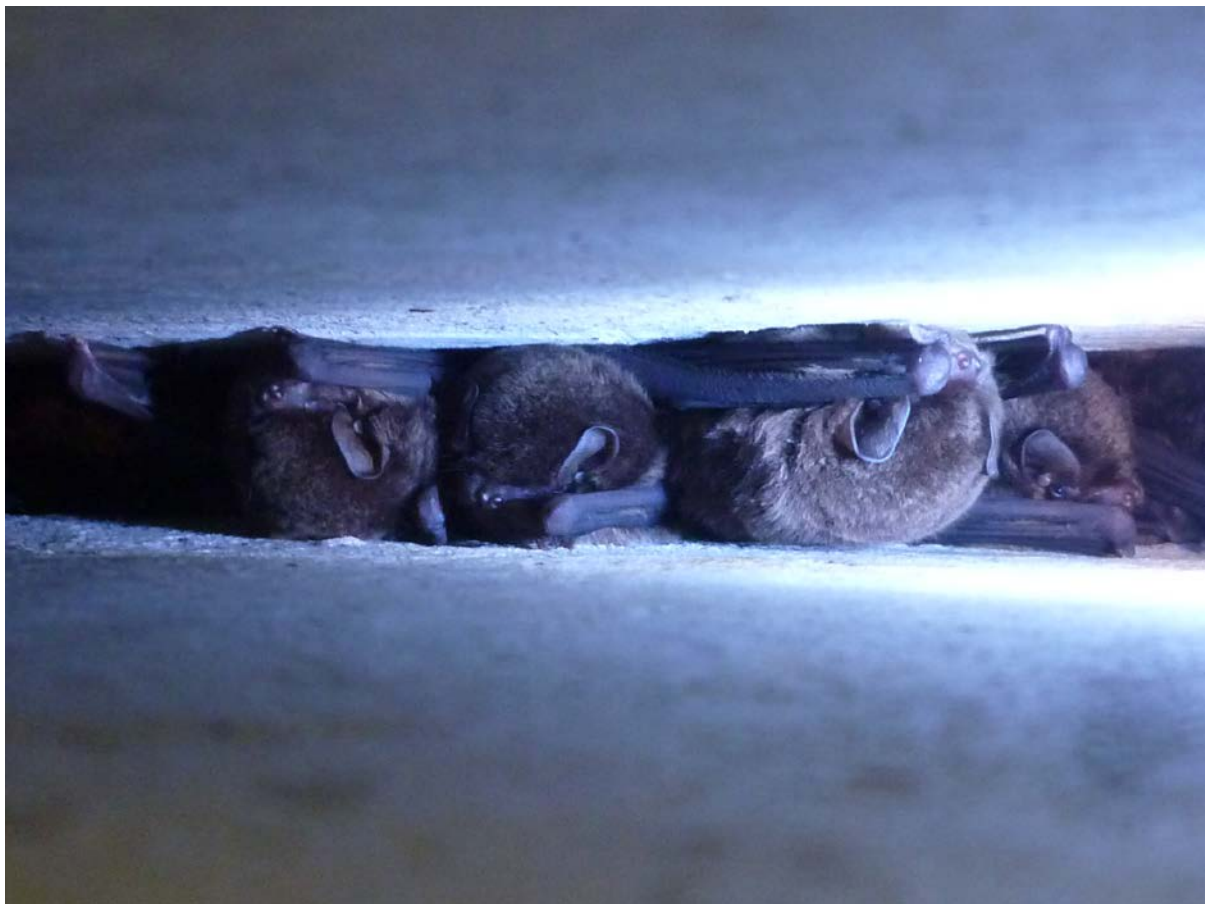
Microbats have been recorded in two of the culvert structures that have been constructed for the project. The microbats were observed roosting in the joint cracks between culvert cells.

At CML 107, one individual was observed on the 30 July. This individual was not identified on the day and has not been observed since. At CML 207, 15 individuals were recorded in two joint cracks on the 14 August. These individuals were identified as Little Bentwing Bat (*Minopterus australis*), a species of conservation concern listed as Vulnerable under the NSW *Threatened Species Conservation Act 1995*.

Little Bentwing Bat (*Minopterus australis*) in culvert structures

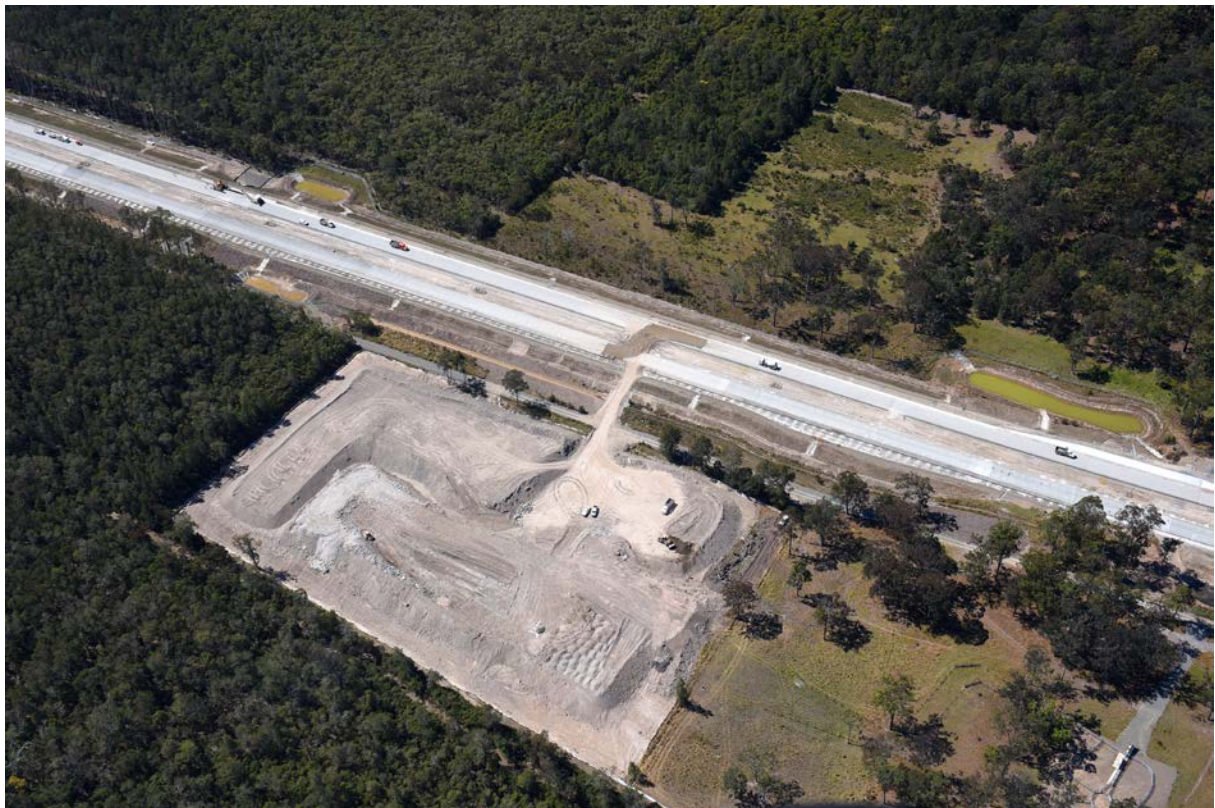
Geotechnical testing identified that the F2E project would yield a significant surplus of upper zone quality material. Through a program of laboratory testing, various blends of the upper zone material with fine sand and/or crushed rock were found to change the plasticity (PI) or CBR (California bearing ratio) to meet the Roads and Maritime specification (R44) requirements for verge material or SMZ which would allow the surplus material to be used for construction of the road.

This initiative has allowed the use or reuse of up to 110,000t of materials which would have otherwise been spoiled or gone to landfill consisting of:

- 70,000t of surplus upper zone rock.
- 30,000t of imported platform and access track rock.
- 7,000t of waste concrete from the paving operation.

Ancillary facility for crushing surplus upper zone rock with rock and waste concrete

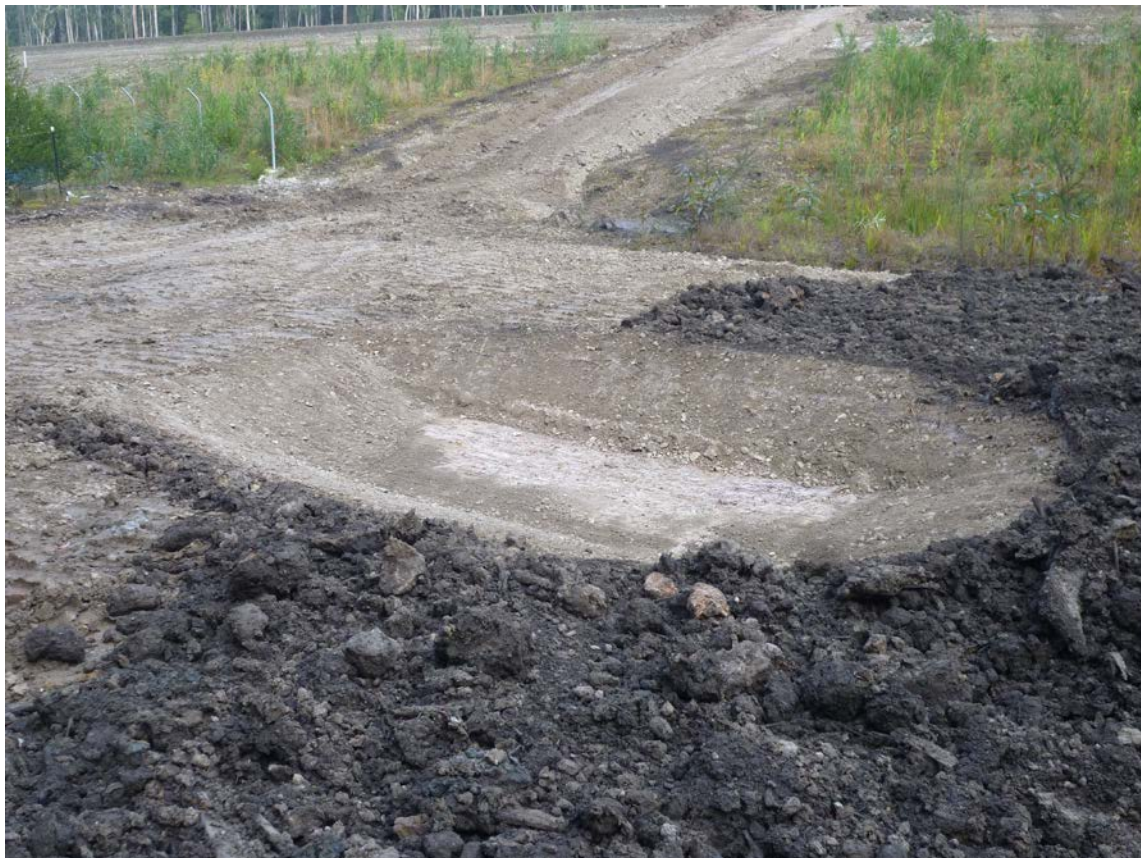
In consultation with Ben Lewis (RMS Ecologist) and Brian Tolhurst from the EPA, it was agreed that where possible, the Green-thighed breeding ponds could be constructed in the backfill of temporary sediment basins (refer to Section 4.4). This is considered a best practice initiative for ecological enhancement as it avoids disturbing otherwise undisturbed areas beyond the limit of clearing to create the breeding ponds.

The formation of the breeding ponds in the backfill of temporary sediment basins will also enhance the habitat diversity of these restored areas for other species of plant and animals by mimicking the natural topographic variation in the landscape.

Green-thighed Frog Pond during construction in former sediment basin at Chainage 26000 – 26200
