COMMONWEALTH APPROVALS EPBC 2013/6963 CONDITIONS COMPLIANCE TRACKING AND MANAGEMENT ANNUAL REPORT

Nambucca Heads to Urunga Pacific
Highway Upgrade

DECEMBER 2013 – FEBRUARY 2015

Pacific Highway Upgrade: Nambucca Heads to Urunga Clearing Report

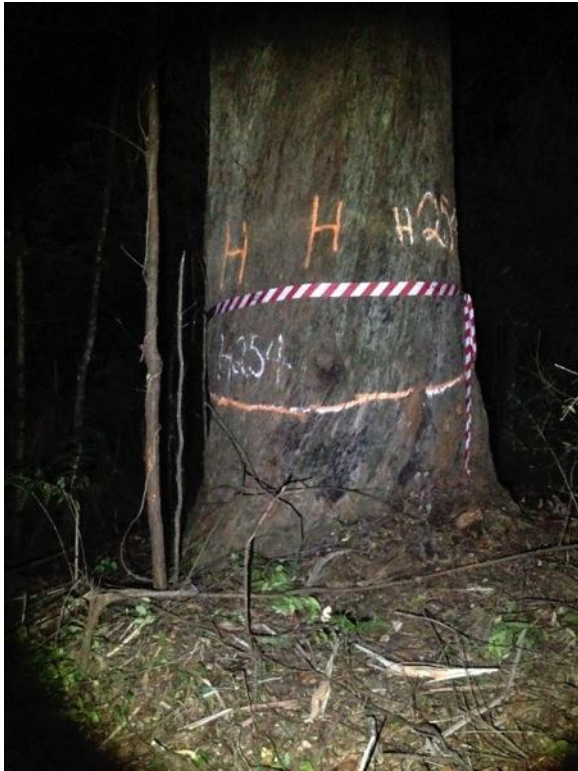
Plate 1: HBT's marking protocol – red and white danger tape and painted orange "H".

Prior to commencement of clearing in a specific area the alignment was traversed to mark fauna habitat resources, including hollow-bearing trees (HBT), nest trees, excavations in arboreal termitaria, dreys and large hollow logs. The HBT survey included remarking of trees identified by Lewis (2013e) and additional trees. HBT were marked with red and white danger tape and four large “H” were painted on the tree (Plate 1). Data collected on each tree included: tree number, species, location (GDA 94), diameter at breast height (DBH), proportion of crown remaining, and hollow size (small 10-50mm, medium 51-150mm, large 151-300mm and very large >300mm) and type (e.g. branch, trunk, spout, fissure, decorticated bark). Habitat resource surveys began one week prior to the commencement of clearing and were undertaken progressively during the clearing phase.

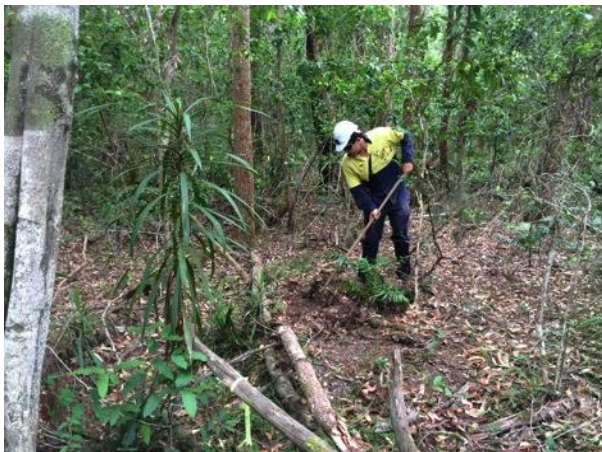
Plate 2: Raking leaf litter in search of green-thighed frogs at chainage 74800.

Targeted surveys were required for green-thighed frog. Potential green-thighed frog habitat was identified in low-lying areas (i.e. flats & drainage lines) in three locations; chainage 74665-74965, chainage 78765-78965 and chainage 79765-80765 (Lewis 2013b). In accordance with the management strategy suitable microhabitats were inspected immediately prior to commencing clearing operations. A wrecking bar was used to split and roll woody debris and a rake used to turn leaf litter (Plate 2). Targeted frog surveys were undertaken concurrently with standard pre-clear surveys and were concentrated on the base and sides of drainage lines within the abovementioned areas. A minimum of 15-person minutes/ha was spent conducting searches in areas of potential habitat.

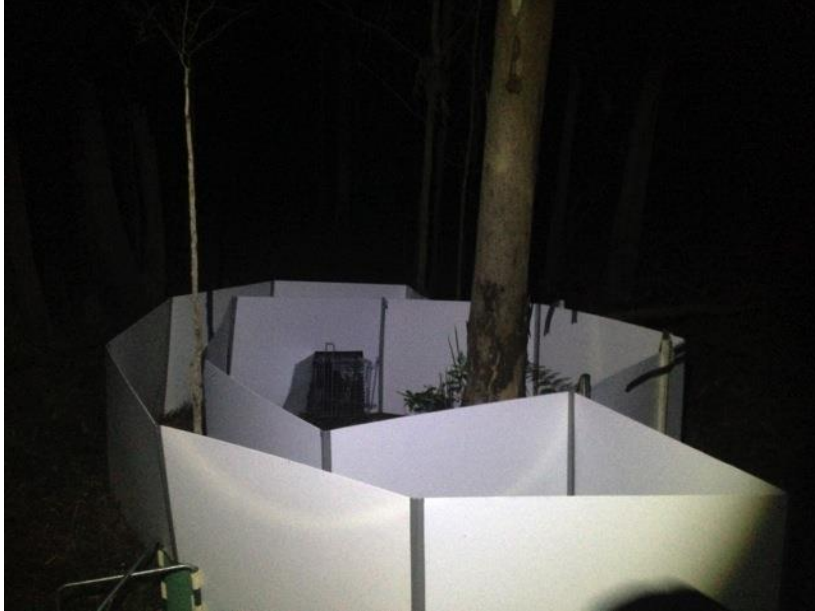
Plate 3: Koala trap installed around a small-fruited grey gum occupied by a male koala. A second section of fence has been installed around the trap.

undertaken during the 48 hour HBT retention period. Traps, baited with peanut butter honey and oats or fruit, were set at the base of HBT in the late afternoon and checked at first light. Captured fauna were processed and released into surrounding habitat at least 100m from the Limit of Clearing (LoC) boundary. A koala trap was used as required. The koala trap was based on Phillips (2011) and included a corflute fence positioned around the occupied tree with a large cage trap fitted into a hole in the fence (Plate 3).

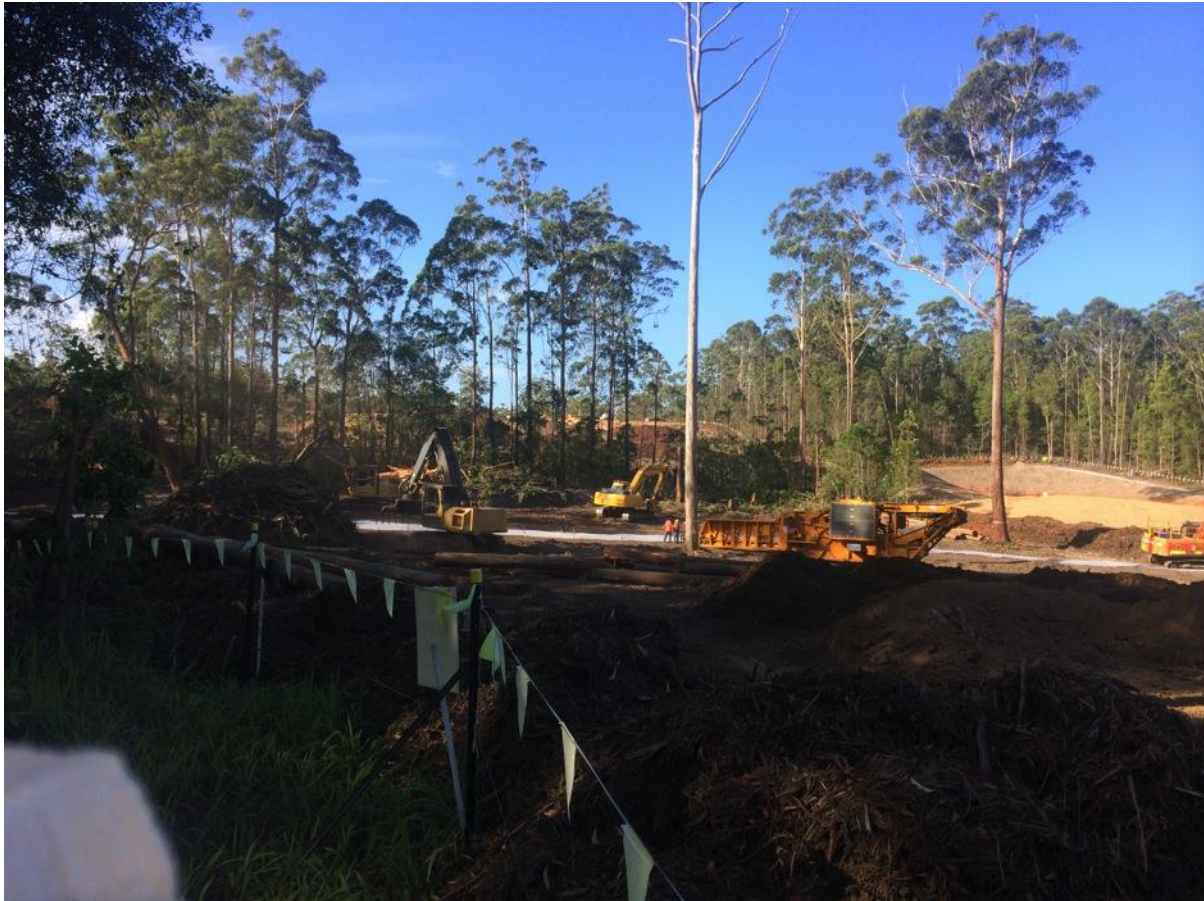
Plate 4: Example of a potentially hazardous HBT, in this case a stag, left within the work zone. Staff excavating drains and laying geofabric are within the fall zone of this tree.

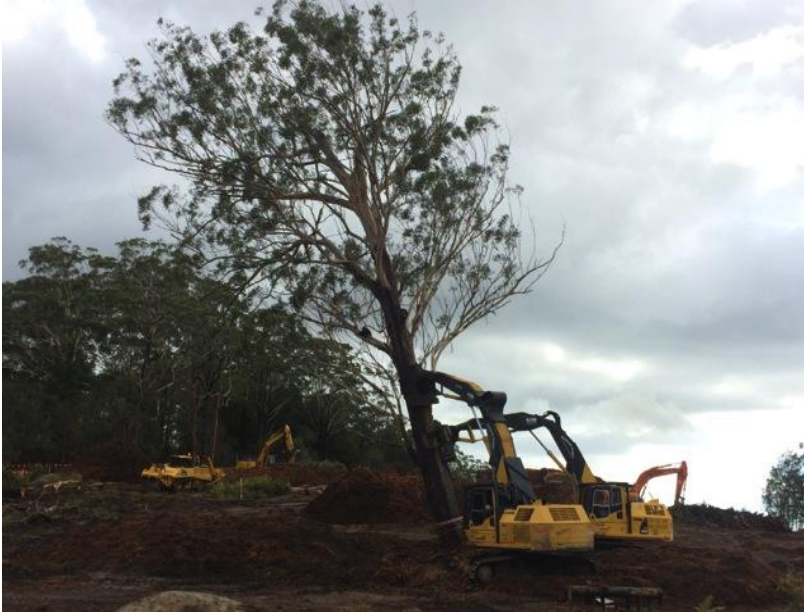
Plate 5: Example of two harvesters falling a large coastal blackbutt.

The clearing method varied between contractors depending on operator skill and equipment capability. In most cases small and medium sized trees were cut near the base and placed on the ground, or the tree was pushed with the root bole intact and lowered to the ground. Large trees were felled with the root bole intact by either direct pushing or use of two machines to slow the fall (Plate 5).

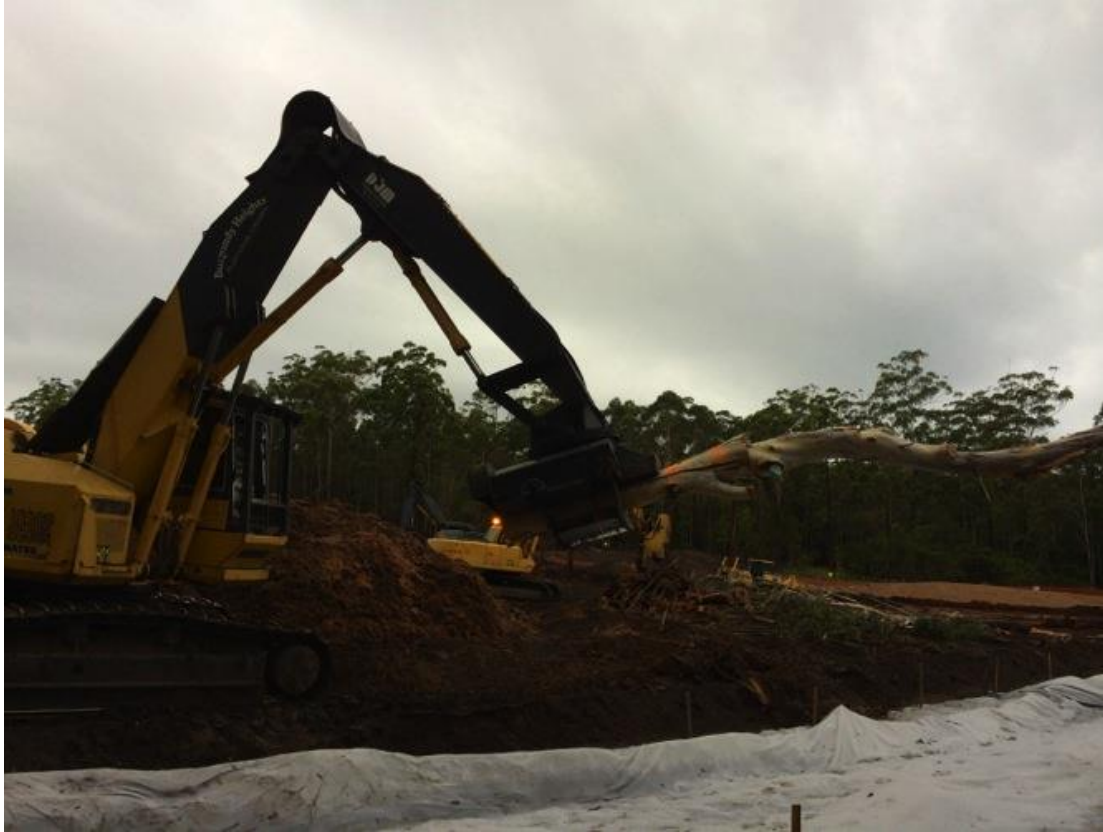
Plate 6: Section of tree with a hollow occupied by two sugar gliders being moved outside the LoC. The hollow (centre of log) is plugged with a cotton bag.

Captured fauna and occupied hollows were placed into the adjoining forest, or the closest area of suitable forest (i.e. appropriate area and habitat type for the subject species) within 100m from the LoC boundary. All gliders and some bats were transferred to nest boxes, which were installed temporarily in adjoining habitat (Plate 7). Nest boxes were inspected the following day and removed if there was no sign of continued use. Reptiles were placed on trees with decorticated bark and hollows or in piles of logs where there was good refuge habitat. Insectivorous bats were released at dusk near their point of capture. Frogs were released on drainage lines or at dams within close proximity to their capture site.

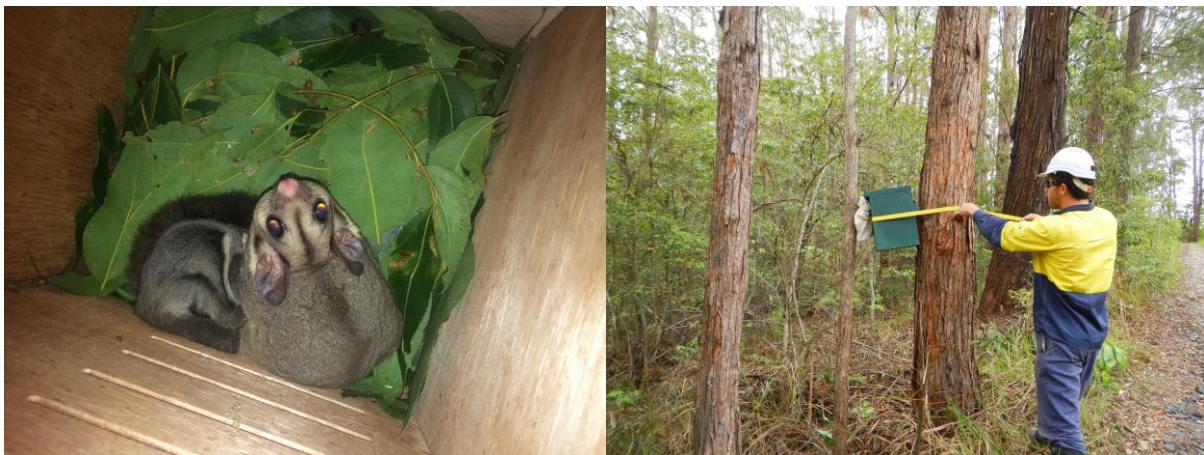
Plate 7: Adult and juvenile sugar glider placed in a nest box with fresh eucalypt leaf (left) and the box is then strapped temporarily to a tree at the relocation site (right).

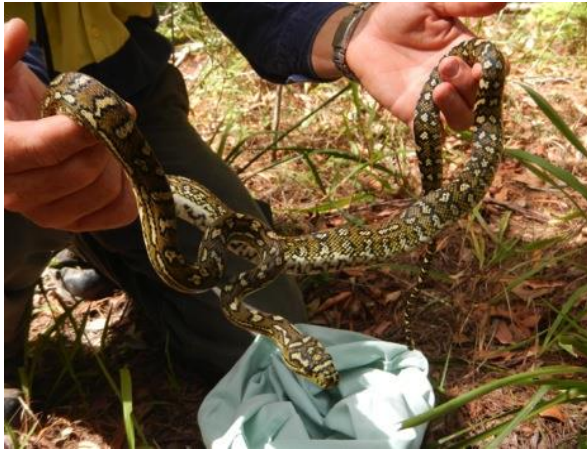
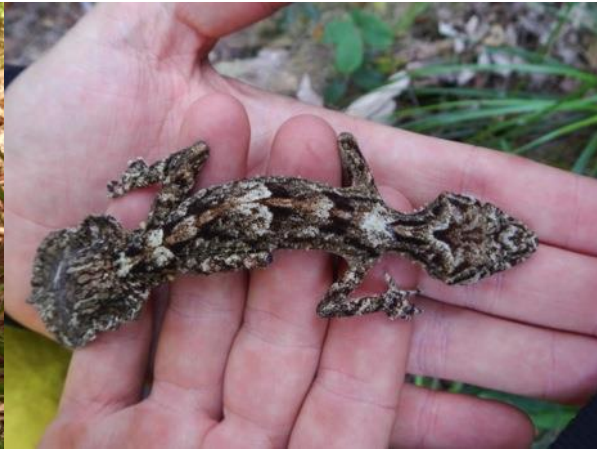
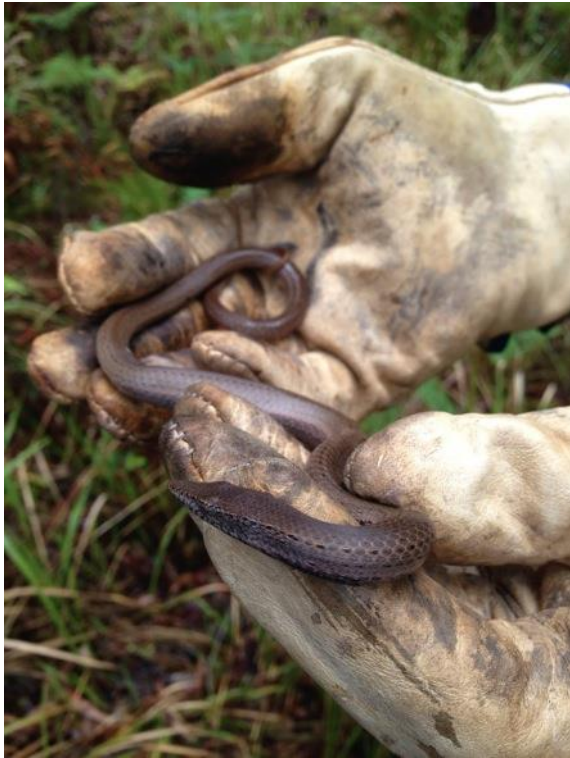
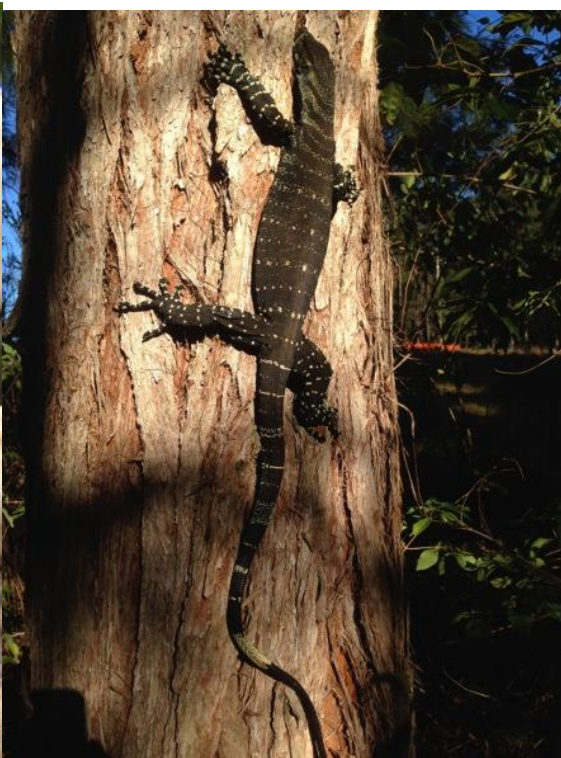
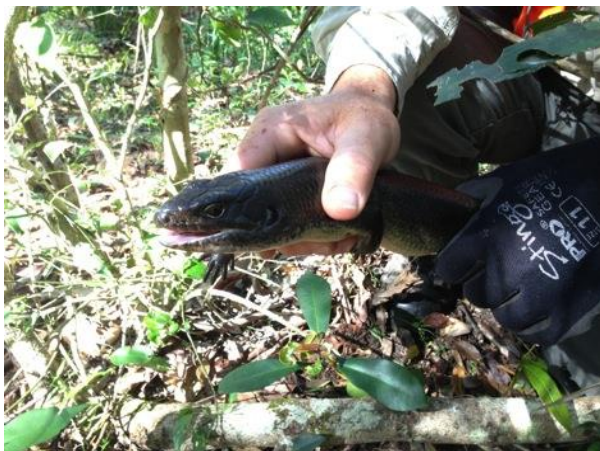
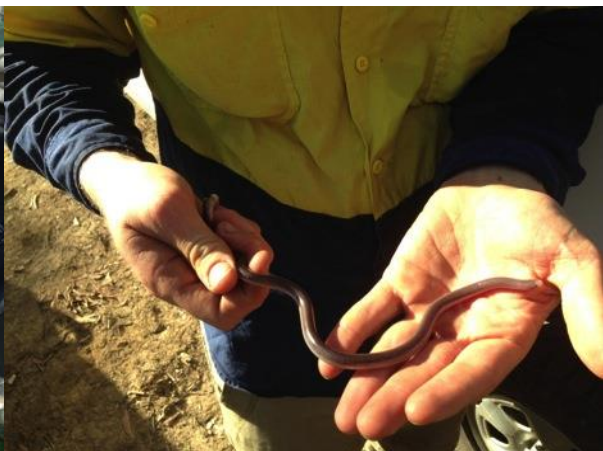
Plate 8: Reptiles captured and relocated during the clearing phase of the NH2U Pacific Highway Upgrade. A) juvenile carpet python, b) southern leaf-tailed gecko, c) Burton's snake lizard, d) lace monitor, e) land mullet and f) blackish blind snake.

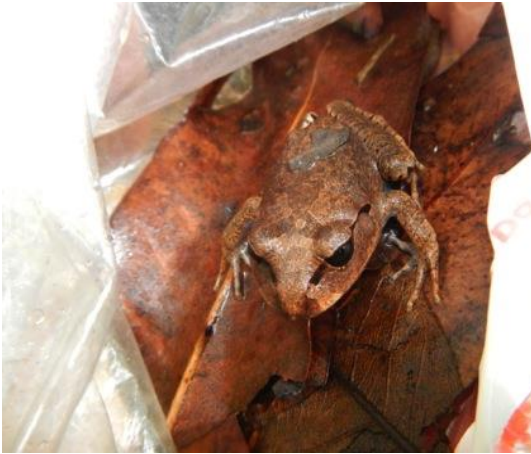
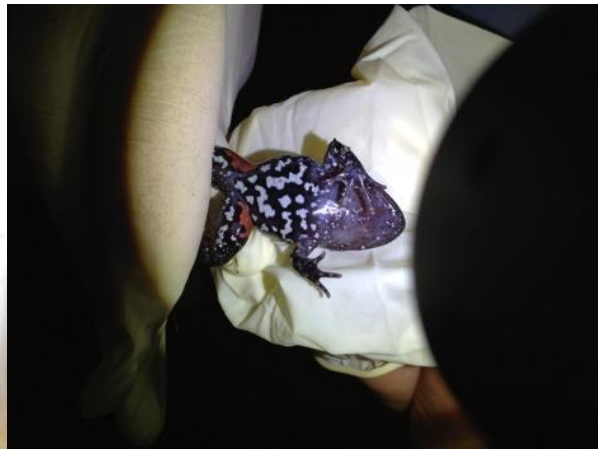
Plate 9: Frogs captured and relocated during the clearing phase of the NH2U Pacific Highway Upgrade. A) great barred frog, B) tusked frog (underbelly).

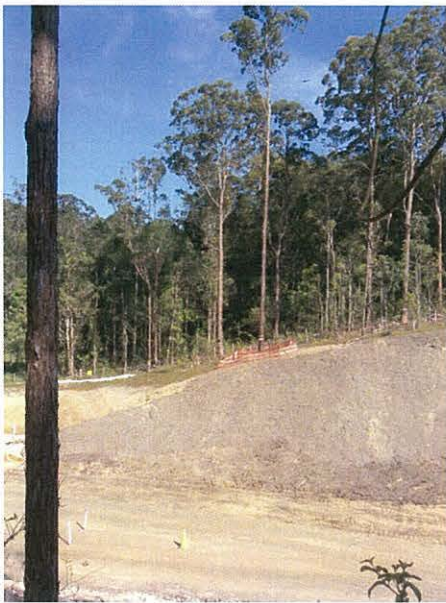
14/11/14

Glider tree CH 80100 North Bound

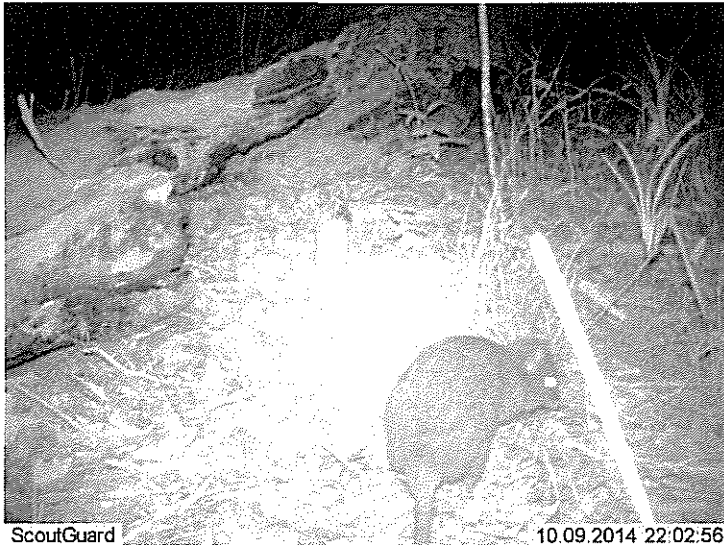
17/11/14

long-nosed potoroo (*Potorous tridactylus*)
~50m to the west of the underpass at
Ch:73800

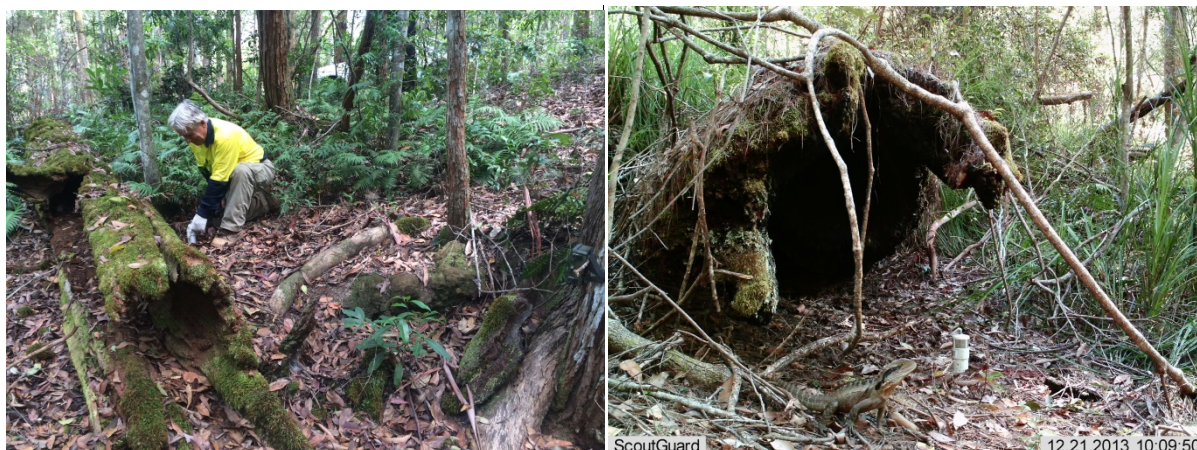
Plate 2.1: Typical sample sites with bait station positioned near large logs.

Baited camera traps were set at a density of 2/100ha. Each trap consisted of a Scoutguard SG560K camera aimed at a small bait station. Cameras were attached to trees at a height of 0.5-1.0m and situated 3-4m from a bait station. Bait stations were pegged to the ground and baited with either chicken wings or fish (blue pilchards) with bait type alternated between stations in the north and central zones. Chicken was the only bait used in the southern zone. Each bait station and surrounding logs/rocks were drizzled with fish oil as an attractant. Cameras were left insitu for a minimum of three weeks. A range of topographic sequences were sampled, but emphasis was placed on sampling mature forest on drainage lines (including steep-sided gullies), moist forest

types and areas with abundant large logs, rock outcrops and hollow-bearing trees. Cameras were typically installed near large logs, clusters of logs, drainage lines, forest trails, or a combination of these elements (*Plate 2.1*). Most sites were accessed by 4WD vehicle and foot traverse except sites 36, 37, 38 and 39 which were accessed by boat. Searches for quoll scats and tracks was undertaken opportunistically whilst installing cameras and moving to and from sites.
