# **Commonwealth approval EPBC 2013/6963 conditions compliance tracking and management annual report**

## **Nambucca Heads to Urunga Pacific Highway Upgrade**

February 2017 – January 2018

Pacific Highway Upgrade - Nambucca Heads to Urunga Operational Phase  
Threatened Flora Monitoring Year 1 Annual Report

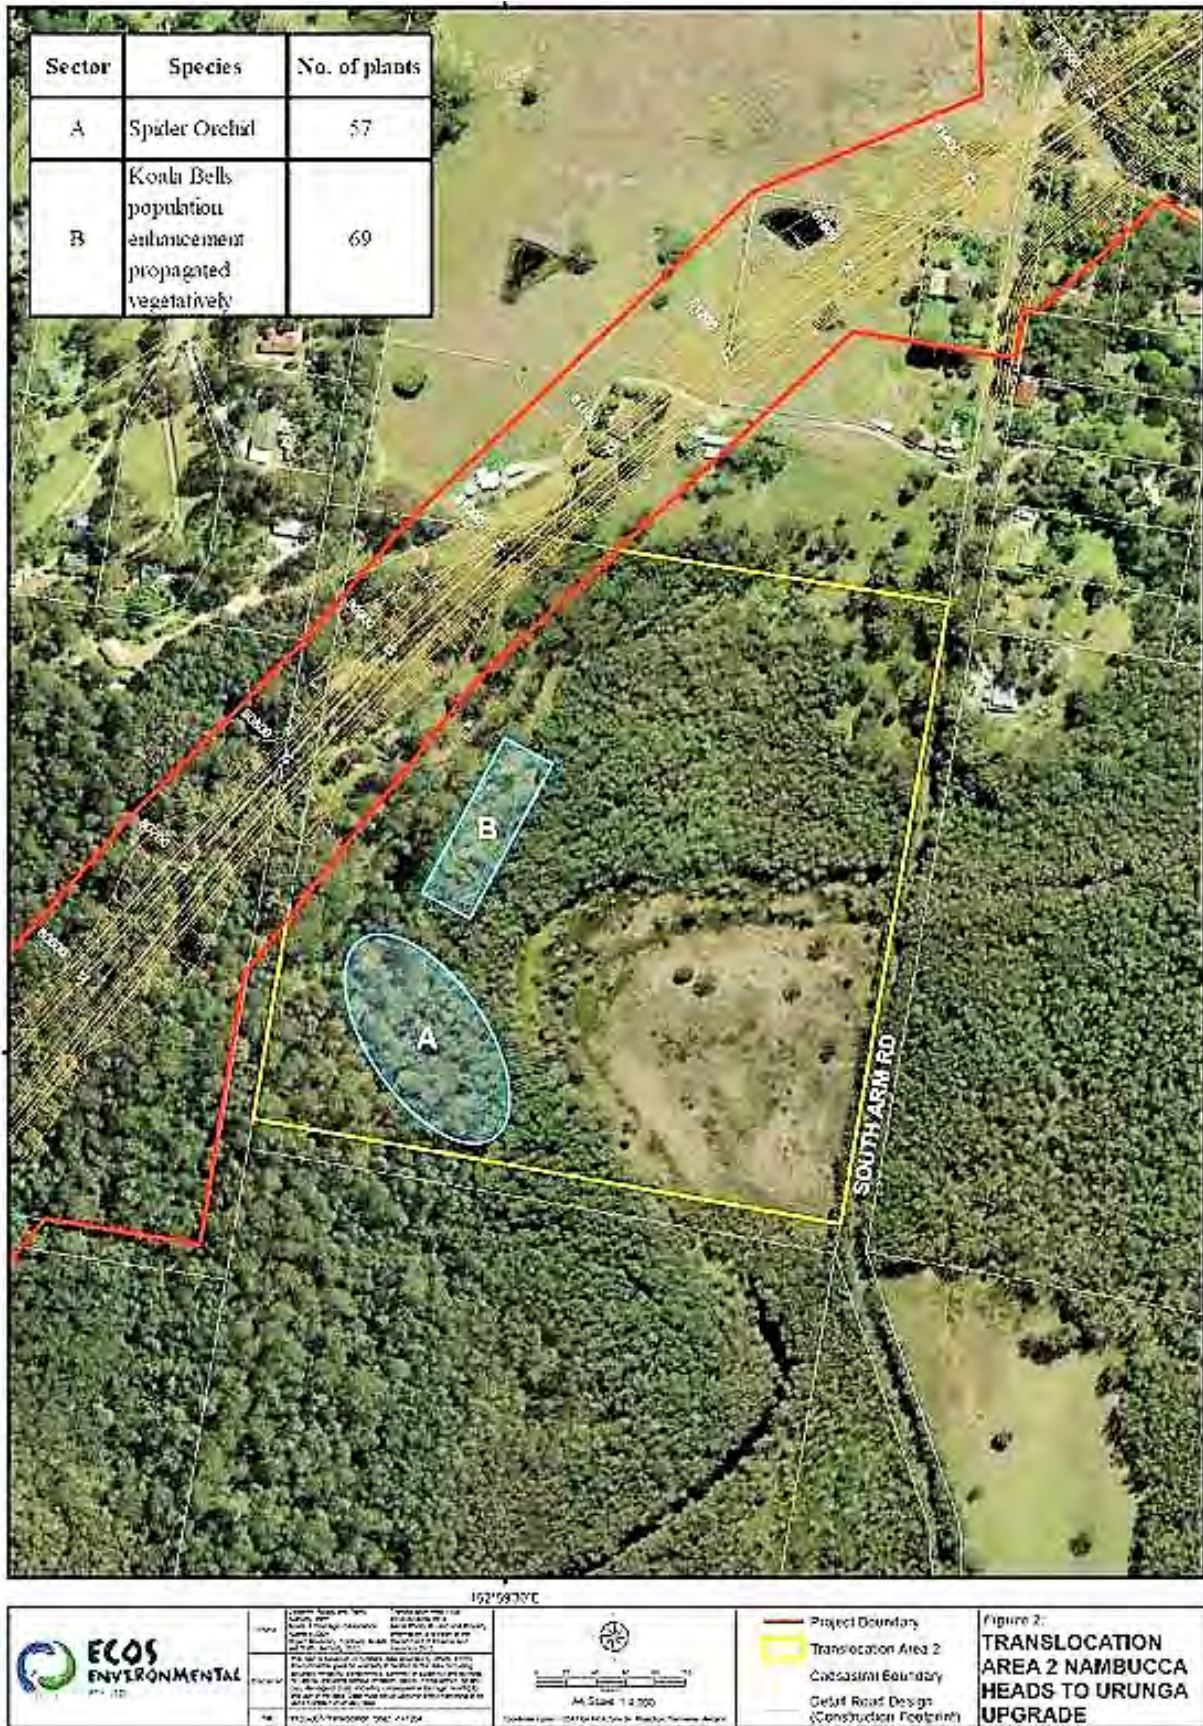
Figure 4: Translocation Area 2 (TA2) showing sectors supporting different species and treatments (from Ecos Environmental 2016a).

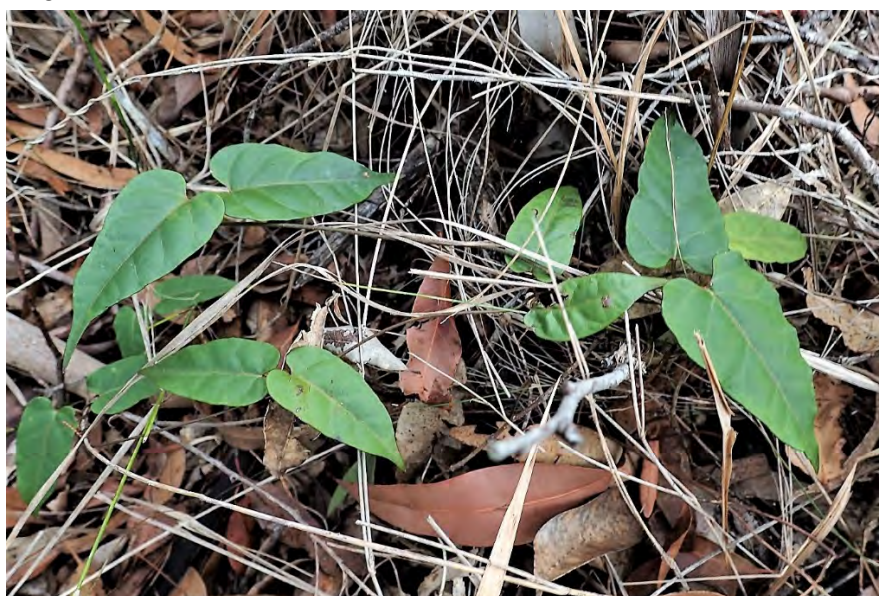
Of the five *in-situ* Slender Marsdenia plants being monitored, two had died back, and the remaining sites supported relatively healthy plants, with a median condition class of 2. Sites UTW3 and UTW4 each had three plants recorded close to the flagged survey point. It is uncertain if all plants were present during past surveys, or if new plants have recruited into the sites, as only single plants had been previously recorded at these sites. Nonetheless, all plants were recorded as being in reasonable health (Figure 5).

Figure 5: *In-situ* Slender Marsdenia at site UTW4 in Oct 2017.

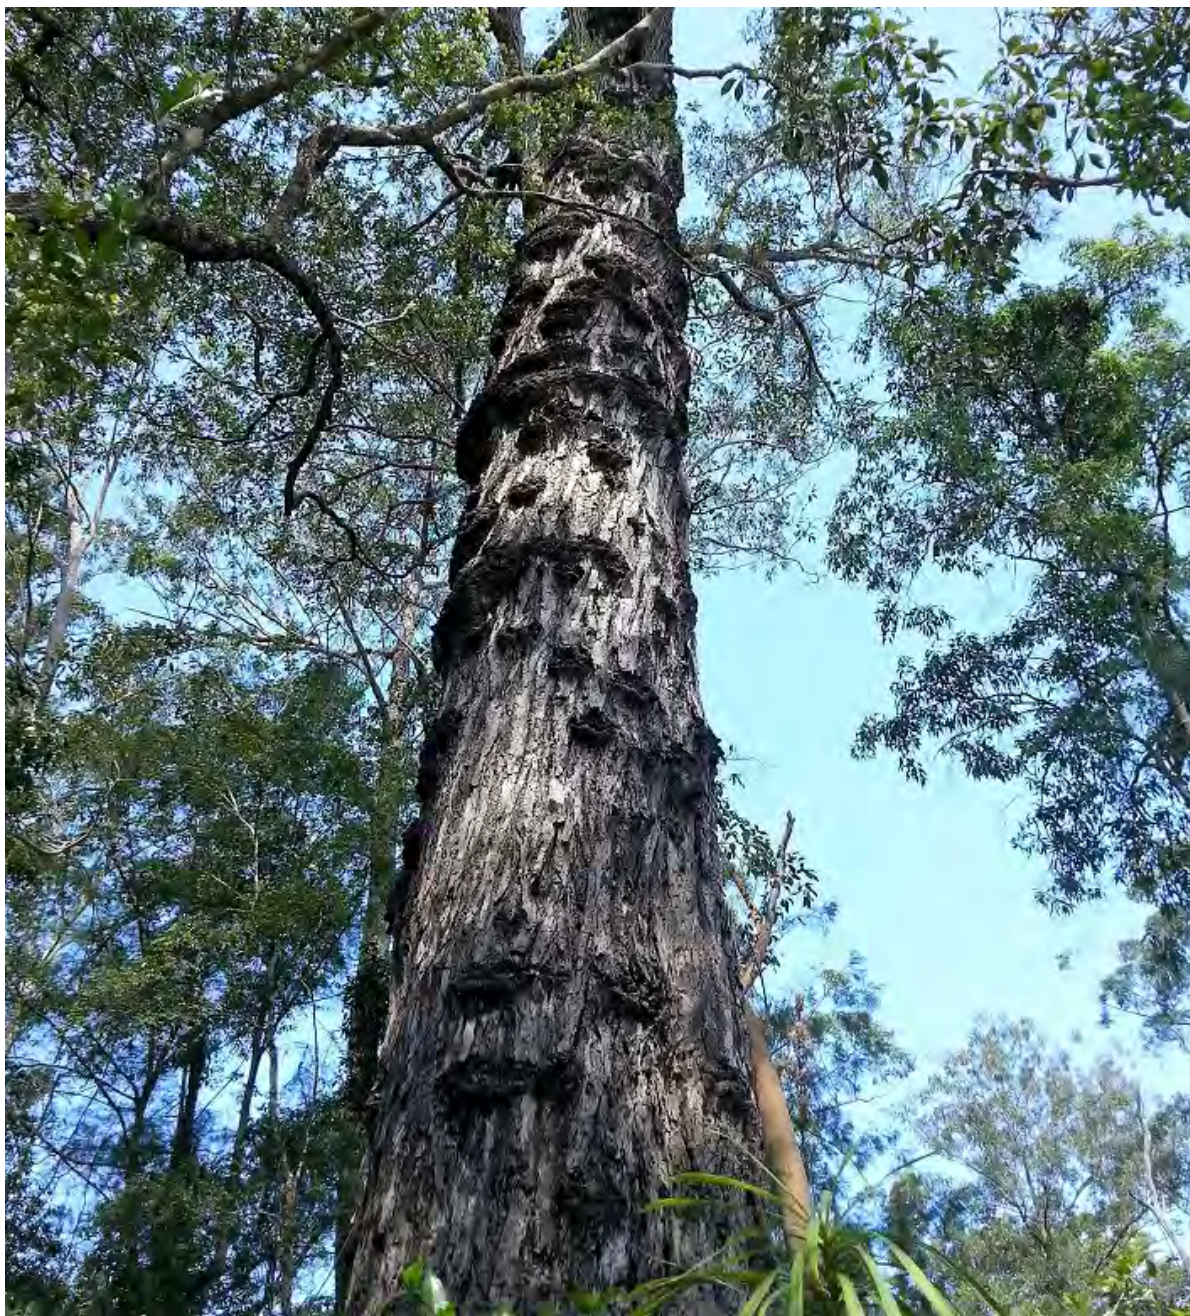
The very large Gully Ironbark, which occurs on a drainage line in the NH2U road reserve directly opposite TA1, was observed to be in good health, with new growth on some limbs. As this specimen is a very old tree, the crown inevitably displays some signs of senescence (Figure 6).

Figure 6: The very large, old Gully Ironbark opposite TA1. Note numerous old Yellow-bellied Glider feeding scars on the trunk.

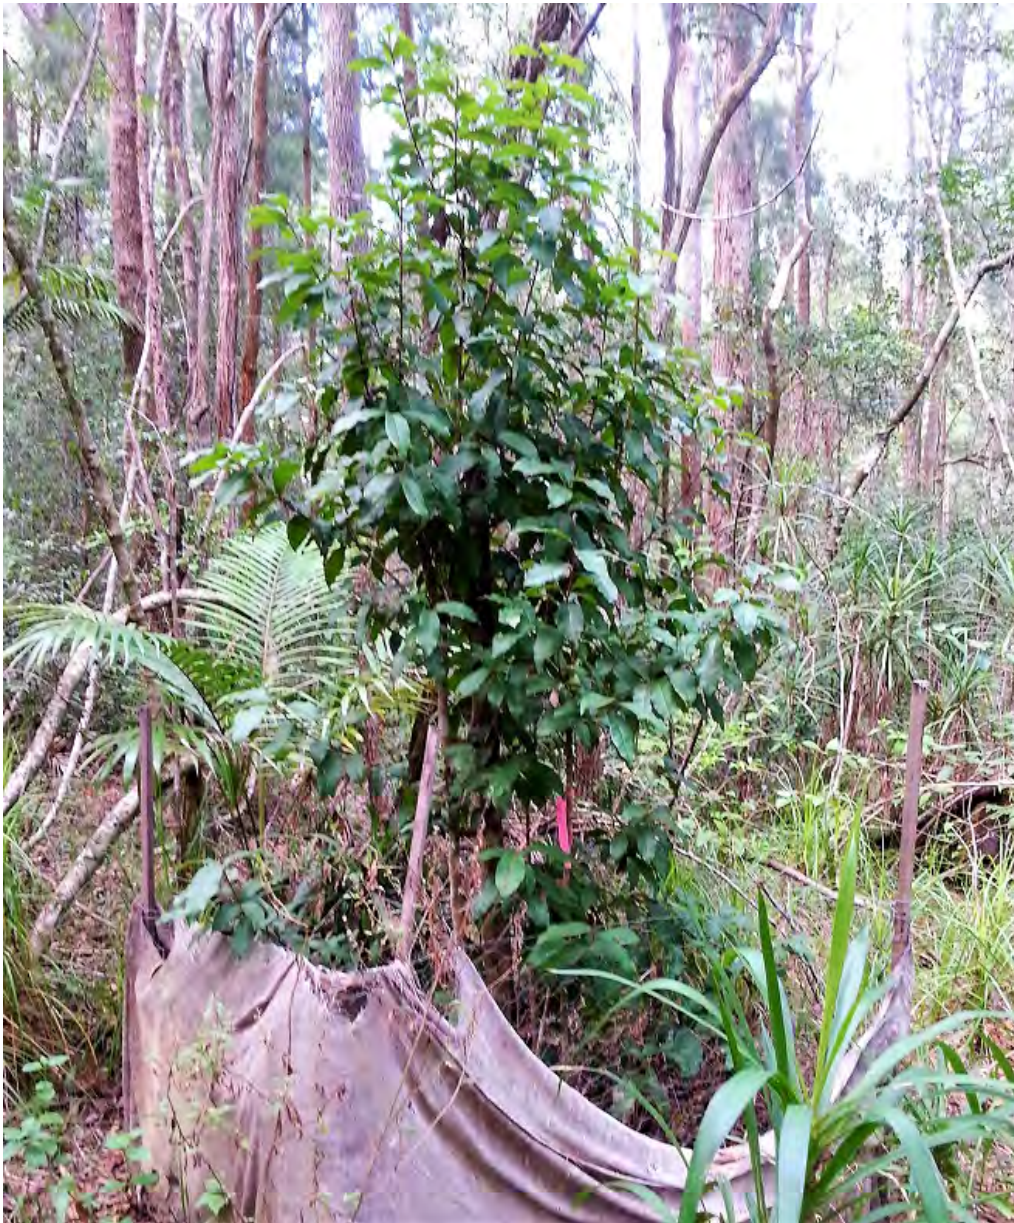
The current survey revealed a survival rate of 67%. Plant 1 bore a healthy, basal stem shoot which had doubled in size from the previous survey in November 2016. Plant 2 appeared to be dead, and Plant 3 was in excellent health with a flush of new growth (Figure 7).

Figure 7: Rusty Plum transplanted tree No. 3 in good health with new growth.
