# APPENDIX B2

## Flora and Fauna Management Sub Plan Nambucca Heads to Urunga

JULY 2014

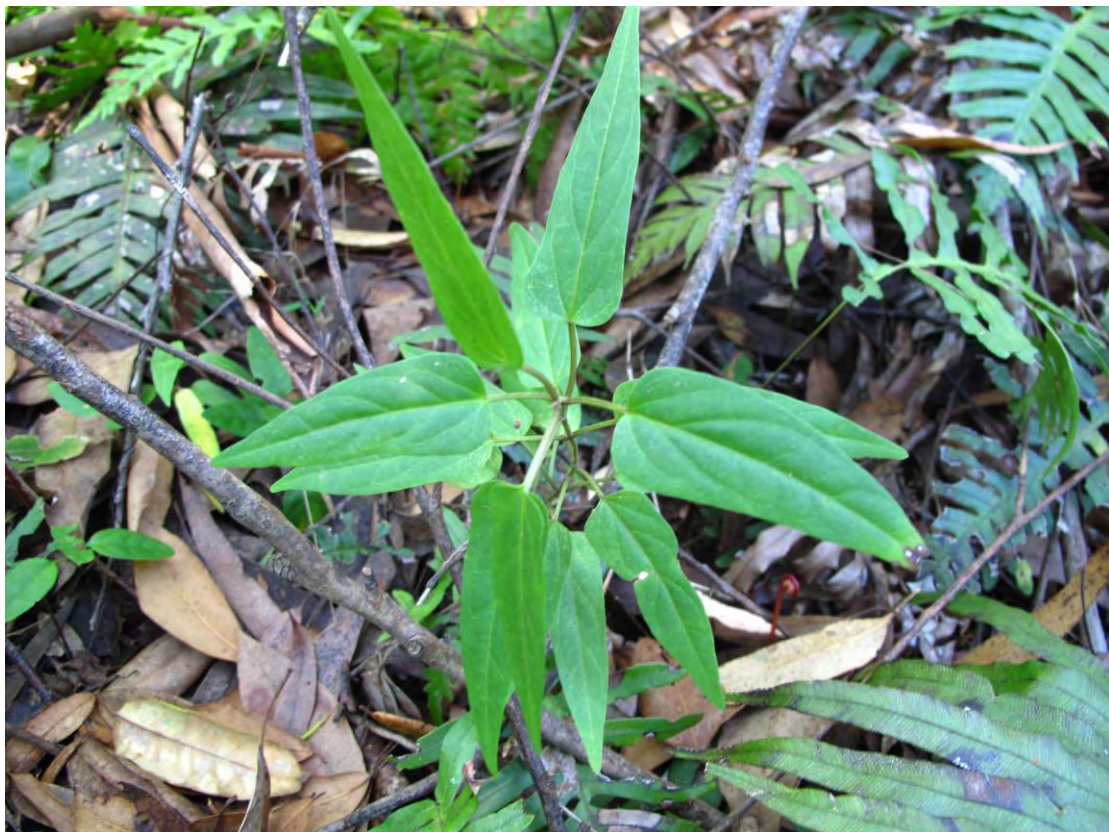
**Plate 1:** Small Slender Marsdenia plant with smooth, hairless leaves.

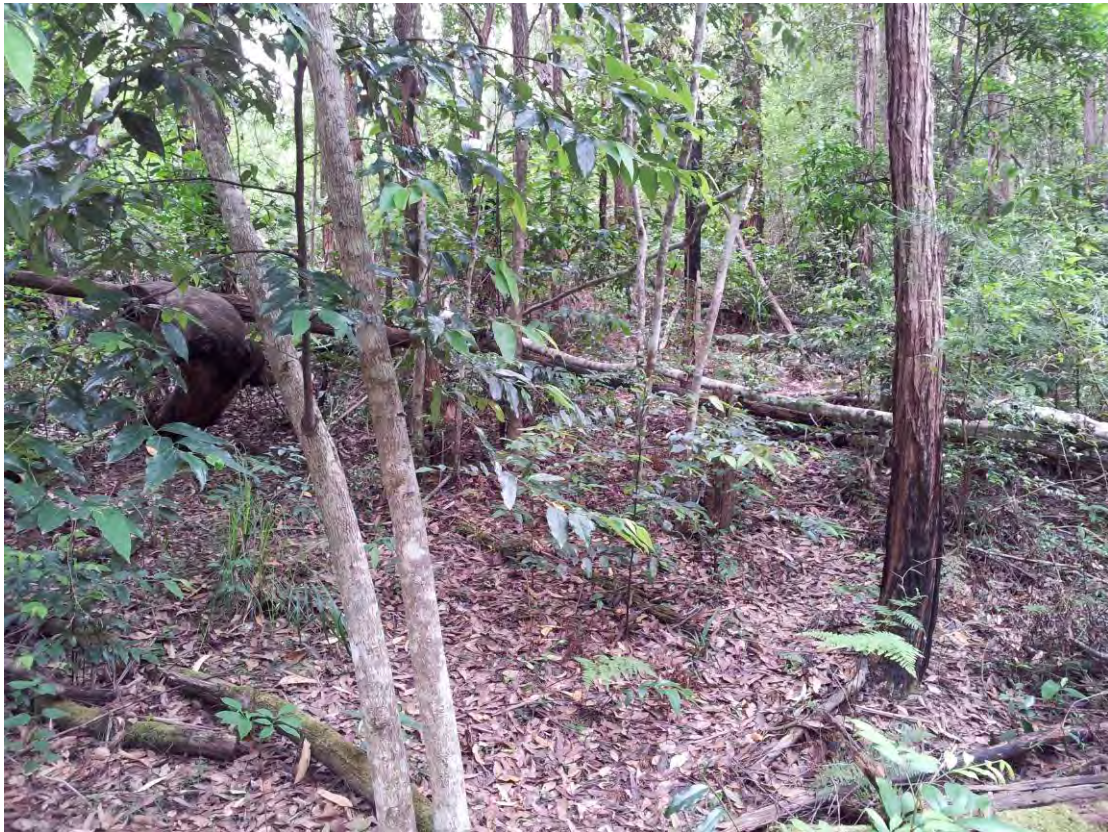
**Plate 2:** Typical Slender Marsdenia habitat in wet sclerophyll forest with understorey of small rainforest trees, shrubs and ground ferns, and open litter or fern covered ground layer, the roughed barked tree is Turpentine.

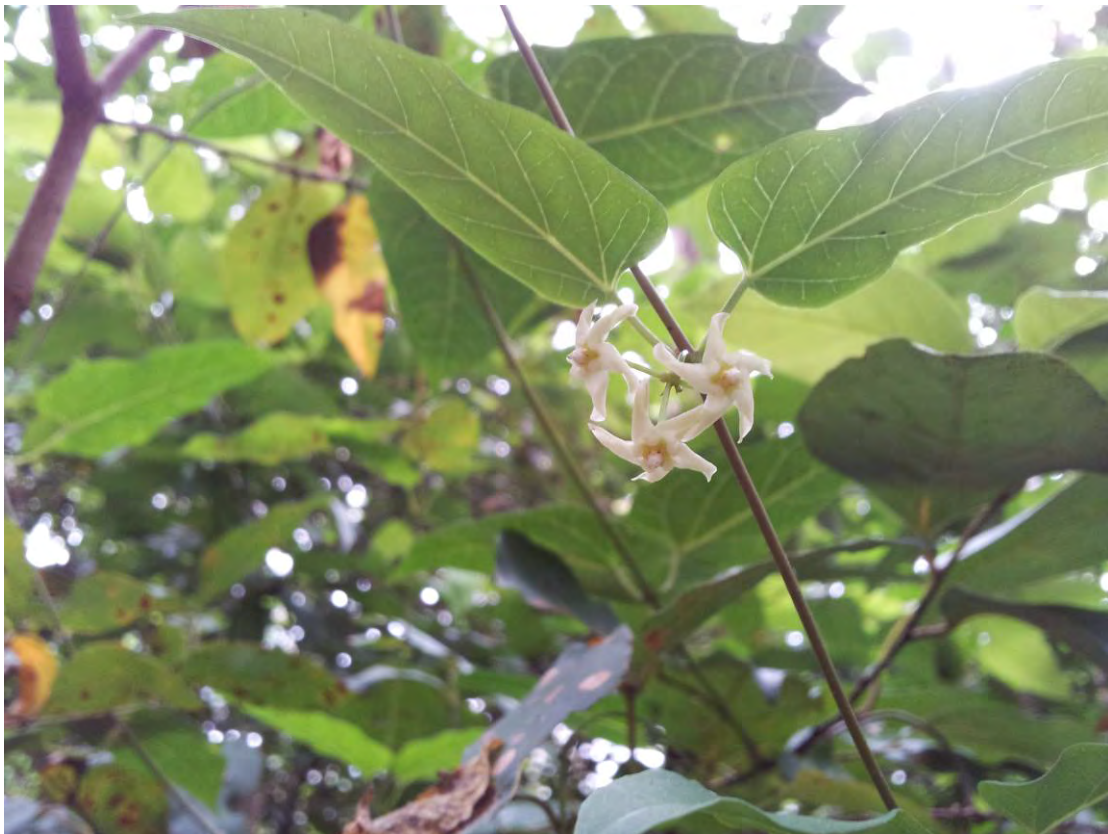
**Plate 3:** Only one plant of Slender Marsdenia was found with flowers. ML-42

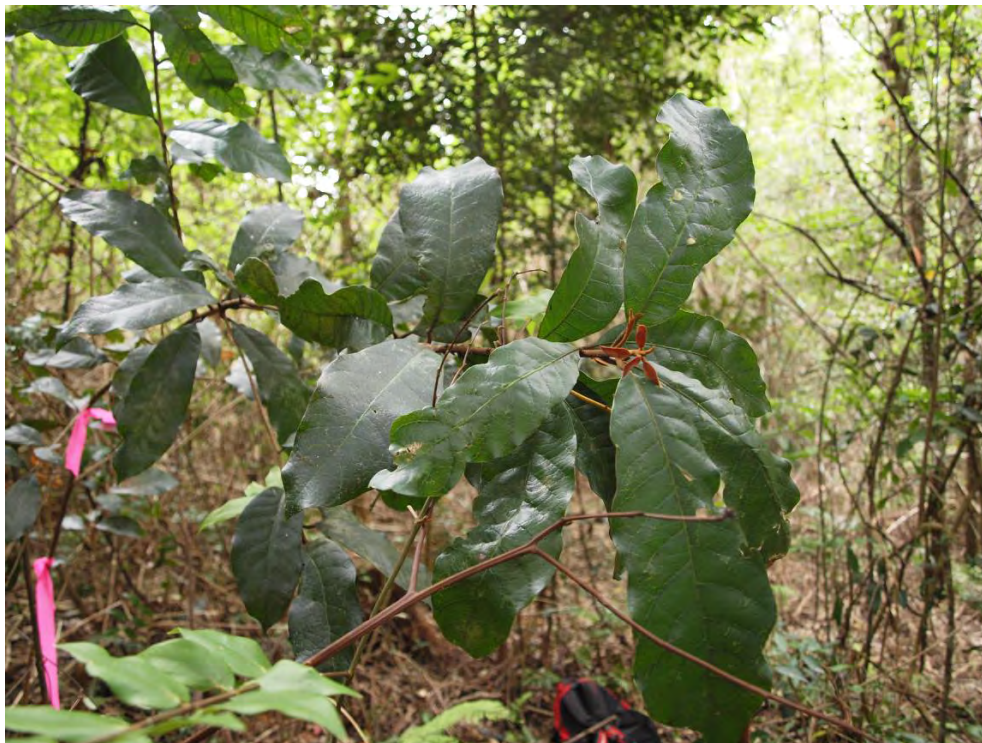
**Plate 4:** Rusty Plum sapling at Cockburns Lane, south of Warrell Creek. NW-50a

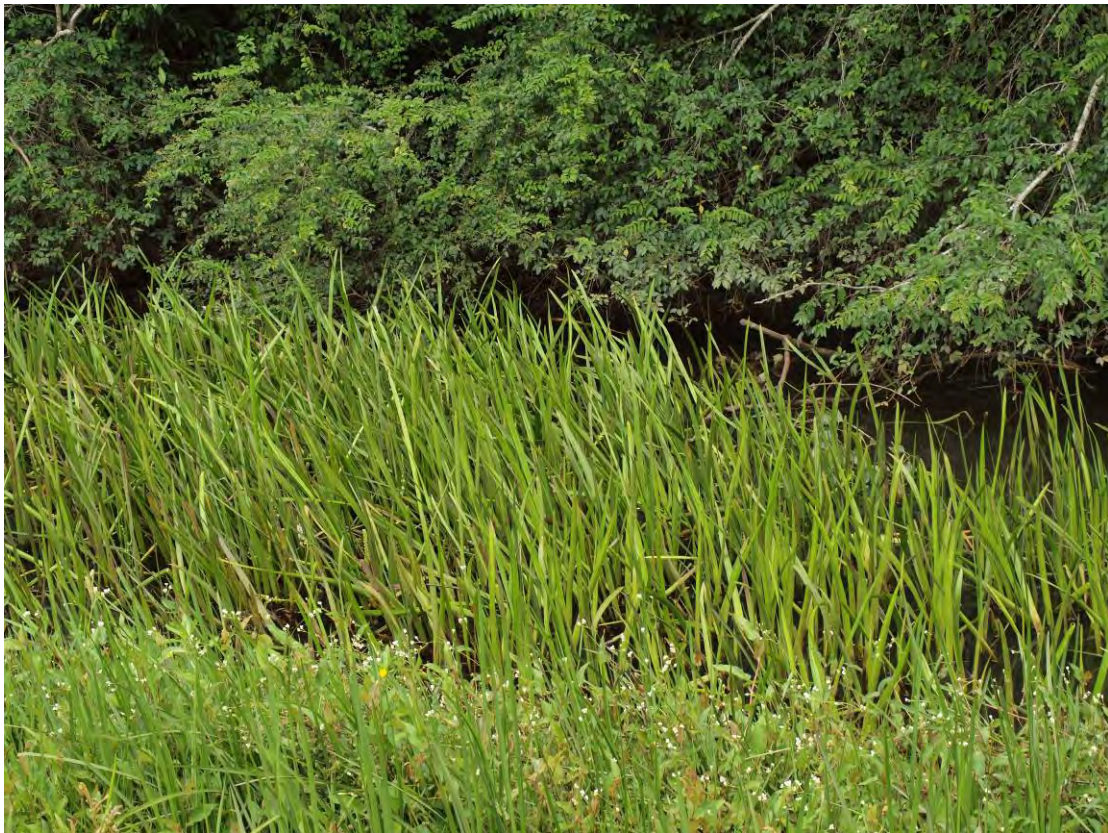
**Plate 7:** Stand of *Maudia* in Crouches Creek, a tributary of Warrell Creek, the water is 0.3-0.5 metres deep.

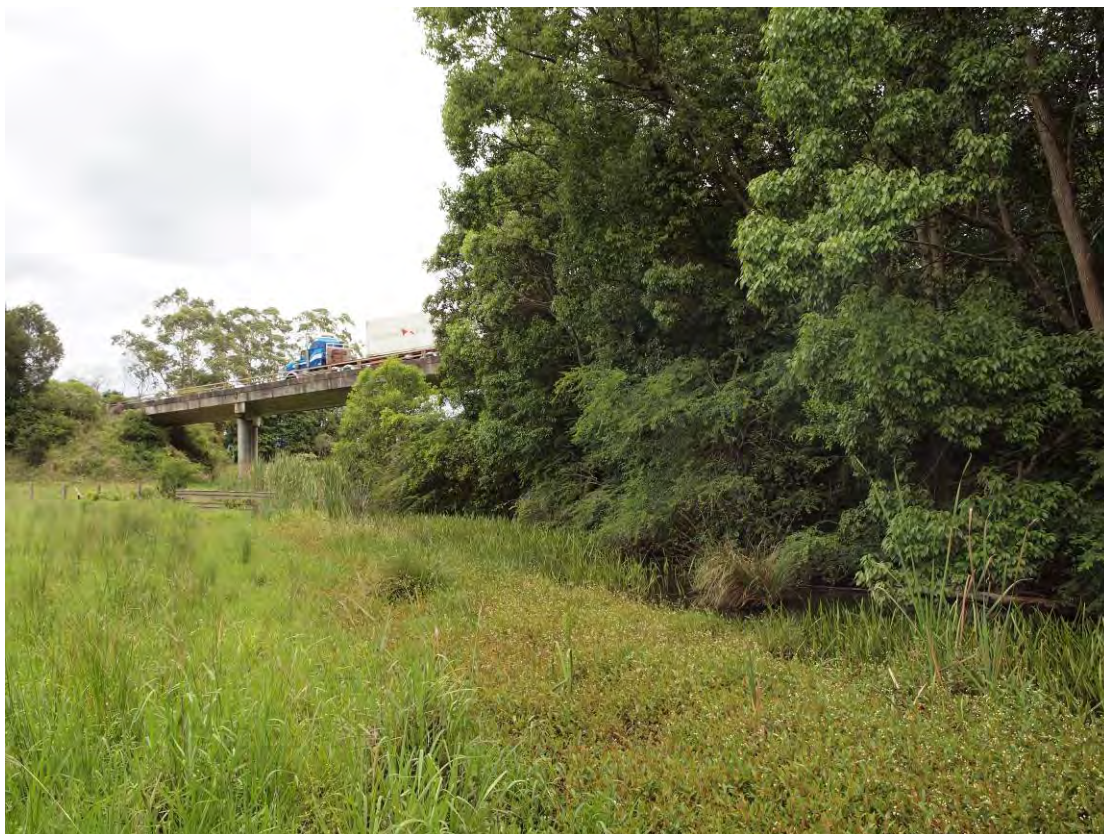
**Plate 8:** Crouches Creek with band of *Maundia* in the creek at the base of slope and edge of tree line. Existing Pacific Highway bridge, looking south-west.

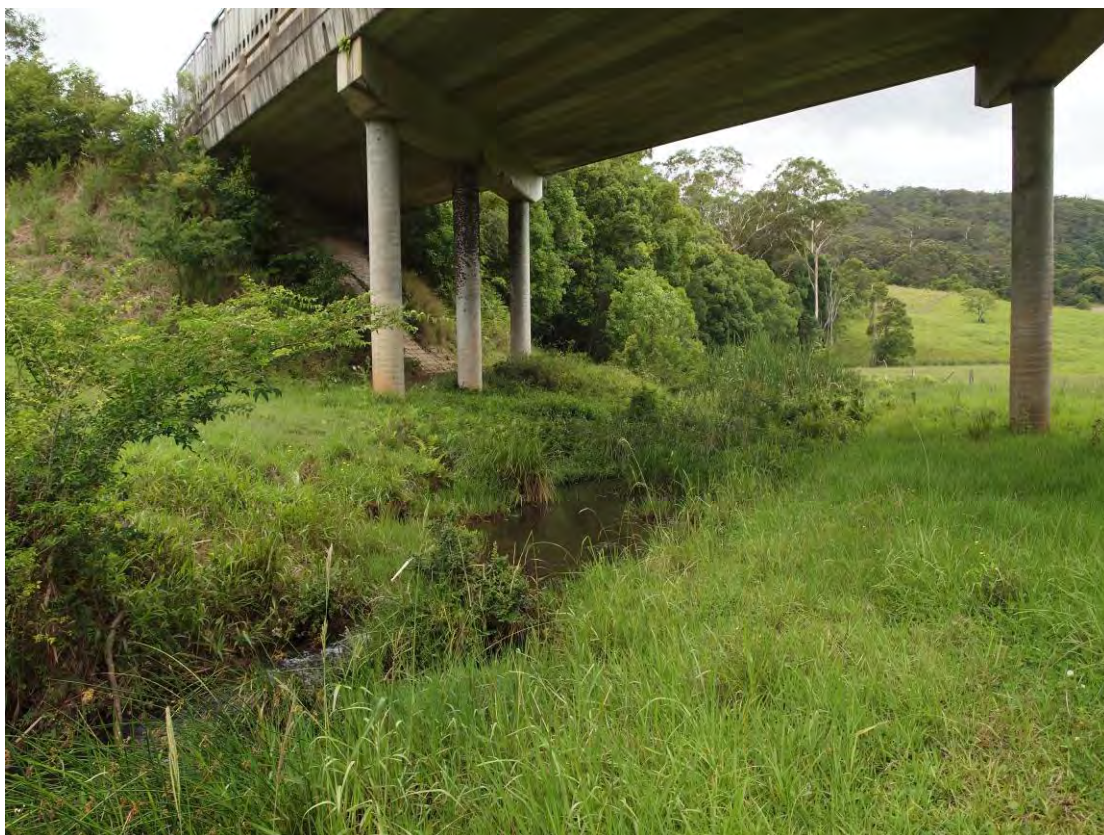
**Plate 9:** Crouches Creek looking east under the existing Pacific Highway bridge; there was no *Maundia* in the section of the creek beneath the bridge and to either side for 20-30 metres.

riffle section underneath the bridge, rather than lower sunlight exposure. As the new bridge is wider, shading may be greater, but some direct sunlight would reach stream vegetation in the morning and afternoon due to the N-S bridge orientation.

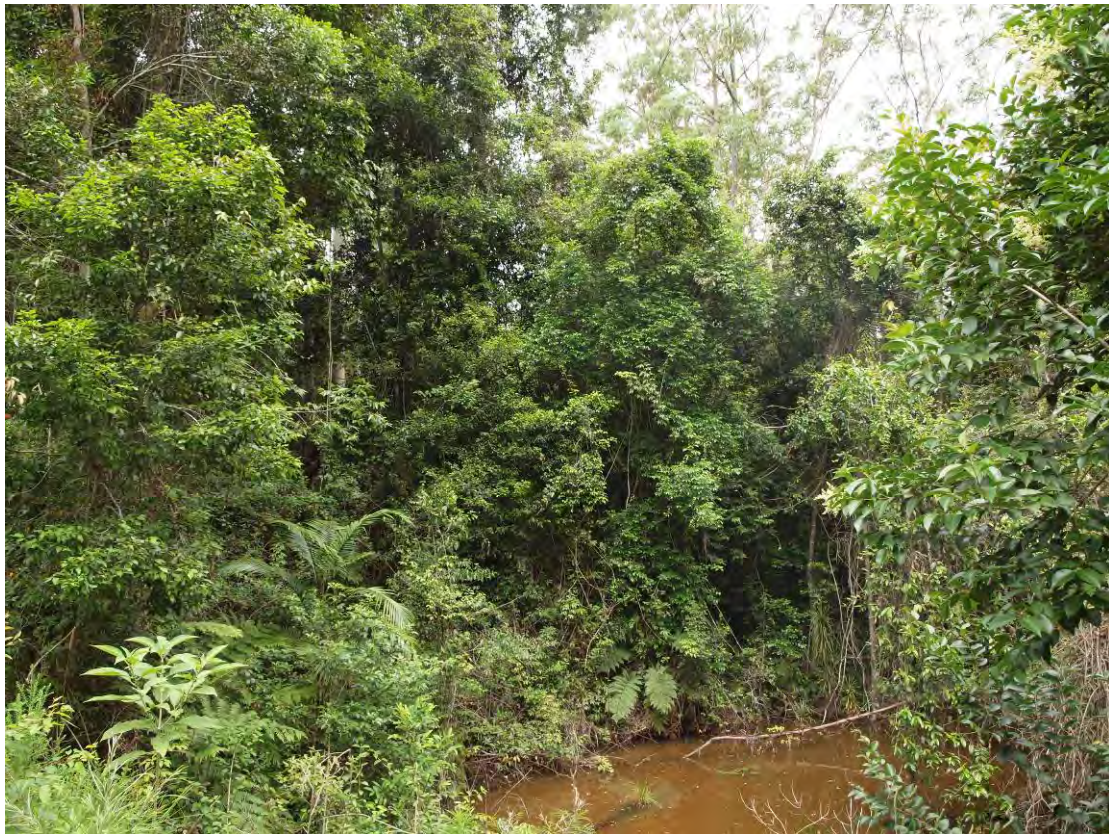
**Plate 15:** A narrow band of rainforest on a gully south of Warrell Creek, backed by tall Flooded Gum wet sclerophyll forest, within the highway alignment.

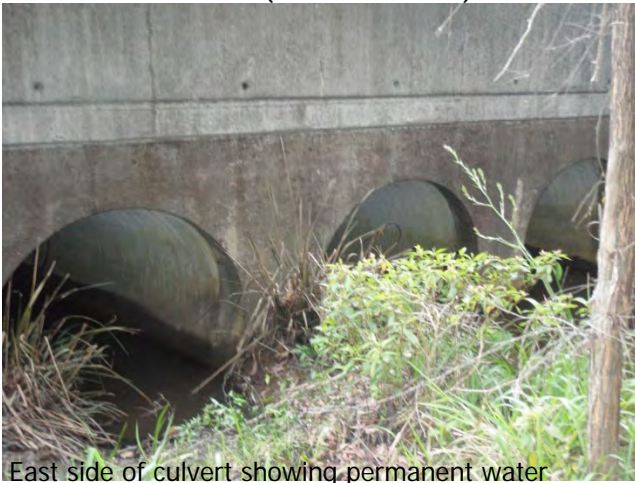
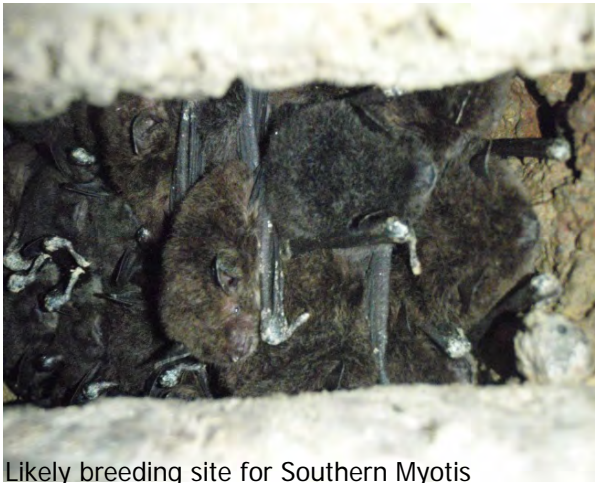
| Structure | Roost Site | Species Recorded | Other Species to Consider | Breeding Site | Overwintering Site | Works 100-200 m from roost | Works Within 100 m | Works on the structure |
|---|--|---|---|---|---|---|---|---|
| <p>599306 (Dalhousie Creek)</p> <p>East side of culvert showing permanent water</p> | <p>Likely breeding site for Southern Myotis</p> | Southern Myotis | - | High | Moderate | A1, A2 | na | na |
