Annual Ecological Monitoring Report 2016/2017

Oxley Highway to Kempsey, Pacific Highway Upgrade

Prepared for Roads and Maritime Services

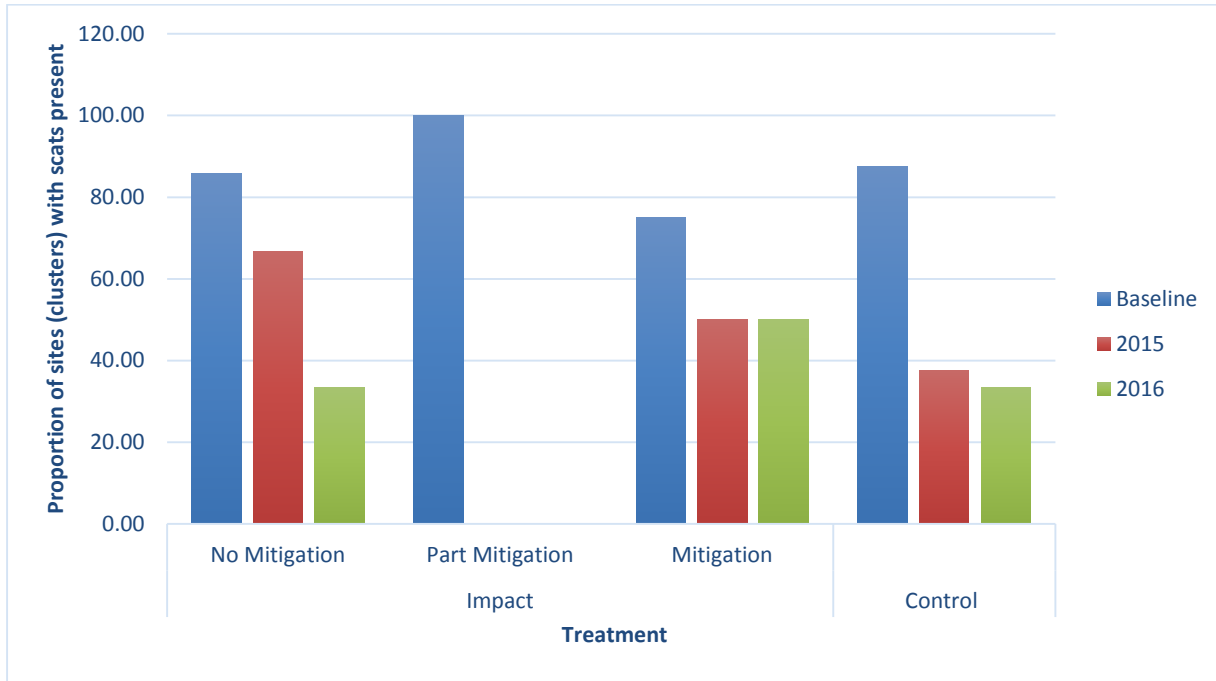
Graph 4: Koala presence at the different treatment sites

Review of Koala presence within the different impact/control categories does not reveal any clear trends regarding Koala presence or absence from these sites according to the treatment group or year (Graph 4). For example the proportion of scats found within the control sites in 2015 and 2016 decreased markedly from the baseline, but there was little difference in the survey results at the control sites between 2015 and 2016. At the impact sites, 50% of the sites with mitigation had Koala scats in 2015 and 2016, while at the unmitigated sites, there was a reduction in the number of Koala scats from 2015 to 2016. No Koala scats were recorded in the part-mitigation site in 2015 and the site could not be surveyed due to fire in 2016. Two of the mitigation sites and one of the control sites also could not be surveyed due to fire.

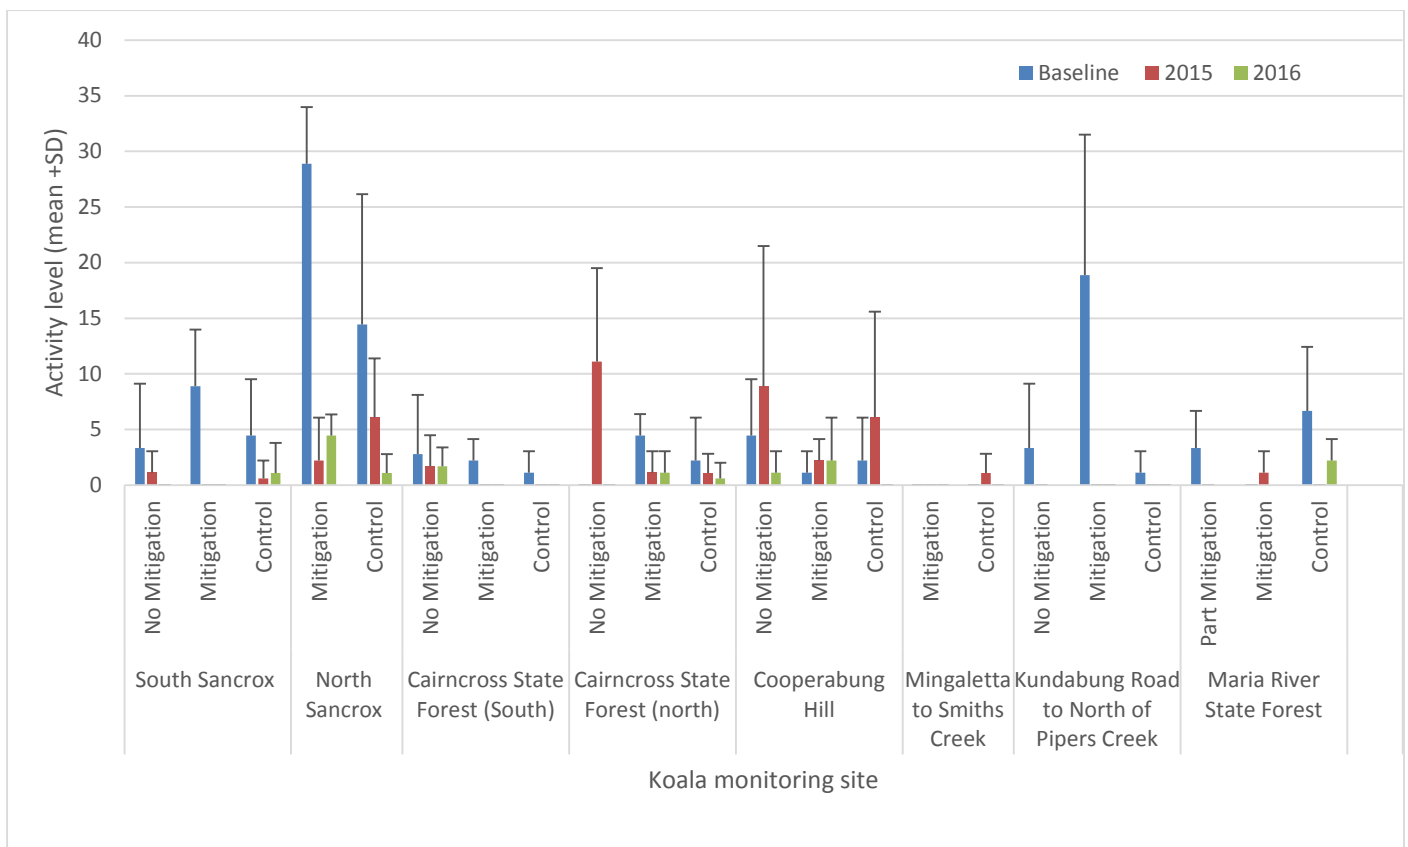
Graph 5: Koala activity at each site (mean ± SD)

Koala activity at each of the sites is shown in Graph 5. Koala activity was generally lower in 2016 than either of the two previous surveys, and as mentioned previously, there were a greater number of sites with no Koala activity recorded. Further monitoring data would be required to determine if the results reflect broader trends in population dynamics.

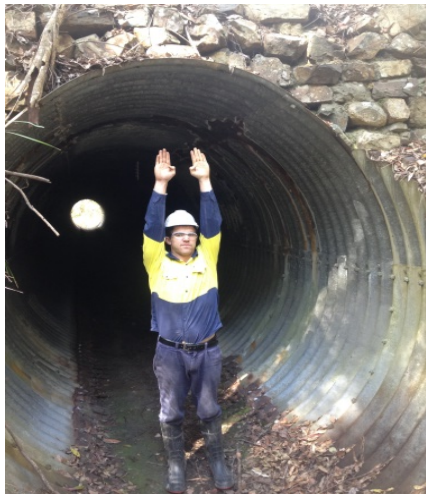
For the twin 3000mm galvanized pipes (chainage 22200 – Plate 4), initial inspections revealed no viable egress roost points and limited roost points on the wall/ceiling surface. However, the pipes are probably used as a microbat flyway and would present an entanglement hazard if curtained. We recommend that this structure, which can be effectively inspected visually, be monitored during clearing (as per item 3) and inspected 48-72 hours prior to decommission, including each morning up to decommission.

Plate 3. C599022 (chainage 22200) features 2x 3000mm galvanised pipes. The structure is likely a major microbat flyway and would present an entanglement hazard if curtained.

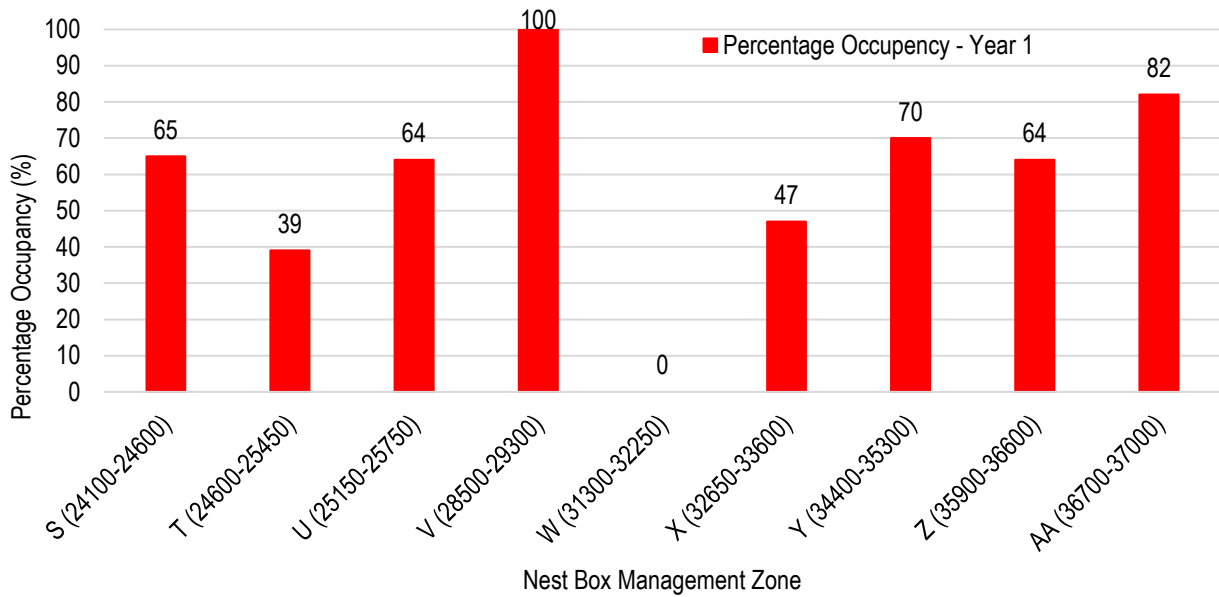
Nest box occupancy varied from 39% in Zone T through to 100% in Zone V (Figure 3-1). No boxes had been installed in Zone W due to some uncertainty about the future extent of retained vegetation. Generally, occupancy rates varied between 47-70%.

Figure 3-1. Year 1 occupancy rates at each of the nest box zones.

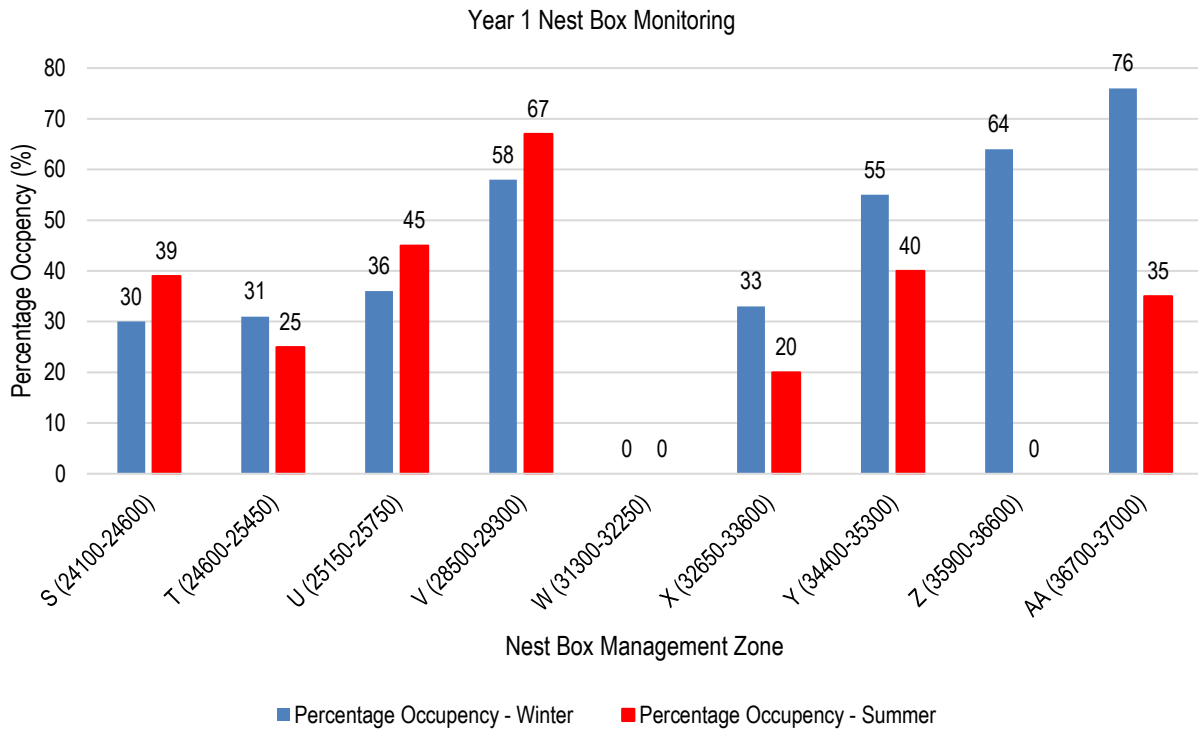
Occupancy rates were higher in winter than summer in Zones T, X, Y, Z and AA (Figure 3-2). There was a general trend of occupancy being greater in summer in the southern zones than the northern zones where a wildfire event had occurred in early November 2016.

Figure 3-2. Occupancy rates at each of the nest box zones.
