Oxley Highway to Kempsey

2017-18 Annual Ecological Monitoring Report

Roads and Maritime Services | November 2018

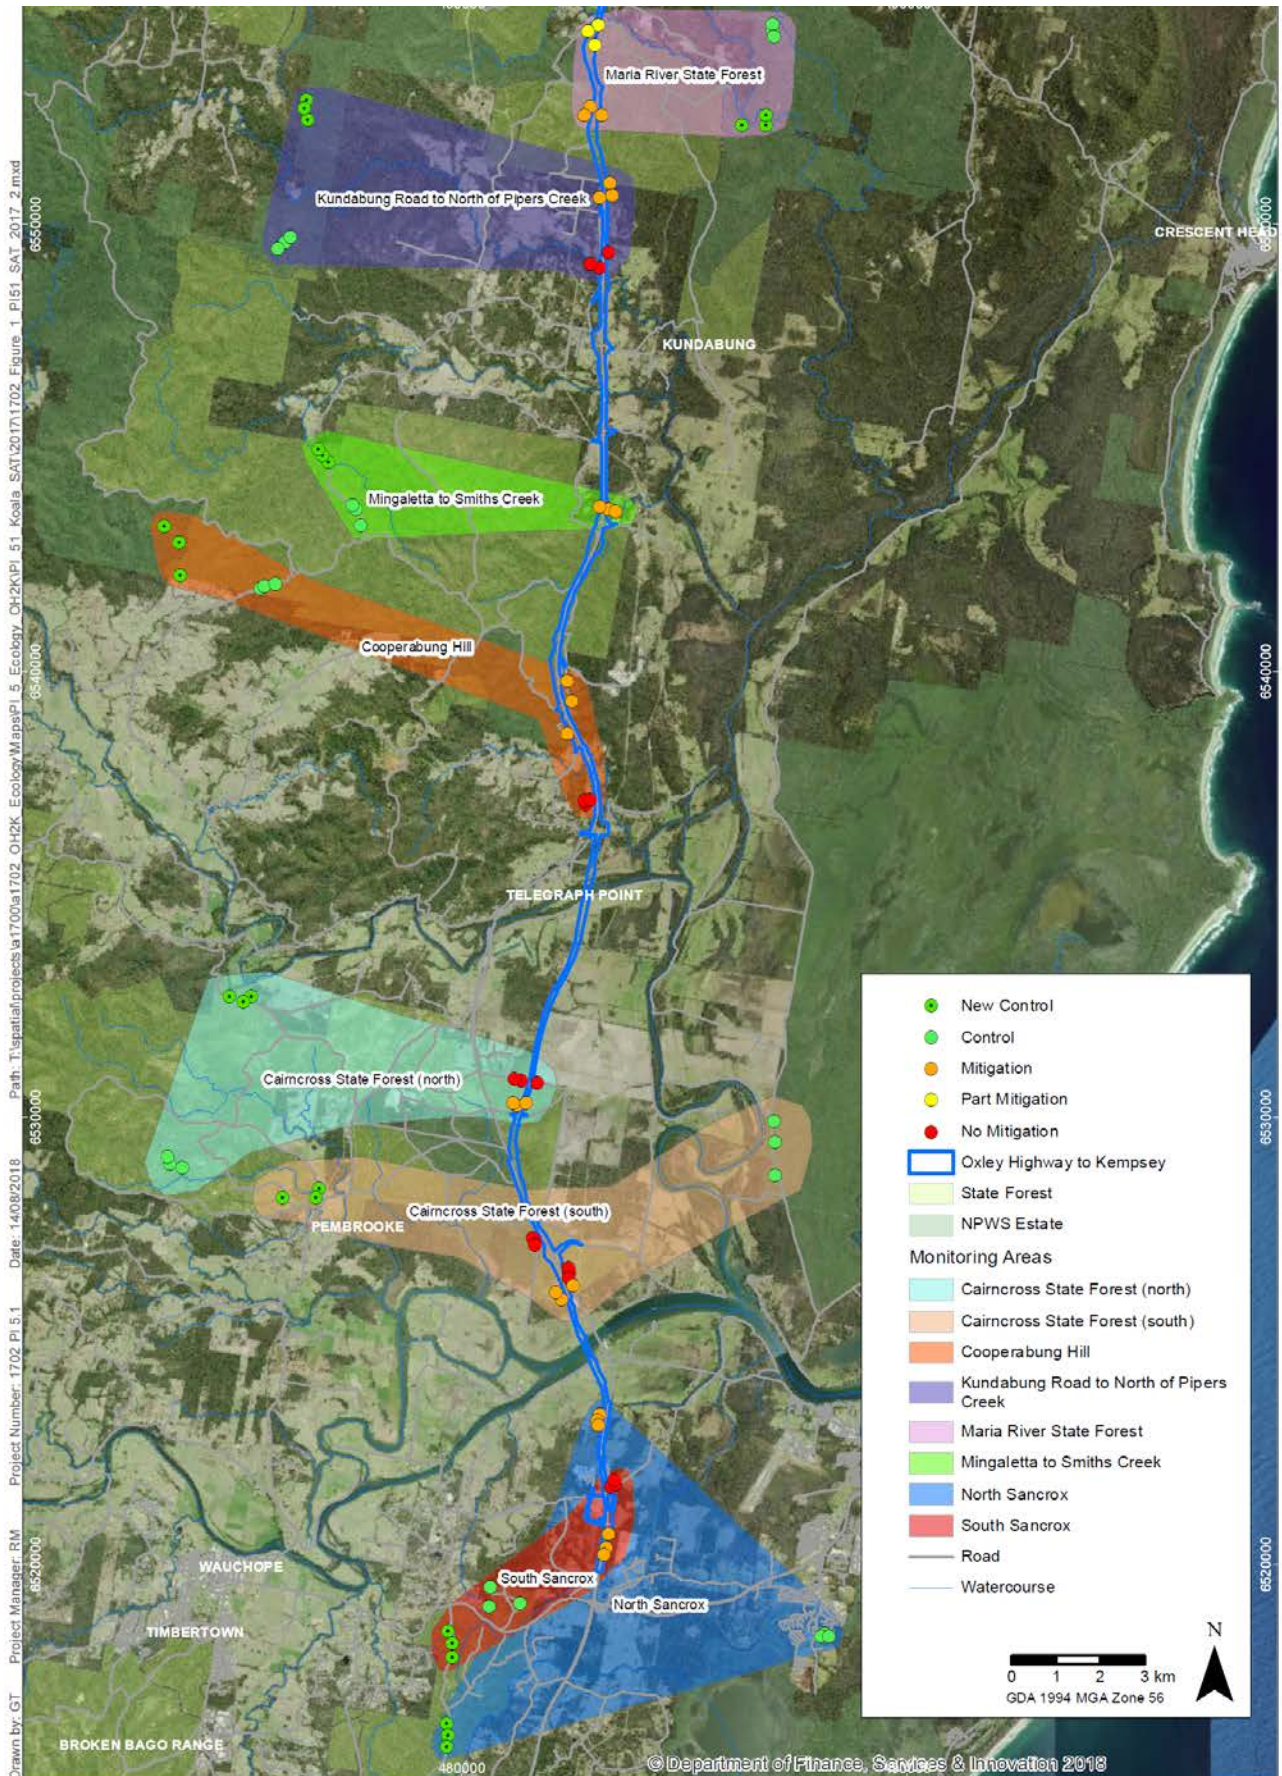
Koala SAT plot locations 2017
Oxley Highway to Kempsey - PI 5.1 Koala report

Surveys were undertaken from 31 October to 29 November 2017. Field data for each SAT plot are presented in Annex 1. It was noted that on a number of occasions the marked tree did not correspond with the previous monitoring SCT (selection criteria tree) species. As such, for clarity of results and to facilitate future monitoring, the DBH (diameter at breast height) is provided for the marked tree, and this tree will be considered as the SCT for the current and future monitoring events. All of the 93 accessible SAT plots were surveyed across the eight monitoring areas (Figure 1). The eleven plots not surveyed in 2016 due to wildfires were monitored in 2017.

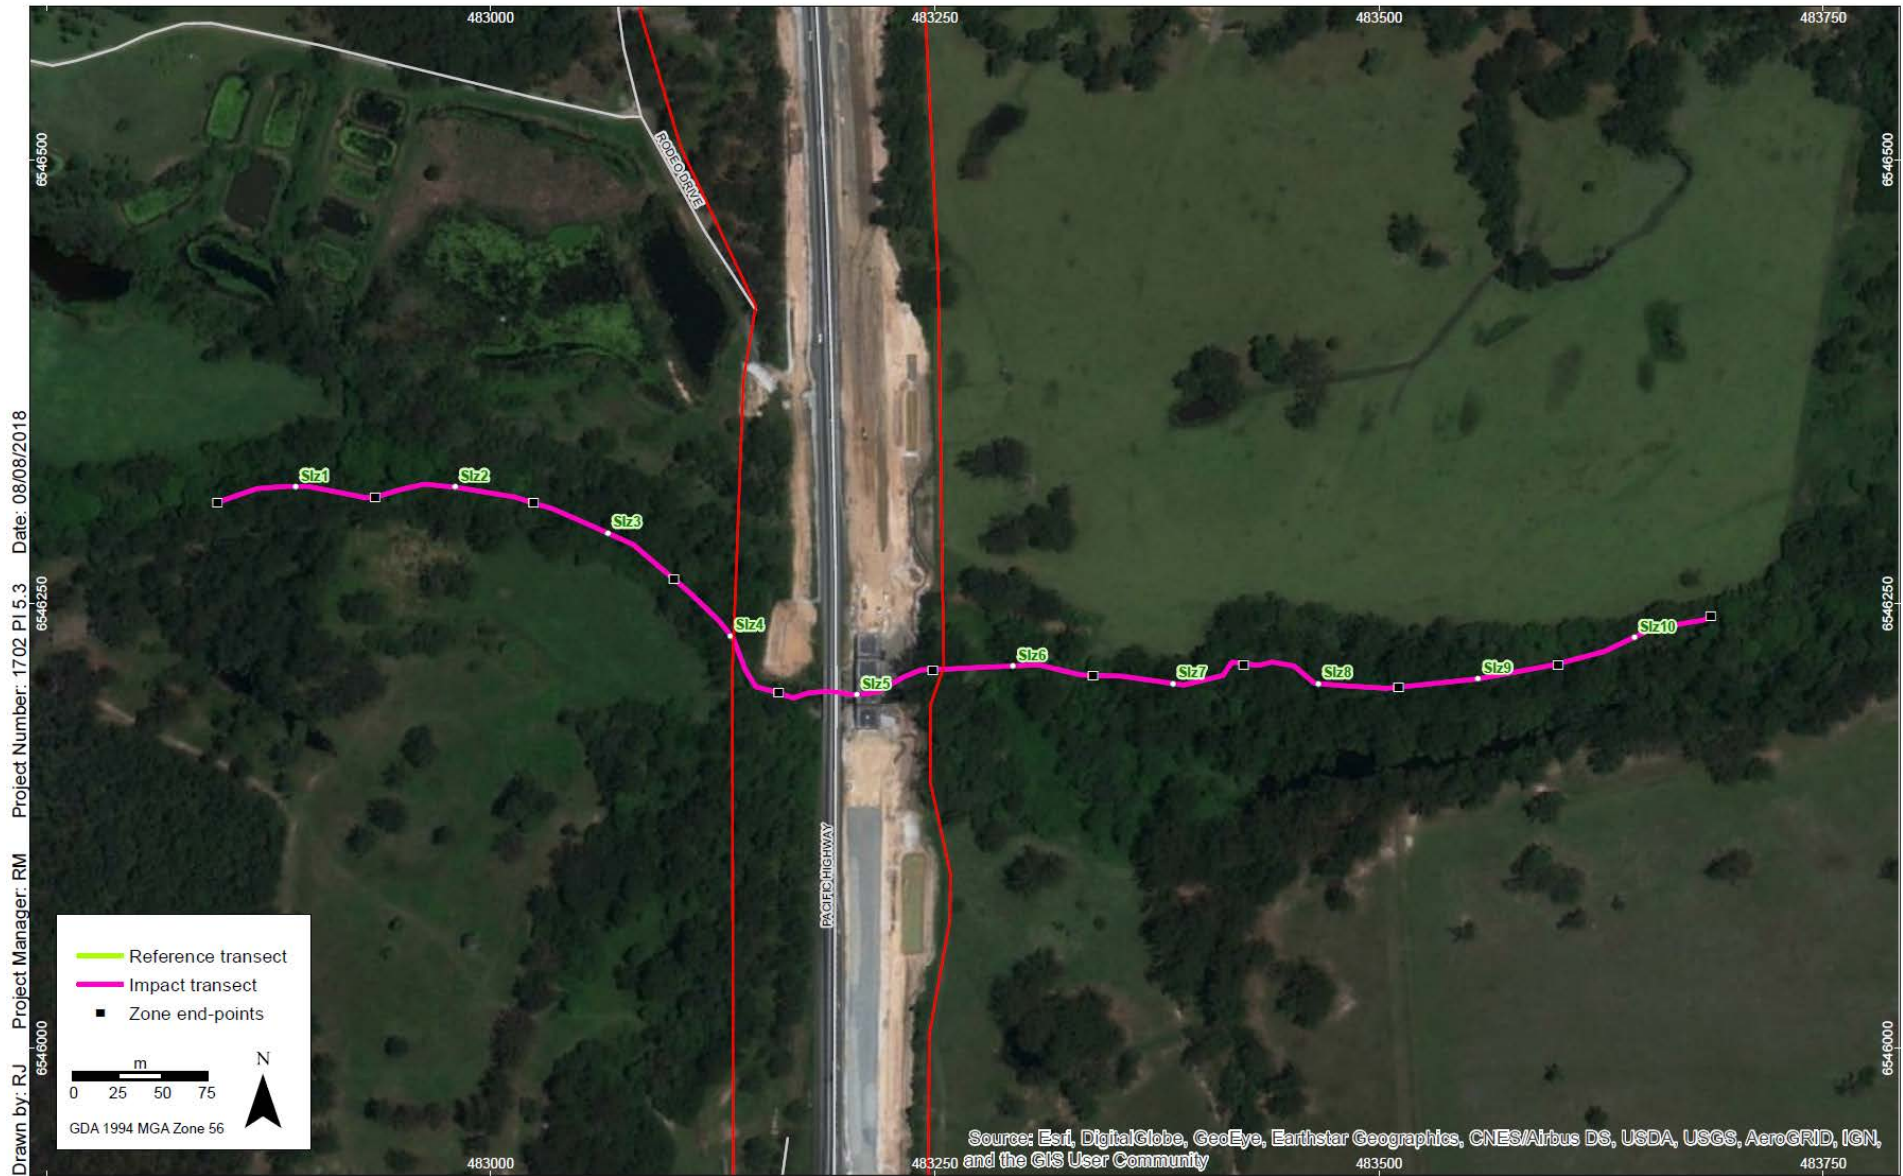
FIGURE 3
Imagery: (c) DigitalGlobe

Giant Barred Frog monitoring: Smiths Creek impact site
Pacific Highway Upgrade - Oxley Highway to Kempsey

The location of all monitoring sites is shown in Figure 1, with detailed locations for each site transect provided in Figure 2 to Figure 7.

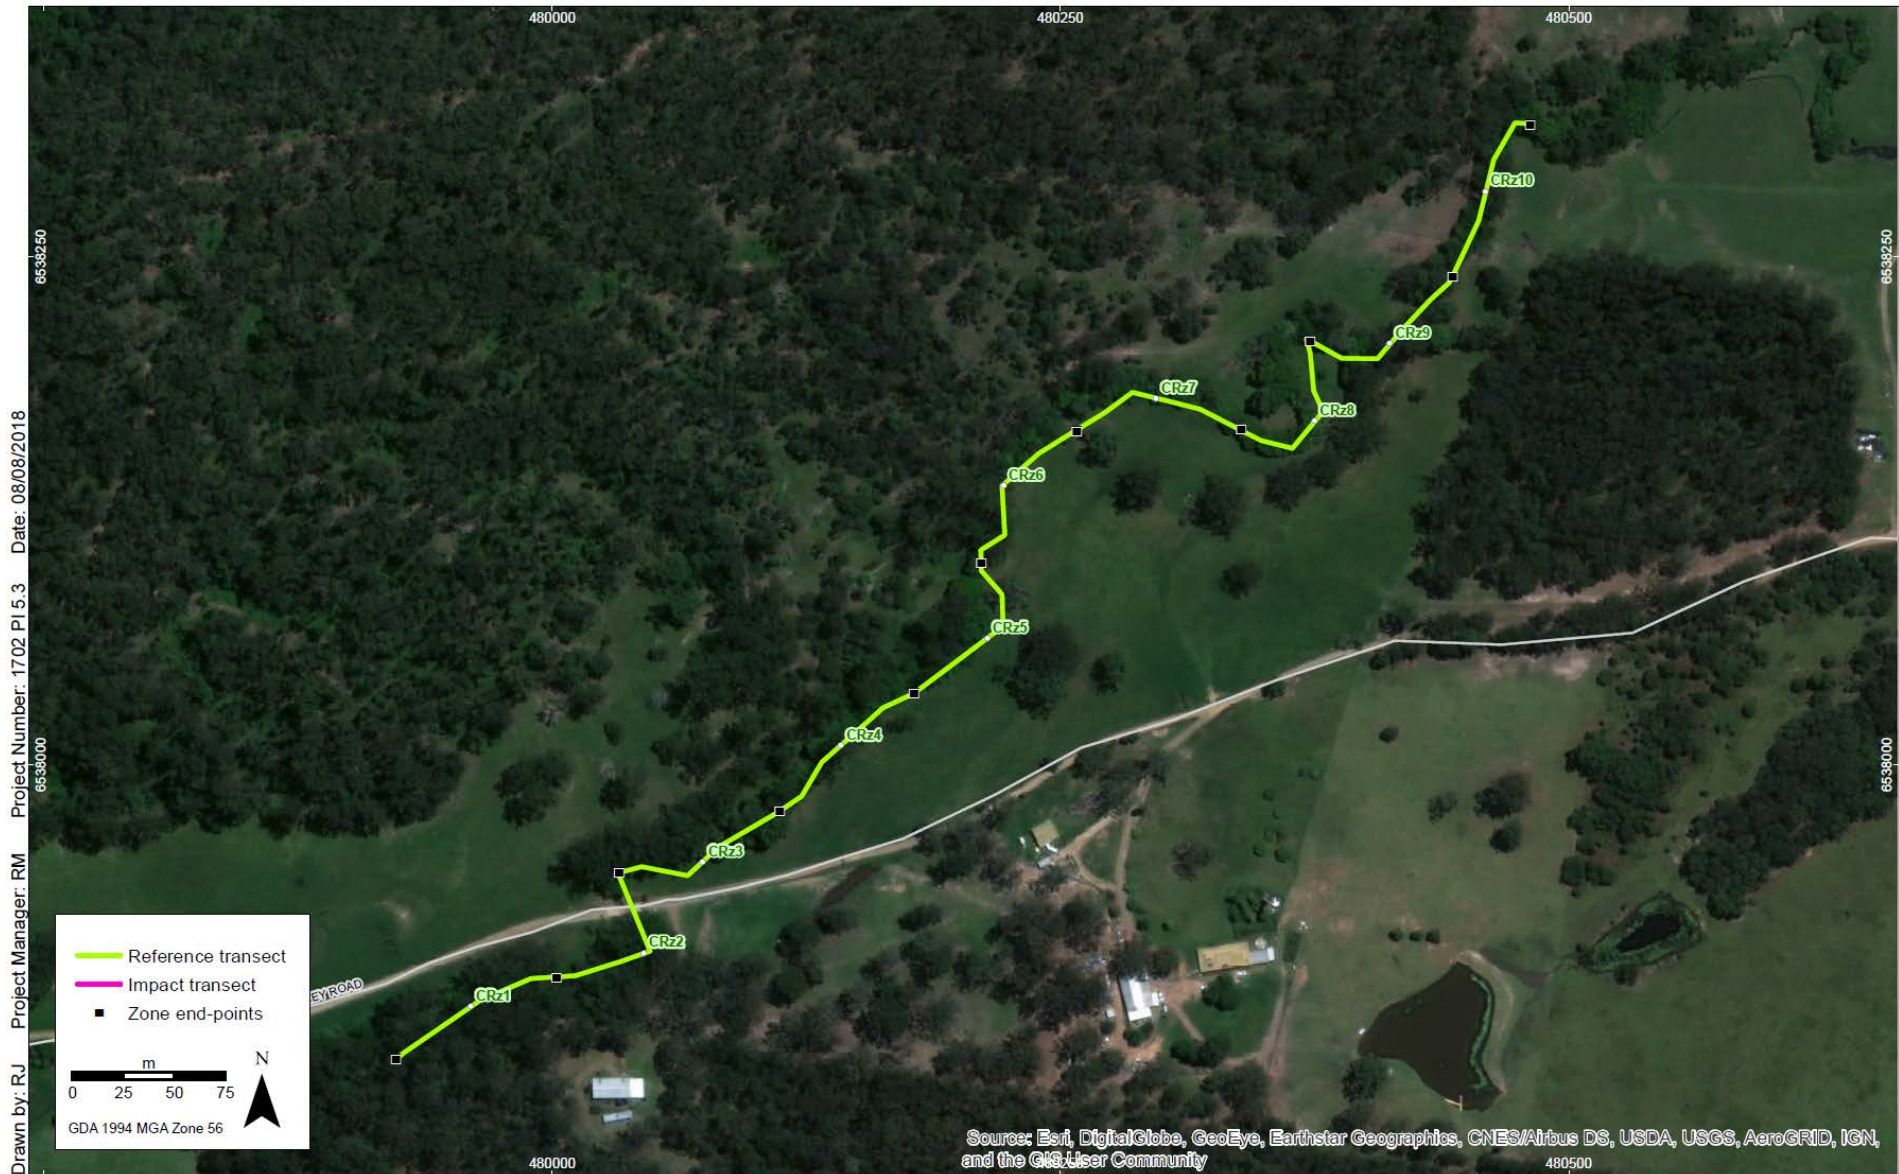
FIGURE 6
Imagery: (c) DigitalGlobe

Giant Barred Frog monitoring: Cooperabung Creek reference site
Pacific Highway Upgrade - Oxley Highway to Kempsey

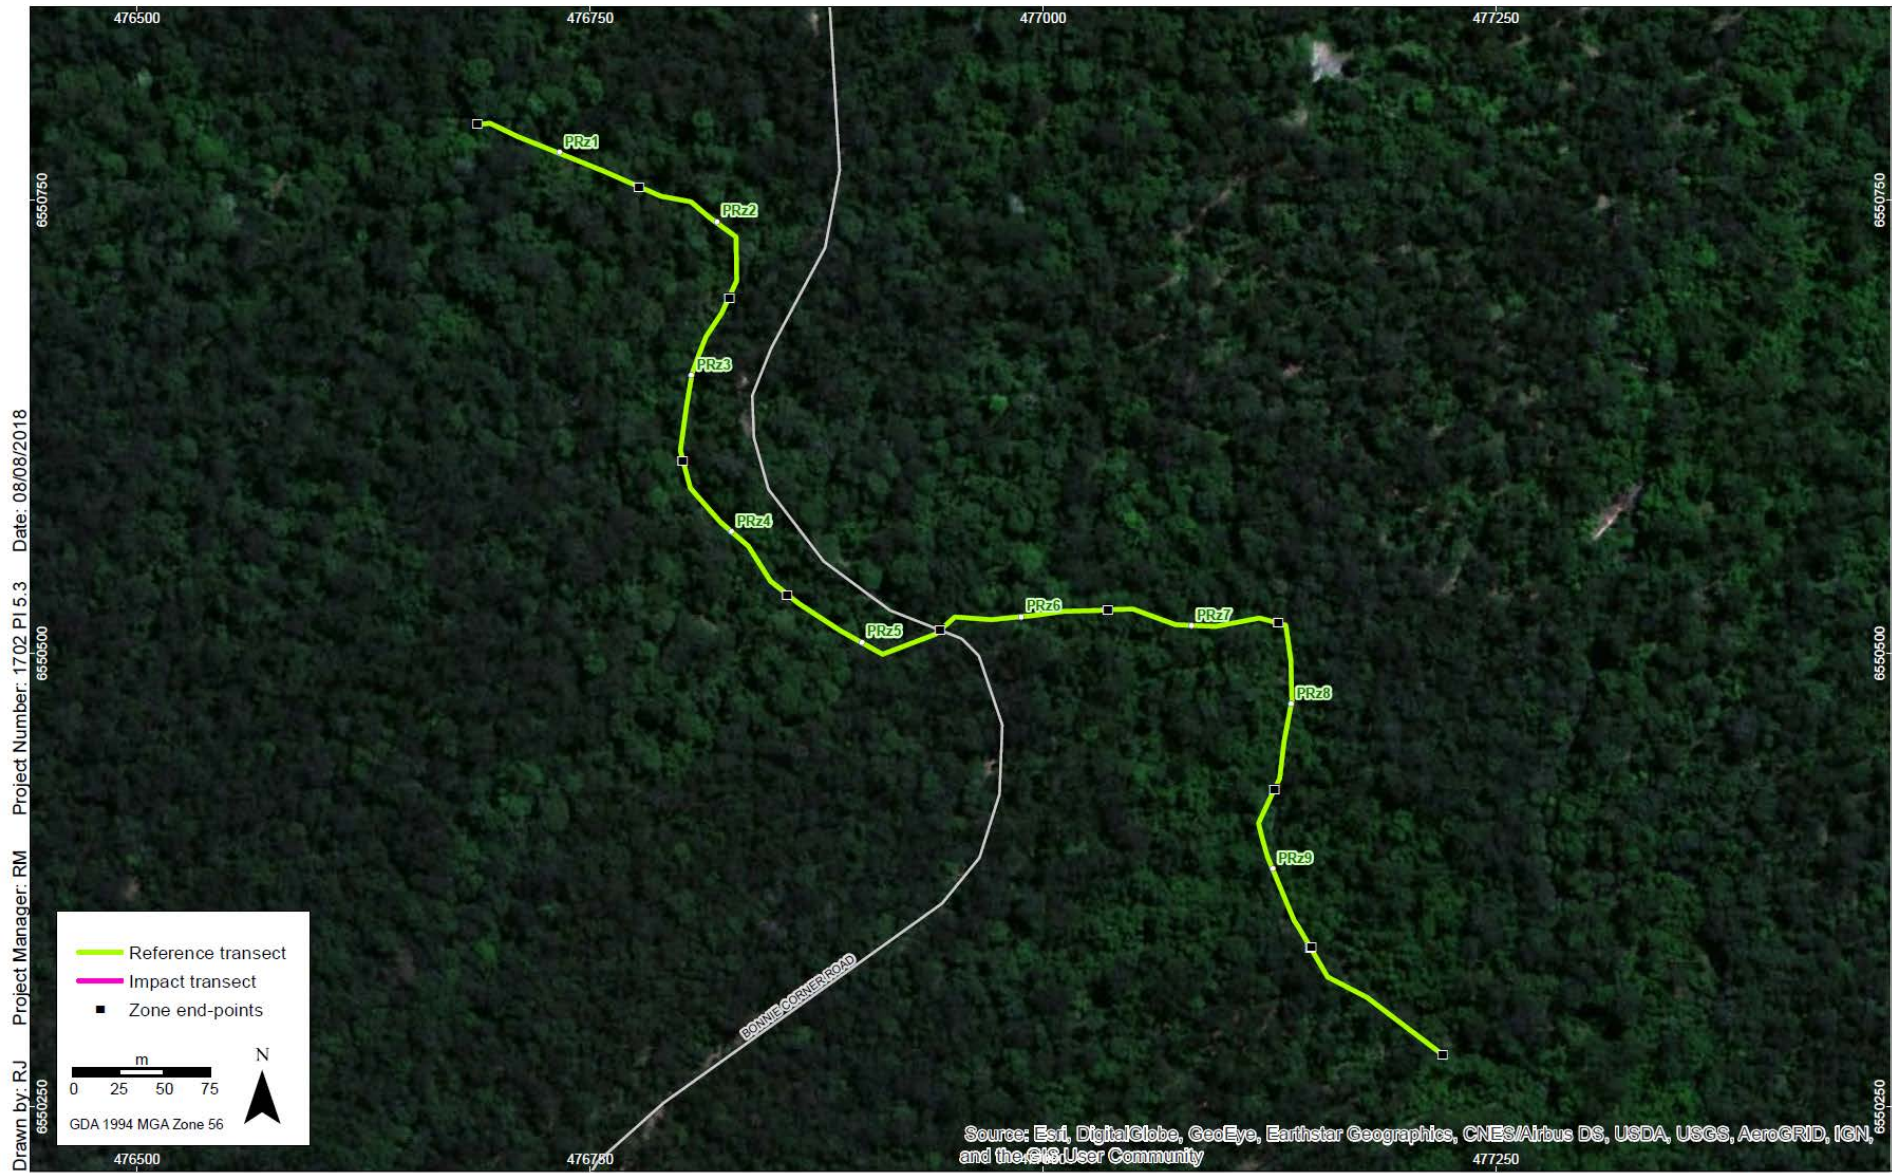
FIGURE 7
Imagery: (c) DigitalGlobe

Giant Barred Frog monitoring: Pipers Creek reference site
Pacific Highway Upgrade - Oxley Highway to Kempsey

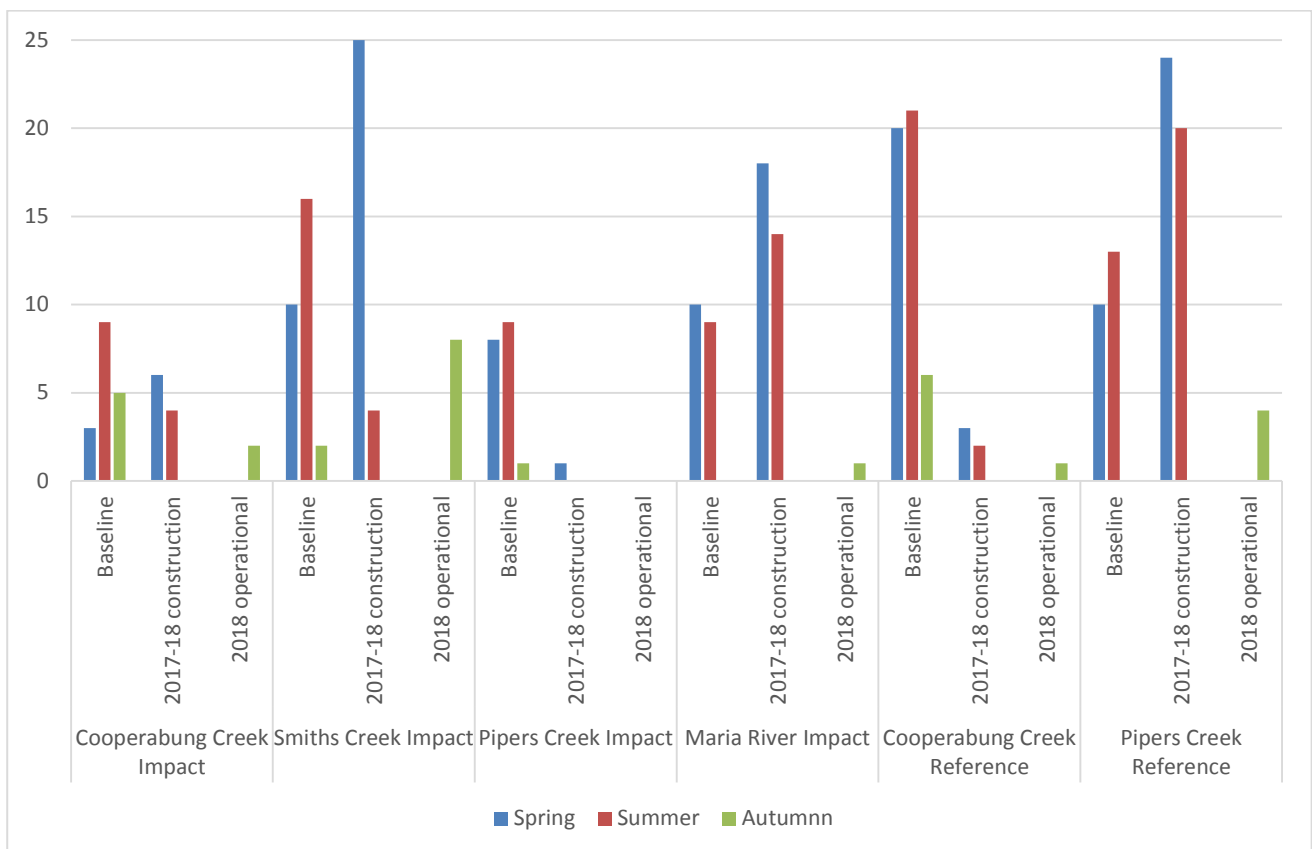
Graph 1: Giant Barred Frog records: baseline and 2017/2018 monitoring

Giant Barred Frogs were therefore recorded during all 2017/2018 surveys at the two sites (one impact site) where they were not recorded during the autumn baseline surveys (Pipers Creek reference site and Maria River impact site), however they were not recorded at the Pipers Creek impact site in the summer and autumn 2017/2018 surveys, where they were recorded during baseline surveys.

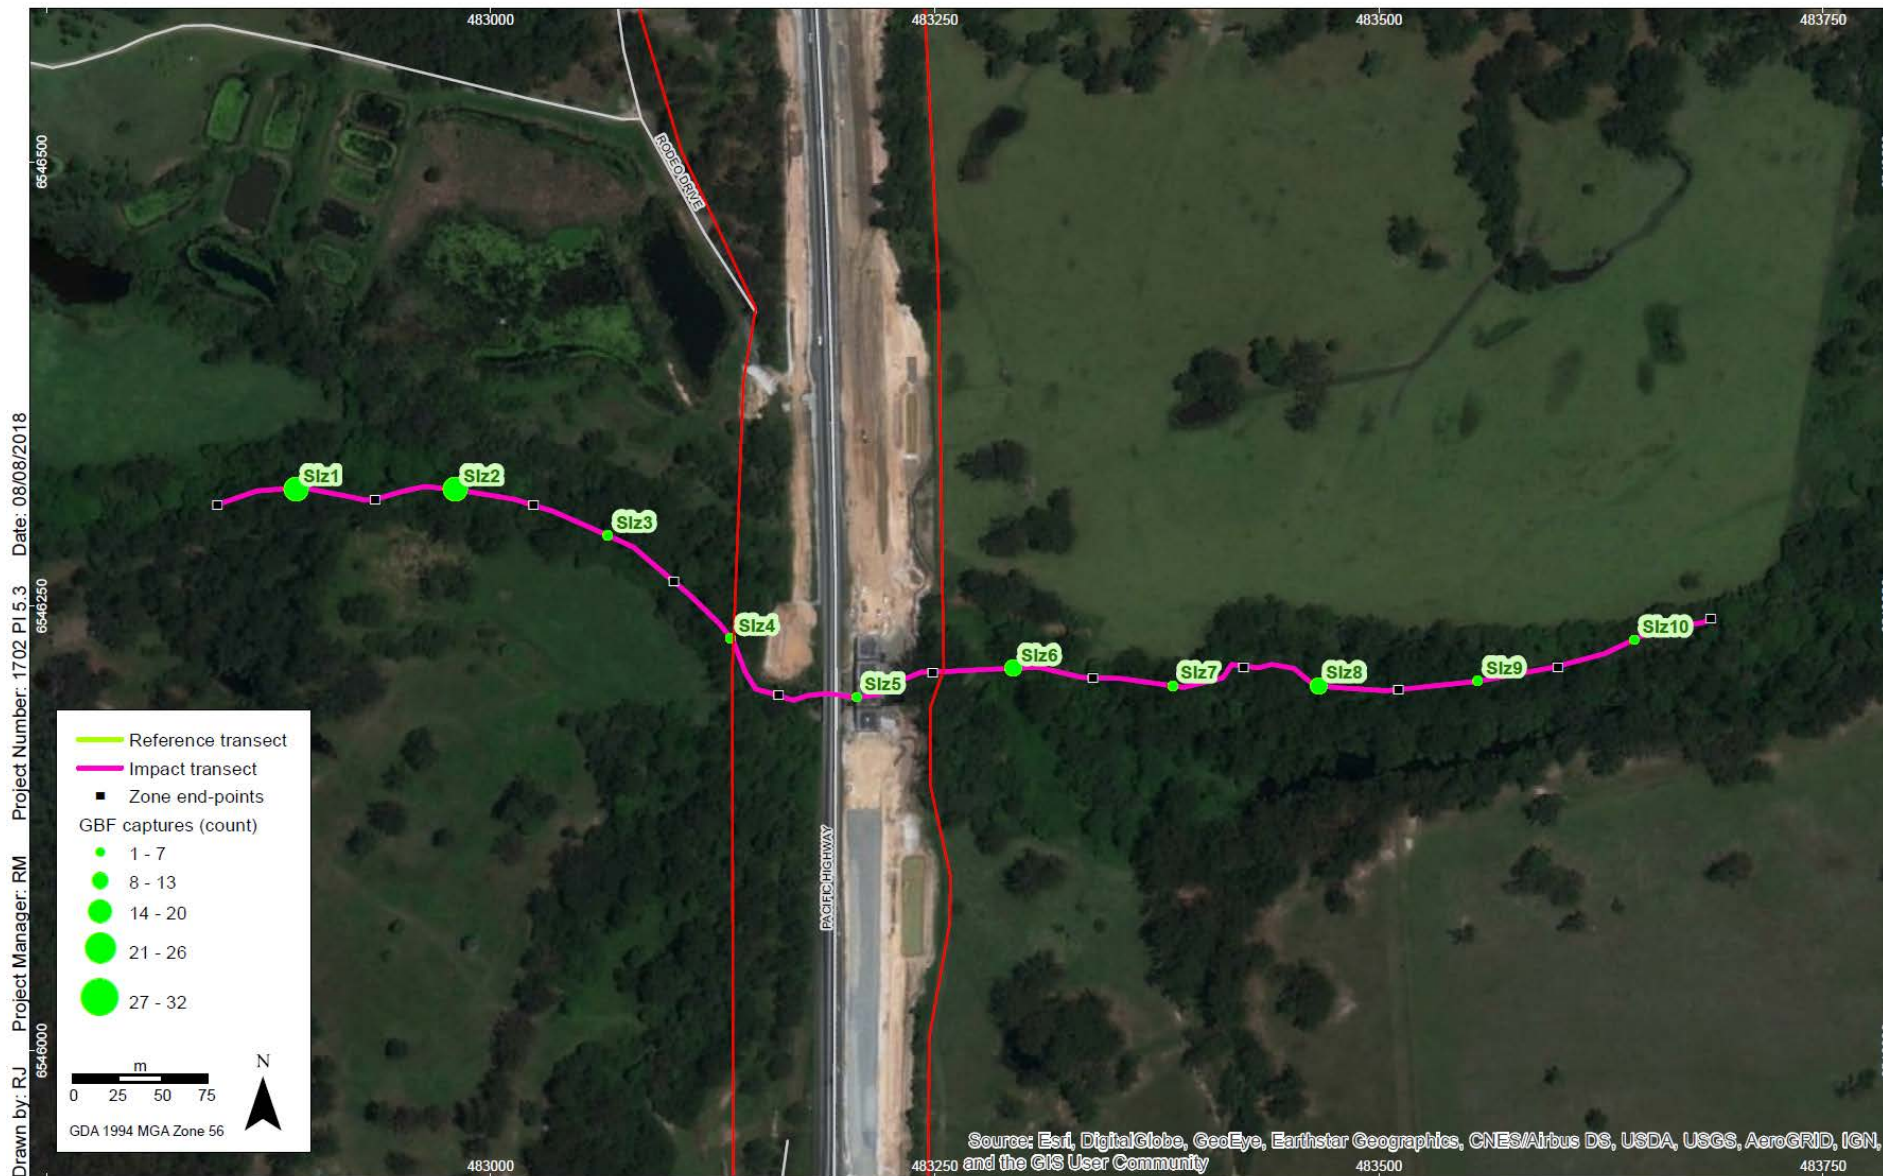
FIGURE 9
Imagery: (c) DigitalGlobe

Giant Barred Frog capture distribution: Smiths Creek impact site
Pacific Highway Upgrade - Oxley Highway to Kempsey

Graph 3 - Graph 8 present the density (annual mean number of Giant Barred Frog records per zone) and distribution of Giant Barred Frog records along the survey transect for each site and each monitoring period. Figure 8 - Figure 13 show the total number of captures within each zone over all monitoring periods.

Figure 8 - Figure 13 consider all capture records, whereby capture records (including recaptures) are shown as count ranges, where larger circles indicate larger frog counts. While density data indicates that frog distribution along the transects varies from year to year, when considering all years, frogs mostly appear to be using the entire length of the transect and there is no evidence of frogs being recorded only in one particular zone. In addition, there is no evidence of frogs being absent from zones 5 and 6. While capture frequency within zones directly under the carriageway consistently fall into the lower range category (1-7 frogs), the low capture frequency range occurs regularly along transects and at all sites.

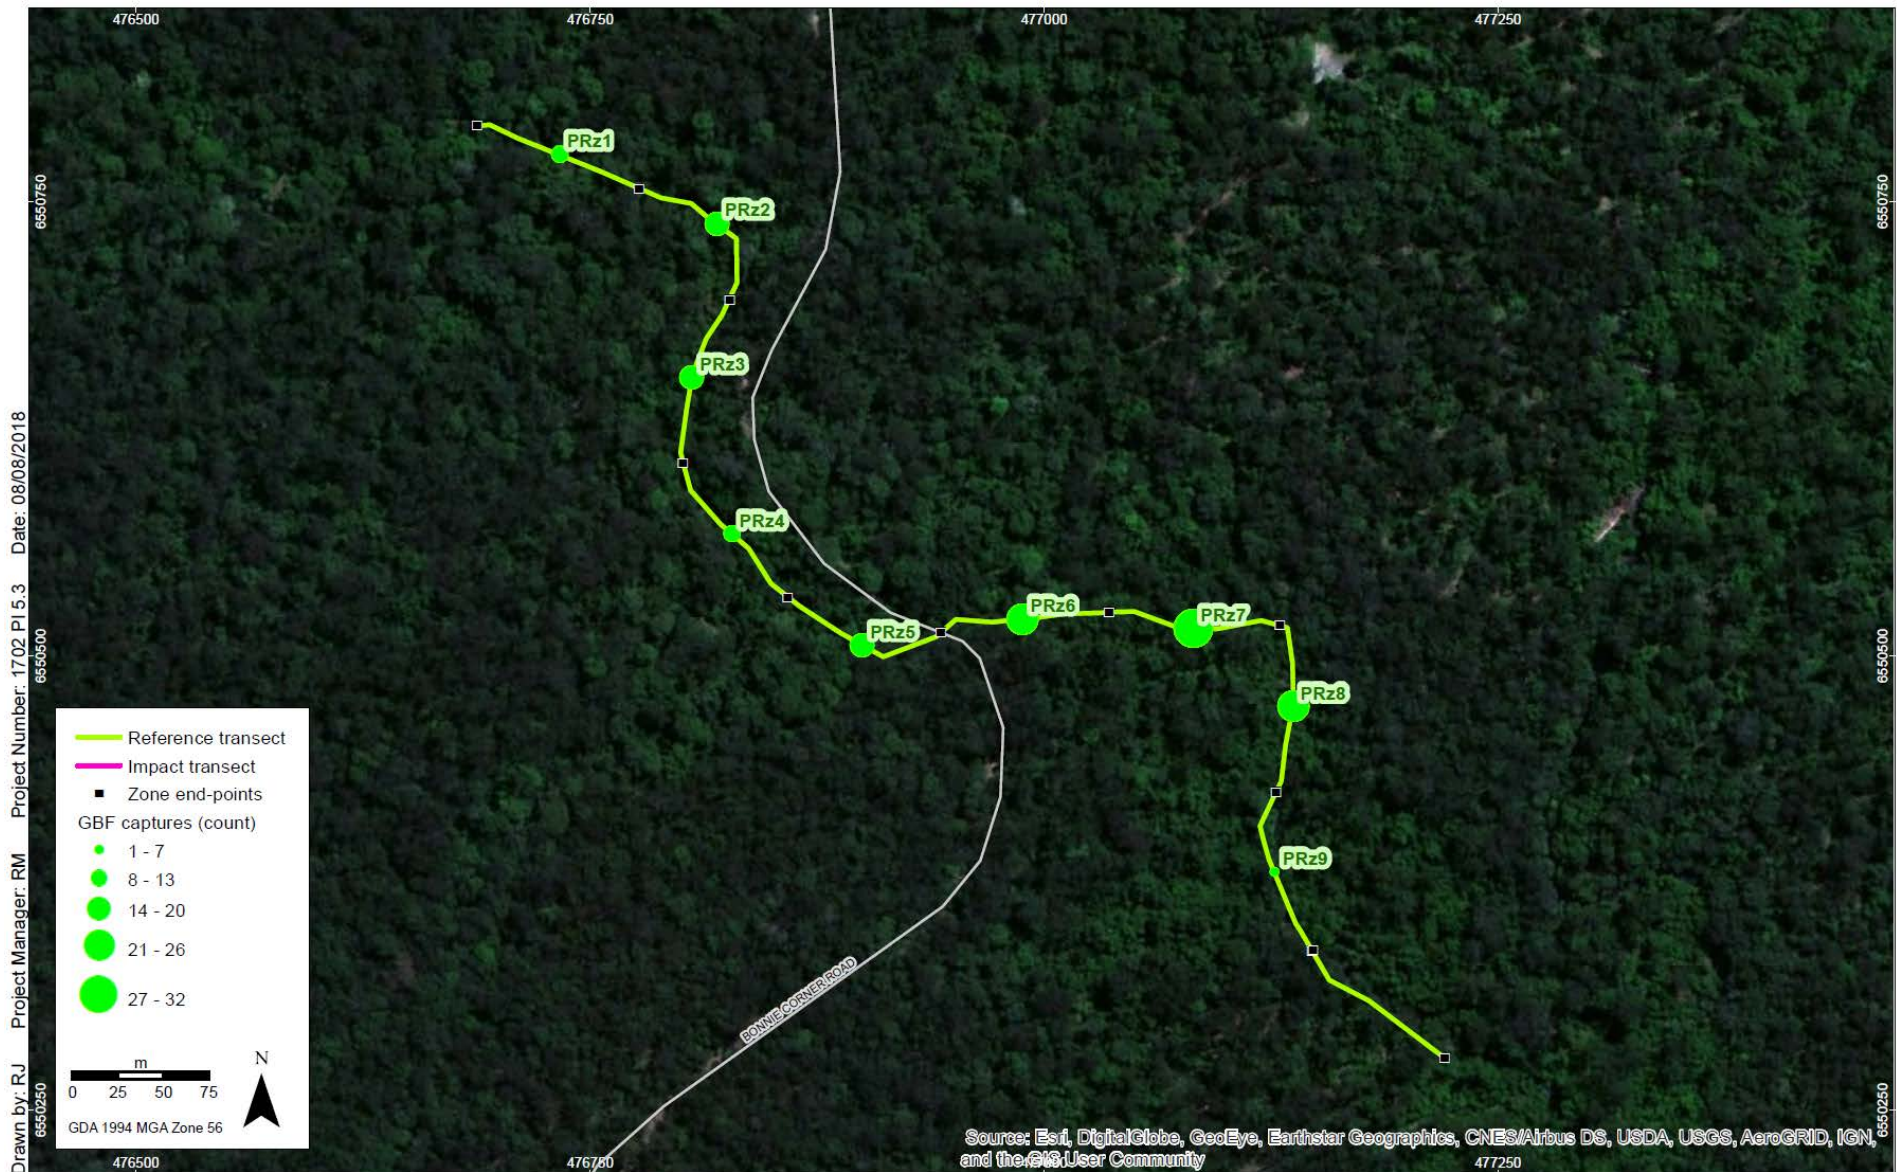
FIGURE 13
 Imagery: (c) DigitalGlobe

Giant Barred Frog capture distribution: Pipers Creek reference site
 Pacific Highway Upgrade - Oxley Highway to Kempsey

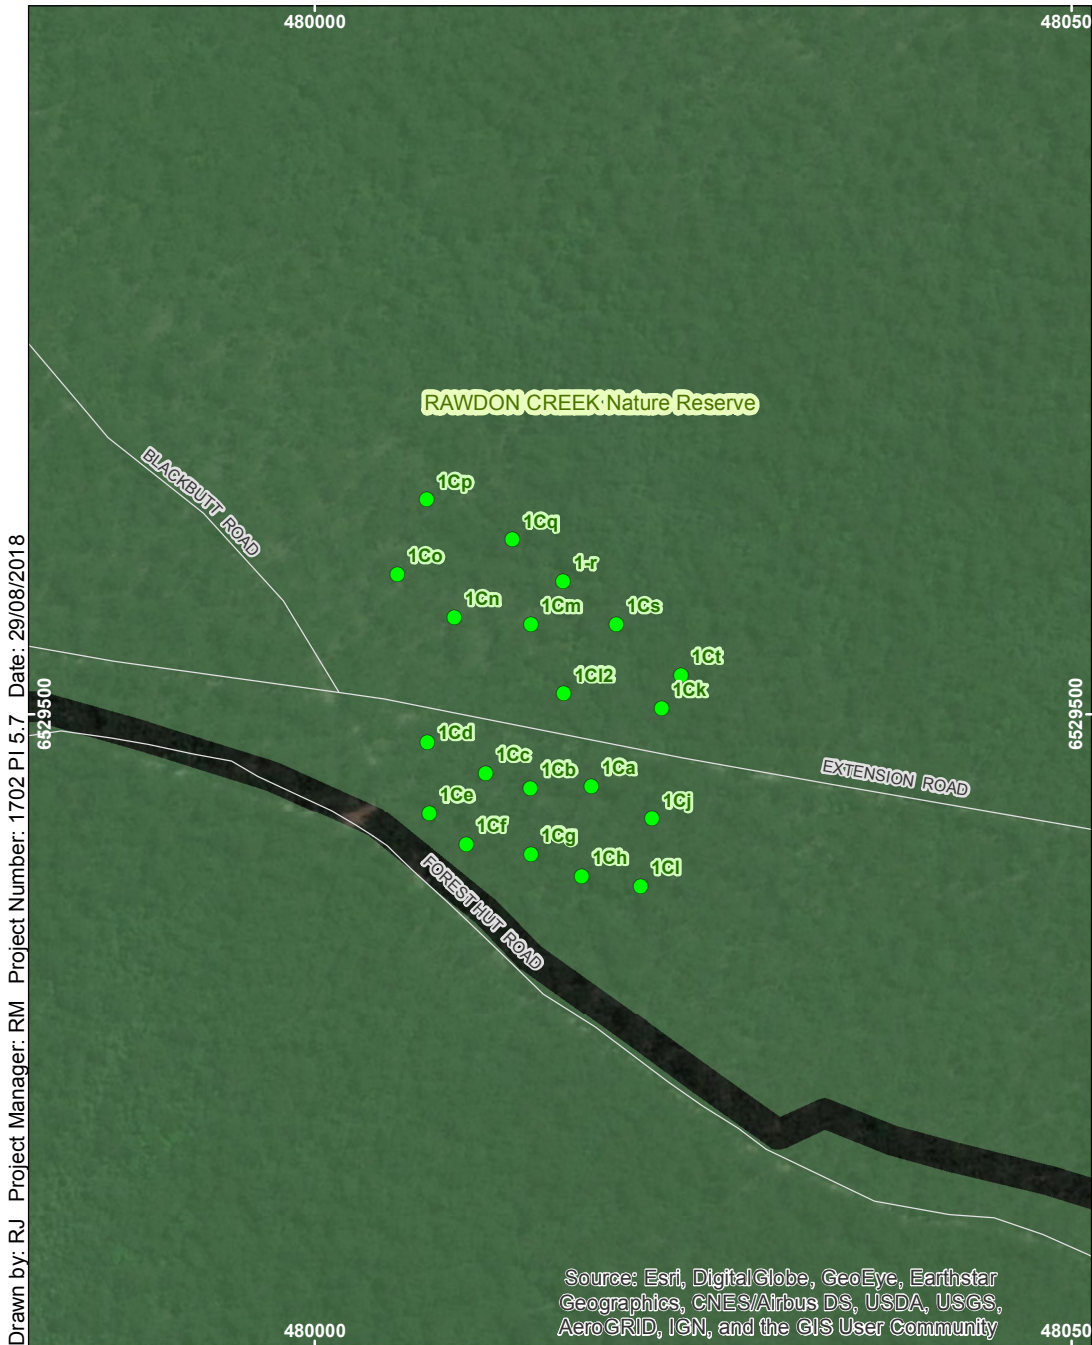
FIGURE 2

Cairncross State Forest: Site 1 trap locations
Squirrel Glider Monitoring: Pacific Highway Upgrade – Oxley Highway to Kempsey

Each site consisted of an impact site and a paired control site. Control sites were located a minimum of 500 metres to one kilometre, where access permitted, from the paired impact site within continuous vegetation. Trap locations are shown in Figure 1 - Figure 5.

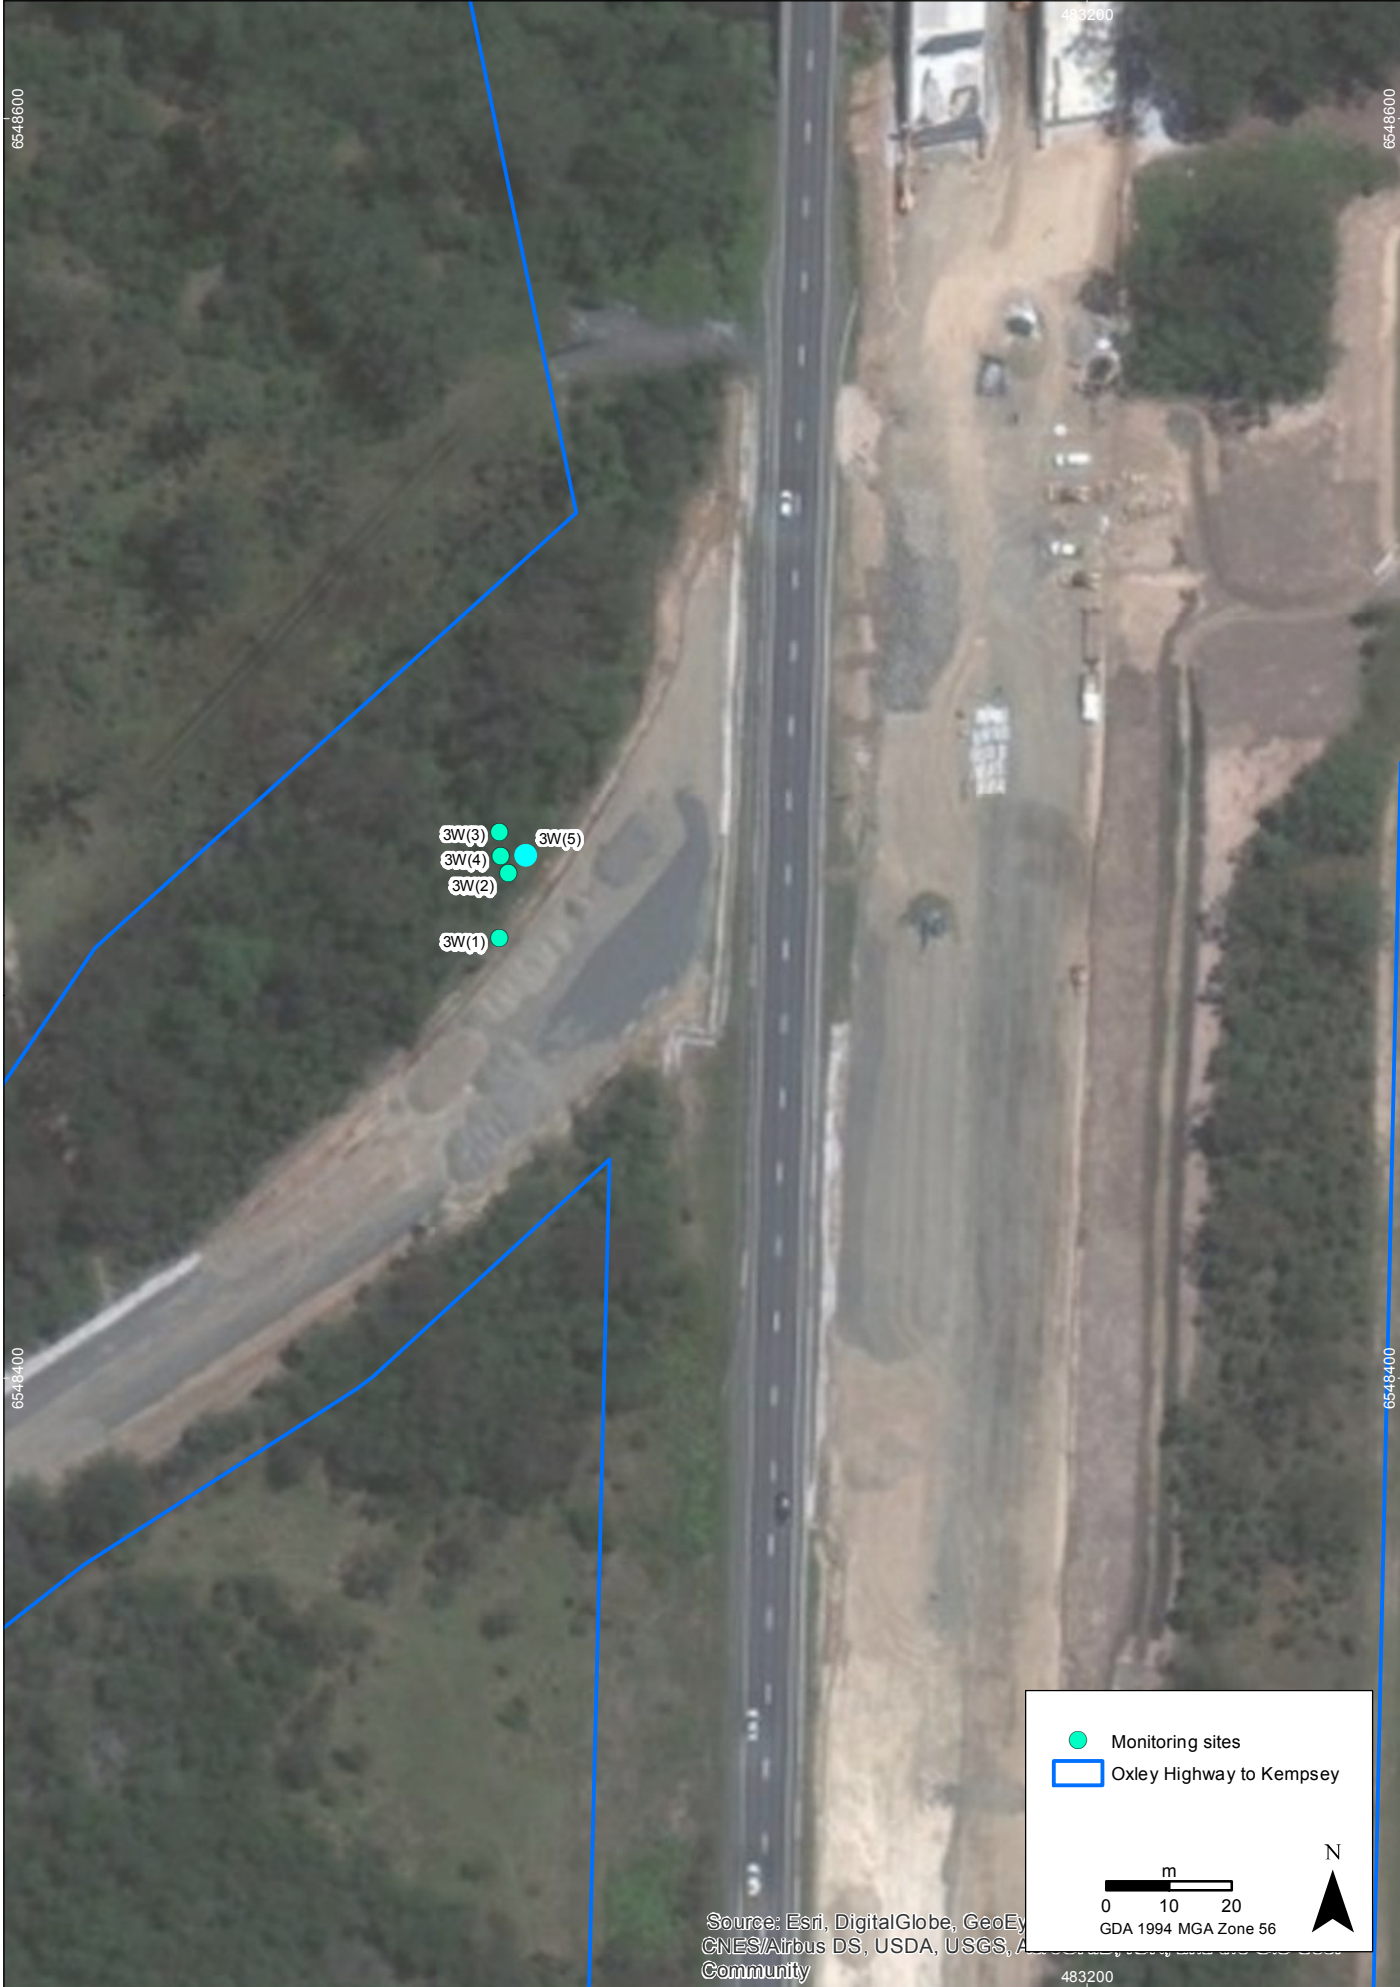
FIGURE 3
Imagery: (c) DigitalGlobe 2015-11-25

Green-thighed Frog monitoring Site 3
Oxley Highway to Kempsey - PI 5.15 GTF Ponds

Green-thighed Frogs were recorded at Site 3W only. At Site 3W individuals were observed in two ponds (ponds 2 and 4) and adjacent habitat, and were heard calling in the vicinity of all ponds. Green-thighed Frogs were not detected at the Collombatti reference site. All 25 ponds contained water, Sites 1 (E&W) and 4 (E&W) ranged from 20-50 cm, while Site 3W recorded water depth of up to 100 cm. As Stage 1 surveys were undertaken over two nights, Site 3W, where frogs were detected on the first night, was revisited on the second night to ensure continued activity. Green-thighed Frogs were still active at Site 3 on the second survey night.

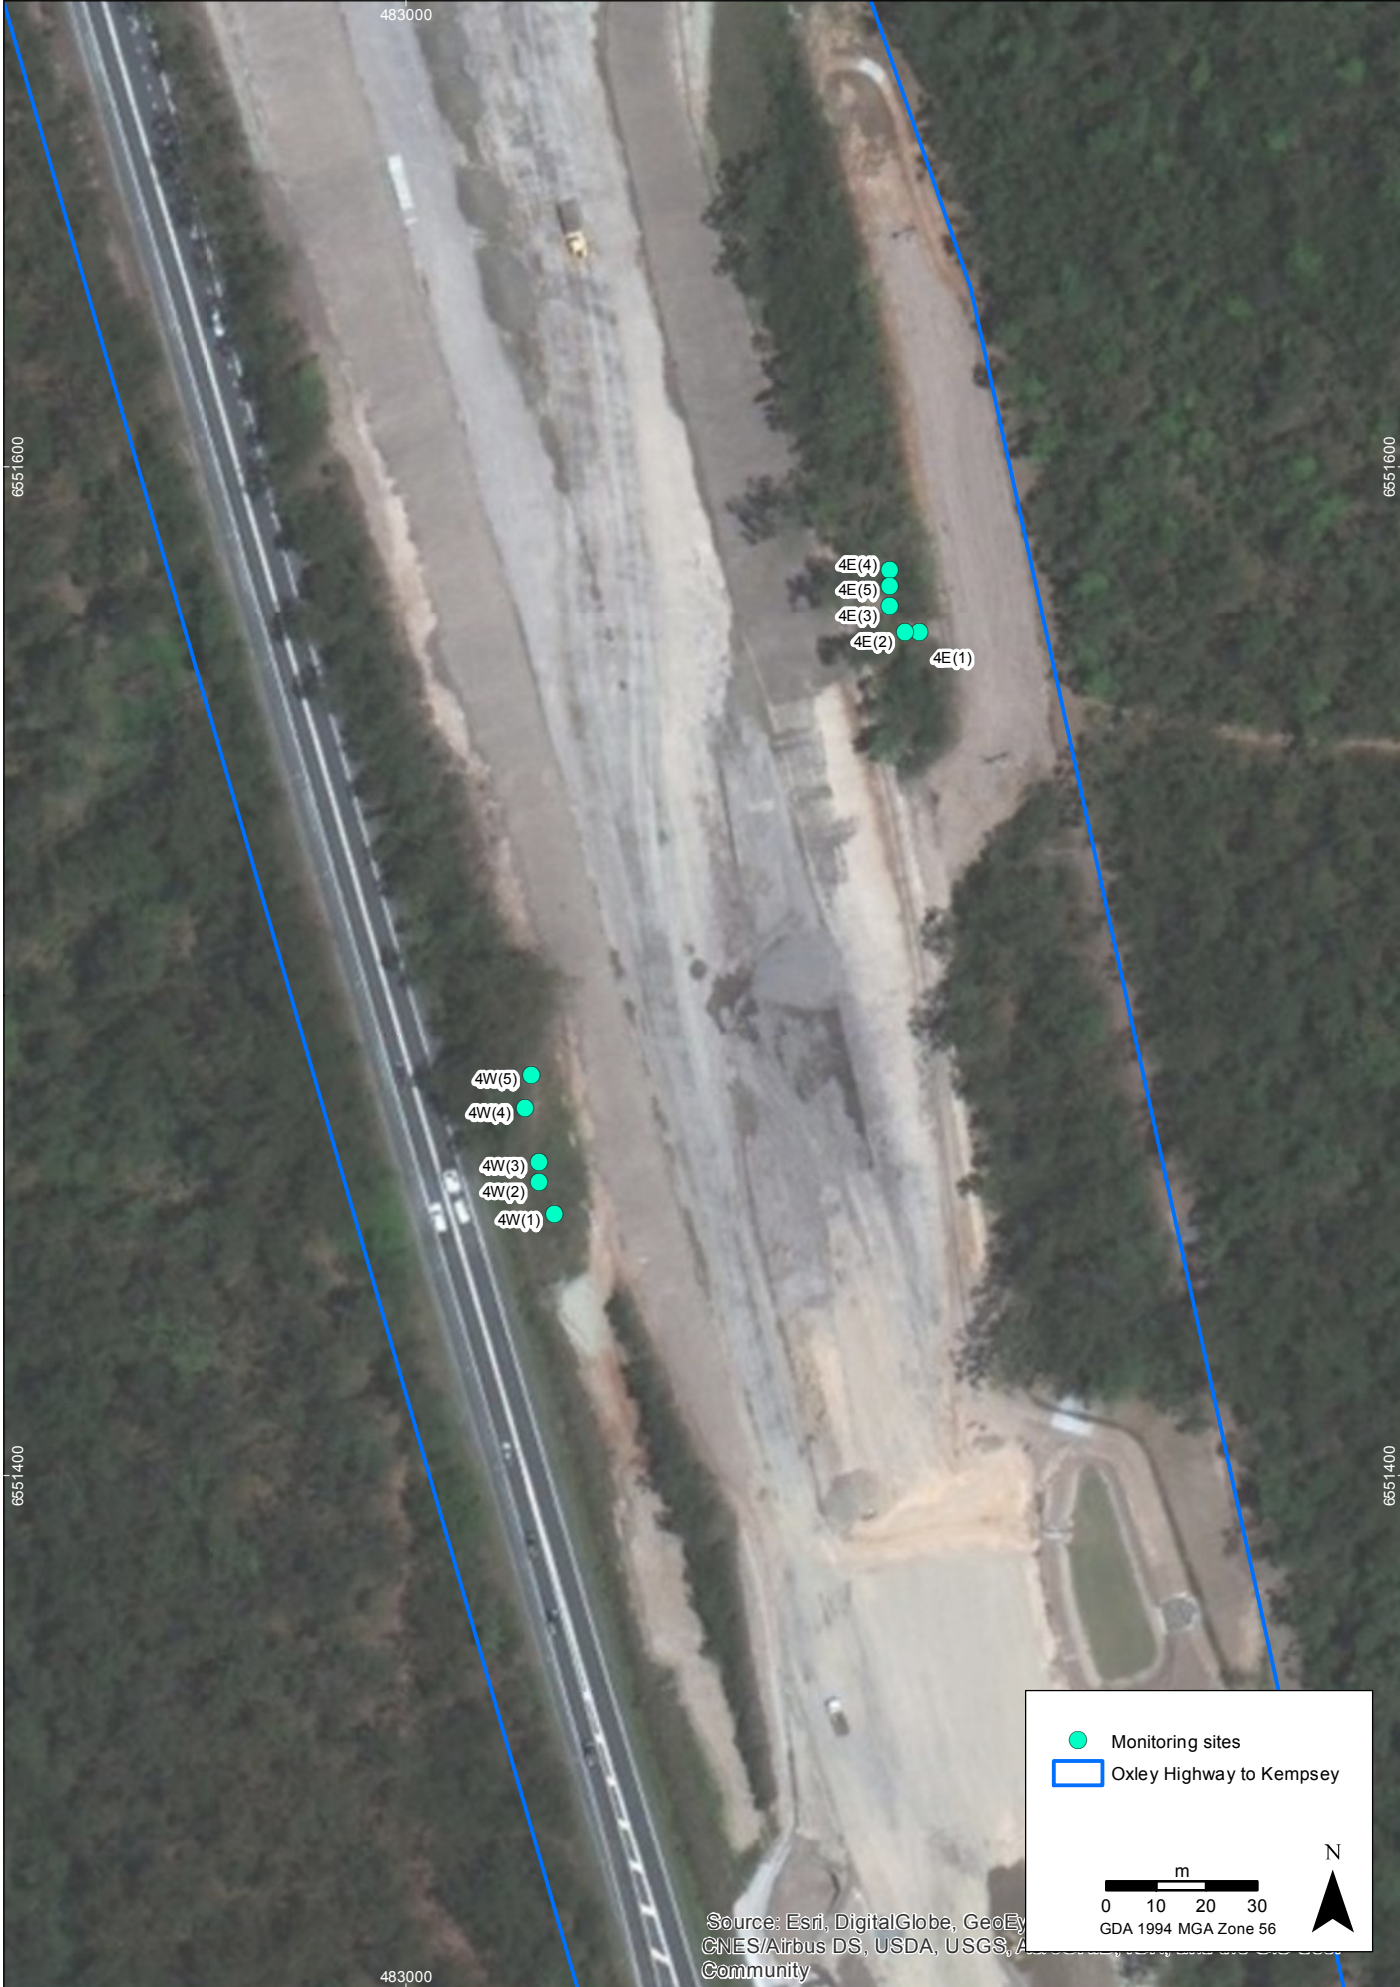
FIGURE 4

Green-thighed Frog monitoring Site 4
Oxley Highway to Kempsey - PI 5.15 GTF Ponds
