Oxley Highway to Kempsey

2017-18 Annual Ecological Monitoring Report

Roads and Maritime Services | November 2018

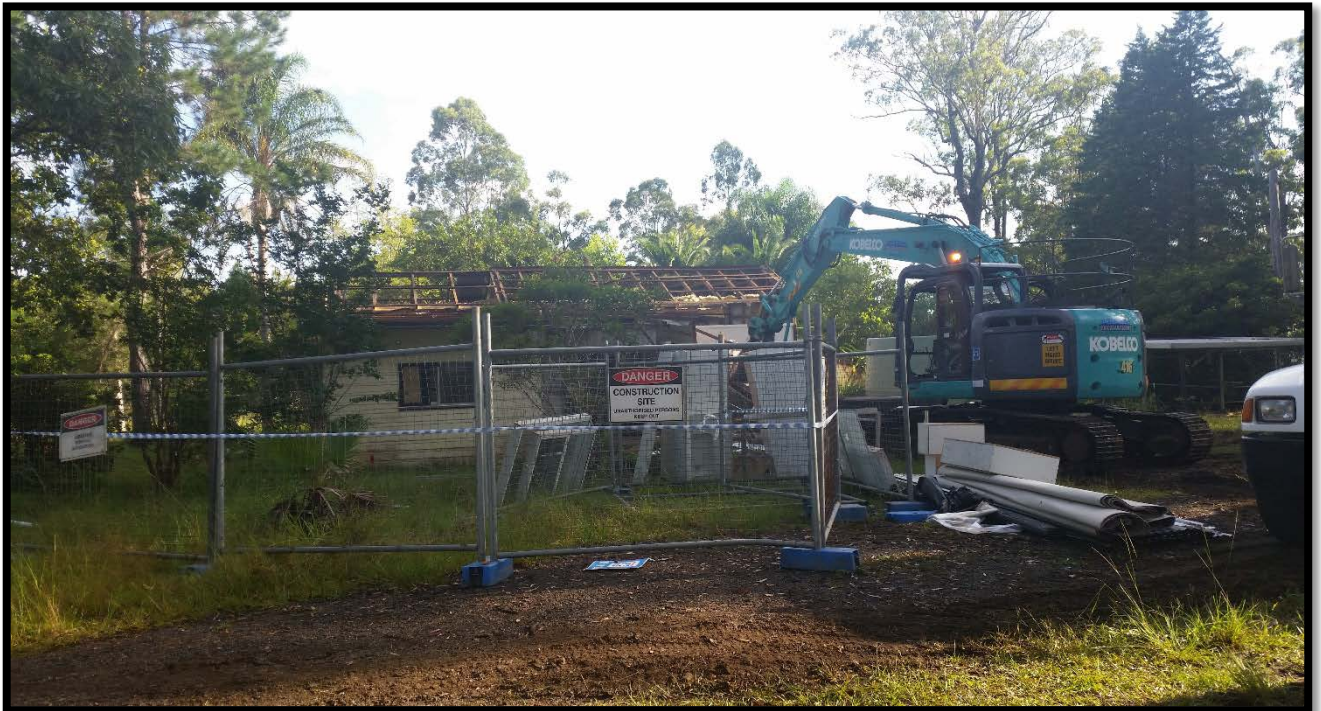
Plate 2-3. House being dismantled near Rodeo Drive was subject to micro bat inspections and works supervision.

Most of the 21 structures identified in the Microbat Management Strategy (MMS) (Lewis 2013d) as containing known or potential habitat were inspected and excluded for microbats between the 14 and 30 September 2014. Maria River Bridge and south bound Stumpy Creek bridge were not subject to exclusion works as no substantive works were planned for these structures. For the remaining 19 structures, the exclusion method proposed in the MMS was adopted. Once both the south and northbound carriageways had been completed, 21 existing but redundant culverts were identified for grout filling in August 2016. All 21 of these were subjected to the exclusion process outlined in the MMS during the field works undertaken between 14 and 17 September 2016. Some house and shed demolition works were also supervised during their dismantling for signs of micro bats (Plate 2-3).

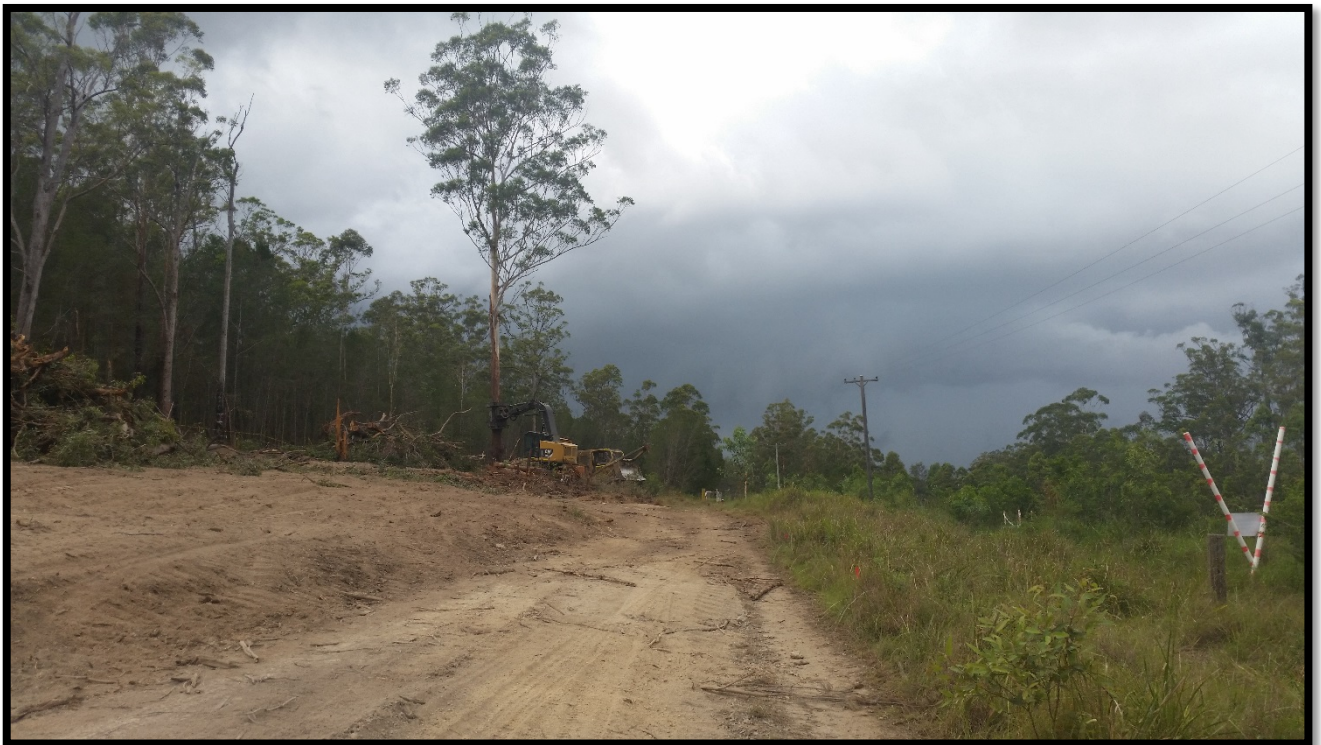
Plate 2-4. Clearing of habitat tree using harvester and dozer at ch. 33100.

The majority of HBTs were felled using a harvester or, in the case of very large trees, a combination of harvester and a bulldozer (Plate 2-4). A small number of trees, mainly in difficult to access areas were felled using a chainsaw. Examples of this occurred around some of the creek lines (i.e. Pipers Creek and Smiths Creek), close to the existing highway or services. The JV obtained approval from EPA prior to using hand-held chainsaws to fell any HBTs.

In most cases, trees were felled with the root ball intact so as to act like a pendulum in slowing the rate of fall. The ability to control the fall of HBTs was dependent on operator skill, machine size and tree size. Many trees were too large to be control felled as the two harvesters were approximately 30-35 ton in size.

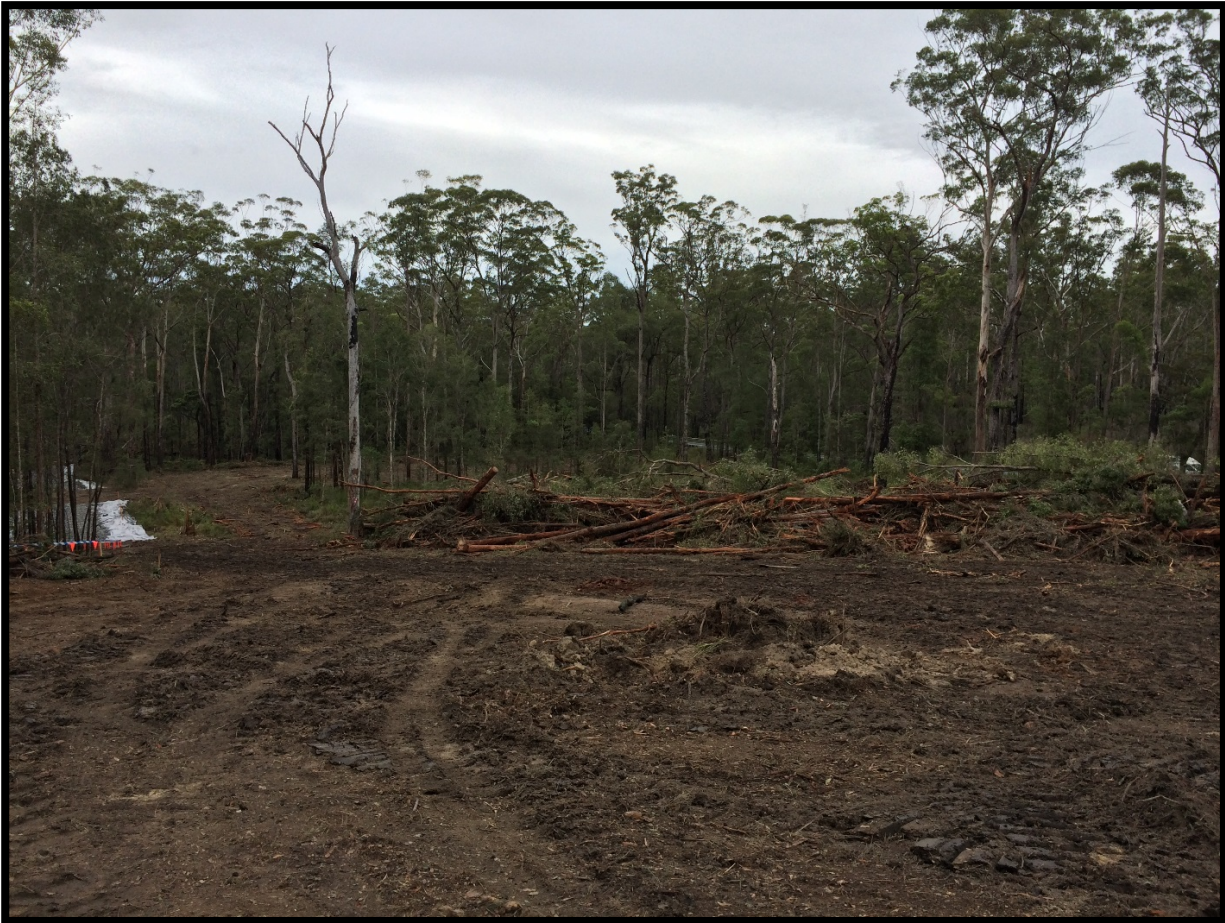
Plate 3-4. Clearing operations at the time of the unexpected Stephens Banded Snake find.

Habitat in this area was mapped as Moist Slopes Forest in the Environmental Assessment (GHD 2010; Plate 3-4). The overstorey features Pink Bloodwood, White Stringybark, Tallowwood and Coastal Blackbutt with a somewhat dense low and mid stratum of Turpentine and Paperbark on the lower slope and along the drainage line with increasing amount of *Allocasuarina* on the lower slope. The drainage line is an unnamed tributary of Maria River and habitat fitting the above description extends for hundreds of meters in either direction. The areas was mapped in the Nest Box Plan of Management as containing numerous hollow bearing trees, an artefact of its southern aspect and its close location to the existing Pacific Highway carriageway probably has created a retained buffer from past timber harvesting operations.

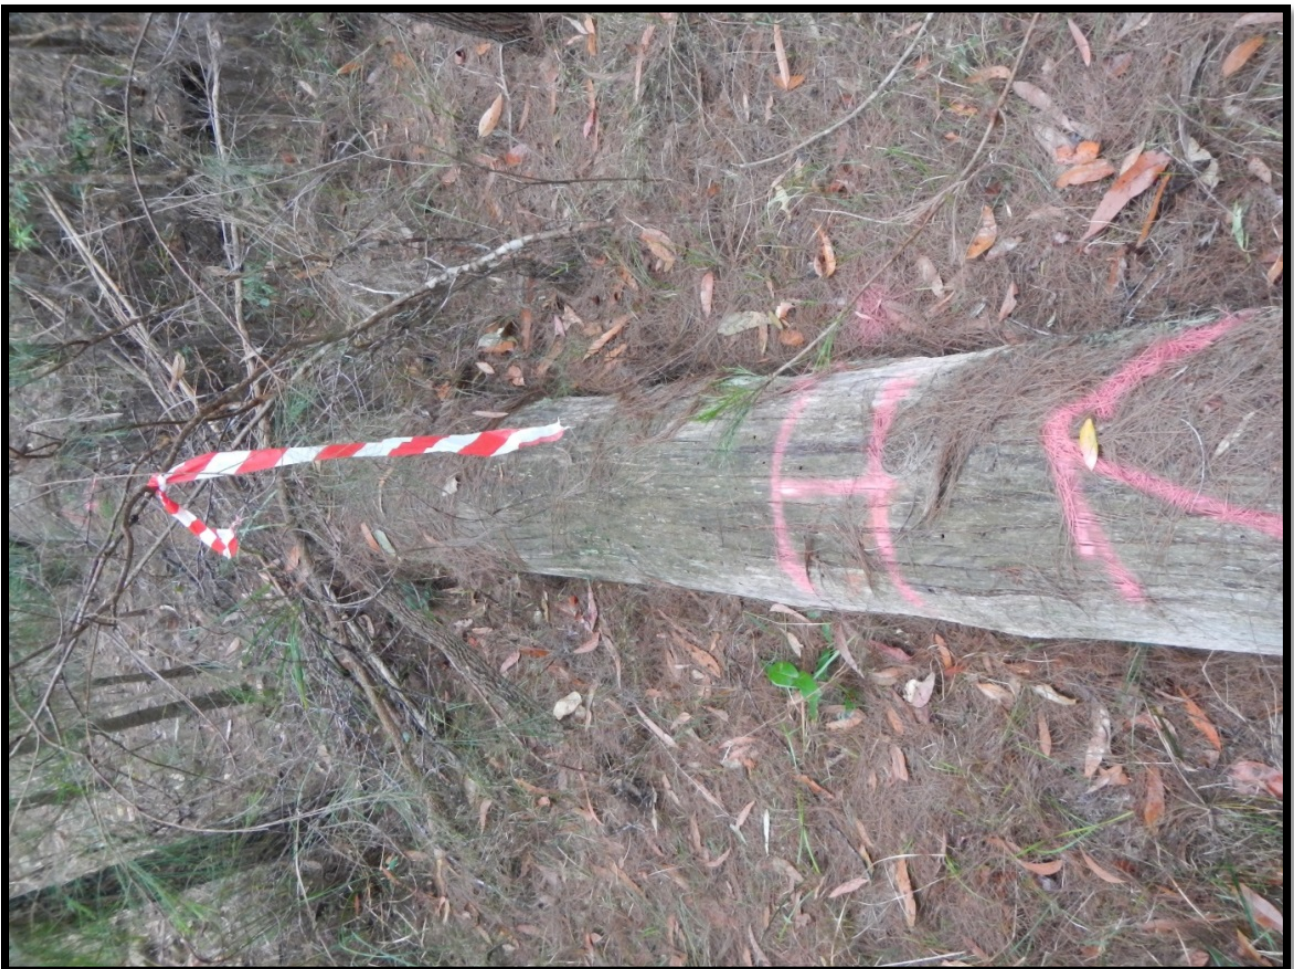
Plate 3-10. Ground log marked up for clearing supervision and relocation.

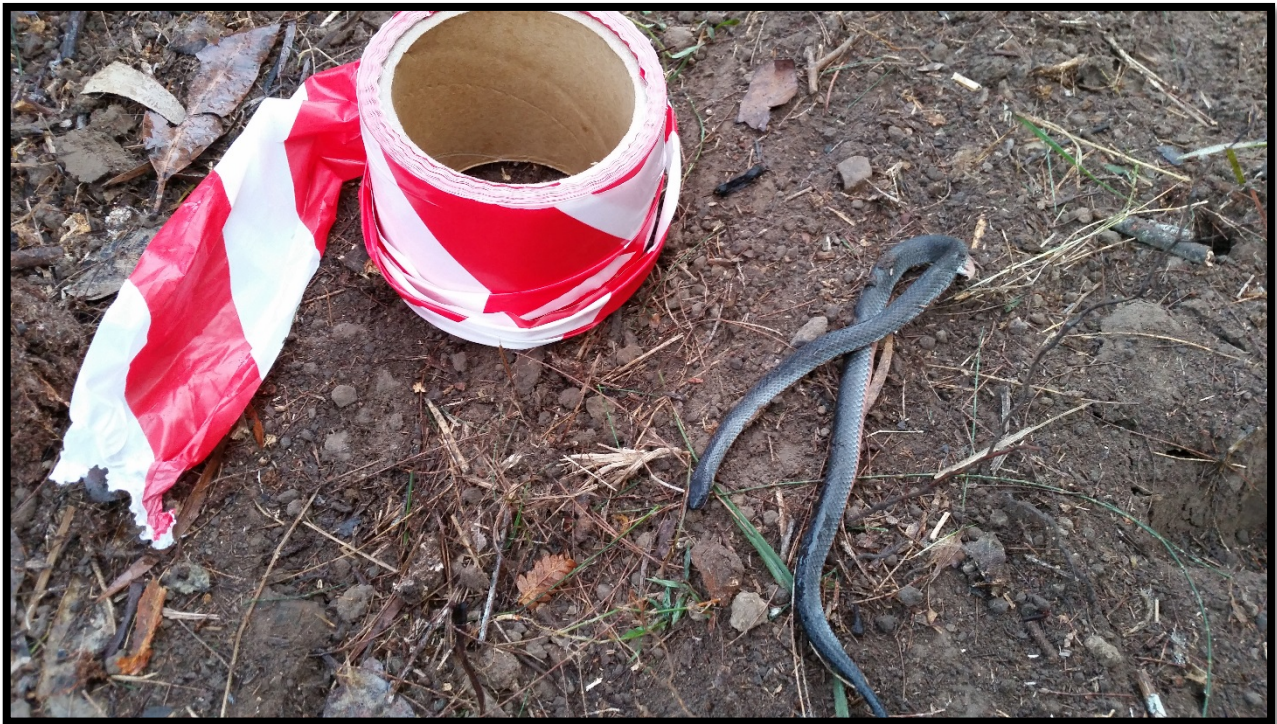
Plate 3-11. Eastern Small-eyed Snake recorded during stage 1 clearing operations at ch. 26350 (north of Mobbs Drive).

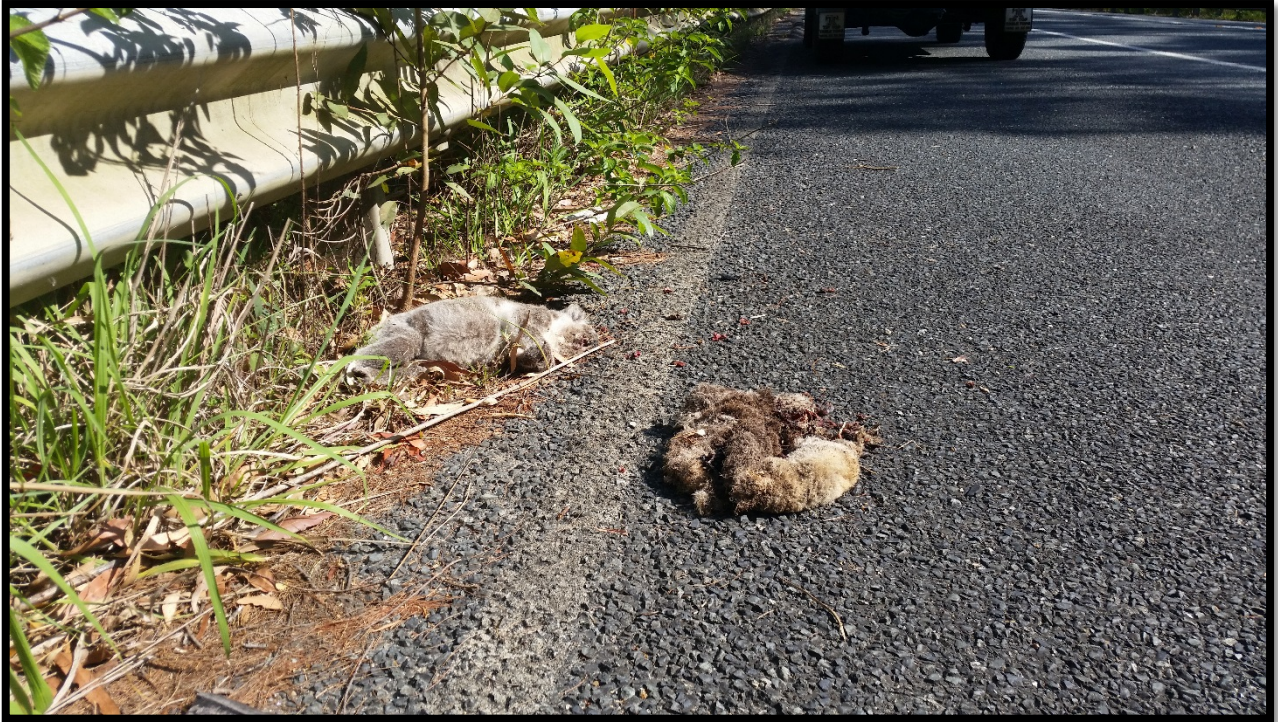
Plate 3-12. Koala recorded during the pre-construction weekly road kill monitoring at ch. 26300.
