Oxley Highway to Kempsey EPBC 2012/6518 **Condition 8 Annual Report**

File name	15 1015 OH2K DoTE CoA 8 Annual Report July 2014 - July 2015_FINAL.docx
Report name	Oxley Highway to Kempsey EPBC 2012/6518 Condition of Approval 8 Annual Report 22 July 2014 – 21 July 2015
Revision number	1

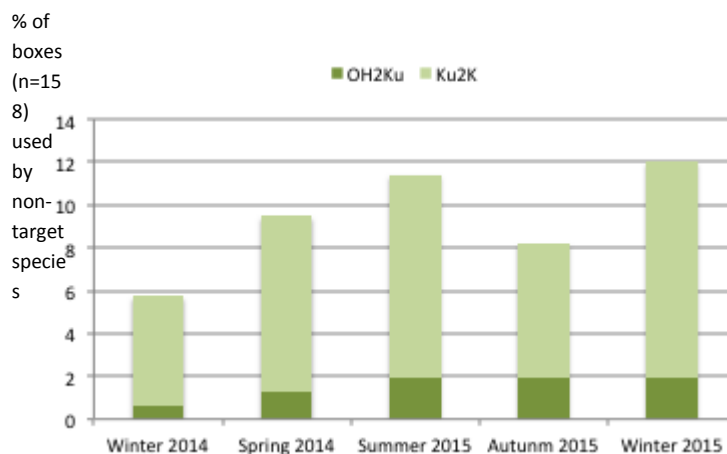
Figure 12.2: Bat roost box usage by non-target native species during the 5 monitoring events

An increasing number of boxes (7 in summer 2015, 12 in autumn 2015 and 13 in winter 2015) have been found with insect material such as mud wasp nest. These boxes weren't included in the non-target native species statistic because it was not possible to determine if they have been inhabited by native or introduced fauna species.

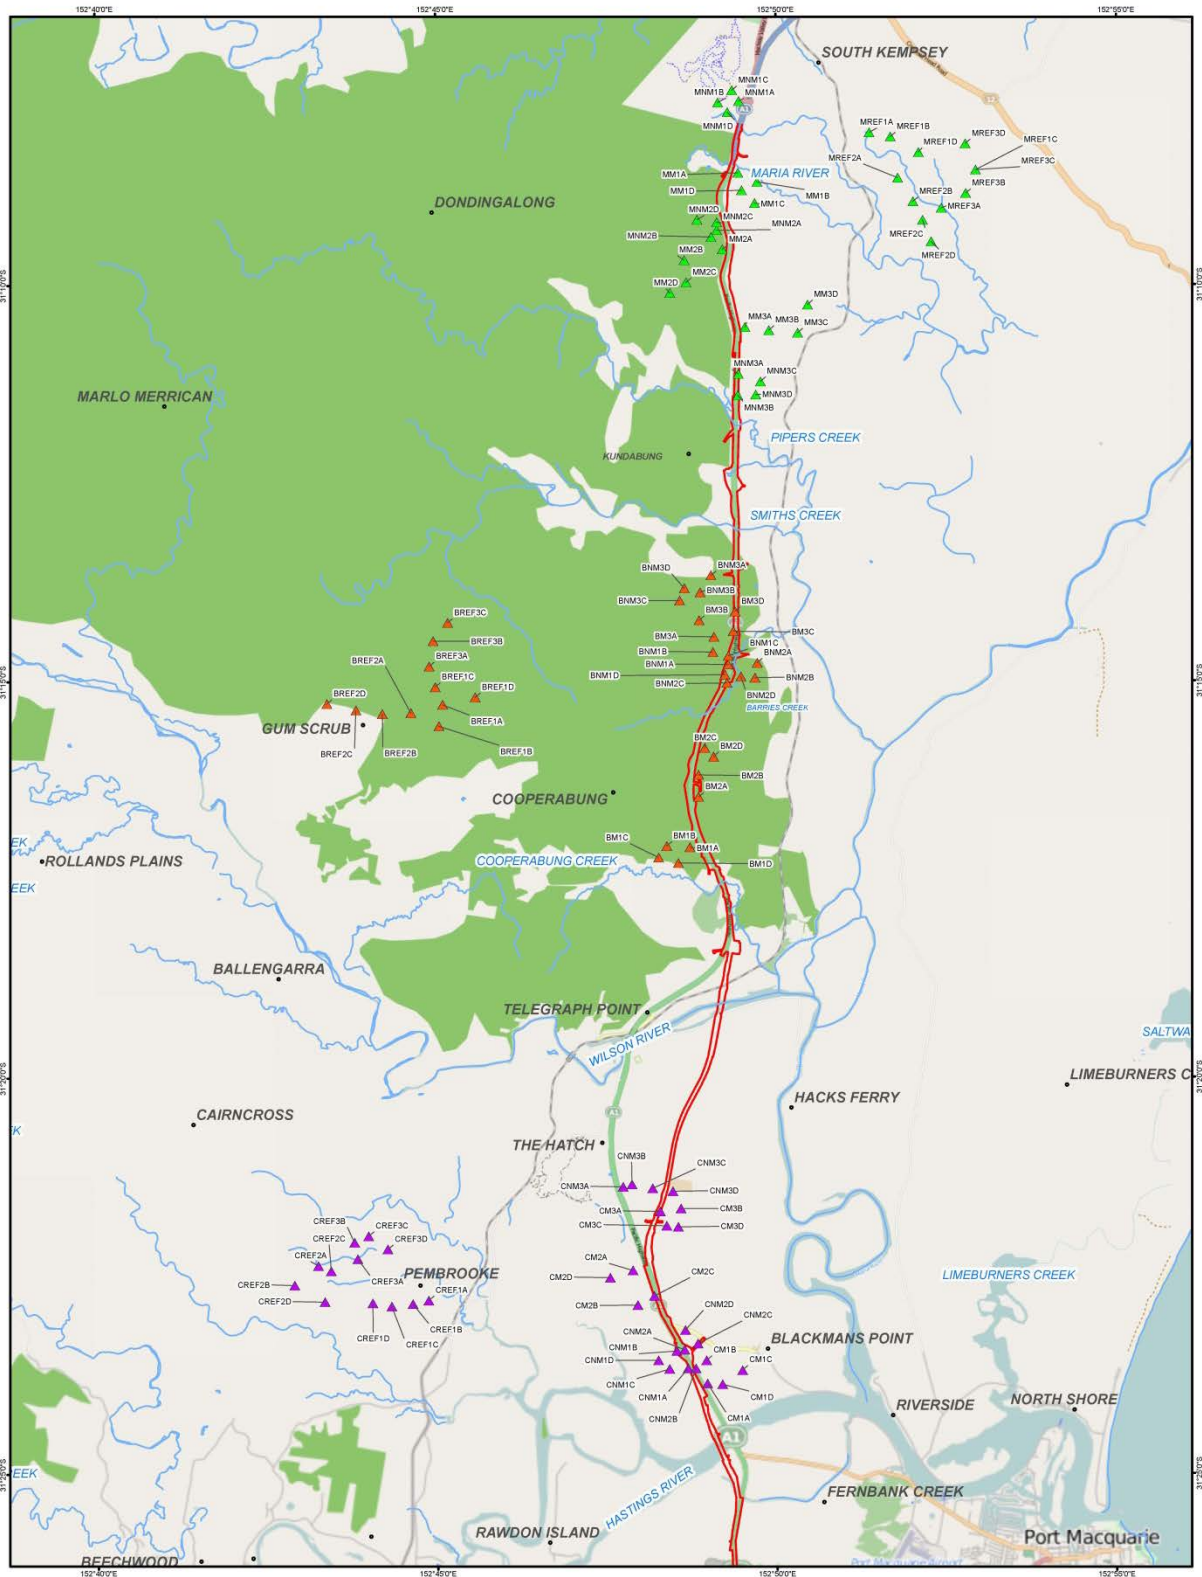
Figure 3-1. Distribution of treatments and camera trap locations for the Spotted-tailed Quoll pre-construction baseline survey.

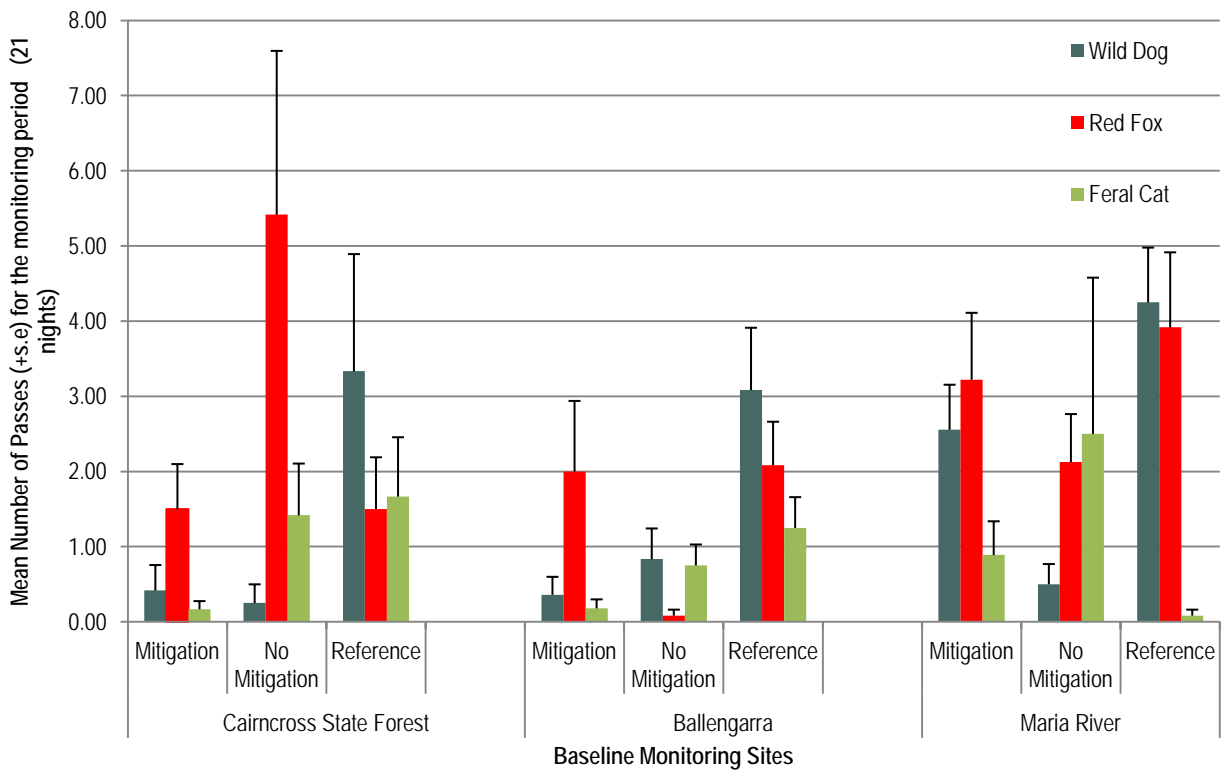
Figure 3-3. Mean number (+s.e bars) of wild dog, red fox and feral cat across each treatment for the monitoring period.

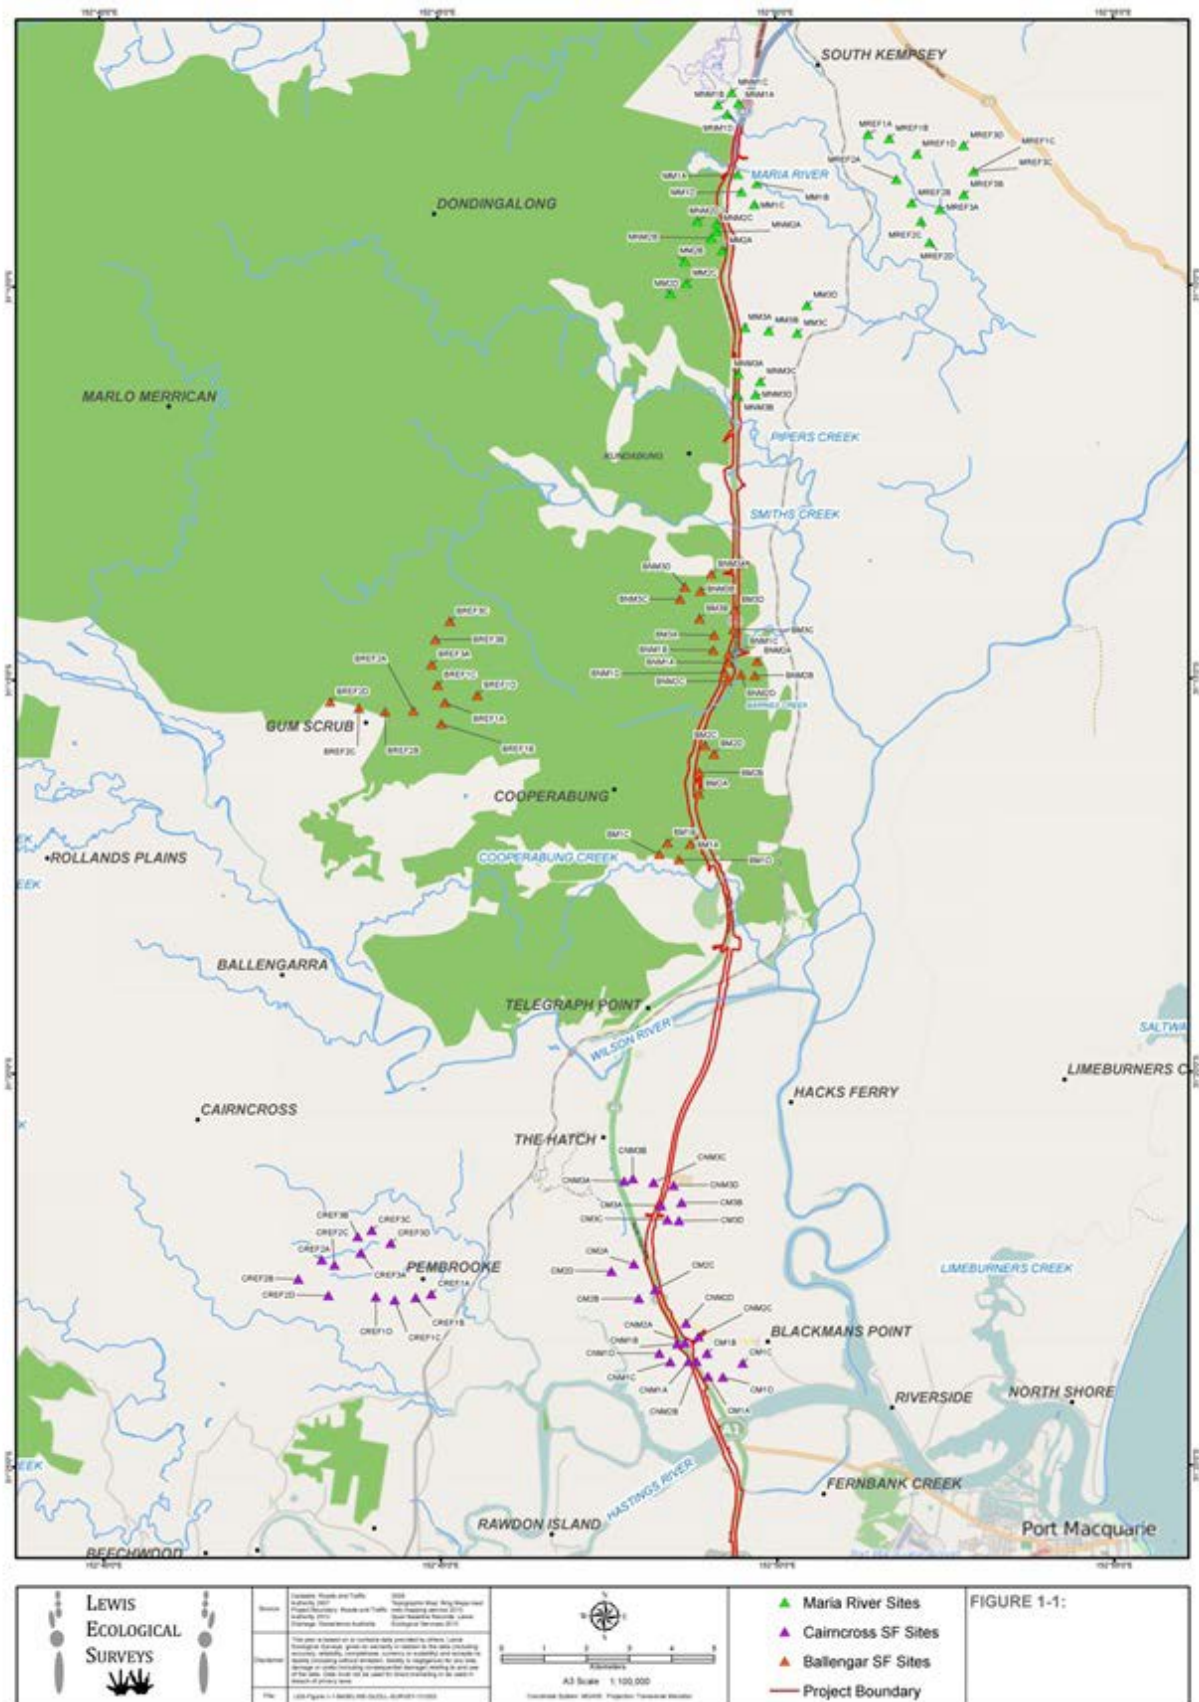
Figure 4-2. Distribution of treatments and camera trap locations during the pre-construction baseline survey.

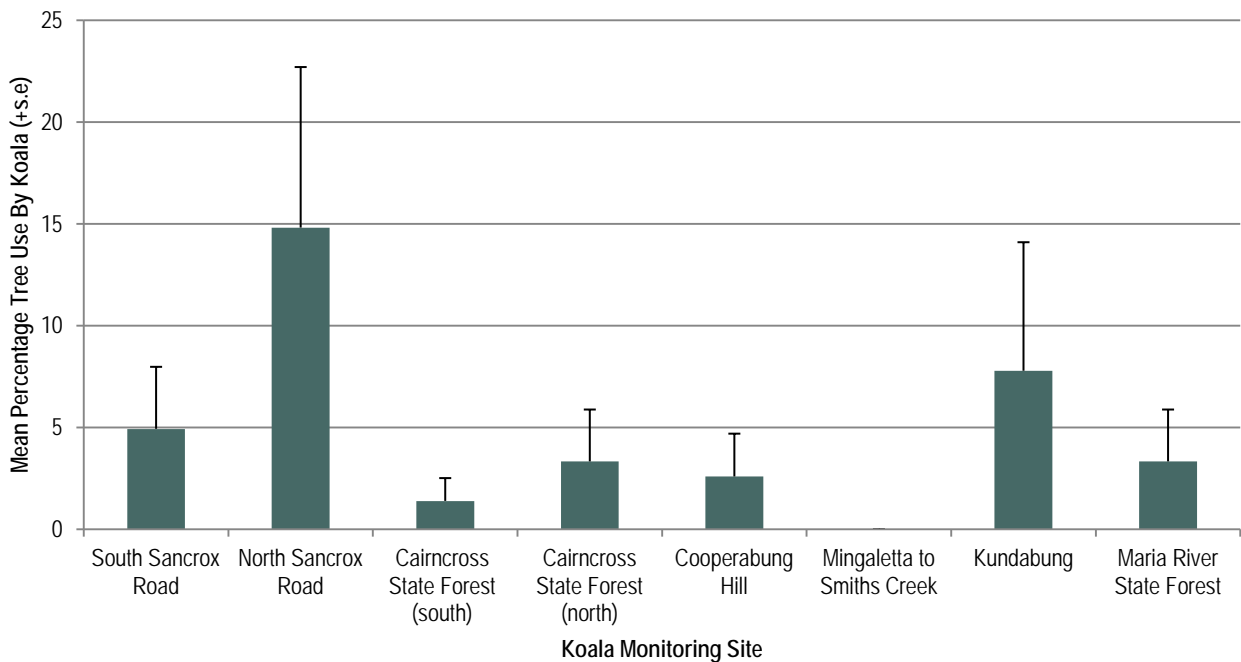
- South of Sancrox Road between ch.1000-1750 and particularly the eastern side of the road where a female was observed and mean activity levels of 8.89% (SD =2.94);
- South of Fernbank Creek between ch. 3350-4450 and particularly the western side of the road where a large male was observed with activity levels reaching 28.89% (SD=2.94); and
- Kundabung in the vicinity of ch. 32700 on both sides of the existing carriageway with activity levels of 18.89% (SD=7.29).

Figure 4-4. Mean (+s.e) SAT activity levels at each of the eight Koala monitoring areas.

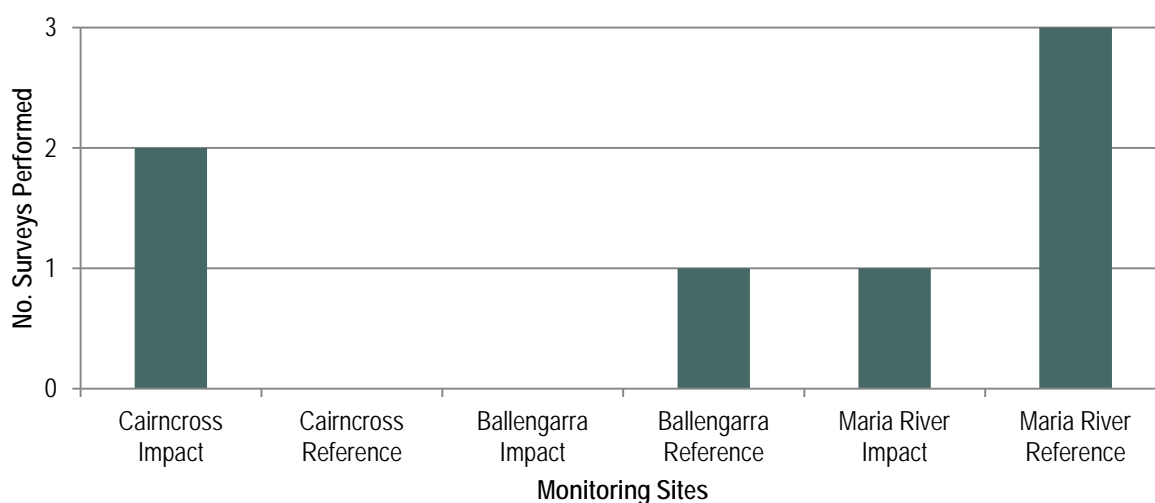
Figure 5-1. Number of surveys Yellow-bellied Glider was recorded during the pre-construction baseline monitoring period.

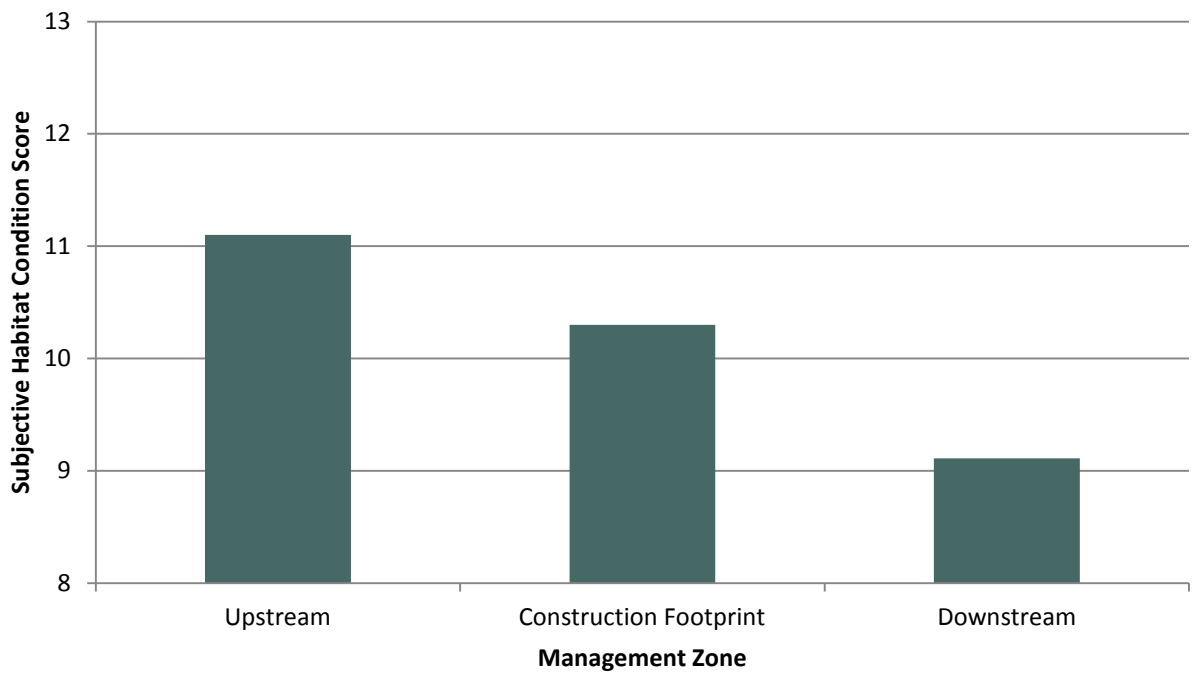
sedimentation from cattle affecting both the terrestrial and aquatic scores. The construction footprint scored quite high due to a lot of the footprint containing intact vegetation (Figure 7-6).

Figure 7-6. Habitat quality scores for each of the management zones at Pipers Creek.

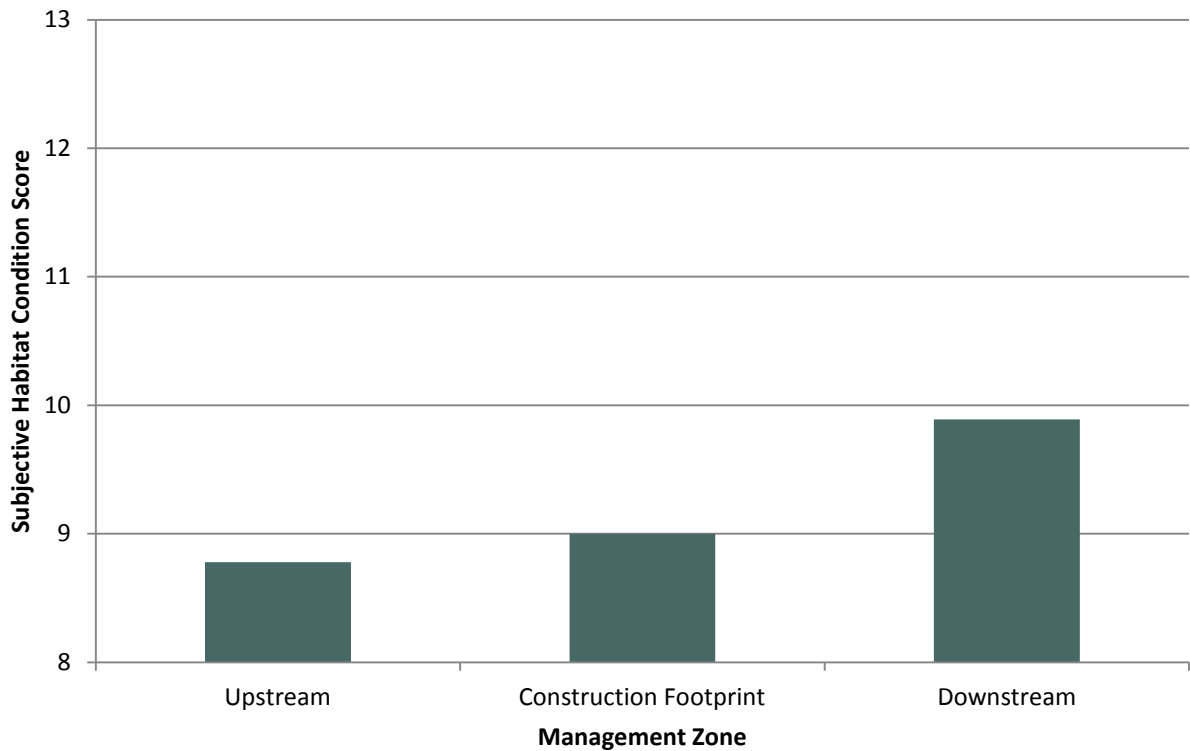
leaf litter. The bottom zone (D1) occurs partly within a powerline easement and has the usual edge associated impacts of dense ground covers dominated by weeds and a reduced overstorey.

Figure 7-8. Habitat quality scores derived for the three management zones at Maria River (impact).

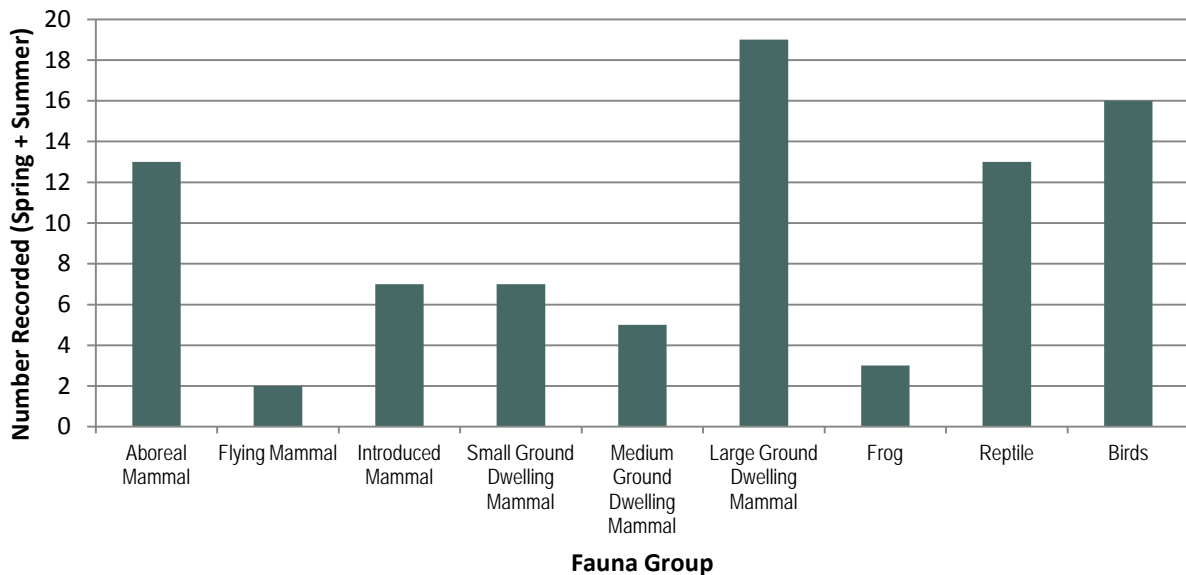
The most commonly recorded fauna group were the large ground dwelling mammals with 19 observations followed by birds with 16, arboreal mammals and reptiles each with 13 observations (Figure 8-1). Very few flying mammals (i.e. bats) and frogs were recorded during the monitoring period.

Figure 8-1. Cumulative number of road kills accordingly to broad fauna group for the spring and summer monitoring.

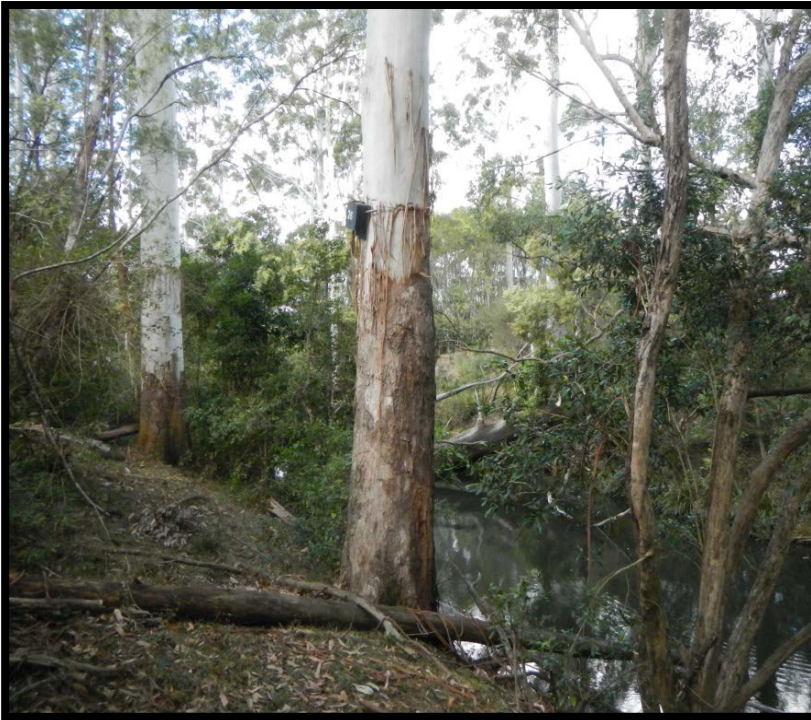
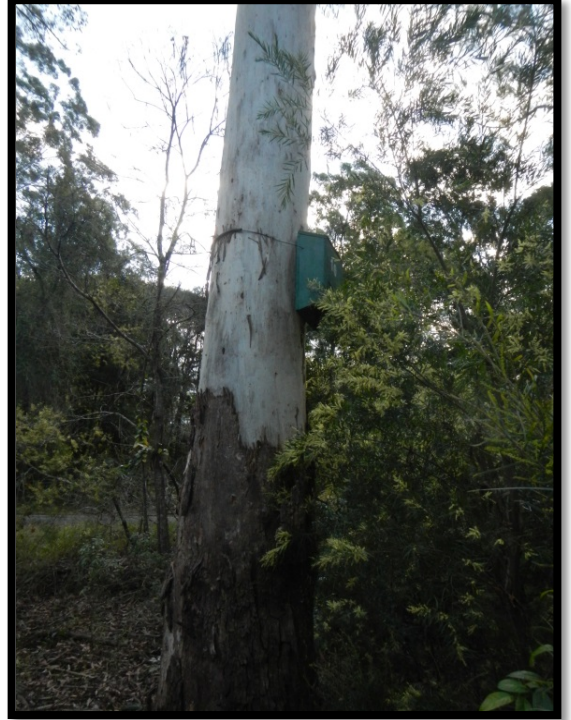
important role in the way bats tend to select their roosts and it is this reason why bats are often found using bridges and culverts with water in them. Plate 1 (right) illustrates a bat box being installed around shrubby vegetation. Shrubs such as this tend to provide access points for predators (i.e. small python) and are therefore less likely to be inhabited by micro bats. It also makes it more difficult for bats to enter and exit the box due to the obstruction of clear passage from the leaves and branches.

Plate 1-1. Example of poor implementation of the microbat management plan. Left - Box not overhanging water and should have been ideally placed on the south bank facing north. Right – Box installed low and with shrubby vegetation growing around its entrance making it more likely for predation events and impeding fly way to and from the box.

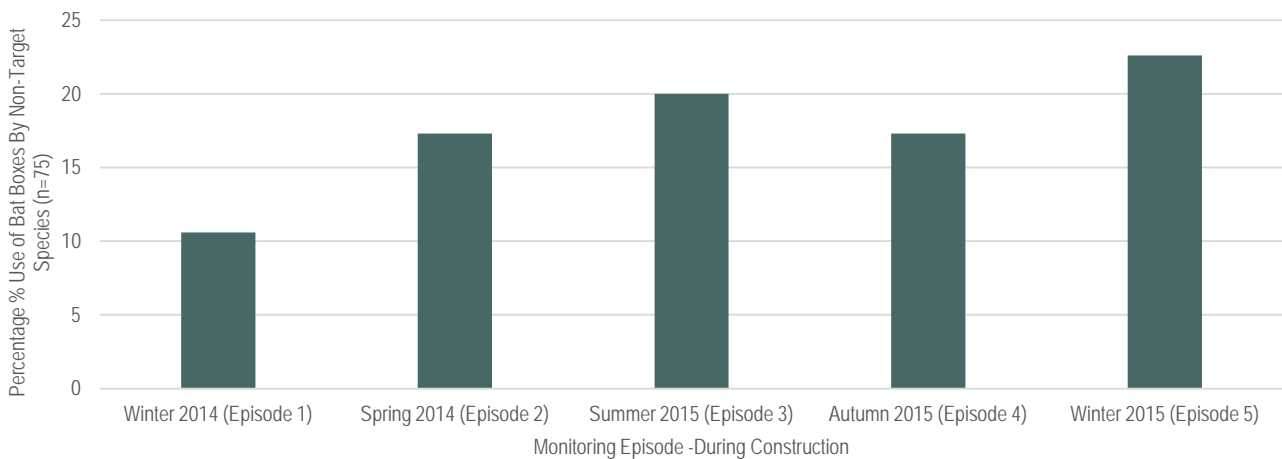
Figure 1-2. Occupancy rates of non target species over the five monitoring episodes.
