Oxley Highway to Kempsey EPBC 2012/6518 **Condition 8 Annual Report**

File name	16 0822 OH2K DoTE CoA 8 Annual Report July 2015 - July 2016
Report name	Oxley Highway to Kempsey EPBC 2012/6518 Condition of Approval 8 Annual Report 22 July 2015 – 21 July 2016
Revision number	2

This report covers the second period from 22 July 2015 to 21 July 2016.

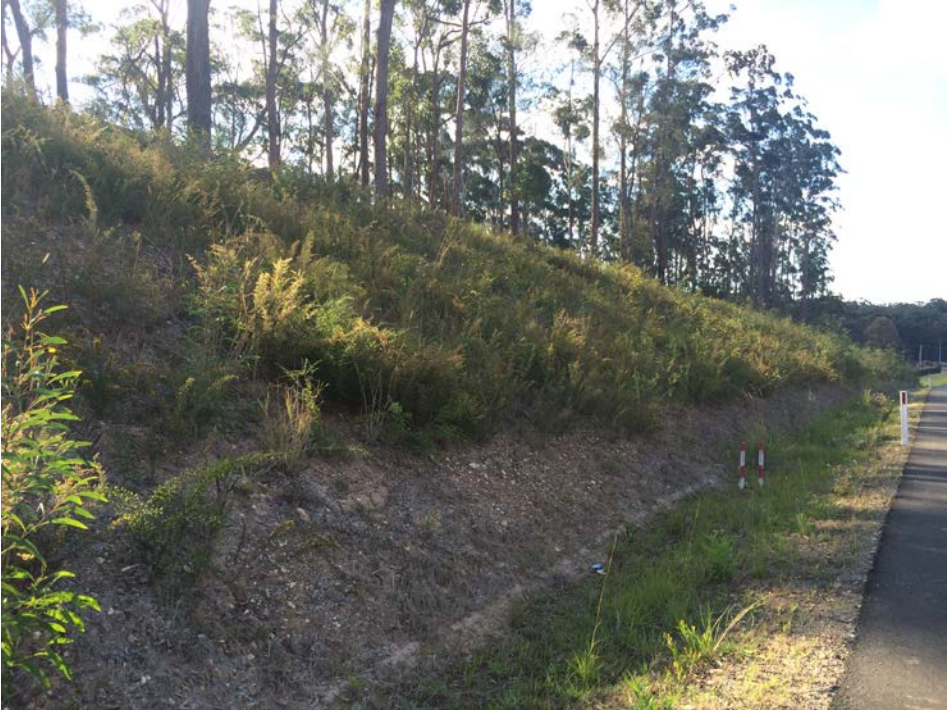
#	Description	Image
Stage 1		
1	Revegetation along a cut batter of the project

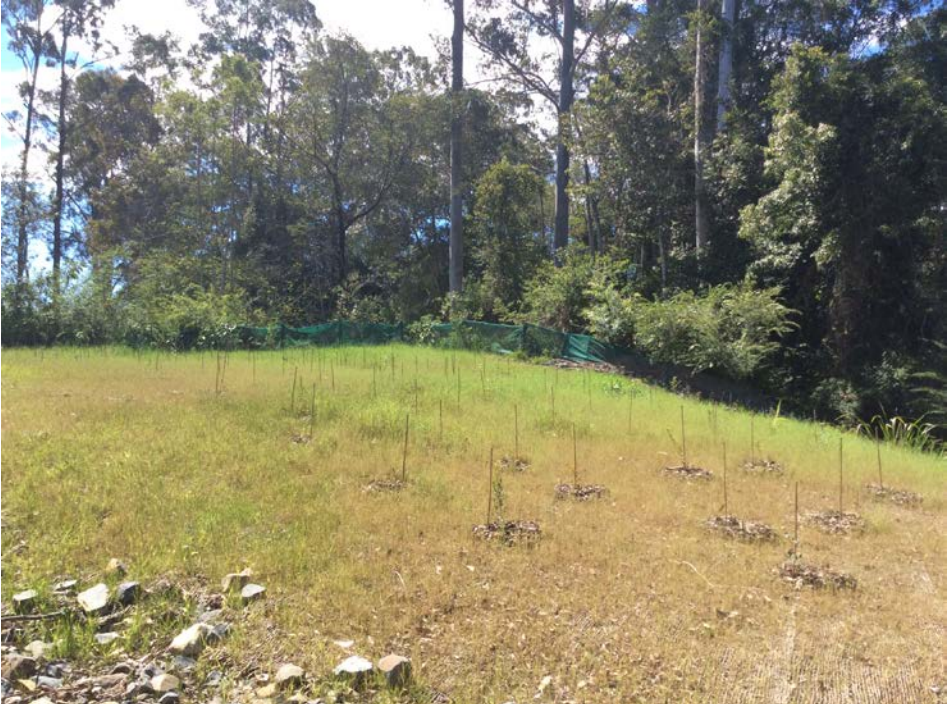
Stage 2		
2	Progressive revegetation through hydromulching and tubestock planting at Smiths Creek (frog fence in background)

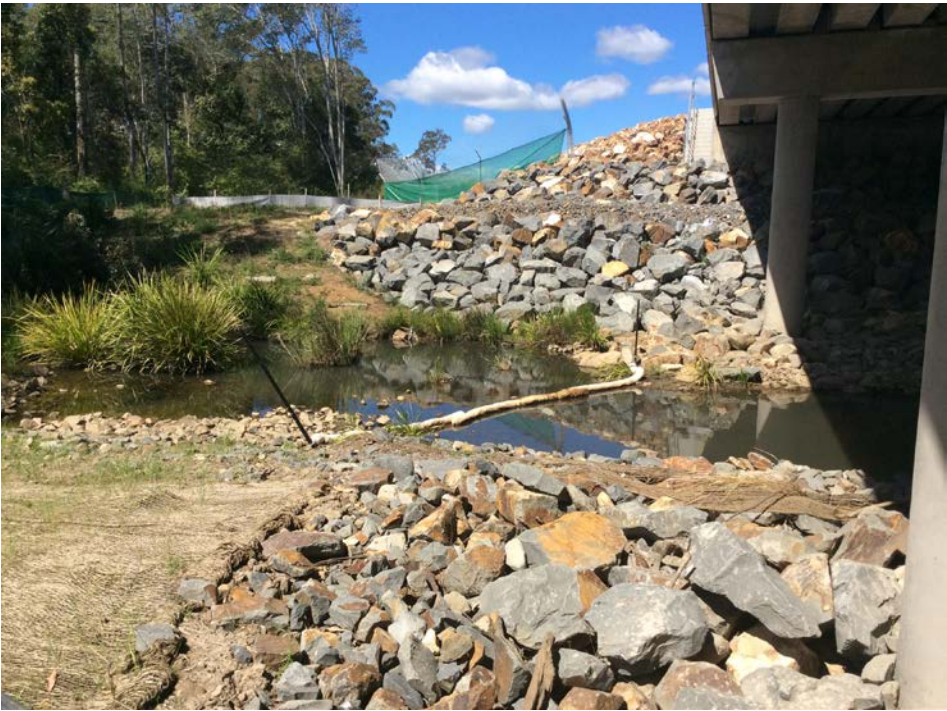
#	Description	Image
3	Hydrocarbon boom installed at Smiths Creek

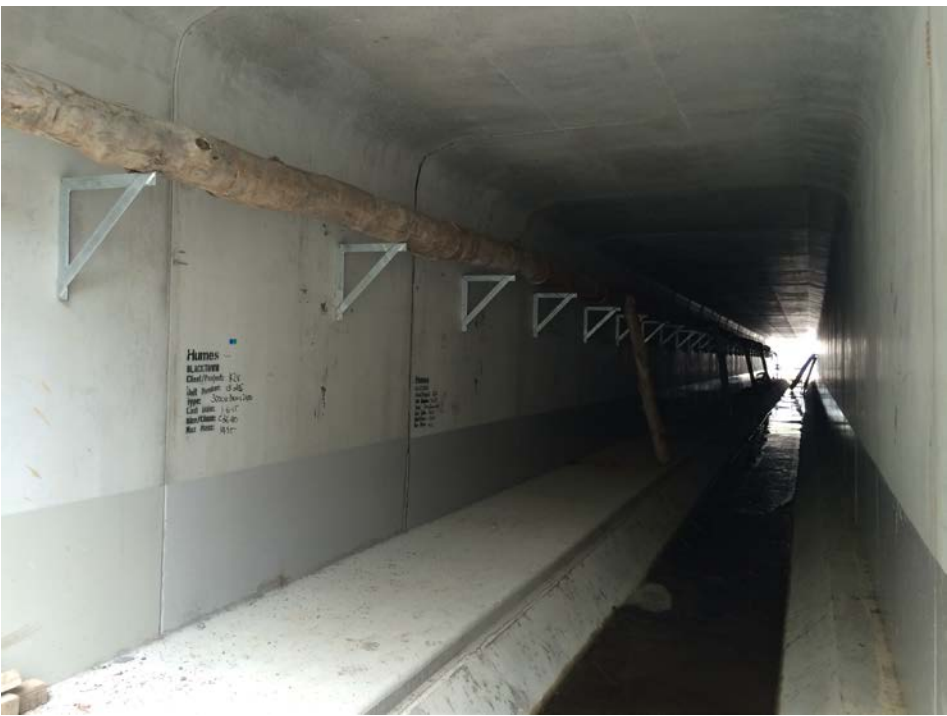
4	Progressive installation of fauna furniture in completed box culvert C36.40 (also shown is low flow fish passage)

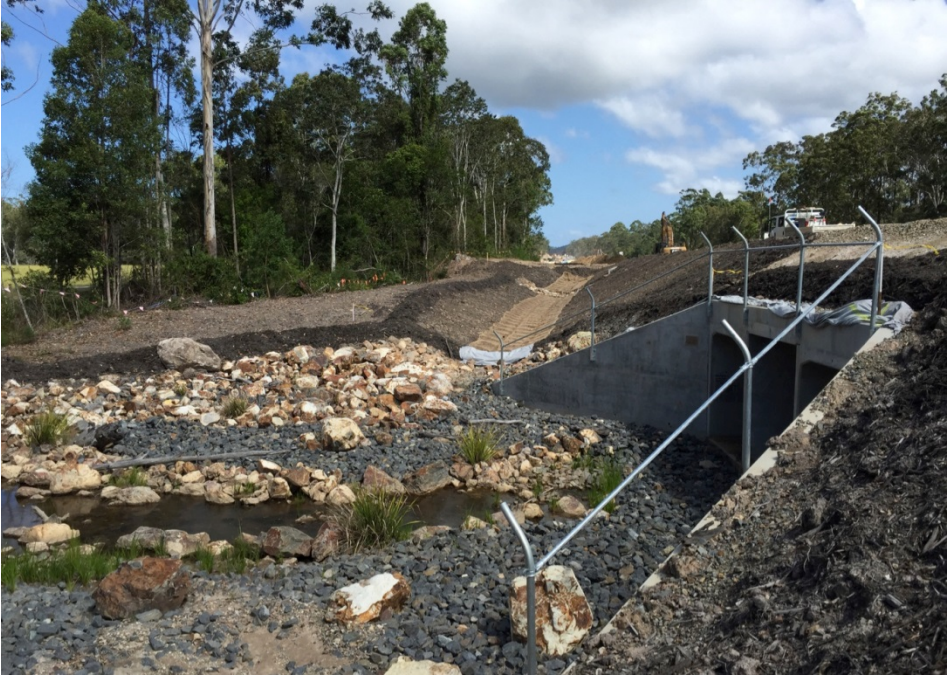
#	Description	Image
5	<p>Completed box culvert including fish passage within scour rock and replanting of salvaged lomandras</p>

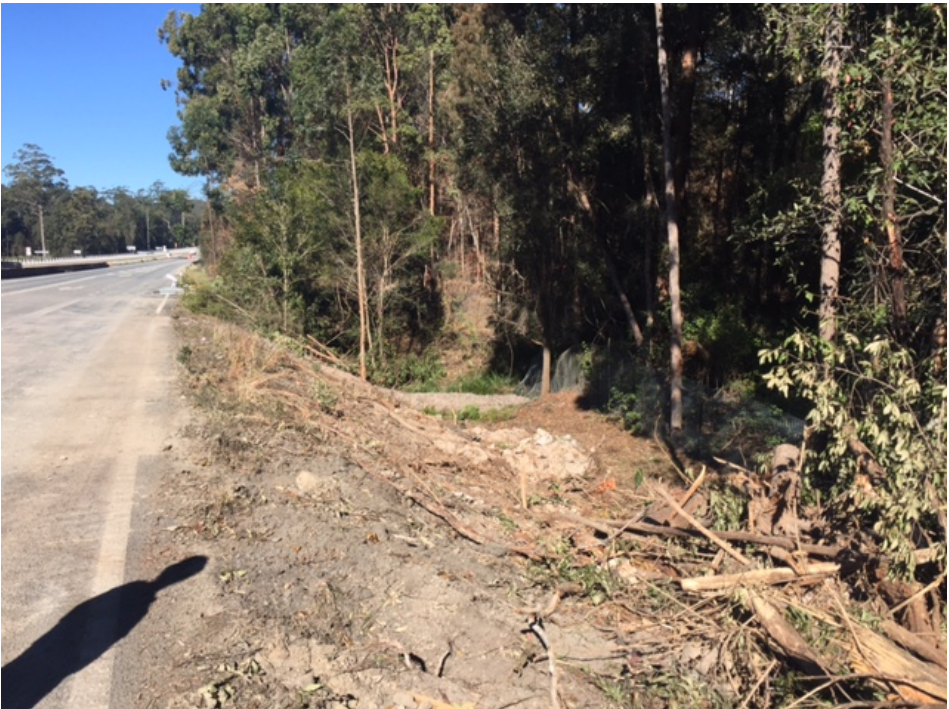
6	<p>Clearing incident on 21 July 2016, showing the area cleared, which was dominated by Pacific Highway regrowth vegetation.</p>

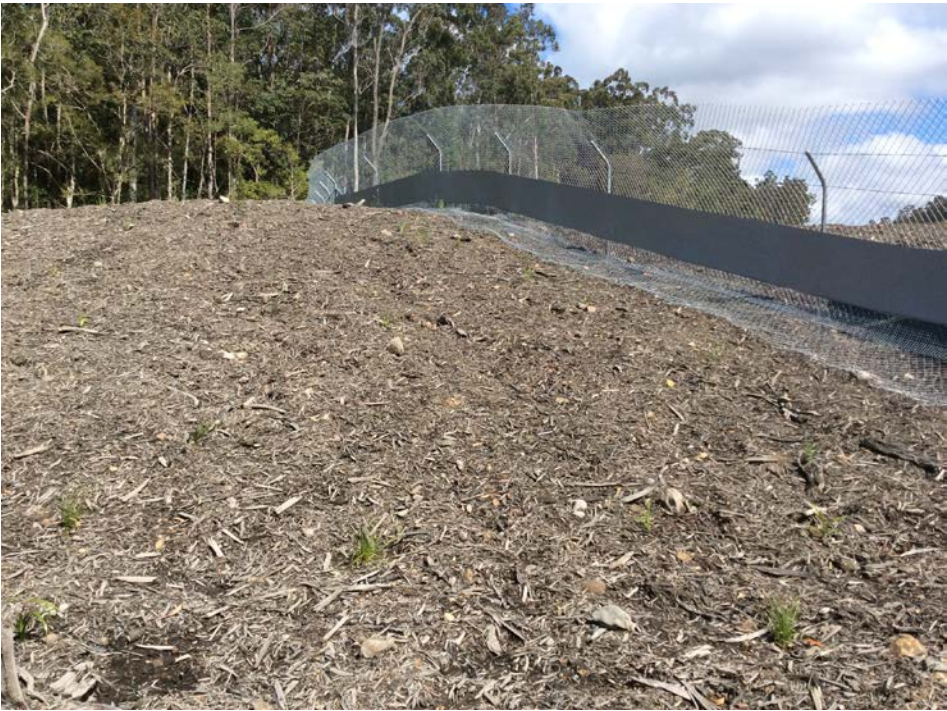
#	Description	Image
7	<p>Tubestock planting, mulch-topsoil stabilisation and fauna (phascogale) fence at Barrys Creek</p>

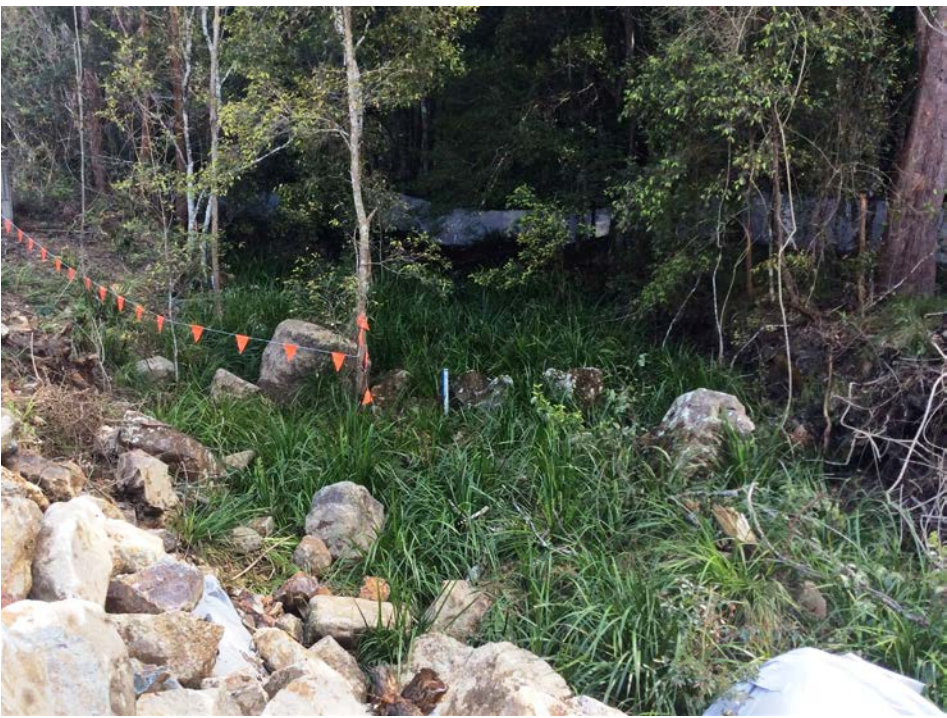
8	<p>Retention of groundcover in Barrys Creek until immediately prior to works commencing. This ultimately led to this area being able to be retained (between the flagging and the frog fence), rather than removed and replaced with scour rock.</p>

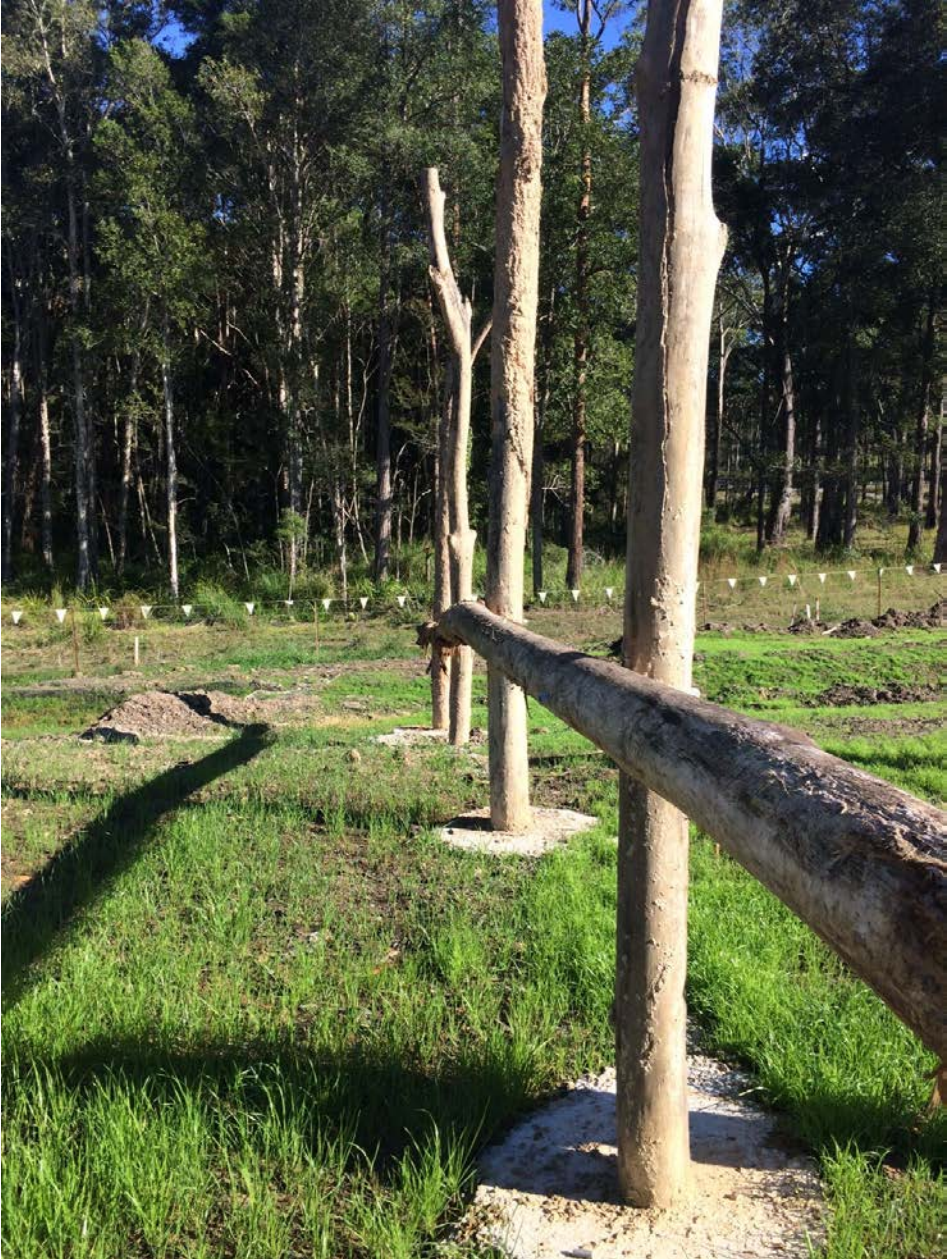
#	Description	Image
9	<p>Fauna furniture out of a half completed box culvert at the southern end of the project (other half to be completed after the traffic switch) and progressive revegetation</p>

A photograph showing a naturalistic 'fauna furniture' structure. In the foreground, a large, weathered log lies horizontally across the frame. To its right, a vertical tree trunk stands upright. In the background, several other tree trunks of varying heights and thicknesses are scattered across a grassy field. The ground is covered with green grass and some patches of bare earth. In the far background, a dense forest of tall trees is visible under a clear blue sky. A string of small white flags or markers is strung across the middle ground.

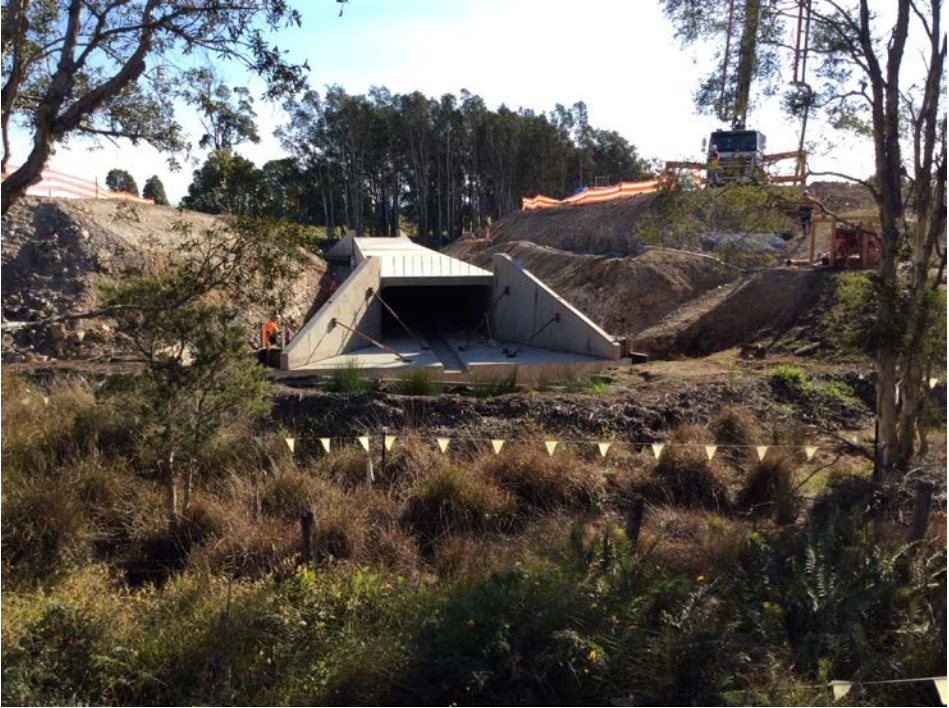
#	Description	Image
10	<p>Culvert construction in progress just south of Fernbank Creek</p>

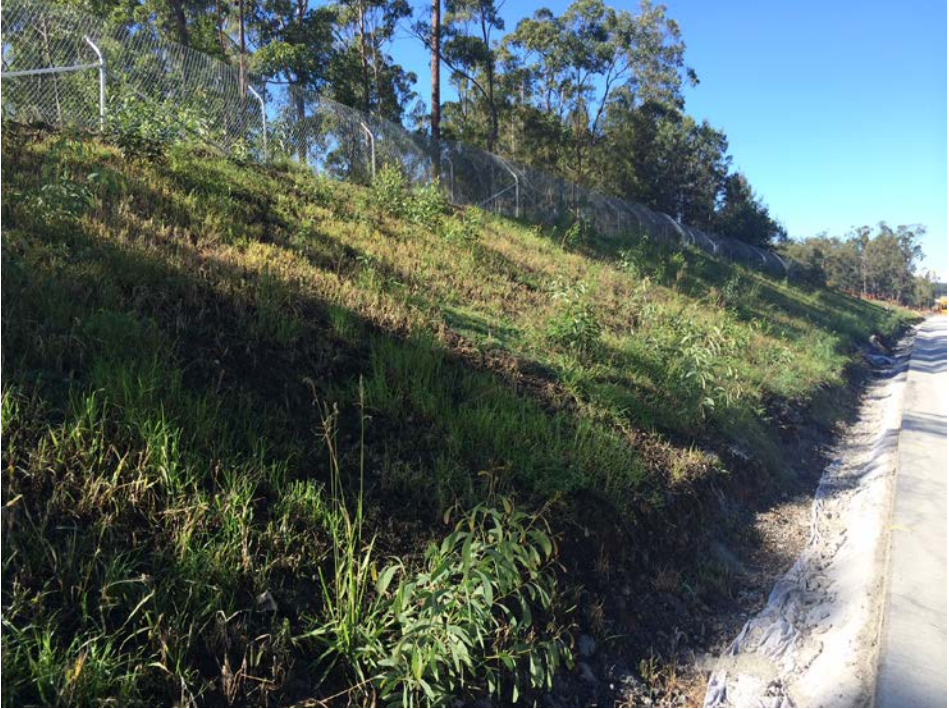
11	<p>Example of progressive revegetation, where 70% cover would be considered to have been achieved (area to the right has been paved)</p>

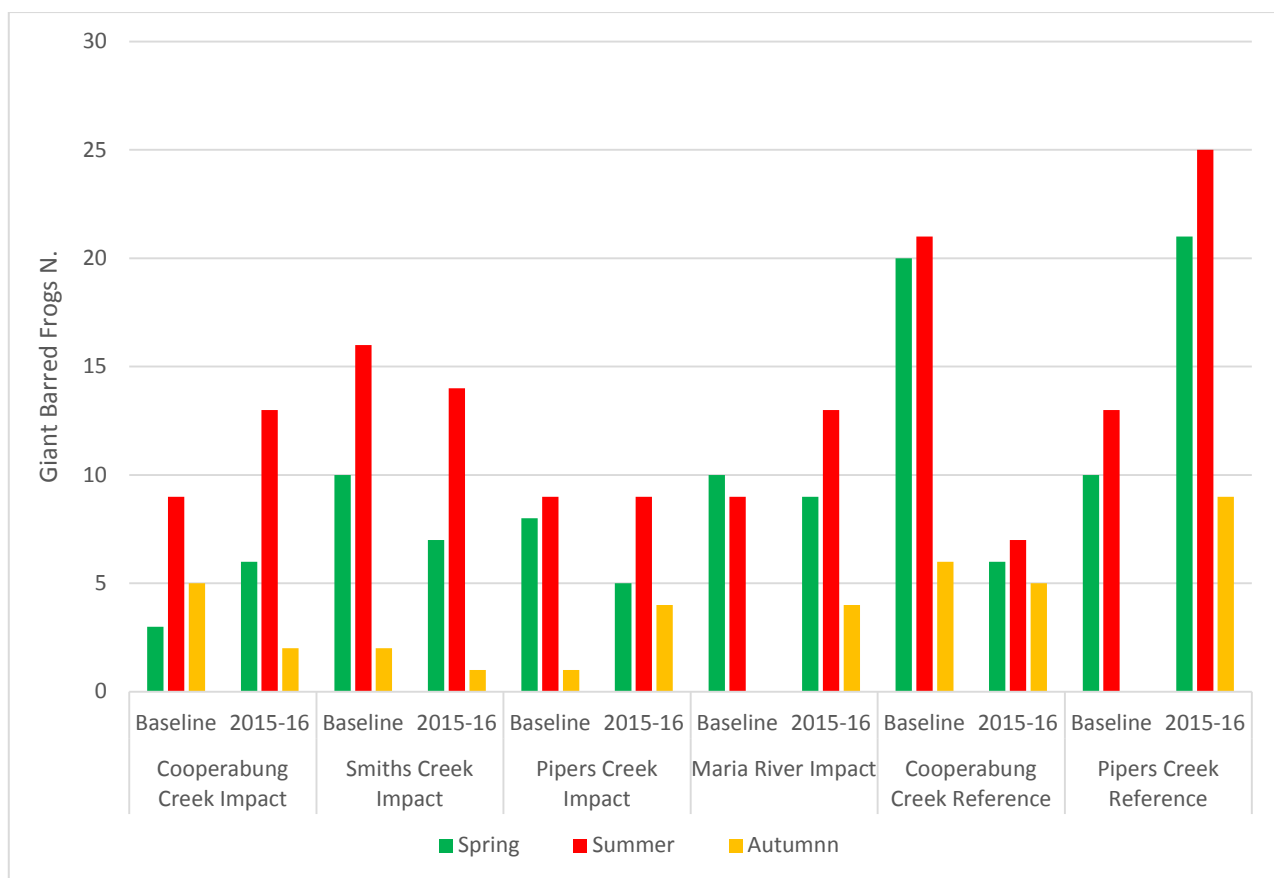
Graph 1 Giant Barred Frogs recorded/captured, baseline vs. 2015/2016

Notably, within these results was the distribution of records for the three categories of frogs. Females were readily detected in all three seasons, whereas male frogs were predominantly recorded in summer and juveniles mainly in autumn. This suggests differences in catchability of the sexes and age groups, depending on the season of the surveys. This does have a significant influence on recapture rates if males are only easily captured in the summer sampling period. Given the very limited number of recaptures for females, it also suggests that individuals are not active every night, and perhaps many nights, or different individuals are active at different times of the year.

MKTBA for the baseline survey and 2015/2016 surveys are relatively similar for the impact sites, with two sites having an increase in numbers, one a decrease and the other no change. The reference sites

presented opposite results to each other with the Cooperabung Creek reference MKTBA decreasing between baseline and 2015/2016, whereas at the Pipers Creek reference site the MKTBA increased.

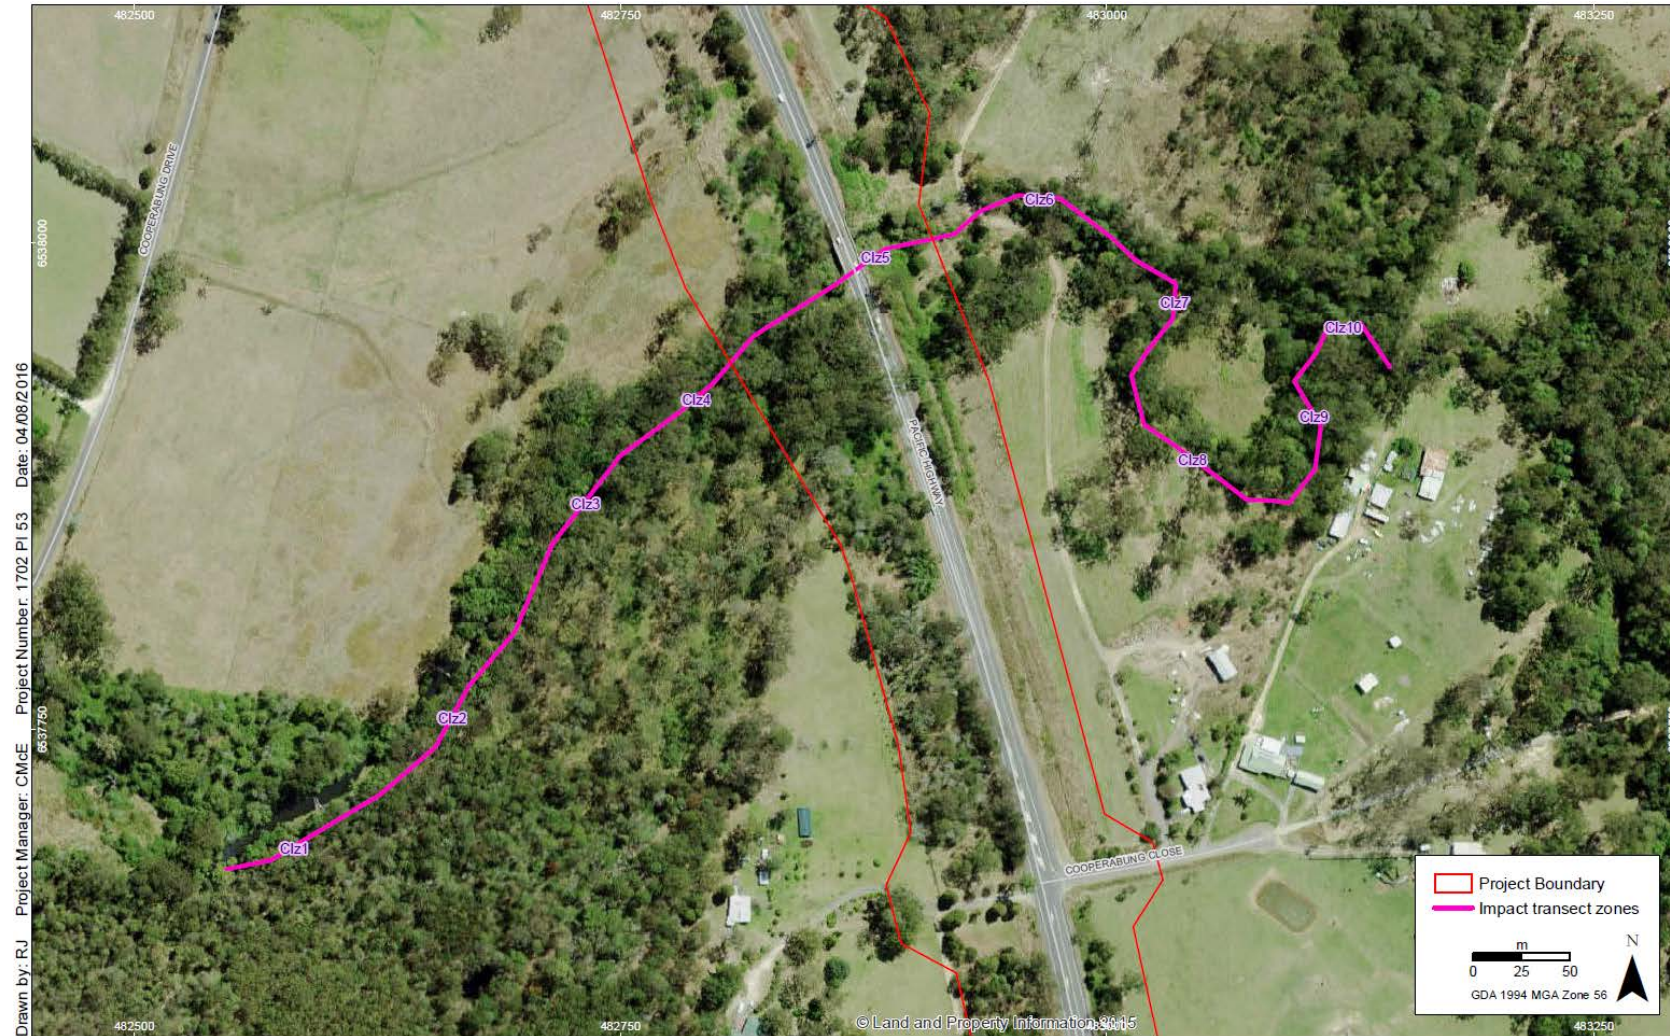
FIGURE 2

Figure 2. Giant Barred Frog 2015 - 2016 monitoring: Cooperabung Creek Impact site

Giant Barred Frog 2015 - 2016 monitoring: Cooperabung Creek Impact site
Pacific Highway Upgrade - Oxley Highway to Kempsey

The locations of all monitoring sites are shown on Figure 1 **Error! Reference source not found.**, with detailed locations for each site transect provided from Figure 2 to Figure 7.

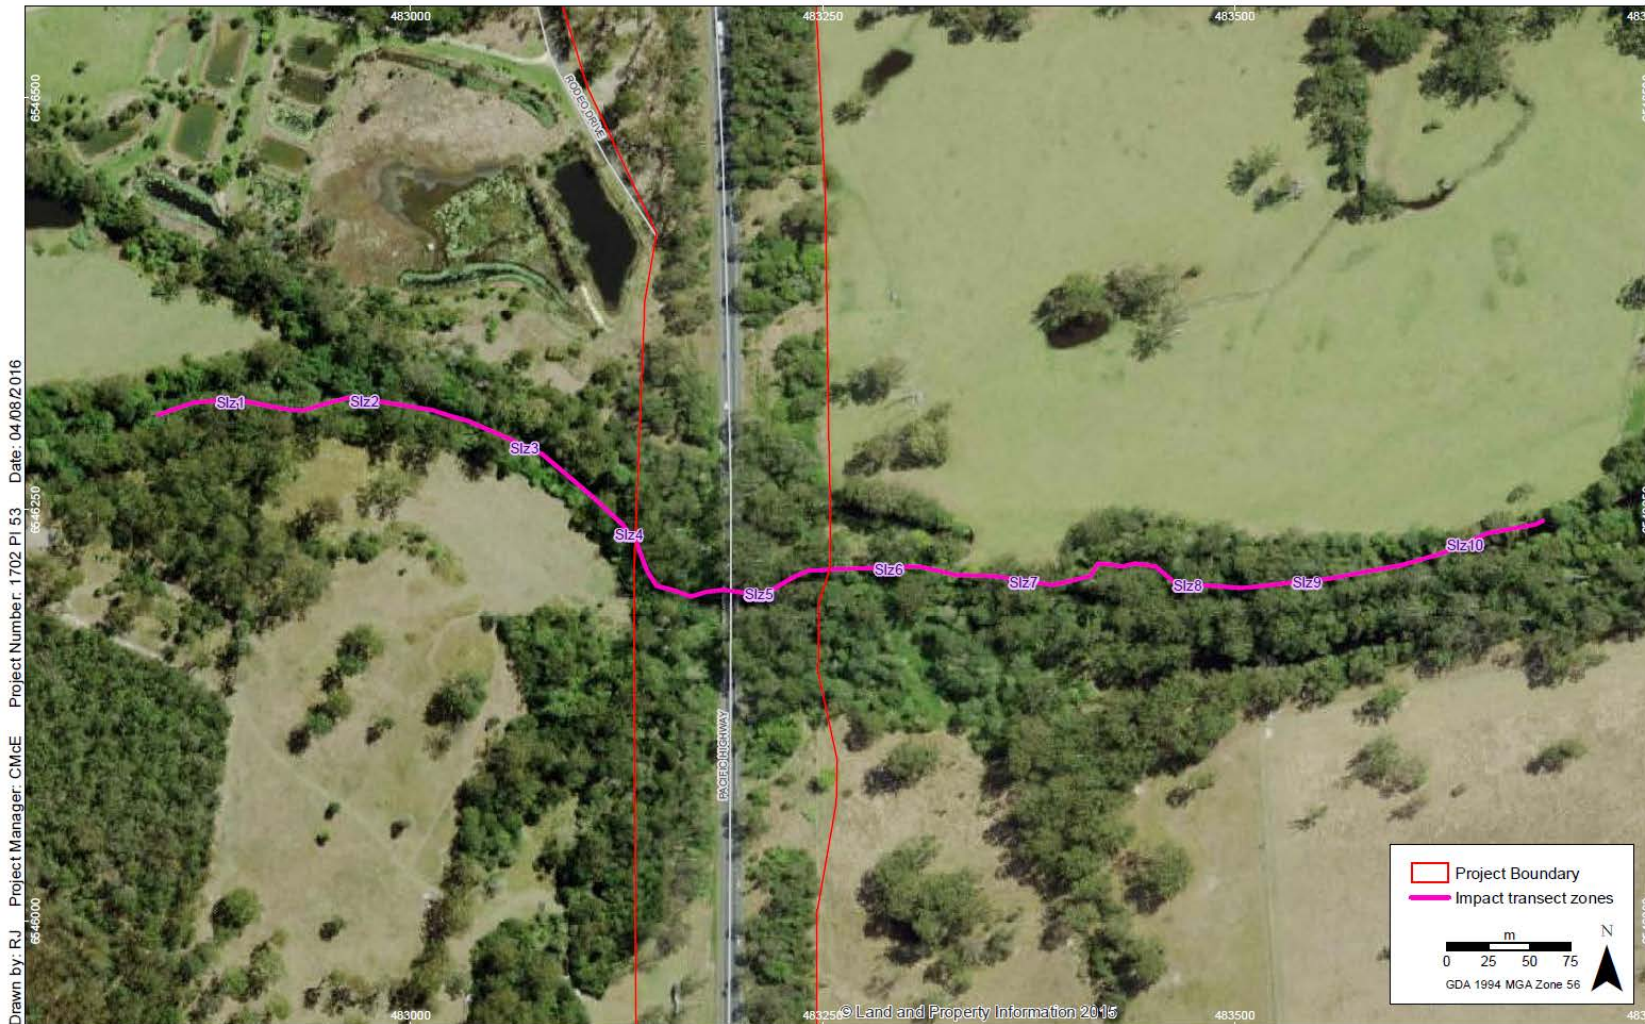
FIGURE 3

Figure 3. Giant Barred Frog 2015 - 2016 monitoring: Smiths Creek Impact site

Giant Barred Frog 2015 - 2016 monitoring: Smiths Creek Impact site
Pacific Highway Upgrade - Oxley Highway to Kempsey

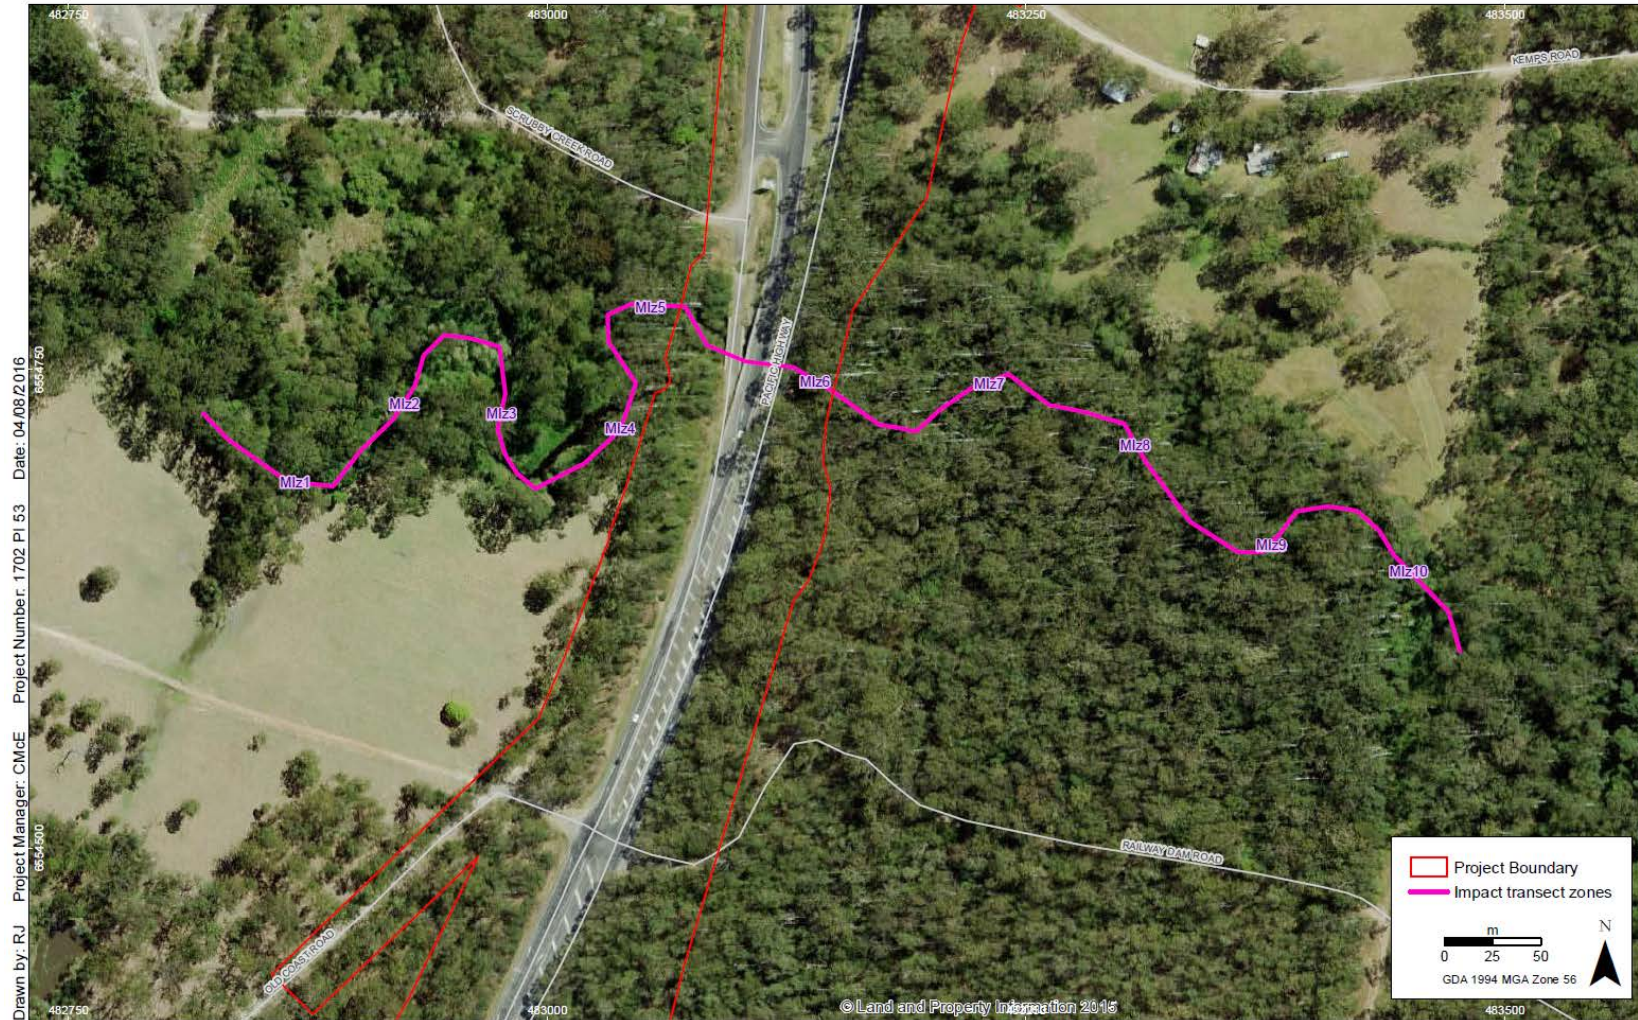
FIGURE 5

Figure 5. Giant Barred Frog 2015 - 2016 monitoring: Maria River Impact site

Giant Barred Frog 2015 - 2016 monitoring: Maria River Impact Site
Pacific Highway Upgrade - Oxley Highway to Kempsey

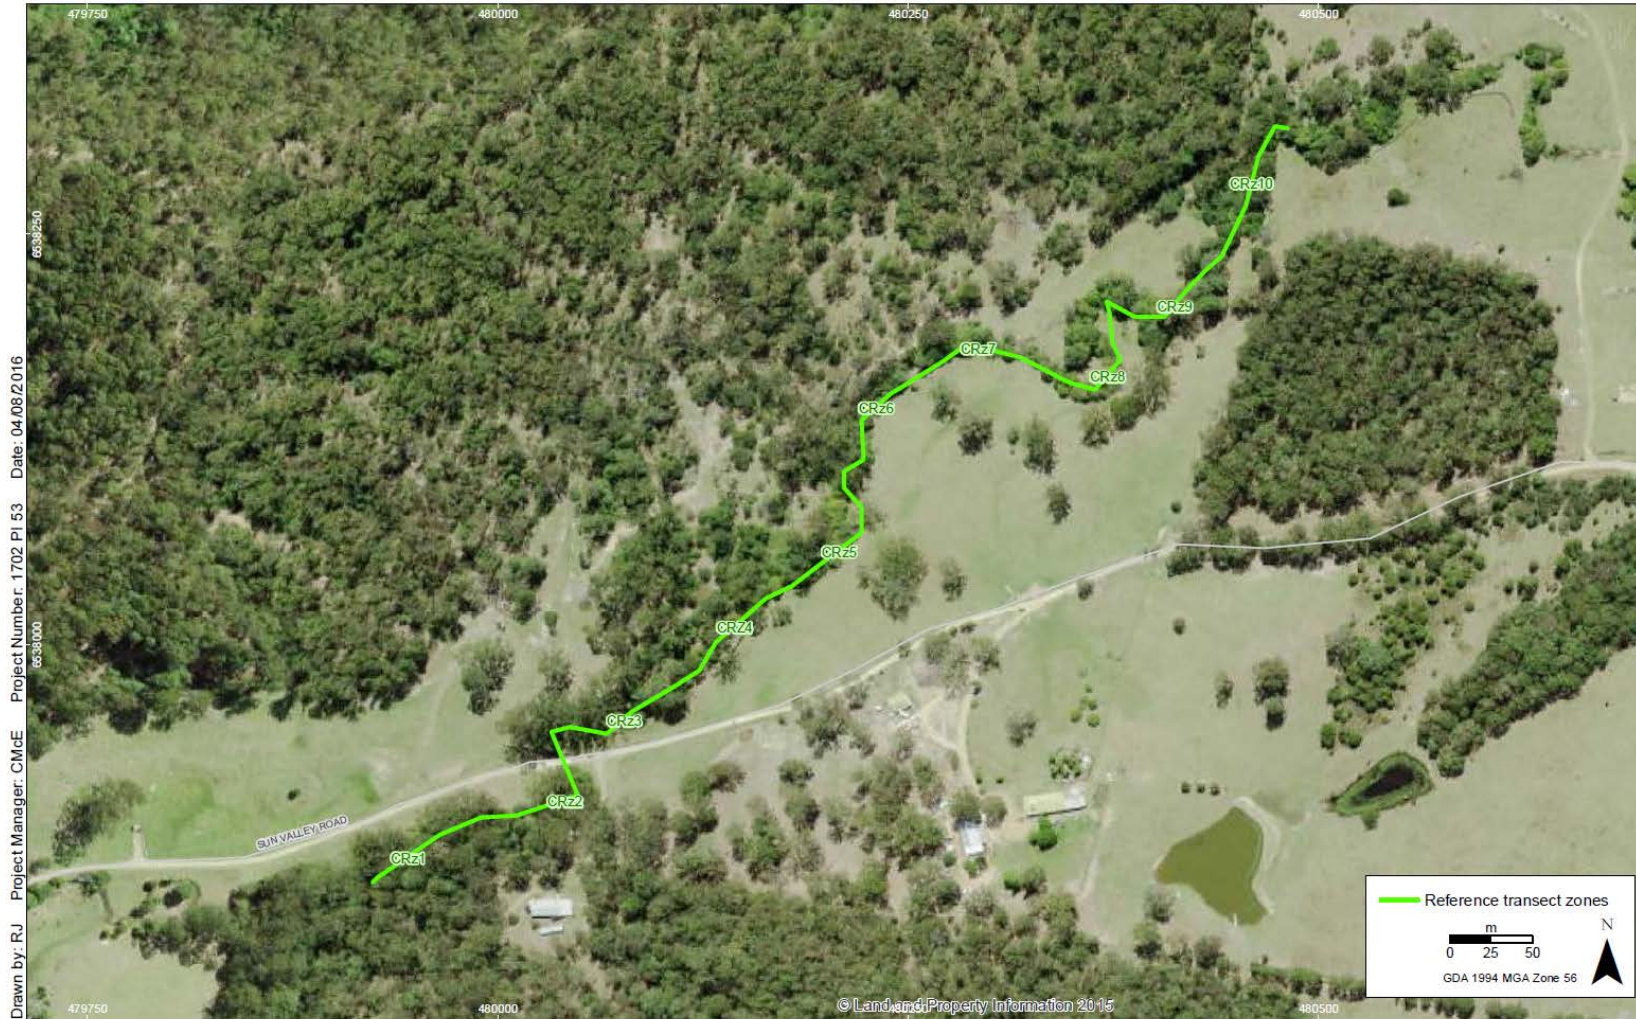
FIGURE 6

Figure 6. Giant Barred Frog 2015 - 2016 monitoring: Cooperabung Creek Reference site

Giant Barred Frog 2015 - 2016 monitoring: Cooperabung Creek Reference Site
Pacific Highway Upgrade - Oxley Highway to Kempsey

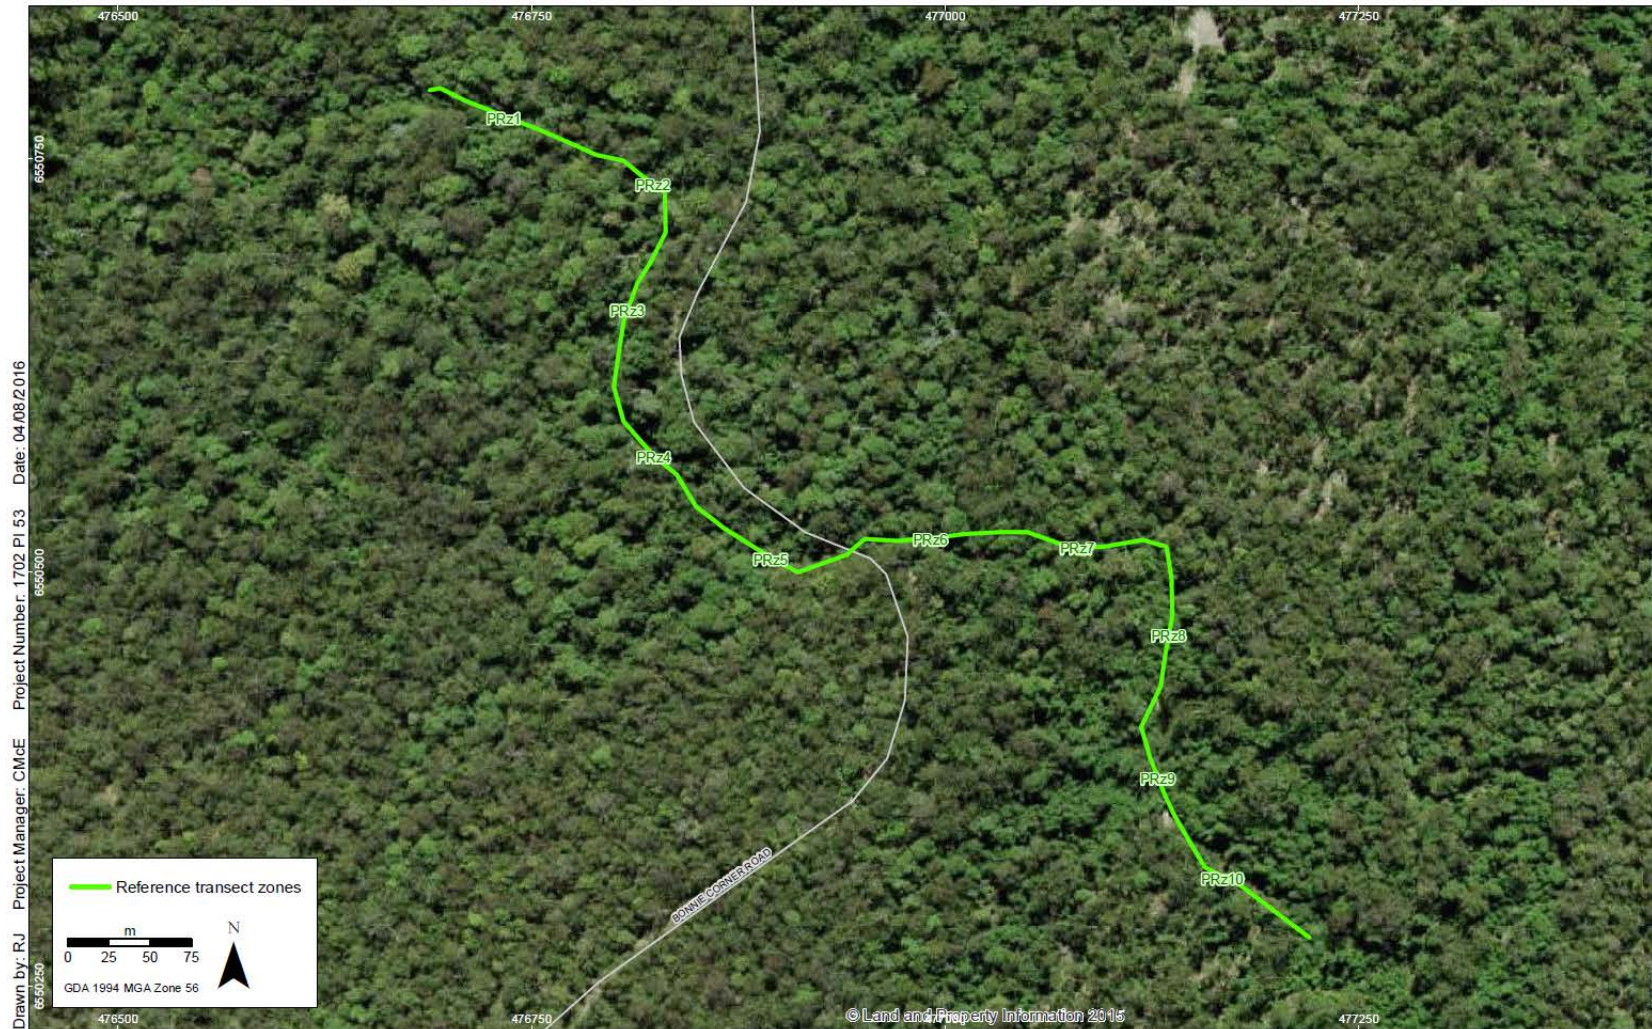
Figure 7. Giant Barred Frog 2015 - 2016 monitoring: Pipers Creek Reference site

Giant Barred Frog 2015 - 2016 monitoring: Pipers Creek Reference Site
Pacific Highway Upgrade - Oxley Highway to Kempsey

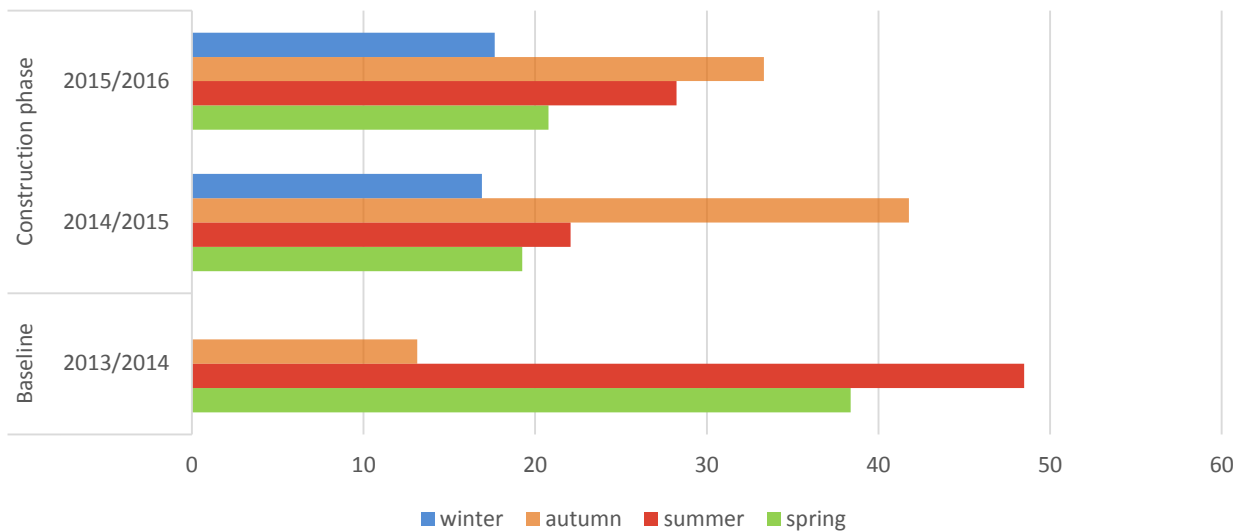
Graph 1: Percentages of road kill records, according to seasons, during baseline and two first years of construction phase (2014/2015 and 2015/2016)

During the baseline monitoring, the lowest number of road kill was recorded in autumn (13% of observed road kills) while in both construction phases, autumn was the season with the highest number (41.9% in 2014/2015 and 33.3% in 2015/2016 of the road kill), indicating little pattern in road kill results in relation to season (Graph 1).

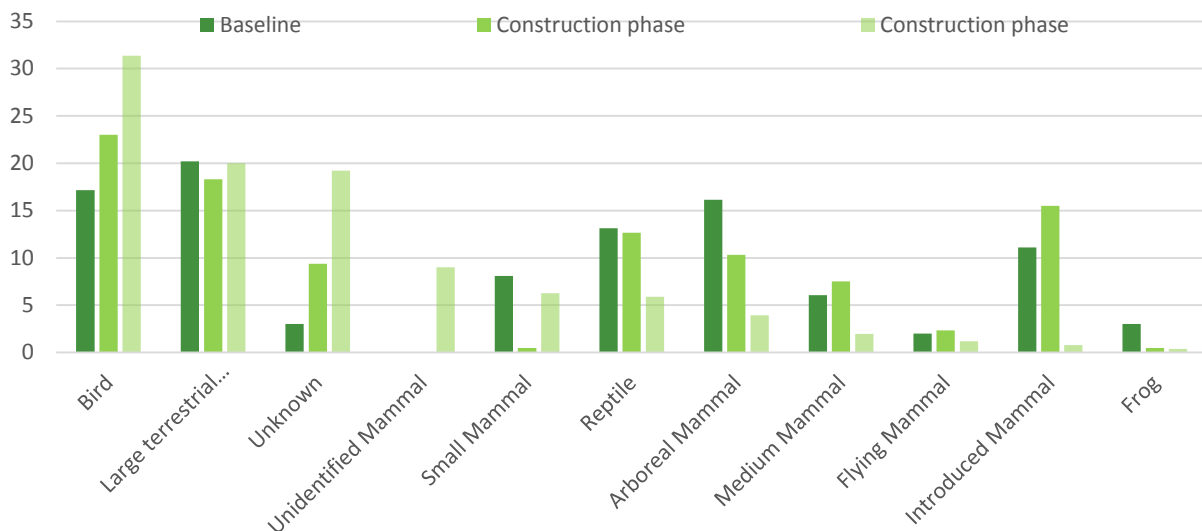
Graph 2: Percentage of road kill records, according to fauna categories, during baseline and two first years of construction phase (2014/2015 and 2015/2016)

In both years of the construction phase, birds were the fauna category with the highest number of road kill followed by large terrestrial mammals. The number of “unknown” and unidentified mammals was much greater in the most recent round of surveys compared to the previous two years, but reptile, arboreal mammals, medium mammals and introduced mammals has decreased compared to the previous two years (Graph 2). There has been a general overall decline in road kill over the three periods of survey to date.

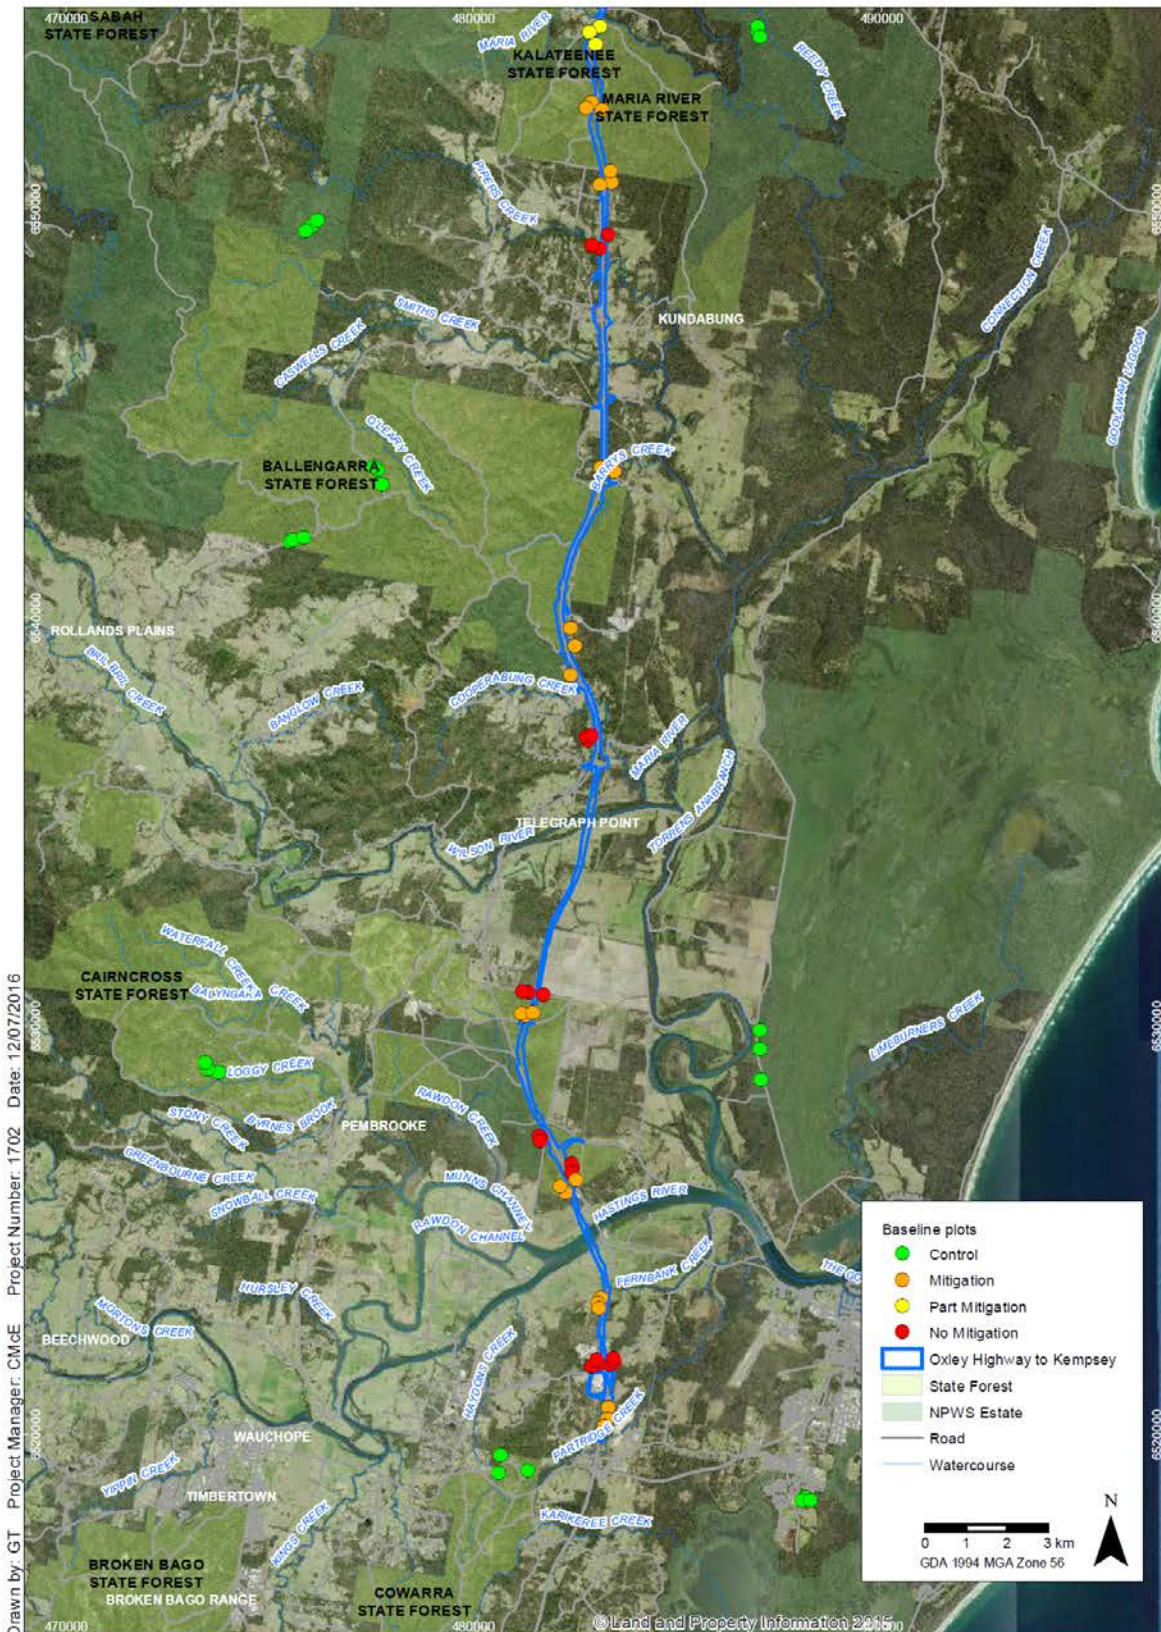
FIGURE 1

Figure 1. Koala SAT plot locations 2015

Koala SAT plot locations 2015
Oxley Highway to Kempsey - PI 5.1 Koala report

Details of all the monitoring sites are presented in Table 2 and their locations in Figure 1.

A total of 93 SAT plots were surveyed across the eight areas (Figure 1). These plots included the location of 69 of the existing 72 baseline SAT plots established by Lewis (2014), with the additional 24 control plots selected by Niche during the first monitoring event (2015). Eight of the baseline plots had to be relocated to nearby locations because they had been established in the construction site itself or because they were located on private propriety and access was not possible. Three of the baseline monitoring plots that could not be accessed could not be relocated because there weren’t any suitable sites nearby. These three plots were all part of the same cluster (impact, no mitigation) located in the North Sancrox area.
