Oxley Highway to Kempsey EPBC 2012/6518 **Condition 8 Annual Report**

File name	16 0822 OH2K DoTE CoA 8 Annual Report July 2015 - July 2016
Report name	Oxley Highway to Kempsey EPBC 2012/6518 Condition of Approval 8 Annual Report 22 July 2015 – 21 July 2016
Revision number	2

This report covers the second period from 22 July 2015 to 21 July 2016.

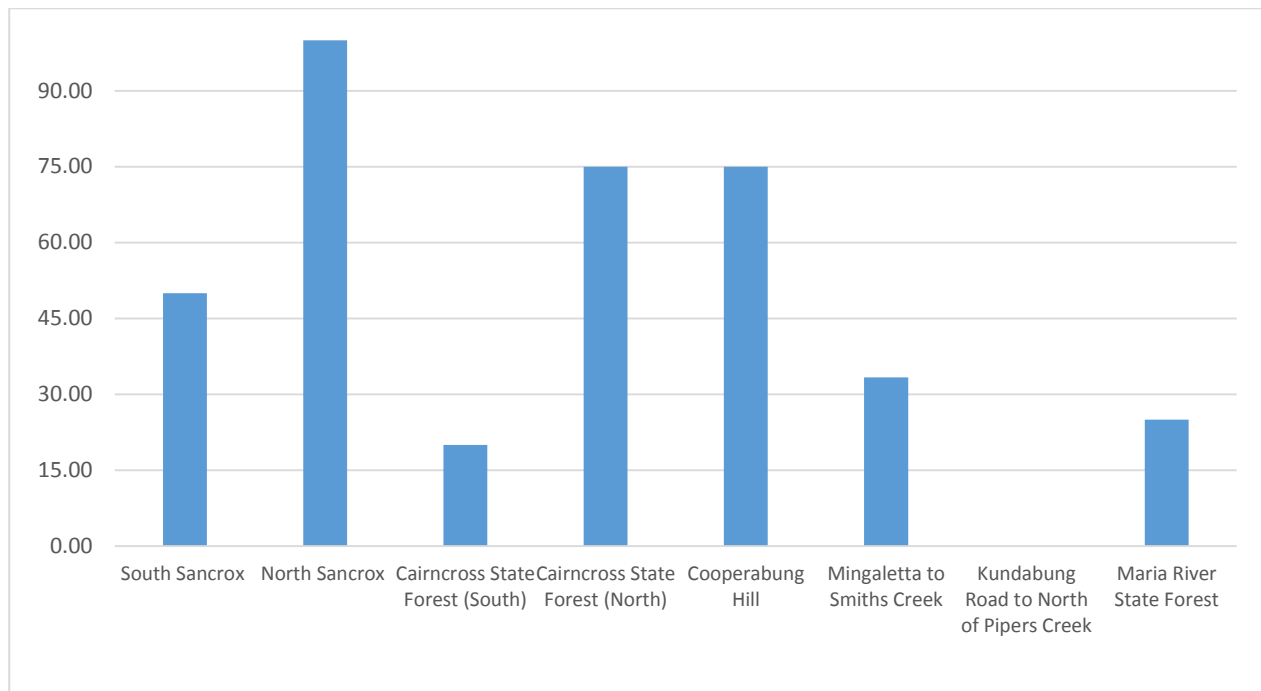
Graph 1. Percentage of clusters with Koala present by area

No Koala scats were recorded in any of the four clusters surveyed in the Kundabung Road to north Pipers Creek area (Graph 1).

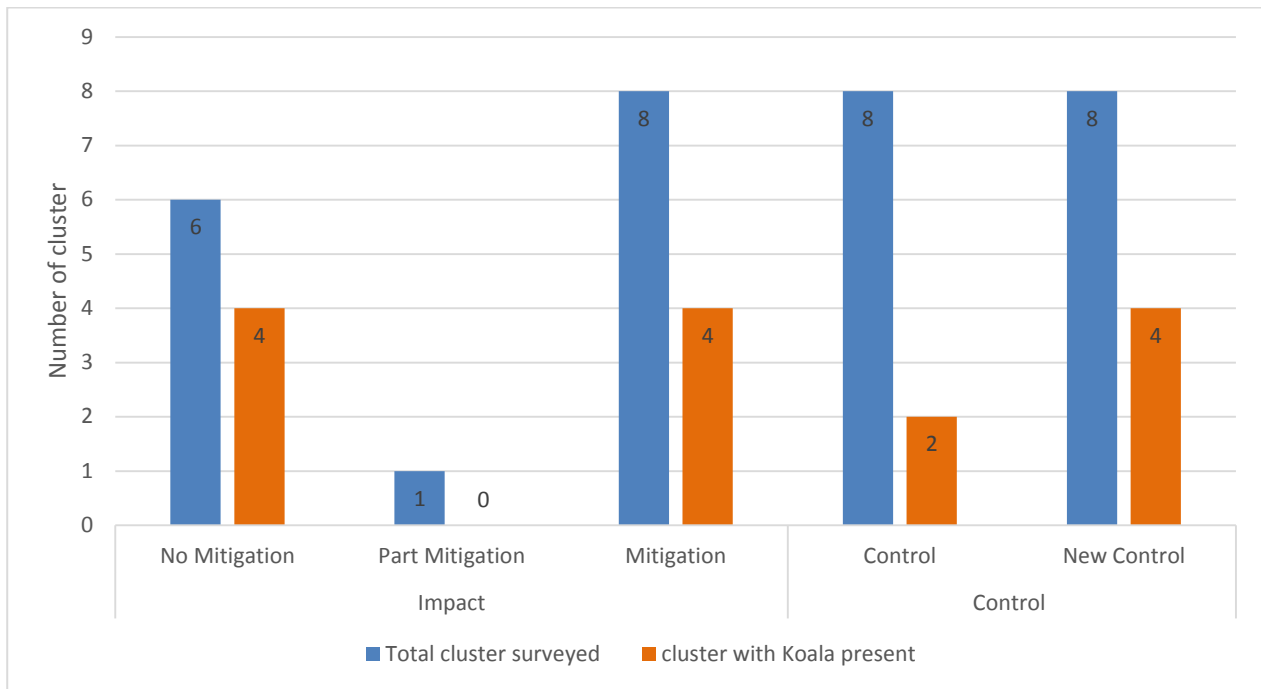
Graph 2. Koala present per treatment classes

At a treatment level, Koala was present at 53.3% of impact clusters (8/15), but only 37.5% of control clusters (6/16).

Of the impact cluster 4/6 were No Mitigation, 0/1 Part Mitigation and 4/8 Mitigation had Koala present. Of the control clusters with Koala present 2/8 were Control, while 4/8 were new Control (Graph 2). In proportion to the number of clusters investigated per treatment class, the highest Koala presence was recorded in the No Mitigation class (66.7%) ,followed by Mitigation and New Control (50% each), and Control (25%). No Koalas were recorded in the Part Mitigation cluster.

If we compare the Koala presence/absence results between control and impact clusters using a chi-Square test there is no significant difference ($p < 0.05$). The chi-square statistic is 0.7837 and the p -value is 0.376017.

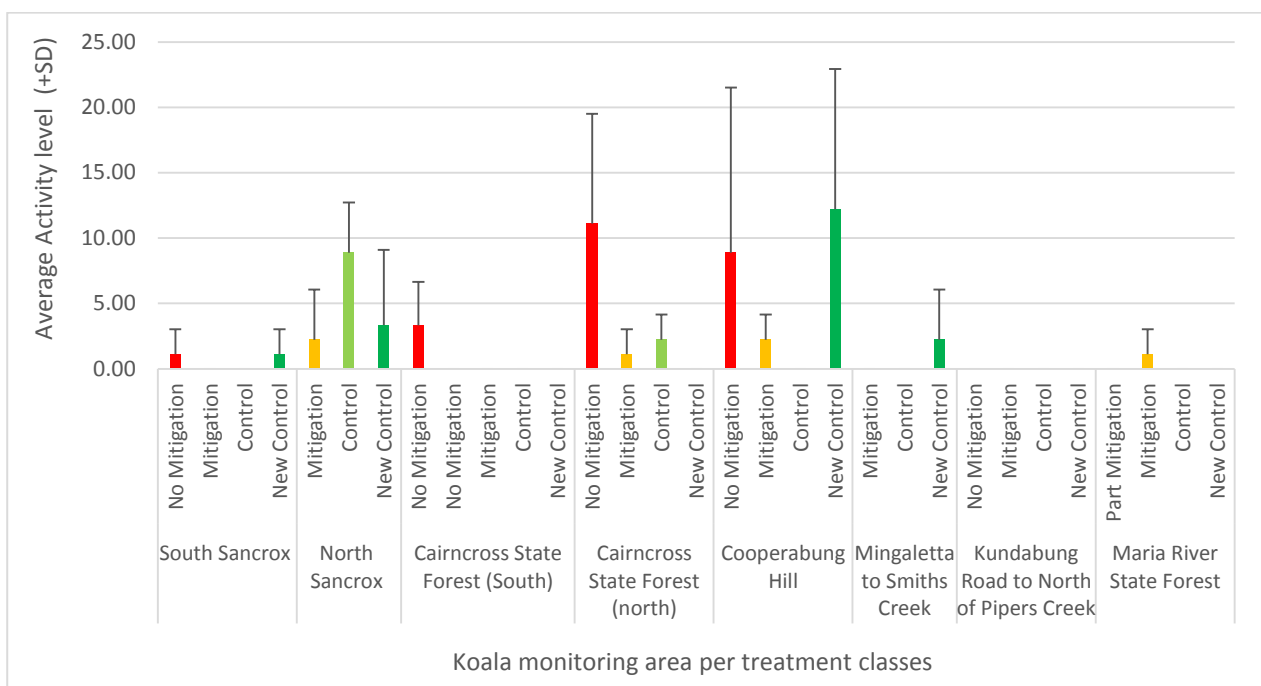
Graph 3. Koala activity level per area and treatment classes

For coherence with the baseline surveys, the 2015 monitoring results are presented per koala activity level by treatment class, and by the eight broad areas as identified during the baseline survey (see Graph 3).
