Oxley Highway to Kempsey EPBC 2012/6518  
**Condition 8 Annual Report  
2017**

File name	16 0919 OH2K DoTEE CoA 8 Annual Report July 2016 - July 2017
Report name	Oxley Highway to Kempsey EPBC 2012/6518 Condition of Approval 8 Annual Report 22 July 2016 – 21 July 2017
Revision number	1

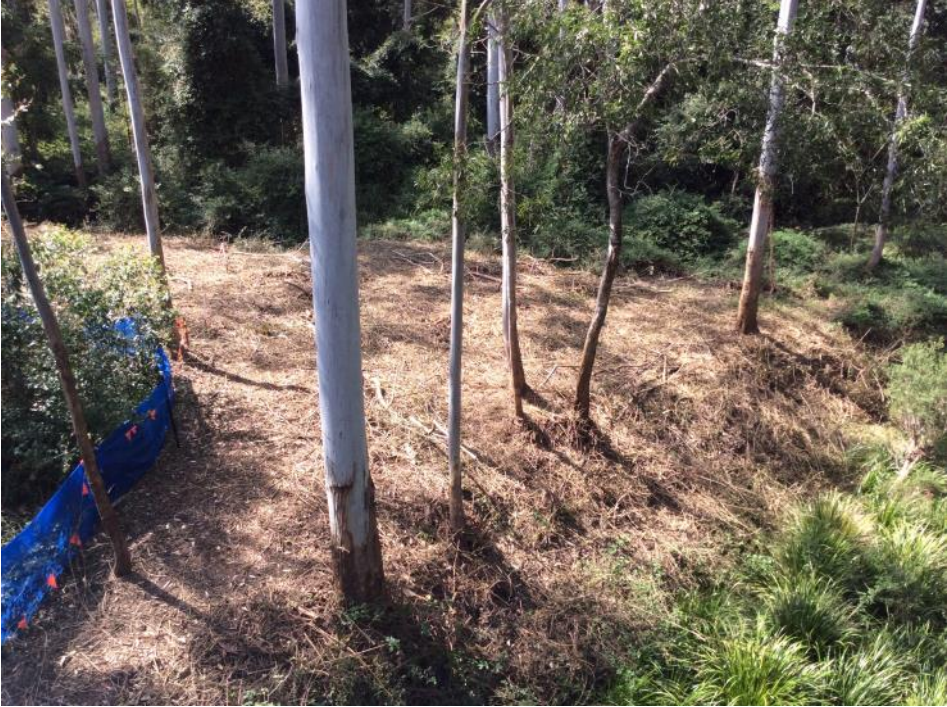
#	Description	Image
<b>Stage 2</b>		
1	Lantana removal at Maria River

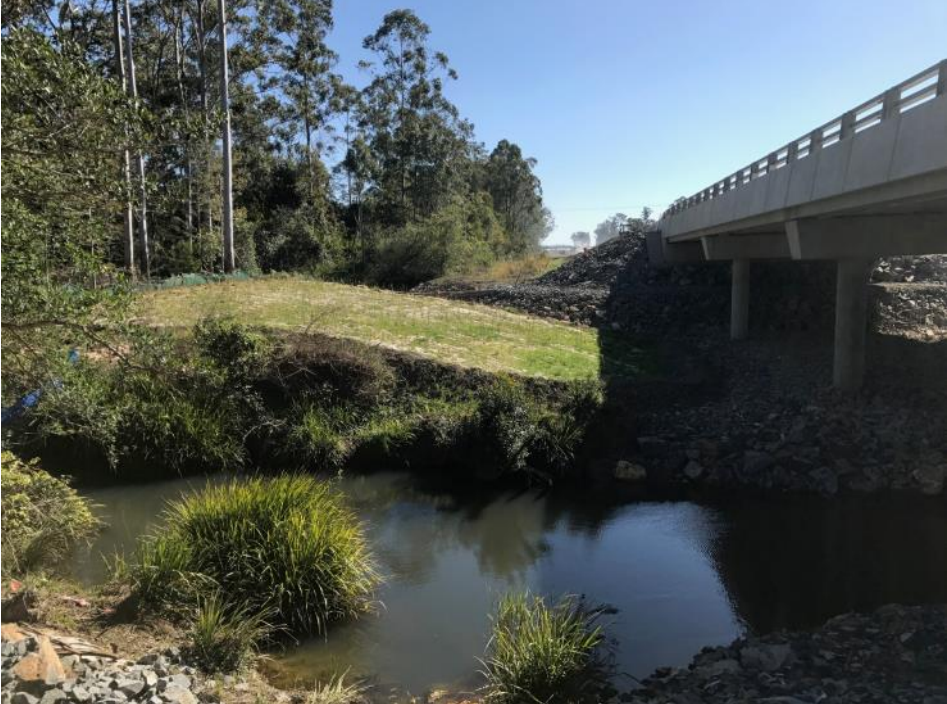
2	Revegetation planting at Smiths Creek

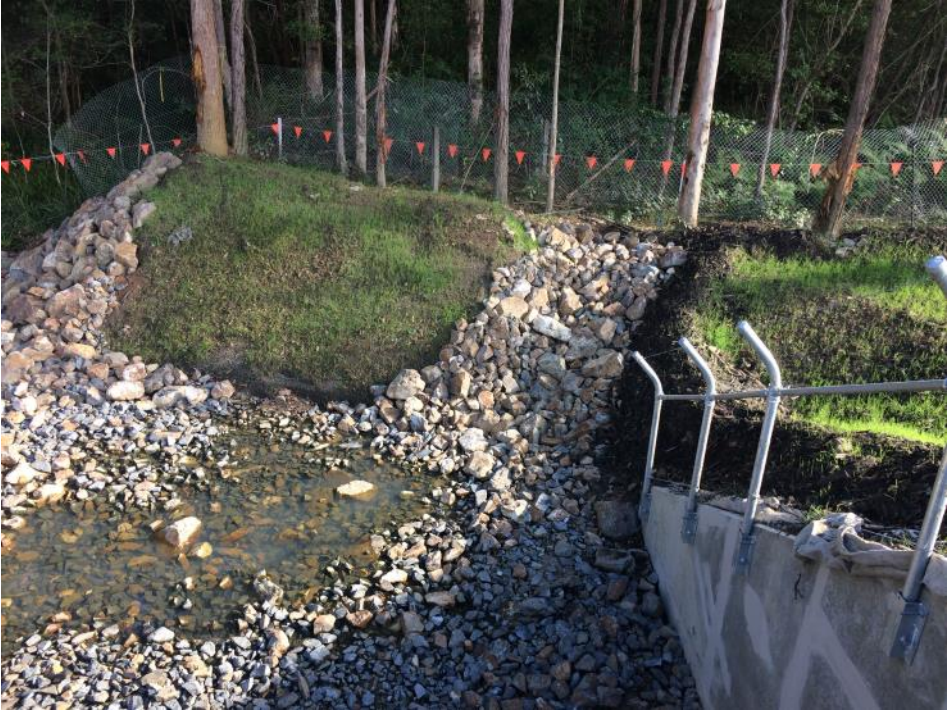
#	Description	Image
3	<p>Permanent scour protection works at a culvert inlet and on drains feeding into the culvert</p>

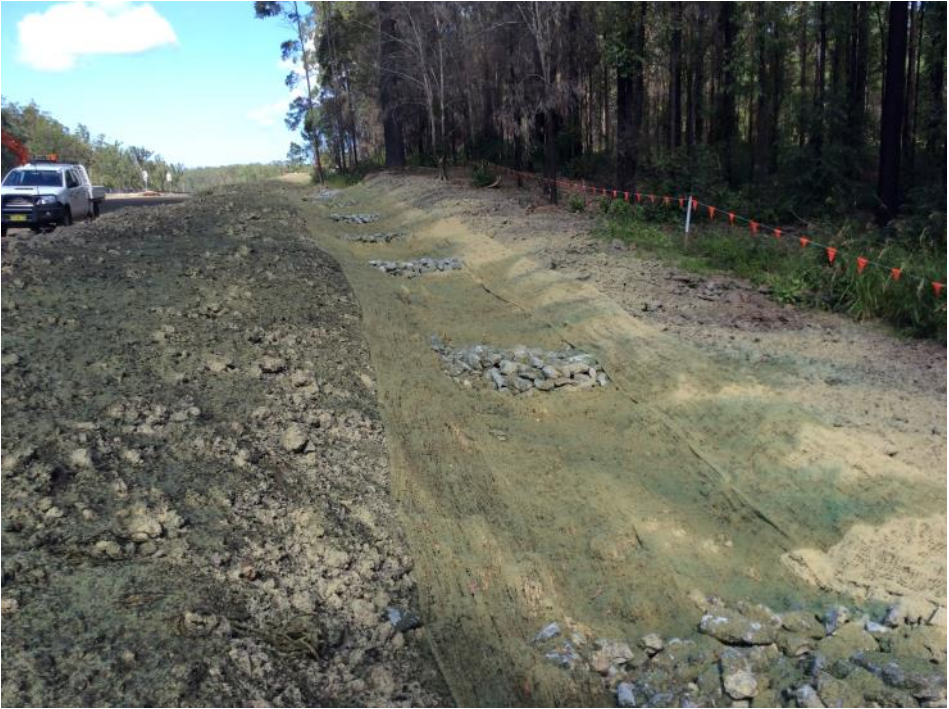
4	<p>Clean water drainage works stabilised with jute mesh, rock checks and hydromulch</p>

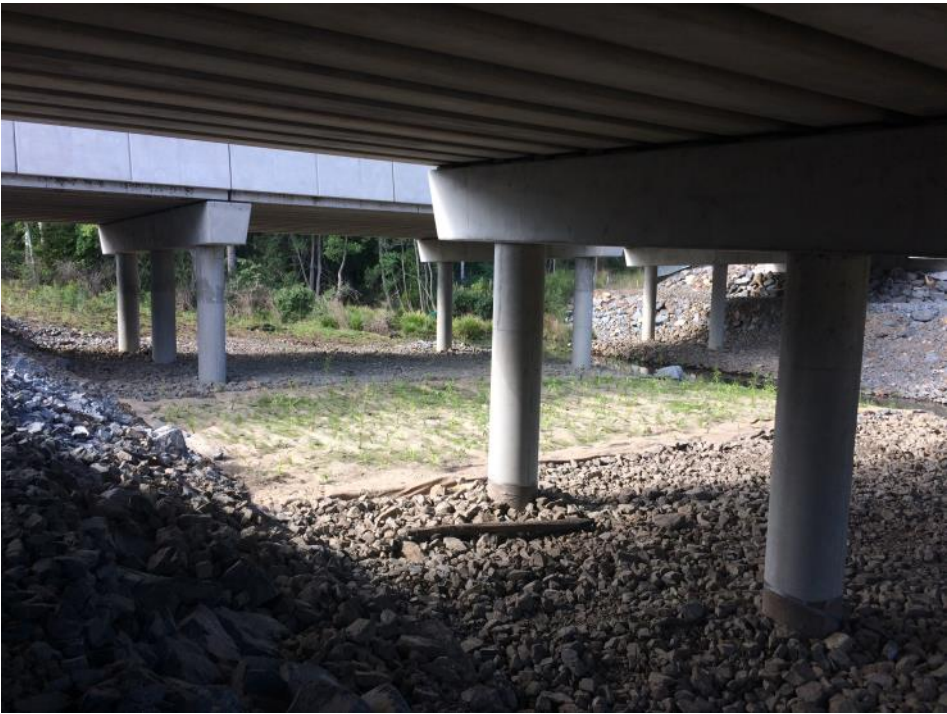
#	Description	Image
5	Completed works at Smiths Creek

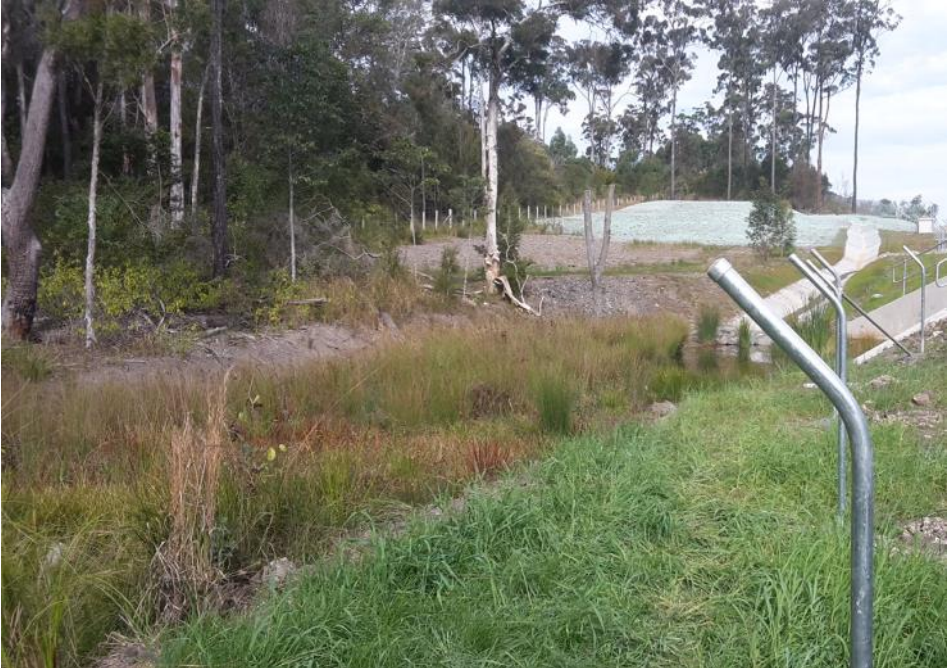
#	Description	Image
7	<p>Revegetation through tubestock planting (within the drain) and hydromulching in the background. This photo also shows the progressive installation of fauna fence</p>

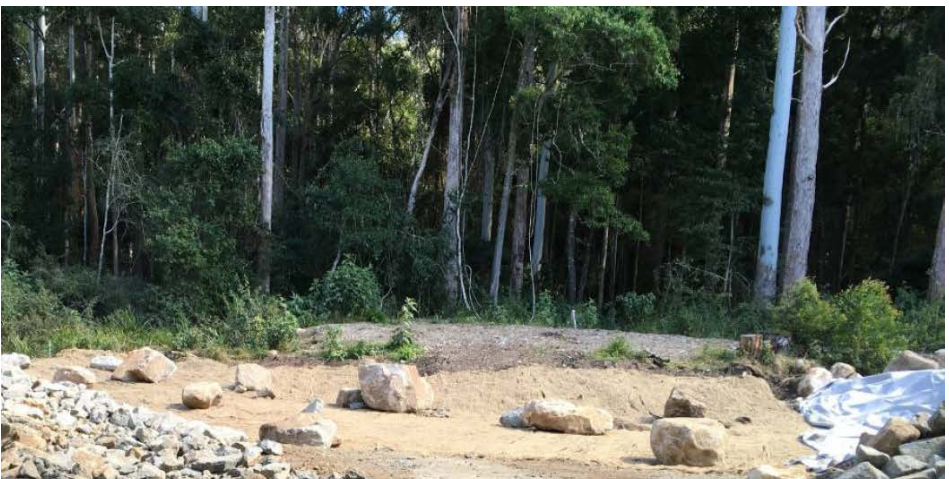
8	<p>Barrys Creek progressively rehabilitation (with jute mesh and seeding). Photo was taken within 24 hours of temporary crossing being removed and as such, the area has not yet been planted with tubestock.</p>

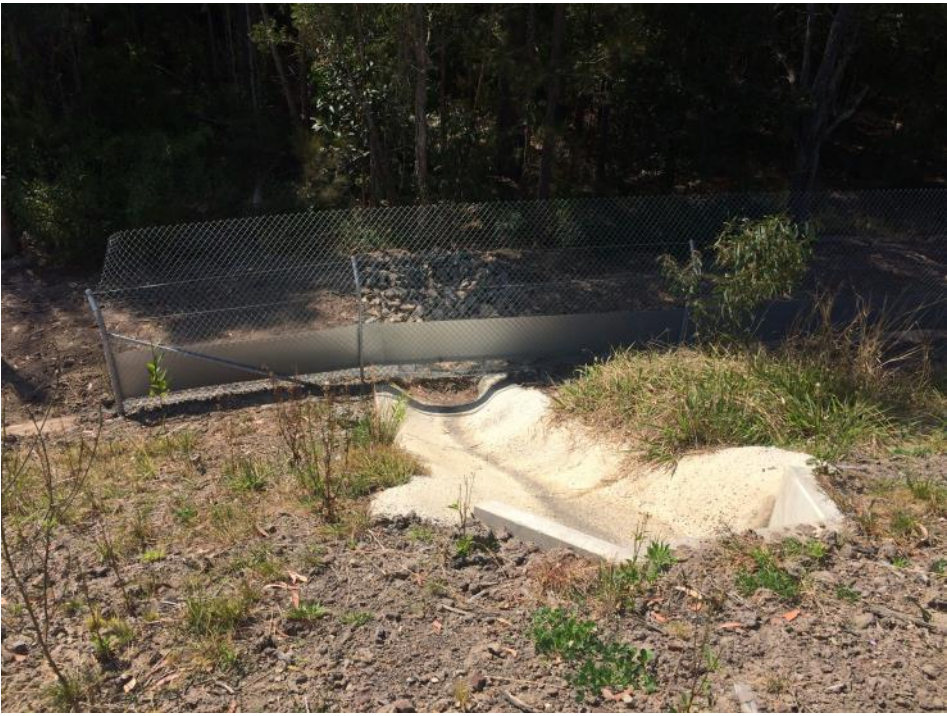
#	Description	Image
9	<p>Permanent drainage works that have been stabilised against erosion by appropriate selection of channel dimensions and lining, and the inclusion of an energy dissipater.</p>

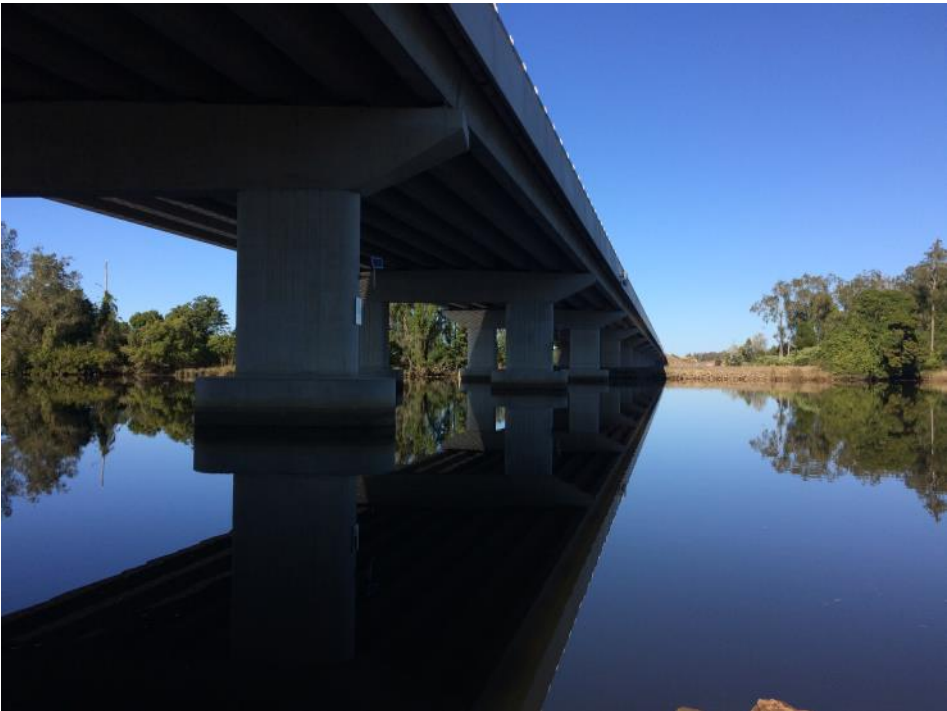
10	<p>The completed Wilson River bridge</p>

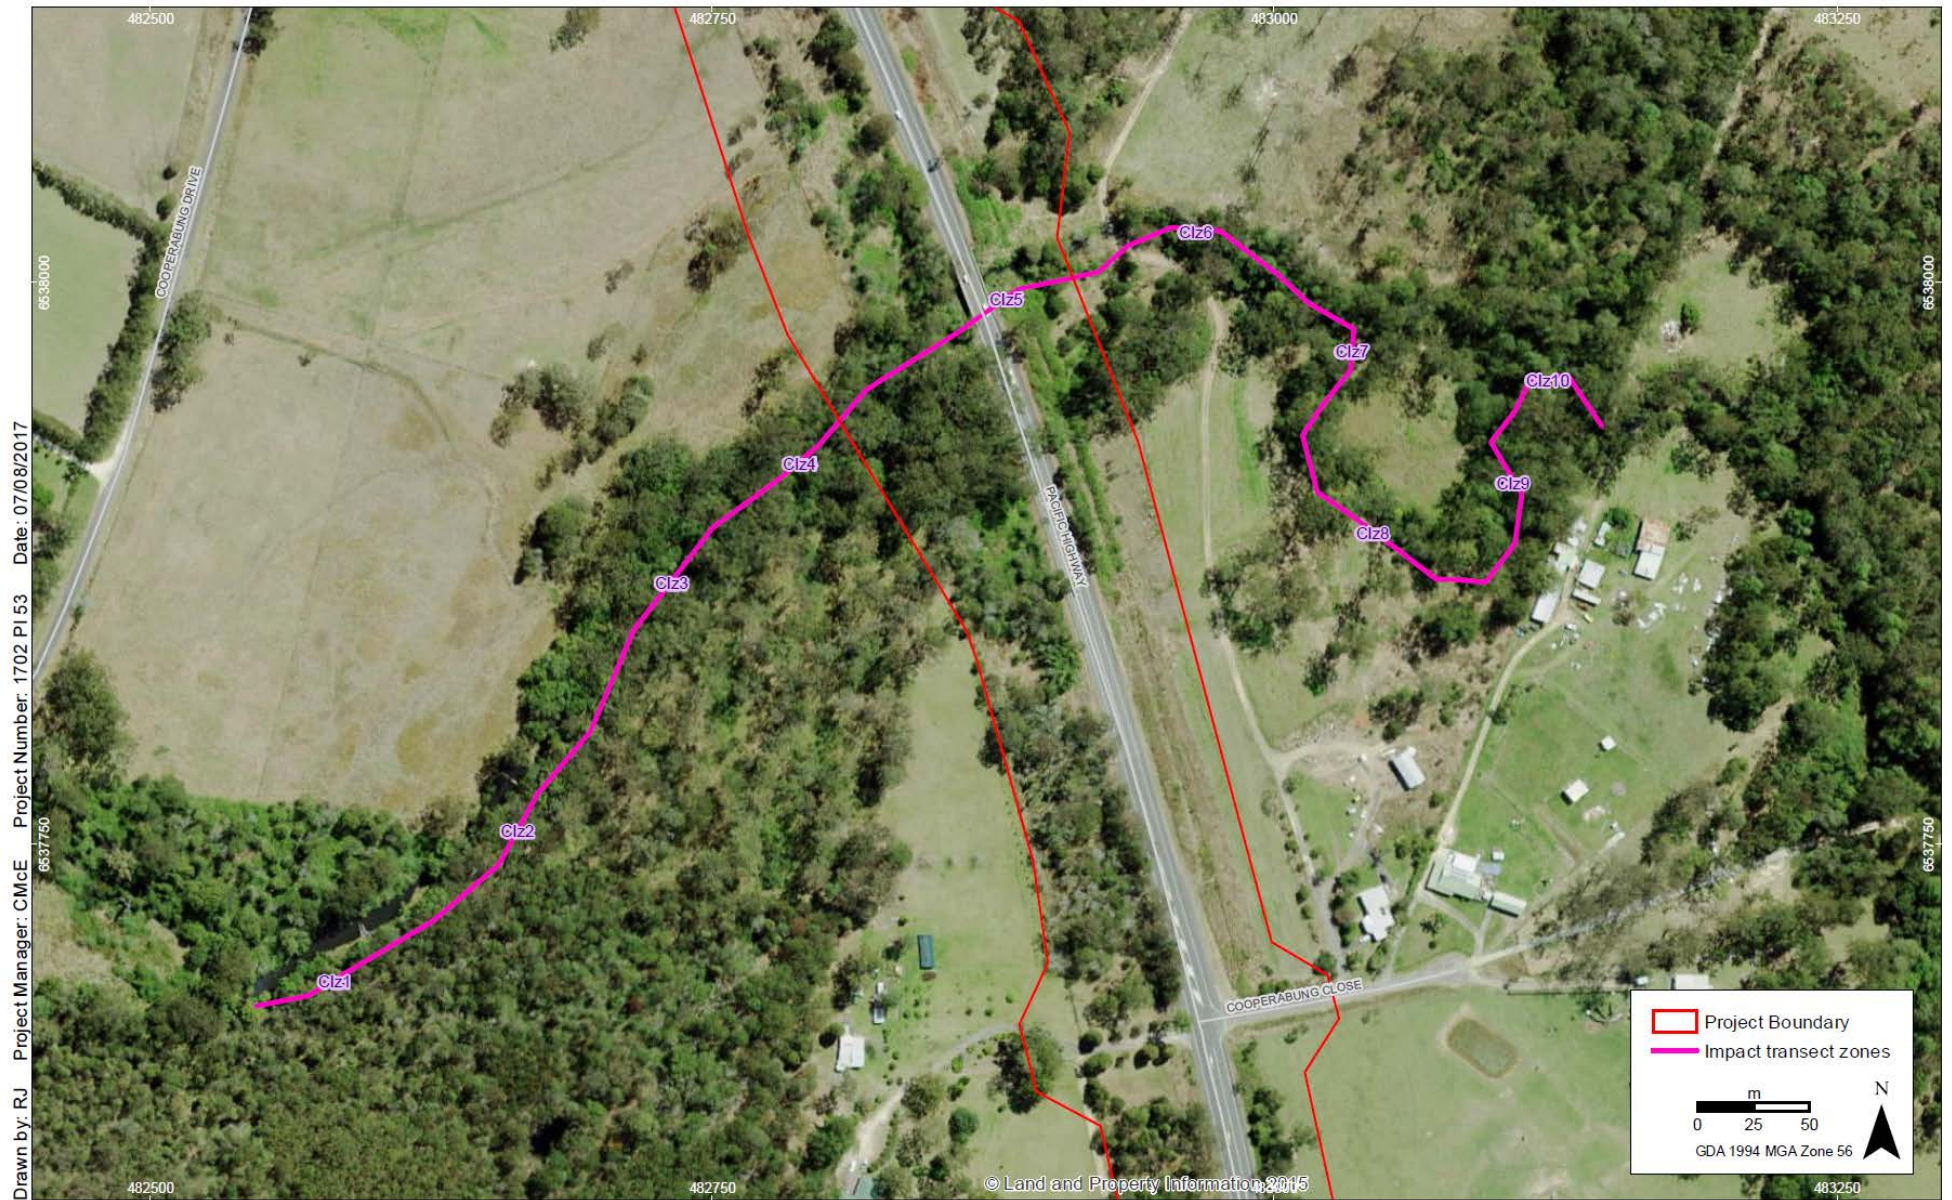
Giant Barred Frog 2016 - 2017 monitoring: sites overview  
Pacific Highway Upgrade - Oxley Highway to Kempsey

The locations of all monitoring sites are shown in Figure 1, with detailed locations for each site transect provided in Figure 2 to Figure 7.

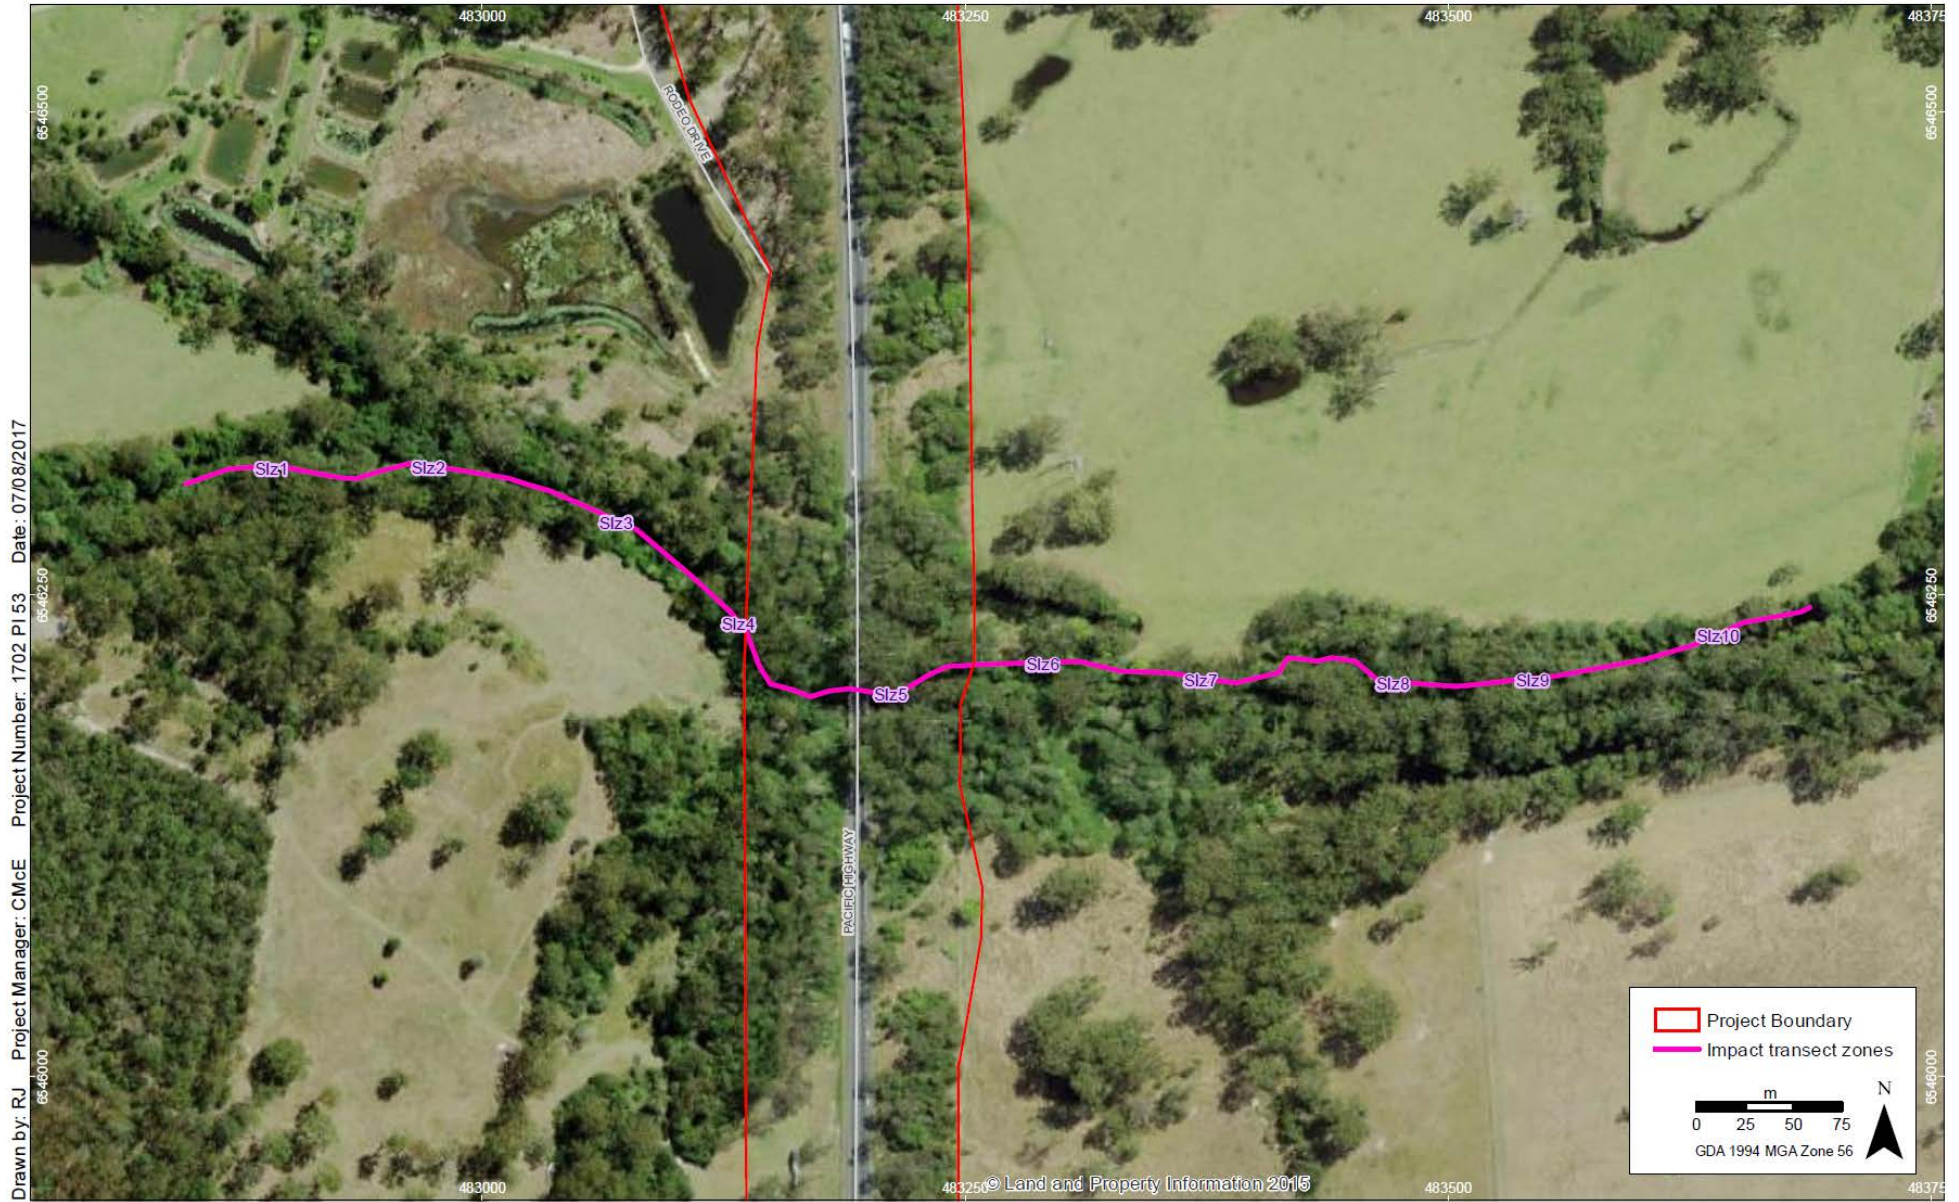
**FIGURE 2**

Giant Barred Frog 2016 - 2017 monitoring: Cooperabung Creek Impact site  
 Pacific Highway Upgrade - Oxley Highway to Kempsey

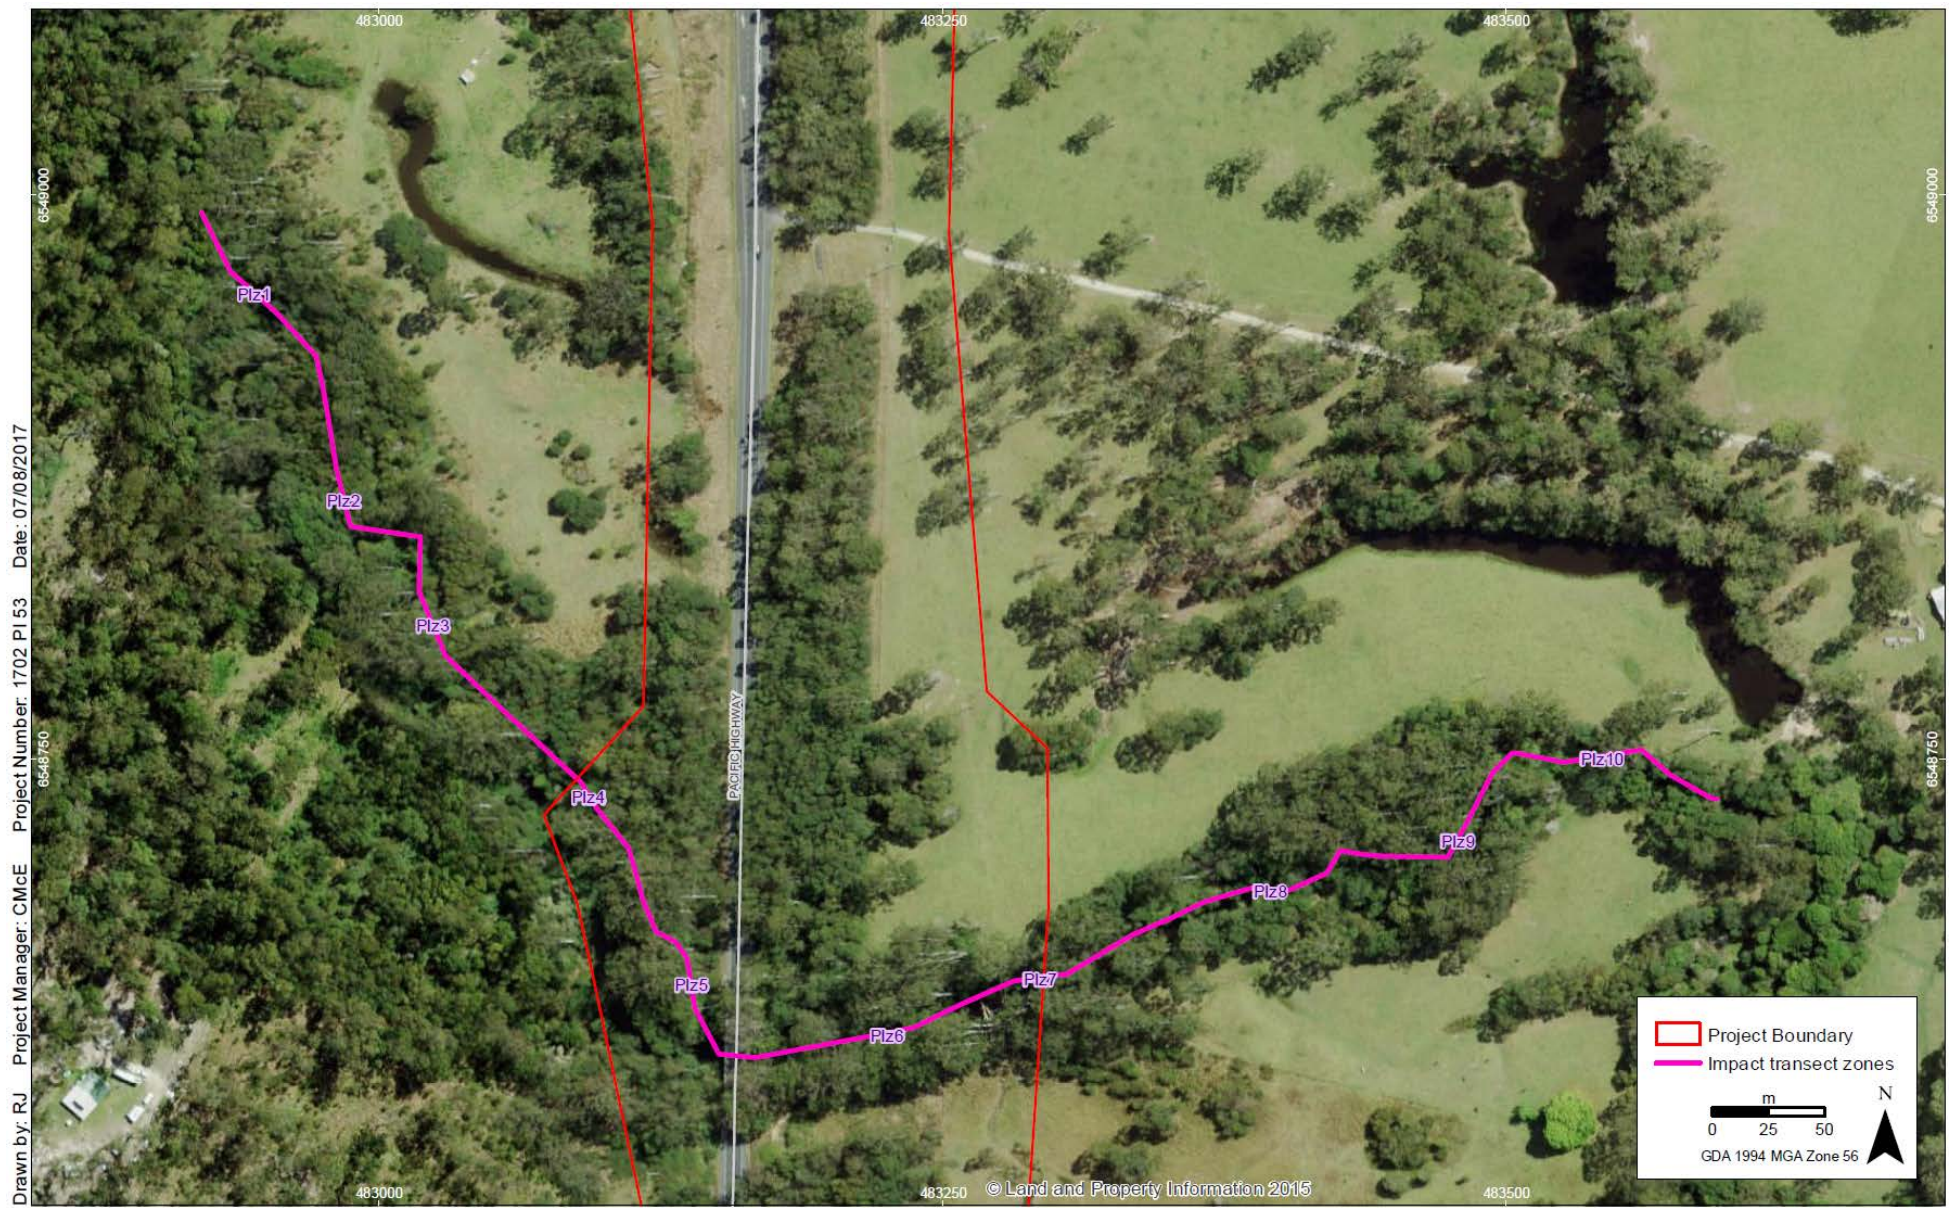
**FIGURE 3**

Giant Barred Frog 2016 - 2017 monitoring: Smiths Creek Impact site  
Pacific Highway Upgrade - Oxley Highway to Kempsey

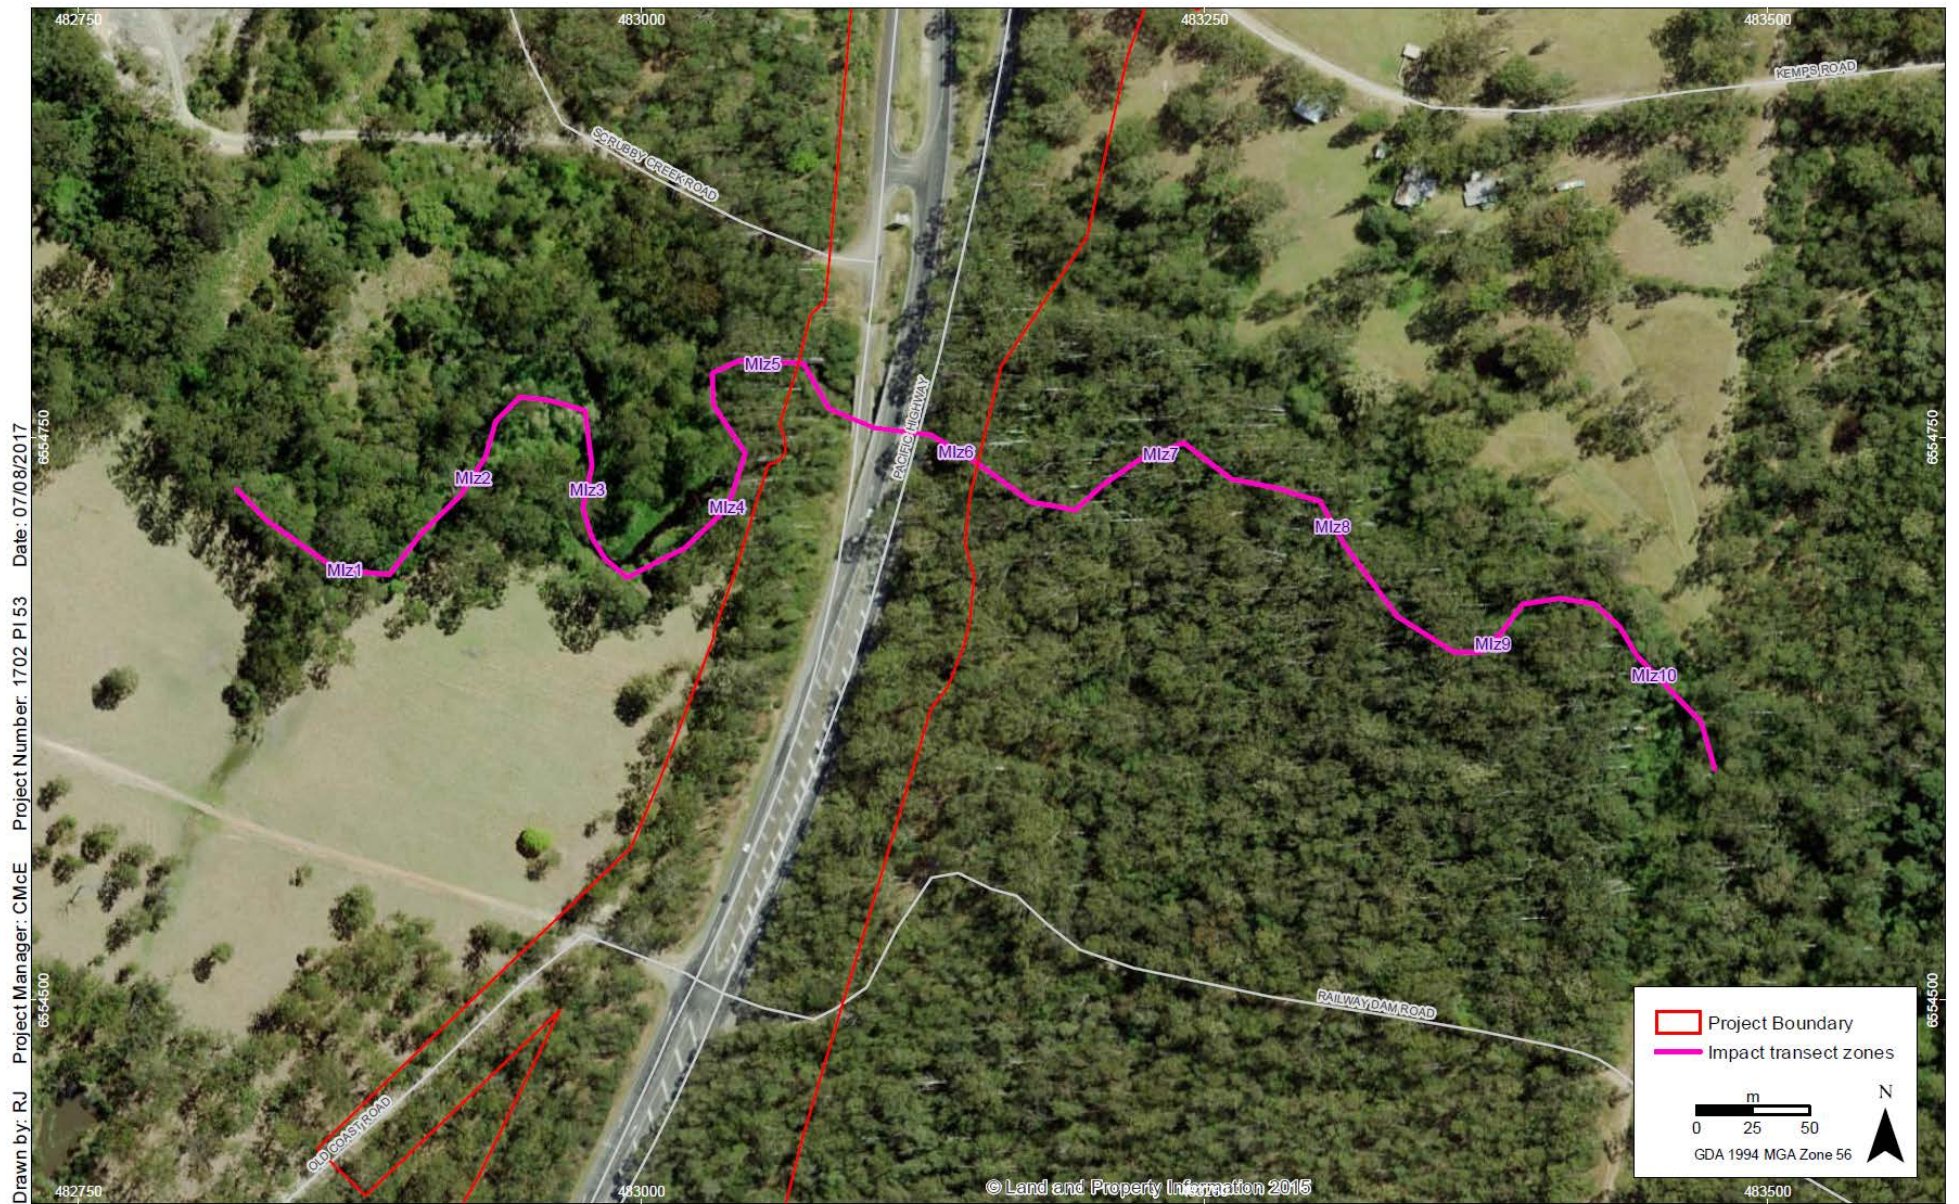
**FIGURE 4**

Giant Barred Frog 2016 - 2017 monitoring: Pipers Creek Impact site  
 Pacific Highway Upgrade - Oxley Highway to Kempsey

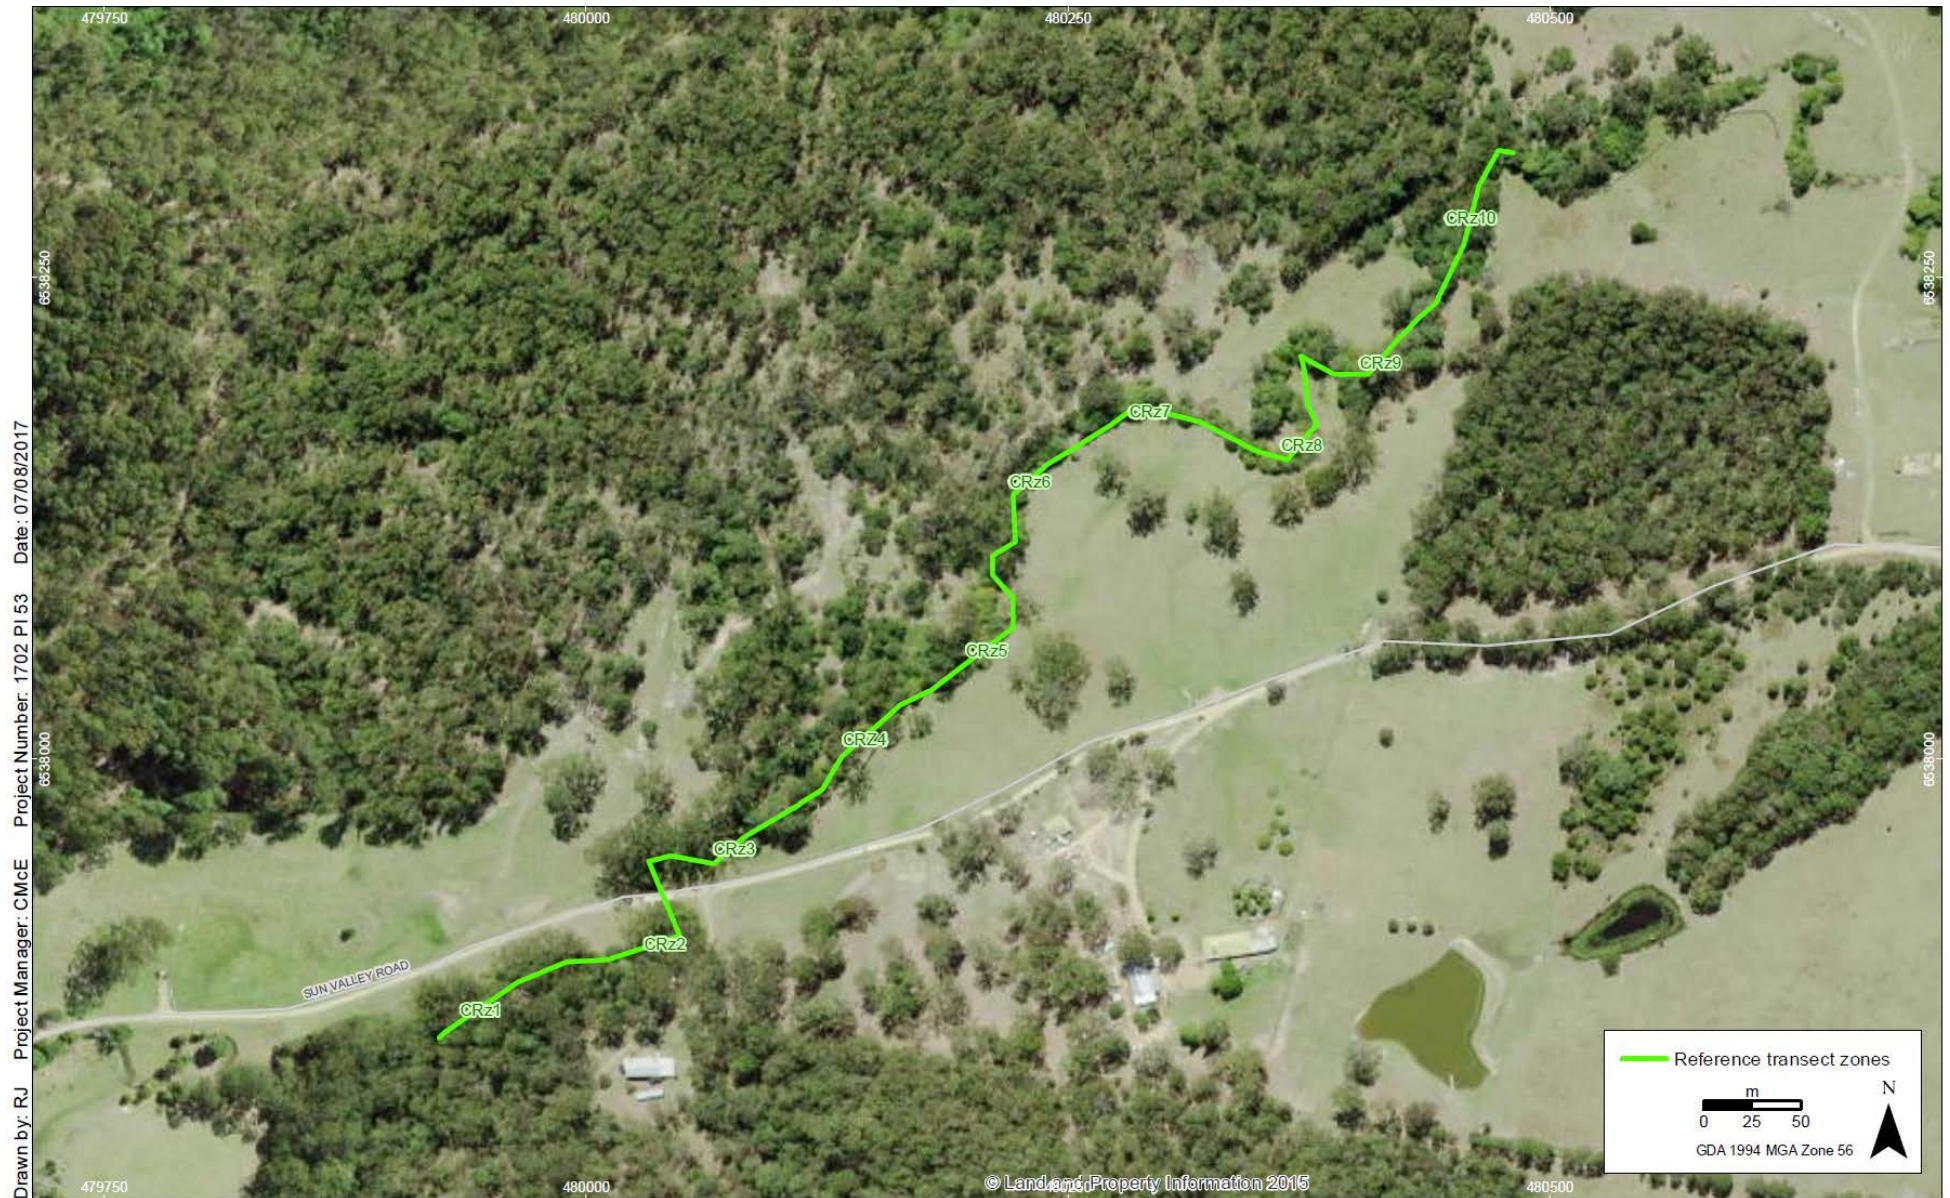
**FIGURE 5**

Giant Barred Frog 2016 - 2017 monitoring: Maria River Impact Site  
 Pacific Highway Upgrade - Oxley Highway to Kempsey

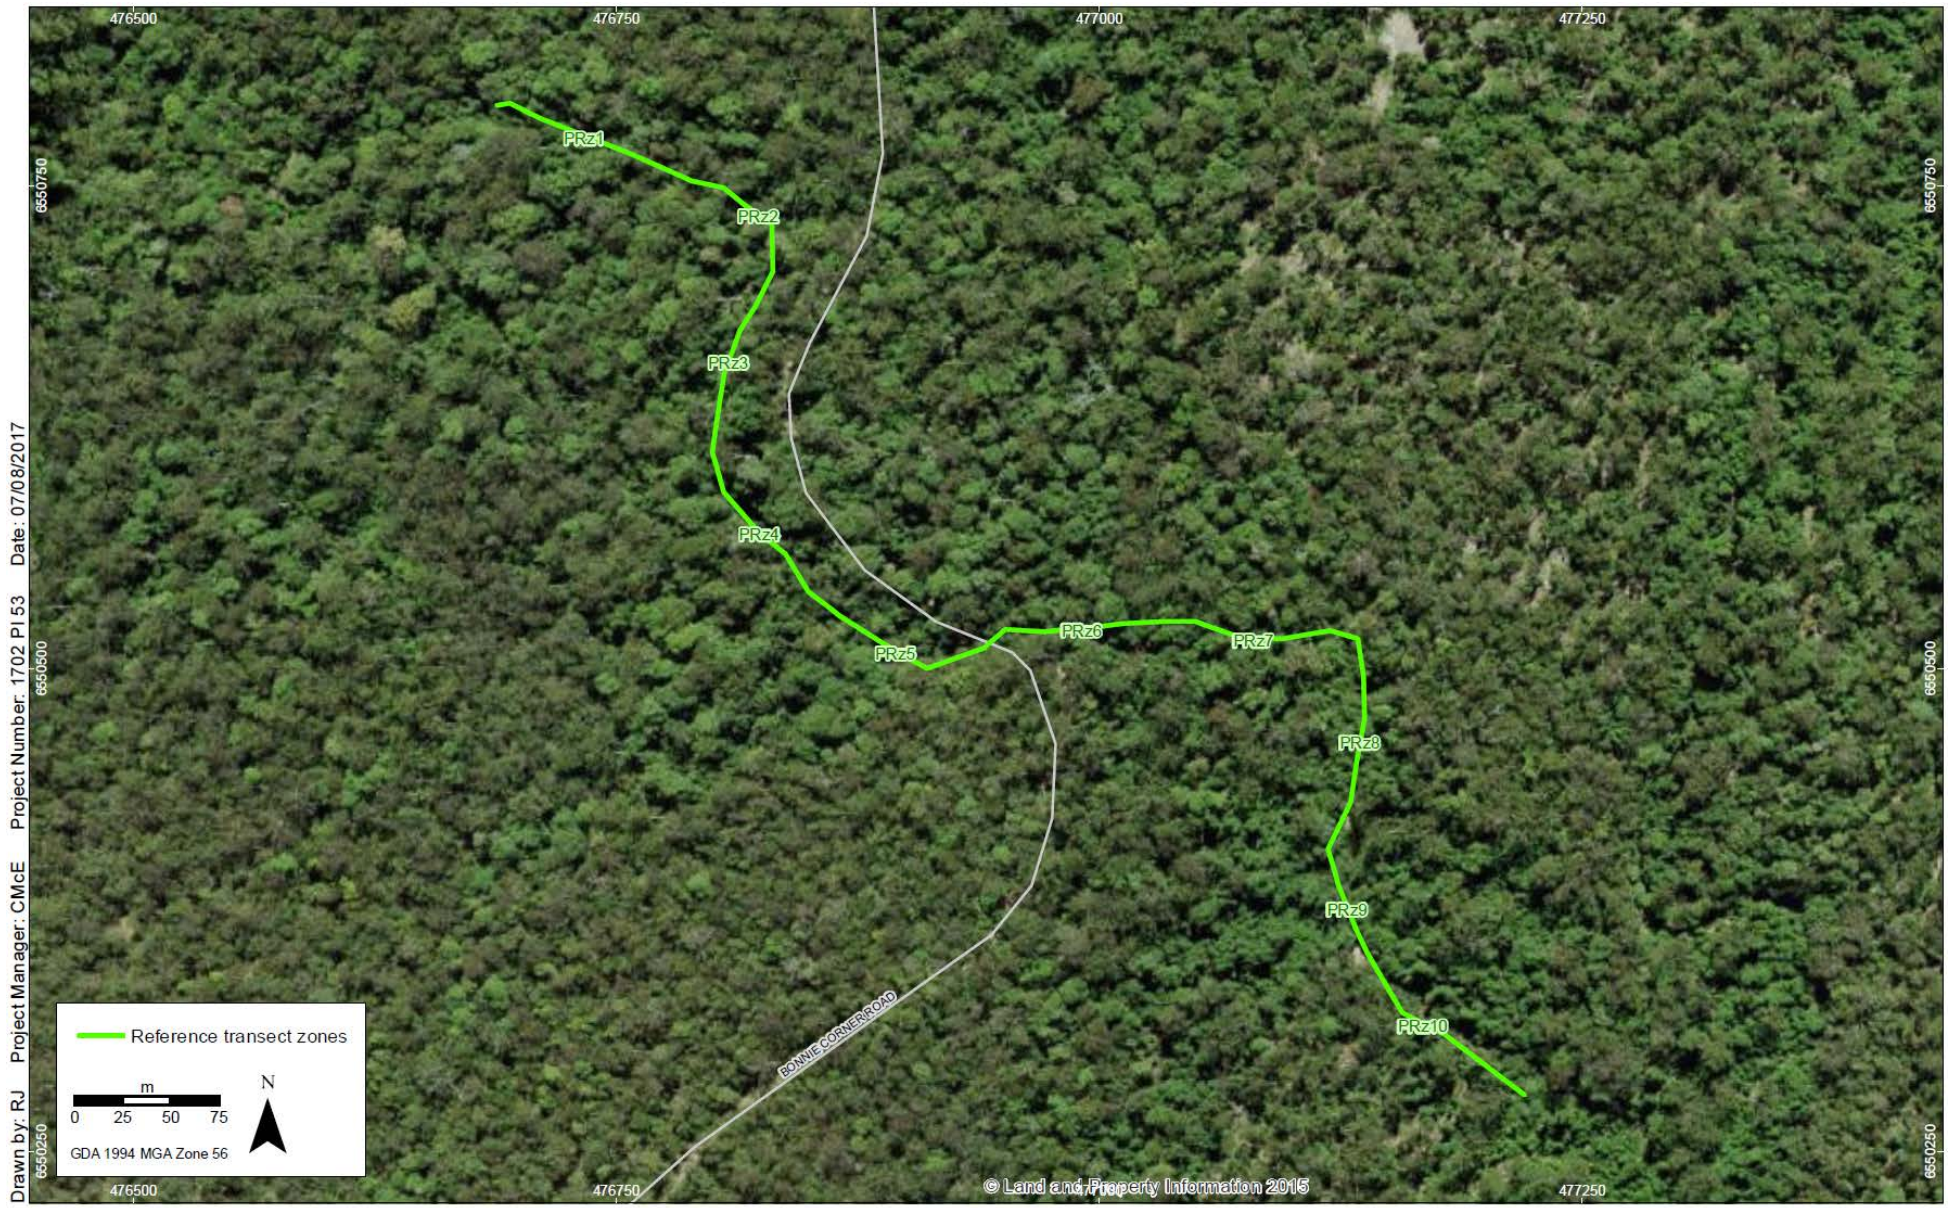
**FIGURE 6**

Giant Barred Frog 2016 - 2017 monitoring: Cooperabung Creek Reference Site  
Pacific Highway Upgrade - Oxley Highway to Kempsey

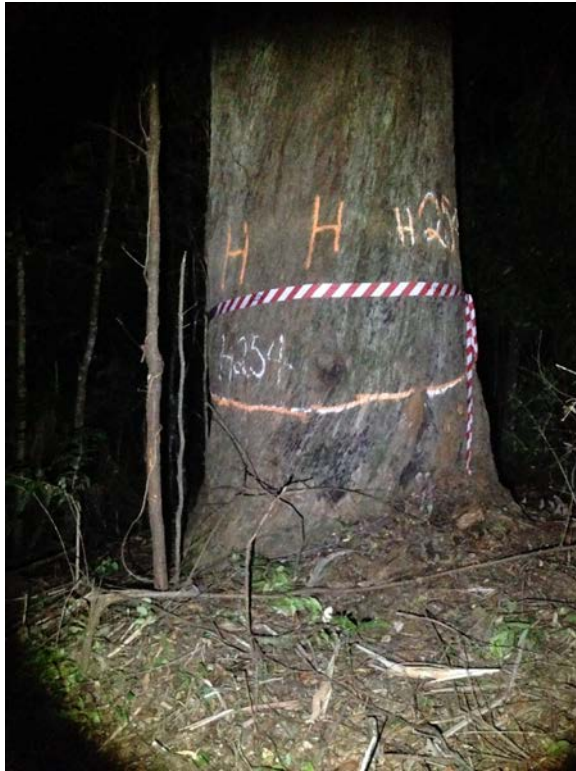
**Plate 1:** HBT's marking protocol – red and white danger tape and painted orange "H".

Prior to commencement of clearing in a specific area the alignment was traversed to mark fauna habitat resources, including hollow-bearing trees (HBT), nest trees, trees with hollow arboreal termitaria, dreys, large hollow logs, bush rock and glider sap trees. The HBT survey included remarking of trees identified by Lewis (2013, NBPoM) and marking additional trees. HBT's were marked with red and white danger tape and four large "H" were painted on the trunk at head height (Plate 1). The tree number was written on the flagging tape and, in some cases, sprayed on the trunk. Data collected on each tree included: tree number, species, location (GDA 94), diameter at breast height (DBH), proportion of crown remaining, and hollow size (small 10-50mm, medium 51-150mm, large 151-300mm and very large >300mm), type (e.g. branch, trunk, spout, fissure, decorticated bark), and evidence of use (i.e. chew marks or wear around entrance, white-wash, pellets, scats, or scratches). Habitat resource surveys began one week prior to the commencement of clearing and were undertaken progressively during the clearing phase. Not all previously marked HBT's were remarked if no evidence of fauna habitat was recorded.

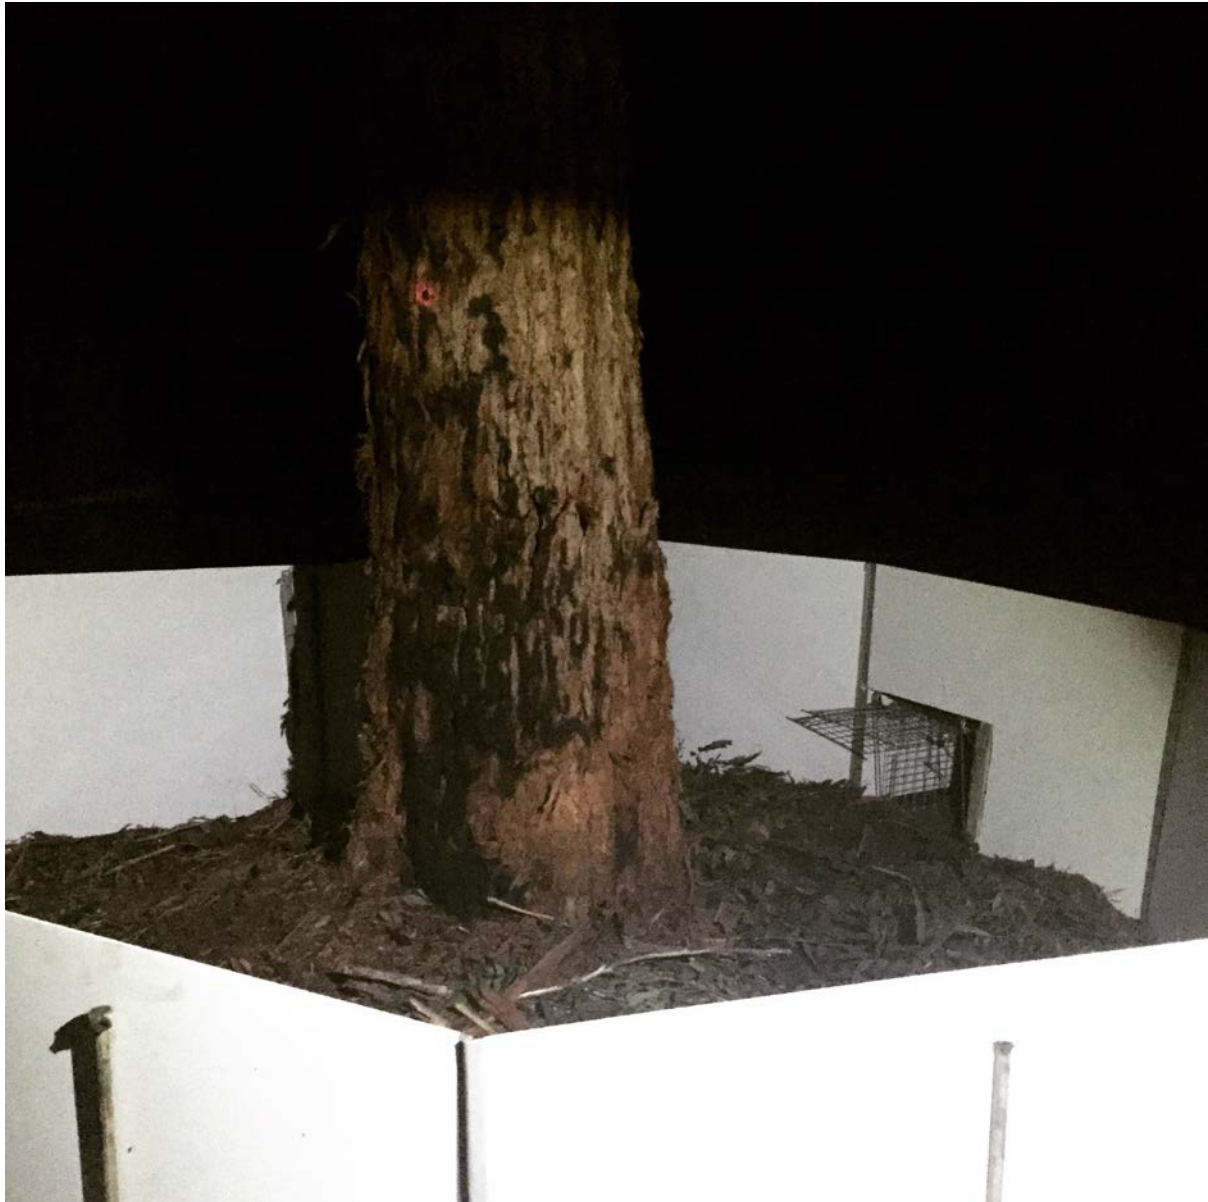
A koala trap was used as required. The koala trap was based on Phillips (2011) and included a corflute pen positioned around the occupied tree with a large cage trap fitted into a hole in the fence (Plate 3). A protocol was developed to deal with koalas recorded in the clearing area (Appendix A). The adopted protocol differs slightly to the method proposed in the EMP. The main difference was that a pen trap was installed immediately upon identifying a koala during spotlighting rather than leaving the individual to move, potentially to another tree in the clearing limit. This approach was preferred due to concern about relocating the koala the following day. There is a high likelihood that a koala identified at night would move prior to the morning pre-clear survey and relocating that individual in tall forest with a dense shrub layer during daylight would be difficult. Due to concern about an increased risk of mortality if an identified individual was left to move elsewhere within the clearing limit it was decided to control the situation and minimise the risk of mortality. The method proposed in the EMP relies on relocating a koala during the morning pre-clear and installing a 50m buffer around the occupied tree. A pen trap would then be installed if the koala does not vacate the area. The EMP does not specify the time between the initial observation and installation of the pen trap.

**Plate 3:** Koala trap installed around a tallowwood occupied by a female koala on 19 January 2015.
