Oxley Highway to Kempsey EPBC 2012/6518  
**Condition 8 Annual Report  
2017**

File name	16 0919 OH2K DoTEE CoA 8 Annual Report July 2016 - July 2017
Report name	Oxley Highway to Kempsey EPBC 2012/6518 Condition of Approval 8 Annual Report 22 July 2016 – 21 July 2017
Revision number	1

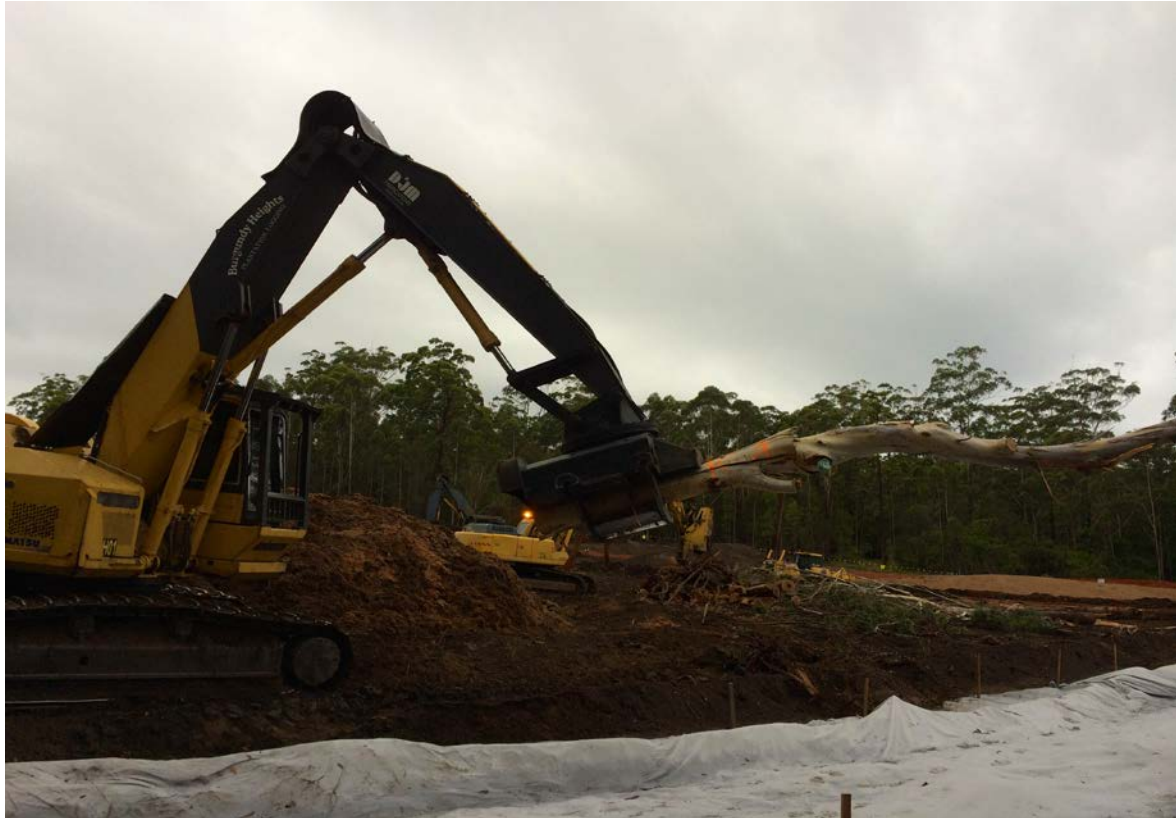
**Plate 4:** Section of tree with a hollow occupied by two sugar gliders being moved outside the LoC. The hollow (centre of log) is plugged with a cotton bag.

Fauna were either left in hollows (by temporarily sealing openings or captured and placed in cotton bags or a cat cage). Frogs were housed individually in plastic clip-seal bags with a small amount of water and leaf litter. Hollows containing fauna were plugged with a cotton bag and placed between the LoC and project boundary (Plate 4). Fauna were only left in-situ if they were uninjured, if the tree could be left undisturbed and if there was minimal activity nearby. Hollows were unplugged at dusk and re-inspected the following morning. In cases

where there was no adjoining forest to place hollows in or animal/s were suspected of being injured a hand-held chainsaw was used to trim retained sections of tree to enable extraction of fauna. Captured fauna and occupied hollows were placed into the adjoining forest, or the closest area of suitable forest (i.e. appropriate area and habitat type for the subject species) within 100m of the LoC boundary. All gliders were transferred to nest boxes, which were installed temporarily in habitat to the point of capture (Plate 5). Nest boxes were inspected the following day and removed if there was no sign of continued use. Reptiles were placed on trees with decorticated bark and hollows or in piles of logs where there was good refuge habitat. Insectivorous bats were released at dusk near their point of capture and frogs were released on drainage lines or at dams. The maximum distance between point of capture and point of release was 150m and most individuals were released immediately adjacent to their point of capture.

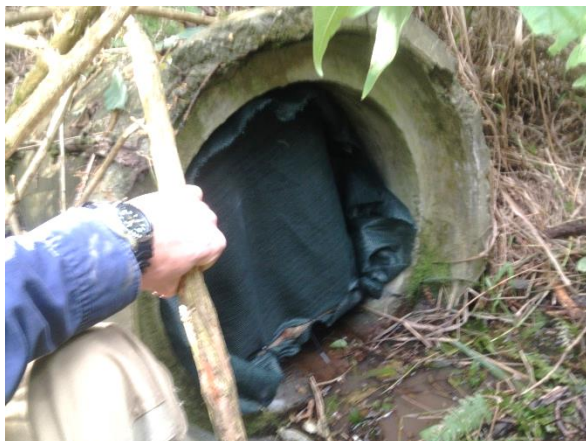
**Plate 3.** RCP 511067 (chainage 1000) was excluded with a nylon curtain after determining microbats were not roosting within the structure. The curtain features a 100mm gap at the base.

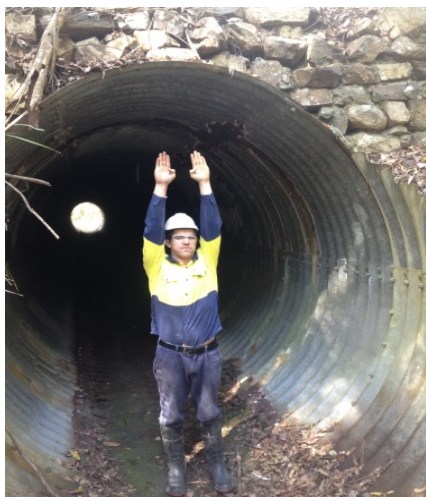
**Plate 3.** C599022 (chainage 22200) features 2x 3000mm galvanised pipes. The structure is likely a major microbat flyway and would present an entanglement hazard if curtained.
