# **Oxley Highway to Kempsey EPBC 2012/6518**

Condition 8 Annual Report

Roads and Maritime Services | September 2018

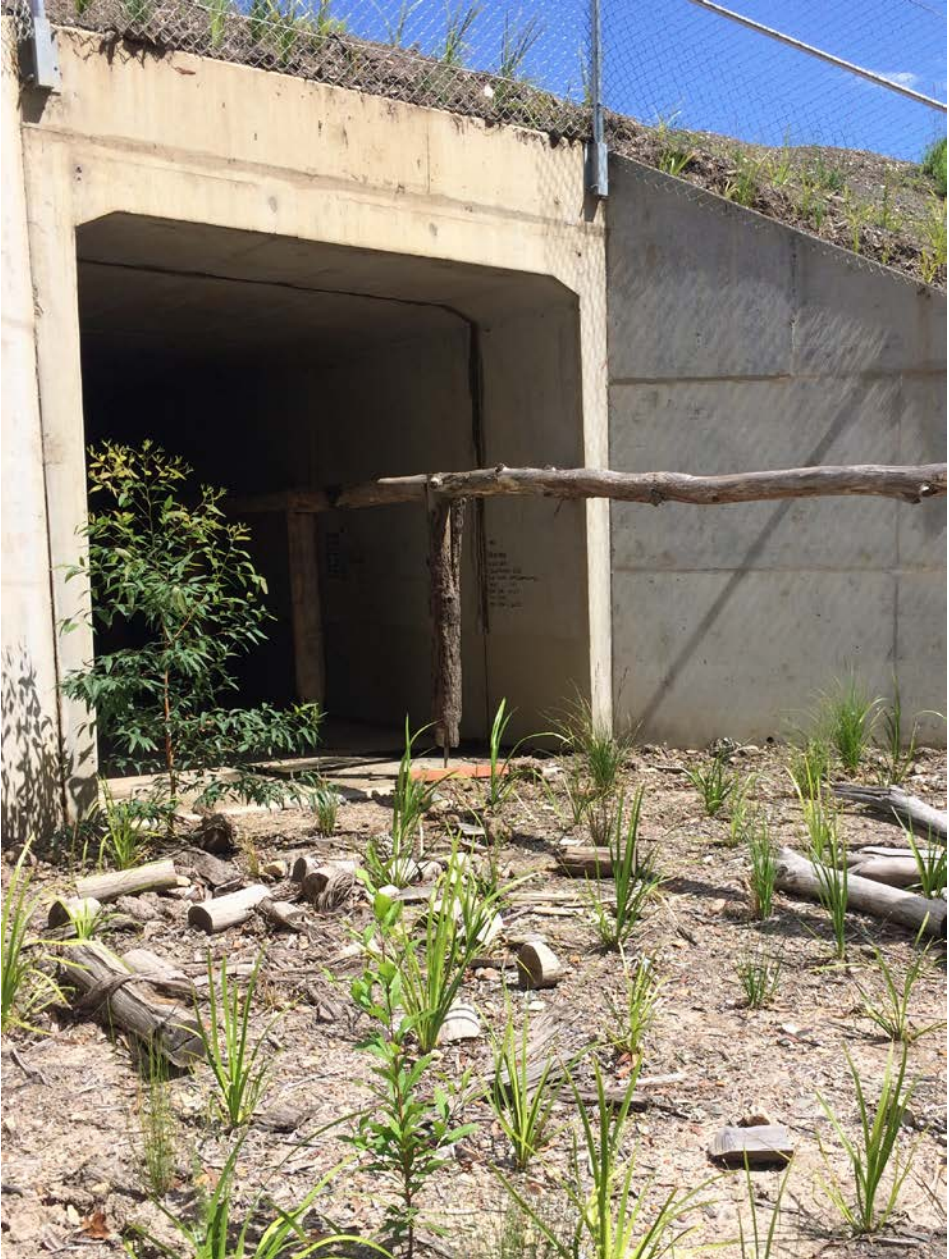
#	Description	Image
<b>Stage 2</b>		
1	Tubestock planting at a dedicated fauna culvert

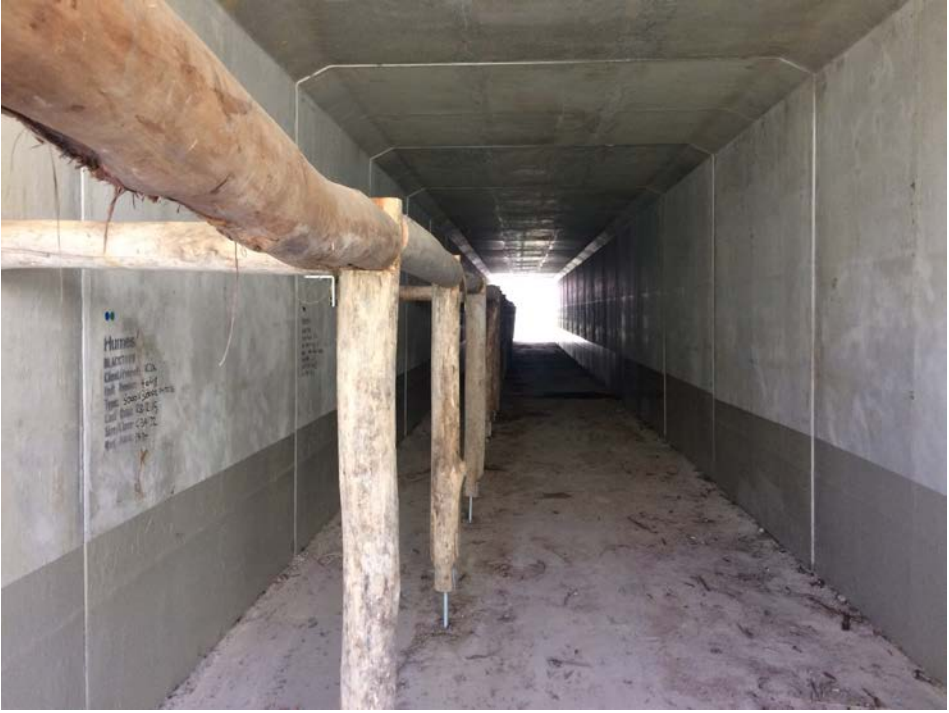
#	Description	Image
2	Completed fauna furniture at a dedicated fauna culvert

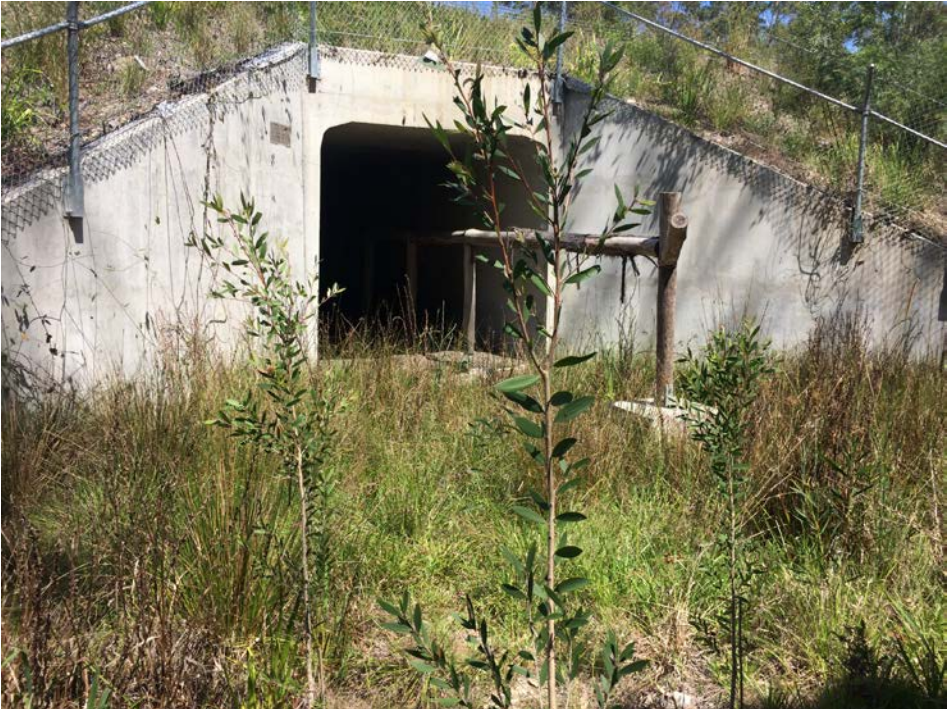
<p>The image shows the interior of a concrete culvert. The walls are light-colored concrete with a darker grey base. The floor is sandy and uneven. Several large, weathered logs are positioned horizontally across the width of the culvert, supported by vertical wooden posts. The logs are arranged in a series, creating a path through the culvert. The lighting is dim, with a bright light source at the far end of the culvert, creating a strong perspective effect.</p>
3	A completed dedicated fauna underpass

<p>The image shows the exterior of a concrete fauna underpass. The structure is built into a grassy embankment. The concrete wall is light-colored and has a dark, arched opening. A wire fence runs along the top of the embankment. In the foreground, there is tall, dry grass and several young green plants. A wooden post is visible near the entrance of the underpass.</p>

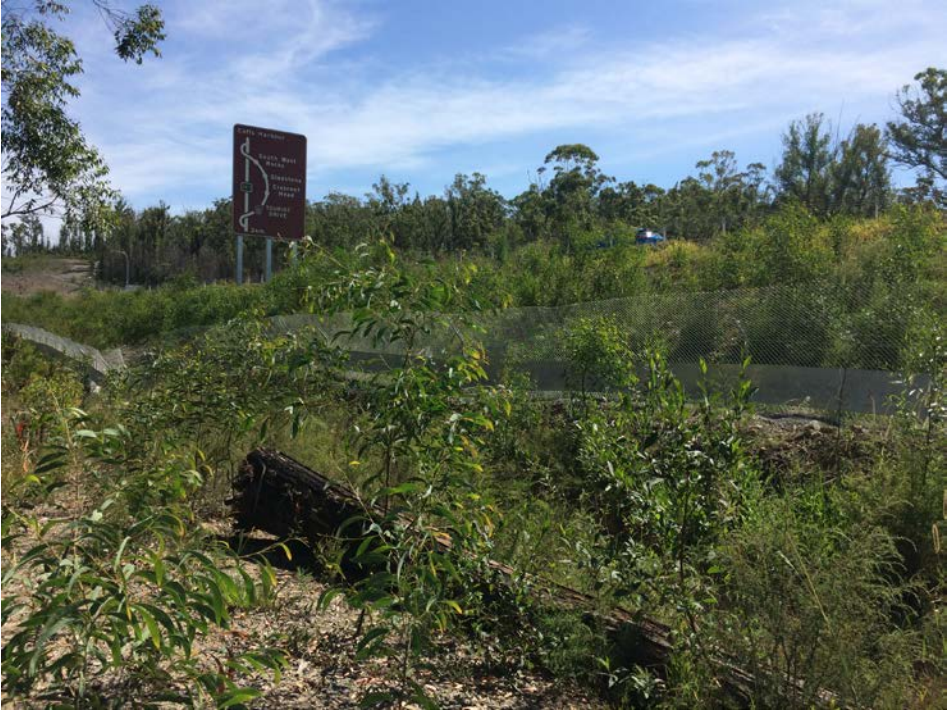
#	Description	Image
4	<p>Good revegetation outcomes on a fill batter</p>

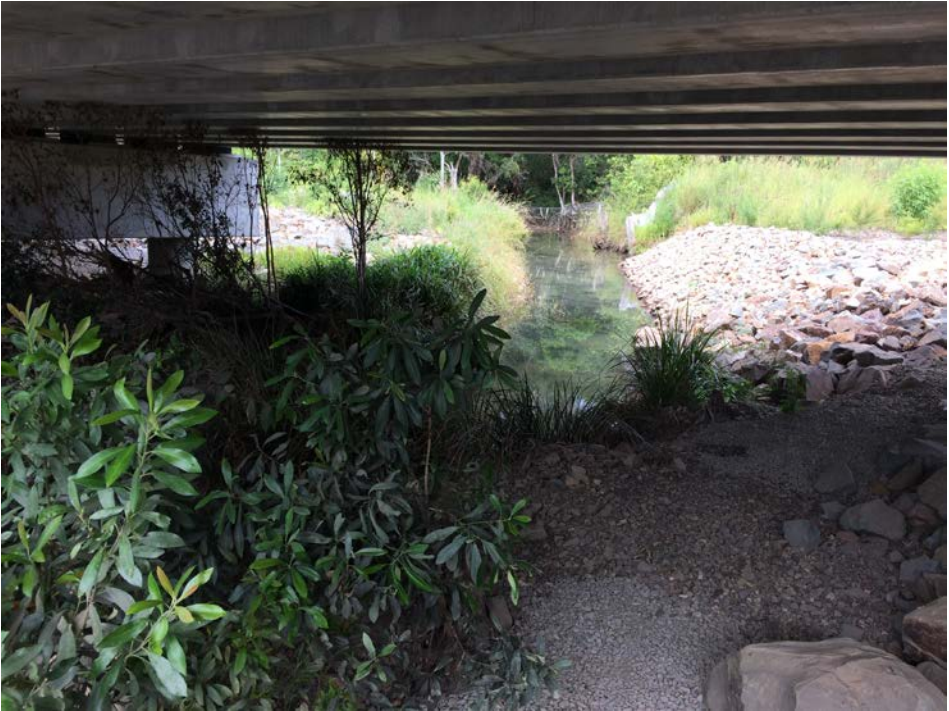
<b>Stage 3</b>		
6	<p>Rehabilitation works under Cooperabung Creek bridge</p>

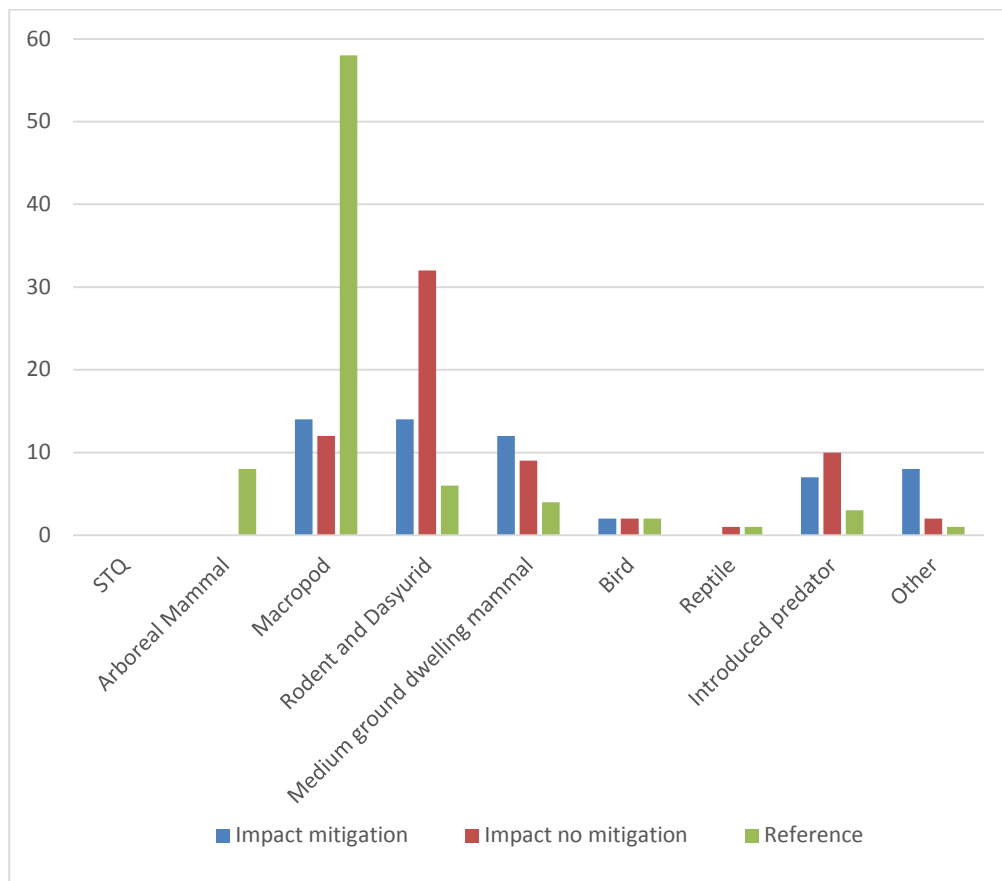
**Graph 1: Cairncross area grouped records**

STQ = Spotted-tailed Quoll; AM = arboreal mammals (Possums and Koala); M = macropods; R&D = rodents and dasyurids; MGD = medium ground dwelling mammals (Echidna, Bandicoot); R = reptile; IP = Introduced predator (Fox, Cat, Wild and Domestic Dog); Other= non-native and non-fauna categories such as people, cars, cows, hares and horses.

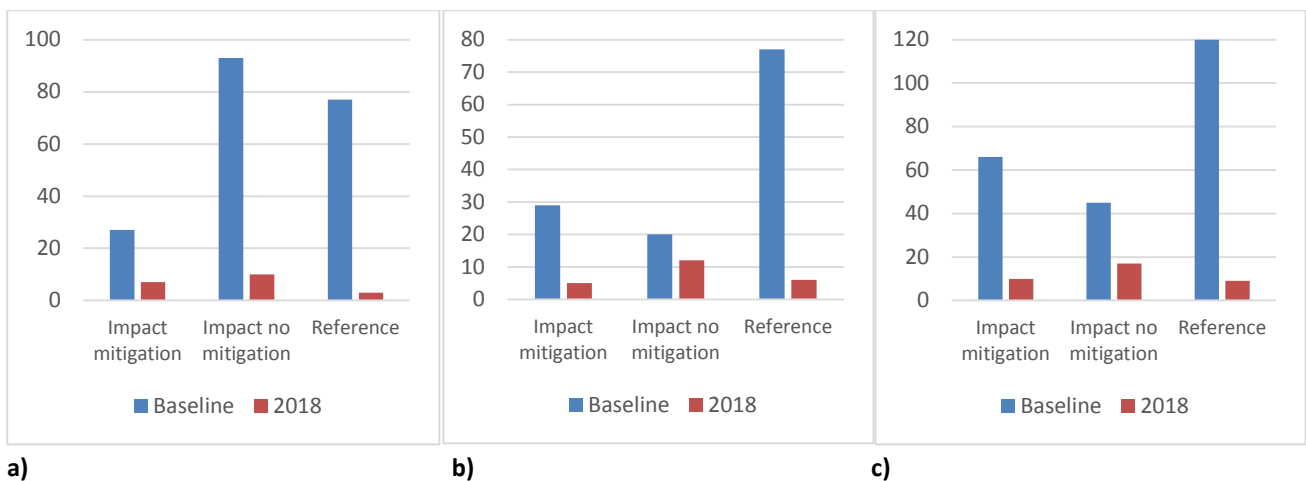
**Graph 4: Introduced predator records within a) Cairncross, b) Ballengarra and c) Maria River areas**

Baseline	2018
Total triggers	28,270	12,329
Total records	1540	688
Native fauna records	46 (3.0%)	578 (84.0%)
Introduced predator records	554 (36.0%)	79 (11.5%)
Other	940 (61.0%)	31 (4.5%)

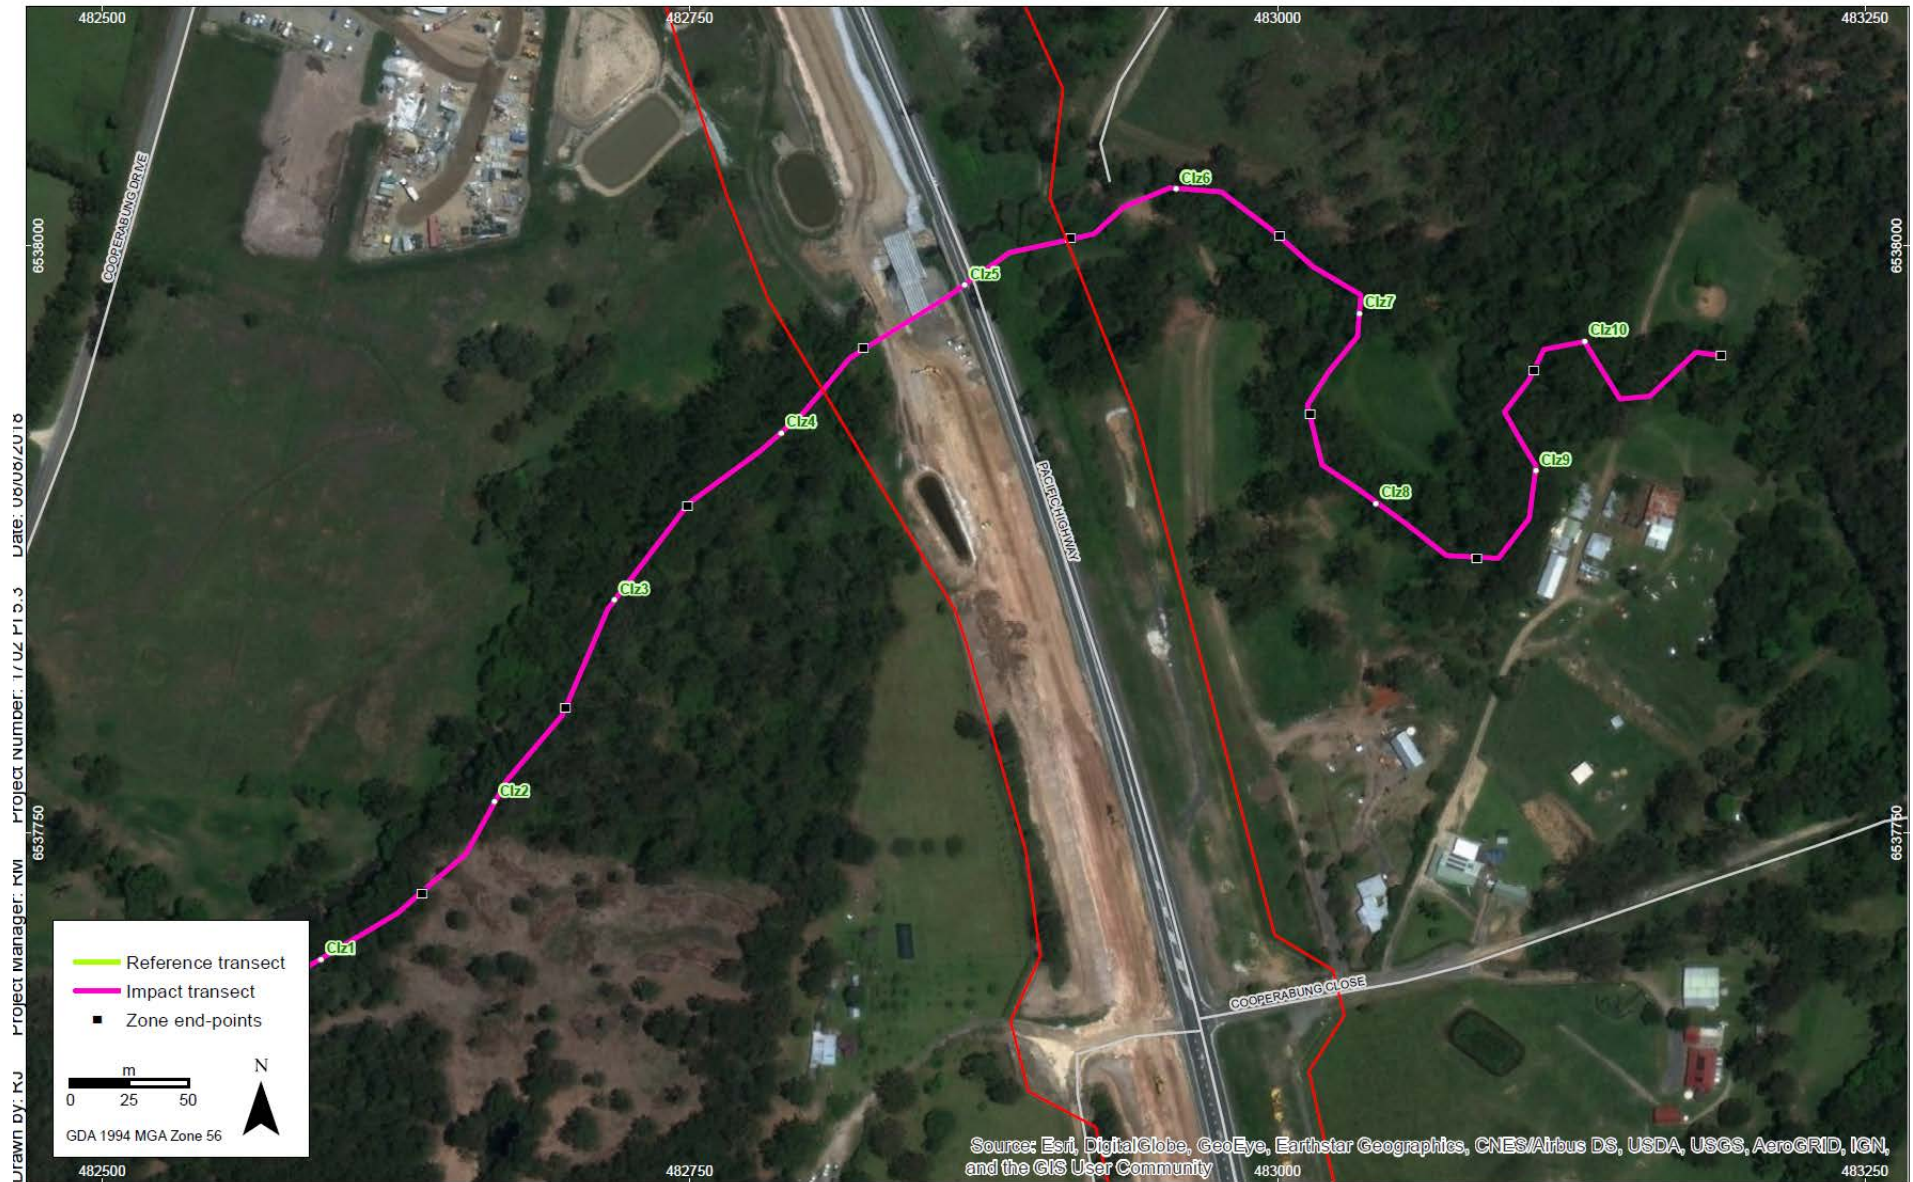
**FIGURE 2**  
Imagery: (c) DigitalGlobe

Giant Barred Frog monitoring: Cooperabung Creek impact site  
Pacific Highway Upgrade - Oxley Highway to Kempsey

The location of all monitoring sites is shown in Figure 1, with detailed locations for each site transect provided in Figure 2 to Figure 7.

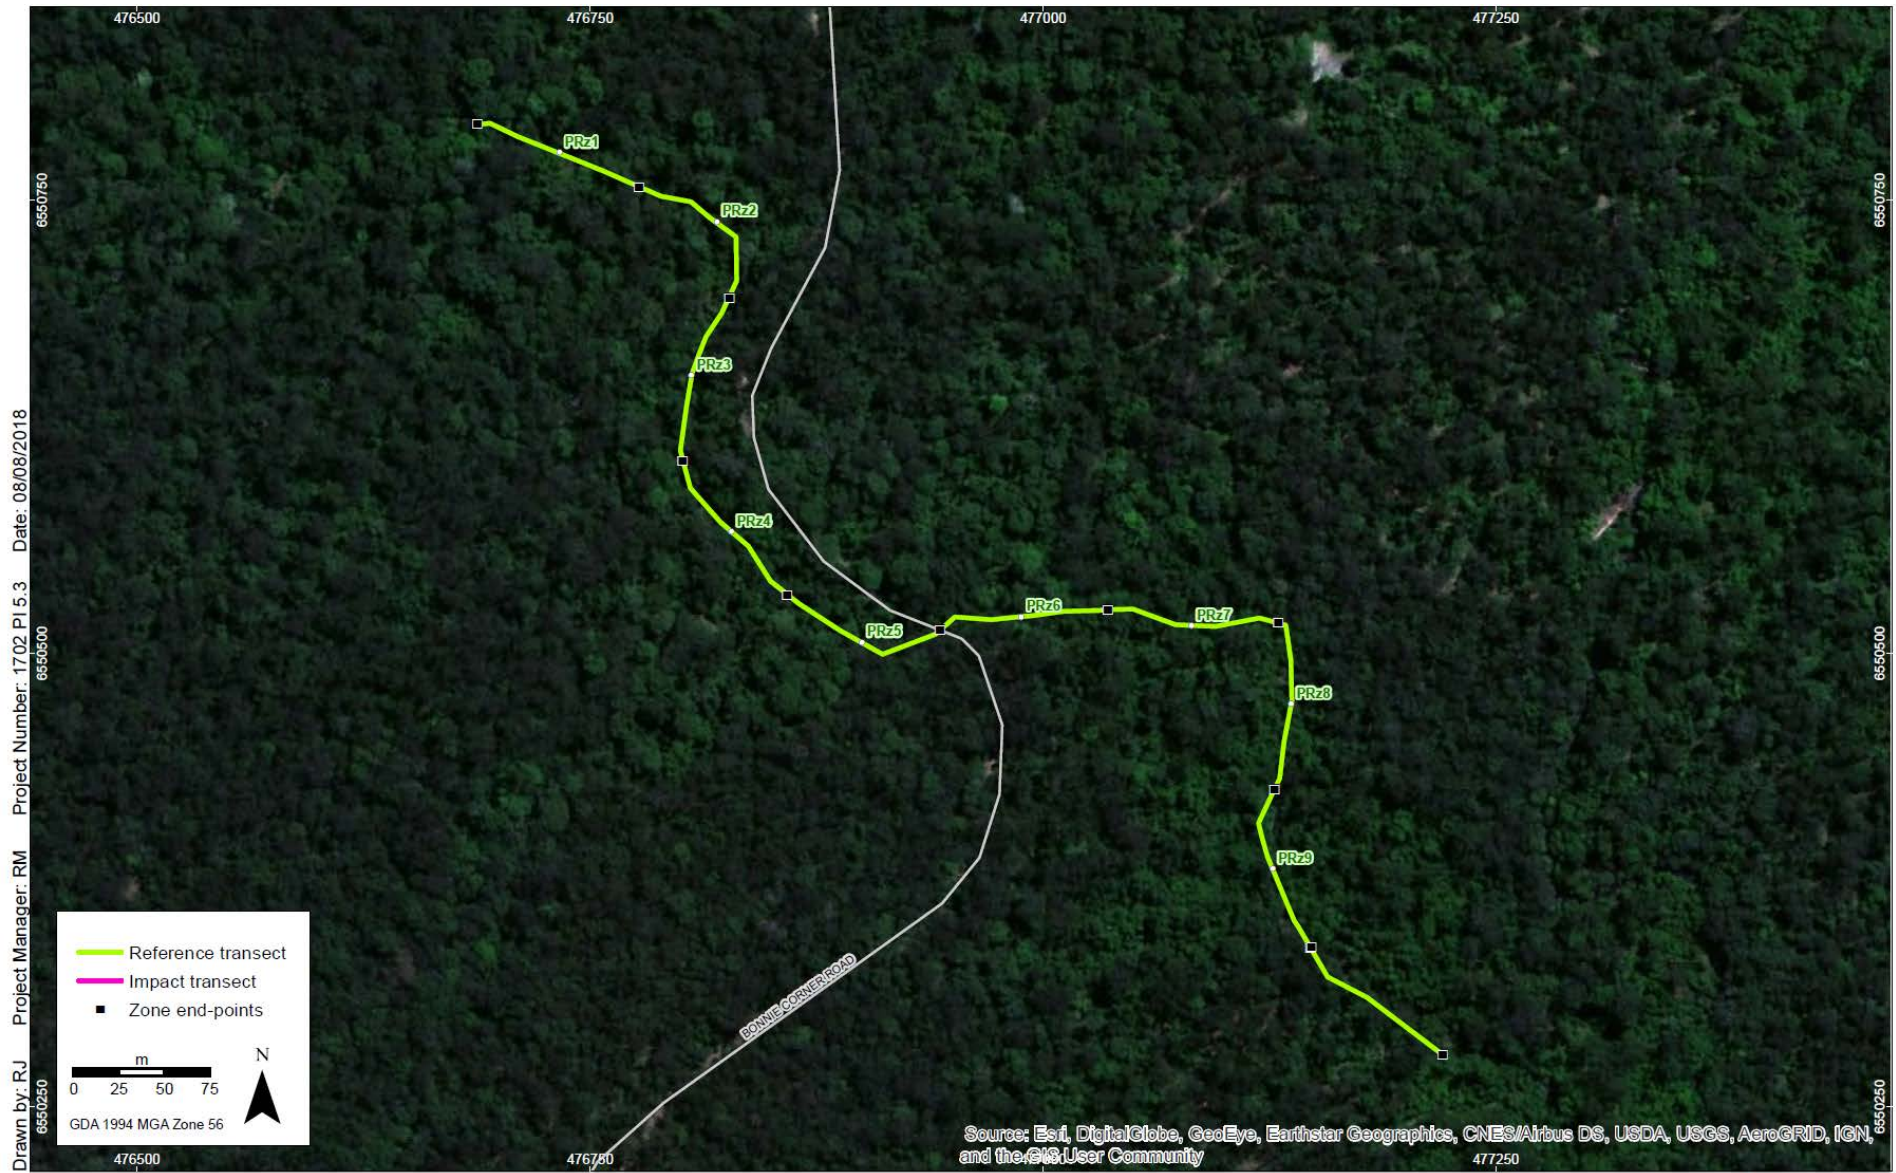
**FIGURE 7**  
 Imagery: (c) DigitalGlobe

Giant Barred Frog monitoring: Pipers Creek reference site  
 Pacific Highway Upgrade - Oxley Highway to Kempsey

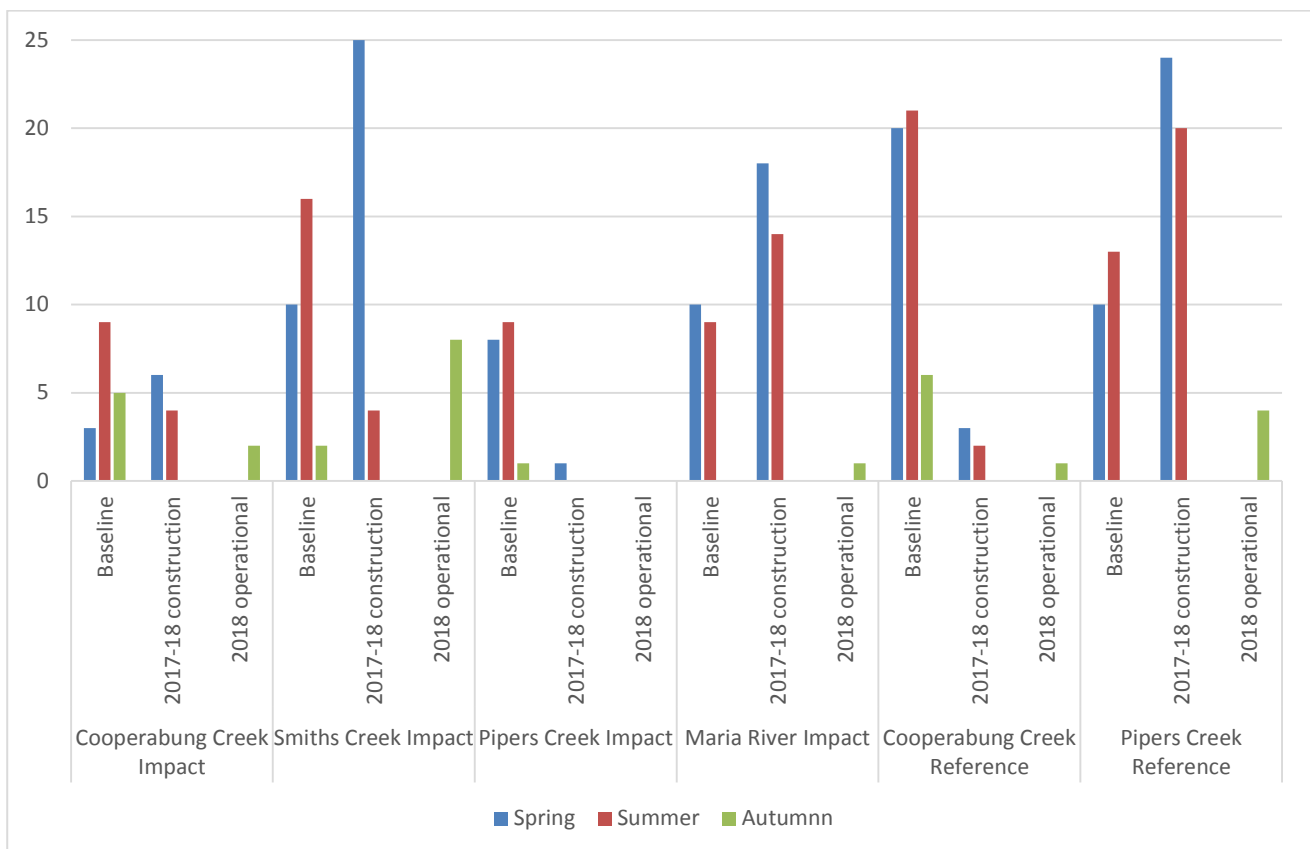
**Graph 1: Giant Barred Frog records: baseline and 2017/2018 monitoring**

Giant Barred Frogs were therefore recorded during all 2017/2018 surveys at the two sites (one impact site) where they were not recorded during the autumn baseline surveys (Pipers Creek reference site and Maria River impact site), however they were not recorded at the Pipers Creek impact site in the summer and autumn 2017/2018 surveys, where they were recorded during baseline surveys.

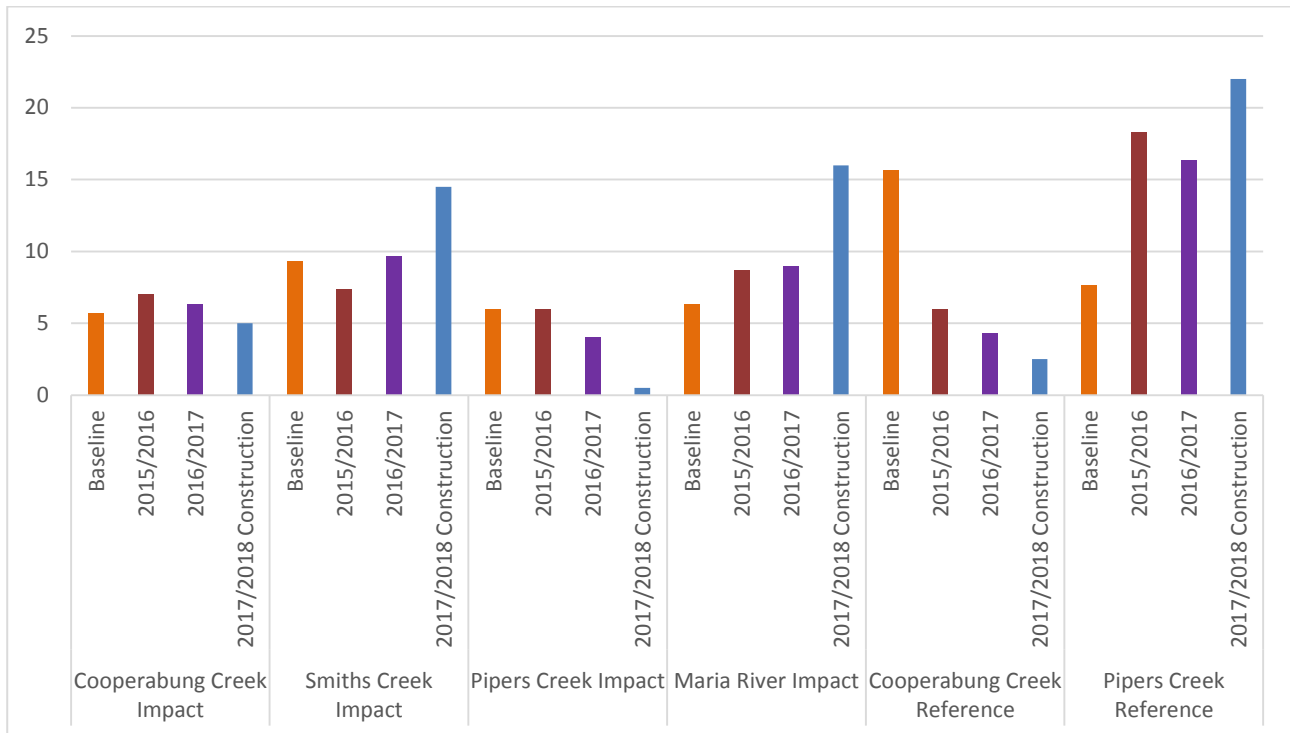
**Graph 2: Mean annual Giant Barred Frog records by site**

For the comparison of means, only 2017/2018 construction monitoring has been included (i.e. spring 2018 and summer 2018). The mean number of records each year is shown in Graph 2. Giant Barred Frog records at Smiths Creek impact, Maria River impact and Pipers Creek reference sites have all increased since baseline surveys. Cooperabung Creek impact, Pipers Creek impact and Cooperabung Creek reference sites all show a decreasing trend in mean number of frogs recorded. As this decreasing trend is evident at both impact and reference sites, it is not possible to attribute these changes to the Project.

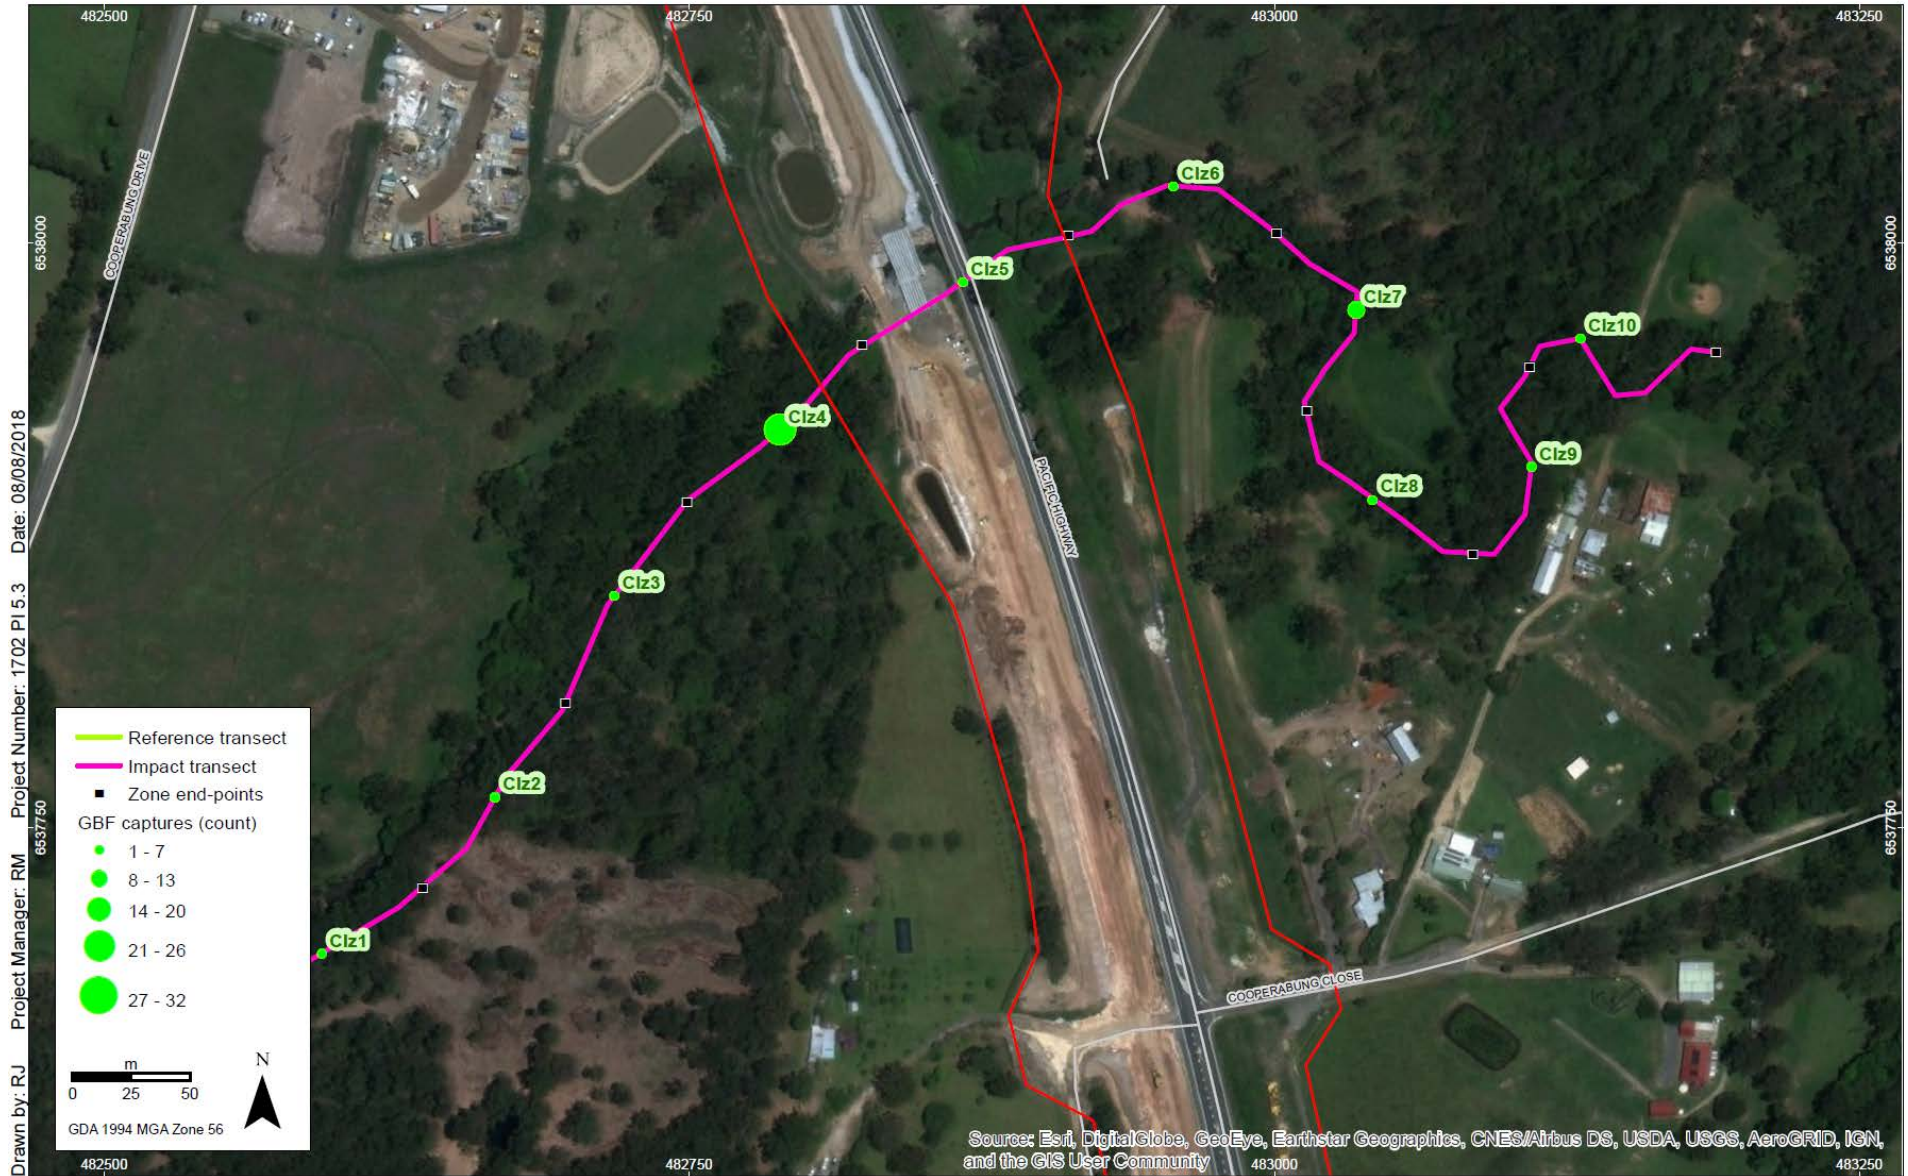
Giant Barred Frog capture distribution: Cooperabung Creek impact site  
Pacific Highway Upgrade - Oxley Highway to Kempsey

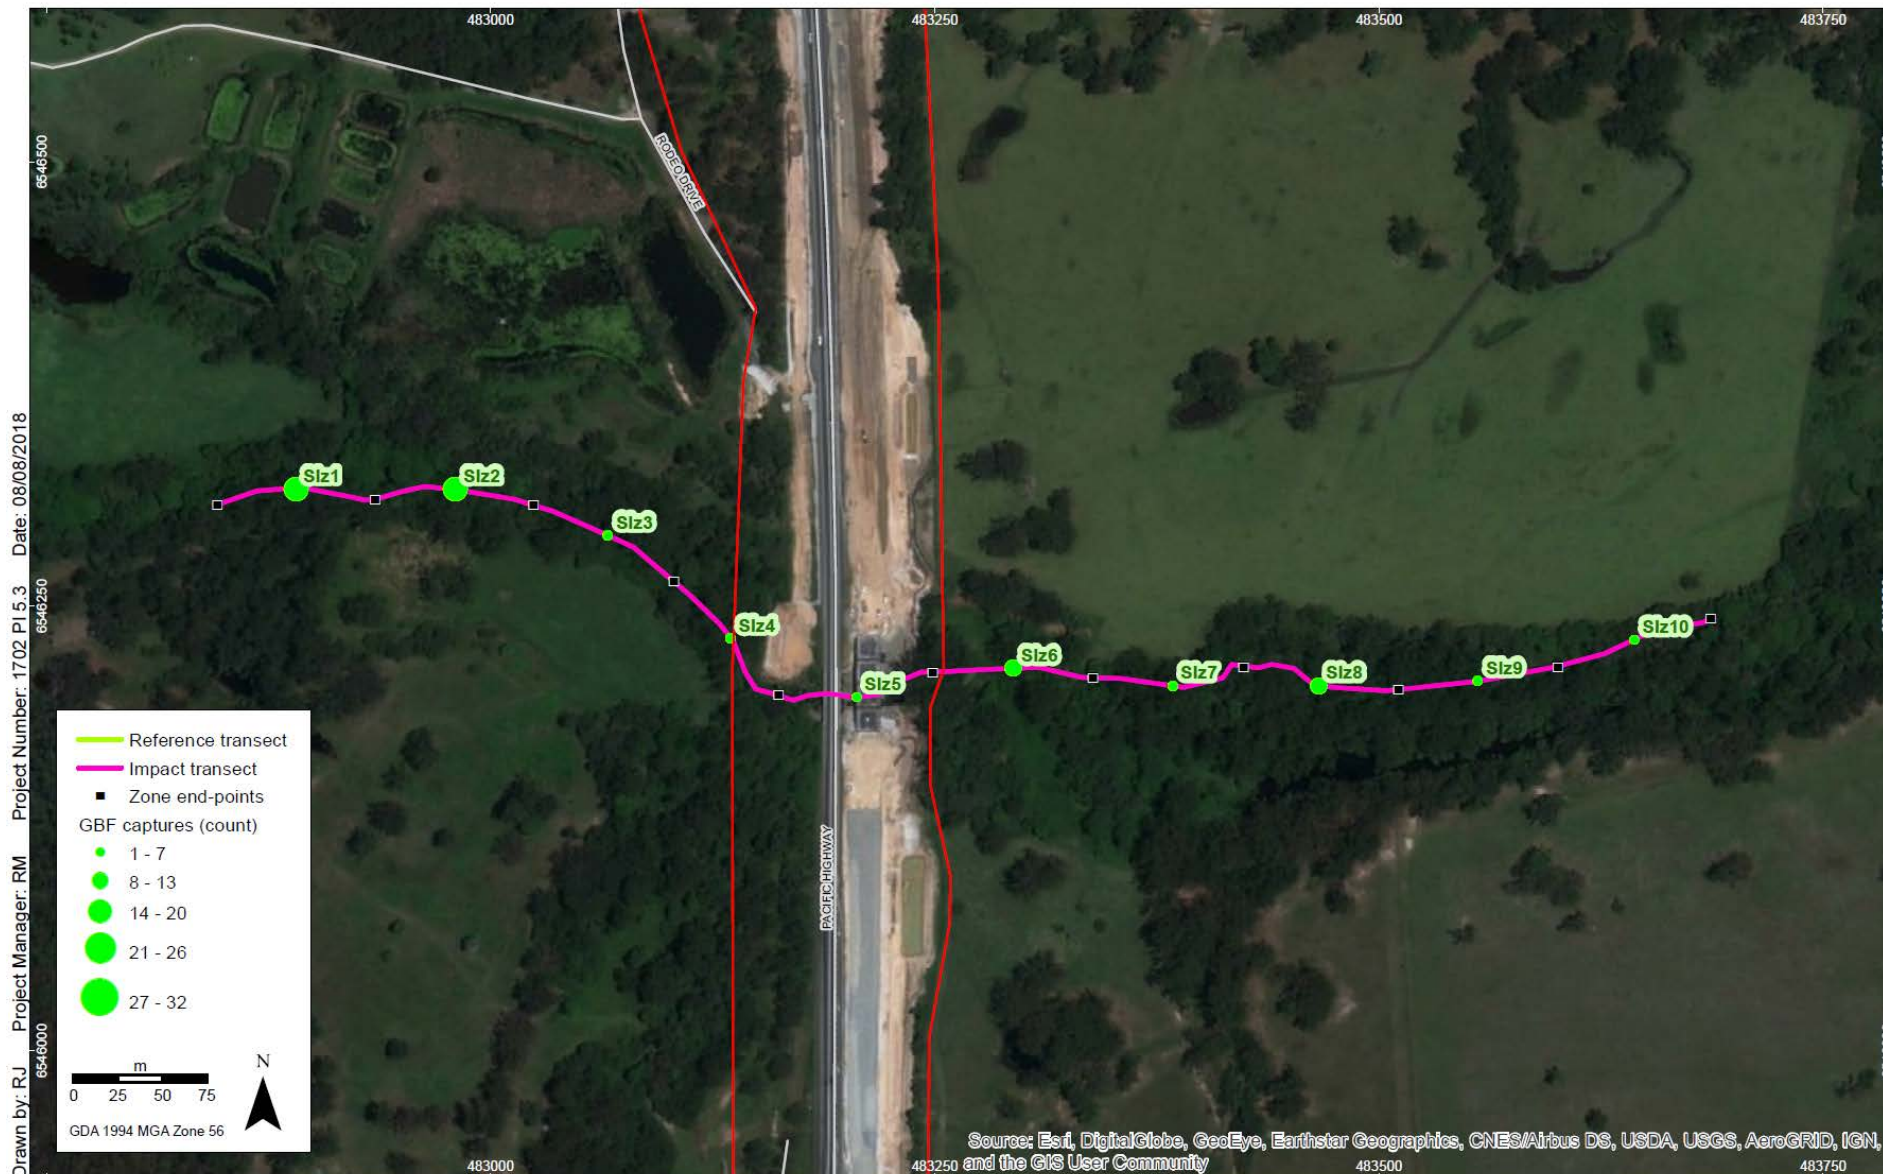
**FIGURE 9**  
Imagery: (c) DigitalGlobe

Giant Barred Frog capture distribution: Smiths Creek impact site  
Pacific Highway Upgrade - Oxley Highway to Kempsey

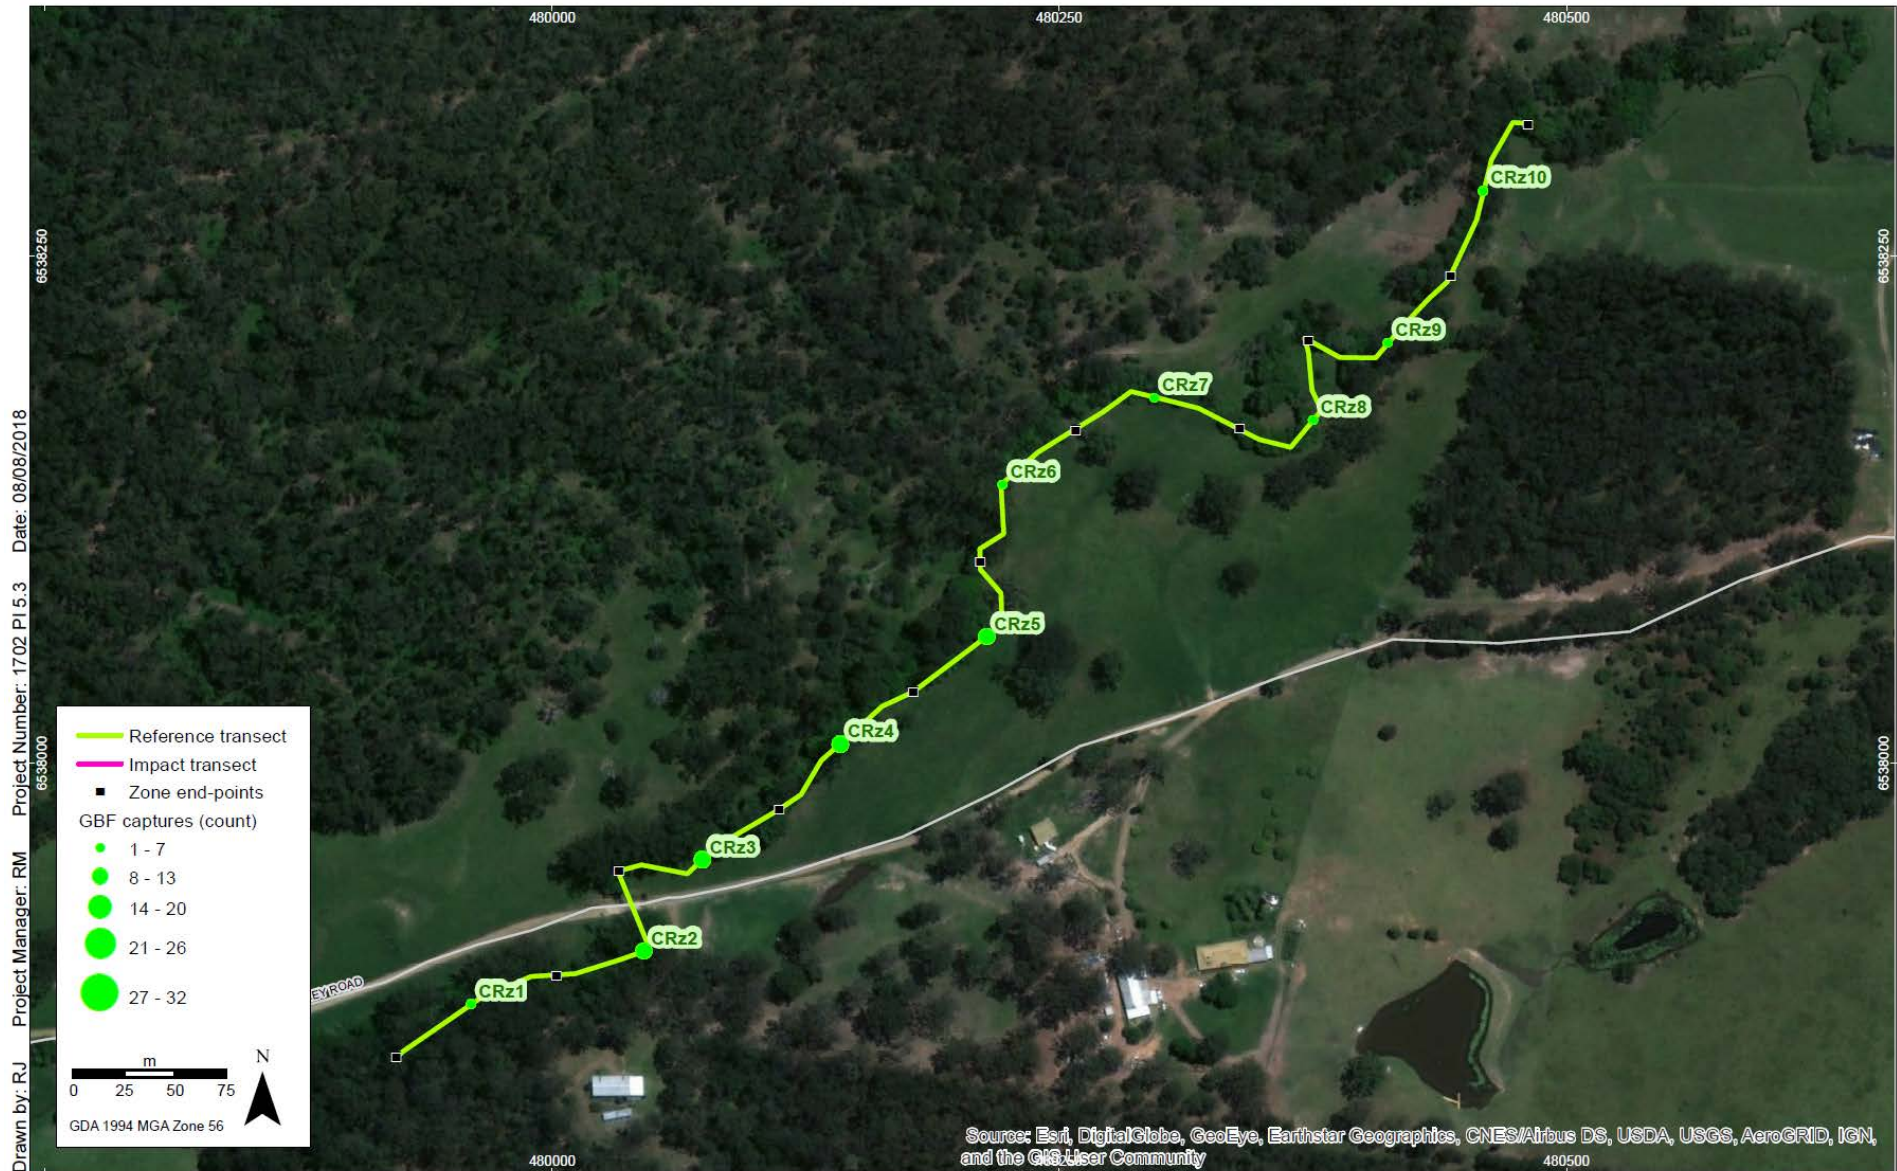
**FIGURE 12**  
Imagery: (c) DigitalGlobe

Giant Barred Frog capture distribution: Cooperabung Creek reference site  
Pacific Highway Upgrade - Oxley Highway to Kempsey

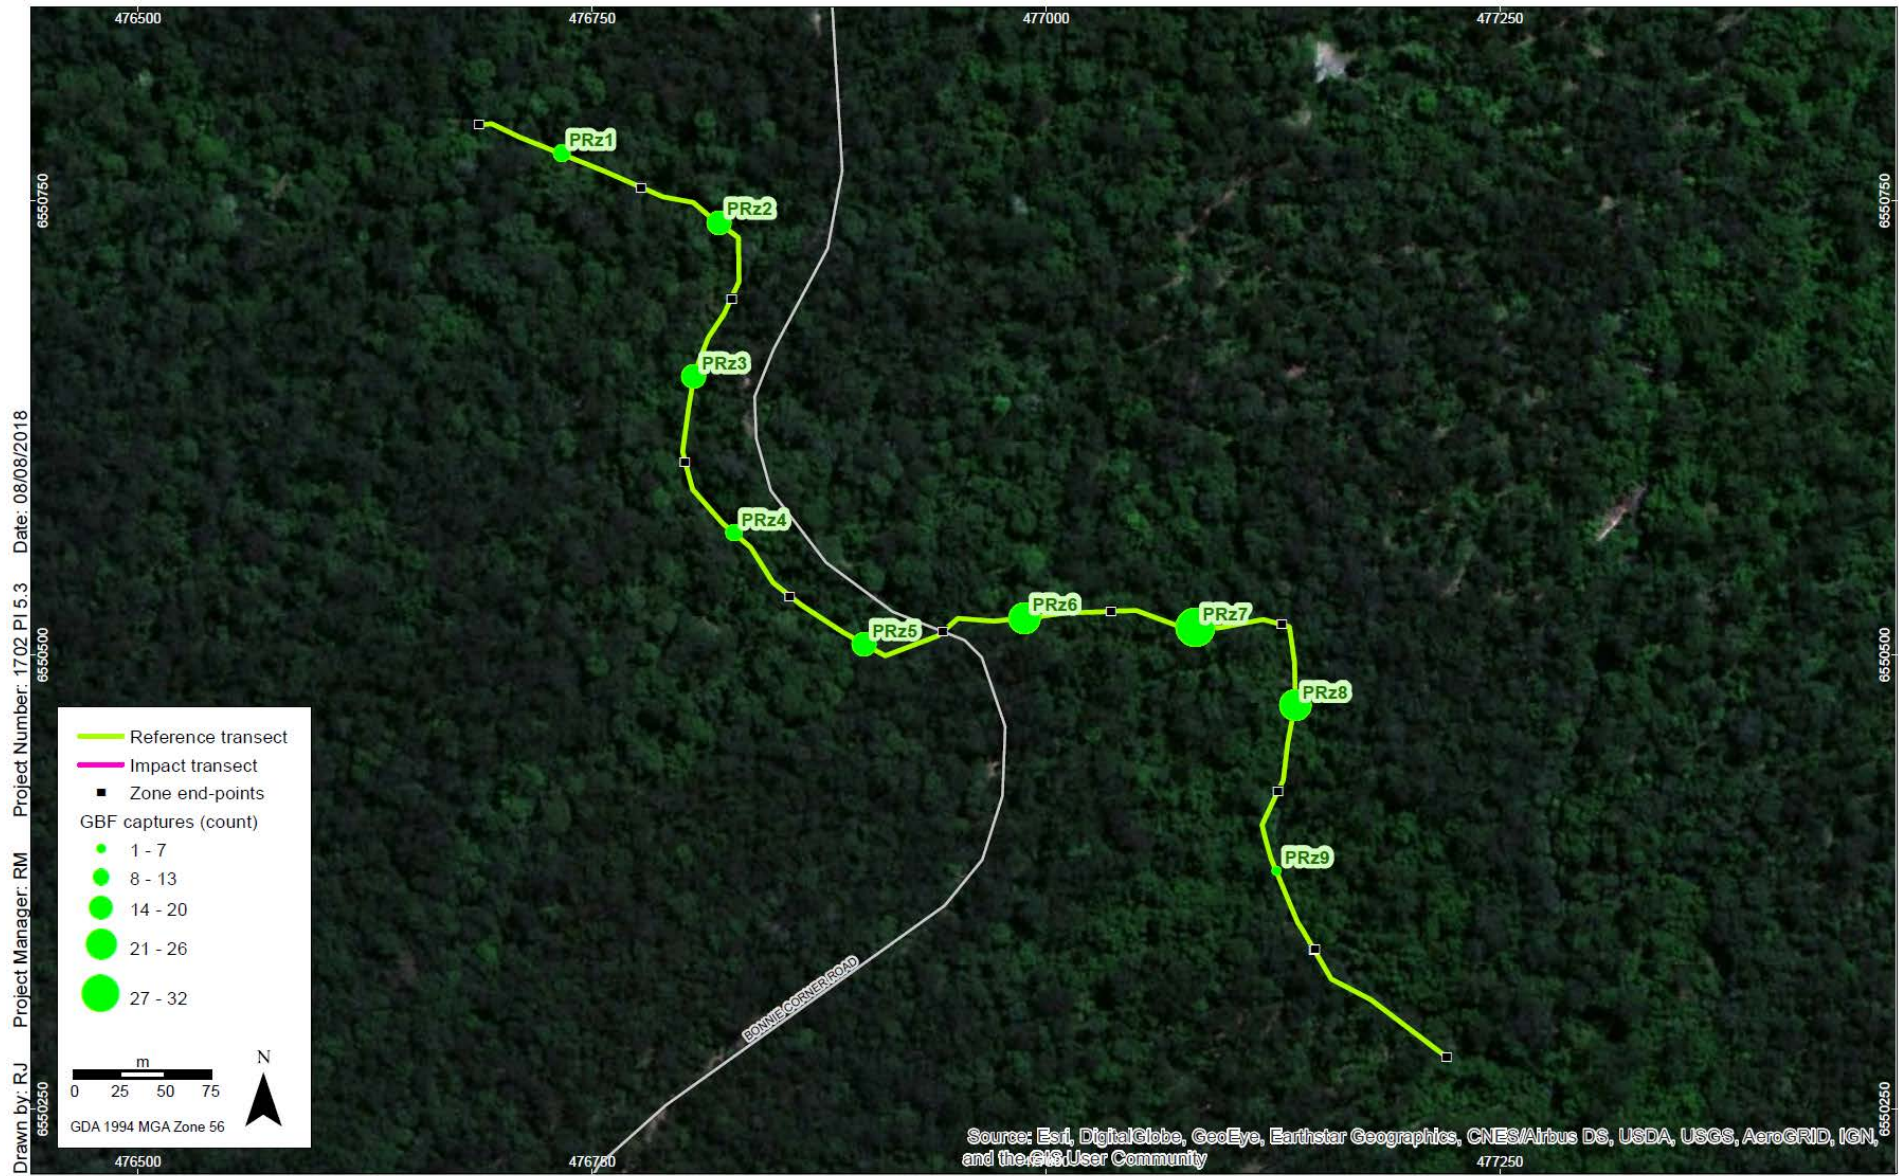
Giant Barred Frog capture distribution: Pipers Creek reference site  
Pacific Highway Upgrade - Oxley Highway to Kempsey
