# **Oxley Highway to Kempsey EPBC 2012/6518**

Condition 8 Annual Report

Roads and Maritime Services | September 2018

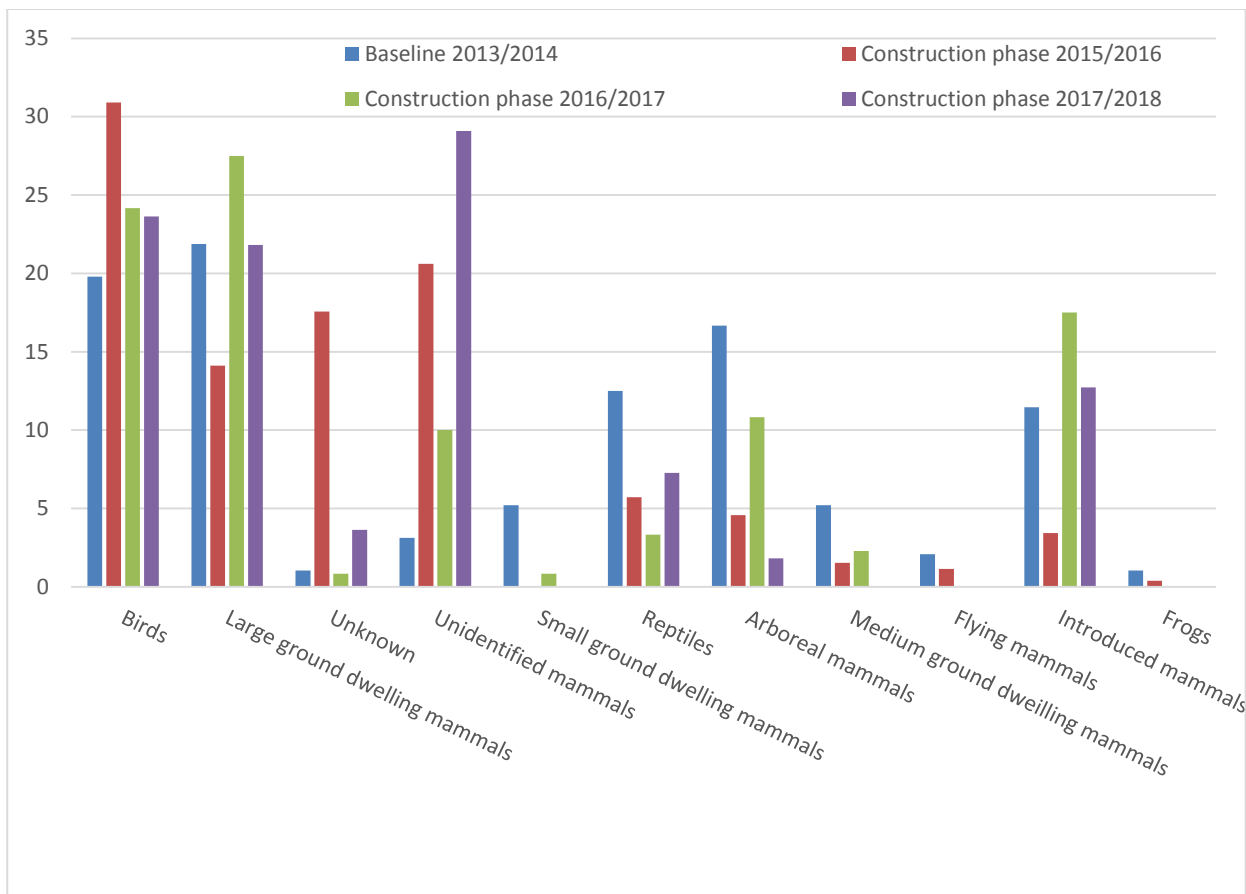
**Graph 1: Comparison of road kill fauna categories for each monitoring period**

‘Unknown’ and ‘unidentified mammal’ categories were included to account for those species that could not be identified. The percentage of road kill records for each category for the current and previous monitoring periods are presented in Graph 1. Birds (24% of road kill, n = 13), large ground dwelling mammals (Kangaroos and Wallabies) (22% of road kill, n = 12), and introduced mammals (13%, n = 7) were the most commonly recorded fauna groups (excluding unidentified mammals) in 2017/2018, which is similar to previous monitoring periods. A high proportion of road kill could not be identified to species level (33% of road kill, n = 18). There is no clear trend that demonstrates a change in the percentage of records for each category over the monitoring periods. All construction monitoring data (i.e. 4 August 2017 – 28 March 2018) have been included.

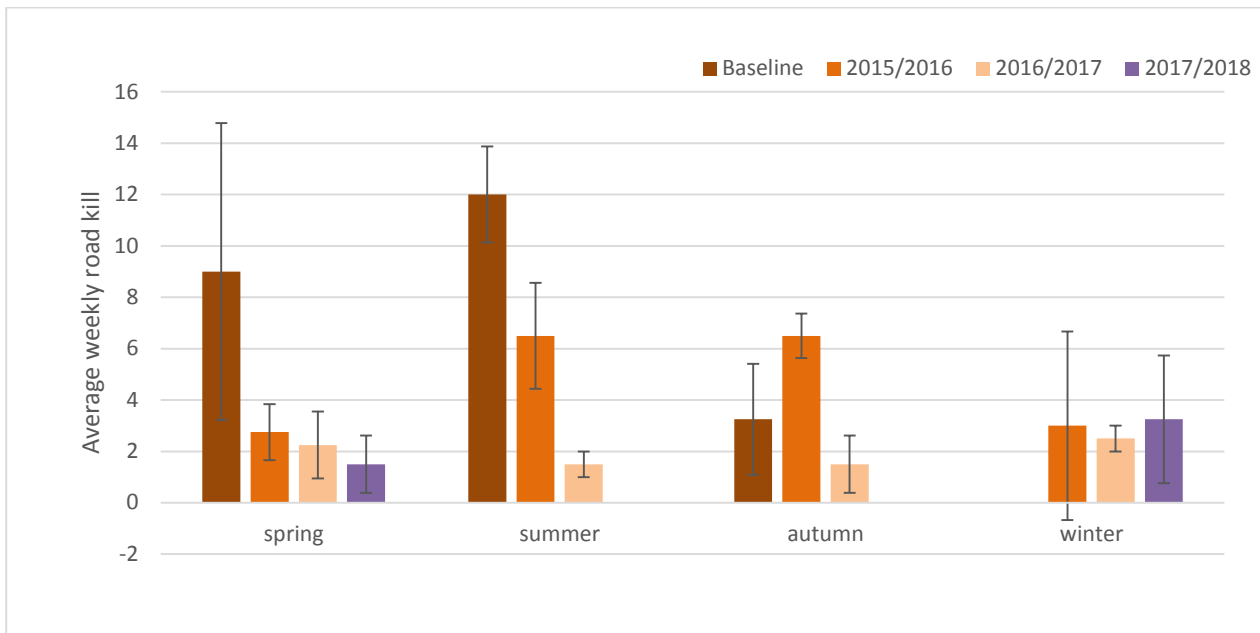
**Graph 2: Average ( $\pm$ SD, n = 4) weekly road kill per season, for baseline and construction monitoring**

n = number of survey weeks; \* = construction partially complete

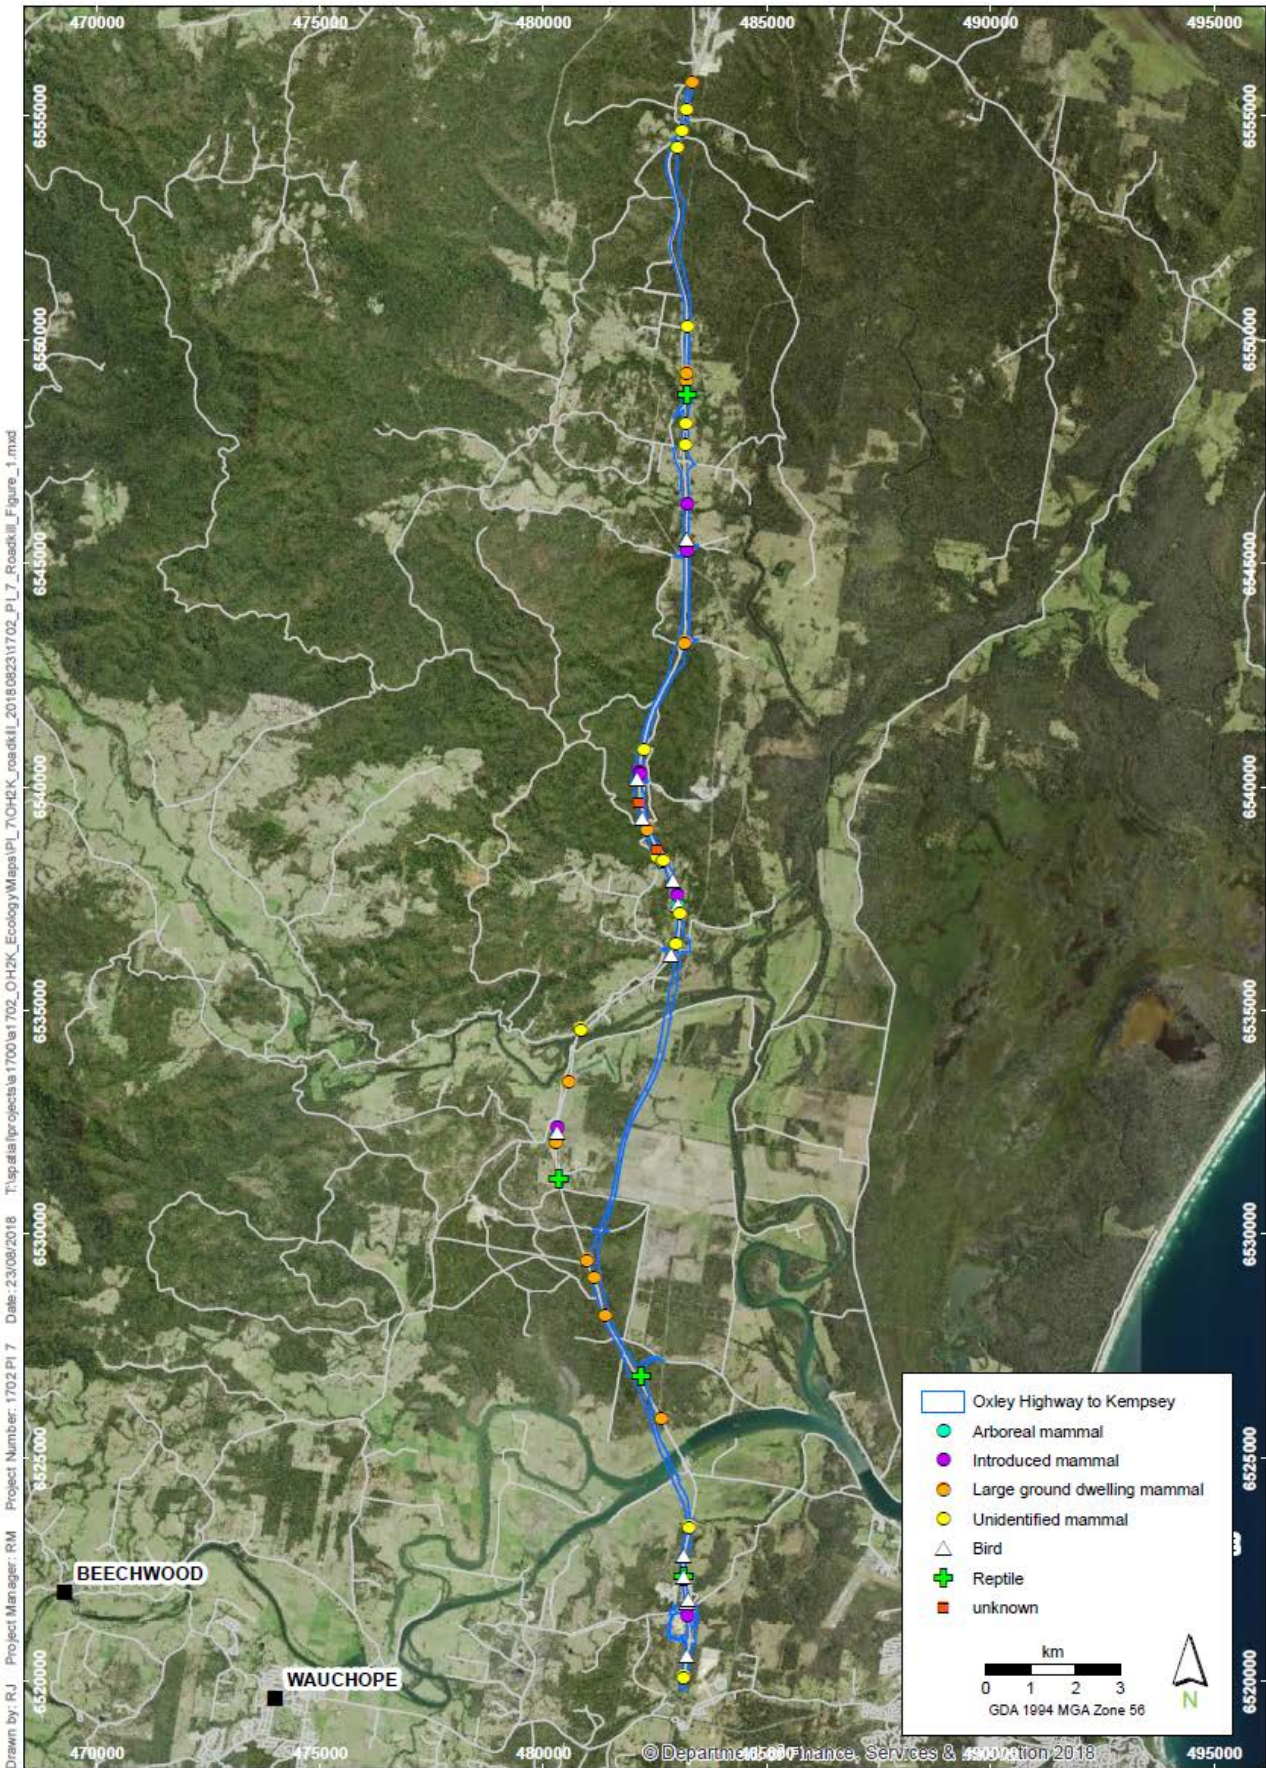
Distribution of road kill records: all construction monitoring 2017/2018

Pacific Highway Upgrade – Oxley Highway to Kempsey

The average weekly road kill for the baseline surveys and construction monitoring periods for all survey events is presented in Table 5. Graph 2 shows the seasonal average weekly road kill for each of the same four week period in baseline and construction monitoring periods. The location of road kill records for baseline (12 weeks) and 2017/2018 entire length monitoring periods (13 weeks) are shown in Figure 3. Note this figure includes only those records from surveys that included the entire length of the Project, which were not undertaken at the same time of year.

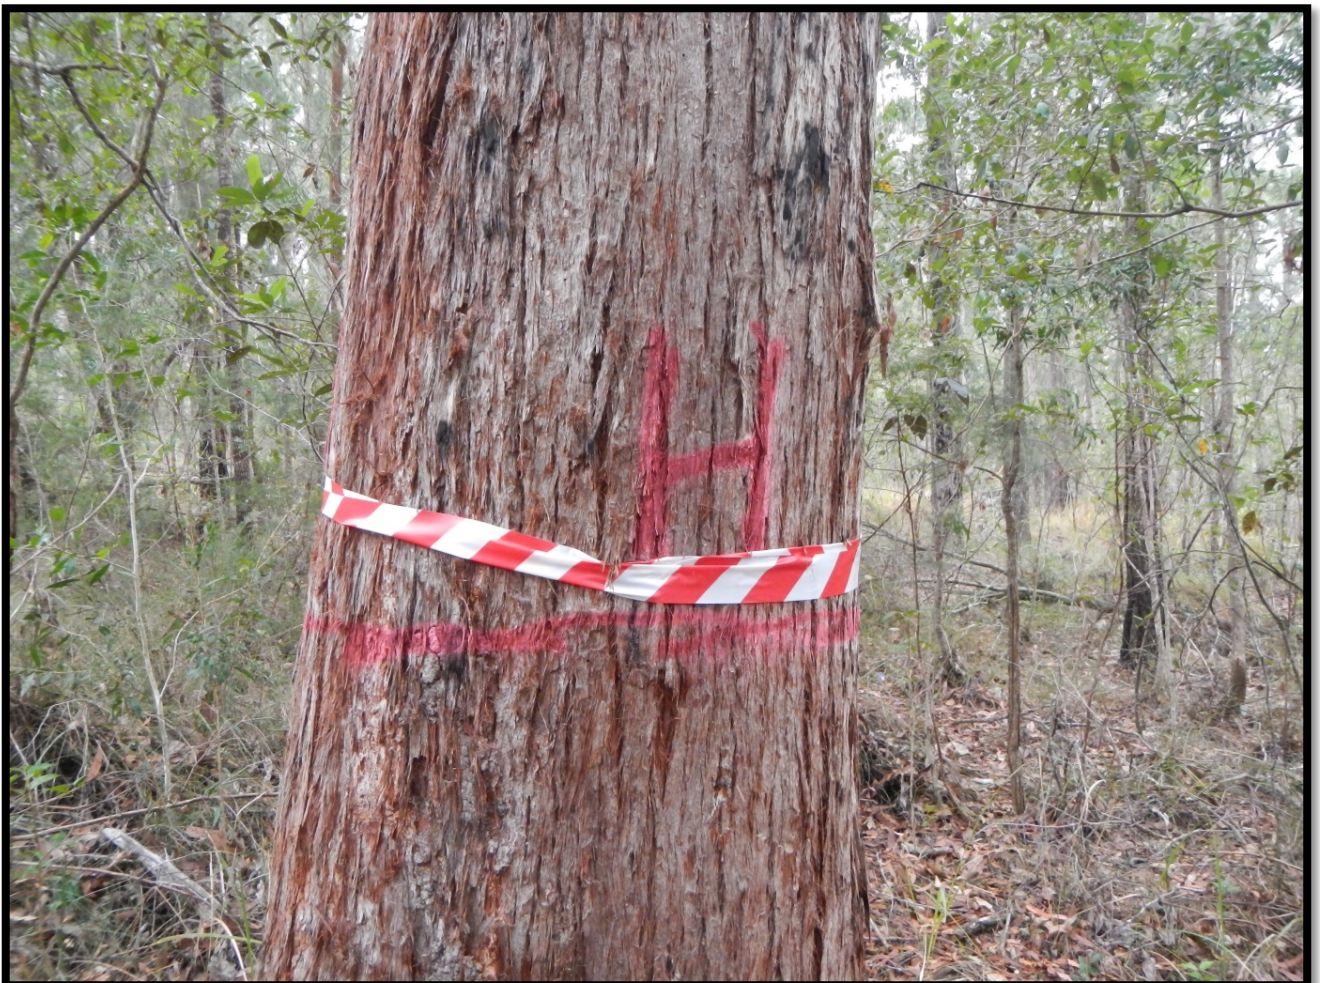
Plate 2-1. Potential hollow bearing tree (HBT) showing their field identification for the clearing and grub program.

All of the identified habitat features were marked with red and white hazard tape and between two to four large "H" were spray painted in pink paint (Plate 1-1). Habitat resource surveys were performed in September and October 2014 or in the case of design refinements and temporary works areas, at least 24 hours prior to the commencement of clearing.

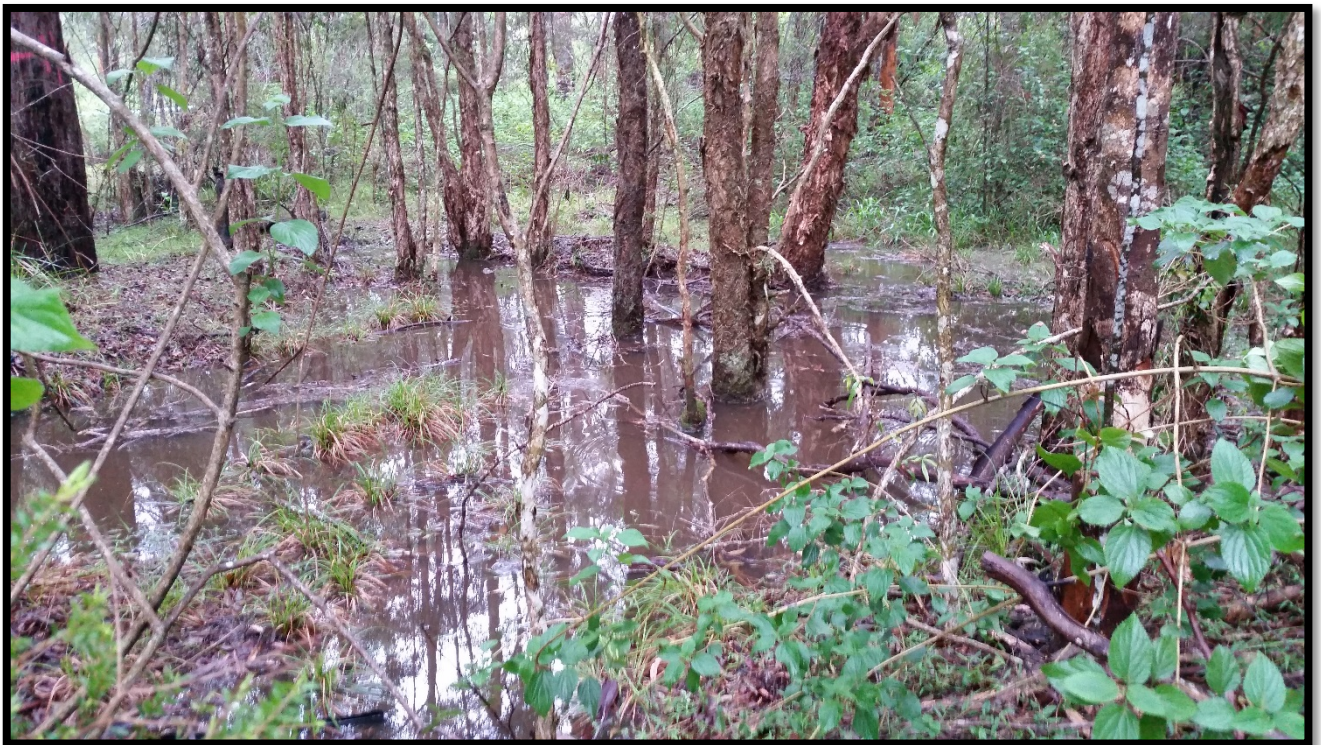
Plate 2-2. Example of a flooded depression (ch. 32600) that was subject to targeted surveys for Green-thighed Frogs.

Targeted surveys for Green-thighed Frog occurred as part of the nocturnal pre-clearing surveys. Typically, this involved spotlighting the ground cover during pre-clear surveys performed either just prior to sunrise or on the evening before. Some surveys also coincided with heavy rainfall, however, such rainfall events normally resulted in substantive delays to clearing operations but were useful in identifying additional breeding habitat and identified areas where spawn, tadpoles or metamorphs would require relocation (Plate 2-2).

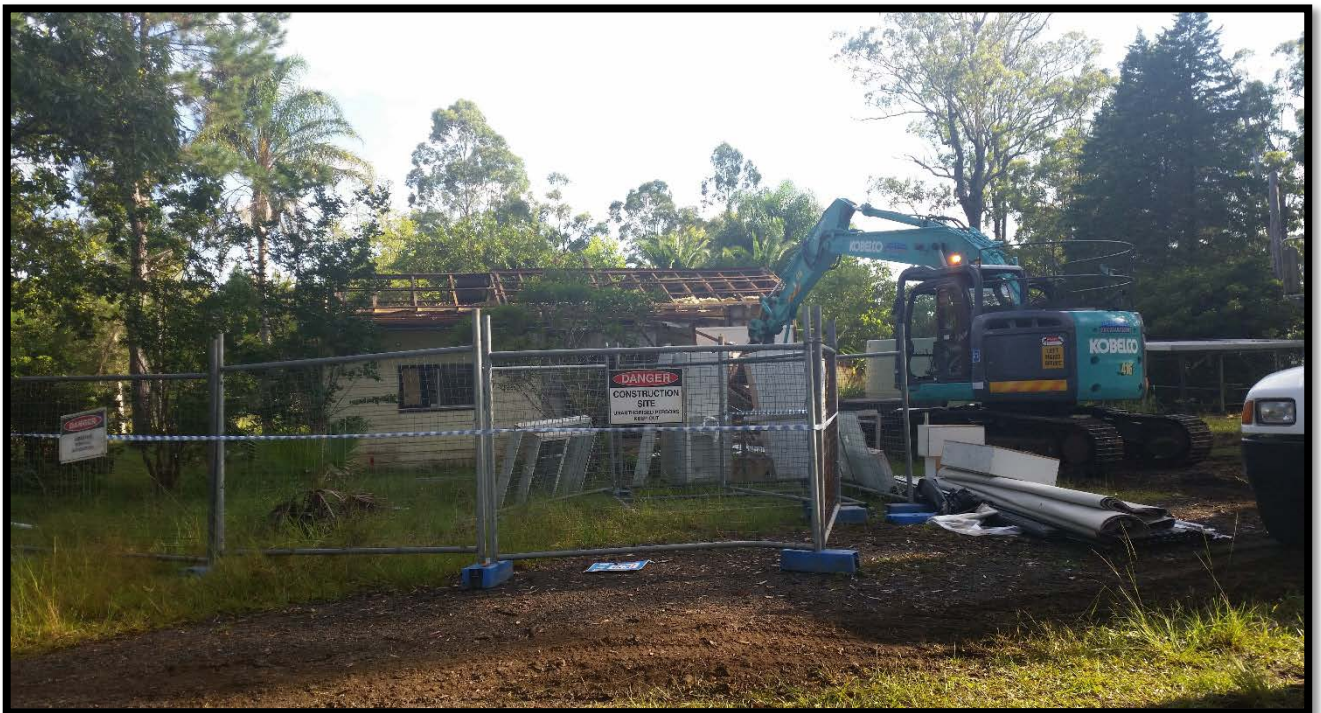
Plate 2-3. House being dismantled near Rodeo Drive was subject to micro bat inspections and works supervision.

Most of the 21 structures identified in the Microbat Management Strategy (MMS) (Lewis 2013d) as containing known or potential habitat were inspected and excluded for microbats between the 14 and 30 September 2014. Maria River Bridge and south bound Stumpy Creek bridge were not subject to exclusion works as no substantive works were planned for these structures. For the remaining 19 structures, the exclusion method proposed in the MMS was adopted. Once both the south and northbound carriageways had been completed, 21 existing but redundant culverts were identified for grout filling in August 2016. All 21 of these were subjected to the exclusion process outlined in the MMS during the field works undertaken between 14 and 17 September 2016. Some house and shed demolition works were also supervised during their dismantling for signs of micro bats (Plate 2-3).

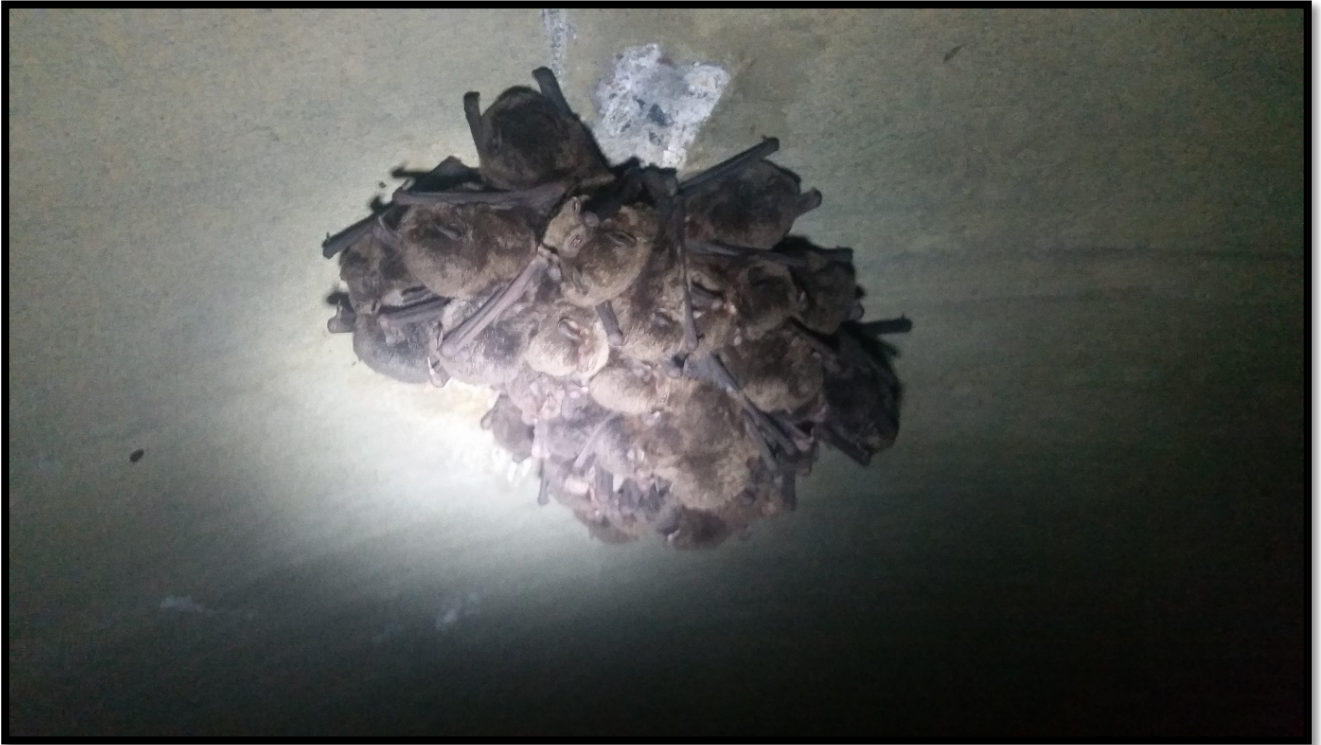
Plate 3-5. Little Bent-wing Bats recorded from culverts at Mingaletta.

Three species of threatened microchiropteran bat were recorded during the pre clear and associated clearing operations (Table 3-3). Little Bent-wing Bat was recorded from a number of culvert and bridge structures with 386 individuals recorded between Mingaletta and Maria River (Plate 3-5). This included three culverts located between Mobbs Drive and

Upper Smiths Creek Road that required grouting. Eastern Bent-wing Bat was recorded from Maria River Bridge with at least three individuals confirmed (Table 3-3). Southern Myotis was recorded from Pipers Creek where two individuals were observed using an old swallow or martin nest on the headstock of the bridge (Table 3-3).
