# Pacific Highway Upgrade - Sapphire to Woolgoolga

Operational Phase Fauna  
Crossing Monitoring Program ~  
Year 1

Version 2 - Final Report

7 February 2017

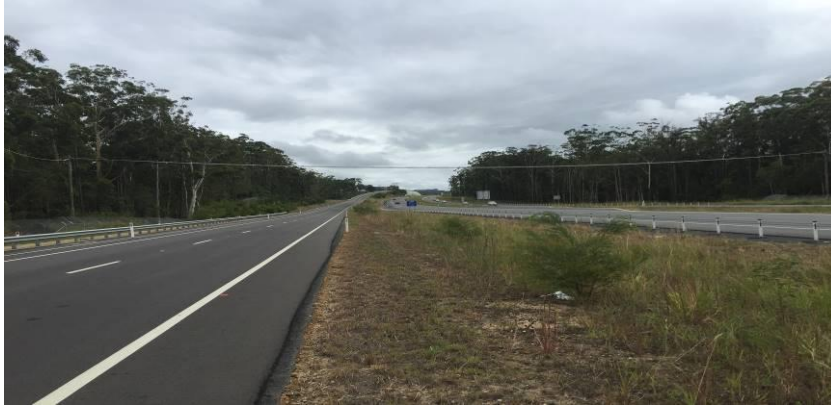
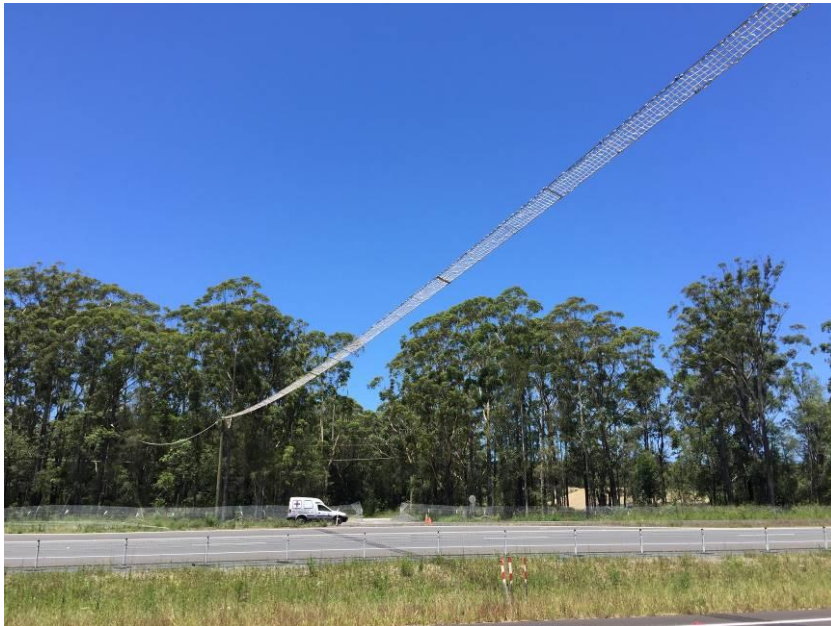
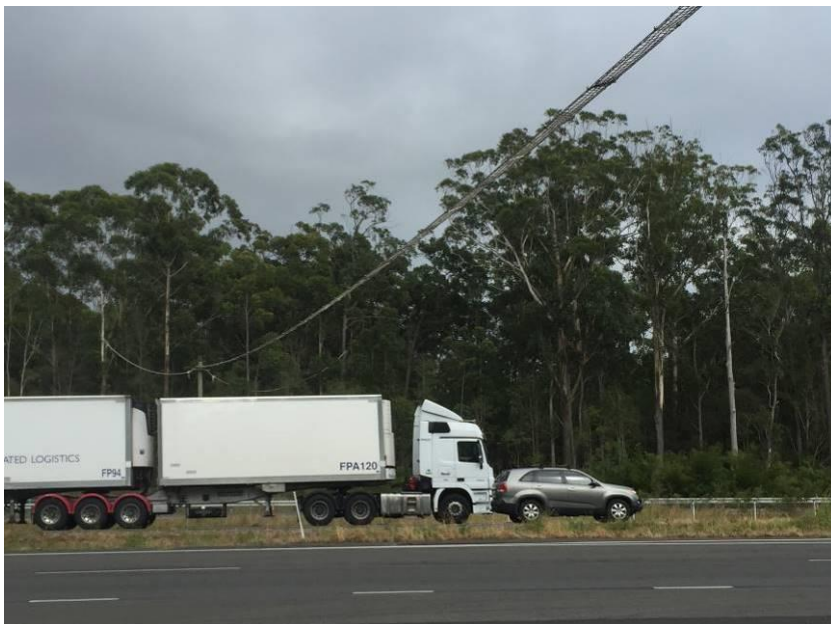
**Plate 1:** Expanse of the 86m-long Moonee rope bridge (ch.10720) looking north (upper). Habitat adjoining rope bridge on the east (middle) and west (lower) side of the alignment.

The rope bridge at Moonee (ch.10720) consisted of a ~400mm wide ladder design made from 10mm diameter silver rope woven into a 100mm wide grid pattern. The rope ladder is slung between 3mm wire rope and supported by 10mm wire rope (Plate 15). The bridge spans 86m from pole to pole and rests ~9m above the centre of the highway and 10m at the pole ends. The bridge ends are adjacent to the mid-canopy of dry open forest. Lengths of 25mm diameter silver rope extend from the bulkhead to adjacent trees (Plate 15).

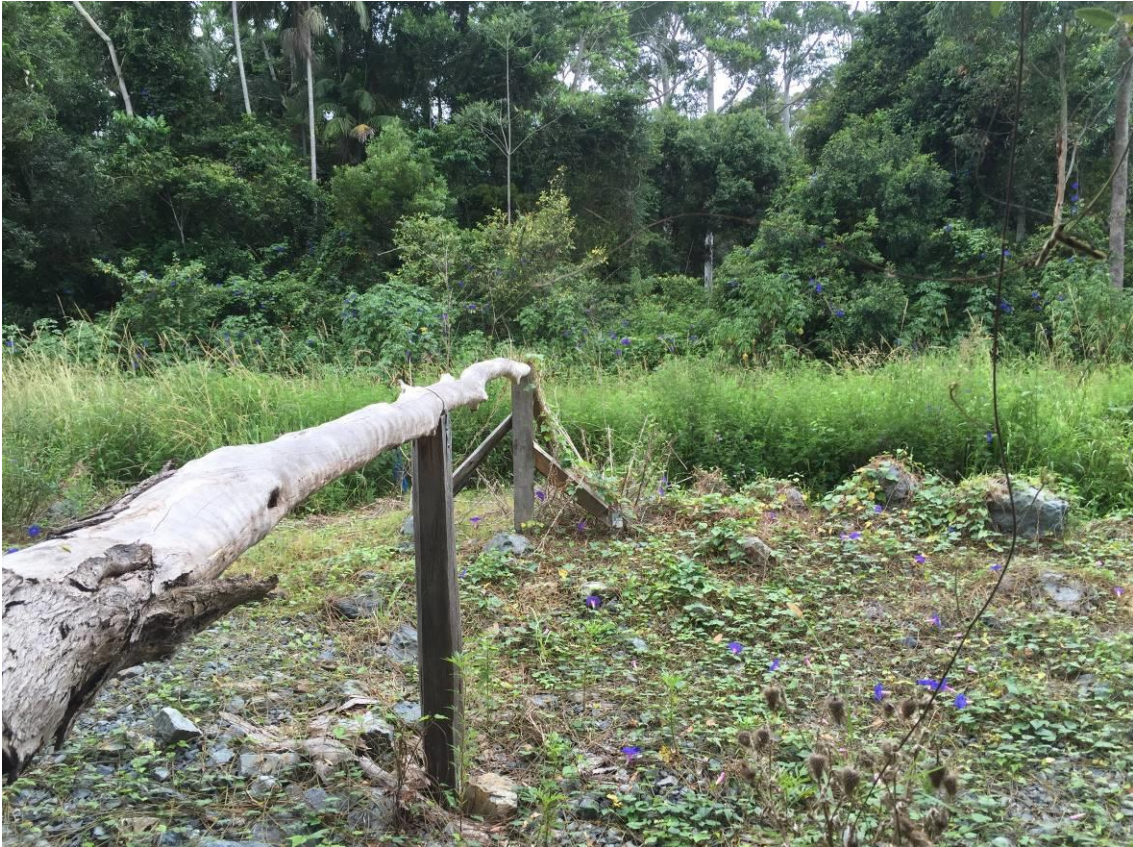
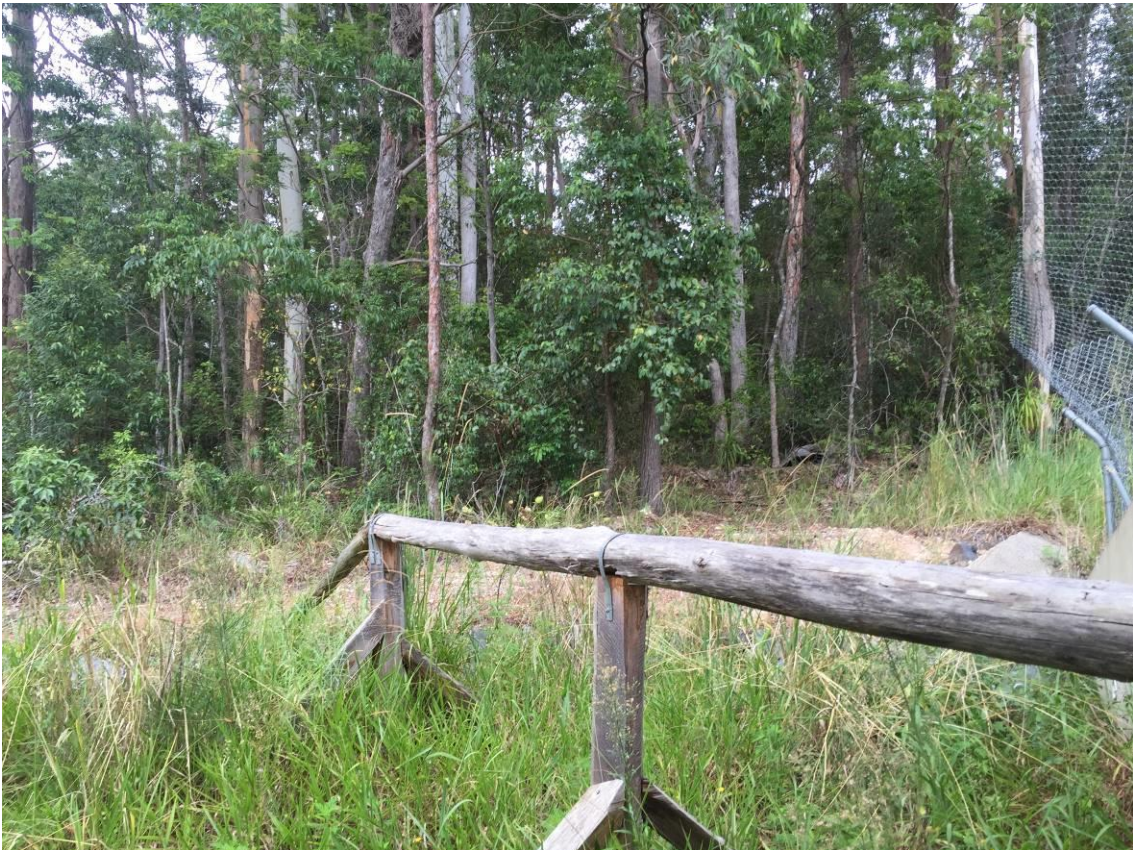
**Plate 2:** Habitat adjoining Moonee underpass (ch.11500) on the east (upper) and west (lower) side of the alignment.

Habitat configuration differed greatly amongst the monitoring sites (Figure 1a&b; Plate 1-7). Habitat surrounding Emerald Beach and Moonee underpasses was highly fragmented, particularly on the west side, and Moonee east and Emerald Beach west adjoined cleared easements (Plate 2 & 3). The section of highway featuring the Arrawarra vegetated median and underpasses traversed Wedding Bells State Forest and was surrounded by contiguous forest (Figure 1a). The Arrawarra glide poles were contiguous with Wedding Bells State Forest to the west and a forested block to the east (Figure 1a). The rope bridge at Moonee connected fragmented but contiguous forest to the west with a large forest block to the east side of the highway (Figure 1b).

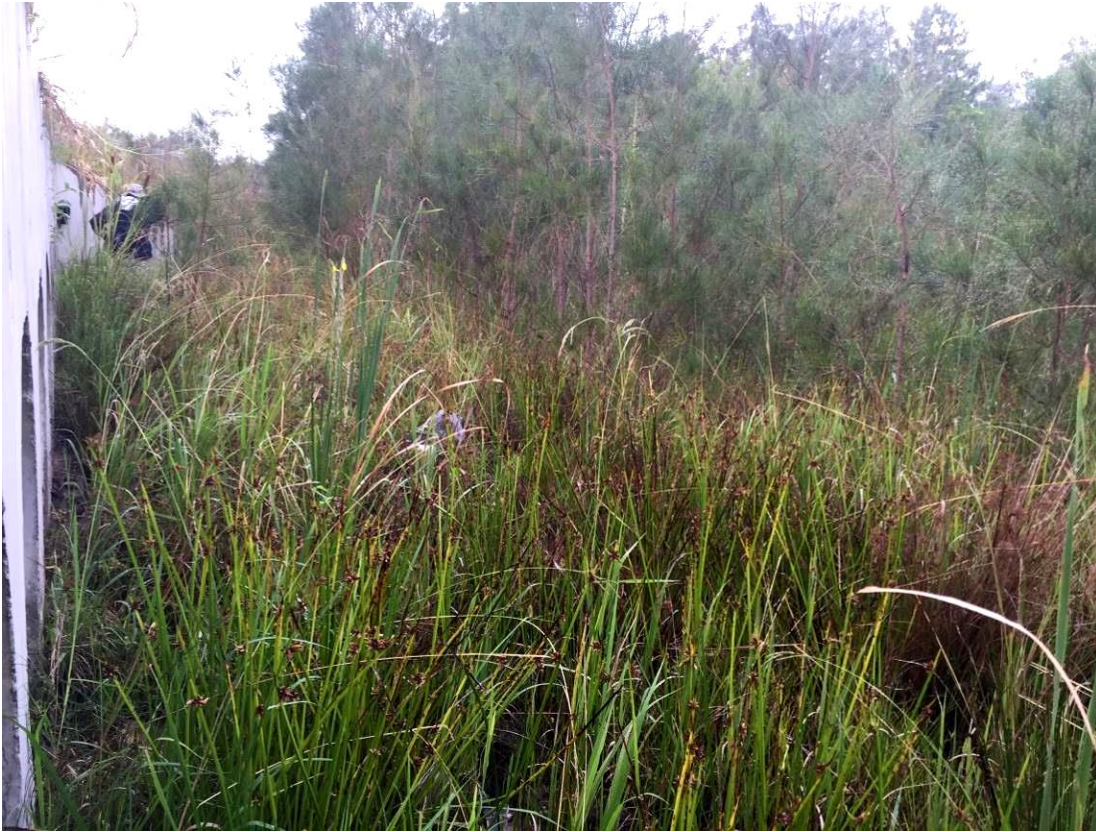
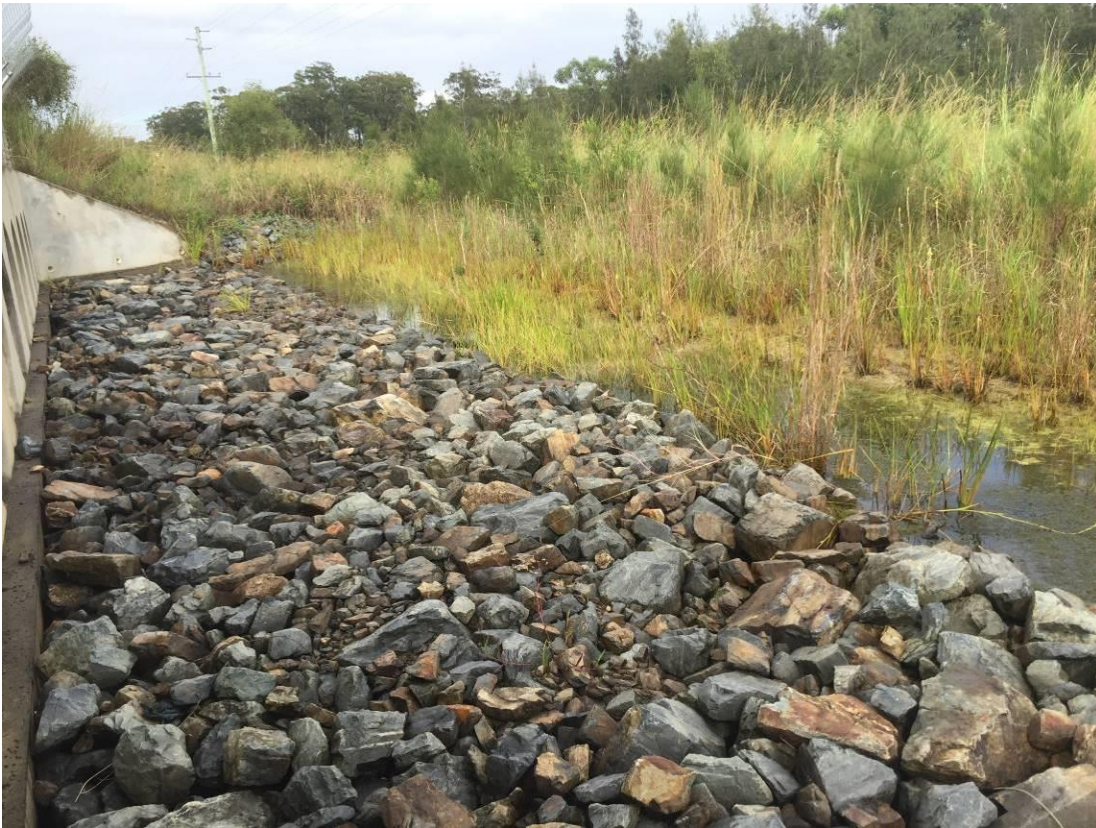
**Plate 3:** Habitat adjoining Emerald beach underpass (ch.17500) on the east (upper) and west (lower) side of the alignment.

Habitat type adjoining crossing structures was mostly dry and moist open forest (Plates 1-7). Emerald Beach and Arrawarra north underpasses also featured areas of swamp forest. The distance between forest edge and underpass entrance ranged between 3.5m (Emerald Beach east) and 29.5m (Emerald Beach west)

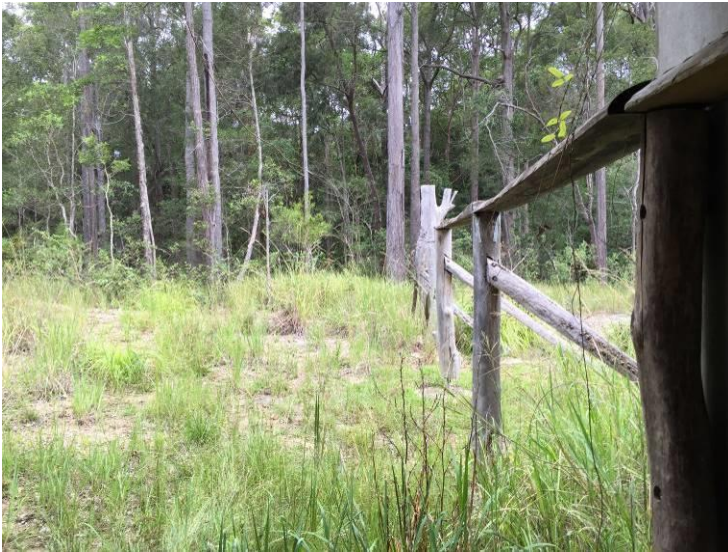
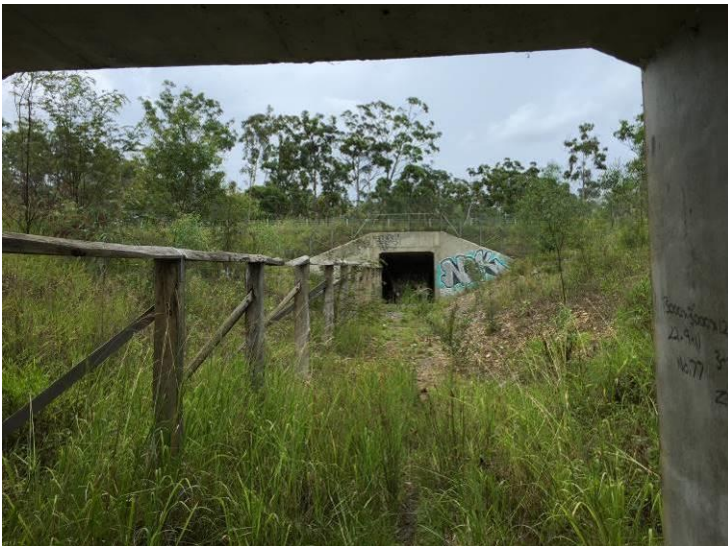
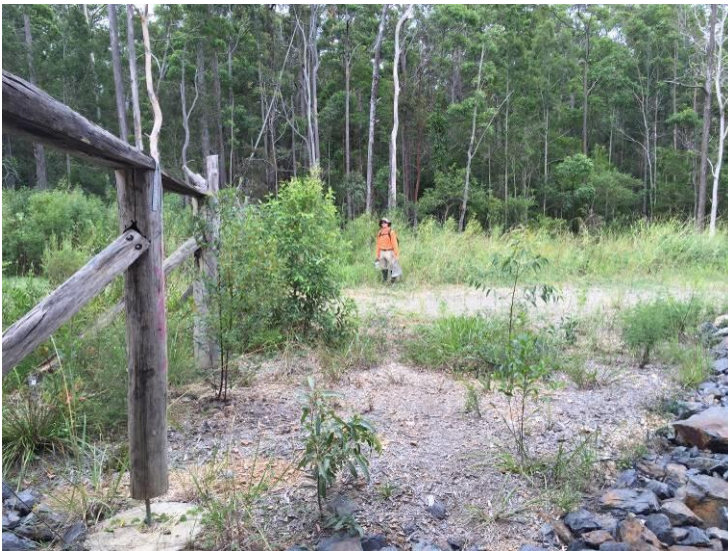
**Plate 4:** Habitat adjoining Arrawarra underpass south (ch.29380) on the east (upper) and west (lower) side of the alignment and across the vegetated median (middle).

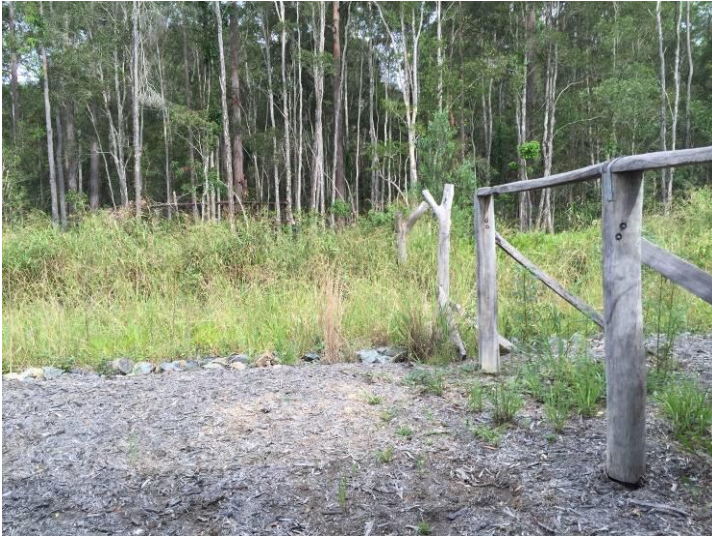
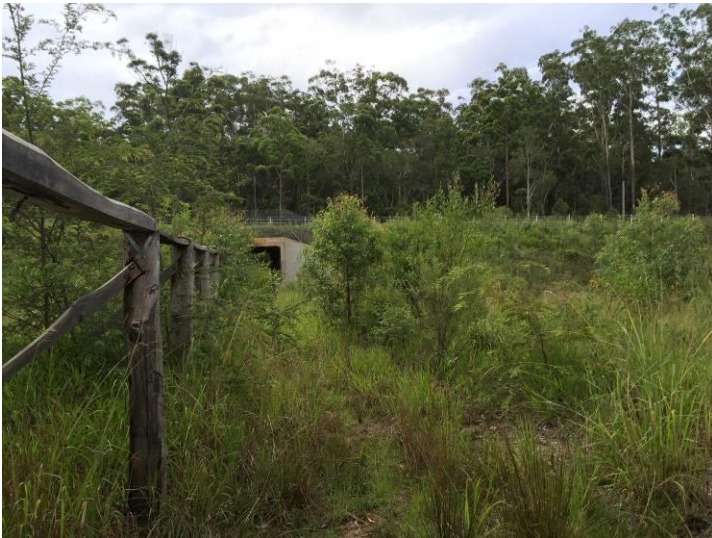
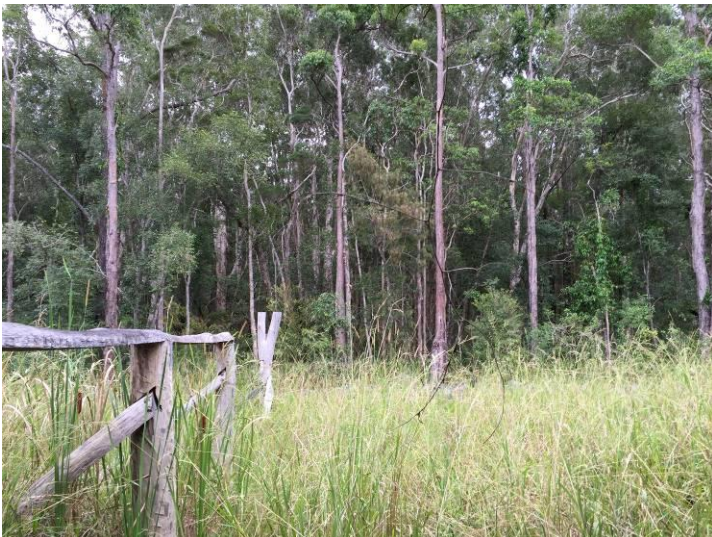
**Plate 5:** Habitat adjoining Arrawarra underpass north (ch.29930) on the east (upper) and west (lower) side of the alignment and across the vegetated median (middle).

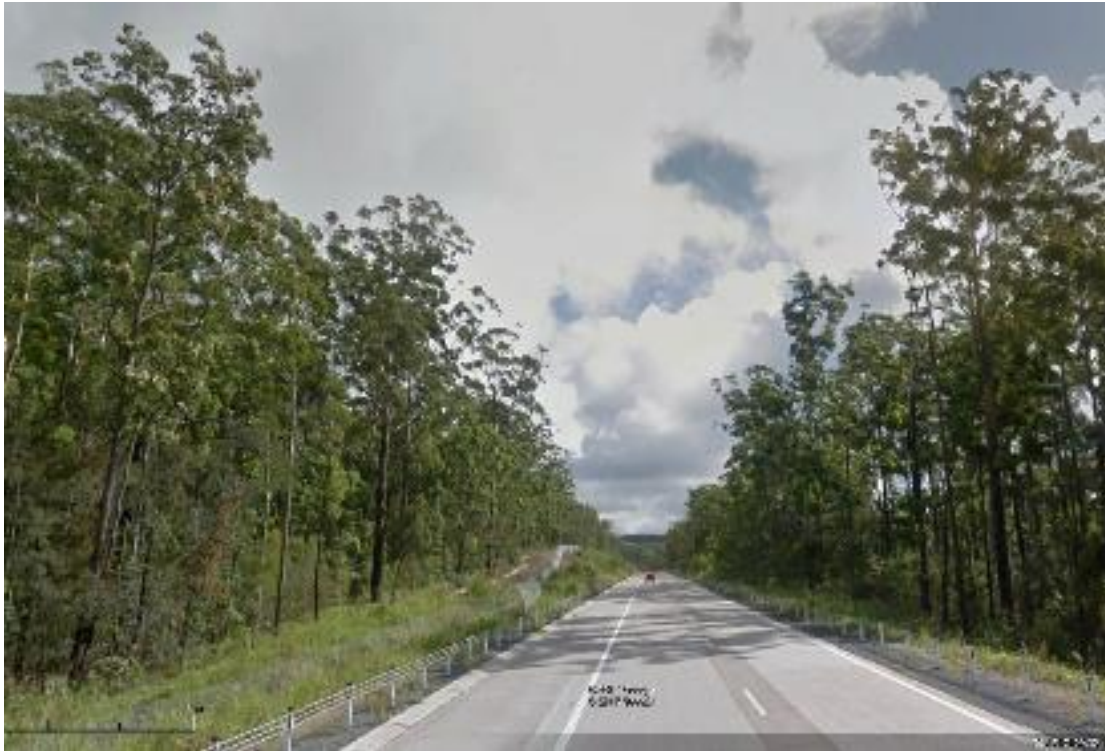
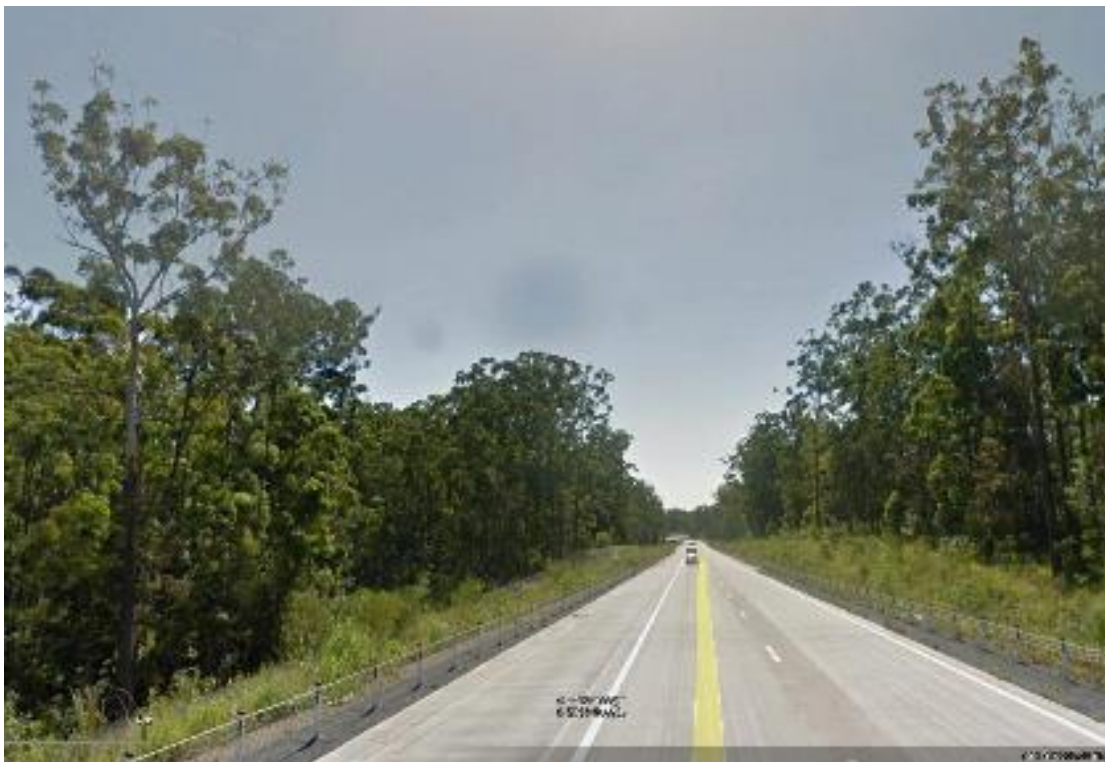
**Plate 6:** Habitat adjoining Arrawarra vegetated median (ch.29100-30200) on the east/southbound (upper) and west/northbound (lower) side of the alignment. Adjoining habitat is on the left side of both pictures. (Image: Google Earth).

The vegetated median at Arrawarra (ch.29100-30200) was 1100m long and ranged in width between 10-35m (Plate 6). The vegetation was largely dry open forest with tree heights of up to  $\sim 35\text{m}$ . The most prominent trees were located in the central 600m of the median. Canopy gaps along the carriageways were  $\sim 30\text{-}60\text{m}$ .

At the beginning of the summer/autumn monitoring period, two 500m-long transects were established in habitat immediately to the east and west of the vegetated median (Figure 1; Plate 6). Each transect ran parallel to the highway and meandered ~5-40m from the forest edge. Transects were used for nest box installation, trapping, hair funnels and spotlighting. A third 500m-long transect was also established in the median for installation of traps, hair funnels and spotlighting.

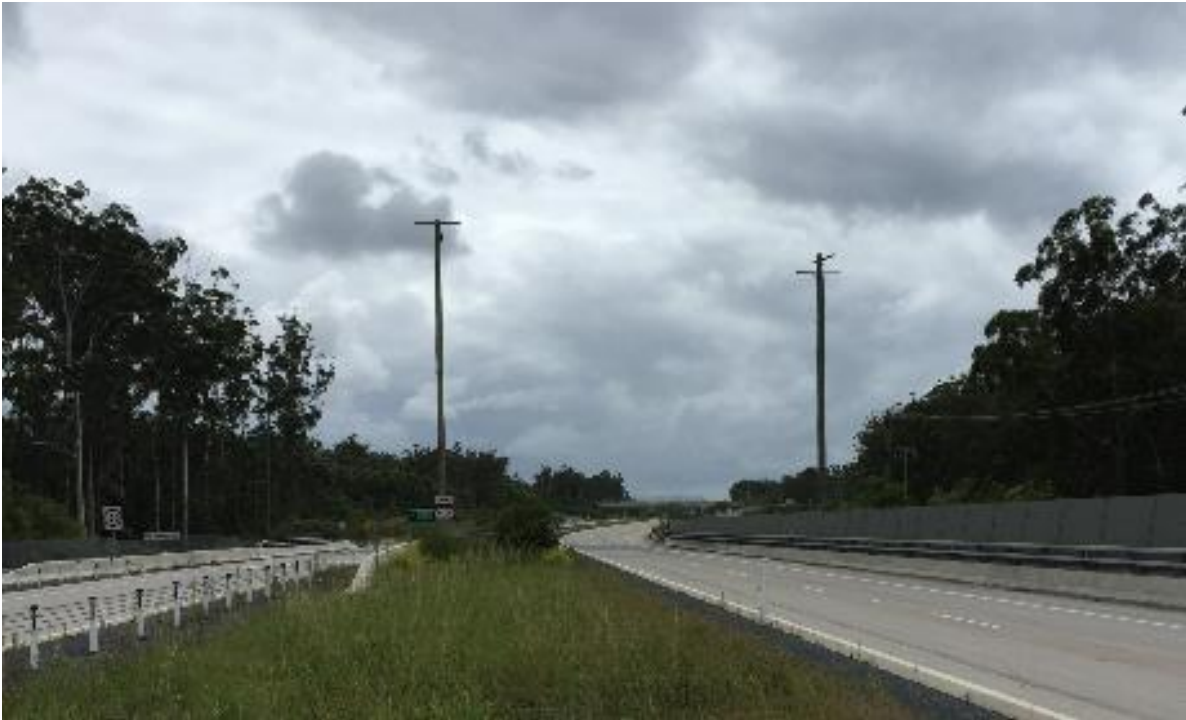
**Plate 7:** Habitat adjoining Arrawarra Creek glide poles (ch.31000) looking north. Cameras were installed on the central pole in the highway median.

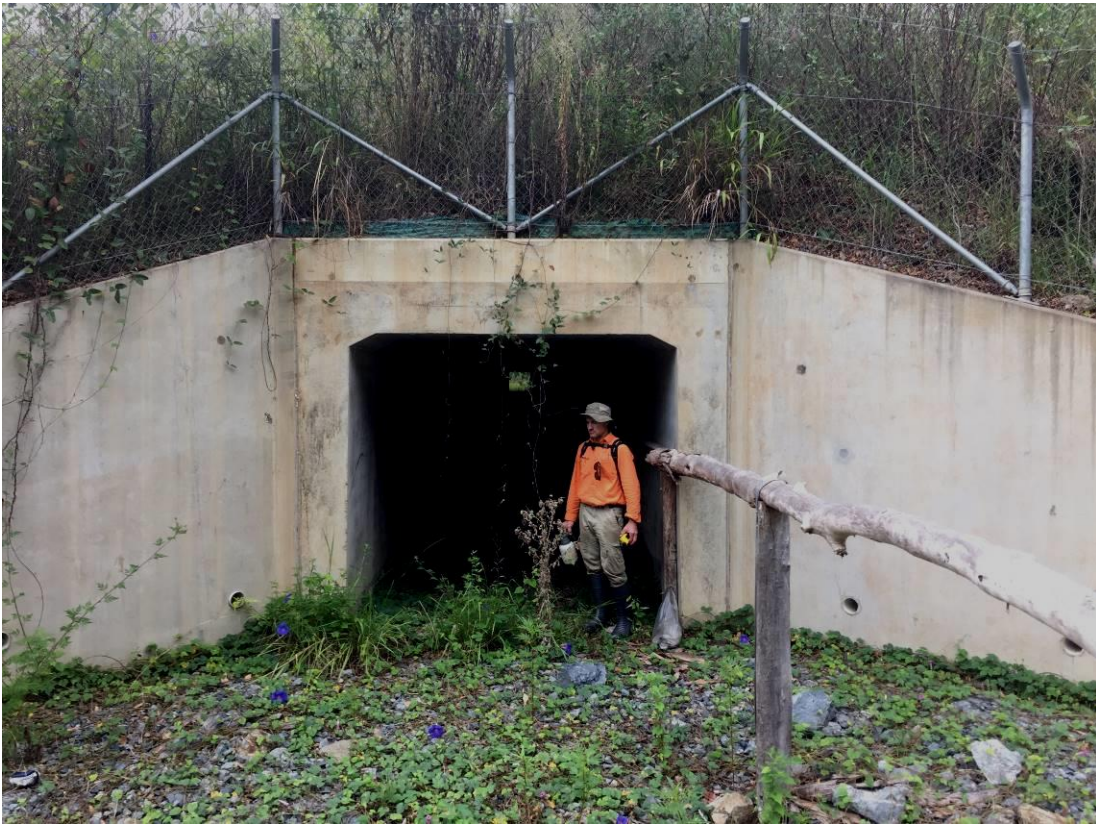
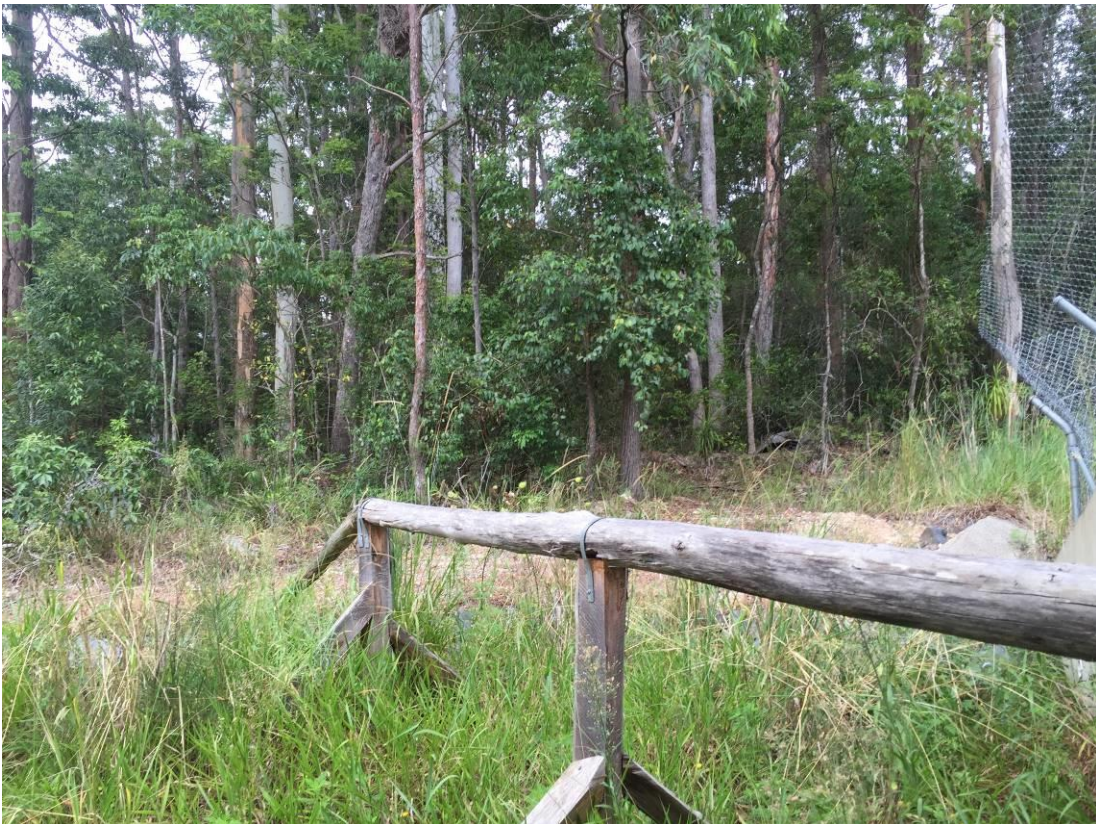
**Plate 8:** Moonee underpass (ch.11500) viewed from the east (upper) and from the west entrance (lower).

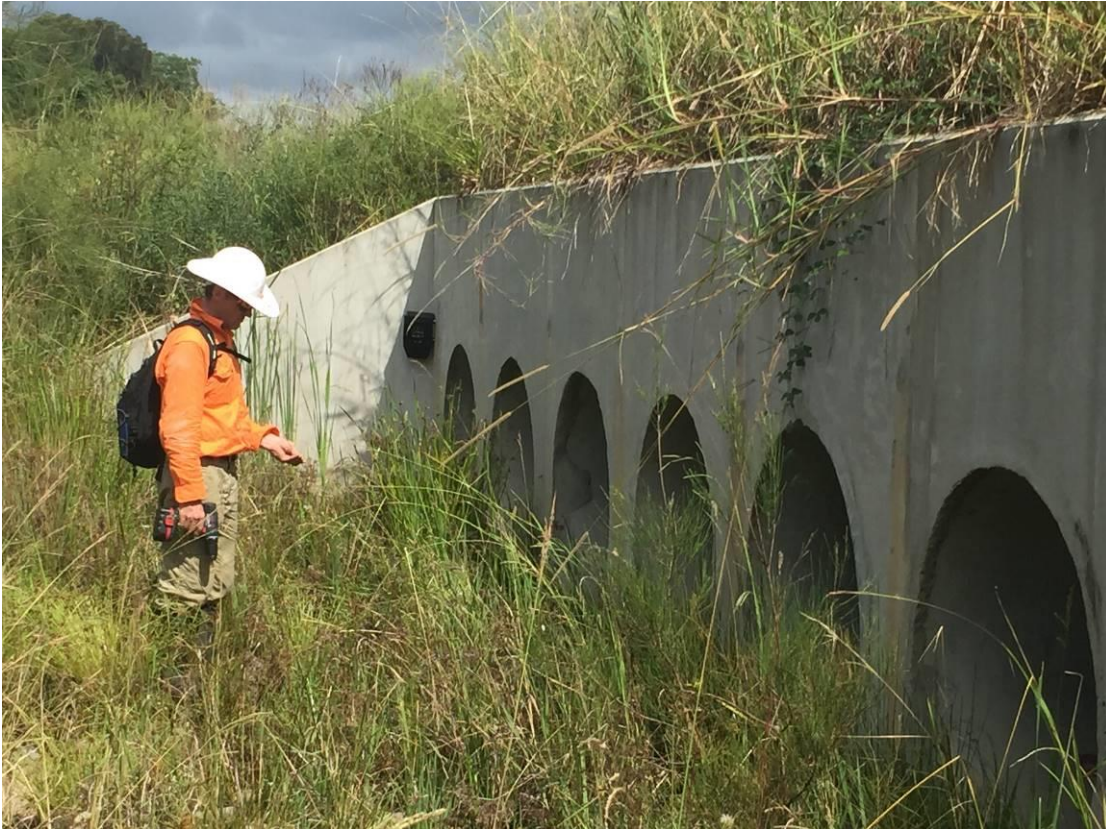
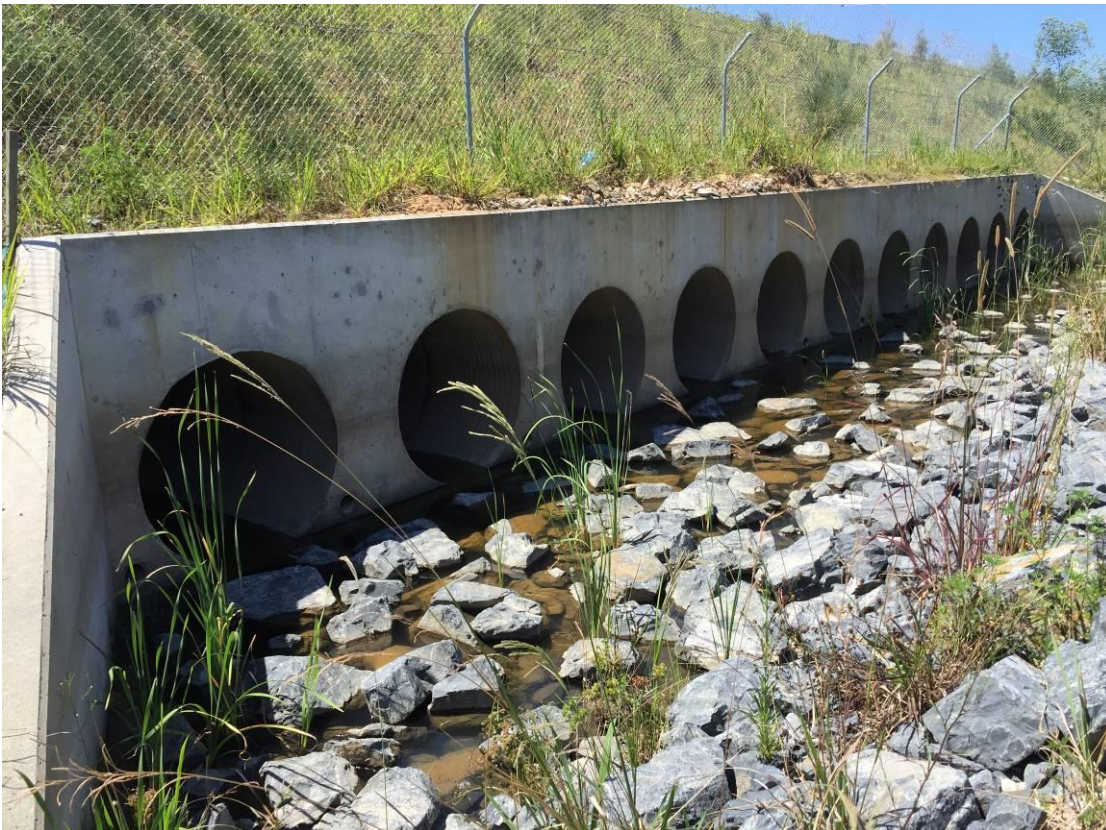
**Plate 9:** Emerald Beach underpass (ch.17500) viewed from the east (upper) and west (lower).

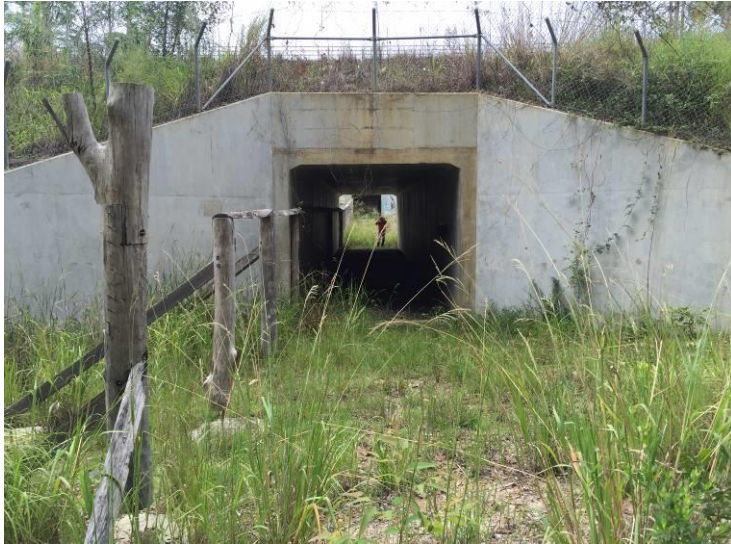
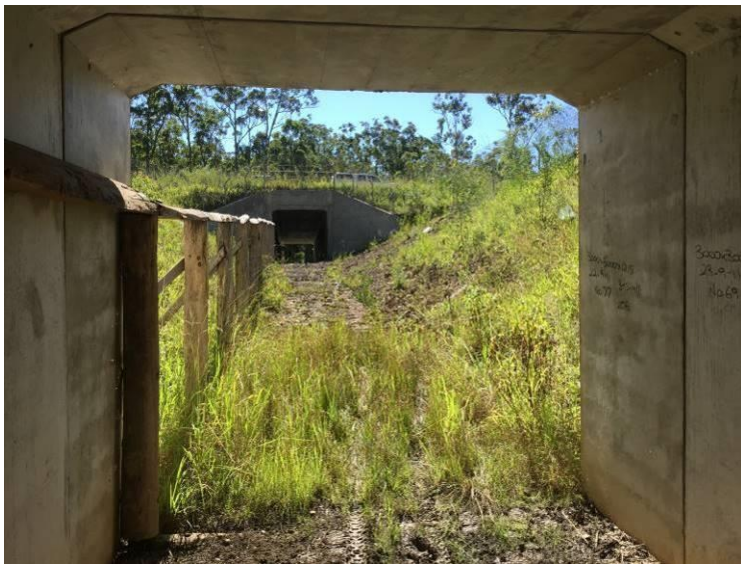
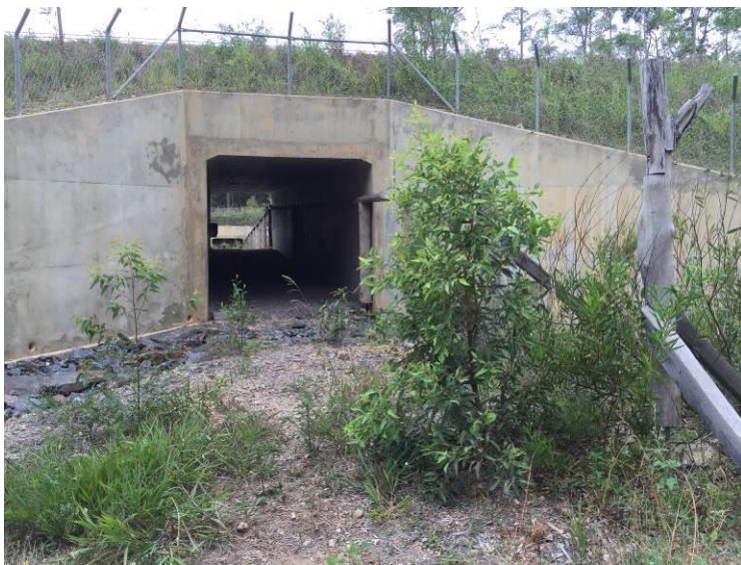
**Plate 10:** Arrawarra underpass south (ch.29380) viewed from the east (upper), across the vegetated median (middle) and from west (lower).

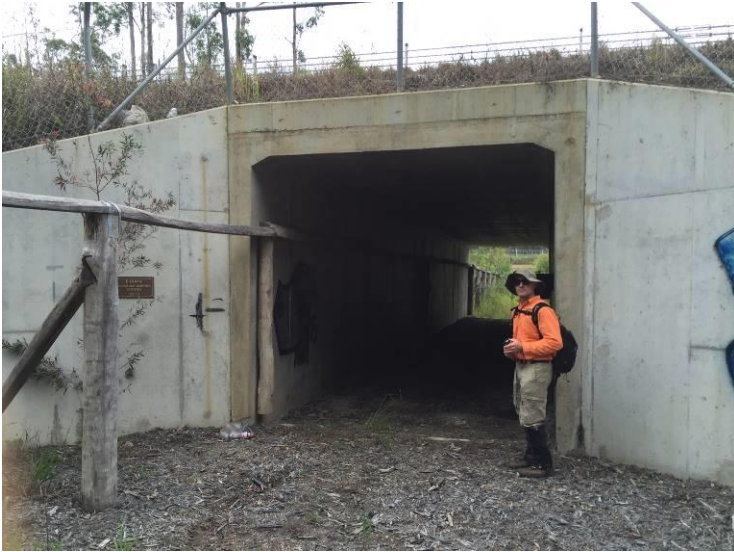
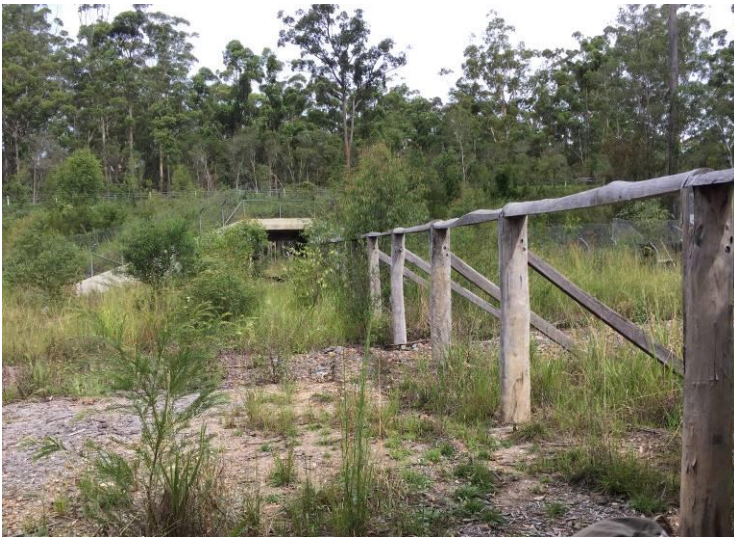
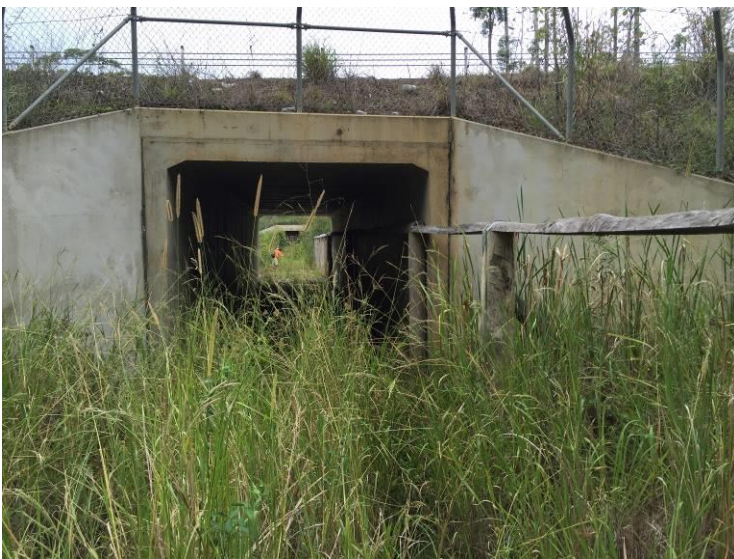
**Plate 11:** Arrawarra underpass north (ch.29930) viewed from the east (upper), across the vegetated median (middle) and from west (lower).

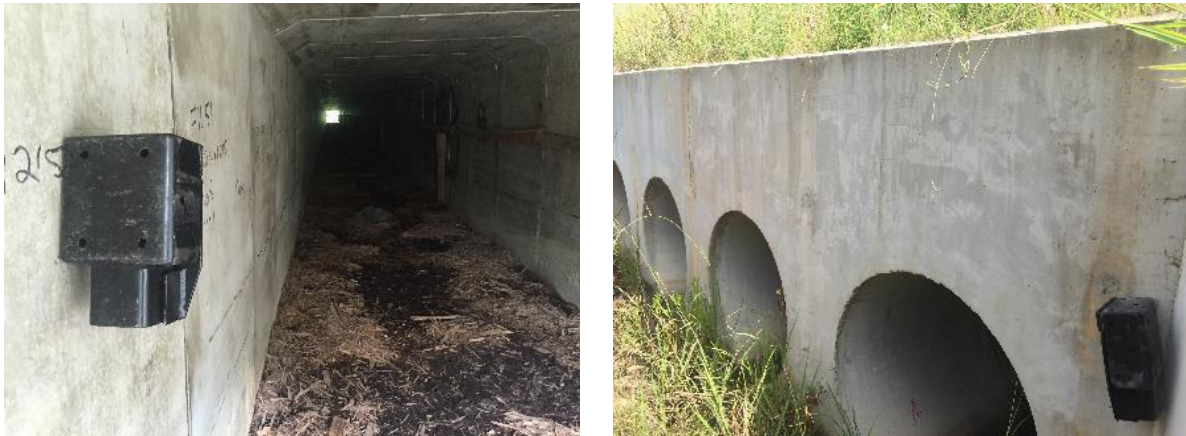
Monitoring was undertaken at the four underpasses using Reconyx HC500 infra-red (IR) cameras. To confirm complete crossings by fauna, a camera was installed at each end of the single cell underpasses (i.e. Arrawarra north & south, Moonee). Cameras were mounted to the side wall opposite the wooden rail, ~1.5m above floor level and ~2m inside the entrance and facing inwards (Plate 12). Cameras were housed in purpose-built security cases. At the Emerald Beach site, the pipe series is almost 20m across, well beyond the field of view of a single camera. Monitoring of single pipes was impractical because the site featured 11 pipes. Instead, the two cameras were used to achieve full coverage of the entire entrance area of one side. As such, two cameras were positioned at the east side only. Each camera was positioned at either end of the pipe series facing across the entrance area (Plate 12).

**Plate 12:** Single cell underpasses were monitored at each end with a Reconyx HC500 camera housed in a security case and mounted to the side wall opposite the wooden rail (e.g. Moonee underpass, Left). For the pipe series at Emerald Beach, a camera was mounted on the wing wall at each end of the pipe series and directed across the entrance area of the east side (Right).

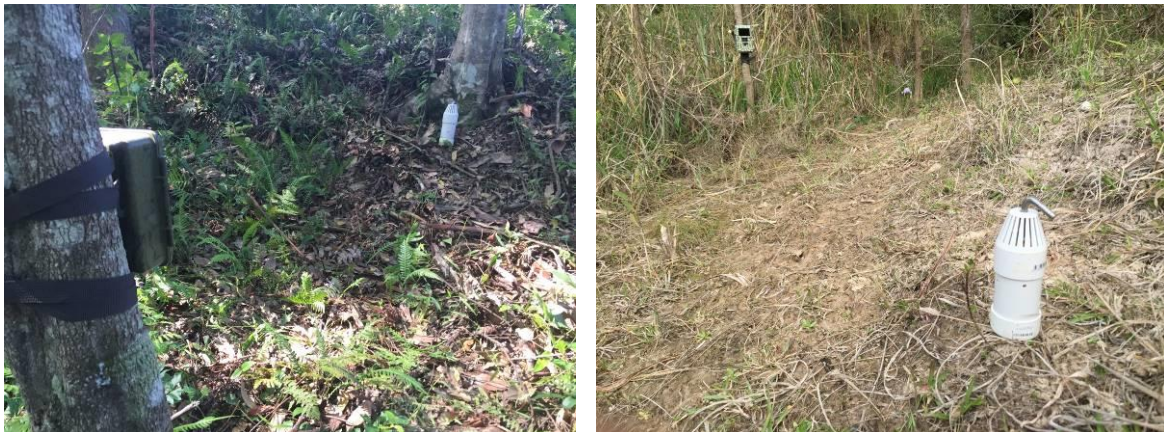
Camera bait stations were installed on either side of each underpass to sample fauna in adjoining habitat. Two bait stations were each positioned at  $\sim 45^\circ$  to and  $\sim 50\text{m}$  from each culvert entrance. Each station featured a Scoutguard KG680V infra-red (IR) camera strapped to a tree or post at  $\sim 1\text{m}$  high and focused on a bait chamber  $\sim 2\text{m}$  away (Plate 13). Bait chambers were 150mm long PVC pipe (50mm diameter) capped at both ends and perforated with numerous holes. One bait chamber was baited with chicken wings and the other with peanut butter, honey and oats. Fish sauce was drizzled over the chicken bait chambers to serve as an additional attractant. Bait chambers were anchored to the ground with a tent peg.

**Plate 13:** Camera bait stations featured a Scoutguard KG680V strapped to a tree at  $\sim 1\text{m}$  high and focused on a bait chamber containing either chicken wings (L) or peanut butter, honey and oats (R).

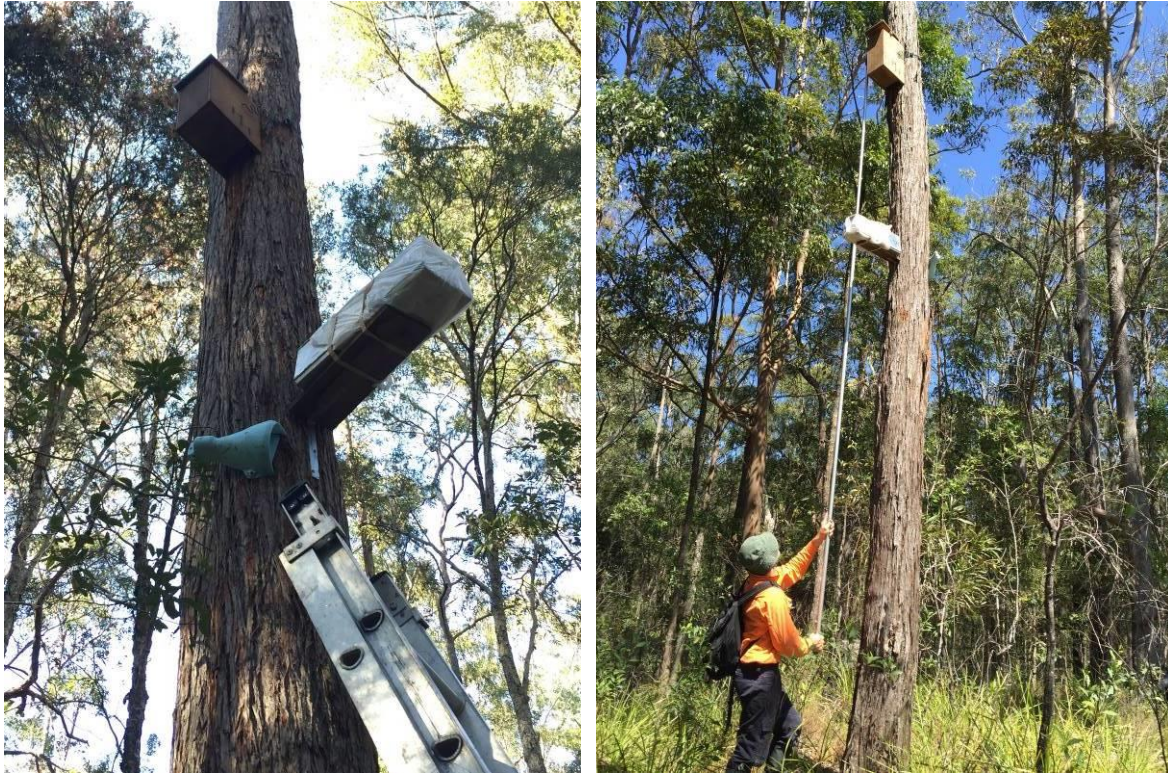
The contents of nest boxes were inspected by two personnel utilising a purpose-built GoPro camera mounted on an extendable pole. Images from the GoPro camera were wirelessly streamed to an iPad for viewing. Fauna present, signs of use and box condition were recorded for each box. If a box contained gliders, a ladder was used to access the box and remove the individuals. Captured gliders were weighed, sexed and breeding status determined. Each individual was then issued a numbered ear tag and returned to the box.

**Plate 14:** Nest box, Elliott trap and hair funnel mounted on a trap-tree (L). Nest boxes were inspected using a purpose built, GoPro camera mounted to an extendable pole (R).

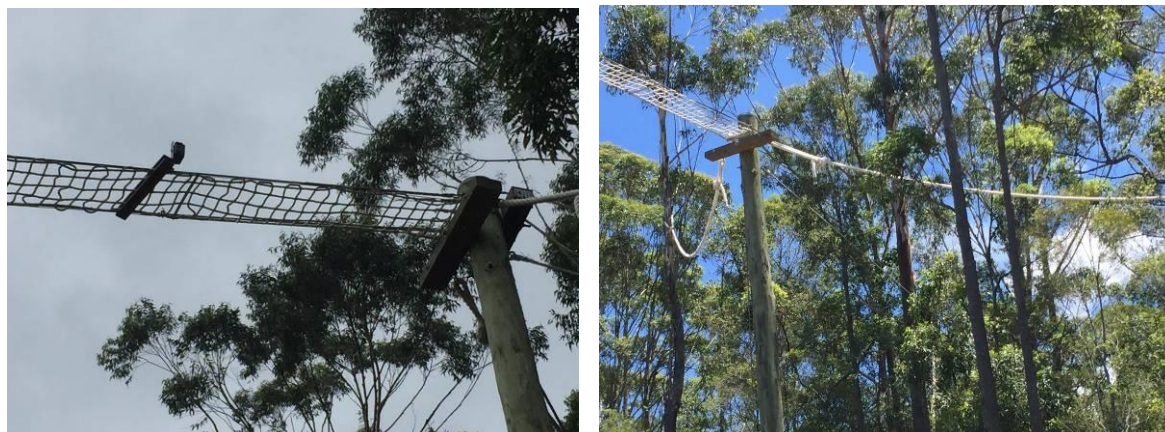
**Plate 15:** A Reconyx camera mounted to a wooden ‘sandwich board’ was positioned ~2m from each end of the rope bridge to capture moving fauna (L). 25mm silver rope was used to link the bulkhead to surrounding trees (R).

Due to the low height of the rope bridge, excessive false-triggering caused by moving traffic resulted in early battery fatigue and/or filled memory cards and loss of monitoring days. The east camera was especially affected resulting in loss of 8 days. To mitigate this, the camera was moved 2m out along the rope bridge and orientated back towards the bulkhead on 14/5/15. Twelve monitoring days were lost from the west camera when it was knocked out of alignment (possibly by a falling branch) during September. To account for lost days and to fulfill the required 220 days, monitoring continued until 15/12/15 (Table 6).

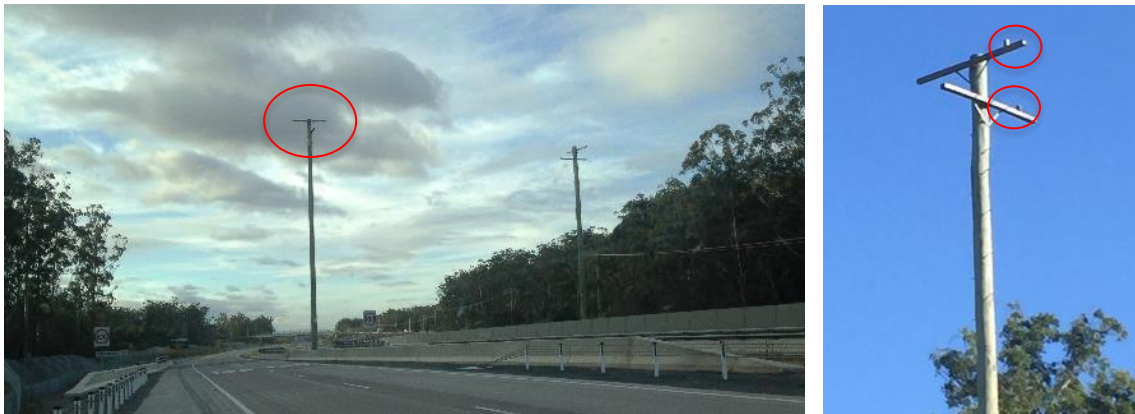
The central glide pole stands 21.5m and the east pole ~18m above road level. Both poles are treated hardwood and ~500mm diameter at breast height. Two arms for gliders to launch from project east-west (upper arm) and north-south (lower arm). Each arm is ~3000mm long and 150 x 100mm thick undressed hardwood and are brace-mounted to the pole. The arms are positioned ~200mm and ~900mm from the pole top. The central pole is 36m from the closest roadside tree to the west and 25m to the glide pole to the east side and a further 23.5m to the closest roadside tree. Roadside tree canopy heights are up to ~25m on the west side and up to ~22m on the east side.

**Plate 16:** View of the glide pole array at Arrawarra creek looking north where cameras were installed on the central glide pole positioned between the carriageways (red circle) (L). Solitary Islands Way adjoins the dual carriageway immediately to the east (right of the photo). A Reconyx camera was mounted near the end of each arm of the pole (R).
