# Pacific Highway Upgrade - Sapphire to Woolgoolga

Operational Phase Fauna  
Crossing Monitoring Program ~  
Year 1

Version 2 - Final Report

7 February 2017

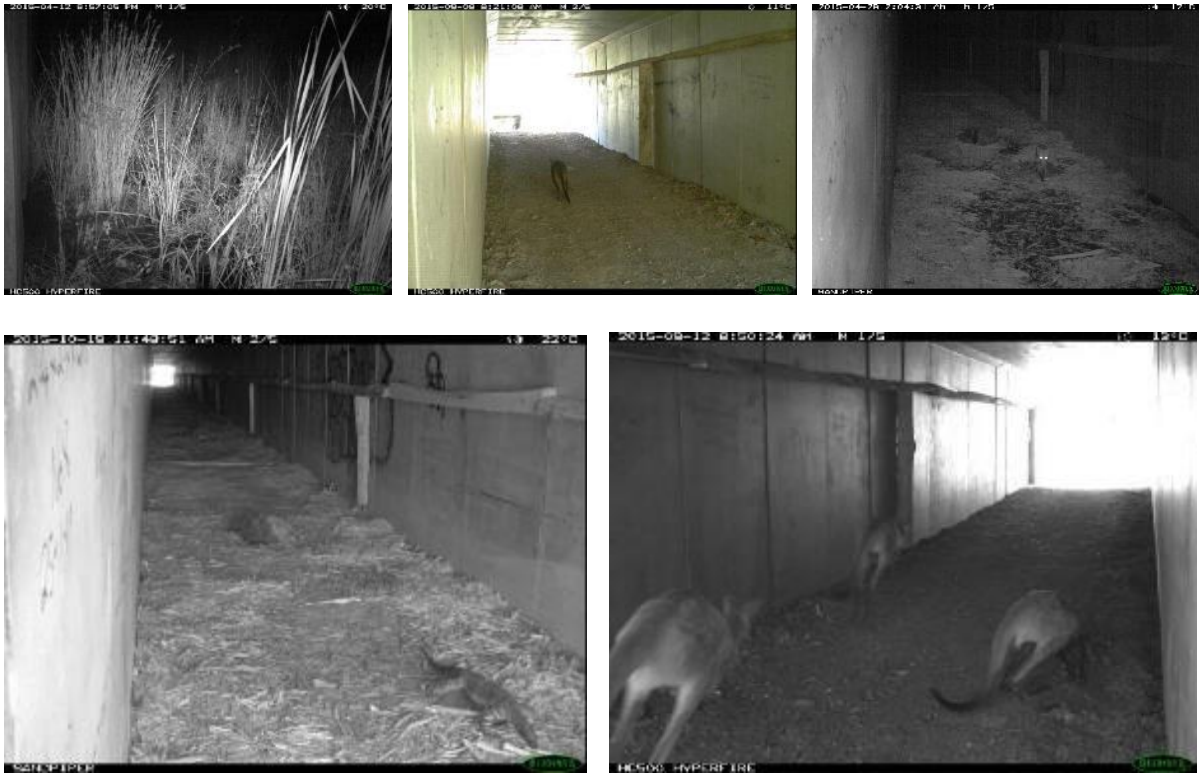
**Plate 19:** Seven species were recorded making crossings of the underpasses, including northern brown bandicoot at Emerald Beach (top L), swamp wallaby at vegetated median south (top M), red fox (top R; with prey in its mouth), lace monitor at Moonee (bottom L) and eastern grey kangaroos at vegetated median south (bottom R).

Seven fauna species were confirmed using at least one of the four fauna underpasses during autumn and spring monitoring (Table 8; Plate 19). Echidna is not included as it was only recorded on one occasion exploring the outside of the Emerald Beach pipe series and did not demonstrate directional movement in or out of a pipe (i.e. visit). One hundred and twenty-seven passes and 89 full crossings were recorded by the eight cameras. More passes and crossings were recorded in spring than autumn (95 and 69 versus 32 and 20) although this was largely attributed to high use of Moonee underpass by red fox during spring. Moonee was the most frequented underpass with 84 passes and 63 full crossings although this is similarly attributed to high use by red fox. Vegetated median north and south were underpasses most frequented by native fauna (14 passes each) and Moonee and Emerald the least frequented (6 and 7 passes respectively). Vegetated median north featured the greatest diversity of native species users, including lace monitor (*Varanus varius*), eastern grey kangaroo (*Macropus giganteus*), red-necked wallaby (*Macropus rufogriseus*) and swamp wallaby. Emerald Beach also recorded four native species around the entrance area but only northern brown bandicoot was recorded crossing based on directional movement toward the pipe opening (Plate 19).

Six mammal species were recorded using the four underpasses (Table 8). Eastern grey kangaroo made passes of cameras at all underpasses yet was only recorded making full crossings at vegetated median north. Swamp wallaby was the most prolific native species user, registering the most passes and crossings (26/20) and was recorded at all underpasses except Emerald Beach (Plate 19). Northern brown bandicoot was recorded making a crossing through a pipe at Emerald Beach based on strong directional movement (Plate 19). Two introduced mammal species, red fox and dog (*Canis familiaris*), were recorded at Moonee and Emerald Beach (fox only) underpasses. Red fox frequently made full crossings of the Moonee underpass and was photographed with prey in its mouth on four occasions (Plate 19). Lace monitor was the only reptile species recorded. It made passes at three of the four underpasses, including full crossings at Moonee and vegetated median north (Plate 19).

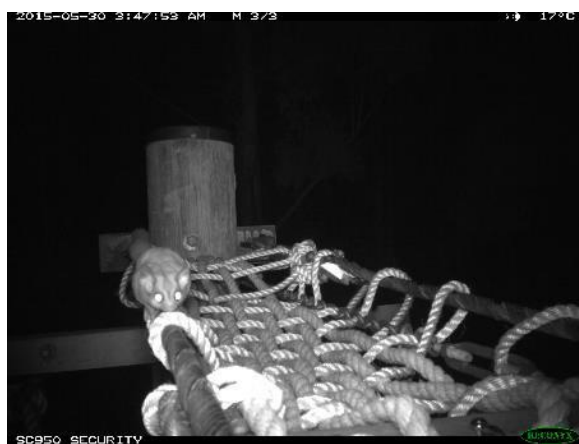
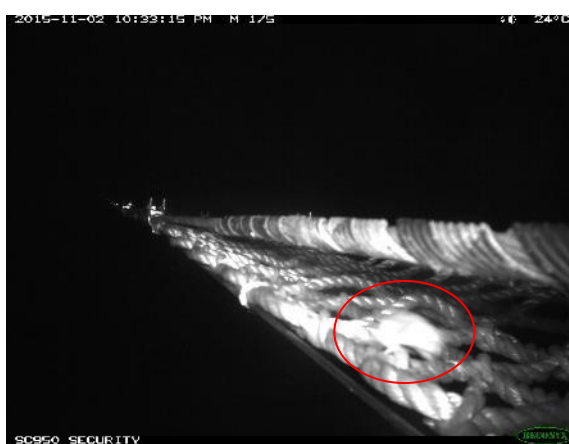
**Plate 21:** A sugar glider was detected exploring the east end of the rope bridge on one occasion (L). Feathertail glider was detected at each end of the rope bridge on three separate occasions including one occasion featuring strong directional towards the west camera (R), probably indicating a crossing.

At S2W, a feathertail glider was recorded at either end of the rope bridge on three occasions and a sugar glider was recorded on one occasion at the east end. Whereas the sugar glider appeared to explore the end and return, one of the feathertail photo sequences included a single photo of an individual moving rapidly in a westerly direction past the west camera. This strong directional movement was scored as a probable crossing. Whilst this may be the case, it should be noted that the behaviour of feathertail gliders on a rope bridge is typically erratic and exploratory and determining clear, directional movement difficult (see Sandpiper 2015a). The absence of photographs at the other end of the bridge may be indicative of an instance of non-detection by that camera or perhaps an individual glided onto the rope bridge (or off, in the case of evading detection at the exit end) and evaded camera detection (see Goldingay *et al.* 2013).

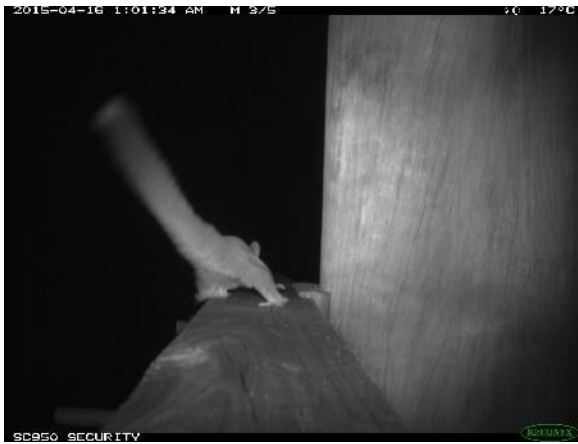
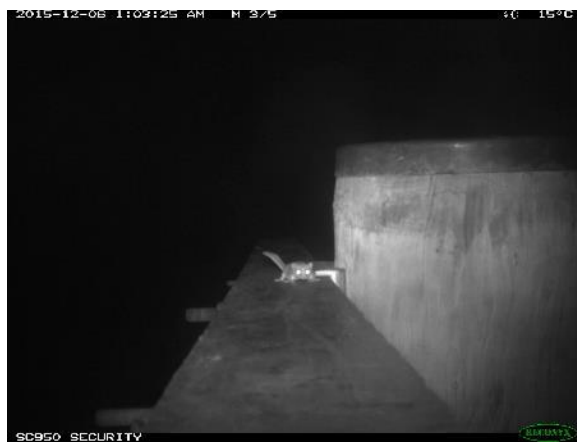
**Plate 22:** A sugar glider was detected on three occasions on the lower arm of the glide pole (L) which orientates E-W. Feathertail gliders were detected on 11 occasions on both the upper (R) and lower arms.

Sugar and feathertail glider were also recorded on a number of occasions on the Arrawarra creek glide pole which we have scored as road crossings. The direction of movement could not be determined in the photographs but the pole is positioned in the center of the dual carriageway and gliding distances in either direction is within the capacity of both species. Video footage may provide insight on direction of movement. Installation of video-capable cameras will be considered for year 2 monitoring. Both sugar and feathertail gliders were observed in east side habitat within 50m of the pole array and feathertail glider was observed on the west side of the highway within 200m of the pole array. As such, a glide crossing in either direction is feasible. The feathertail record is one of few records of this species using glide poles to cross a highway (see Goldingay and Taylor 2014).
