# Tintenbar to Ewingsdale

Working paper 5 – Aquatic ecology  
assessment

**Aquatic Ecology Assessment**  
**Pacific Highway Upgrade – Tintenbar to Ewingsdale**

June 2008

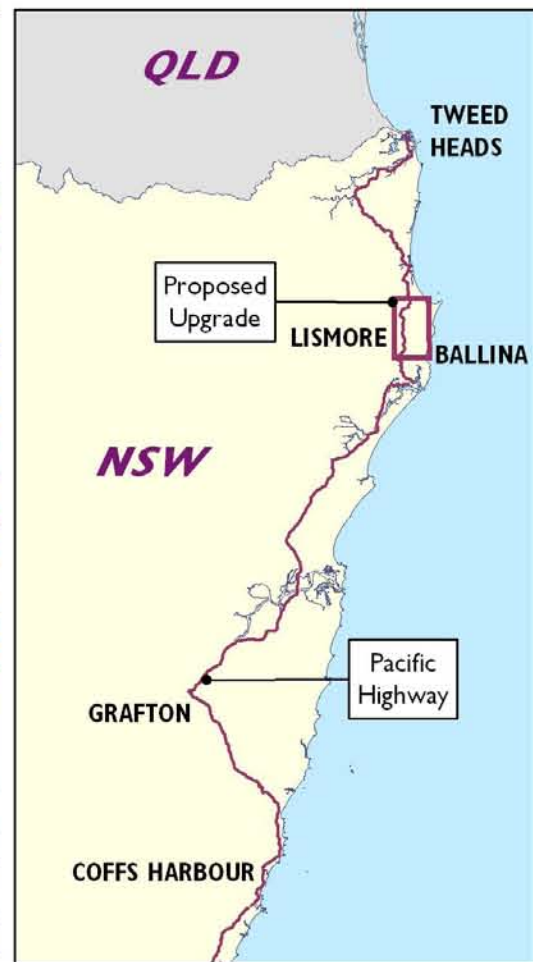
Figure 3: Proposed upgrade and distribution and risk classification of acid sulfate soils.

- Pacific Highway
- Regional and Local Roads
- Railway Line
- Major Watercourse
- Potential Acid Sulfate Soils**
- Disturbed soils
- High risk
- Low risk
- Proposed Upgrade**
- Proposed Road Acquisition Boundary

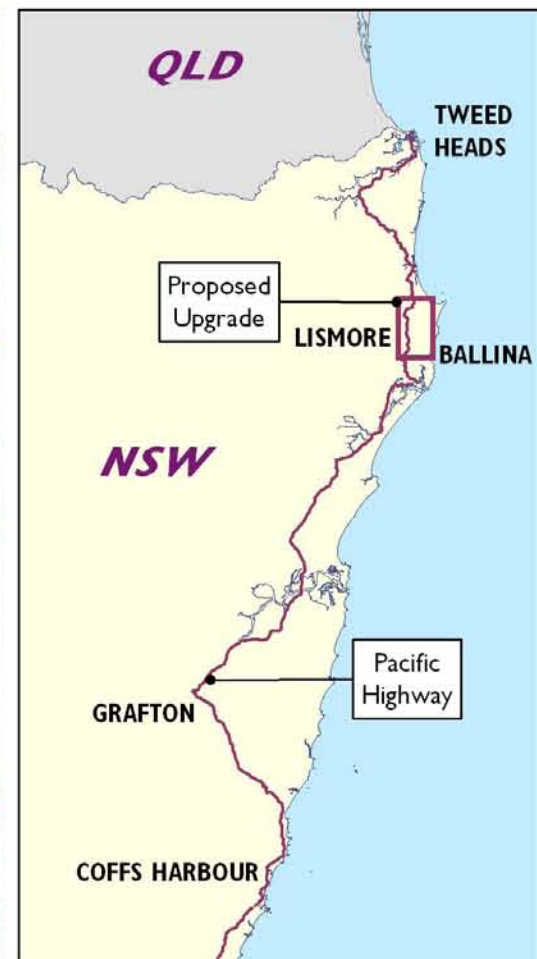
Figure 4: Proposed upgrade and locations of fish and mobile invertebrate sampling sites.

- Existing Pacific Highway
- Regional and Local Roads
- Railway Line
- Major Watercourse
- Catchment Boundary
- Fish and mobile macroinvertebrate sampling site (November 2005)

Fish were sampled in a tributary of Emigrant Creek to the west of where the existing Pacific Highway and a new bridge cross the creek, east of the created wetland (Table 3: Site 9, Figure 4). Freshwater catfish, flathead gudgeon, empire gudgeon and mosquito fish were collected using electrofishing and bait trapping techniques at these sites (Table 3, Figure 4). Two turtles were also observed.

Fish and mobile invertebrate sampling was done in the lower Byron Creek catchment, downstream of the inflow of Tinderbox Creek (Site 1, Figure 4). This reach of Byron Creek was classified as having potential fish habitat and sampling was done upstream and downstream of the proposed upgrade crossing. A total of six species of fish, four species of freshwater crustaceans (prawns and yabbies) and turtles were observed (Table 3: Site 1). No introduced mosquito fish (*Gambusia holbrooki*) were collected. These results indicate that this reach of the creek provides moderate to good habitat for fish and mobile macroinvertebrates.

Fish were sampled in the upper reaches of Byron Creek during the route selection phase of the project (tunnel approaches from the east) (Table 3: Site 2, Figure 4). One of the sampling sites was downstream of a causeway across Byron Creek. At this site, five species of fish were sampled, four species of mobile macroinvertebrates were present and turtles were observed (Table 3: Site 2). At a second site approximately 500 m upstream of the causeway, no fish or mobile invertebrates were caught, indicating that the causeway was an effective barrier to upstream fish passage.

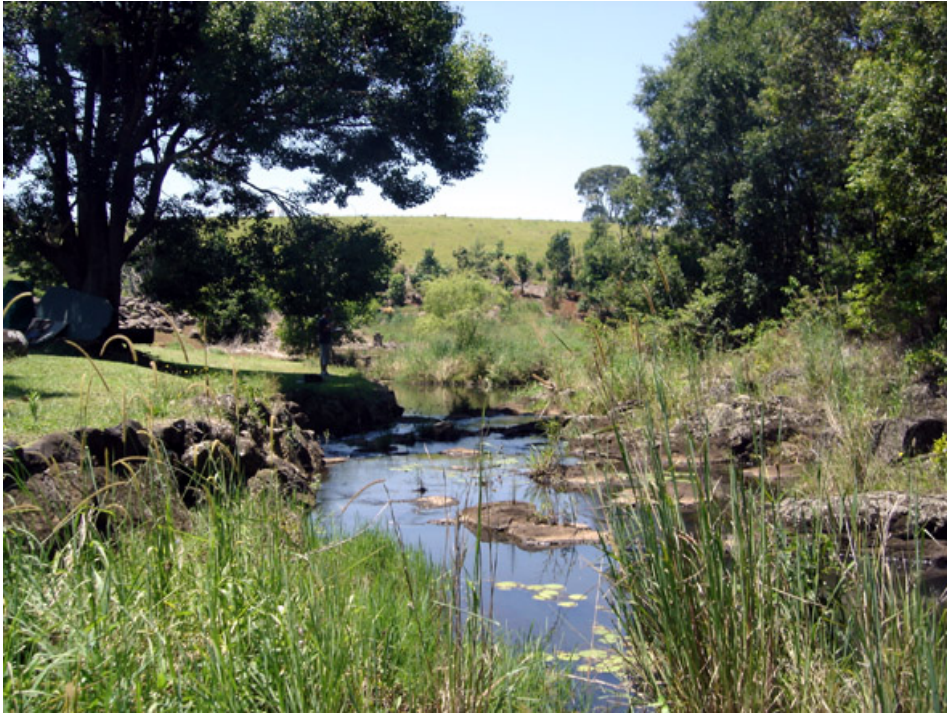
Plate 1 Upper: Emigrant Creek, Yarrenbool, looking downstream.

The upstream reaches of Emigrant Creek and its tributaries along the proposed upgrade are graded Class 2, 3 and 4 fish habitat. Areas of moderate fish habitat include the main channel of Emigrant Creek, downstream of the existing highway crossing (Plate 1 upper). In this reach of the creek there are numerous deep pools providing refuge for fish during extended periods of low flow. There is important variability in the instream habitat including sections of rapid shallow flow, aquatic plant beds, riparian vegetation and snags. The upper reaches of Emigrant Creek and its numerous unnamed tributaries provide mainly minimal to unlikely fish habitat (Plate 1, lower). These watercourses are heavily influenced by extensive agriculture and grazing land use in the area (Plate 2 upper). Much of the riparian vegetation has been cleared, flow has been restricted by numerous farm dams (Plate 2 lower), and numerous causeways and culverts have created barriers to fish passage into upstream areas. Some of the larger farm dams in the catchment are likely to provide habitat for some species, such as silver perch which have been stocked for recreational fishing.

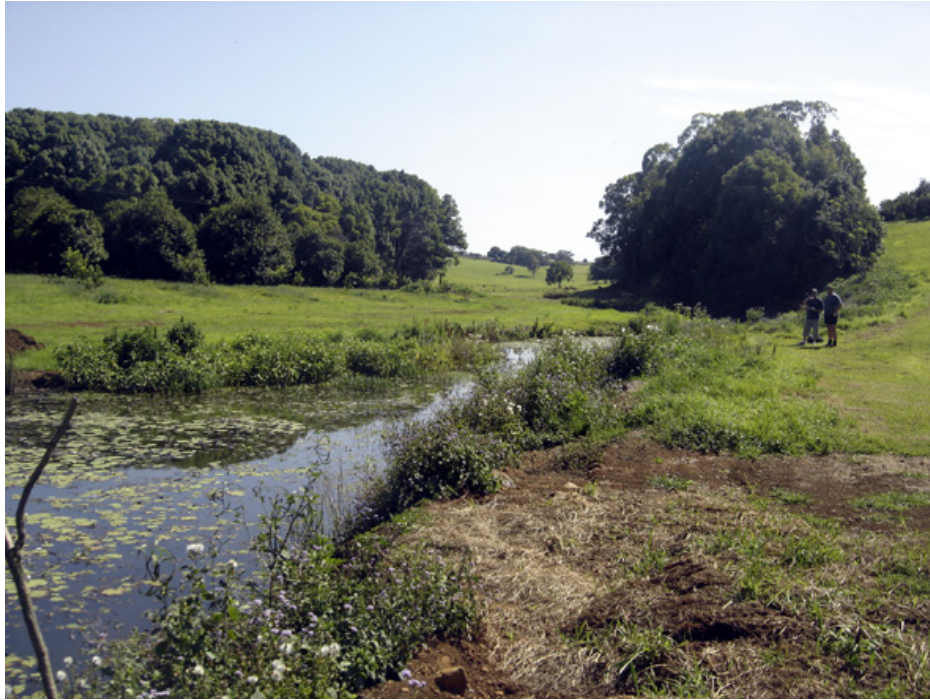
Plate 2 Upper: Unnamed tributary of Emigrant Creek, Deenford Plantation, looking upstream.

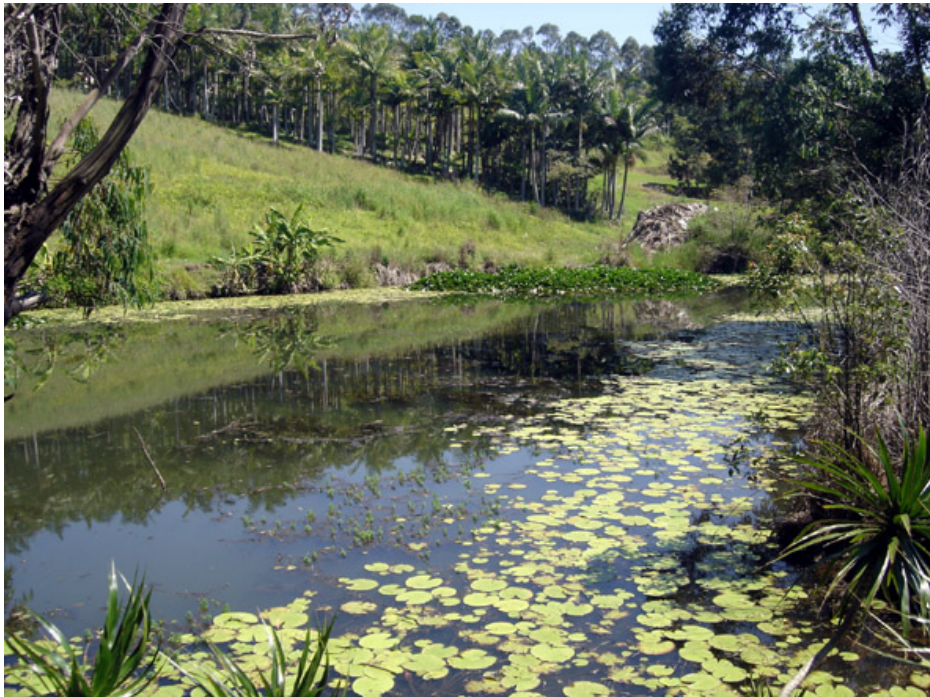
Plate 2 Lower: Pond on unnamed tributary of Emigrant Creek, Palm Springs fish hatchery, looking upstream.

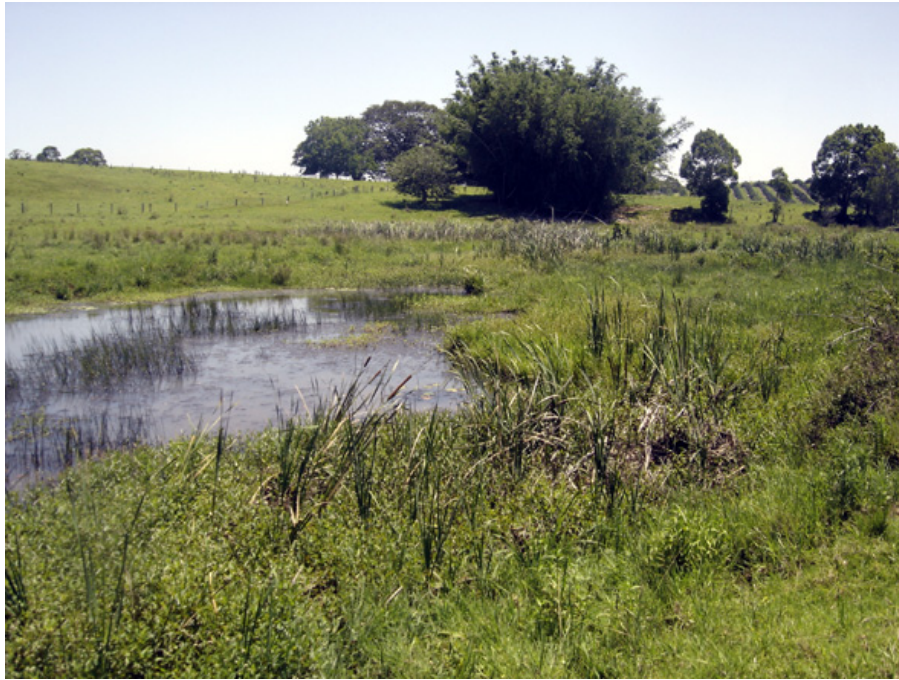
Plate 3 Upper: Skinner Creek, Pacific Highway crossing, looking downstream.

Skinners Creek is a tributary of the Wilsons River which flows through Lismore and joins the Richmond River estuary at Coraki. The upper reaches of Skinners Creek and its tributaries that lie within the investigation area are all graded Class 3 and 4 fish habitat. The main channel of Skinners Creek flows through a valley in which grazing and agriculture are the dominant land uses (Plate 3). There is minimal riparian vegetation along the watercourse. Areas of permanent wetland habitat occur along the watercourse and are thickly vegetated with aquatic plants. The dominant fish habitat was aquatic macrophyte beds, with limited deep (1 -2 m) permanent pools, and few snags which provide habitat for native fish. Little to no riffle habitat was present. The existing Pacific Highway crossing of Skinners Creek consists of an eight-pipe (2 m diameter) culvert that creates barriers to fish passage.
