# Warrell Creek to Nambucca Heads Pacific Highway Upgrade

Commonwealth Approval EPBC 2013/7101  
Annual Compliance Report  
February 2017 – February 2018

Roads and Maritime Services | May 2018

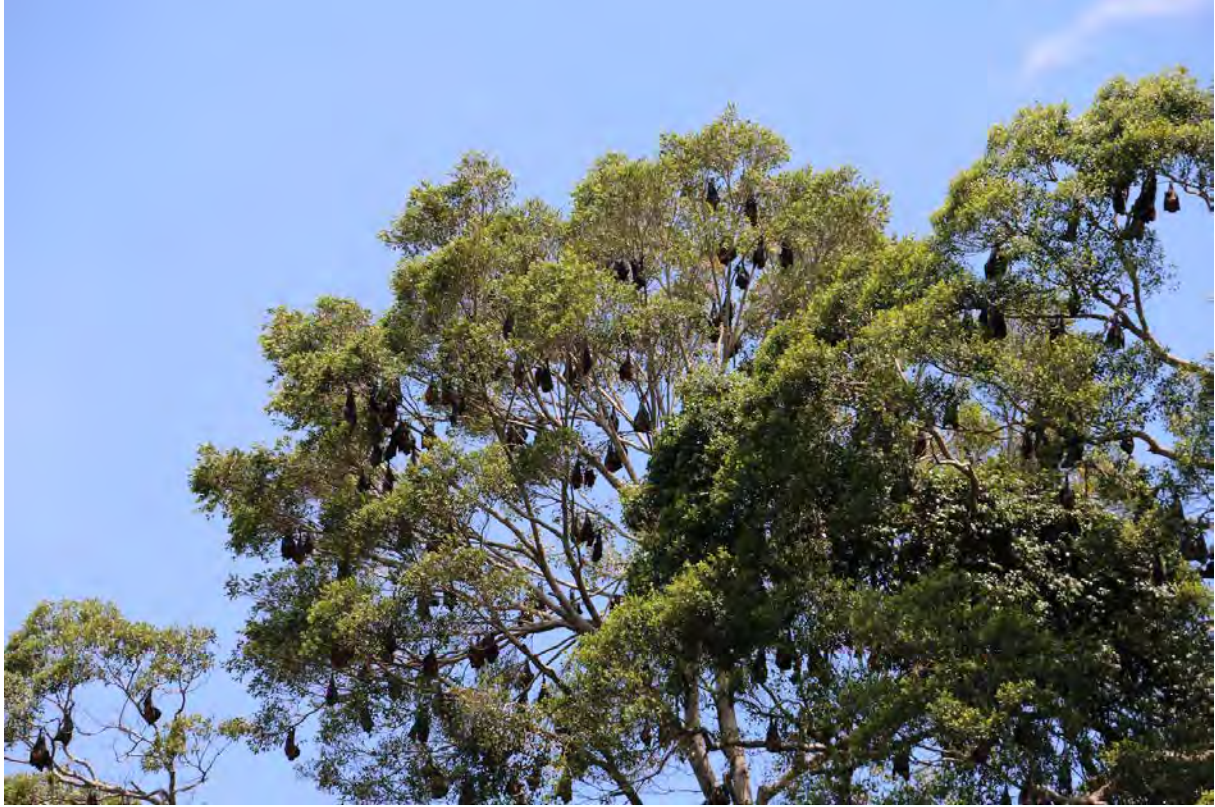
**Plate 2.1** GHFF roosting in the upper canopy of figs at Bellingen Island

Regionally, flying-foxes were observed to be roosting at Bellingen Island and Gordon Park (Nambucca Heads). The extent of the roost footprint at Bellingen Island was observed to be covering a larger area than that recorded in the previous monthly monitoring event (GeoLINK 2017), including substantial roosting in the upper canopy of the emergent fig trees within the rainforest remnant (refer to Plate 2.1). In contrast, at Gordon Park the roost extent had not changed from that recorded in the previous monitoring event.

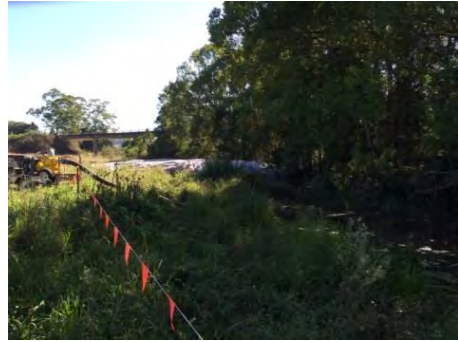
Plate 1.1 April 2015

**Crouches Creek – east looking west**

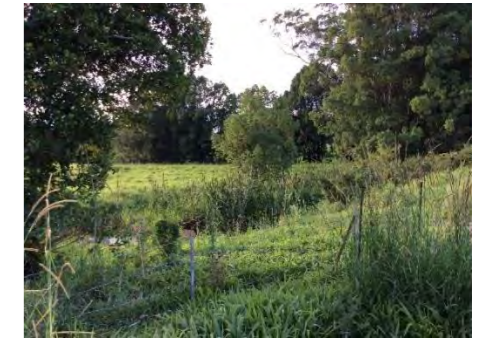
Plate 1.12 January 2018

**Crouches Creek – east looking east**

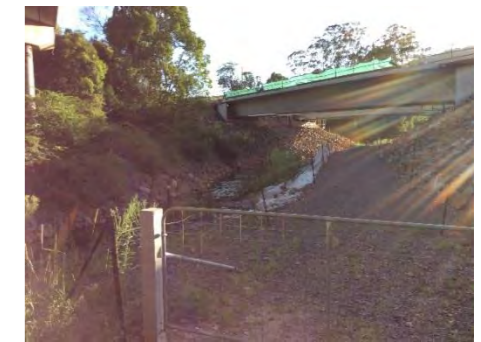
Plate 1.18 January 2018

**Crouches Creek – west looking east**

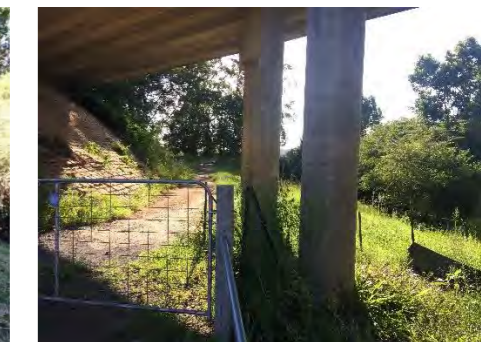
Plate 1.24 January 2018

**Crouches Creek – west looking west**

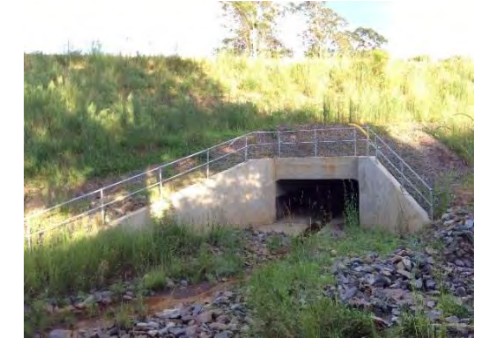
Plate 1.30 January 2018

**Rosewood Creek – east looking west**

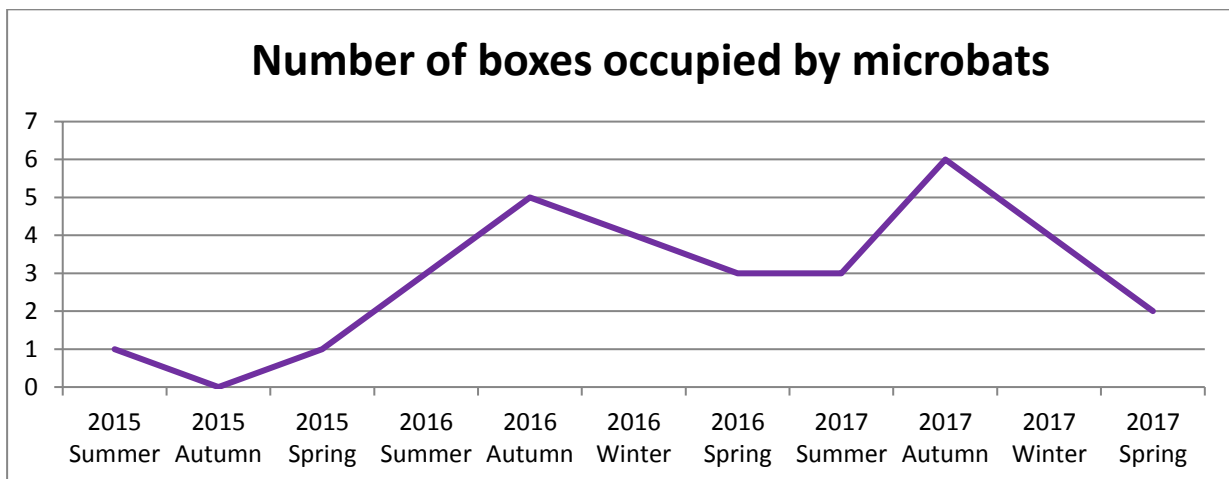
**Figure 1.2 Number of boxes occupied by microbats.**

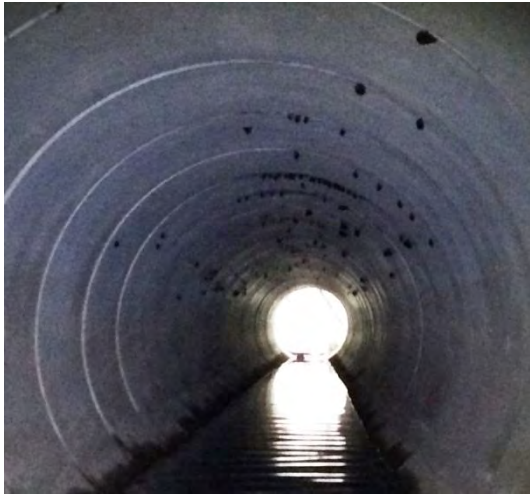
**Plate 1.1** Structure ID 37 (599205) - Deadman's Gully pipe culvert: approximately 400 Eastern Bentwing Bats in segment gaps.

Photos of selected roosts or evidence of use within structures are provided in **Plates 1.1, 1.2, 1.3 and 1.4**.

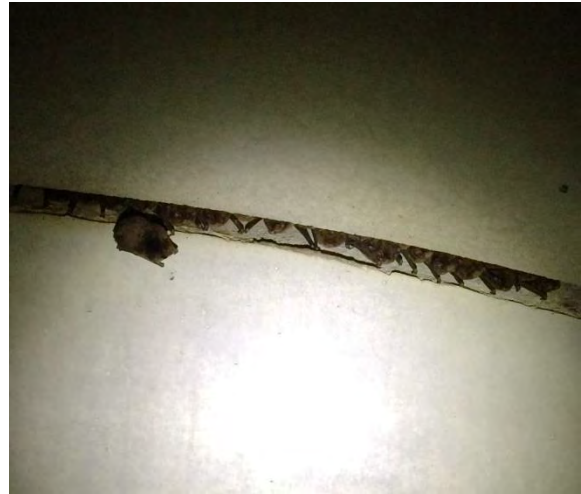
**Plate 1.2** Structure ID 37 (599205) - Deadman's Gully: Eastern Bentwing Bats in segment gaps.

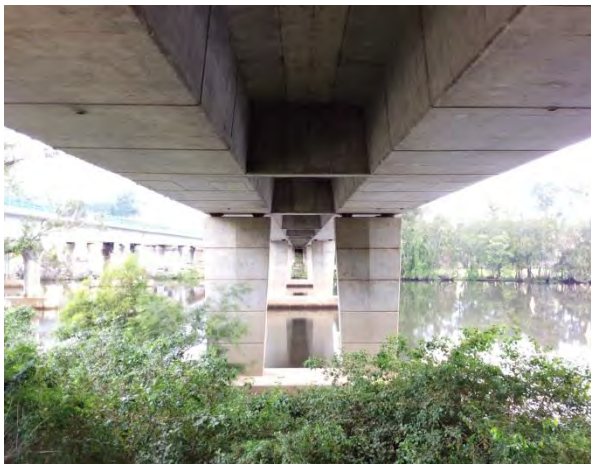
**Plate 1.3** Lower Warrell Creek Bridge Structure ID 21 (1871): northern abutment recorded guano and staining beneath.

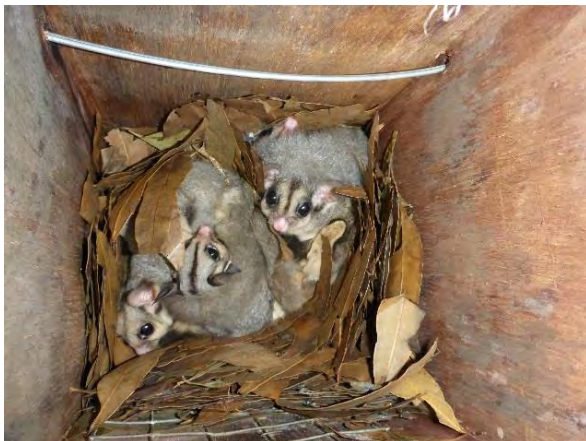
**Plate 1.1** C1.10 (Zone OC5) Four Sugar Gliders in a scissor mammal box.

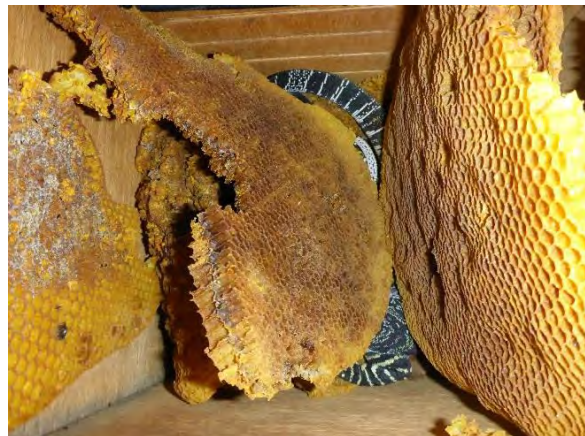
**Plate 1.2** Box C4.10 (Zone New NBRZ) Lace Monitor beneath abandoned honeycomb in a large Glider box.

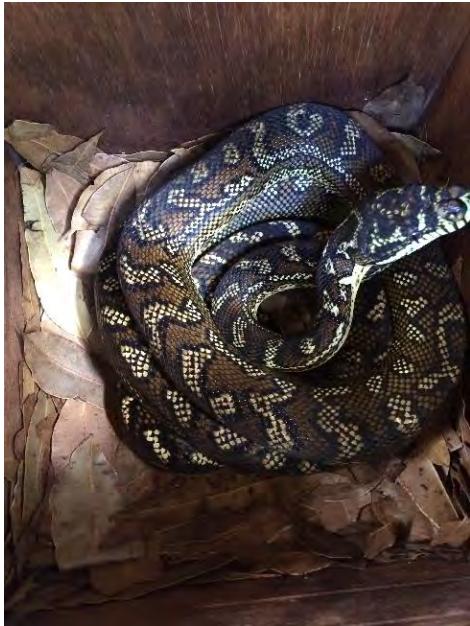
**Plate 1.3** Box SG3.8 (Zone U) Carpet Python in a Small Glider box.

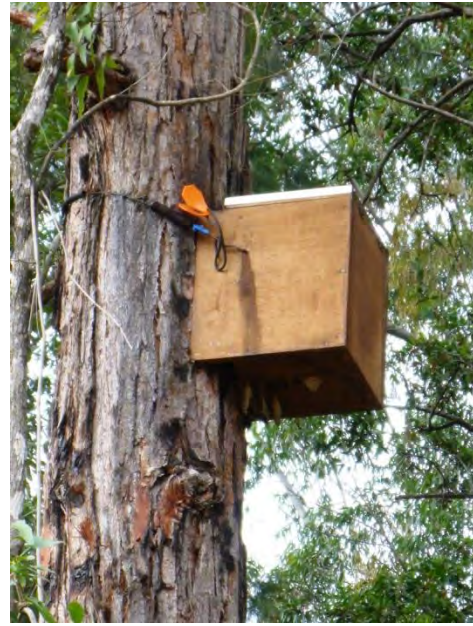
**Plate 1.4** Box LG4.10 (Zone G) Active European bee hive in a large Glider box, recorded each monitoring event since installation. New *Patriot* cattle ear tags attached.

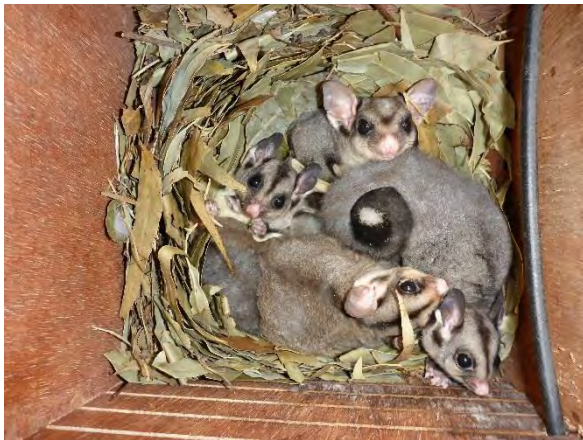
**Plate 1.5** Box C3.12 (Zone S) Four Sugar Gliders in a small Glider box.

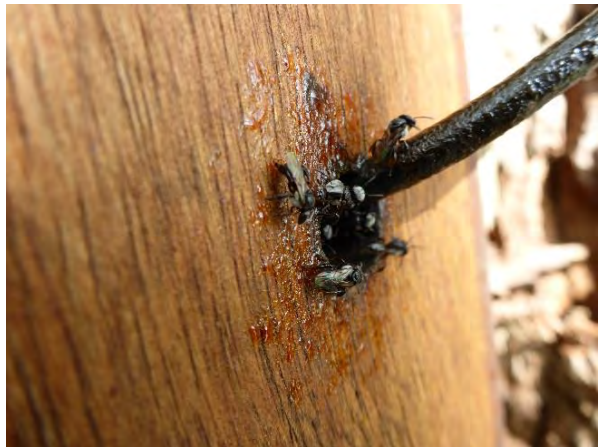
**Plate 1.6** Box SF1.4 (Zone S) Native Stingless Bees in a scansorial mammal box using the wire hole as entry/exit

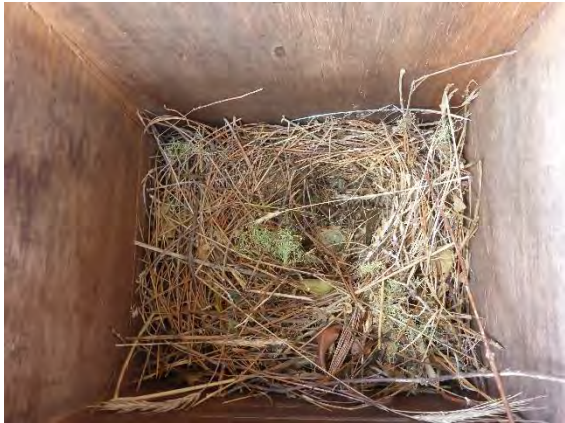
**Plate 1.7** Box Po5.13 (Zone S) Ringtail Possum or bird nest in a Possum box.

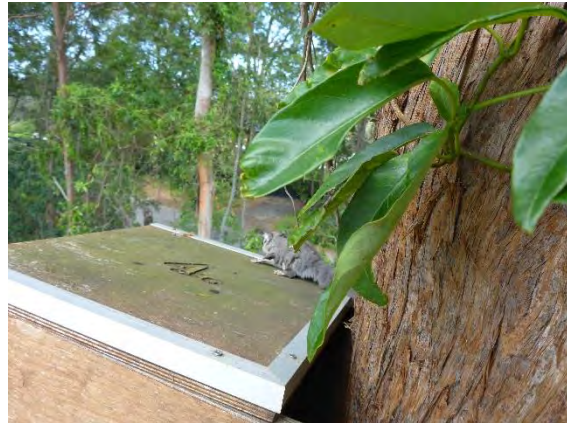
**Plate 1.8** Box LG4.6 (Zone S) Sugar Glider exiting the large glider box prior to inspection.

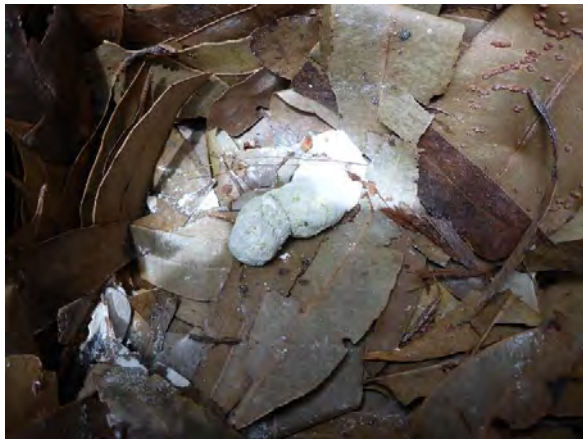
**Plate 1.9** Box C3.4 (Zone T) Snake uric acid pellet on Glider nesting material in a small Glider box.

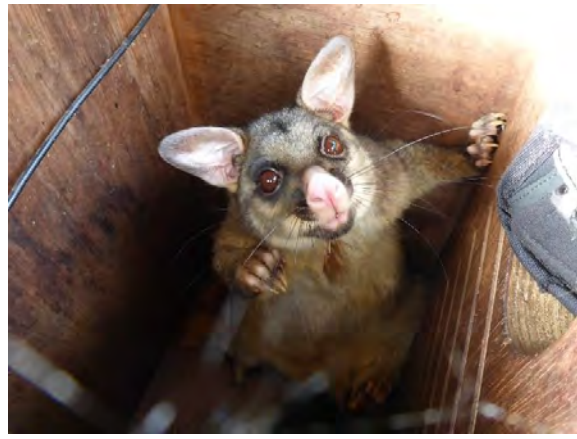
**Plate 1.10** Box Po5.17 (Zone S) Common Brushtail Possum in Possum box. This box has recorded a Brushtail Possum during the last four monitoring events.

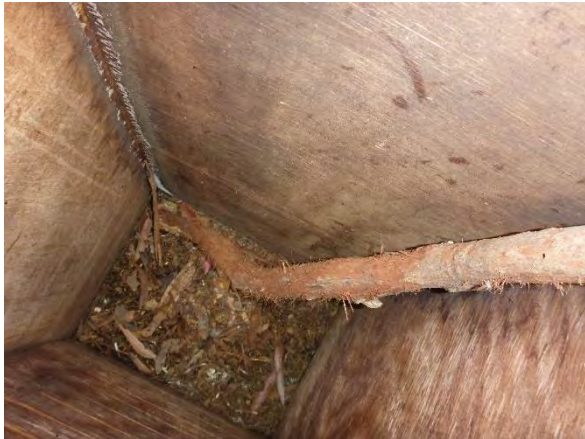
**Plate 1.11** Box Cockatoo 7.1 (Zone U) Nesting material in a Cockatoo box and scratched bark on stick indicates use by climbing fauna. This stick was placed inside the box to facilitate access out of the box due to a dead parrot observed inside the box during summer 2017

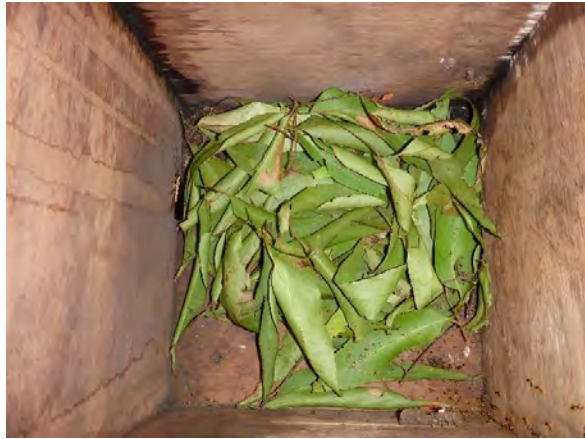
**Plate 1.12** Box C3.7 (Zone U) Fresh leaves brought into small Glider box as glider nesting material.

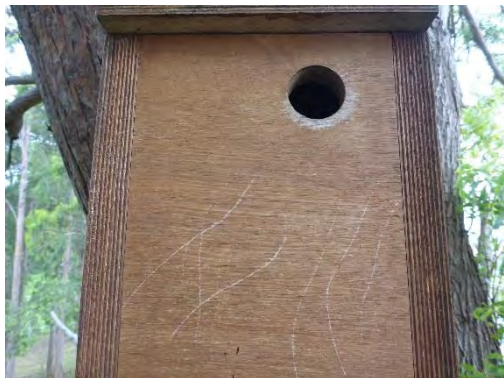
**Plate 1.13** Box SG3.4 (Zone U) Scratches and chew marks on the exterior of the box with Sugar Gliders inside.

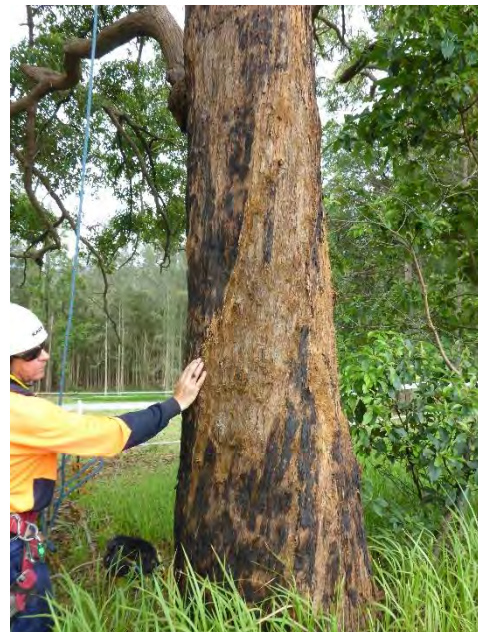
**Plate 1.14** Box SG3.4 (Zone U) Heavy use of tree trunk which supports Box SG3.4 likely Glider landing pad.

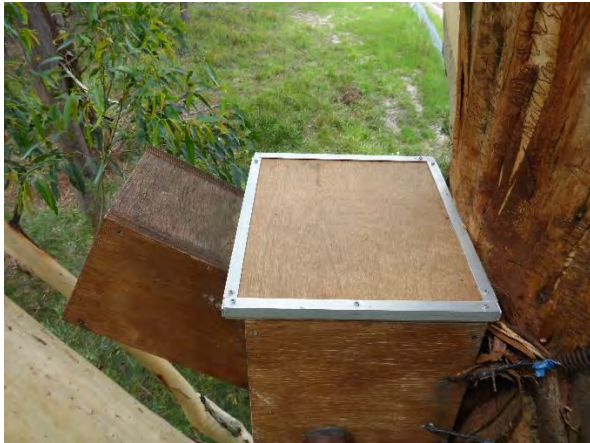
**Plate 1.15** Cockatoo Box 7.1 (Zone U) Lid previously damaged by termites - replaced new lid pictured.

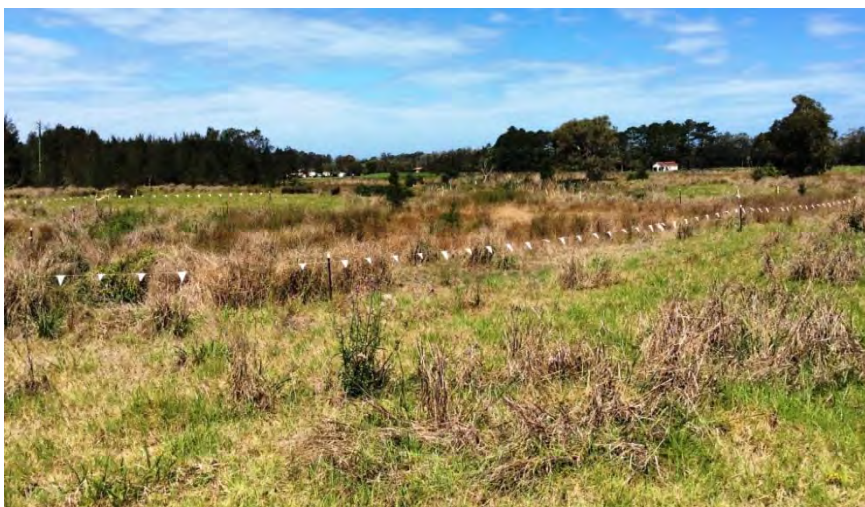
**Plate 3.1 No Tall Knotweed recorded during spring 2017, no obvious signs of construction related impacts or excessive weed incursions were observed.**

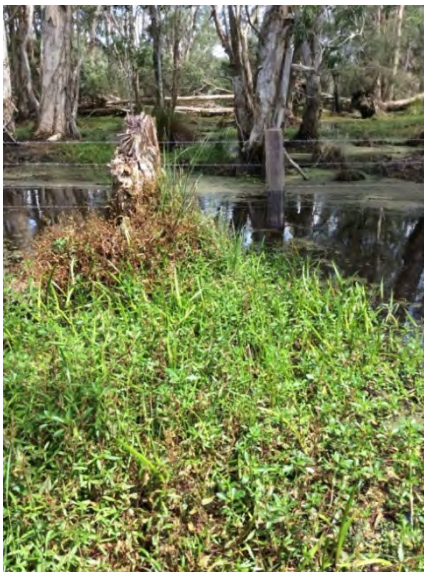
- During the months preceding spring 2017 monitoring lower than usual rainfall levels were recorded which may have contributed to the reduction in cover and abundance of Maundia within the Nambucca Floodplain. Although a reduced percentage cover of Maundia has been recorded, these patches are distributed broadly across the monitoring site with good health and leaf condition with a class condition score of 3 to 4. To date this population of Maundia has had periods of higher and lower recorded numbers of cover and abundance which is typical of the lifecycle of this species which can be affected by natural hydrology and weather conditions with natural dieback occurring seasonally. During October 2017 156 mm of rain was recorded within the Macksville area which may make growing conditions favourable for Maundia during the spring/summer growing season.

**Plate 3.2** Reduced patches of Maundia plants within the Nambucca Floodplain site appear to be in good health.

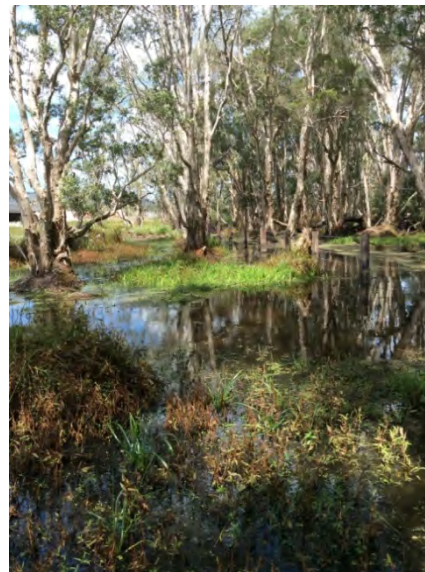
**Plate 3.3** Healthy Maundia plants on the Nambucca Floodplain (centre of image).

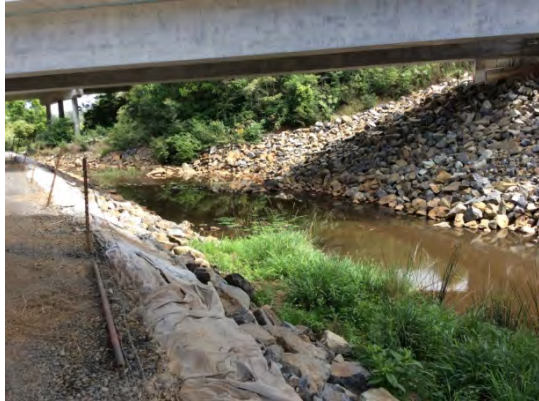
- The population of Maundia within Crouches Creek was removed as part of the diversion of the creek in this location. Although translocation of this species was not prescribed as part of the WC2NH Threatened Flora Management Plan, salvage translocation was attempted within the new alignment of Crouches Creek. This translocation was considered to have been successful during the spring 2016 monitoring, however no visible Maundia plants were recorded within Crouches Creek during the spring 2017 monitoring event. It is possible that seasonal or natural die-back of this species may be occurring at this location. Alternatively, altered instream parameters due to the creek realignment, such as changes in water depth (Maundia prefers 30 - 60 cm water depth), sedimentation and/or reduced quality of substrate may have attributed to the lack of visible

**Plate 3.4** Maundia translocation site within Crouches Creek, no obvious signs of Maundia within the translocation site.

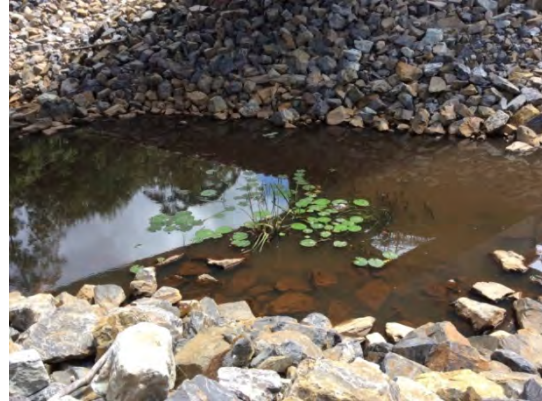
**Plate 3.5** Maundia translocation site within Crouches Creek, no obvious signs of Maundia within the translocation site.

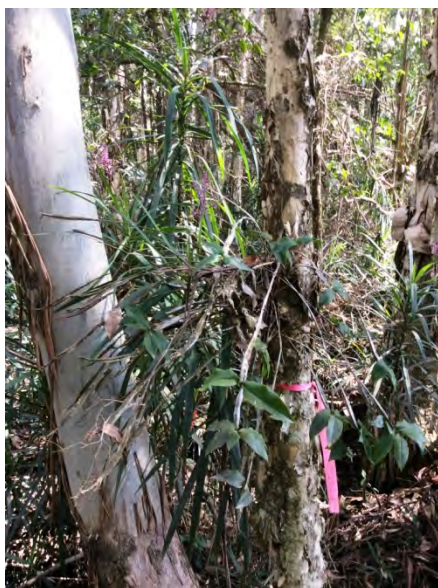
- The single in-situ Spider Orchid specimen remains in a healthy condition. The number of pseudobulbs (storage organs) on this plant has increased substantially during recent monitoring events. The recruitment of an additional individual occurring immediately below this plant on the same tree was first recorded during spring 2016. At the time of spring 2017 monitoring the strip of paperbark which the juvenile spider orchid was attached to was nearly detached. Yellow survey tape was wrapped around the bark with the expectation that the juvenile orchid will reattach to the tree trunk.

**Plate 3.6** Existing mature Spider Orchid with evidence of flowering on pseudobulbs.

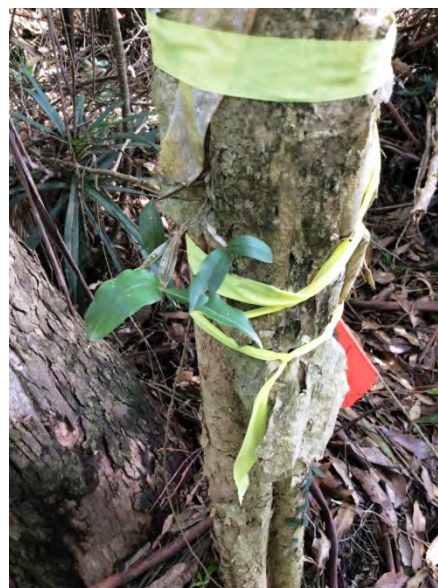
**Plate 3.7** Juvenile Spider Orchid with yellow tape to affix strip of paperbark to the tree trunk.

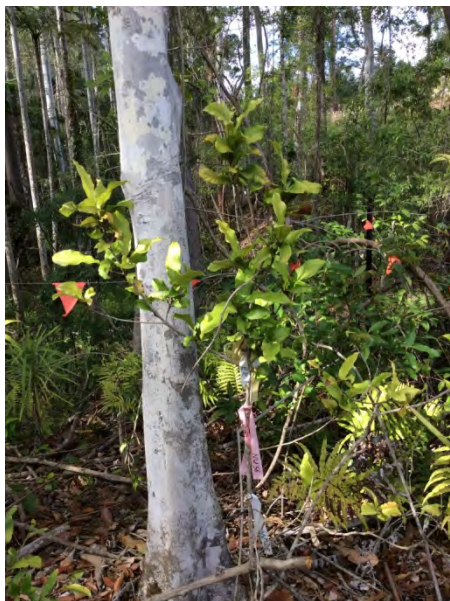
**Plate 3.8** Rusty Plum (nw-56) with new growth appears to be improving in condition class compared to spring 2016.

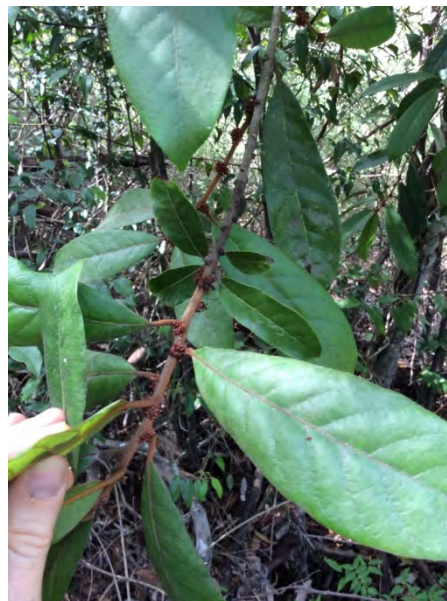
**Plate 3.9** Rusty Plum (nw-64) with new growth and evidence of flowering in the leaf axils.

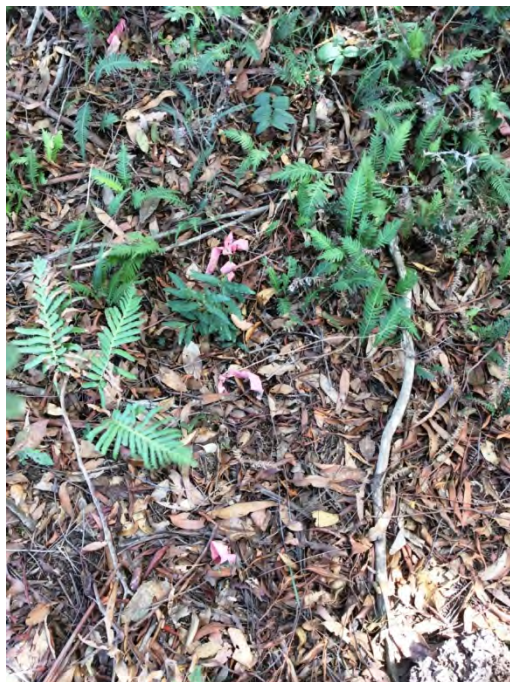
**Plate 3.10 Spring 2016 (pink tape)  
recruits of Marsdenia plants Old Coast  
Road Site (ml-93)**

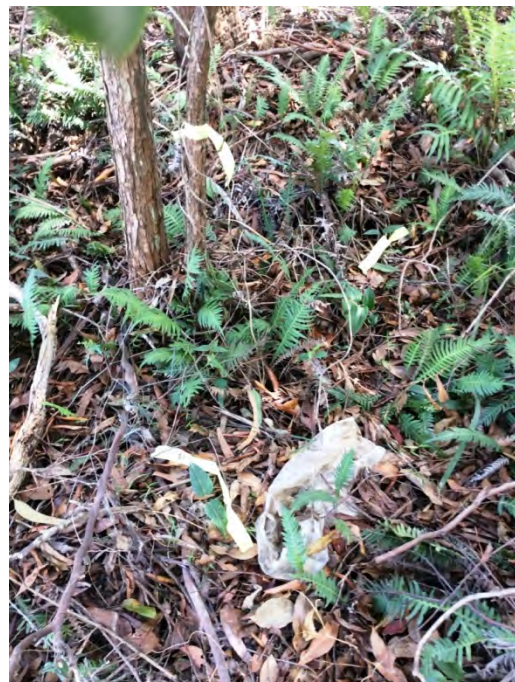
- No Slender Marsdenia monitoring sites recorded any obvious construction related impacts by means of encroachment into protected areas, project related erosion or sedimentation or significant weed incursion.
- Site ml-93 has a healthy and dynamic population of Slender Marsdenia plants which are located directly adjacent to Old Coast Road which at varying times have been observed to receive increased dust deposition from passing traffic. Regardless, this population of plants has recorded large numbers of new recruits during spring 2016 and 2017 monitoring events.
- A number of plants previously included in the monitoring regime have been translocated as part of the approved WC2NH North-facing Ramps project.

**Plate 3.11 Spring 2017 (yellow tape)  
recruitment of Marsdenia plants Old Coast  
Road Site (ml-93)**

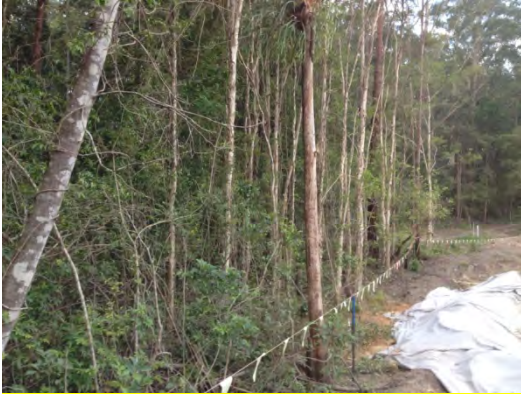
**Plate 3.12 Example of Habitat Condition Monitoring Plots**

Photographs of the monitoring plots are shown in **Plates 3.12 and 3.13**.

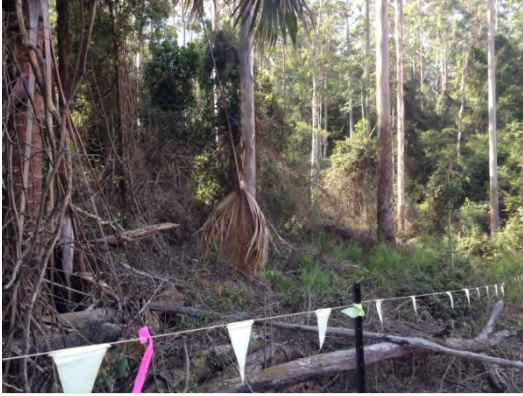
**Plate 3.13 Example of Habitat Condition Monitoring Plots**

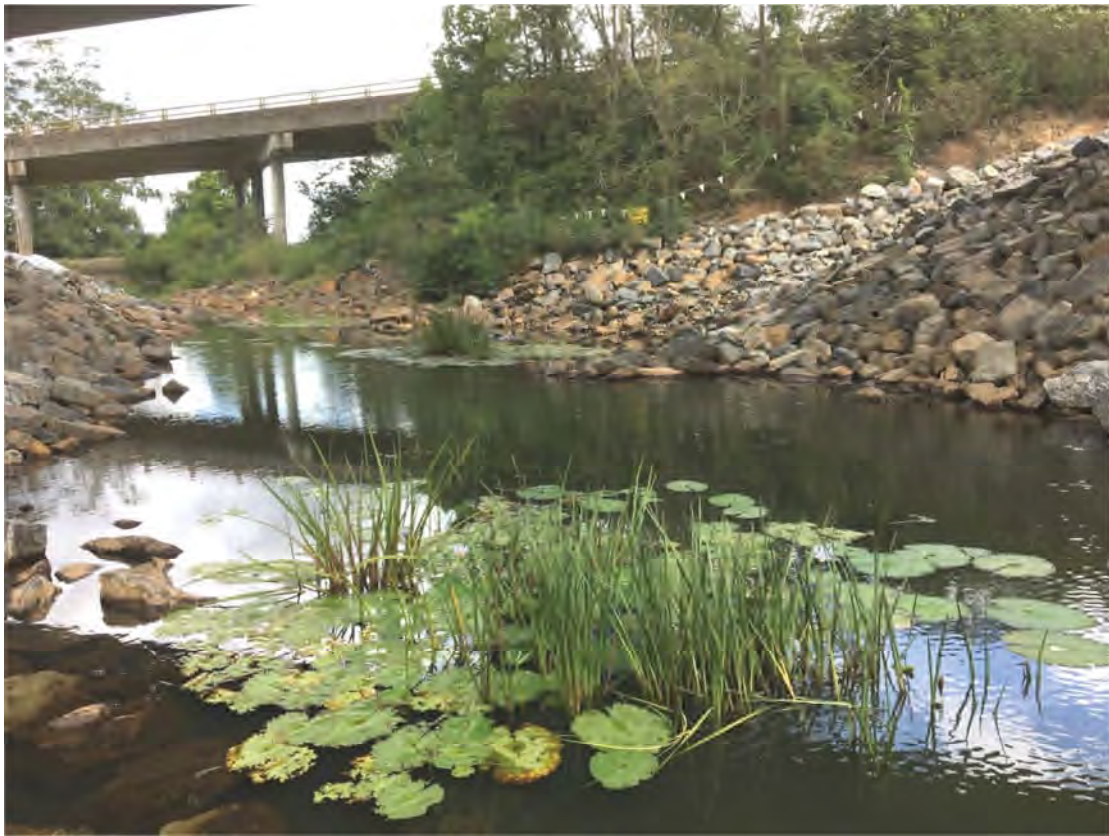
**Plate 7:** Clumps of *Maundia* (the sword-leaved aquatic plant) reinstated along Williamson's Creek two years after salvaging *Maundia* from the creek prior to construction of a new bridge and stabilisation of the creek banks.

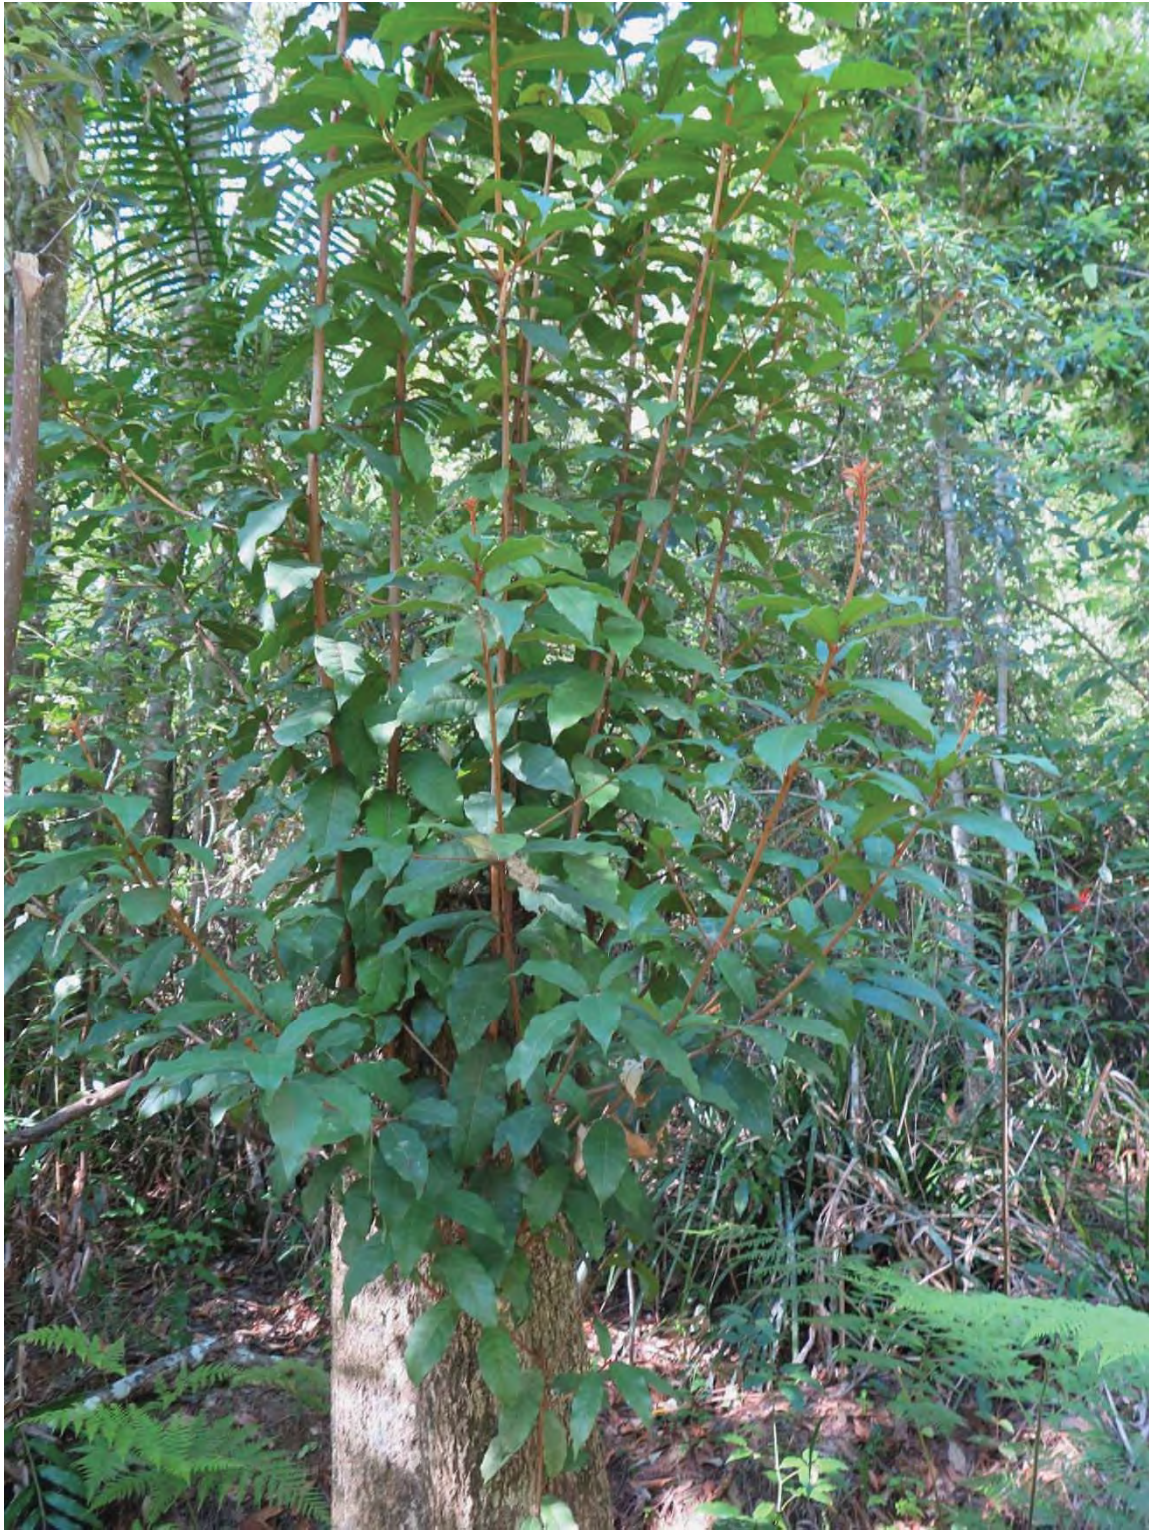
**Plate 8:** Rusty Plum (*Niemeyera whitei*) No. 5, three years after transplanting. New branches have reshot from near top of bare trunk cut down to about 1 metre high.

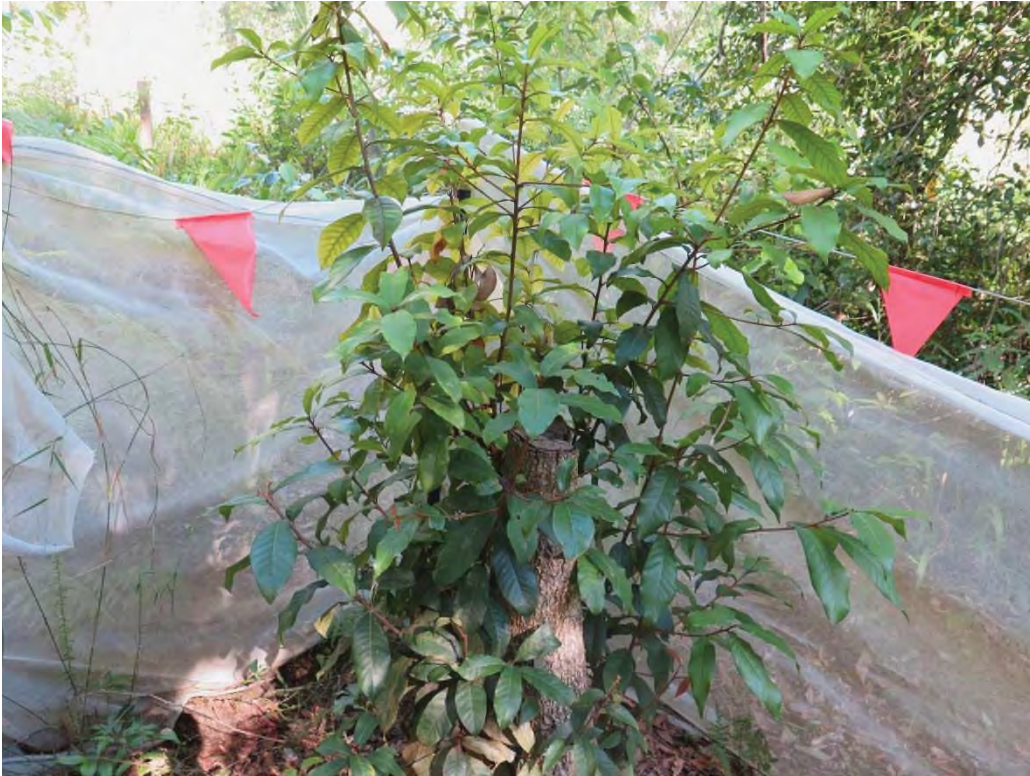
**Plate 9:** Rusty Plum (*Niemeyera whitei*) No. 6, three years after transplanting

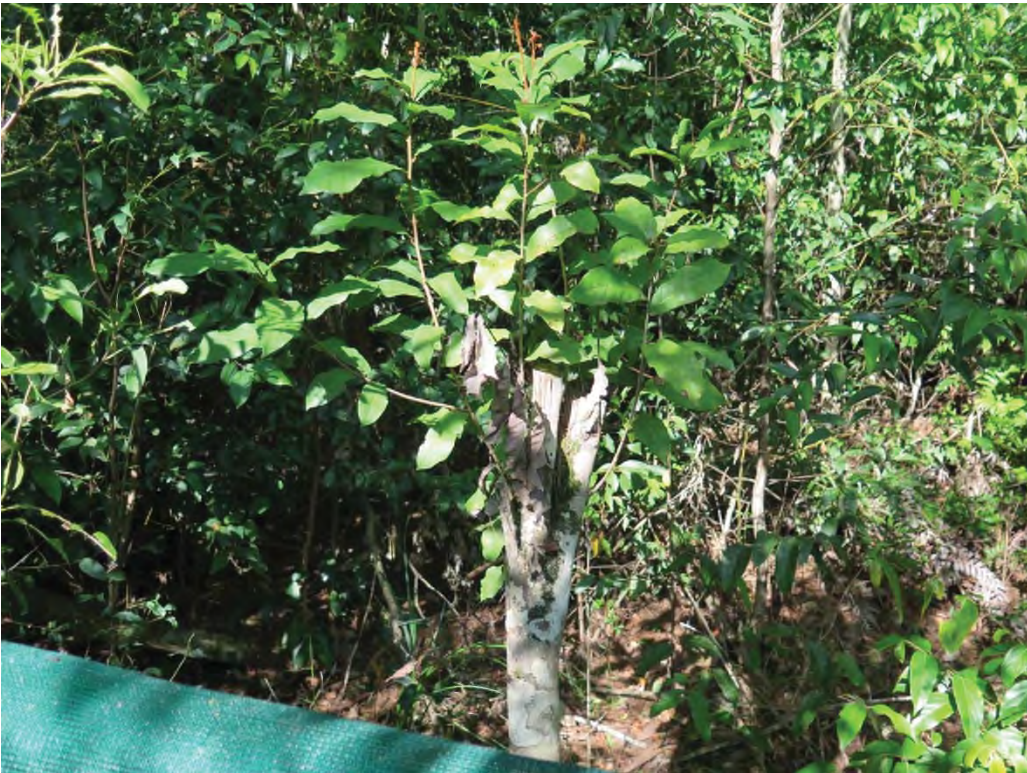
**Plate 10:** Rusty Plum (*Niemeyera whitei*) No. 7, three years after transplanting

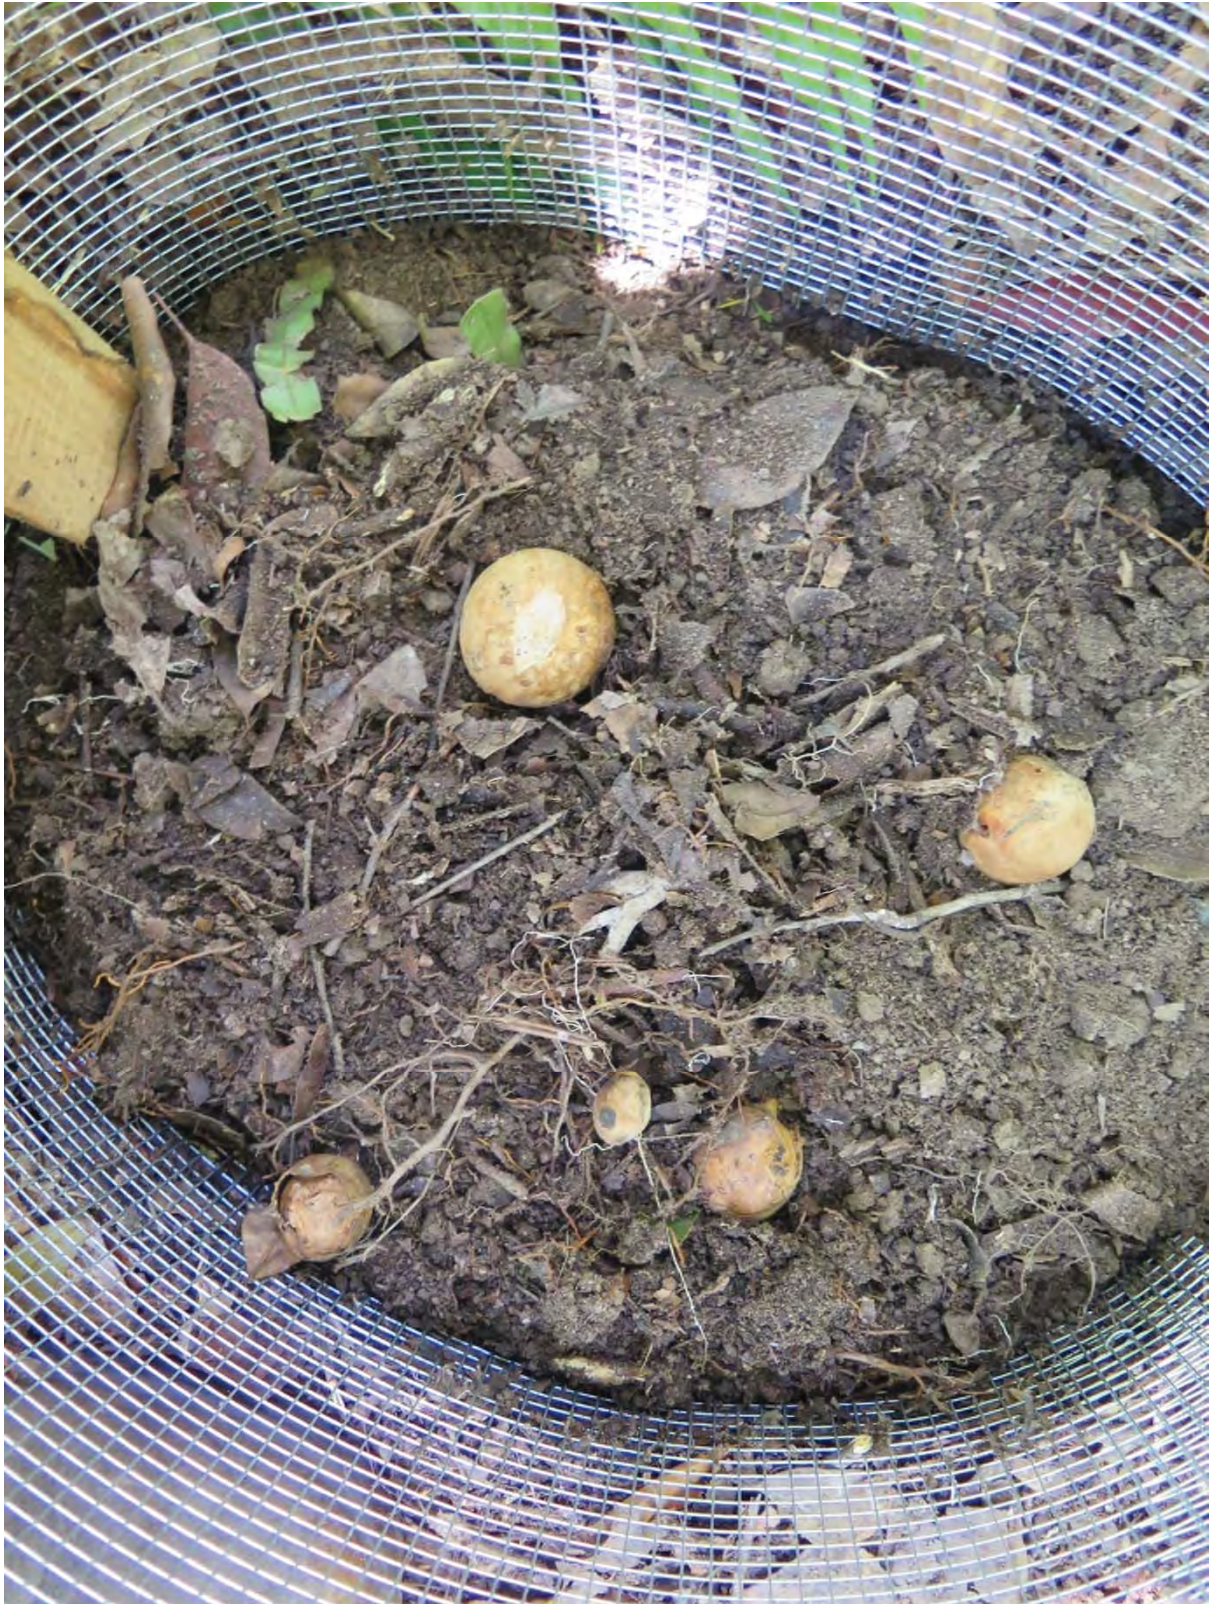
**Plate 11:** Rusty Plum seeds were directed seeded into wire enclosures at Receiveal Site 5 (7a) in Nov/17. This measure addressed the population enhancement requirement of the Management Plan for Rusty Plum, which aimed to replace possible translocation losses and maintain population number at the pre-construction level.

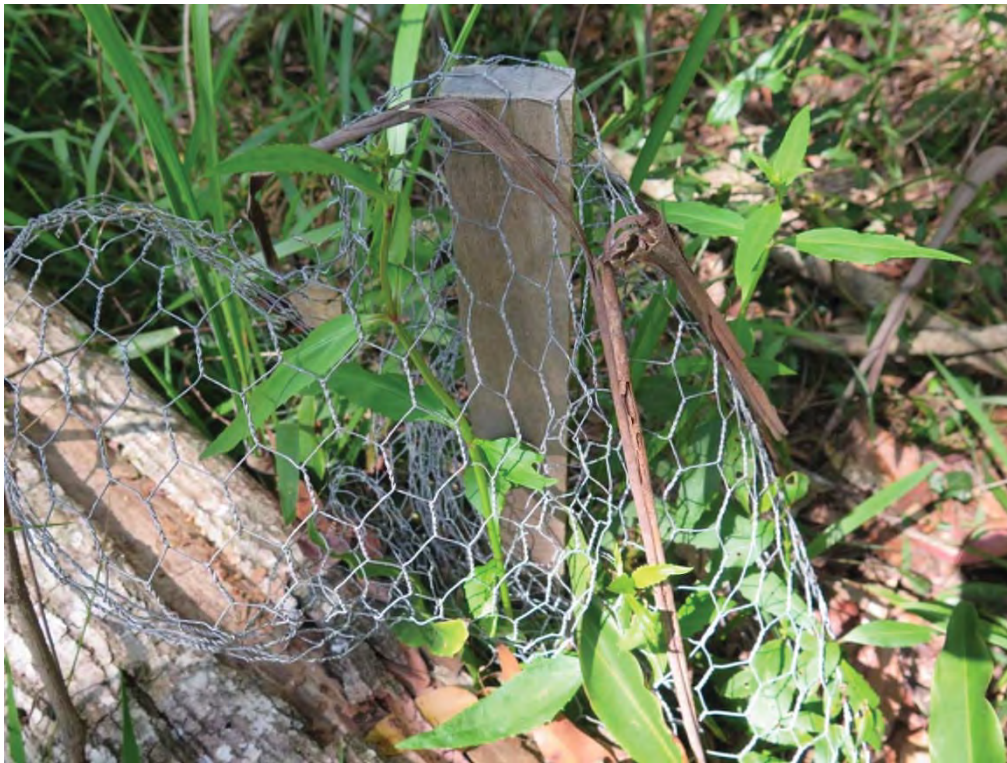
**Plate 12:** Koala Bells (*Artanema fimbriatum*) No. 10, three years after transplanting. A tree has fallen on the edge of the wire guard but the plant has reshot in and outside the cage. Only two plants were still alive after 3 years. Most plants responded as annuals, flowering and dying in the first year.

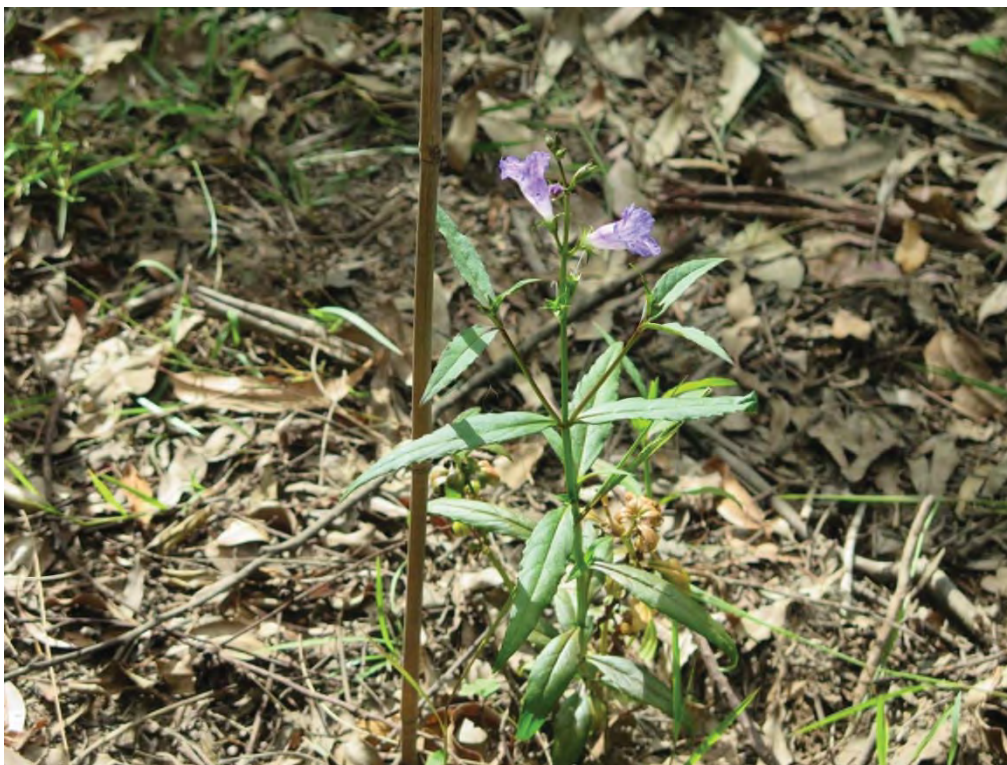
**Plate 13:** Propagated Koala Bells (*Artanema fimbriatum*) six months after planting out in the Floyds Grass translocation area (Area 2).

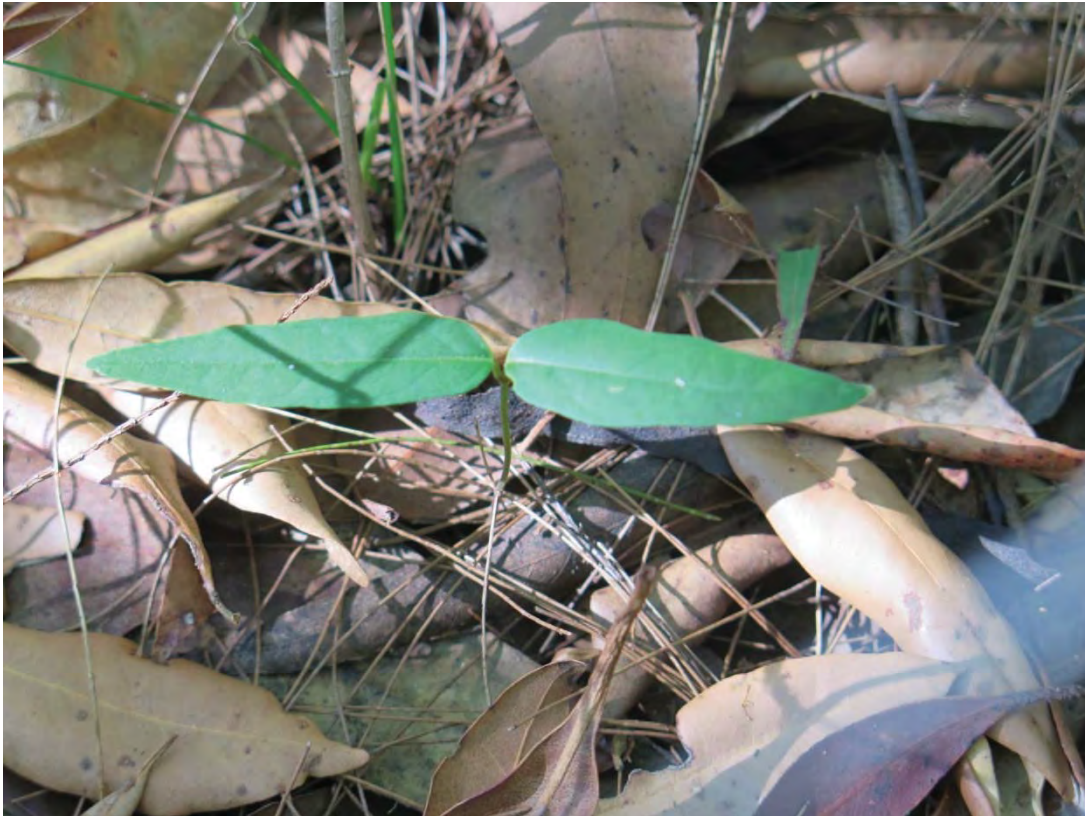
**Plate 14:** Slender Marsdenia (*Marsdenia longiloba*). Site 1 (Cockburns Lane) No.11. The height of this plant recorded over 3 years starting 2015 was 5 (cm), 5, 5, 0, 0, 2, 4, an example of how little above ground growth can occur over a long period of time in this species.

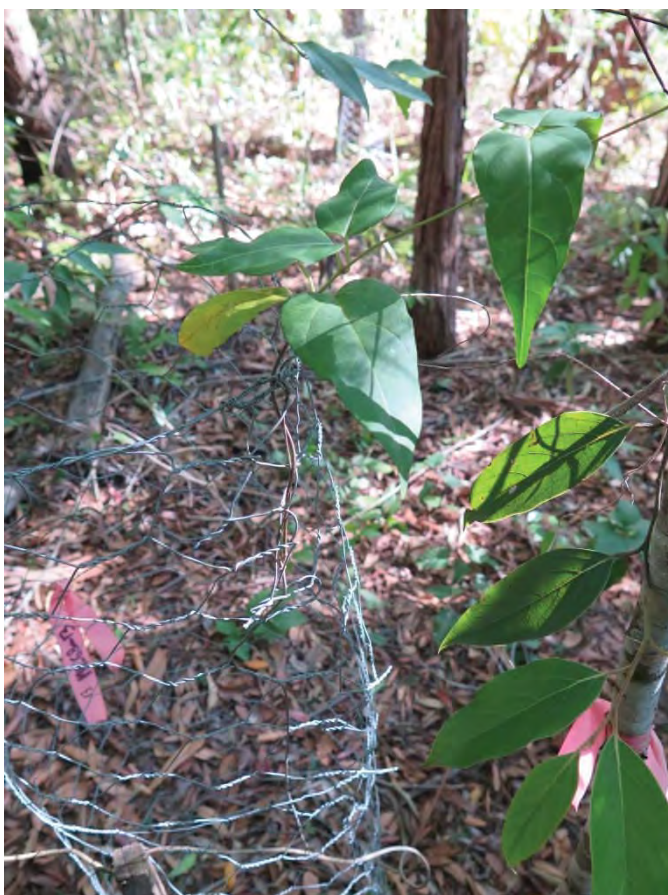
**Plate 15:** Site 1, No. 13. This plant started as an old pruned stem when transplanted. It shot a new stem off the old one and maintained growth. Height over 3 years starting 2015 was 124 (cm), 133, 144, 137, 12, 170, 205.
