# Warrell Creek to Nambucca Heads Pacific Highway Upgrade

Commonwealth Approval EPBC 2013/7101  
Annual Compliance Report  
February 2017 – February 2018

Roads and Maritime Services | May 2018

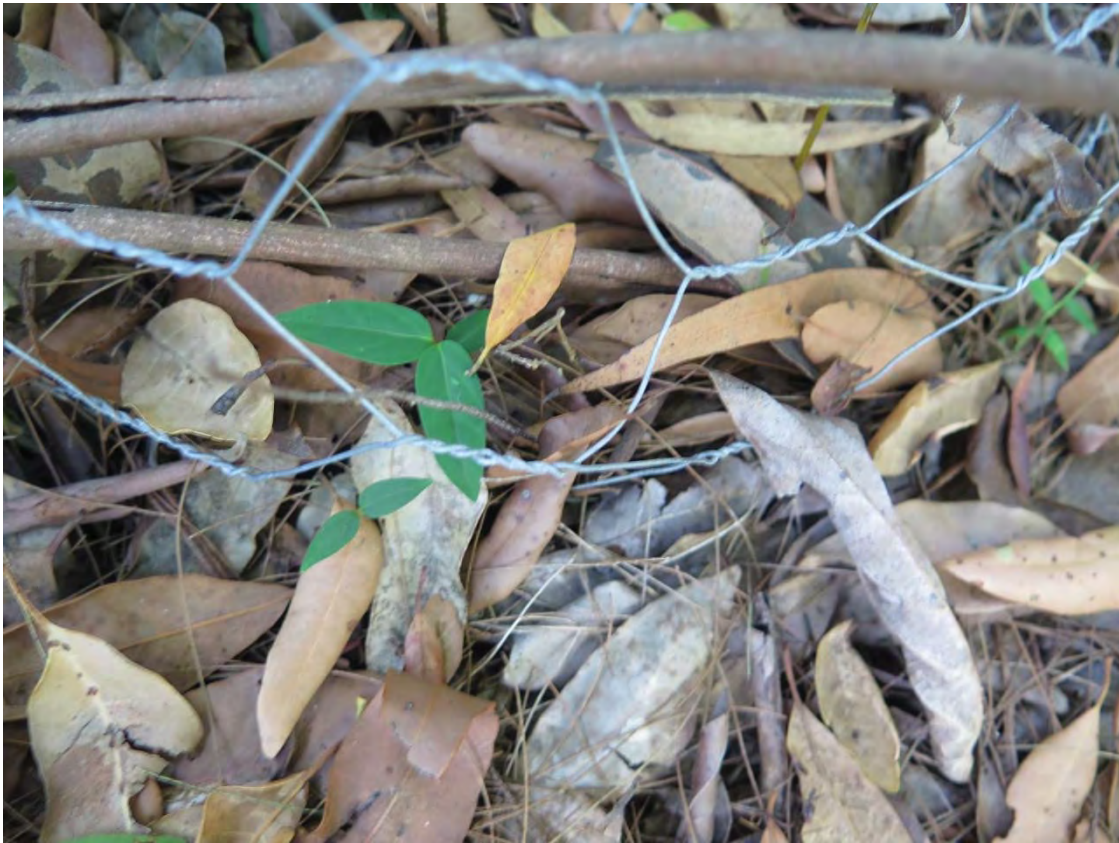
**Plate 16:** Slender Marsdenia. Site 1, No.14. This plant had produce a second small shoot at the Nov/17 monitoring. The height of this plant recorded over 3 years starting 2015 was 26 (cm), 20, 9, 0, 10, 10, 4. After appearing to die off it shot again.

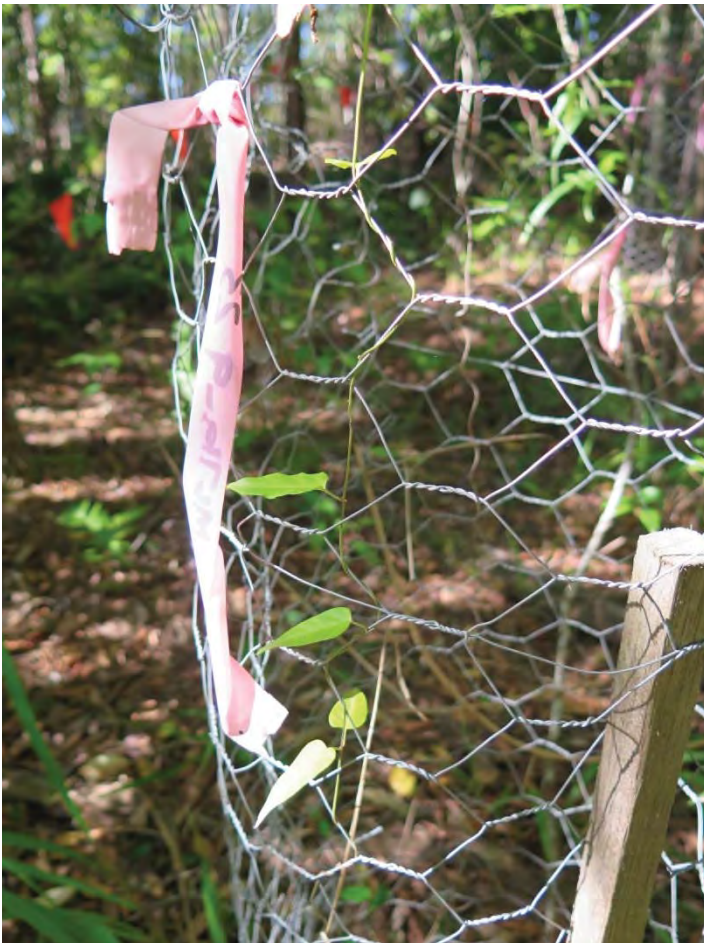
**Plate17:**Site 1, No. 23. This plant maintained size but only a small number of leaves and these were often yellowish. Plant height over 3 years starting 2015 was 119(cm), 120, 49, 15, 62, 76, 102.

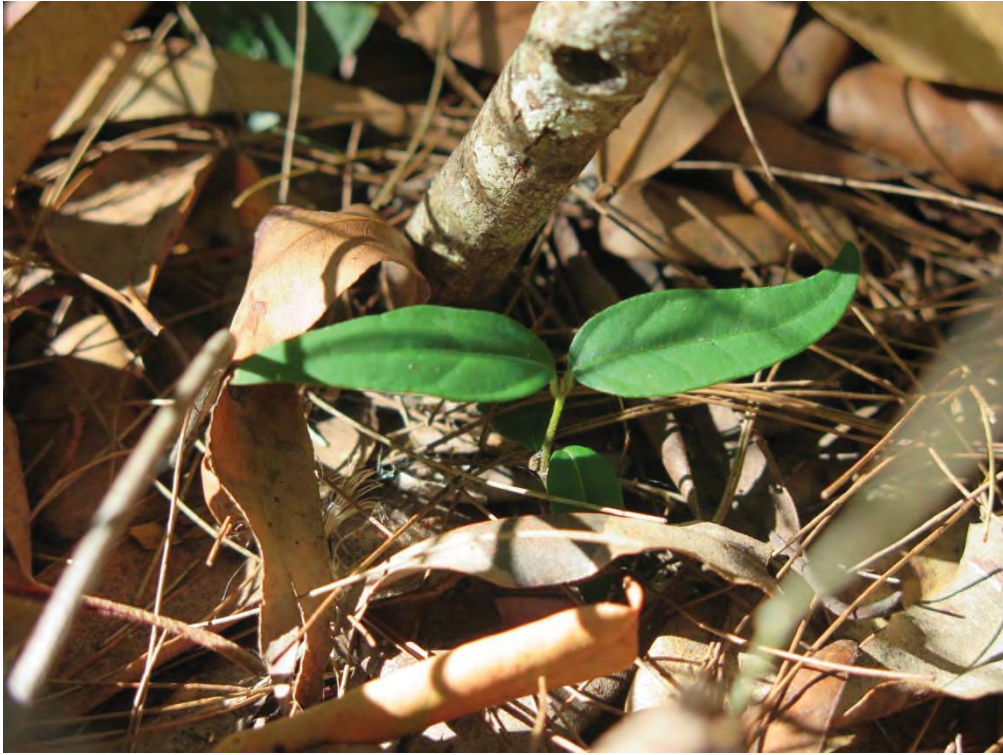
**Plate 18:** Slender Marsdenia. Site 1, No.25. The height of this plant recorded over 3 years starting 2015 was 10 (cm), 10, 25, 4, 3, 3, 3. About 20% of plants remained small like this over 3 years in Site 1 – Response Syndrome S1.

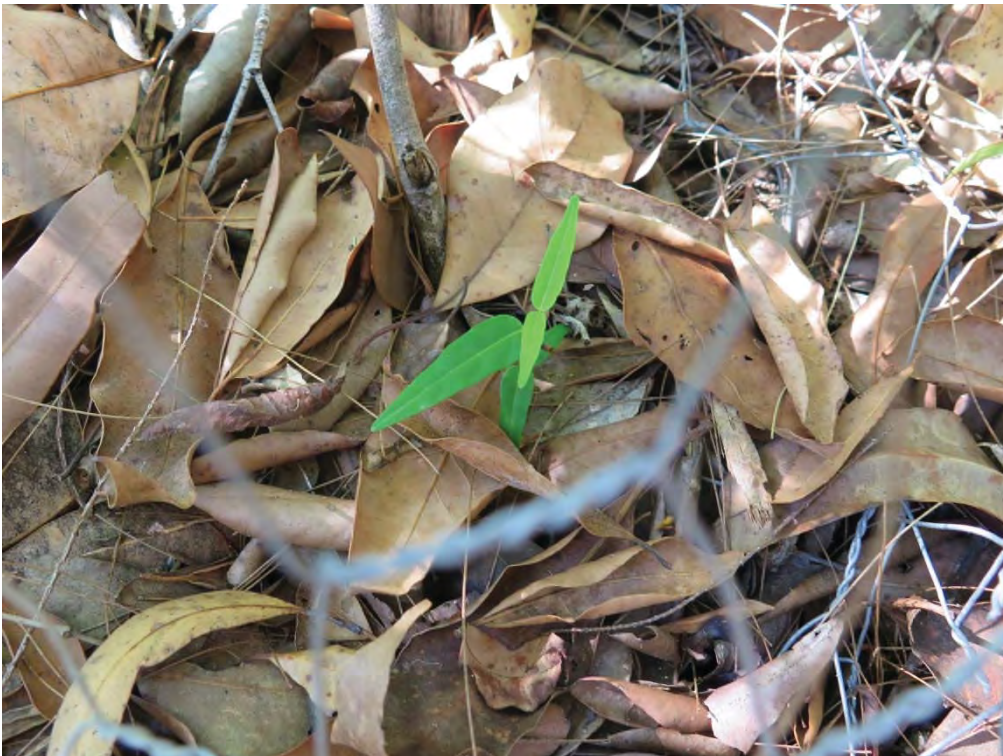
**Plate 19:** Slender Marsdenia. Site 1, No.9. The height of this plant recorded over 3 years starting 2015 was 52 (cm), 41, 32, 6, 0, 0, 4. After dying off this plant had reshot in Nov/17. Response Syndrome S2.

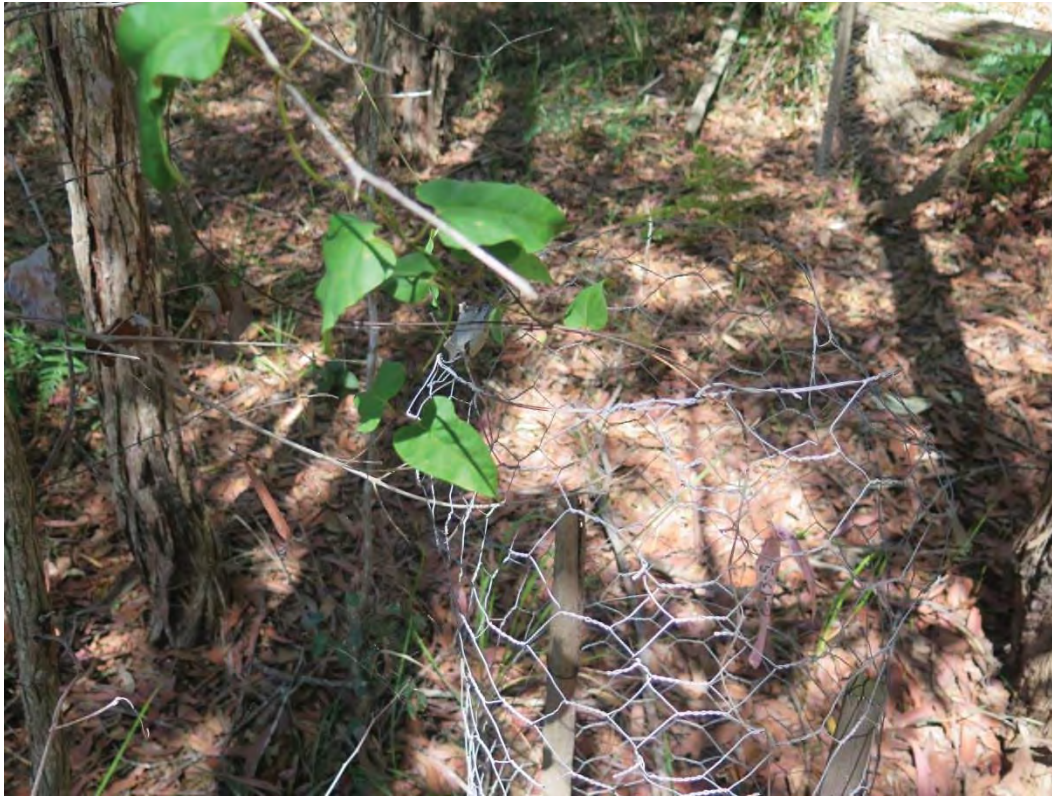
**Plate 20:** Slender Marsdenia. Site 2 (3), No.3. The height of this plant over 3 years starting 2015 was 7 (cm), 7, 72, 87, 85, 88, 181, an example of Response Syndrome T1.

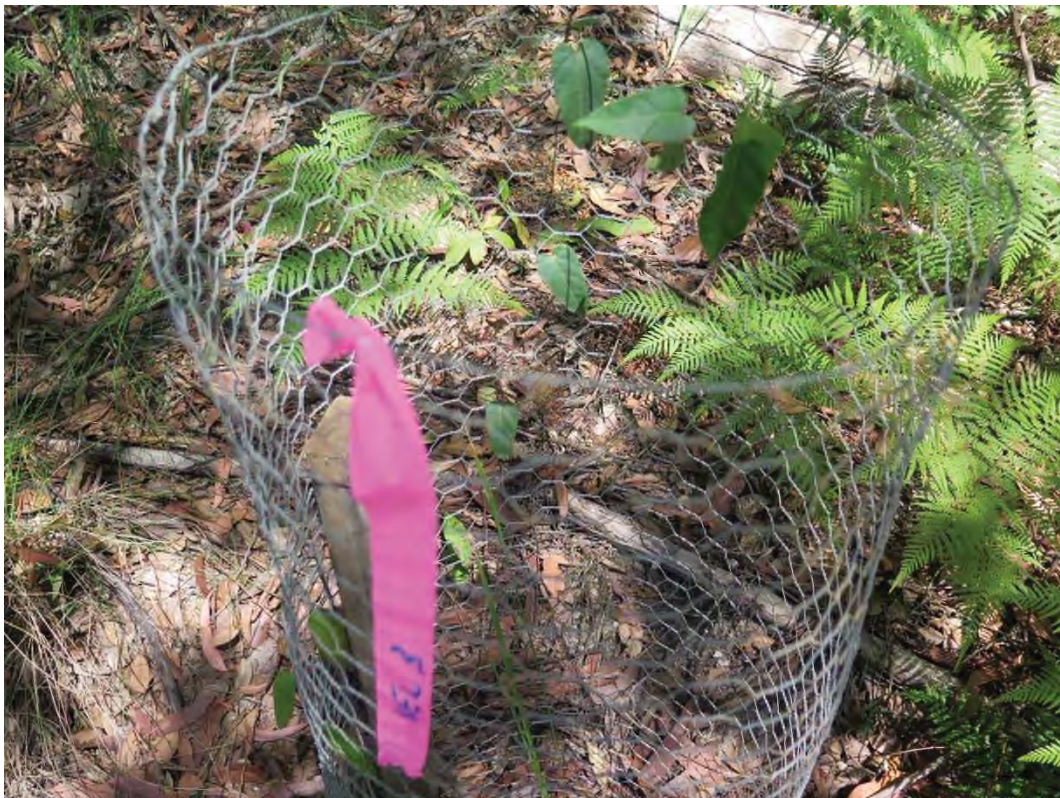
**Plate 21:** Slender Marsdenia. Site 2 (3), No. new 3. The height of this plant over 3 years starting 2015 was 7 (cm), 7, 72, 87, 85, 88, 181, an example of Response Syndrome T1.

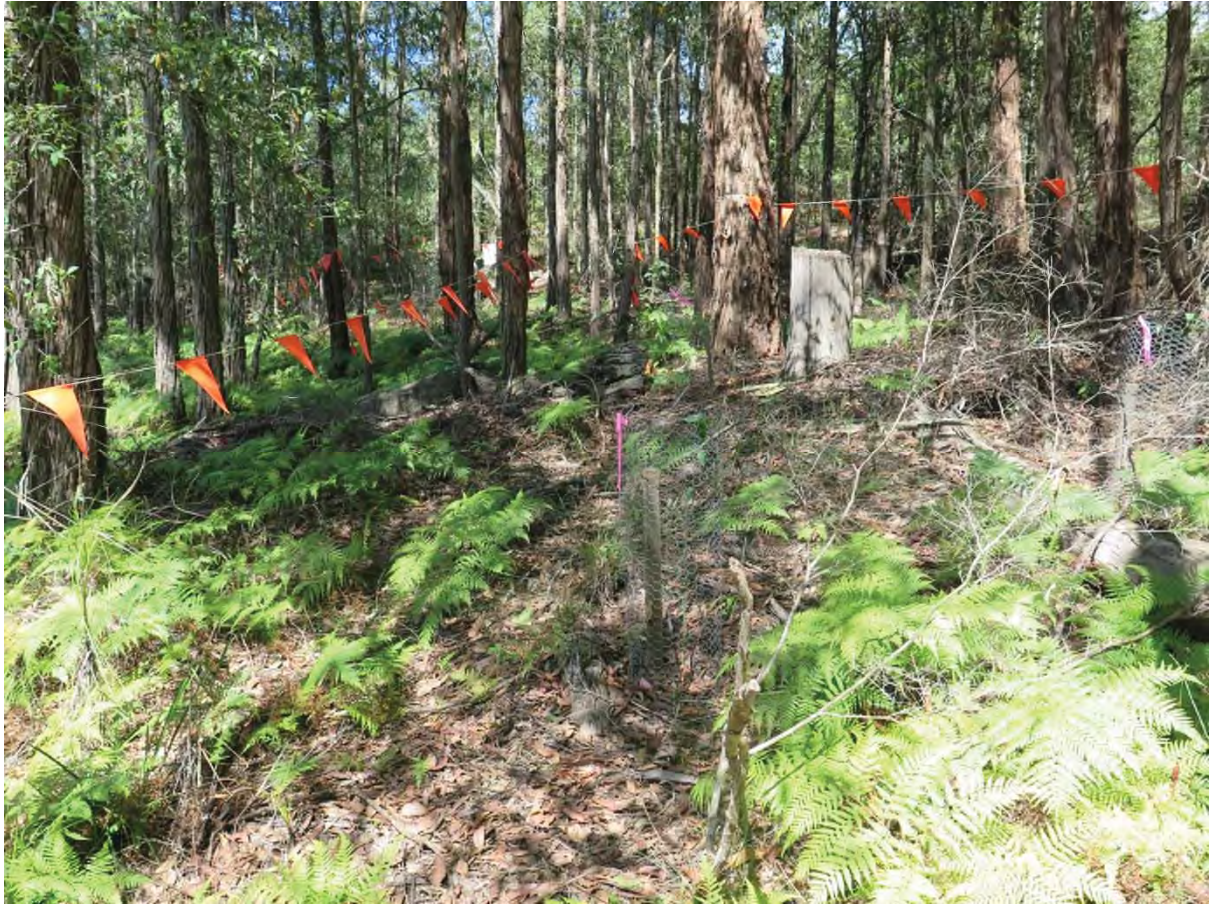
**Plate 22:** Receival Site 2 (3). Habitat – moist open forest with fern and leaf litter ground layer, mature forest regrowth. This site was more open than most other sites, less protected from the cleared road corridor and more exposed to wind, yet the translocated plants performed well.

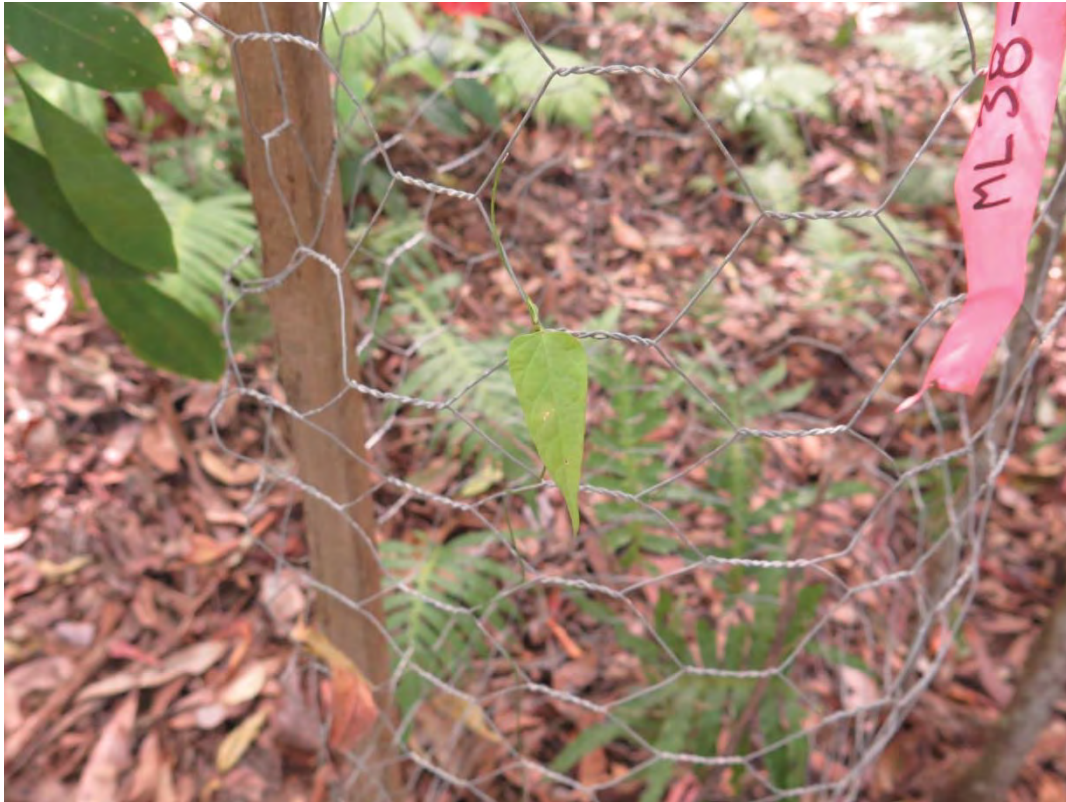
**Plate 23:** Slender Marsdenia. Site 3 (5a), No. 1. The height of this plant over 3 years starting 2015 was 46 (cm), 44, 45, 45, 45, 46, 72. This plant was either leafless or had only 1-3 leaves over 3 years.

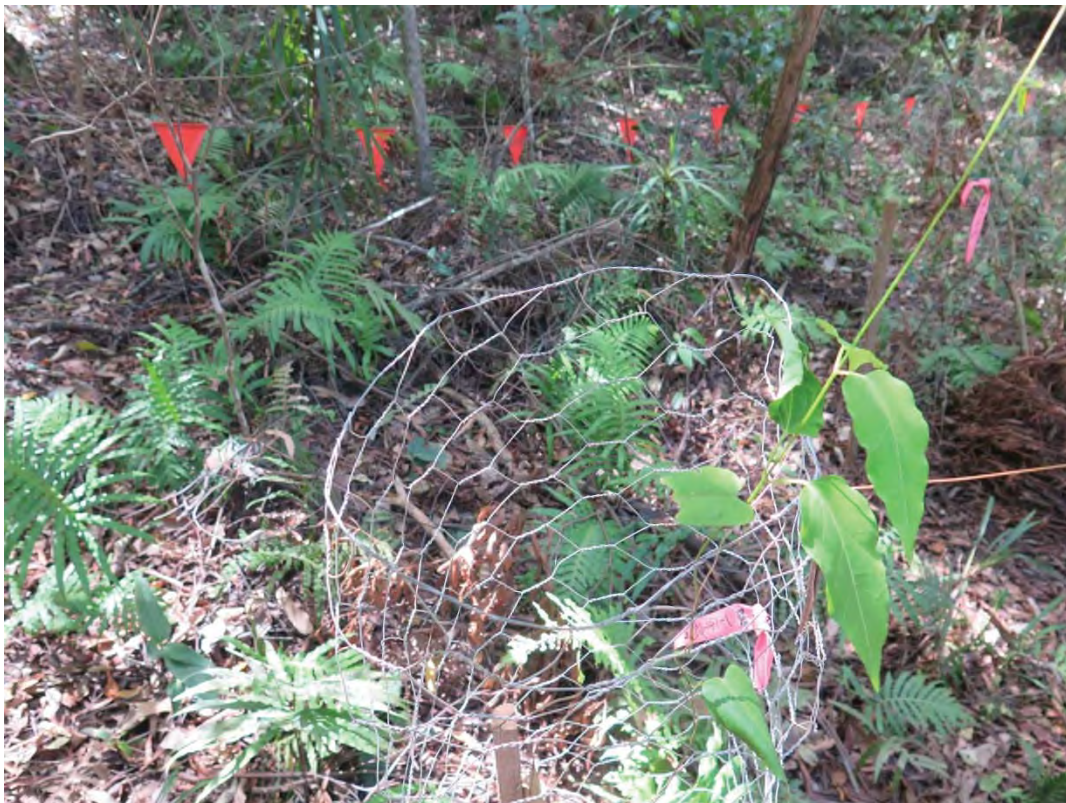
**Plate 24:** Slender Marsdenia. Site 3 (5a), No. 6. Plant height over 3 years starting 2015 was 25 (cm), 25, 125, 130, 118, 70, 147. This is an example of Response Syndrome T1 'large, thriving'.

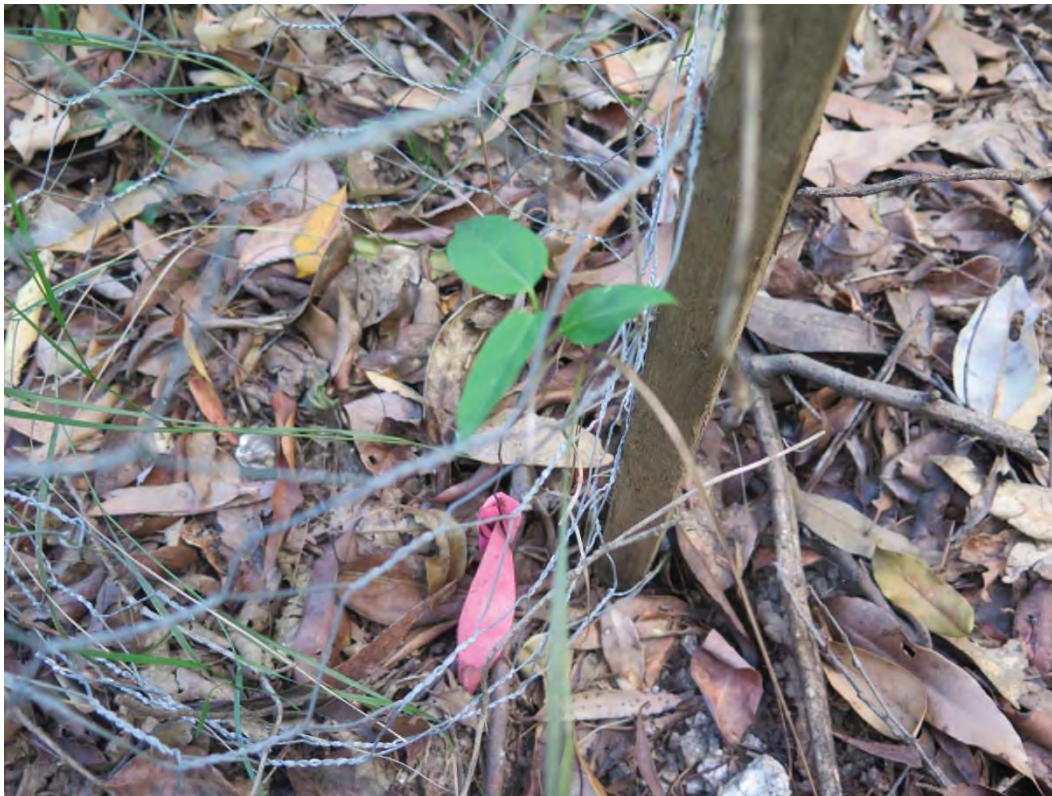
**Plate 25:** Slender Marsdenia. Site 3 (5a), No. 16. Plant height over 3 years starting 2015 was 64 (cm), 64, 124, 140, 64, 78, 28. This is an example of Response Syndrome S3 'bell-shaped'.

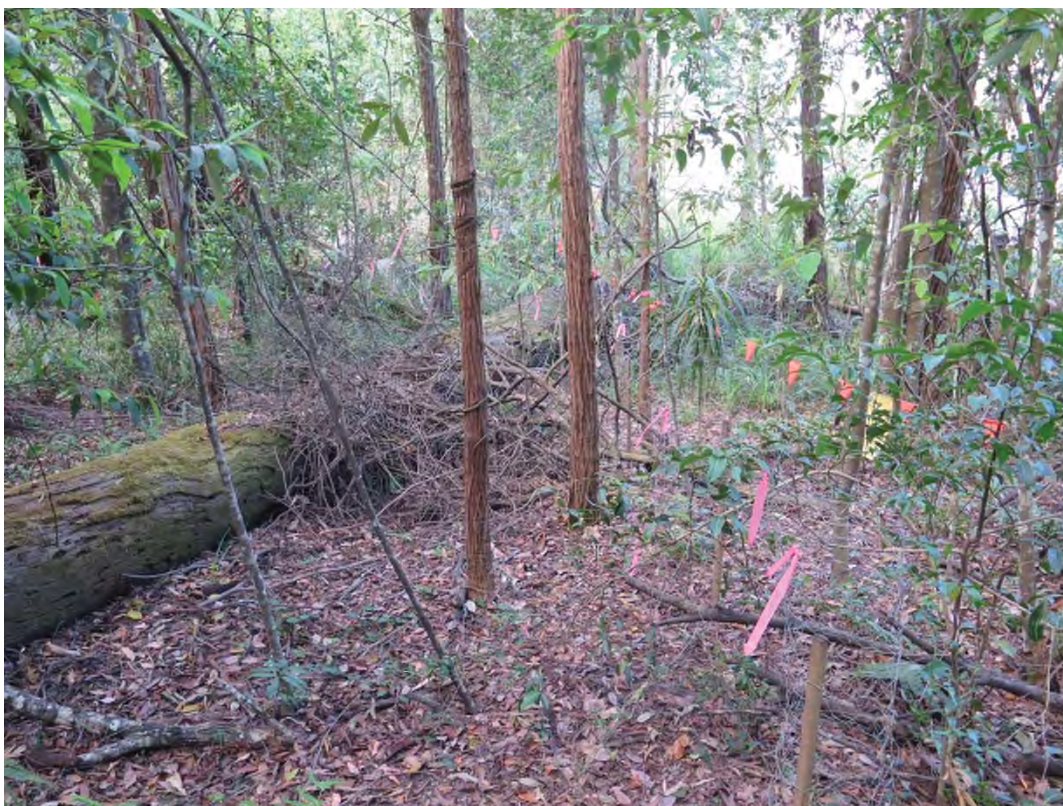
**Plate 26:** Receival Site 3 (5a). Habitat – moist open forest with leaf litter and fern ground layer in mature forest regrowth.

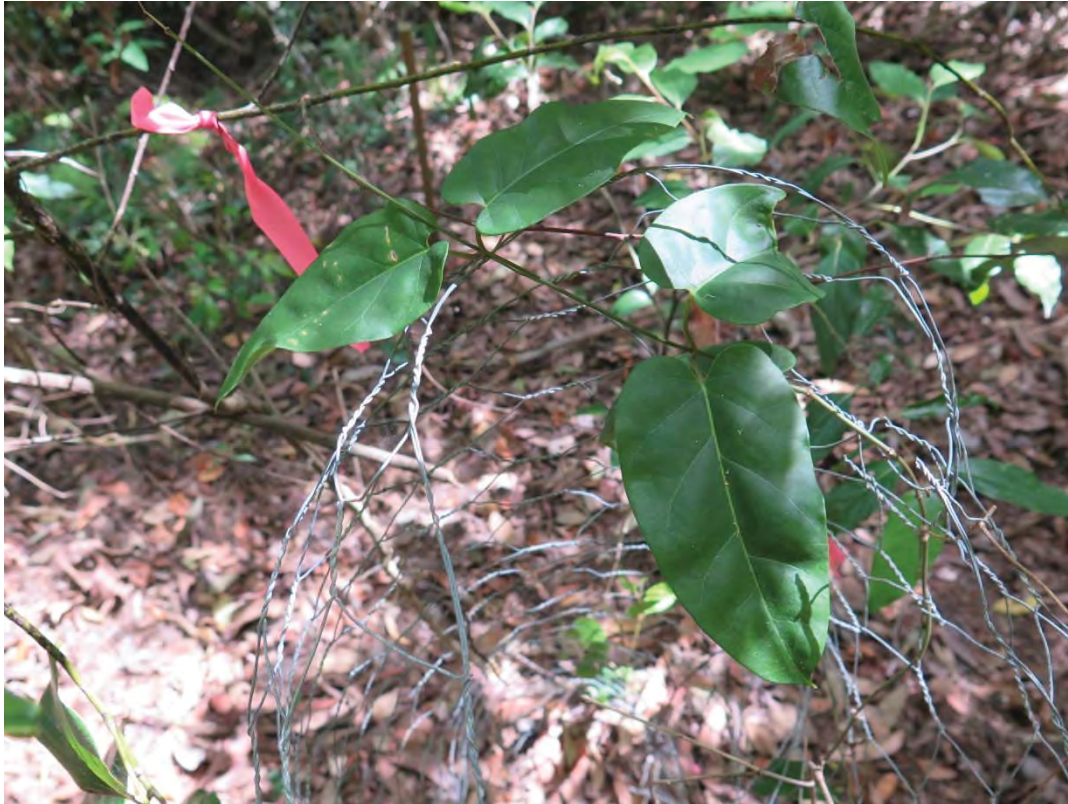
**Plate 27:** Most *Marsdenia* plants transplanted to Receival Site 4 (5b) appear to be *Marsdenia liisae* (Large-flowered *Marsdenia*), which has larger leaves than *M. longiloba*. This wasn't clear at the time of transplanting. *M. liisae* is a rare species (ROTAP) but not listed as threatened.

Combining the receival sites, the survival rate of Slender Marsdenia after three years was 74.4%. Survivorship per site varied from 63% to 88%, down from 72% to 93% in Year 2 (Table 7). Most individuals translocated to Site 5b turned out to be *Marsdenia liisae* (see Plate 27).

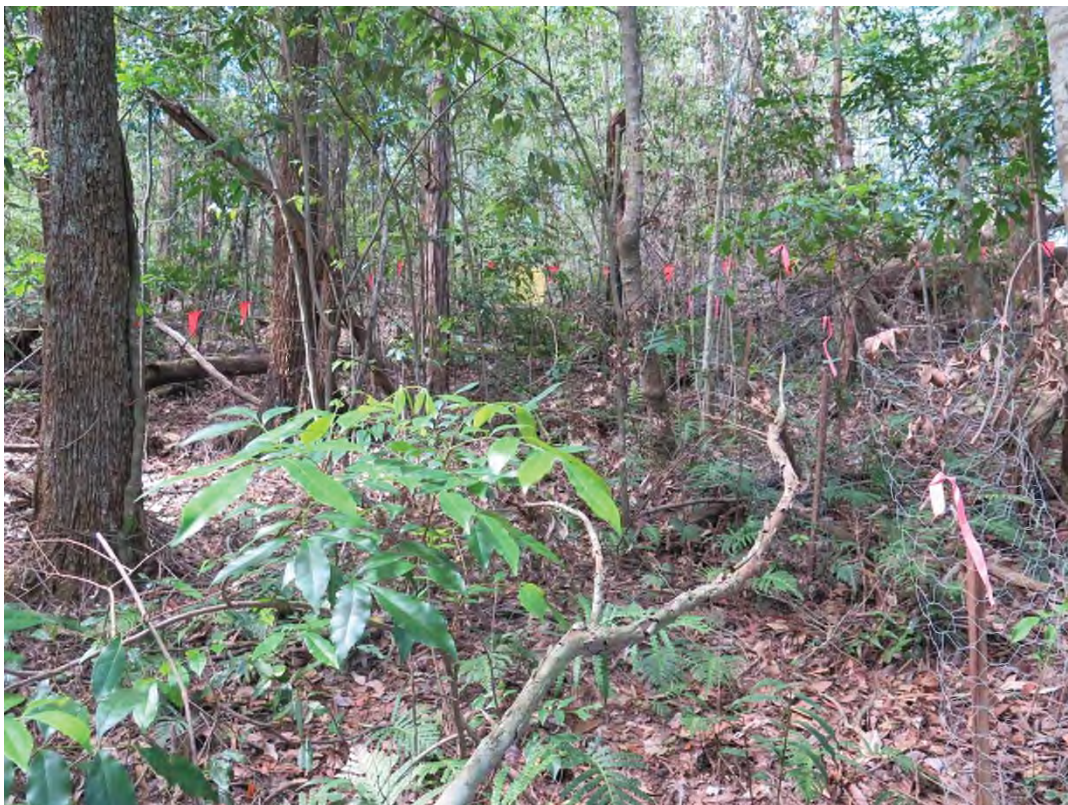
**Plate 28:** Receival Site 4 (5b) habitat – moist open forest with fern and leaf litter ground layer.

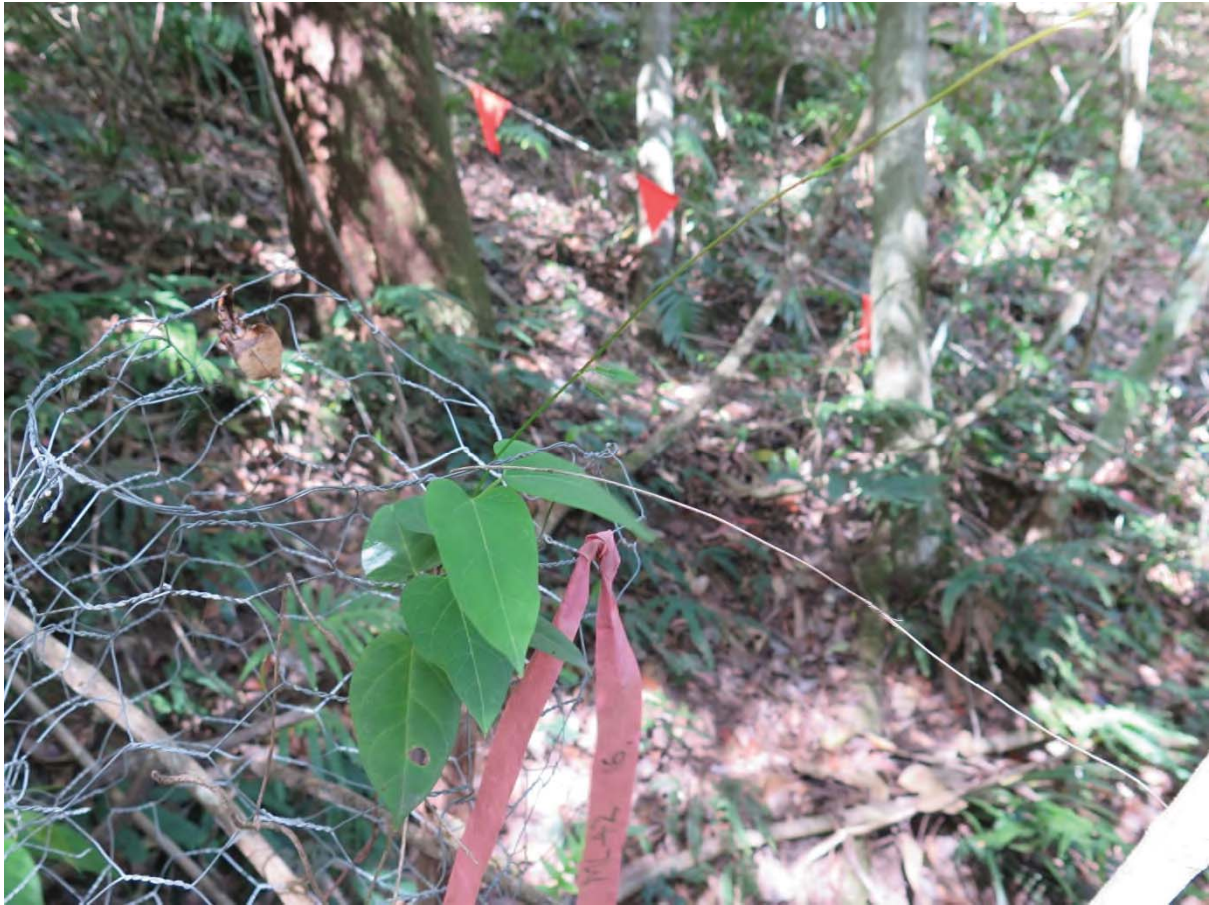
**Plate 29:** Receival Site 4 (5b), No. 16. This was an important individual for translocation and research on the ecology of *Marsdenia longiloba*. It was the only plant found with seed pods (2 in total), one of which was collected before the start of construction of WC2NH. Seedlings propagated from the pod were introduced to the NH2U translocation area for *M. longiloba*, which started two years earlier. This plant also had flowers allowing positive species identification and it was used as one of the marker plants for the *M. longiloba* genetic study (Shapcott et al. 2016), which investigated genetic variation across the species' range from the Mid North Coast to South East Qld. After transplanting successfully it was damaged by an animal colliding with its cage and then reshot again. Plant height over 3 years starting 2015 was 145 (cm), 145, 221, 110, 110, 119, 132.

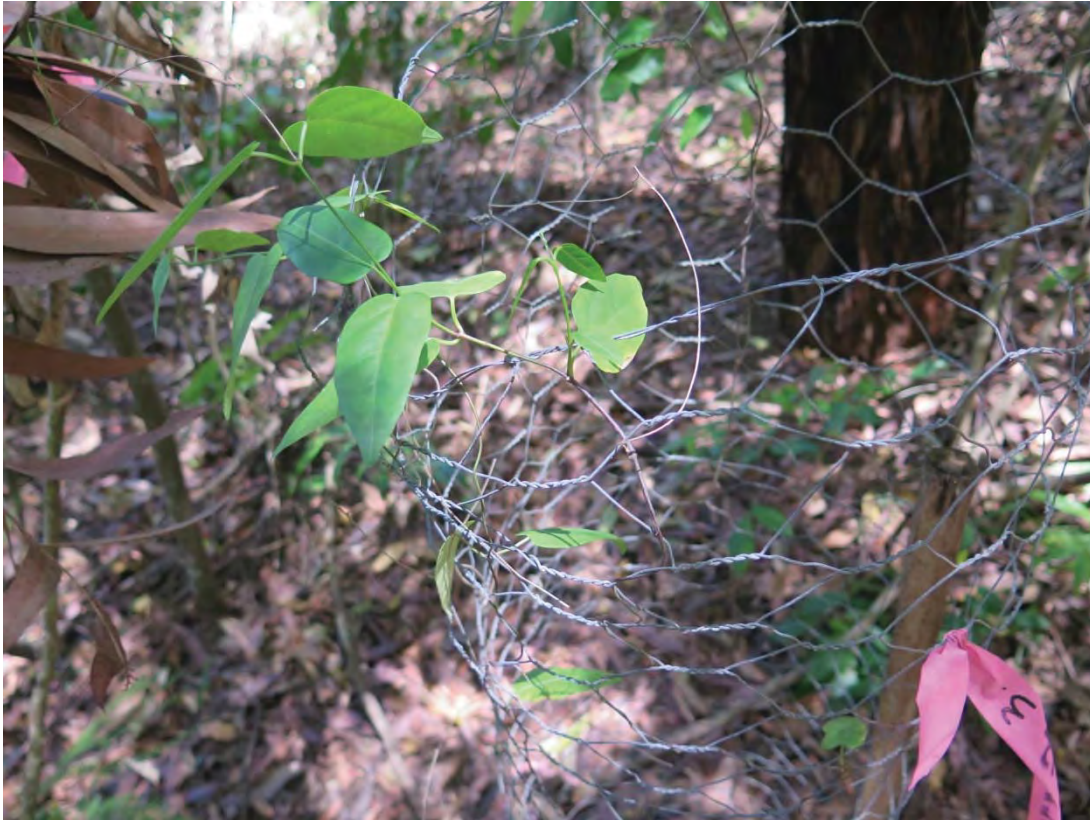
**Plate 30:** Receival Site 5 (7a) No. 3. Plant with actively growing shoot and 19 leaves in Nov/17. Plant height over 3 years starting 2015 was 48 (cm), 46 118, 110, 130, 132, 130.

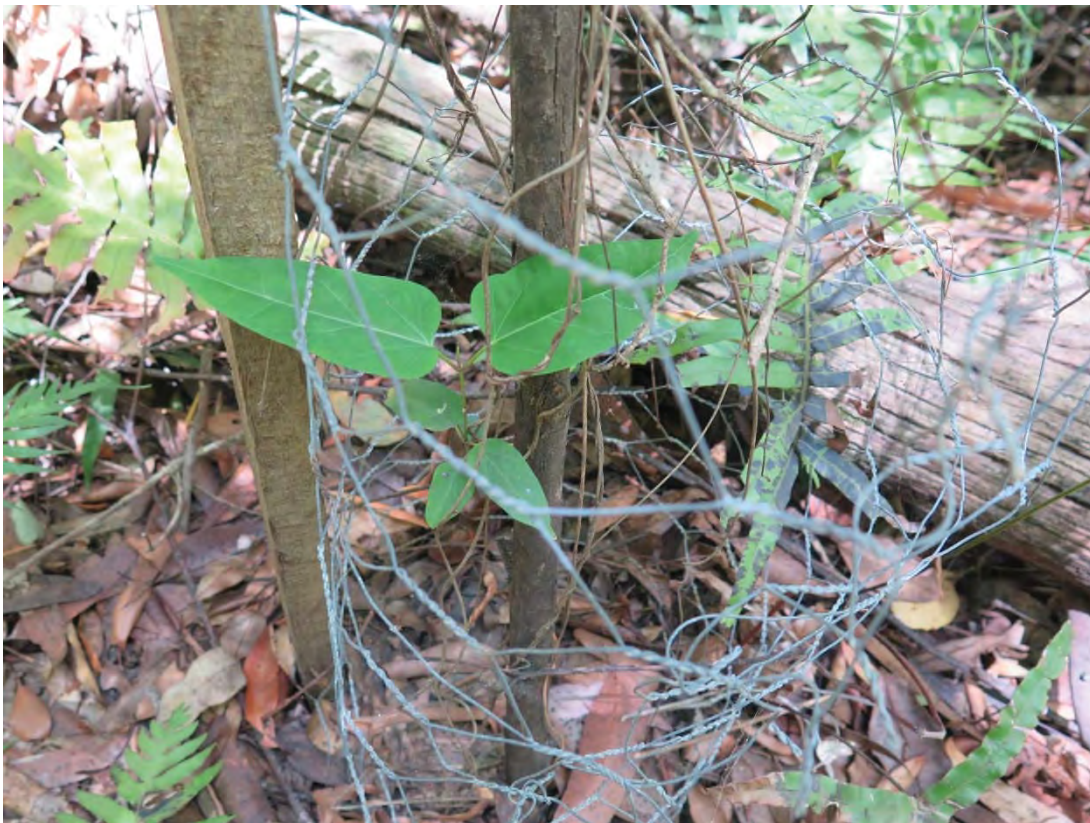
**Plate 31:** Receival Site 5 (7a) No. 34. Plant height over 3 years starting 2015 was 45 (cm), 45 124, 115, 112, 34, 35

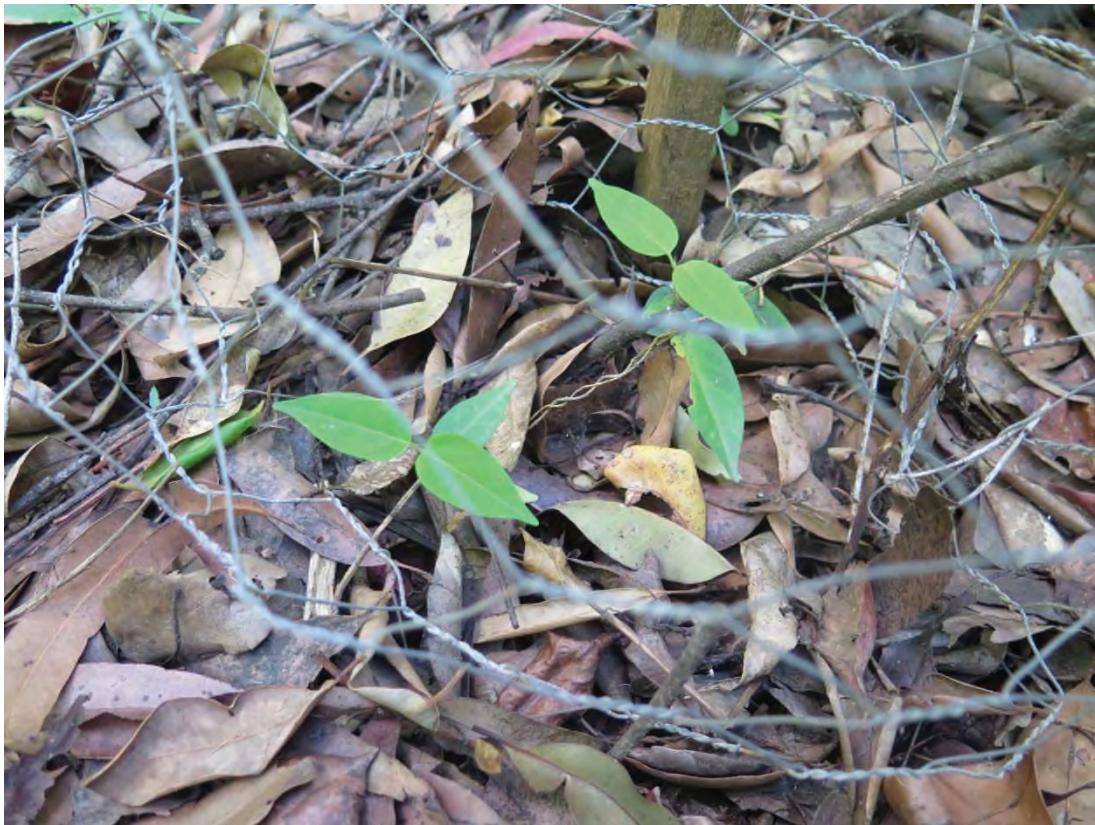
**Plate 32:** Receival Site 5 (7a) No. 17. A second shoot appeared in Year 2. Plant height over 3 years starting 2015 was 27 (cm), 22, 13, 3, 10, 10, 10. This is an example of Response Syndrome S1 'stayed small'.

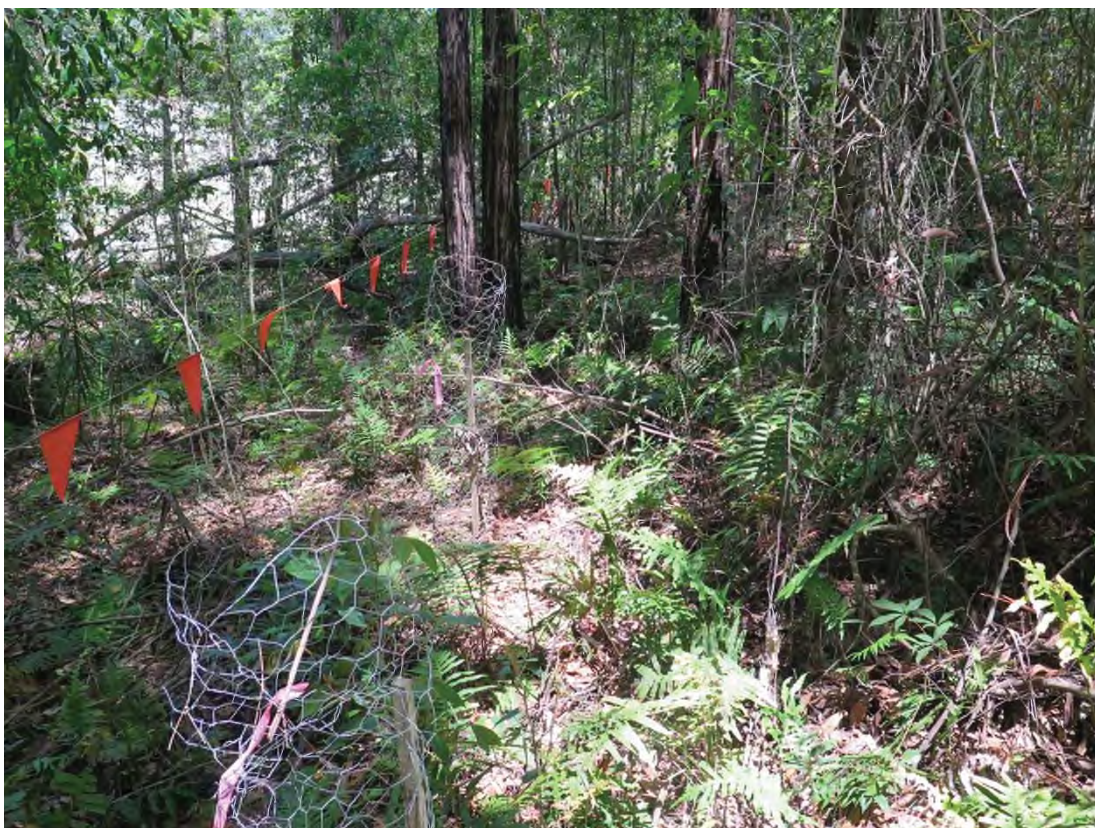
**Plate 33:** Receival Site 5 (7a) habitat – moist open forest regrowth with fern and leaf litter ground layer. Highway embankment in the background, wire cages at each *M. longiloba* transplant in the foreground.

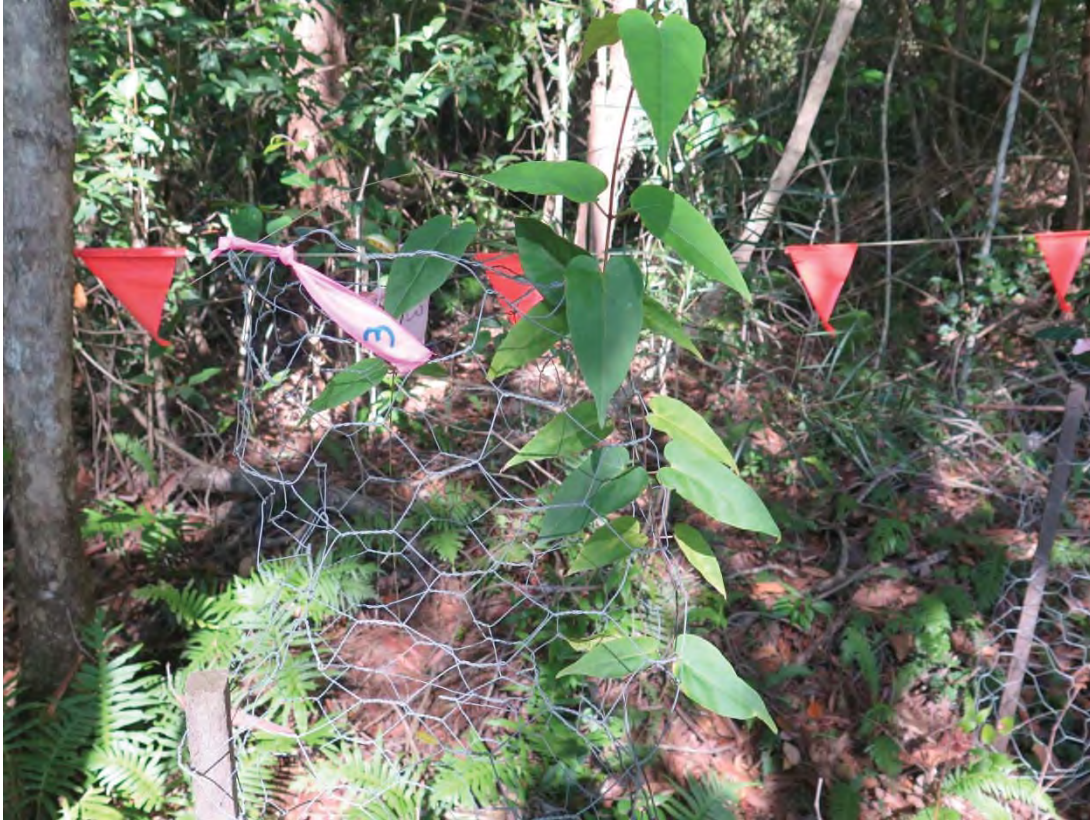
**Plate 34:** Receival Site 6 (8a) No. 3. Plant height over 3 years starting 2015 was 5 (cm), 5, 66, 97, 150, 135, 175. This is an example of Response Syndrome T1 ‘large, thriving’.

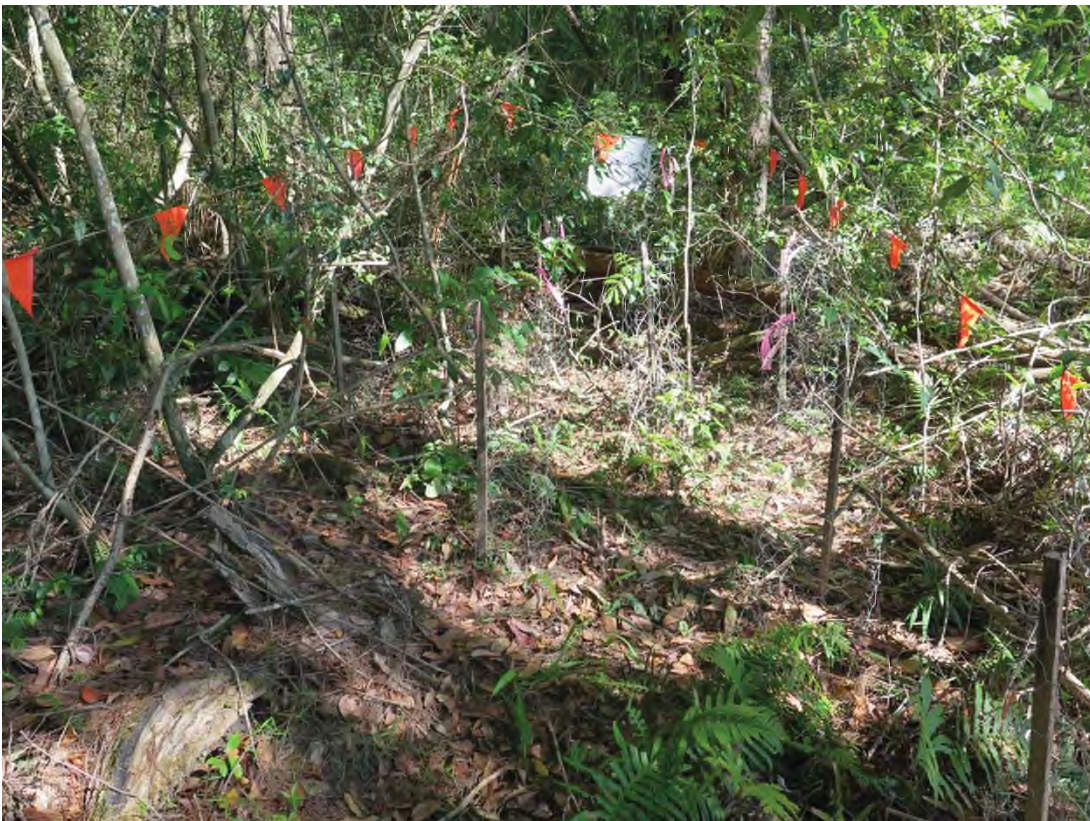
**Plate 35:** Receival Site 6 (8a) habitat – moist open forest with fern and leaf litter ground layer.

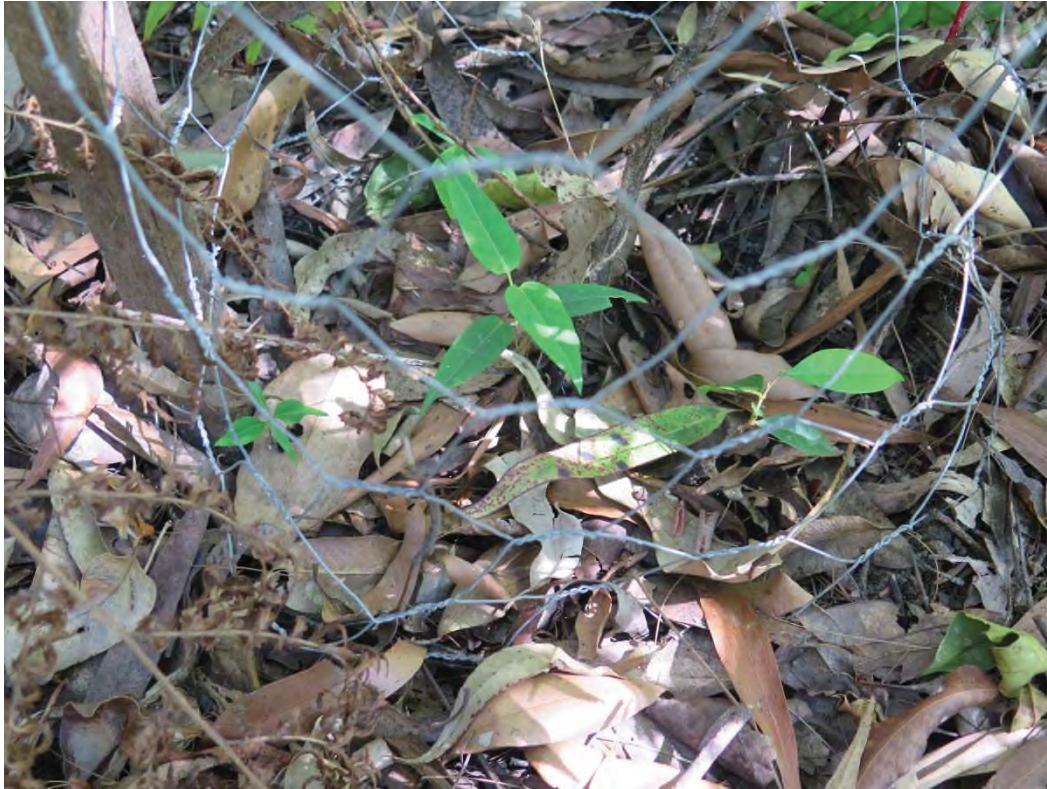
**Plate 36:** Receival Site 8 (8c) No. 6. Plant height over 3 years starting 2015 was 21 (cm), 15, 18, 4, 6, 6, 10. This is an example of Response Syndrome S1 ‘stayed small’.

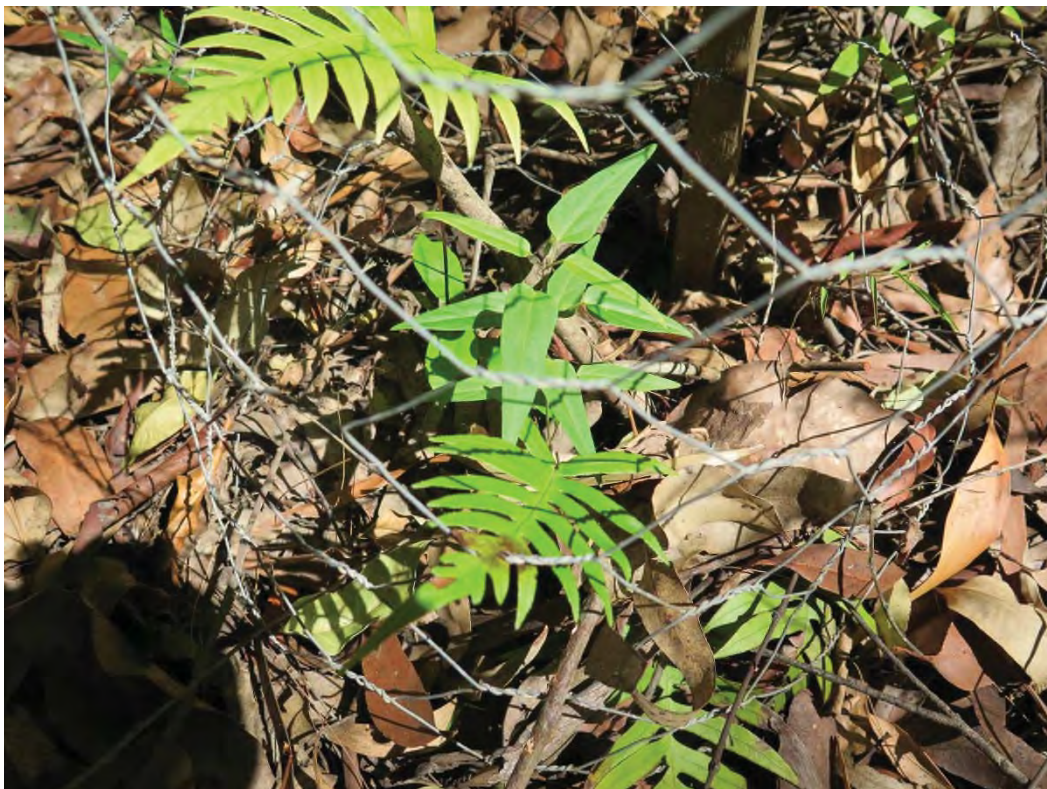
**Plate 37:** Receival Site 8 (8c) No. 7. Plant height over 3 years starting 2015 was 55 (cm), 53, 40, 0, 7, 10, 13. This is an example of Response Syndrome S2 ‘small, died off, reshot again’

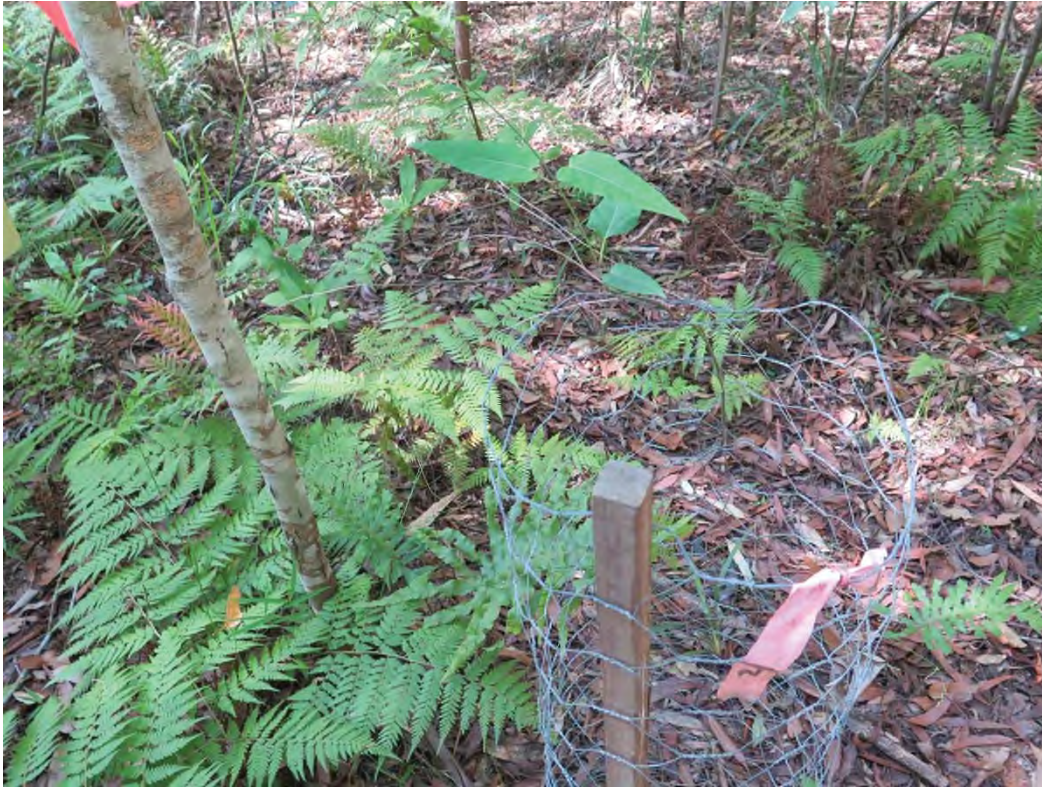
**Plate 38:** Receival Site 8 (8c) No. 24. Plant height over 3 years starting 2015 was 10 (cm), 13, 106, 94, 108, 102, 112. This is an example of Response Syndrome S2 'medium, increased height'

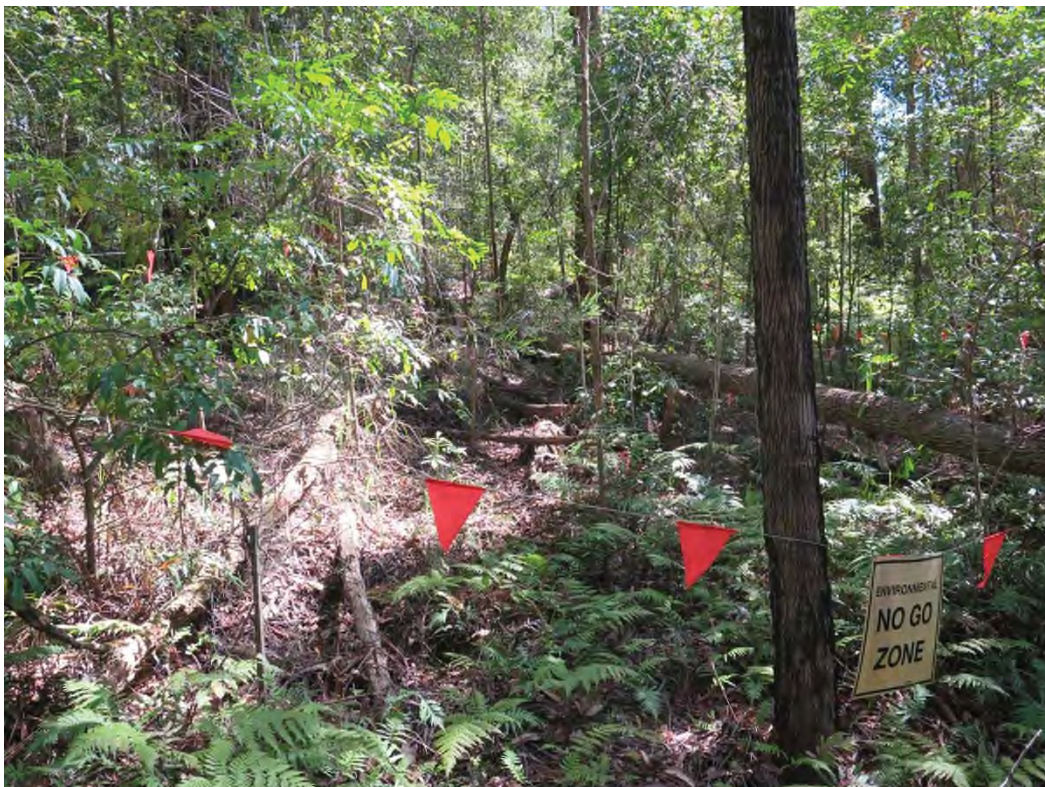
**Plate 39:** Receival Site 6 (8c) habitat – moist open forest regrowth with fern and leaf litter ground layer.
