# Warrell Creek to Nambucca Heads Pacific Highway Upgrade

Commonwealth Approval EPBC 2013/7101  
Annual Compliance Report  
February 2017 – February 2018

Roads and Maritime Services | May 2018

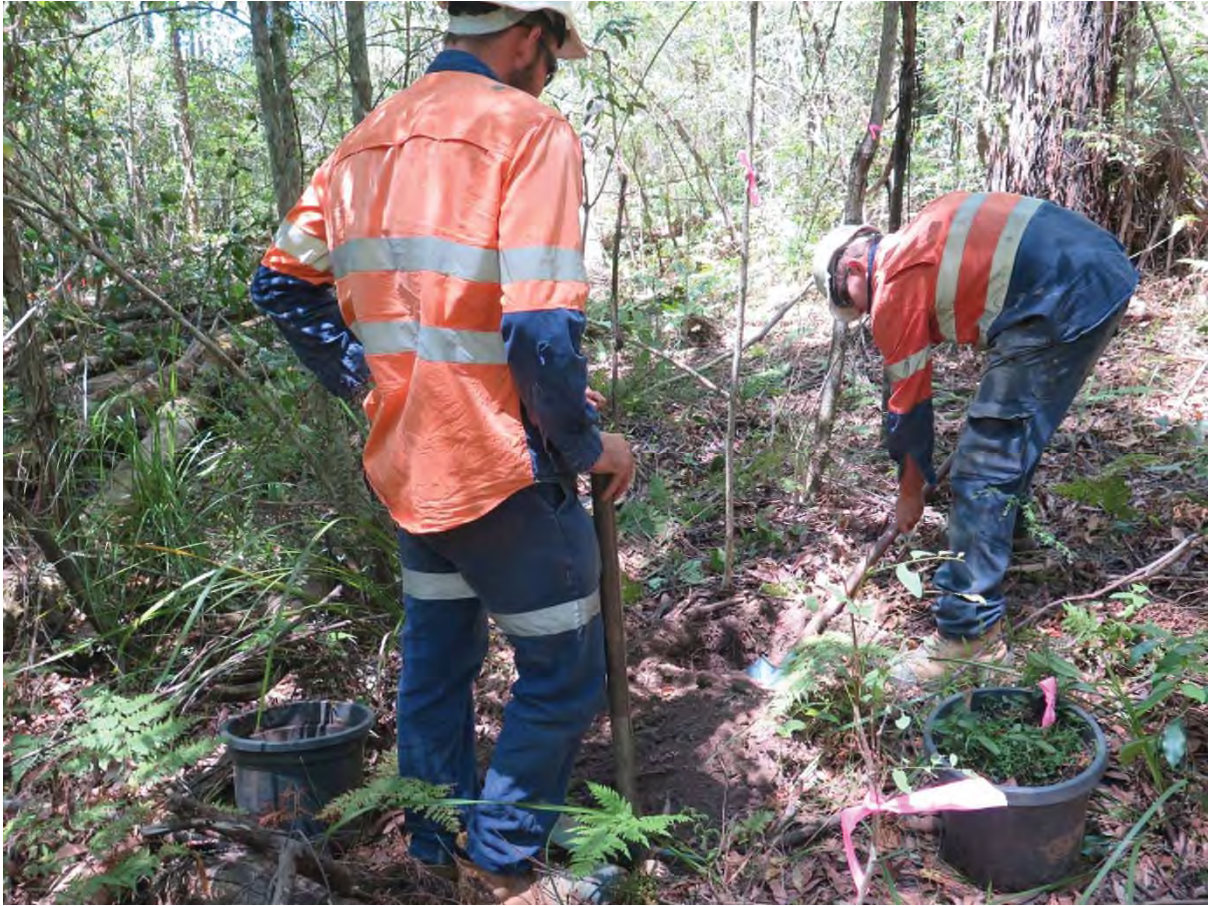
**Plate 40:** Planting propagated Slender Marsdenia plants for population enhancement in Nov/17 next to Receival Site 5 (7a). Only a small number of population enhancement plants were propagated (12) due the low strike rate of rhizome cuttings (<5%) and absence of seed.

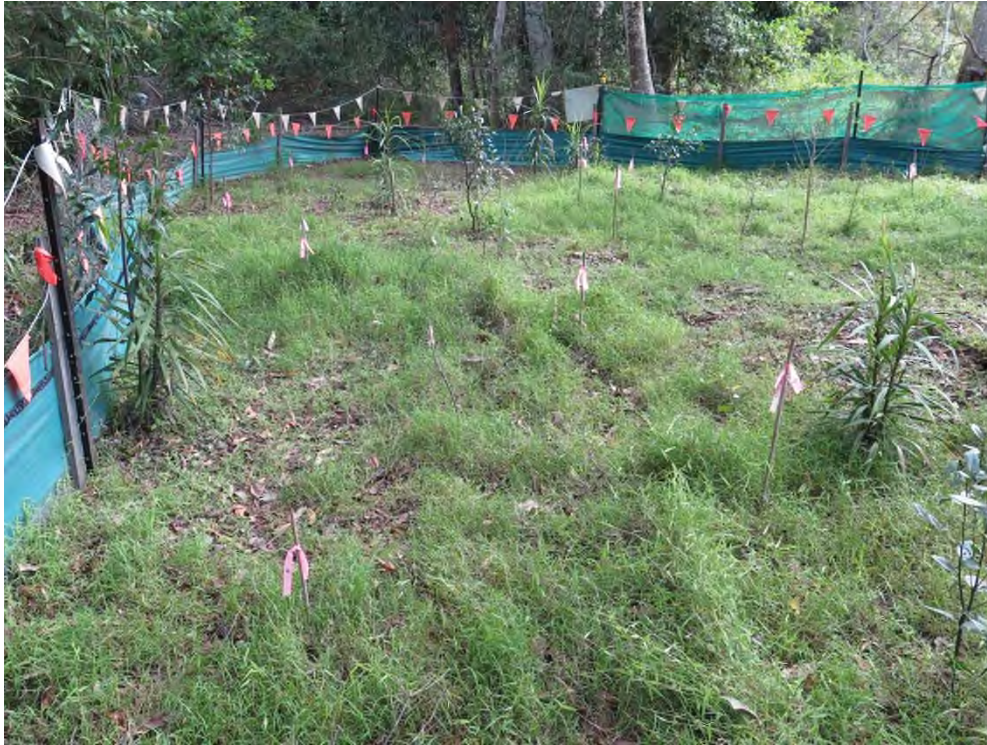
**Plate 41:** Floyds Grass (*Alexfloydia repens*) Receival Site 9, Area 1. Floyds Grass spreads by runners and now covers most of the receival site closest to Warrell Ck, which started as bare ground after topsoil and ground layer plant removal. Sapling regrowth was removed during maintenance in Nov/17 to reduce competition and shading. Markers show where initial plants were introduced.

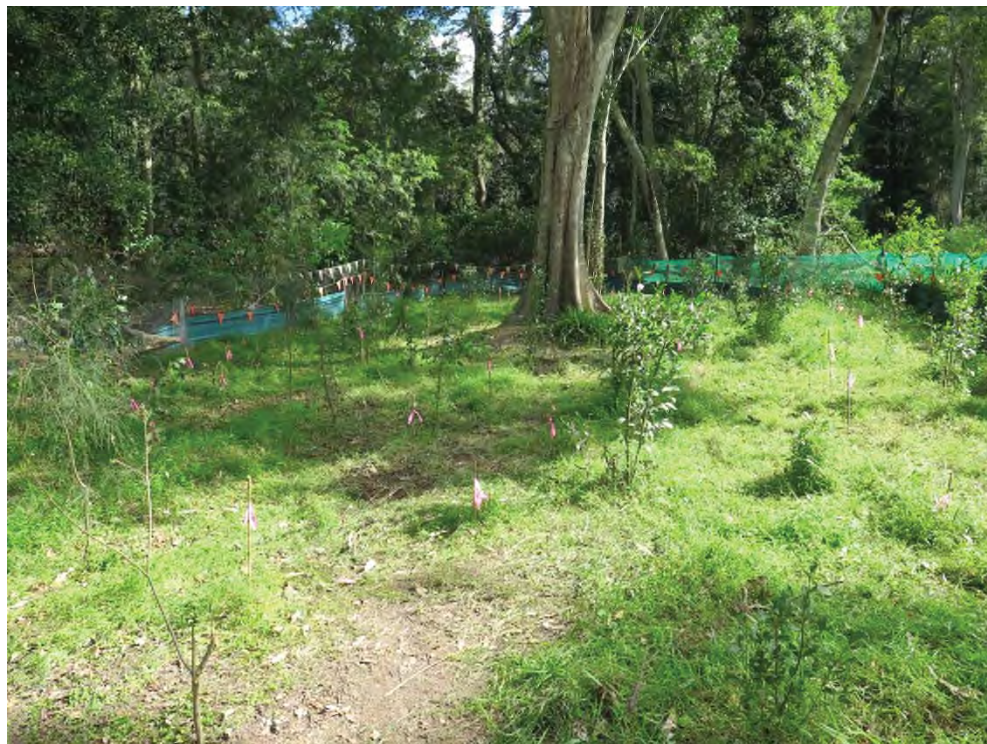
**Plate 42:** Overall shot of Area 1 above. Floyds Grass dominates the left hand side closest to Warrell Creek and the native creeping grass *Ottochloa gracillima* dominates the right hand side. Nov/17, 2.5 years after transplanting.

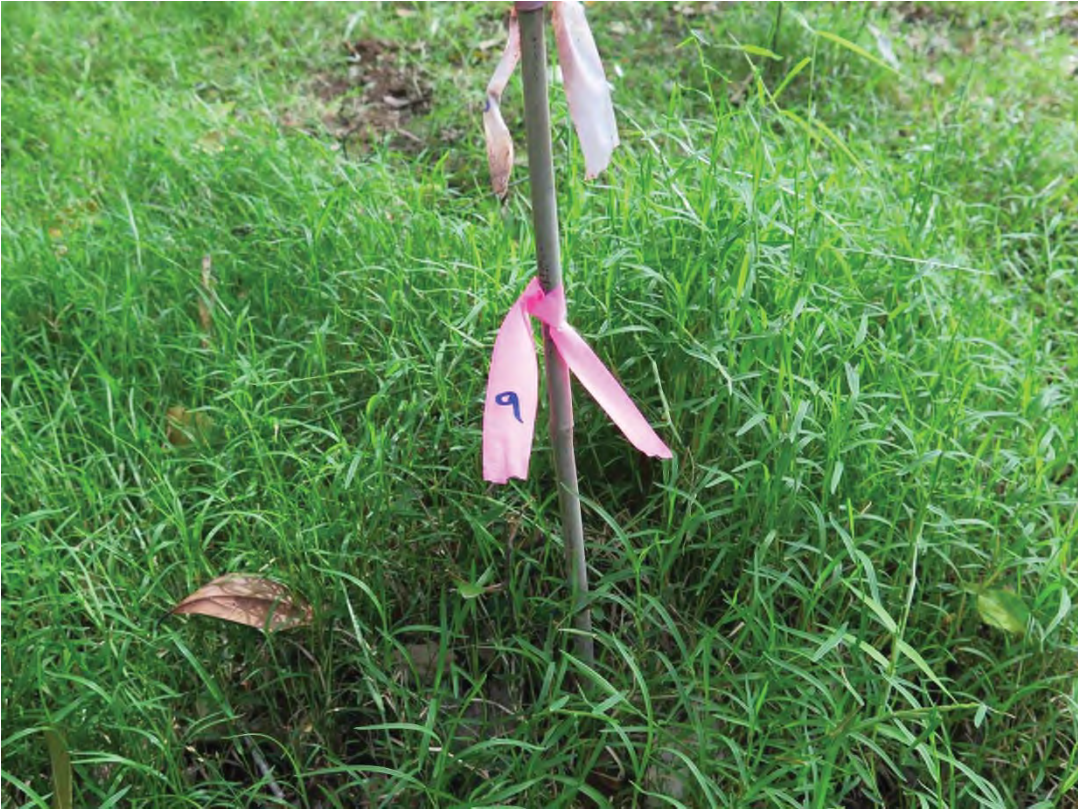
**Plate 43:** Floyds Grass, Receiving Site 9, Area 1. Close-up of Floyds Grass clump.

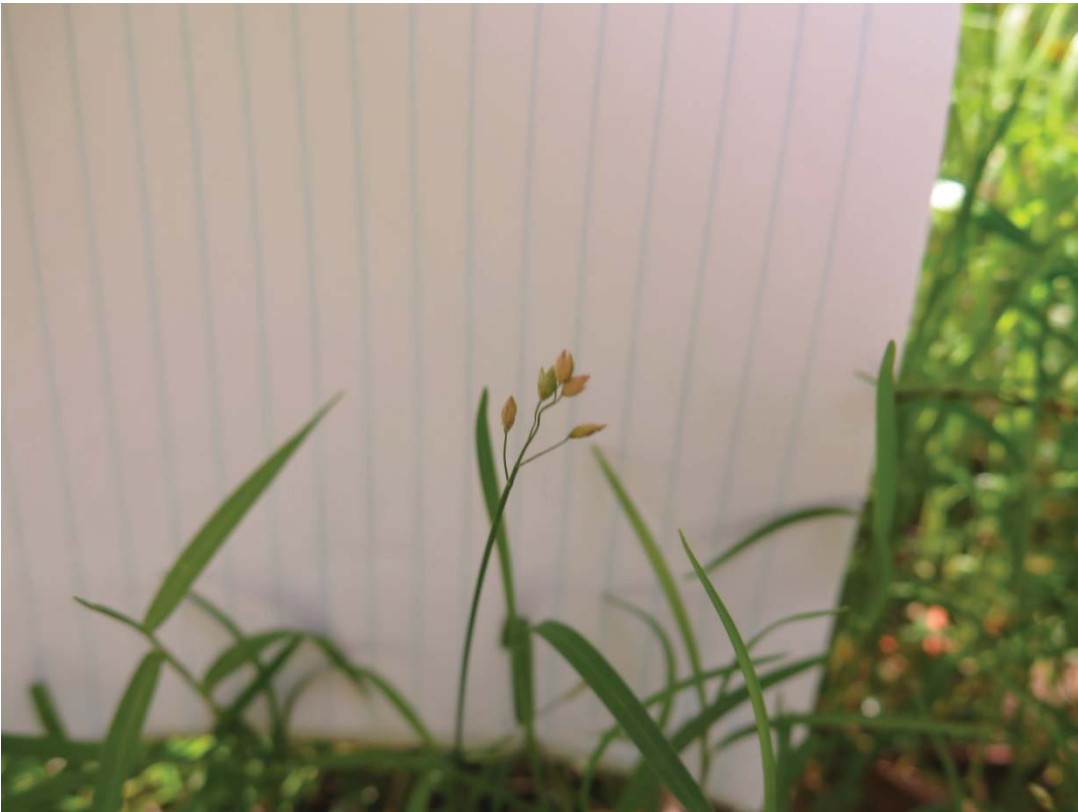
**Plate 44:** Floyds Grass, Receiving Site 9, Area 1. The majority of clumps were producing flowers and seeds in Nov/17 although they were relatively sparse.

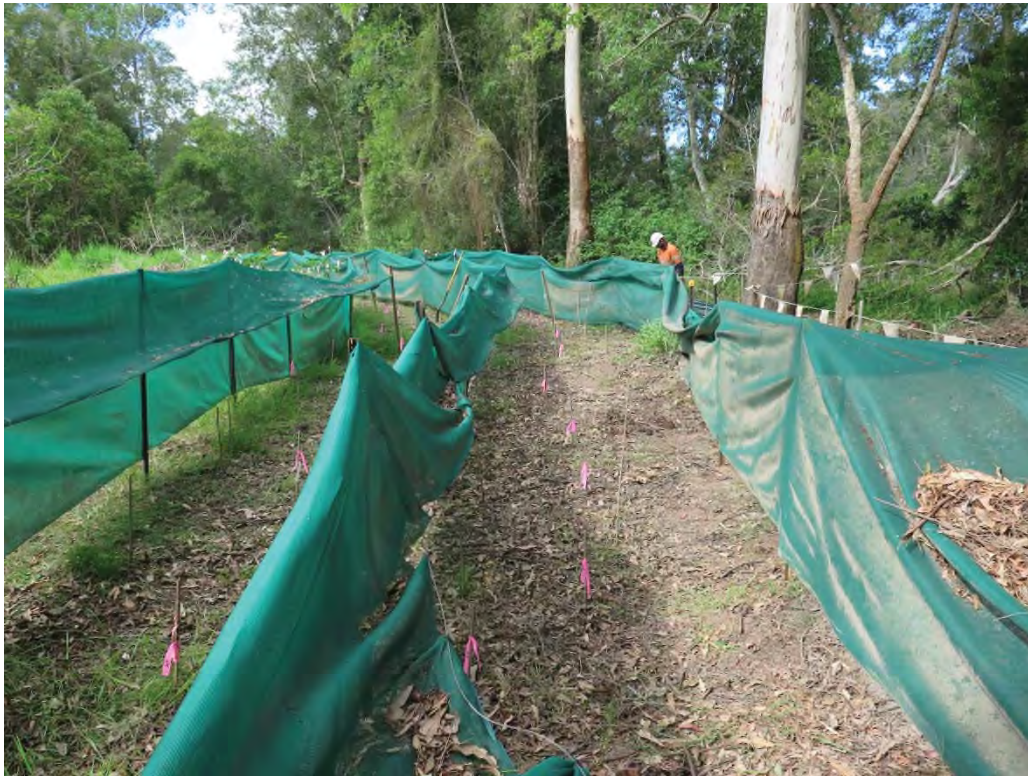
**Plate 45:** Floyds Grass, Receival Site 9, Area 2. Propagated, population enhancement plants were introduced this site following the same weed and topsoil removal treatment. The shade cloth rows with an awning are for shade as there is no tree shade to the west. Nov/17, 1.5 years after planting.

Small clumps of Floyds Grass approximately 10cm square were dug up with a spade and planted at the receival site. The clumps were watered thoroughly and sugar cane mulch (weed free) spread lightly over the soil surface to protect from raindrop compaction. Follow-up watering was carried out as conditions were dry. 'Seasol' seaweed and fish emulsion fertiliser was applied two weeks after introduction to stimulate growth. As the site was exposed to the afternoon sun, shade-cloth fences approximately 1m high and running N-S were erected to provide additional shade (Plate 45). These have now been removed from Area 1 (Plate 42).

To promote population establishment by increasing initial population size, approximately 100 additional Floyds Grass plants were propagated at Ecos Environmental's nursery and planted out in a second area at Receival Site 9 in March 2016. These plants were propagated from small pieces of runner that broke off during transplanting. As Area 2 was more exposed than Area 1 and had little shade, shade cloth fences installed to protect the young Floyds Grass plants also had a roof to protect from the overhead sun (Plate 45). Hand weeding to remove competing

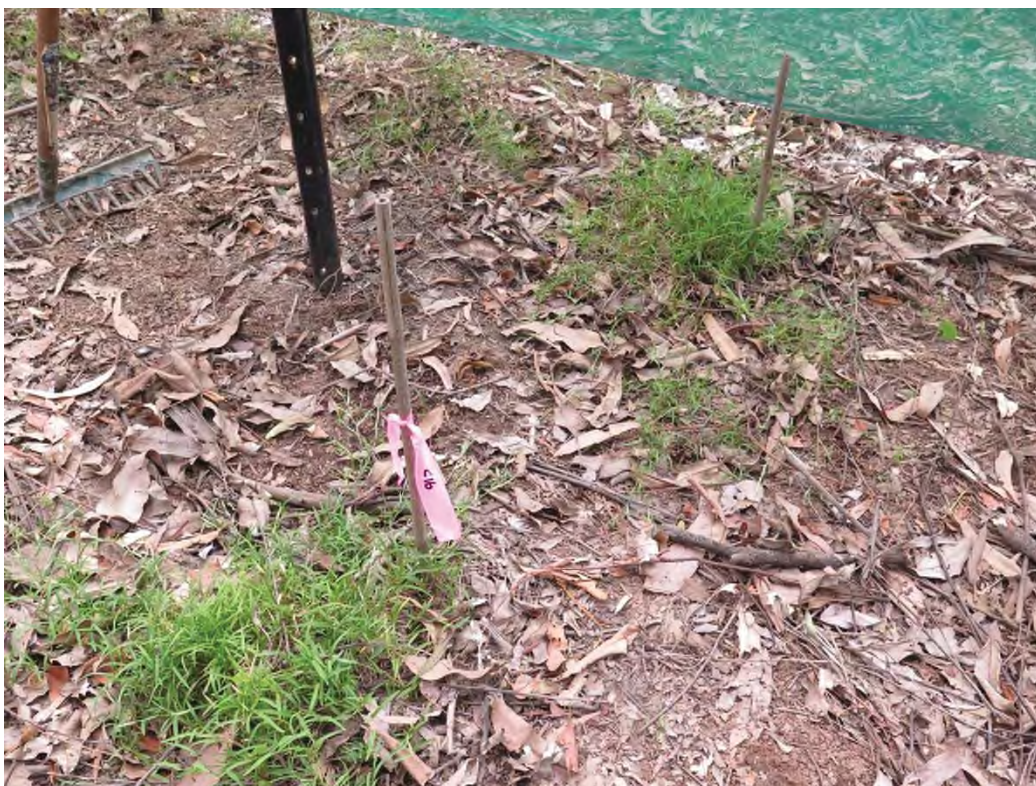
**Plate 46:** Floyds Grass, Receival Site 9, Area 2. Floyds Grass pots were planted in pairs at each tagged point. Clumps grew slower than in Area 1, apparently due to slightly poorer soil (deeper excavation by different operator) and less shade. The site was hand weeded, herbicide was only used in dense Broad-leaved Paspalum around the receival site.

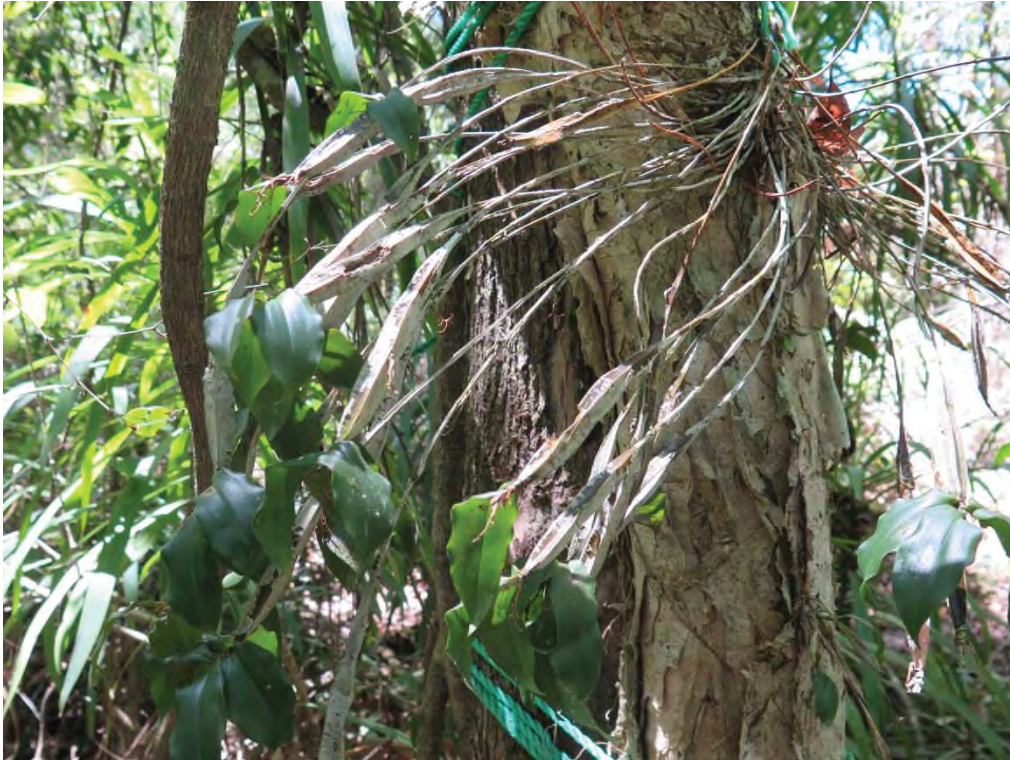
**Plate 47:** Large Spider Orchid clump relocated with its supporting branch to the trunk of a tree in the gully next to Receive Site 5 (7a). The branch with orchid has been tied onto the trunk resulting in minimal disturbance to the orchid and its epiphytic roots.

Two mature Spider Orchid plants were salvaged from the highway footprint from Prickly Paperbark (*Melaleuca stypheloides*) trees. The orchids were translocated by cutting out the stem or branch section supporting the orchid. These were tied onto the trunks of understory rainforest trees in a gully at Receival Site 5 (7a) (Plate 47). Apart from watering during transport, no additional watering or other treatments were applied.

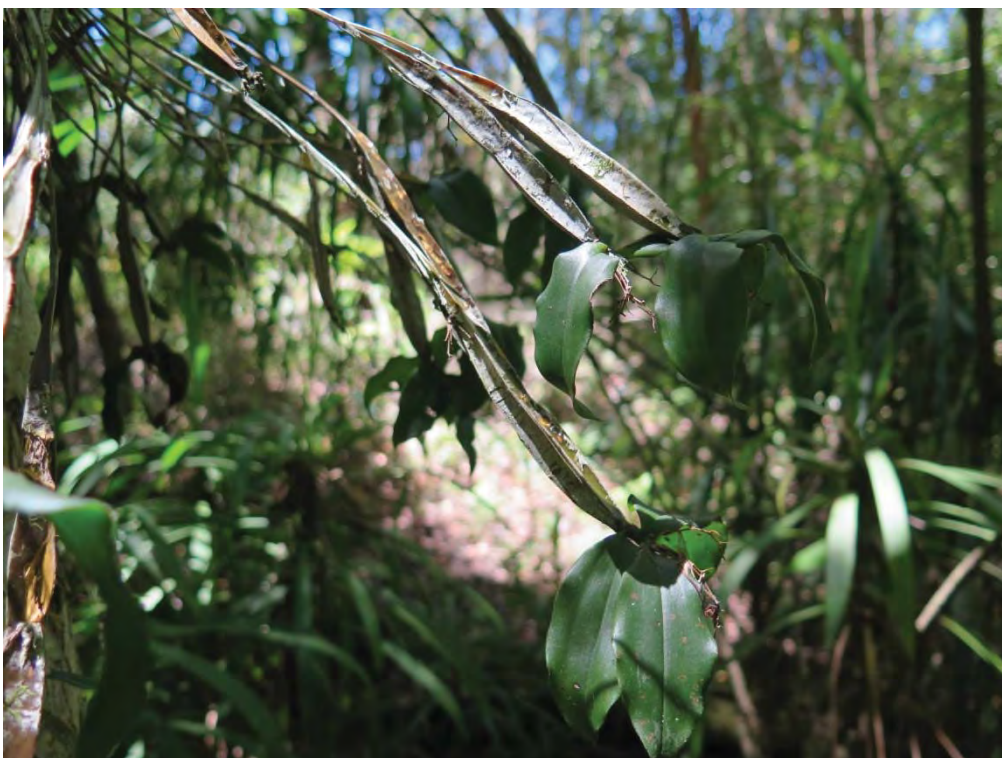
**Plate 48:** Close up of Spider Orchid showing leaves at the apex of the pseudobulbs, and just visible, the short dead inflorescence axes projecting at the tip. These are the remains from flowering in August-September/17. No pods were formed probably indicating an absence of insect pollinators, or insufficient food reserves although this seems unlikely considering the health of the plants.

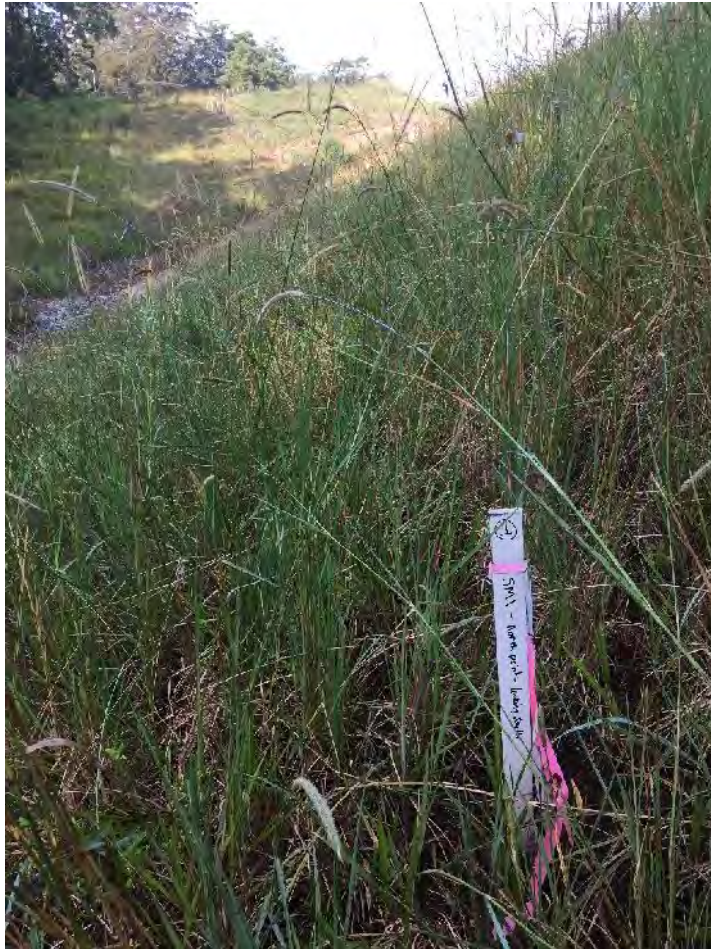
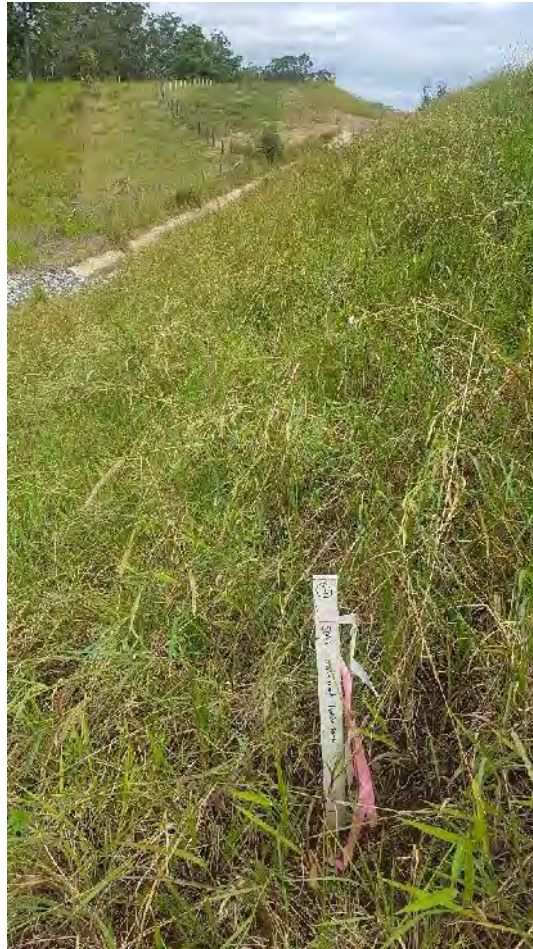
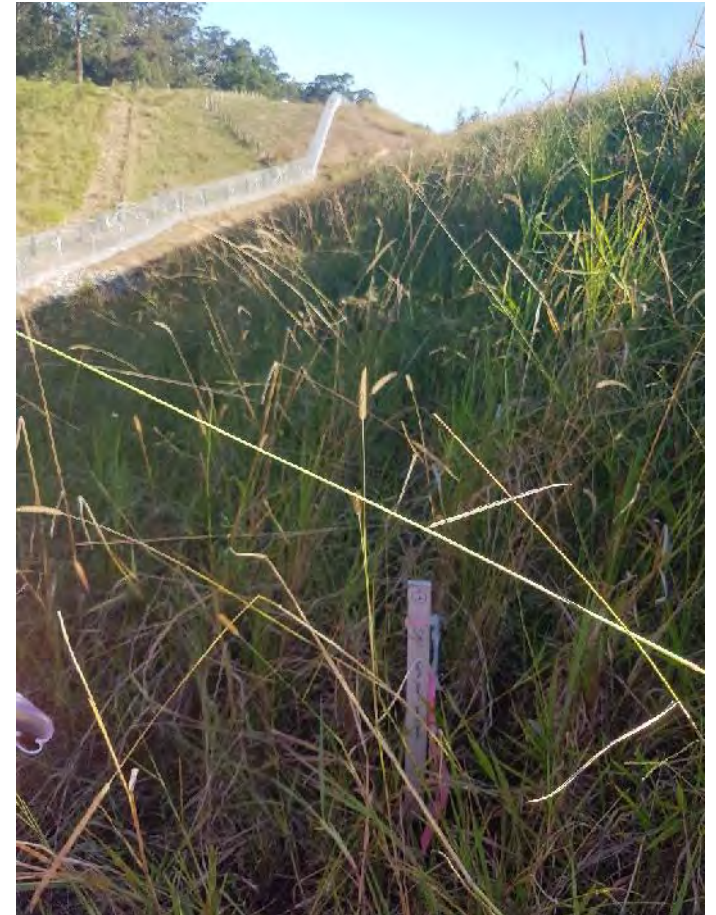
Monitoring Site no.	Location	General Cover %	% of cover = native species	General plant health	Condition of soil and batter	Maintenance Comments	Compliance with UDLP objectives
1	Fill 4	90	7	Good	Good – no evidence of rilling or slumping	Nil – Weed’s appear well managed. Seteria grass most common species present due to presence in nearby pasture. Batter meets the objectives of the UDLP as the batter assimilates with the surrounding landscape. Batter is stable with good robust growth.	SM1 mix (Native grasses) Although there is mostly Seteria grass present, the batter has assimilated with the surrounding landscape.
2	Fill 4	90	5	Good	Good – no evidence of rilling or slumping	Nil – Weed’s appear well managed. Seteria grass most common species present due to presence in nearby pasture. Batter meets the objectives of the UDLP as the batter assimilates with the surrounding landscape. Batter is stable with good robust growth.	SM2 mix (Native Pasture grasses) Although there is mostly Seteria grass present, the batter has assimilated with the surrounding landscape.

Site	1
Location	Full 4
Weather	Fine
Rainfall Average	
Walk 50m transect (as per photo) what general species are present?	Setaria Kennodia, Senecio, Dandelion, Banksia, Acacia.
What is general total ground cover?	90%
What percentage of native vegetation cover?	7% natives
What is the general plant height?	500mm + Shrubs + grass.
Comments on growth of batter: e.g condition of soil?	Growth appears robust, no mulling, erosion, etc.
Maintenance recommendations: e.g are there any weeds that need treating?	Nd - no weed issues Verbena has died off naturally.
Overall compliance / UDLP Comments e.g does batter look like surrounding landscape?	Good - batter is 3m1 pasture grass + currently meets objectives.

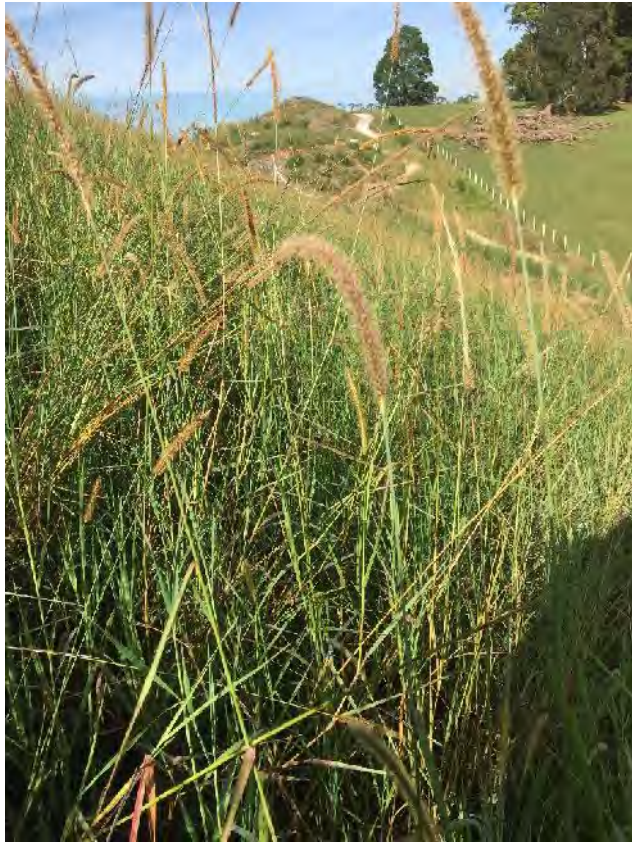
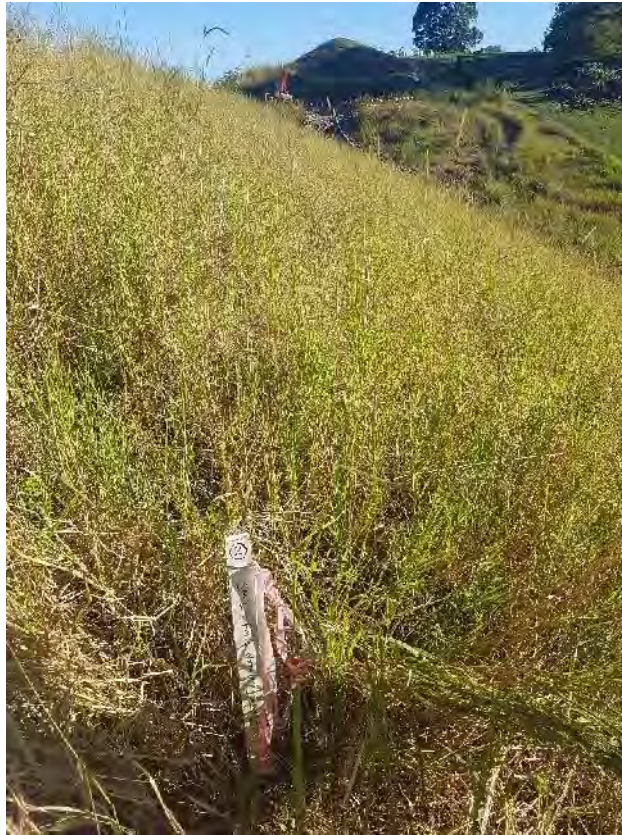
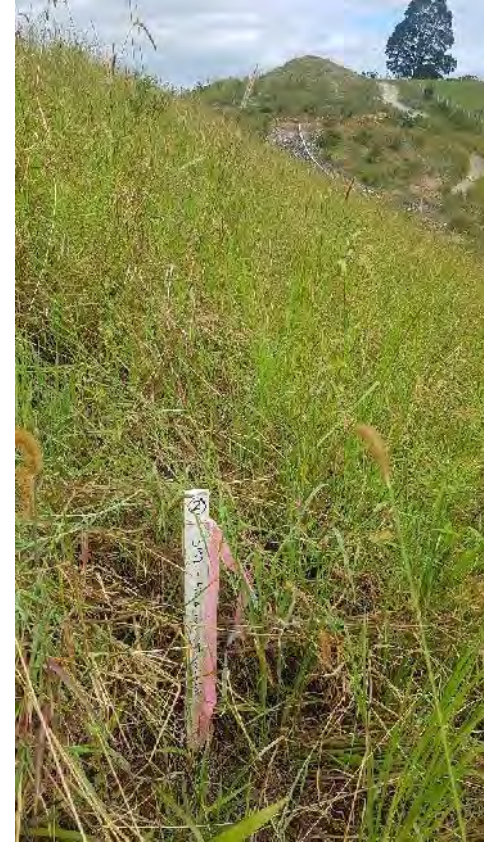
Site 2

Site	2.
Location	Fu 4
Weather	Fine
Rainfall Average	
Walk 50m transect (as per photo) what general species are present?	Setaria, Verbena, hardenbergia, Acacia, Hakea, Centaurea. Banksia, Kennedia, Callistemon. Paddy's Laverne, Leptospermum.
What is general total ground cover?	90%.
What percentage of native vegetation cover?	5%.
What is the general plant height?	500mm+
Comments on growth of batter: e.g condition of soil?	Large scour of secondary bench needs repair
Maintenance recommendations: e.g are there any weeds that need treating?	Nil weed treatment Fi
Overall compliance / UDLP Comments e.g does batter look like surrounding landscape?	Good, batter compliant with SM1 + adjacent landscape.

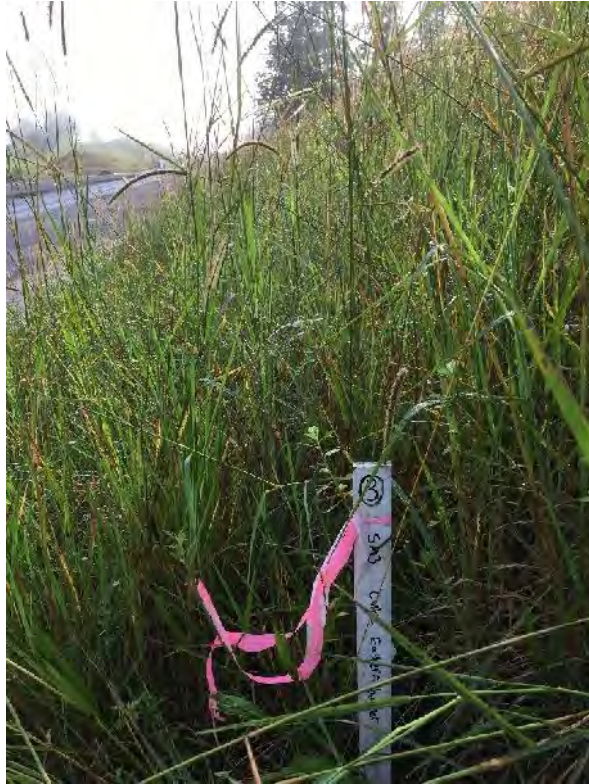
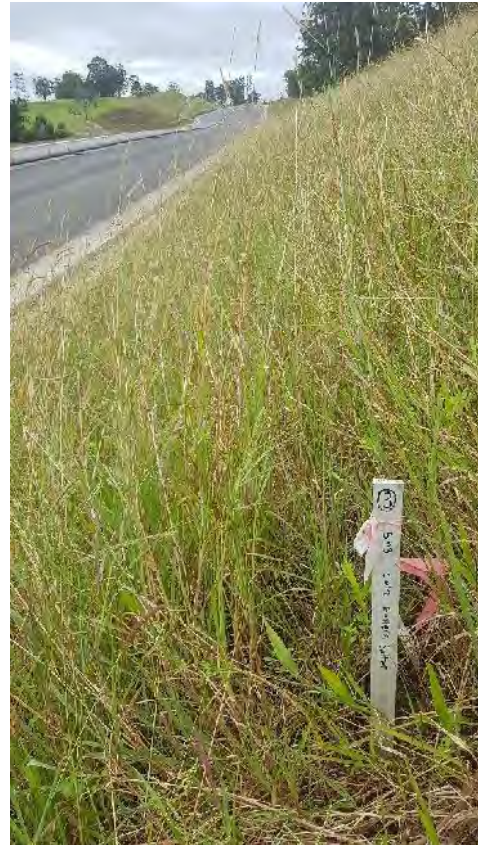
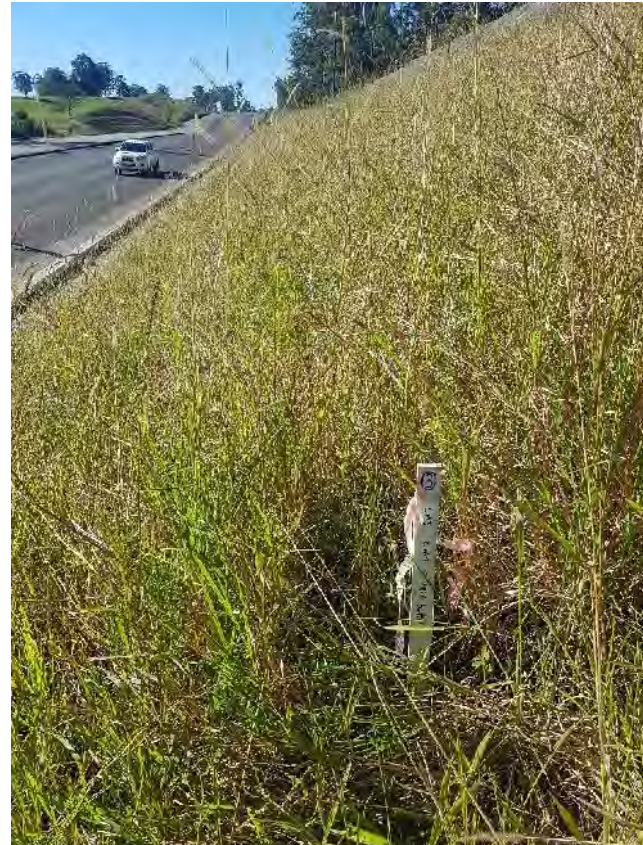
Site	3
Location	Cut 2
Weather	Fine - no rainfall.
Rainfall Average	
Walk 50m transect (as per photo) what general species are present?	<p>Setaria <del>Koeleria</del> Banksia.          Acacia spp. Hardenbergia          Callistemon. Daviesia.  <del>Heteropogon</del></p>
What is general total ground cover?	90% grasses mostly.
What percentage of native vegetation cover?	2-3%.
What is the general plant height?	300-500mm Shrubs + grasses.
Comments on growth of batter: e.g condition of soil?	<p>Resprayed in may with sm3 hydroseed.          Concrete waste on batter          Batter in good condition, no pilling, scour, etc.</p>
Maintenance recommendations: e.g are there any weeds that need treating?	<p>Concrete waste on batter to be removed.          Nil weed treatment.</p>
Overall compliance / UDLP Comments e.g does batter look like surrounding landscape?	<p>In progress, shrubs are actively growing. Setaria due to surrounding pasture land.          Overall compliance is good average.</p>

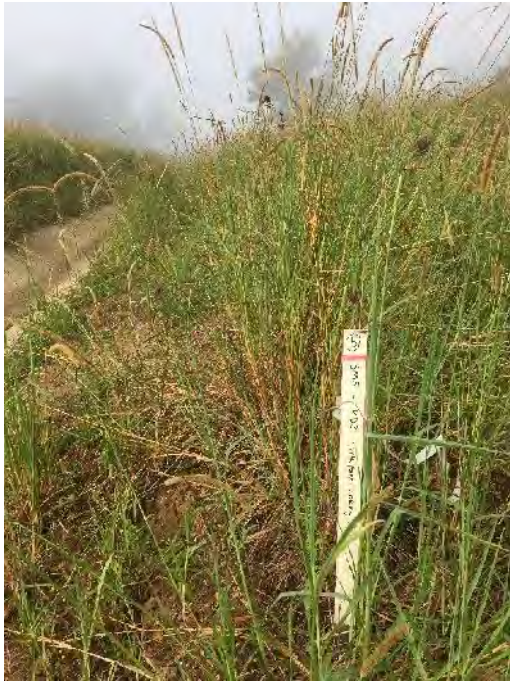
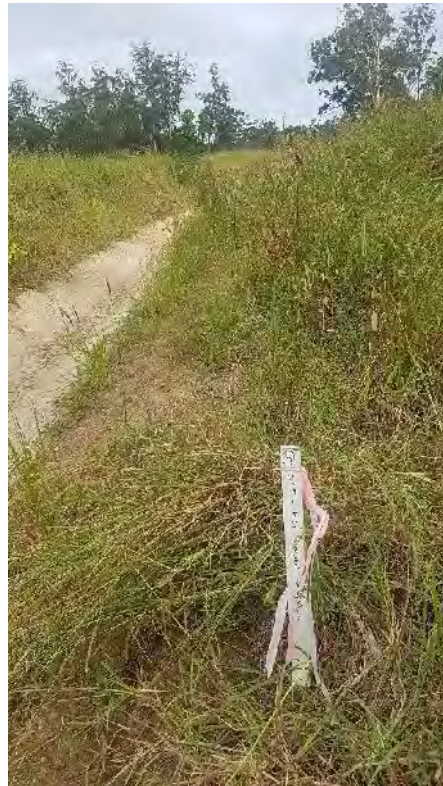
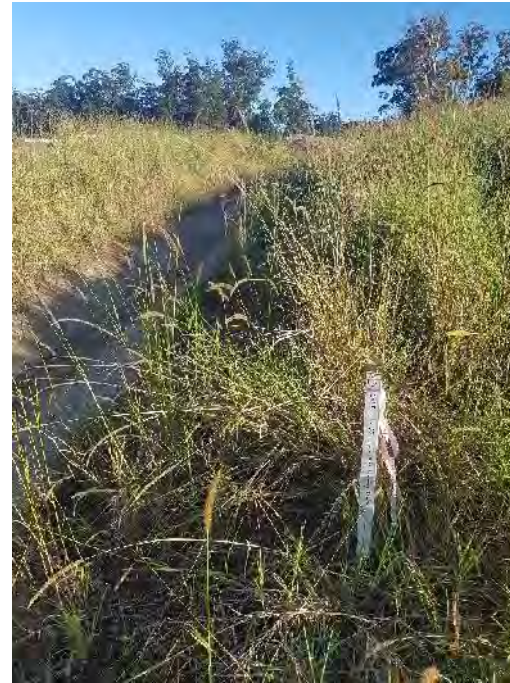
Site 5

Site	5.
Location	Fill S
Weather	Fine
Rainfall Average	
Walk 50m transect (as per photo) what general species are present?	Acacia Purple Verbena Betonia Banksia Pea-Kennedia Lantana Couch Tobacco bush
What is general total ground cover?	70%
What percentage of native vegetation cover?	2%
What is the general plant height?	500mm
Comments on growth of batter: e.g condition of soil?	Good growth, no dieback / plant stress signs
Maintenance recommendations: e.g are there any weeds that need treating?	Nil
Overall compliance / UDLP Comments e.g does batter look like surrounding landscape?	Matches agricultural paddock surroundings

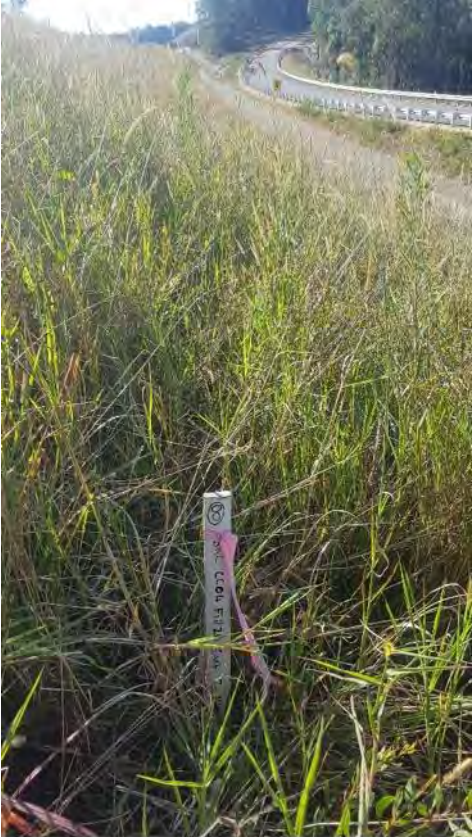
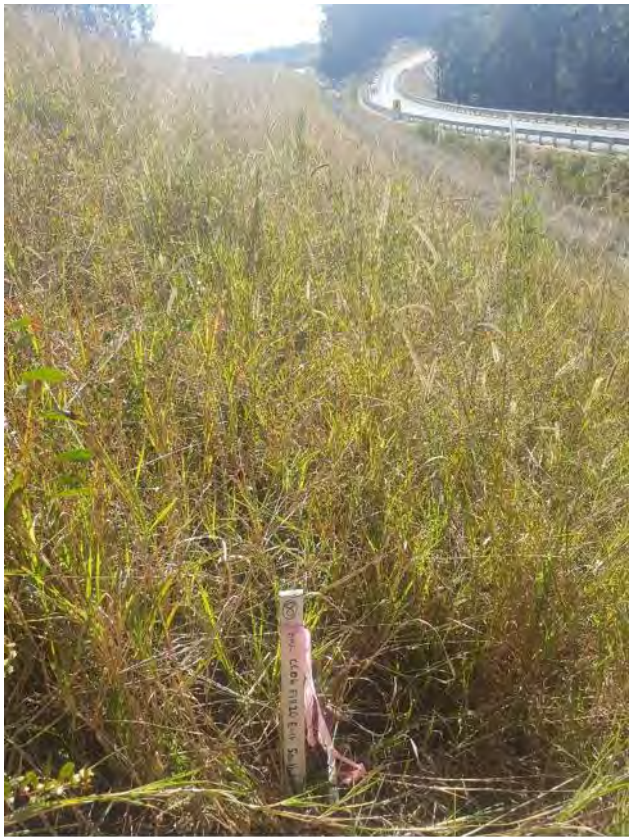
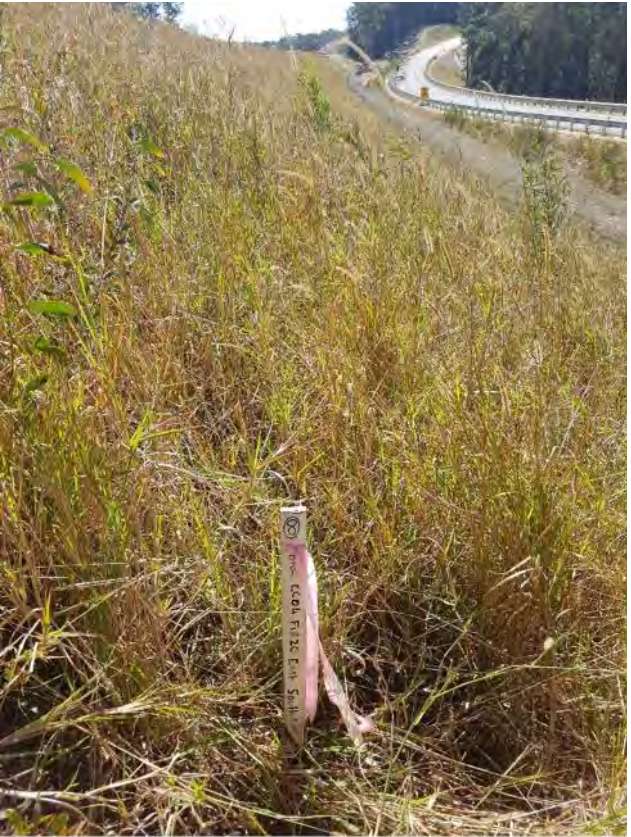
Site 8 (Fill 20 EAST)

Site 8
Location Fill 20
Weather Fine
Rainfall Average
Walk 50m transect (as per photo) what general species are present? - Acacia sp.                      - Kennedia rubicunda - Hardenbergia violacea      - Solanum lacianatum - Centella asiatica              - Setaria
What is general total ground cover? 75%
What percentage of native vegetation cover? 10%
What is the general plant height? 300-1000mm
Comments on growth of batter: e.g condition of soil? Good growth, natives coming through setaria
Maintenance recommendations: e.g are there any weeds that need treating? Nil
Overall compliance / UDLP Comments e.g does batter look like surrounding landscape? Compliant w/BRC - Good health - no signs of stress/disease

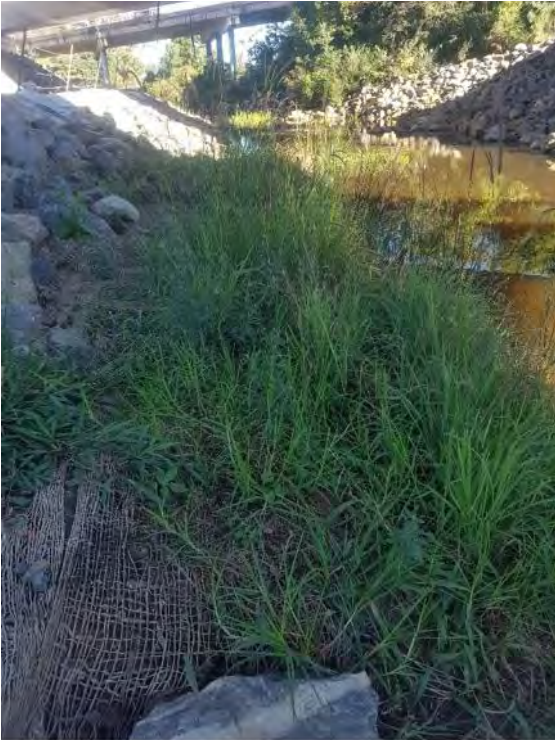
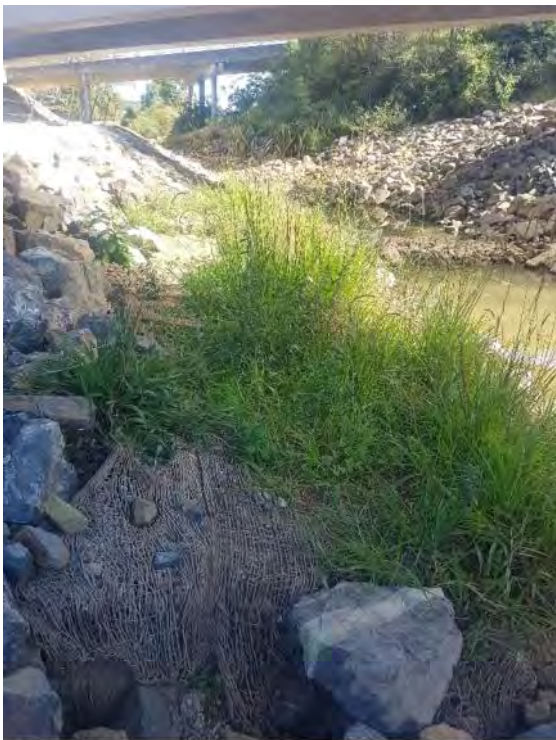
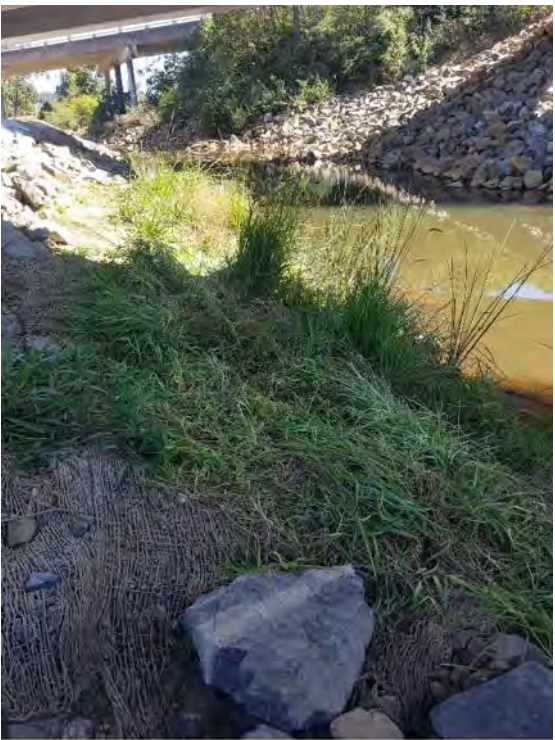
**Site 10 (Williamson Creek)**

Site 10
Location Williamson's Creek
Weather Fine
Rainfall Average
Walk 50m transect (as per photo) what general species are present? - Setaria                      - Murrumbidgee - Paddy's lucerne            - Eleocharis acuta - Paspalum
What is general total ground cover? 50%
What percentage of native vegetation cover? 1%
What is the general plant height? 500mm
Comments on growth of batter: e.g condition of soil? Good regrowth
Maintenance recommendations: e.g are there any weeds that need treating? Beds edging needed
Overall compliance / UDLP Comments e.g does batter look like surrounding landscape? Not compliant currently - complete re-beds req'd

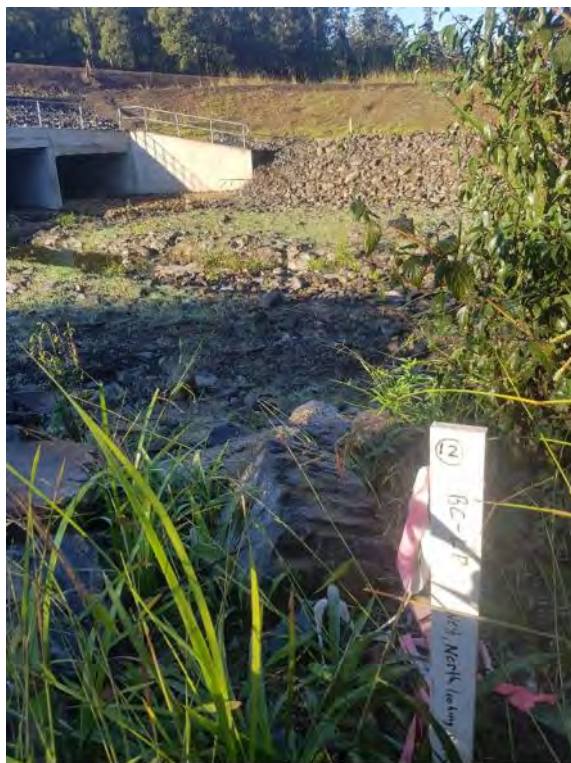
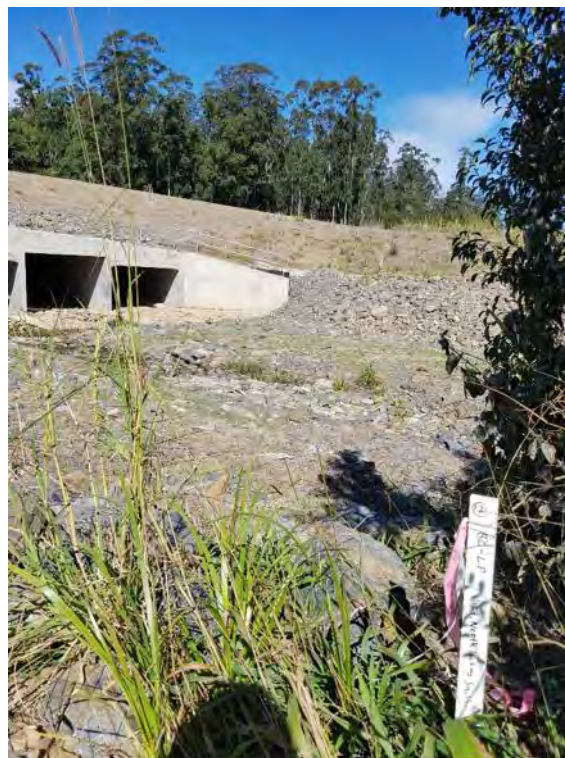
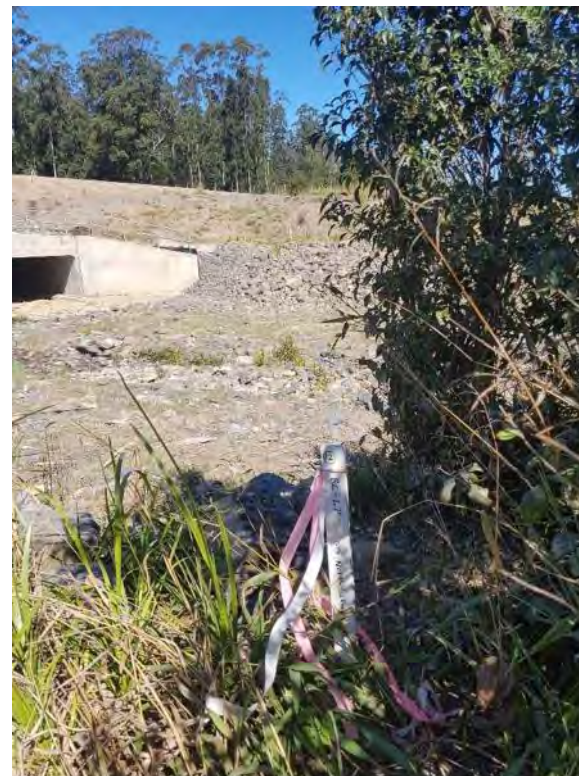
Site 12 (Butchers Creek)

Site	12.
Location	Butchers Cr.
Weather	Fine
Rainfall Average	
Walk 50m transect (as per photo) what general species are present?	Lomandra Setaria. Dianella. Seneo.
What is general total ground cover?	2% vs (note 100% not needed due to presence of slow rock).
What percentage of native vegetation cover?	<del>100%</del> < 1% (as above note).
What is the general plant height?	200-300mm.
Comments on growth of batter: e.g condition of soil?	Healthy <del>veg</del> growth. Freshly hydromulched w/ sm 5 in May.
Maintenance recommendations: e.g are there any weeds that need treating?	Handpulling of weeds - Fireweed recommended.
Overall compliance / UDLP Comments e.g does batter look like surrounding landscape?	Average - Soft treatments are in progress.

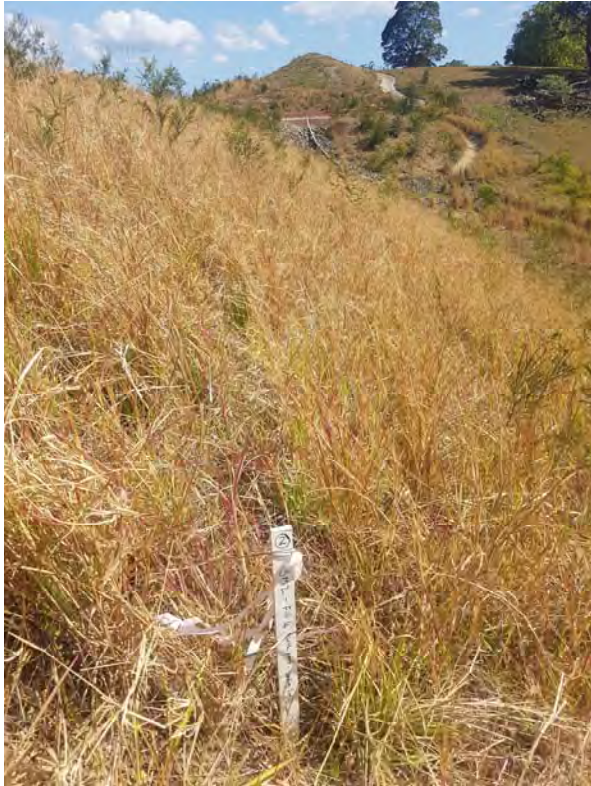
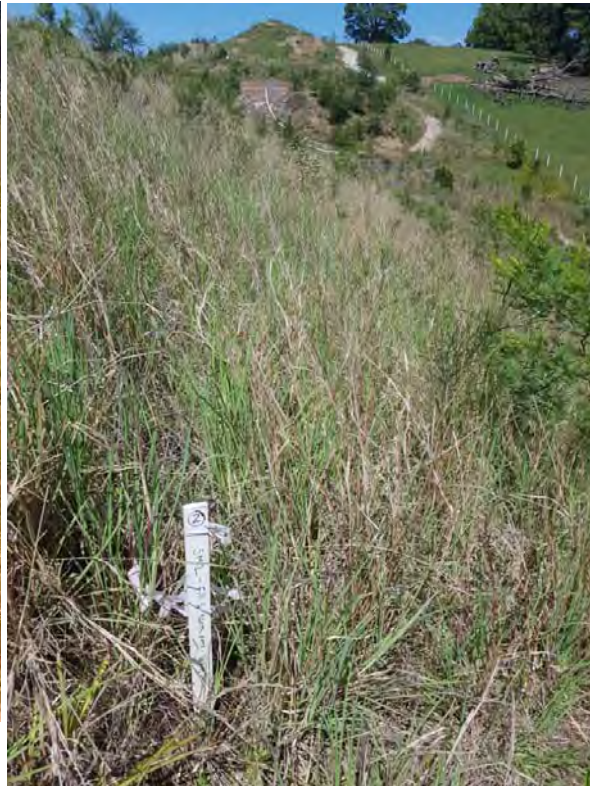
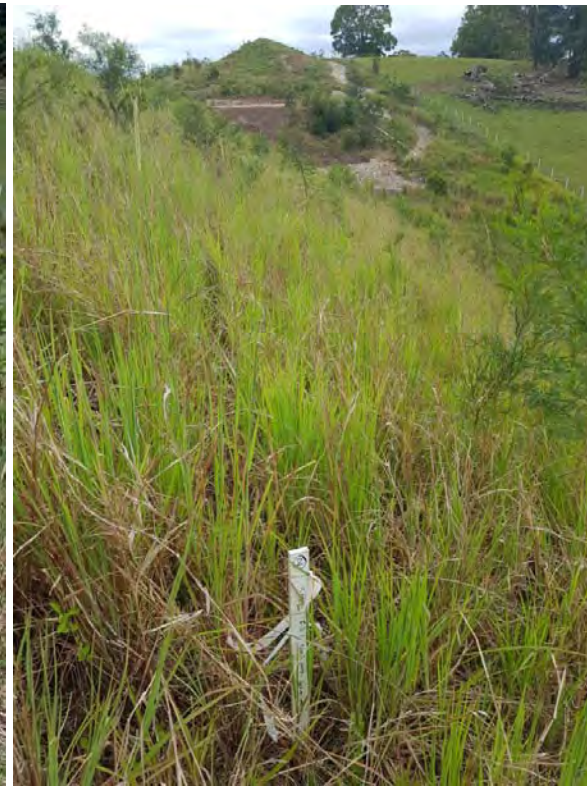
**Site 2 (Fill 4 WEST)**

Setaria	Kennedia	Paddy's lace	Acacia sp.	Hakea	Verkani	Callistemon sp.	Centella			Leptospermum	
Setaria	Kennedia	Paddy's lace											
Acacia sp.	Hakea	Verkani											
Callistemon sp.	Centella												
	Leptospermum												
What is general total ground cover?	95%												
What percentage of native vegetation cover?	10%												
What is the general plant height?	600mm - 1900mm												
Comments on growth of batter: e.g condition of soil?	<p>Batter good condition          No signs of predation / major stress</p>												
Maintenance recommendations: e.g are there any weeds that need treating?	Nil												
Overall compliance / UDLP Comments e.g does batter look like surrounding landscape?	Compliant w/UDLP
