# Warrell Creek to Nambucca Heads Pacific Highway Upgrade

Commonwealth Approval EPBC 2013/7101  
Annual Compliance Report  
February 2017 – February 2018

Roads and Maritime Services | May 2018

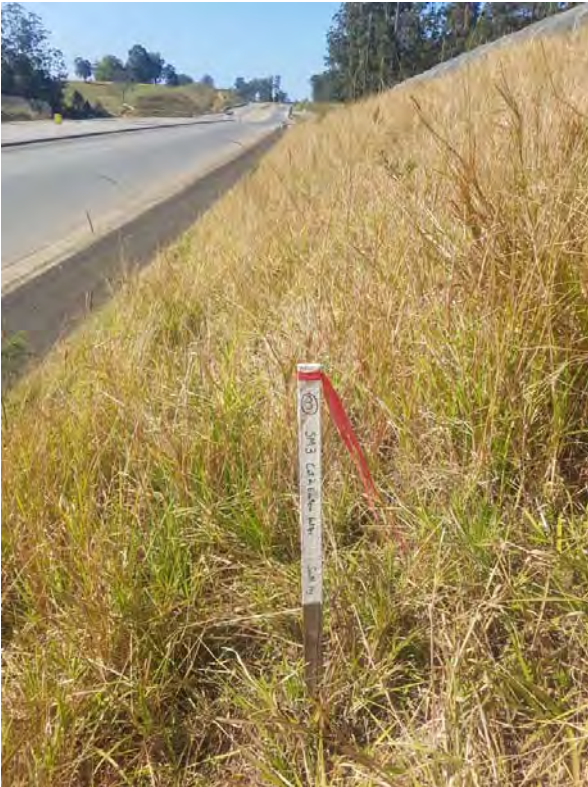
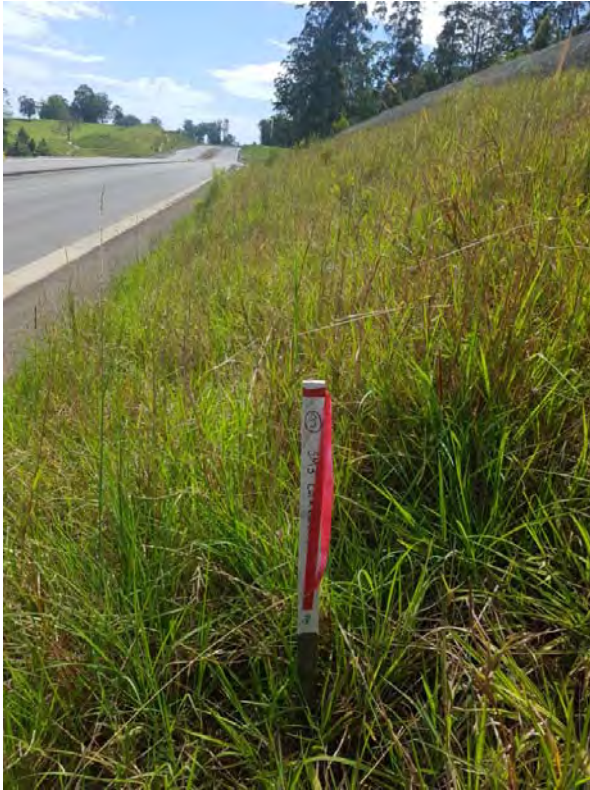
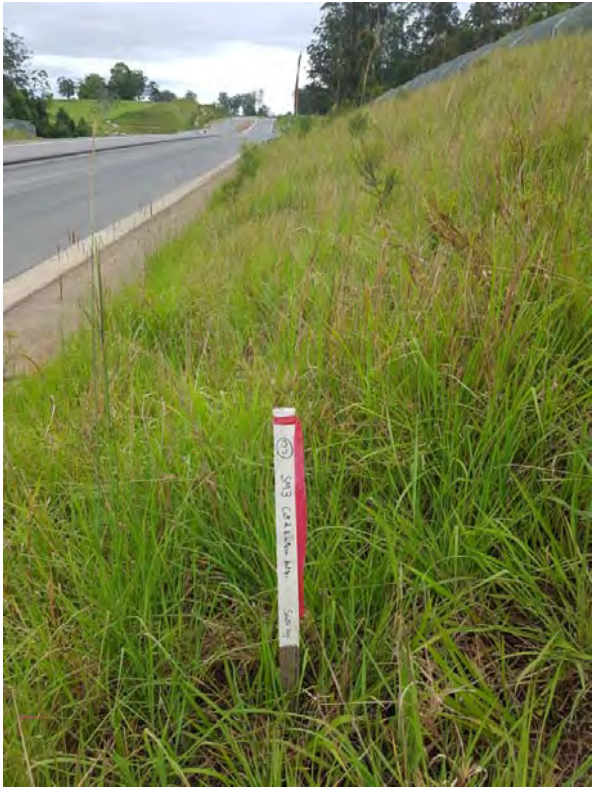
Site 3 (Cut 2 EAST)

Site	3
Location	Cut 2 East
Weather	Cloudy
Rainfall Average	Below Spring average
Walk 50m transect (as per photo) what general species are present?	<p>Setaria                      Hardenbergia          Acacia Sp.                Banksia          Callistemon sp.</p>
What is general total ground cover?	90%
What percentage of native vegetation cover?	7%
What is the general plant height?	300-1000mm
Comments on growth of batter: e.g condition of soil?	<p>Natives growing above setaria          No signs of predation or stress          No rilling in batter</p>
Maintenance recommendations: e.g are there any weeds that need treating?	Nil
Overall compliance / UDLP Comments e.g does batter look like surrounding landscape?	<p>Overall compliant w/UDLP          Native strike noted post hydroseed SMS          Consistent with surrounding landscape</p>

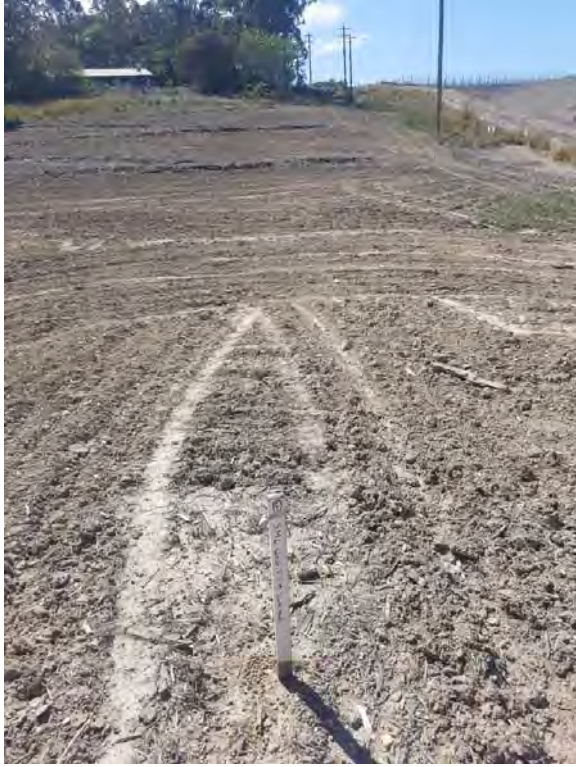
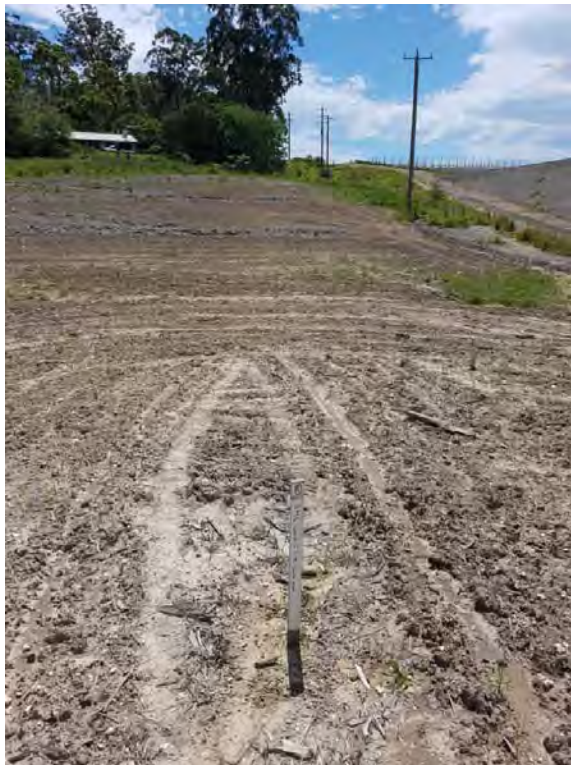
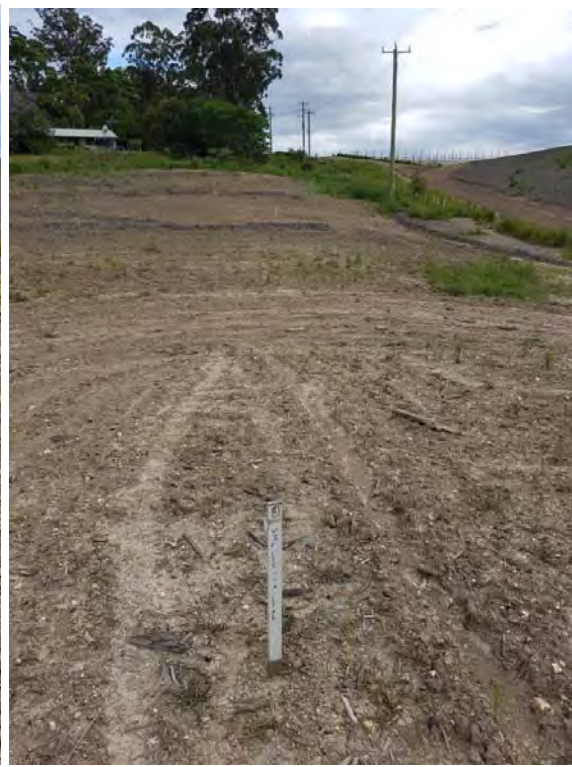
Site 4 (Fill 19 WEST)

Site 4
Location Fill 19 West
Weather Cloudy
Rainfall Average Below average for Spring
Walk 50m transect (as per photo) what general species are present? Setaria Acacia sp.
What is general total ground cover? 15%
What percentage of native vegetation cover? 2%
What is the general plant height? 100 mm
Comments on growth of batter: e.g condition of soil? Lack of natural grasses Some natives beginning to grow
Maintenance recommendations: e.g are there any weeds that need treating? Tractor seeding completed July 2017
Overall compliance / UDLP Comments e.g does batter look like surrounding landscape? Ongoing monitoring required

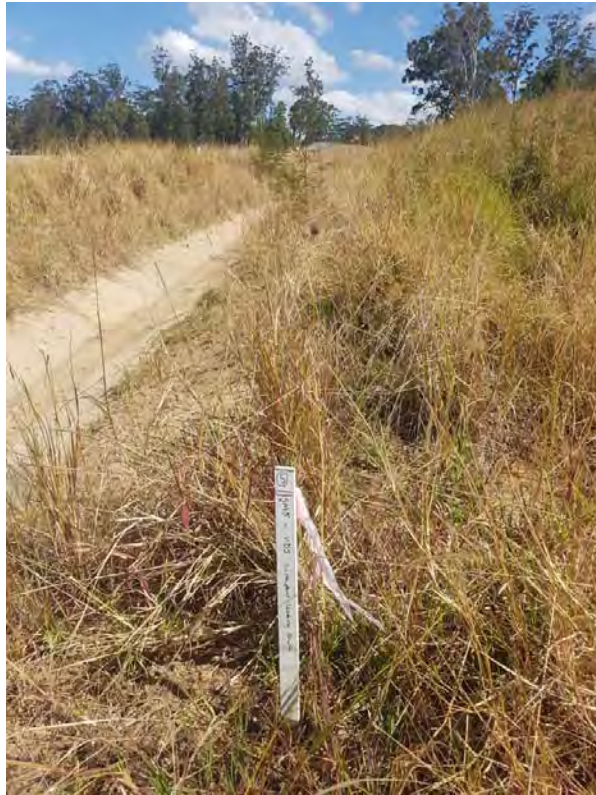
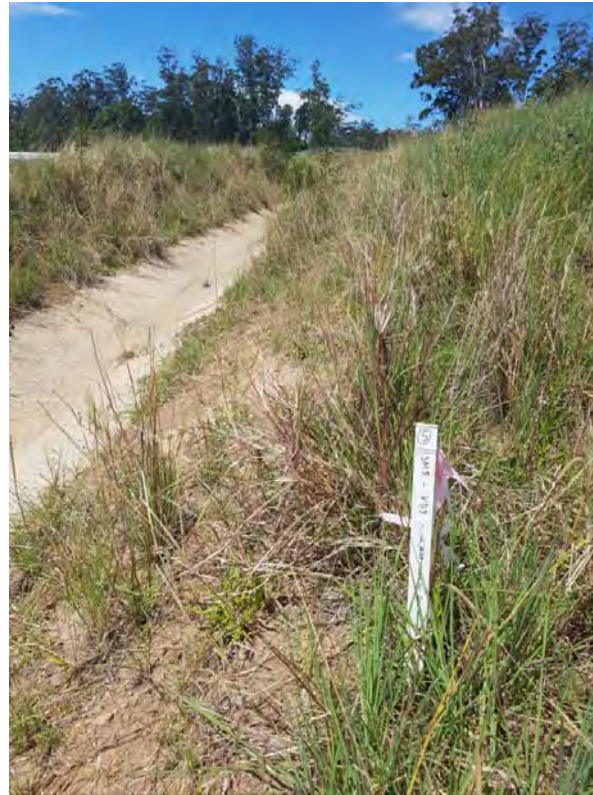
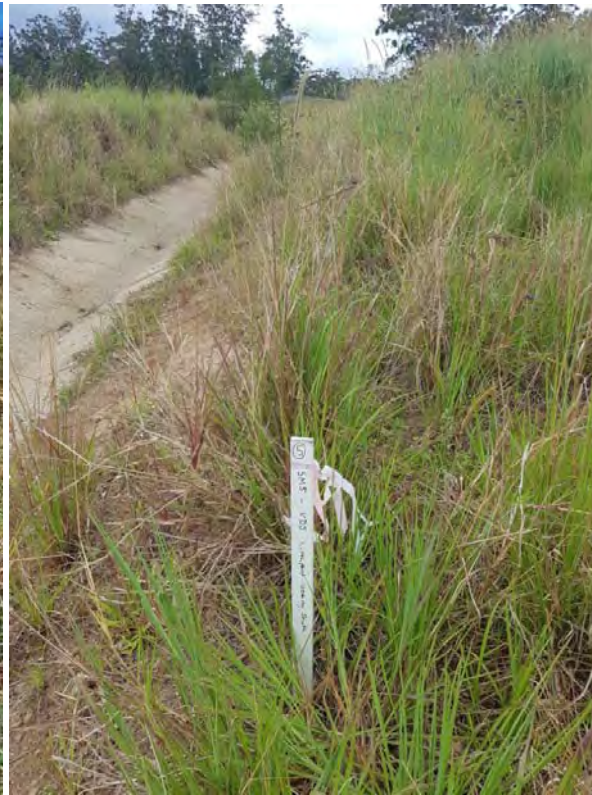
Site 5 (Fill 5 WEST)

Site	S
Location	Fill S West
Weather	Cloudy
Rainfall Average	Below Spring average
Walk 50m transect (as per photo) what general species are present?	<p>Acacia sp. Tobacco bus          couch <del>lactuca</del>          Setaria Kennedyia          Banksia</p>
What is general total ground cover?	77%
What percentage of native vegetation cover?	10%
What is the general plant height?	Spans - 2200mm
Comments on growth of batter: e.g condition of soil?	<p>Good growth          No sign of stress or predation</p>
Maintenance recommendations: e.g are there any weeds that need treating?	Nil
Overall compliance / UDLP Comments e.g does batter look like surrounding landscape?	<p>Compliant w/UDLP          matches surrounding landscape</p>

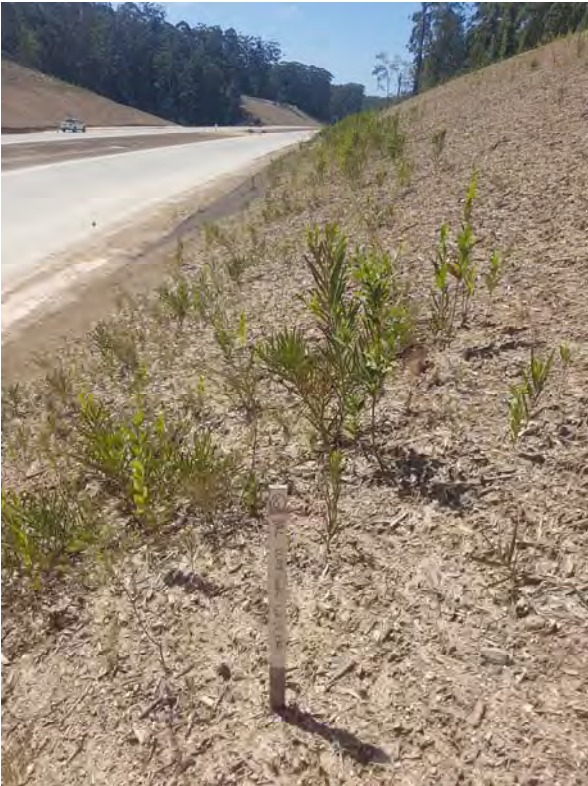
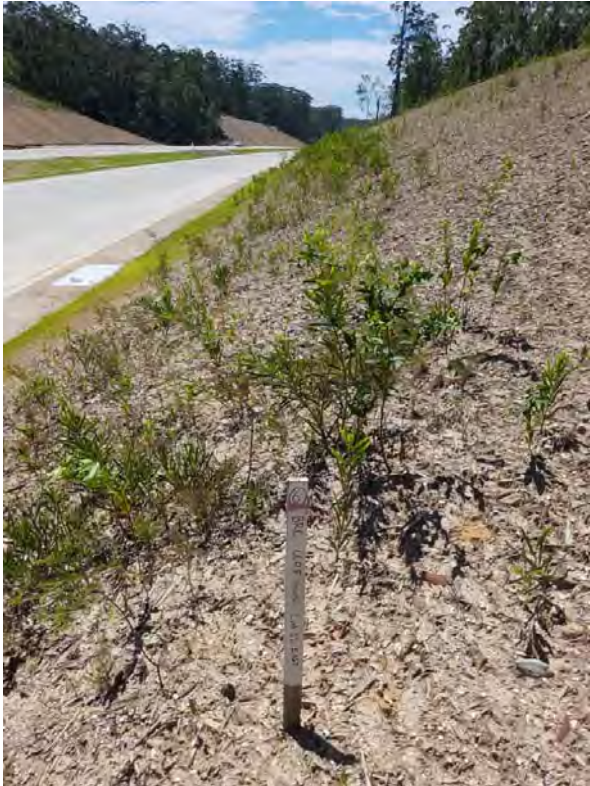
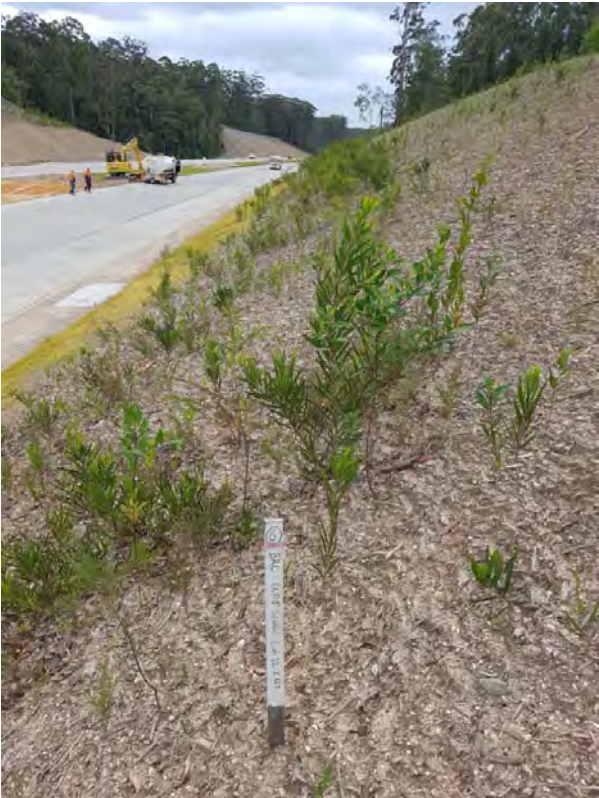
Site 6 (Cut 22 EAST)

Site	6
Location	Cut 2A East
Weather	Cloudy
Rainfall Average	Below average for spring
Walk 50m transect (as per photo) what general species are present?	<p>Acacia sp. (several)      Indigofera australis</p> <p>Callistemon sp.      Acacia longifolia</p> <p>Kennedia rubicunda      Kunzea capitata</p> <p>Hardenbergia violacea</p>
What is general total ground cover?	20%
What percentage of native vegetation cover?	18%
What is the general plant height?	500mm - 700mm
Comments on growth of batter: e.g condition of soil?	<p>No weeds noted</p> <p>No major signs of stress</p>
Maintenance recommendations: e.g are there any weeds that need treating?	Nil
Overall compliance / UDLP Comments e.g does batter look like surrounding landscape?	Compliant w/UDLP

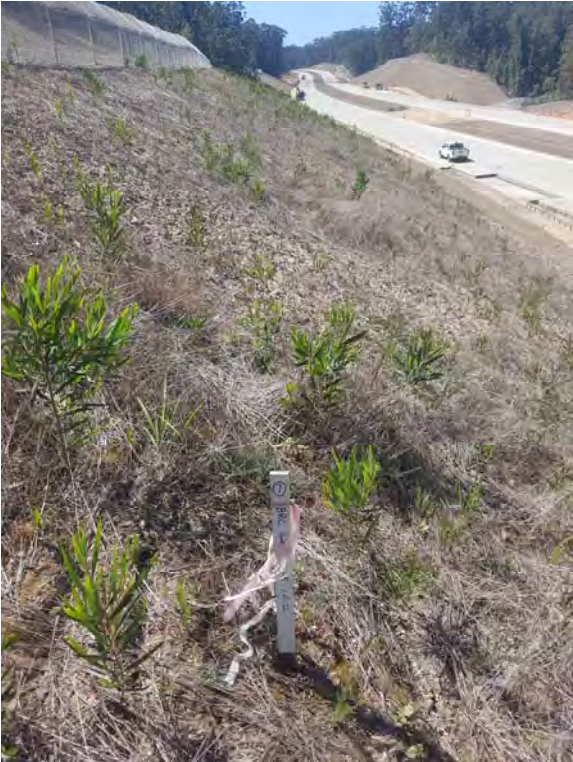
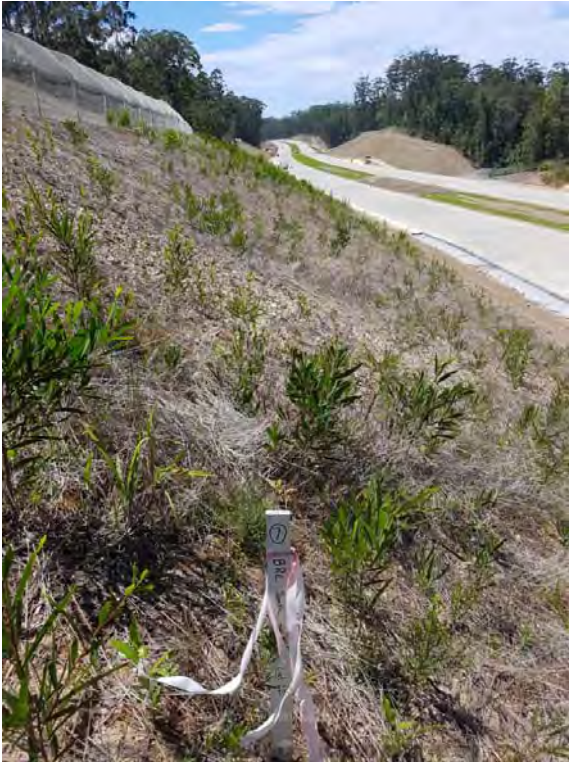
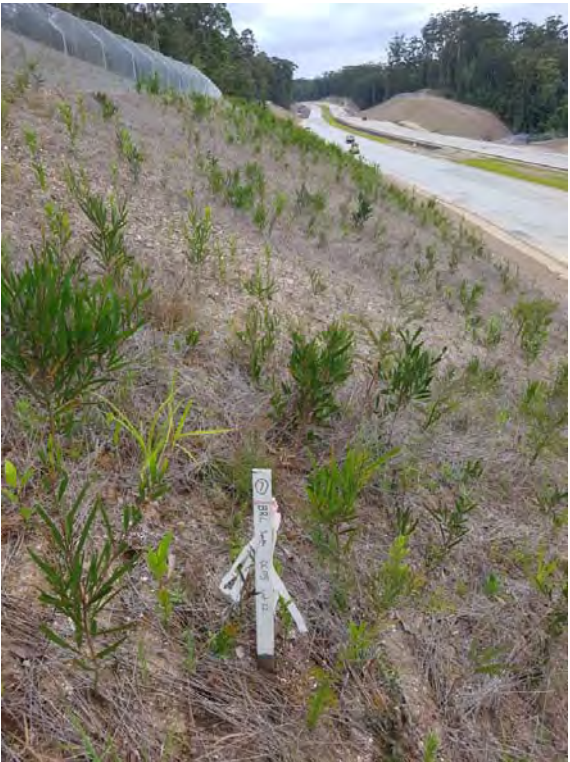
Site 7 (Cut 22 WEST)

Site	7
Location	Cut 22 West
Weather	Cloudy
Rainfall Average	Below average for spring
Walk 50m transect (as per photo) what general species are present?	Acacia sp. (various) Hardenbergia violacea Kennedia rubicunda Goodenia sp.
What is general total ground cover?	55%
What percentage of native vegetation cover?	15%
What is the general plant height?	200mm - 400mm
Comments on growth of batter: e.g condition of soil?	No weeds noted No signs of stress or predation
Maintenance recommendations: e.g are there any weeds that need treating?	Nil
Overall compliance / UDLP Comments e.g does batter look like surrounding landscape?	Compliant w/UDLP

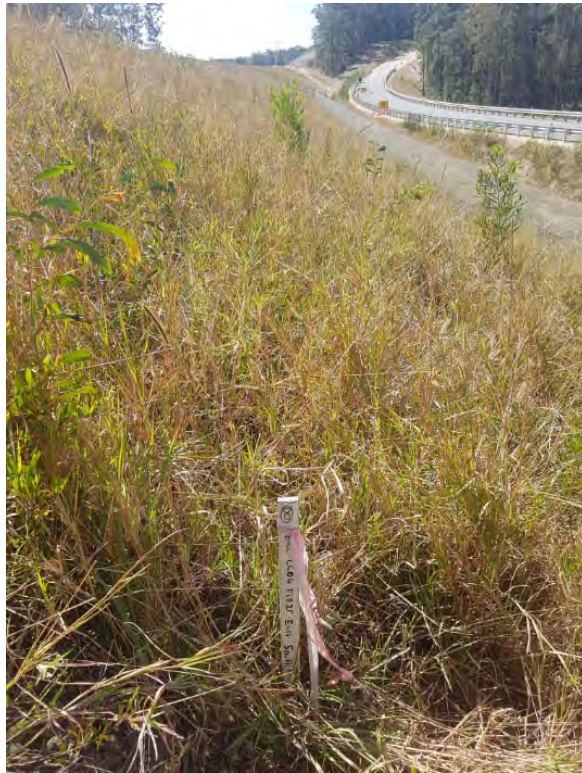
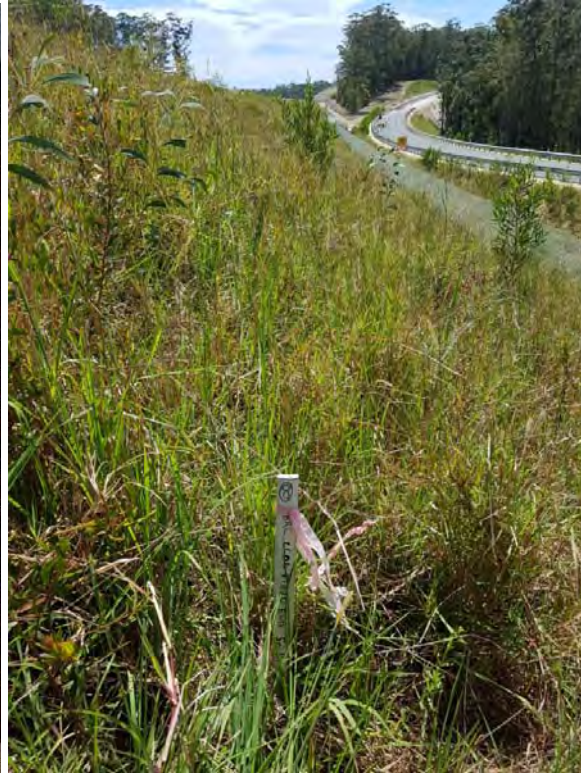
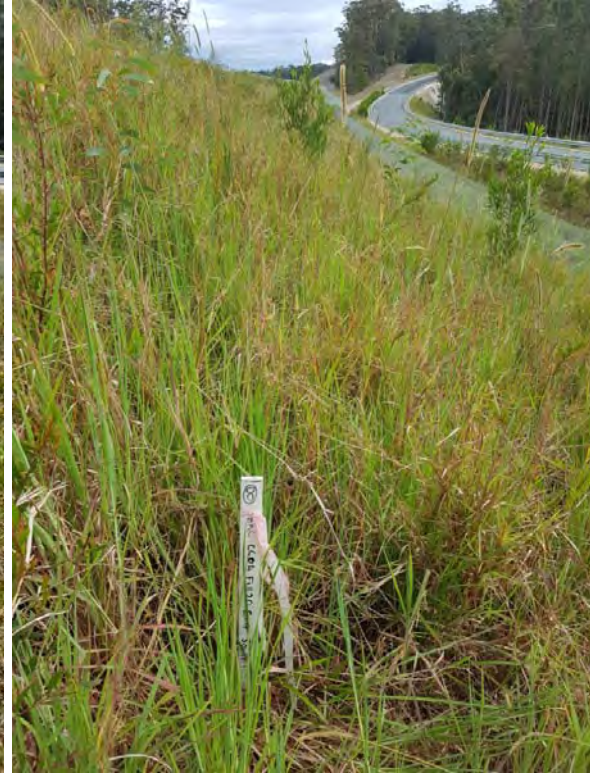
**Site 8 (Fill 20 EAST)**

Site 8
Location Fill to East
Weather Cloudy
Rainfall Average Below average for Spring
Walk 50m transect (as per photo) what general species are present? Acacia sp. (several) Solanum laciniatum Hardenbergia violacea Setaria Centella asiatica Kennedyia rubicunda
What is general total ground cover? 80%
What percentage of native vegetation cover? 15%
What is the general plant height? 300mm - 800mm
Comments on growth of batter: e.g condition of soil? Good growth, natives growing above setaria Slight browning of some natives - likely from low rainfall No signs of predation or major stress
Maintenance recommendations: e.g are there any weeds that need treating? Nil
Overall compliance / UDLP Comments e.g does batter look like surrounding landscape? Compliant w/UDLP

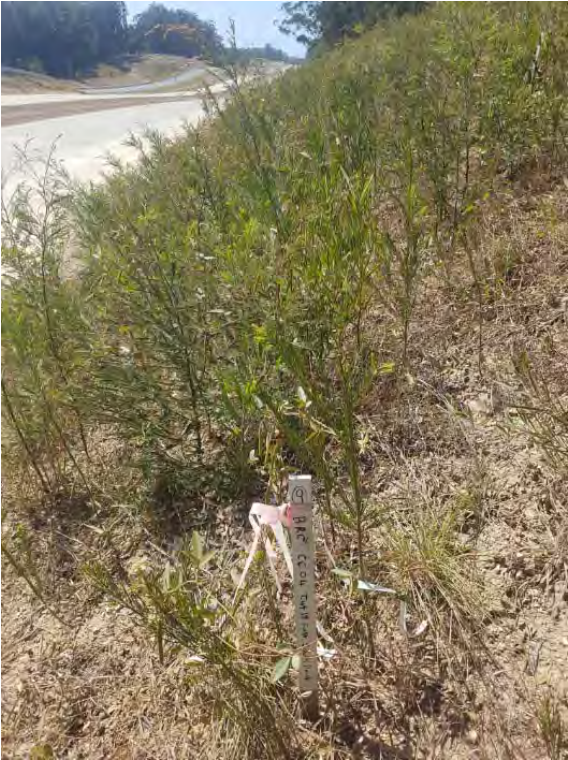
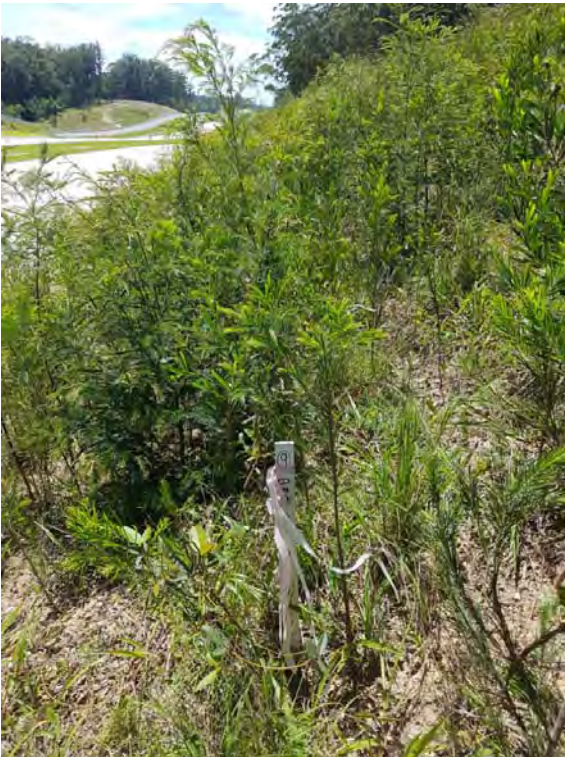
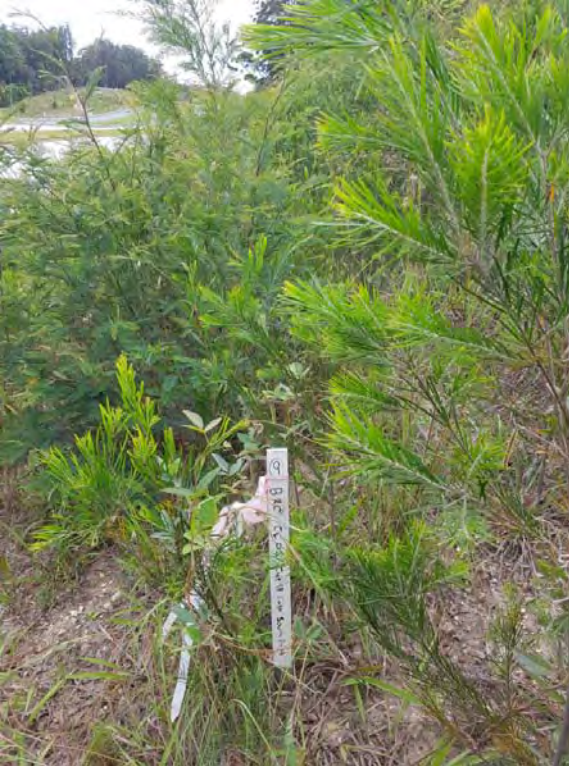
Site 9 (Cut 18 (EAST))

Site	9
Location	Cut 18 East
Weather	Cloudy
Rainfall Average	Below average
Walk 50m transect (as per photo) what general species are present?	<p>Acacia sp. (several)      Callistemon sp.      setaria</p> <p>Kennedia rubicunda      Eucalyptus sp.      Centella asiatica</p> <p>Hardenbergia violacea      Cymbopogon refractus</p>
What is general total ground cover?	70%
What percentage of native vegetation cover?	60%
What is the general plant height?	700-1300mm
Comments on growth of batter: e.g condition of soil?	Good growth, no slips noted
Maintenance recommendations: e.g are there any weeds that need treating?	N.I
Overall compliance / UDLP Comments e.g does batter look like surrounding landscape?	Compliant w/UDLP, no signs of stress or predation

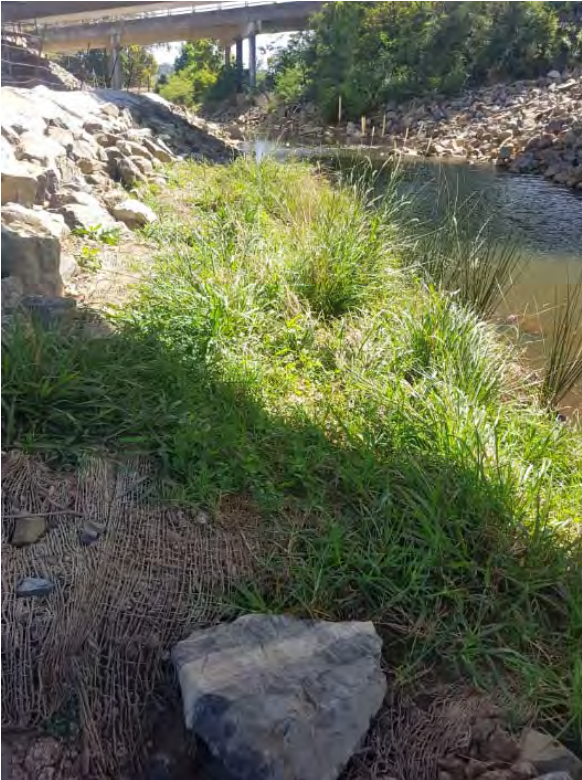
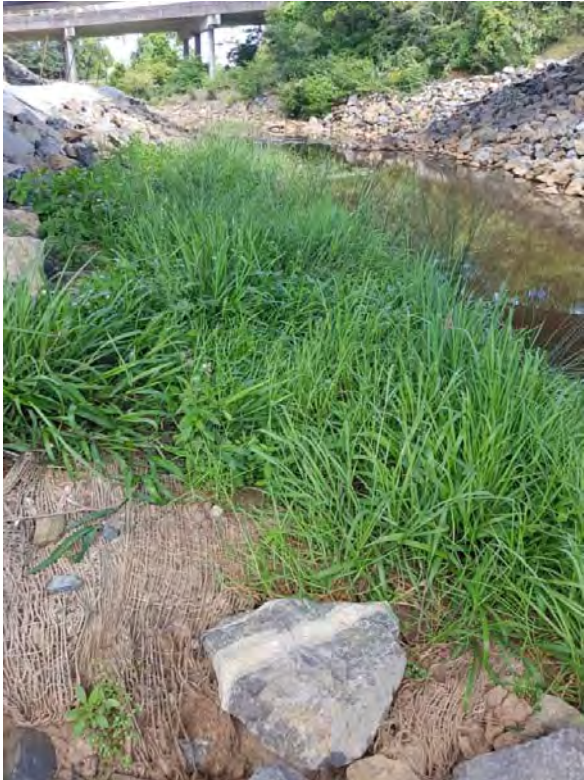
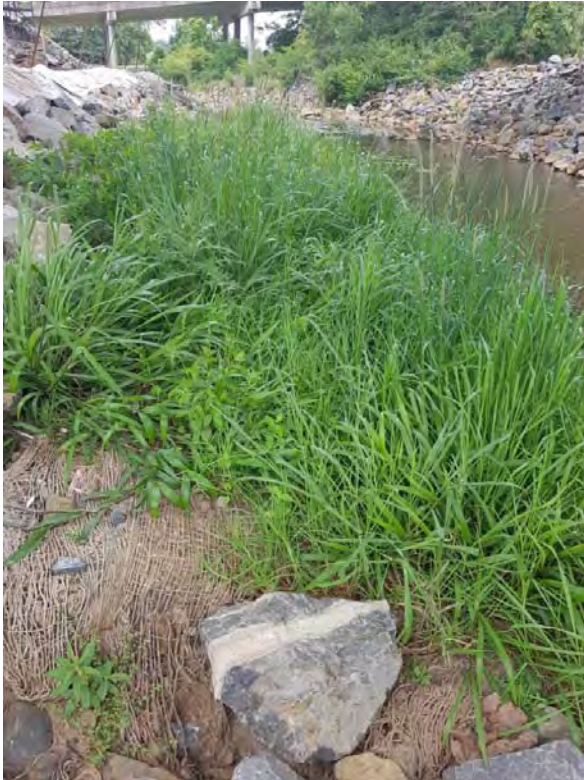
**Site 10 (Williamson Creek)**

Site 10
Location Williamson's Creek
Weather Fine
Rainfall Average Below Spring average
Walk 50m transect (as per photo) what general species are present? Setaria Paspalum Mountain Eleocharis acuta jointed twig rush Bulrush Spikerush } new planting bed.
What is general total ground cover? 60%
What percentage of native vegetation cover? 6%
What is the general plant height? 200-400mm
Comments on growth of batter: e.g condition of soil? Regrowth has been good Sep 17 plants installed when haul rd removed PM4C
Maintenance recommendations: e.g are there any weeds that need treating? Removal of weeds/grasses prior to plant replacement (Feb 18)
Overall compliance / UDLP Comments e.g does batter look like surrounding landscape? Area looks like surrounding landscape (Williamson's creek)

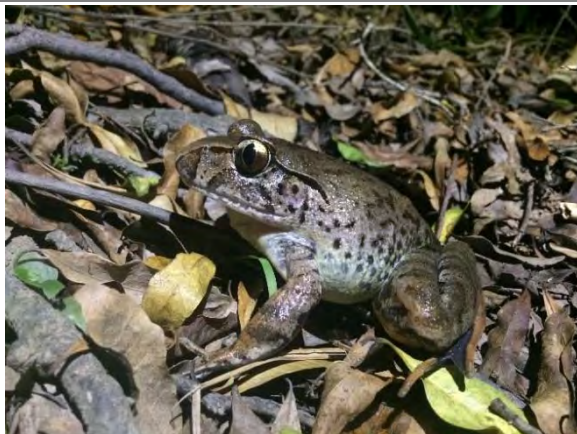
**Plate 3.1 Frog 00078ABC66 (new capture) measured 95 mm snout to vent length and 130 grams**

Three of the eight frogs captured during summer 2018 were very large in size and weight and as such were recorded as females (refer to **Table 3.5**). Frog two (00078ABC66) (refer to **Plate 3.1**) weighed 130 grams and had a snout to vent (S2V) length of 95 mm. Frog 3 (microchip #00078ABBF2) (refer to **Plates 3.2 and 3.3**) weighed 152 grams and had a S2V length of 100 mm with the fourth frog captured (00077E9014) weighing 159 grams and 96 mm S2V (the largest frog captured since the commencement of monitoring; refer to **Plate 3.5**).

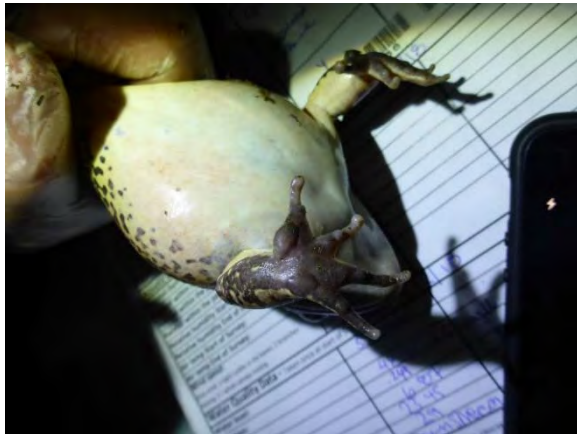
**Plate 3.3** 00078ABBF2 (new capture) photo of nuptial pads recorded as moderately grey (note this frog was recorded as female)

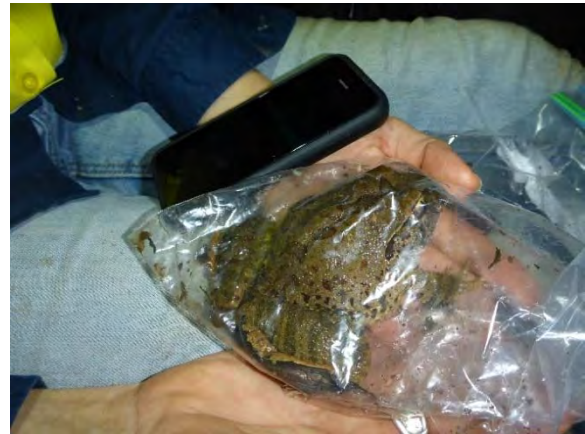
**Plate 3.4** Frog 00077E9014 (recapture) is the heaviest frog captured weighing 159 grams and has been captured four times over Years 1 and 3, first in spring 2015

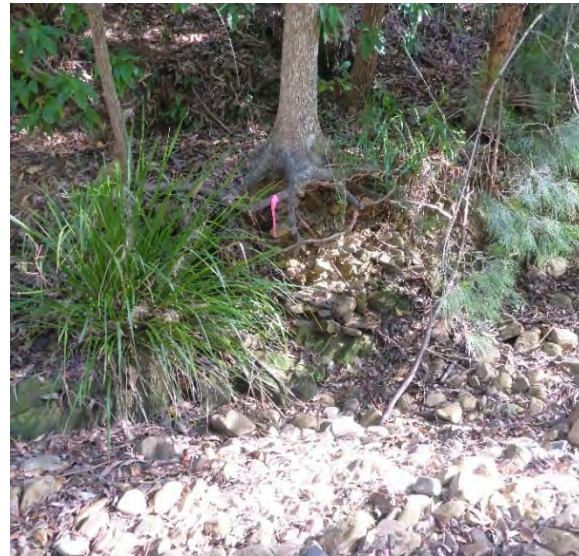
**Plate 3.6 Butchers Creek water level between Zones 5 and 6 summer 2018**

Additionally, water levels at Butchers Creek have dropped considerably since the commencement of monitoring, with a drop of ~105 cm since the initial water level measurement was taken in April of 2015. Below average monthly rainfall was received in the lead up to spring 2017 and summer 2018 monitoring. Rainfall averages are compared from the Smokey Cape monthly rainfall averages (refer to **Table 3.4**) to the rainfall received at the Southern Compound weather station (refer to **Table 3.3**). A number of pools and sections with stream flow which previously recorded moderate water depth and flow are now completely dry or significantly reduced (refer to **Plate 3.5** and **3.6**). Weeds have begun to encroach on the now dry creek bed and along the creek bank at Zones 6 and 7. Pasture grasses such as Broad-leaved Paspalum (*Paspalum mandiocanum*) and Pigeon Grass (*Setaria sphacelata*) have started to invade the dry creek bed. Along with dense infestations of Lantana (*Lantana camara*) and Small-leaved Privet (*Ligustrum sinense*) growing along the banks of Zones 6 and 7 these weed infestations have the potential to become a barrier to frog movement. However, Butchers Creek is not considered as confirmed GBF habitat, based on the monitoring results to date.

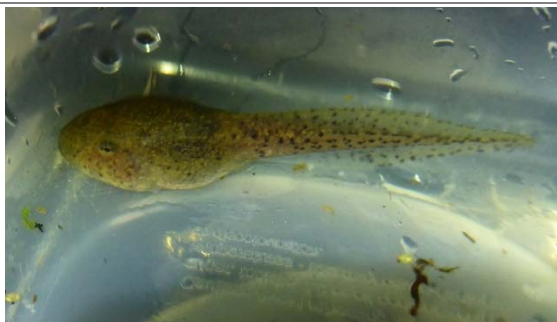
**Plate 3.7** *Mixophyes fasciolatus* (Great Barred Frog) tadpole, top/side view - Butchers Creek – Zone 7

During spring 2017 monitoring, a tadpole was captured within a tadpole trap set within a pool in Zone 7 of Butchers Creek. Using the keys in Anstis (2013), it was concluded that the tadpole was the Greater Barred Frog (*Mixophyes fasciolatus*); refer to **Plates 3.7** and **3.8**) and not the GBF.

- Venter is a whitish-blue sheen no gold or bronze as in *M. iteratus*.
- Dorsum is dark golden brown not bright gold with distinct gold patches as in *M. iterates*.
- The tadpole is approximately stage 25-27 but does not have a distinct dark band across the base of the body or around the mid ventral region or gills area. The dorsum is not predominantly gold as for *M. iteratus*.
- Gold iris is present but no gold ring around the pupil as for *M. iteratus*.
- The eye is more flattened in the head not prominent (slightly bulging) as for *M. iteratus*.
- Although it does have more dark and angular spots on the tail than is typical for *M. fasciolatus*.
- Total approximate length 85 mm.

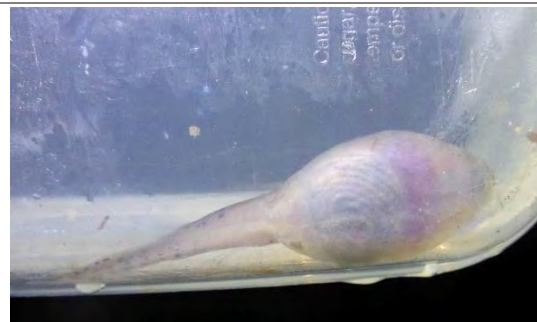
**Plate 3.8** *Mixophyes fasciolatus* (Great Barred Frog) tadpole, ventral view - Butchers Creek – Zone 7

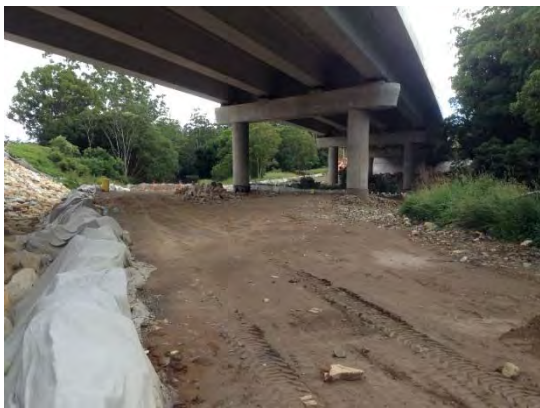
**Plate 4.1 UWC construction area through Zones 9 and 10 view to the north**

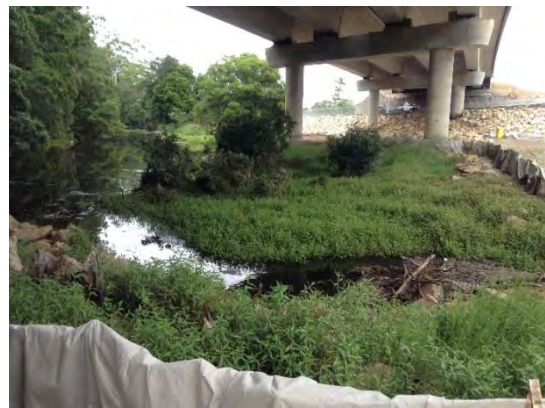
**Plate 4.2 UWC construction area through Zones 9 and 10 view to the south**

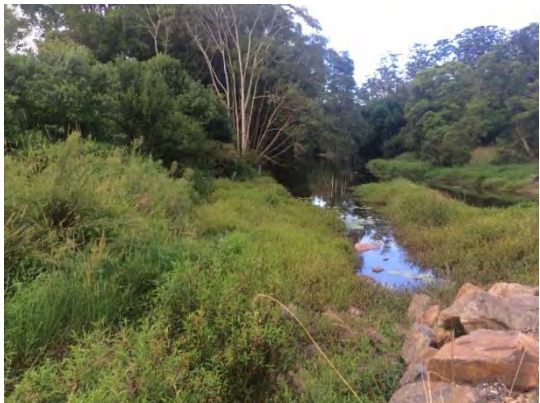
- Zone 5 has had a corridor of vegetation cleared for powerlines which has left a 20 m wide corridor of felled tree trunks, limbs and branches which obstructs north to south passage along the width of the western bank from the water level to the top of bank.
- Increased growth of grass and herbaceous species within Zone 8 (refer to **Plate 4.3** in Section 4.2).

**Plate 4.3 Western side of UWC causeway view to the north through Zone 8**
