PACIFIC HIGHWAY UPGRADE:

WARRELL CREEK TO URUNGA

MICROCHIROPTERAN BAT MANAGEMENT STRATEGY

OCTOBER 2014

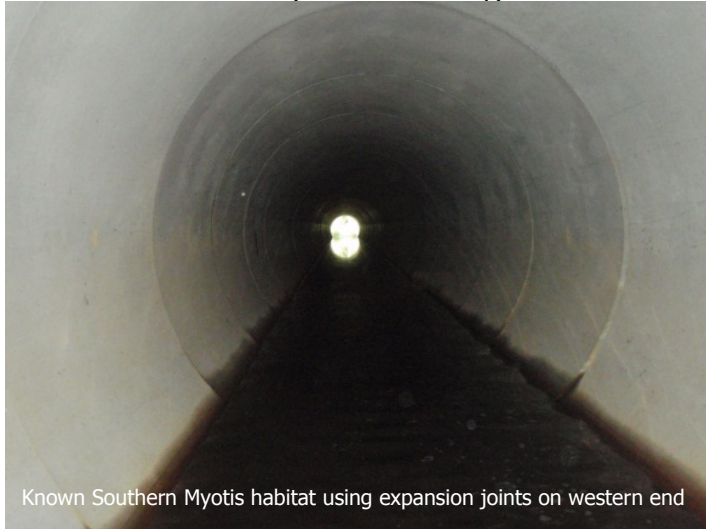
Warrell Creek to Nambucca Heads									
Culverts									
<p>599205 (Deadman's Gully)</p>

<p>Known Southern Myotis habitat using expansion joints on western end</p>

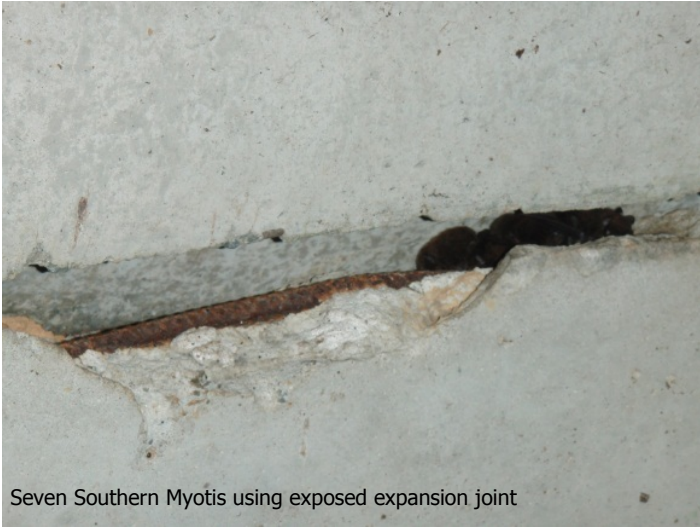
<p>Seven Southern Myotis using exposed expansion joint</p>	Southern Myotis	-	High	Moderate	E1, E2	B, E1, E2	A (option 1), B, C, D, E1, E2, G1, G2	No impact from current design
			Little Bent-wing Bat	Low	Moderate	E1, E2	B, E1, E2	A (option 1), B, C, D, E1, E2, G1, G2	
			Eastern Horseshoe Bat	Low	Moderate	E1, E2	B, E1, E2	A (option 1), B, C, D, E1, E2, G1, G2	
<p>599222 (Donnellyville)</p>

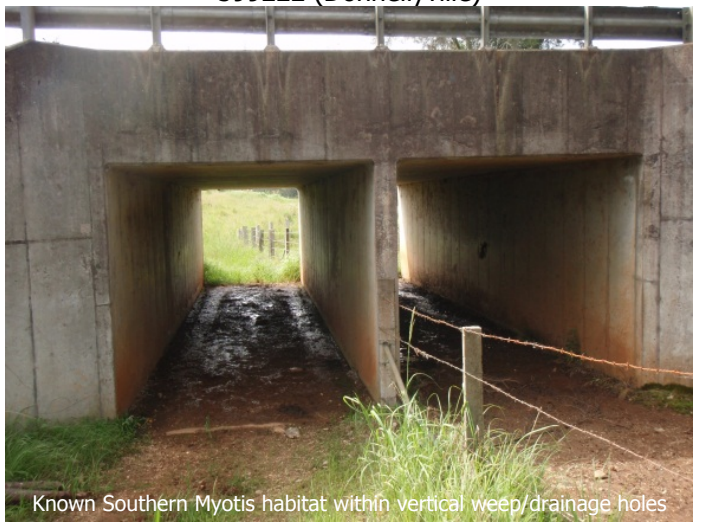
<p>Known Southern Myotis habitat within vertical weep/drainage holes</p>

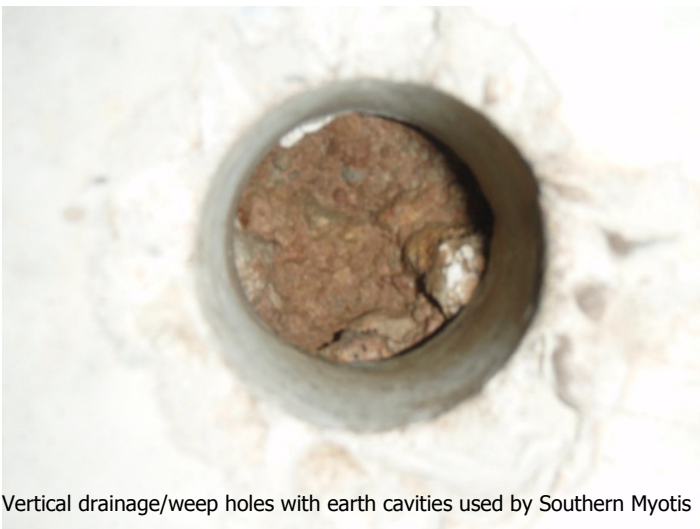
<p>Vertical drainage/weep holes with earth cavities used by Southern Myotis</p>	Southern Myotis	-	Low	Moderate	E1, E2	B, E1, E2	A (option 1), B, C, D, E1, E2, G1, G2	May require clean out
			Little Bent-wing Bat	Low	Moderate	E1, E2	B, E1, E2	A (option 1), B, C, D, E1, E2, G1, G2

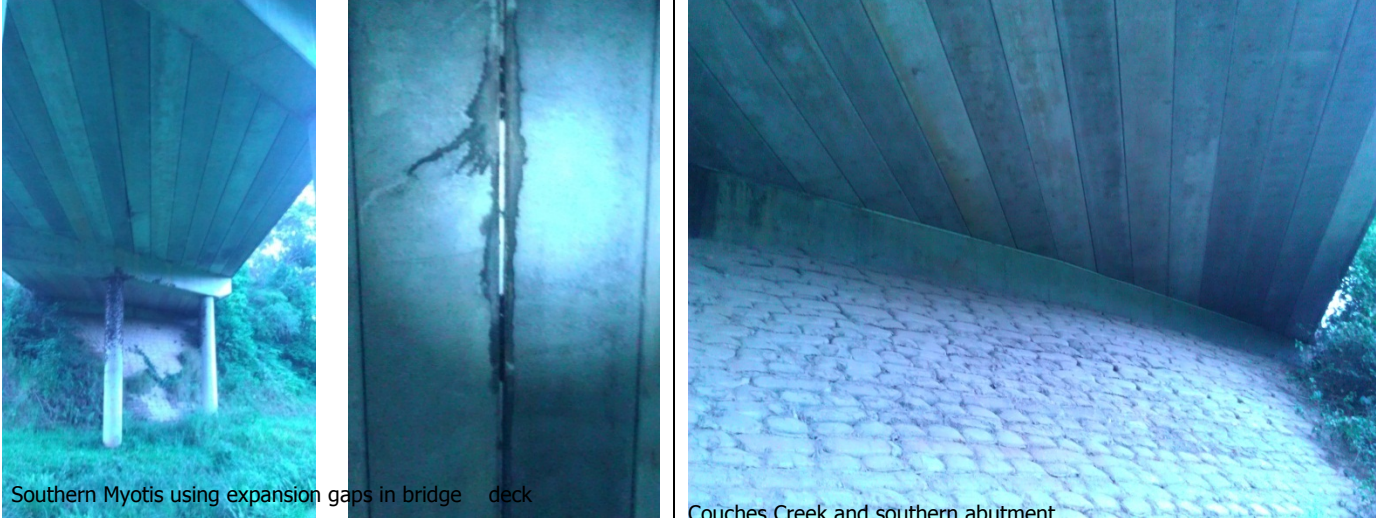
Bridges										
<p>Crouches Creek</p>

<p>Southern Myotis using expansion gaps in bridge deck</p> <p>Crouches Creek and southern abutment</p>		<p>Southern Myotis</p> <p>Gould's Wattled Bat</p> <p>Little Bent-wing Bat</p> <p>Eastern Horseshoe Bat</p>	<p>-</p> <p>-</p> <p>-</p> <p>-</p>	<p>High</p> <p>Moderate</p> <p>Low</p> <p>Low</p>	<p>High</p> <p>Moderate</p> <p>Moderate</p> <p>Low</p>	<p>E1, E2</p> <p>E1, E2</p> <p>E1, E2</p> <p>E1, E2</p>	<p>B, E1, E2, G3</p> <p>B, E1, E2, G3</p> <p>B, E1, E2, G3</p> <p>B, E1, E2, G3</p>	<p>A (option 2), B, C, E1, E2, G1, G2, G3</p> <p>A (option 2), B, C, E1, E2, G1, G2, G3</p> <p>A (option 2), B, C, E1, E2, G1, G2, G3</p> <p>A (option 2), B, C, E1, E2, G1, G2, G3</p>	<p>No impact from current design</p>	
<p>Warrell Creek Bridge (1871)</p>

A roost assigned to this category would require careful planning during the planned roost exclusion and may require additional monitoring if bats are found to be present throughout the year. For example, the Crouches Creek Bridge (7881) may require additional monitoring to evaluate the overall importance of this roost throughout the year. Sites assessed as being high conservation value roosts would also require at least some bat boxes to be installed more than 100 m away from the construction works. Bat boxes would be installed at least 6-12 months prior to construction.

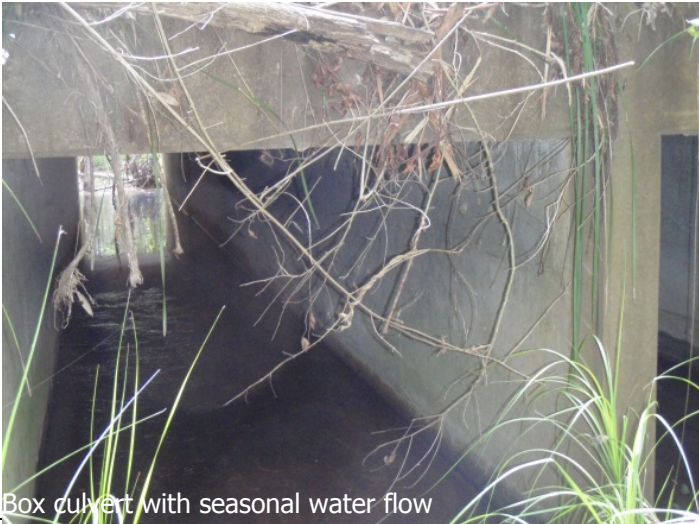
Southern Myotis	-	Moderate	High	E1, E2	B, D, E1, E2	A (option 1), B, C, D, E1, E2, G1, G2
				Little Bent-wing Bat	Low	Moderate	E1, E2	B, D, E1, E2	A (option 2), B, C, D, E1, E2, G1, G2
				Eastern Horseshoe Bat	Low	Moderate	E1, E2	B, D, E1, E2	A (option 2), B, C, D, E1, E2, G1, G2
599306 (Dalhousie Creek)	 	 	Southern Myotis	-	High	Moderate	A1, A2	na	na
				Little Bent-wing Bat	Low	Moderate	A1, A2	na	na
				Eastern Horseshoe Bat	Low	Moderate	A1, A2	na	na

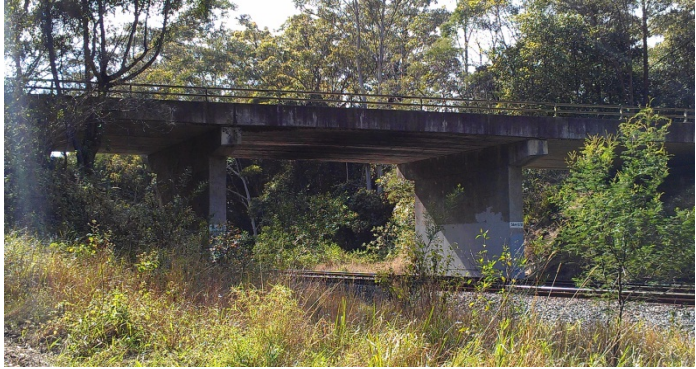
Bridges									
<p>North Coast Railway Bridge (Nambucca Heads)</p>

<p>No pic</p>	<p>Gould's Wattled Bat</p>	<p>-</p>	<p>Moderate</p>	<p>Moderate</p>	<p>E1</p>	<p>E1, A (option 2), B,</p>	<p>E1, A (option 2), B,</p>	
			<p>Little Bent-wing Bat</p>	<p>Low</p>	<p>High</p>	<p>E1</p>	<p>E1, A (option 2), B,</p>	<p>E1, A (option 2), B,</p>	
			<p>Eastern Horseshoe Bat</p>	<p>Low</p>	<p>Low</p>	<p>E1</p>	<p>E1, A (option 2), B,</p>	<p>E1, A (option 2), B,</p>

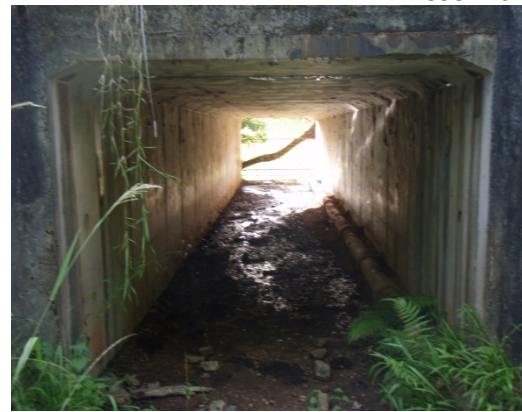
Warrell Creek to Nambucca Heads								
Culverts								
599228

No pic	Little Bent-wing Bat	Low	High	E1, E2, B	E1, E2, B,	E1, E2, B, A, C, G1, G2	Not directly impacted (maintenance works may require cleaning)
		Southern Myotis	Low (typically have water beneath – this is a dry passage culvert)	Moderate	E1, E2, B	E1, E2, B,	E1, E2, B, A, C, G1, G2	
		Eastern Horseshoe Bat	Low	Moderate	E1, E2, B	E1, E2, B,	E1, E2, B, A, C, G1, G2	
599229

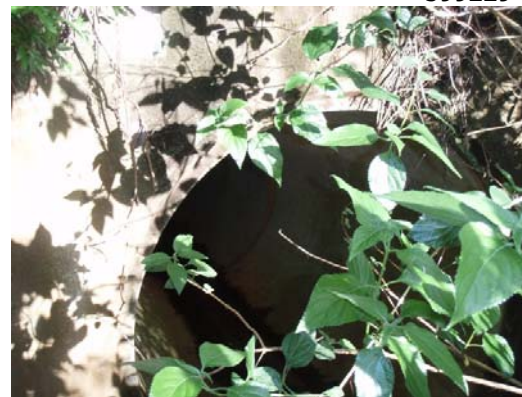
No pic	Little Bent-wing Bat	Low	Moderate	E1, E2, B	E1, E2, B,	E1, E2, B, A, C, G1, G2	Not directly impacted (maintenance works may require cleaning)
		Southern Myotis	Low (most likely towards the eastern end where water tends to pool in the culvert)	Moderate	E1, E2, B	E1, E2, B,	E1, E2, B, A, C, G1, G2	
		Eastern Horseshoe Bat	Low	Moderate	E1, E2, B	E1, E2, B,	E1, E2, B, A, C, G1, G2	
599237

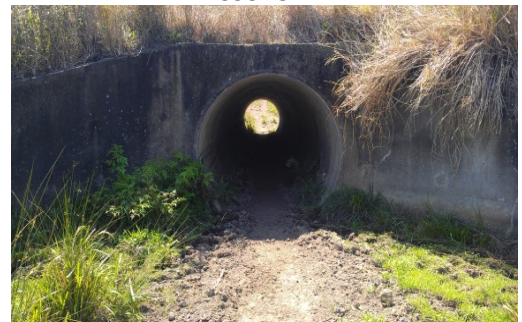
Southern Myotis	Low (typically have water beneath – this is a dry passage culvert with high cattle use)	Moderate	E1, E2, B	E1, E2, B,	E1, E2, B, A, C, G1, G2	
		Eastern Horseshoe Bat	Low	Moderate	E1, E2, B	E1, E2, B,	E1, E2, B, A, C, G1, G2

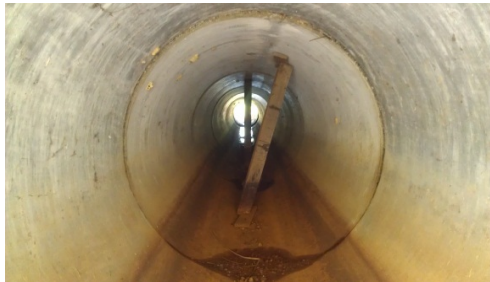
<p>599238</p>

<p>No pic</p>	<p>Little Bent-wing Bat</p> <p>Southern Myotis</p> <p>Eastern Horseshoe Bat</p>	<p>Low</p> <p>Low (typically have water beneath – this is largely a dry passage culvert)</p> <p>Low</p>	<p>High</p> <p>Moderate</p> <p>Moderate</p>	<p>E1, E2, B</p> <p>E1, E2, B</p> <p>E1, E2, B</p>	<p>E1, E2, B,</p> <p>E1, E2, B,</p> <p>E1, E2, B,</p>	<p>E1, E2, B, A, C, G1, G2</p> <p>E1, E2, B, A, C, G1, G2</p> <p>E1, E2, B, A, C, G1, G2</p>	<p>Not directly impacted (maintenance works may require cleaning)</p>
<p>Bridges</p>								
<p>None identified</p>								
<p>Nambucca Heads to Urunga Culverts</p>								
<p>599265</p>

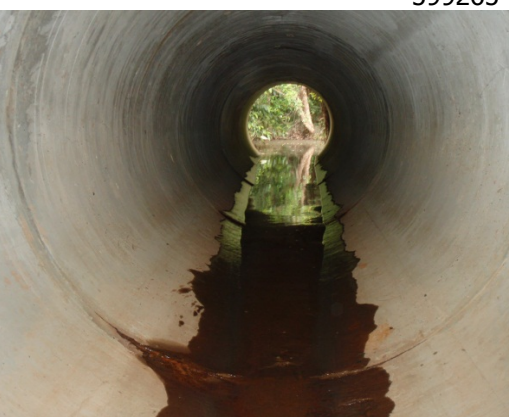
<p>No pic</p>	<p>Little Bent-wing Bat</p> <p>Southern Myotis</p> <p>Eastern Horseshoe Bat</p>	<p>Very Low</p> <p>Low (most likely towards the eastern end where water tends to pool in the culvert)</p> <p>Very Low</p>	<p>Low</p> <p>Moderate</p> <p>Very Low</p>	<p>E1, E2, B</p> <p>E1, E2, B</p> <p>E1, E2, B</p>	<p>E1, E2, B, D</p> <p>E1, E2, B, D</p> <p>E1, E2, B, D</p>	<p>E1, E2, B, A, C, D, G1, G2</p> <p>E1, E2, B, A, C, D, G1, G2</p> <p>E1, E2, B, A, C, D, G1, G2</p>

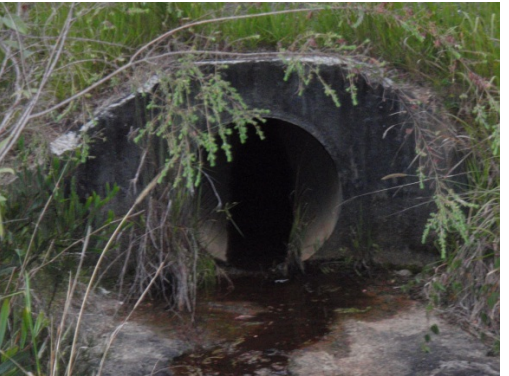
<p>599272</p>

<p>No pic</p>	<p>Little Bent-wing Bat</p> <p>Southern Myotis</p> <p>Eastern Horseshoe Bat</p>	<p>Very Low</p> <p>Low</p> <p>Very Low</p>	<p>Low</p> <p>Low</p> <p>Low</p>	<p>E1, E2, B</p> <p>E1, E2, B</p> <p>E1, E2, B</p>	<p>E1, E2, B, D</p> <p>E1, E2, B, D</p> <p>E1, E2, B, D</p>	<p>E1, E2, B, A, C, D, G1, G2</p> <p>E1, E2, B, A, C, D, G1, G2</p> <p>E1, E2, B, A, C, D, G1, G2</p>

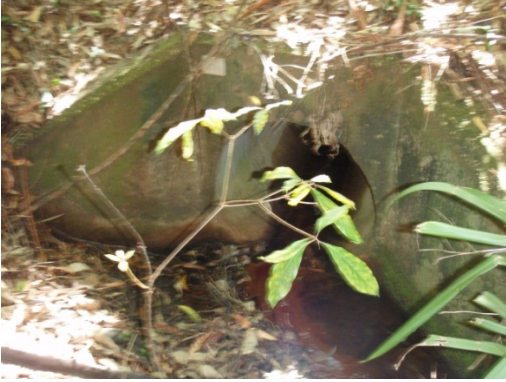
<p>599291</p>

<p>No pic</p>	<p>Little Bent-wing Bat</p> <p>Southern Myotis</p> <p>Eastern Horseshoe Bat</p>	<p>Very Low</p> <p>Low</p> <p>Very Low</p>	<p>Low</p> <p>Moderate</p> <p>Low</p>	<p>E1, E2, B</p> <p>E1, E2, B</p> <p>E1, E2, B</p>	<p>E1, E2, B, D</p> <p>E1, E2, B, D</p> <p>E1, E2, B, D</p>	<p>E1, E2, B, A, C, D, G1, G2</p> <p>E1, E2, B, A, C, D, G1, G2</p> <p>E1, E2, B, A, C, D, G1, G2</p>	
<p>599302</p>  	<p>No pic</p>	<p>Little Bent-wing Bat</p> <p>Southern Myotis</p> <p>Eastern Horseshoe Bat</p>	<p>Very Low</p> <p>Very Low</p> <p>Very Low</p>	<p>Low</p> <p>Low</p> <p>Low</p>	<p>E1, E2, B</p> <p>E1, E2, B</p> <p>E1, E2, B</p>	<p>E1, E2, B, D</p> <p>E1, E2, B, D</p> <p>E1, E2, B, D</p>	<p>E1, E2, B, A, C, D, G1, G2</p> <p>E1, E2, B, A, C, D, G1, G2</p> <p>E1, E2, B, A, C, D, G1, G2</p>	
<p>599323</p>

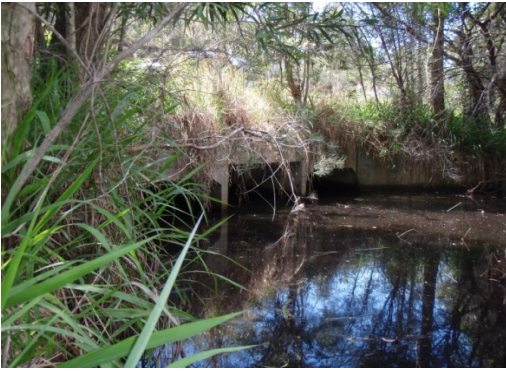
<p>No pic</p>	<p>Little Bent-wing Bat</p> <p>Southern Myotis</p> <p>Eastern Horseshoe Bat</p>	<p>Very Low</p> <p>Moderate</p> <p>Very Low</p>	<p>Low</p> <p>Moderate</p> <p>Moderate</p>	<p>E1, E2, B</p> <p>E1, E2, B</p> <p>E1, E2, B</p>	<p>E1, E2, B, D</p> <p>E1, E2, B, D</p> <p>E1, E2, B, D</p>	<p>E1, E2, B, A, C, D, G1, G2</p> <p>E1, E2, B, A, C, D, G1, G2</p> <p>E1, E2, B, A, C, D, G1, G2</p>

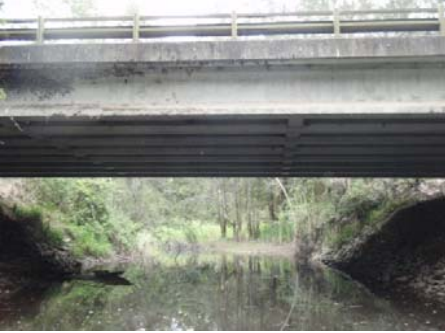
<p>Little Bent-wing Bat</p> <p>Southern Myotis</p> <p>Eastern Horseshoe Bat</p>	<p>Very Low</p> <p>Moderate</p> <p>Very Low</p>	<p>Moderate</p> <p>Moderate</p> <p>Low</p>	<p>E1, E2, B</p> <p>E1, E2, B</p> <p>E1, E2, B</p>	<p>E1, E2, B, D</p> <p>E1, E2, B, D</p> <p>E1, E2, B, D</p>	<p>E1, E2, B, A, C, D, G1, G2</p> <p>E1, E2, B, A, C, D, G1, G2</p> <p>E1, E2, B, A, C, D, G1, G2</p>
