2 December 2015
Ref No: 2378-1175

WC2NH: Monitoring of In-situ Threatened Flora (Annual Report 2015)

In-situ Threatened Flora - Map 6 of 6

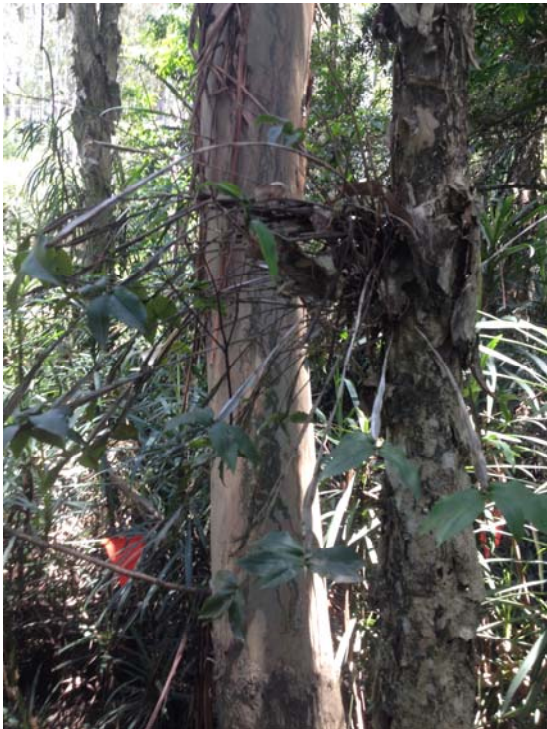
Plate 1.1 *Spider Orchid* subject to monitoring

- The in-situ Spider Orchid is in a healthy condition with recruitment of an additional individual occurring immediately below this plant on the same tree.

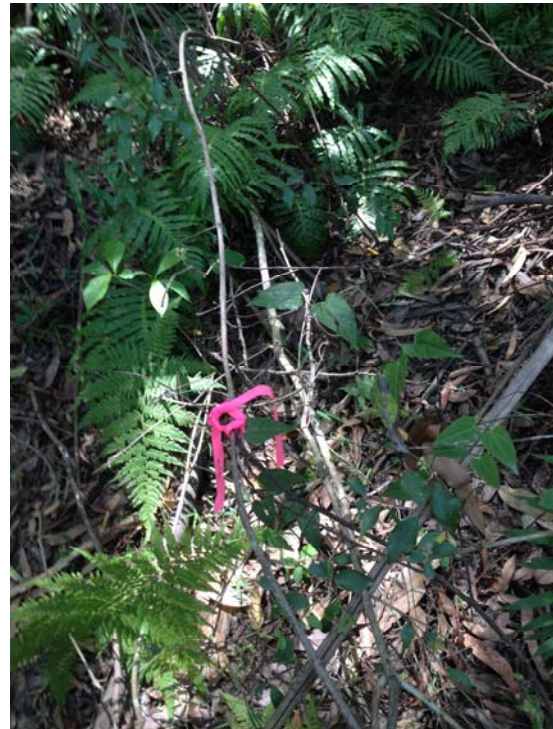
Plate 1.2 *Slender Marsdenia* monitoring plant

- A number of Slender Marsdenia individuals have recently died back. This finding is not surprising given that this species is known to naturally die back as part of its natural lifecycle. Monitoring undertaken next year would expect to see continued recruitment of juvenile vines associated with dead vines.

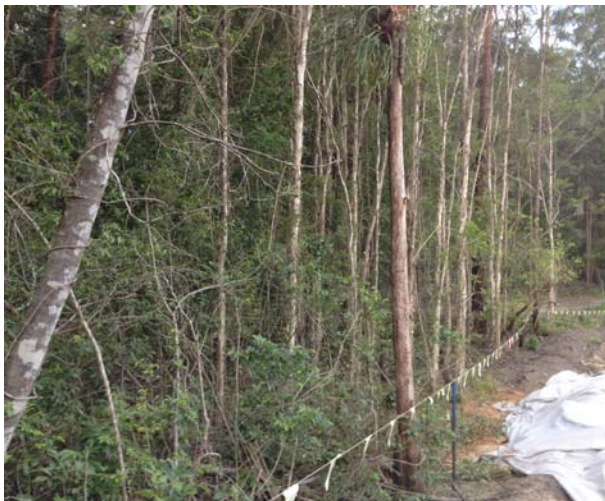
Plate 1.3 Example Habitat Condition Monitoring Plots

Permanent plots were established in the indirect impact zones at ten representative points in Slender Marsdenia and Wools' Tylophora habitat as mapped by Andrew Benwell. The plots are 10 m wide and 20 m long, with the long axis parallel to the edge of clearing. The corners of each plot were marked with pink flagging tape with the GPS co-ordinates of the corners of plots also recorded. Plots were established on 26th November 2015 which was around the time that clearing operations in the northern zone of the project were being completed. The following parameters were measured at each plot (refer to TFMP **Section 5.4** for more information):
