MICROBAT MANAGEMENT PLAN

Warrell Creek to Urunga upgrade

MICROCHIROPTERAN BAT MANAGEMENT STRATEGY

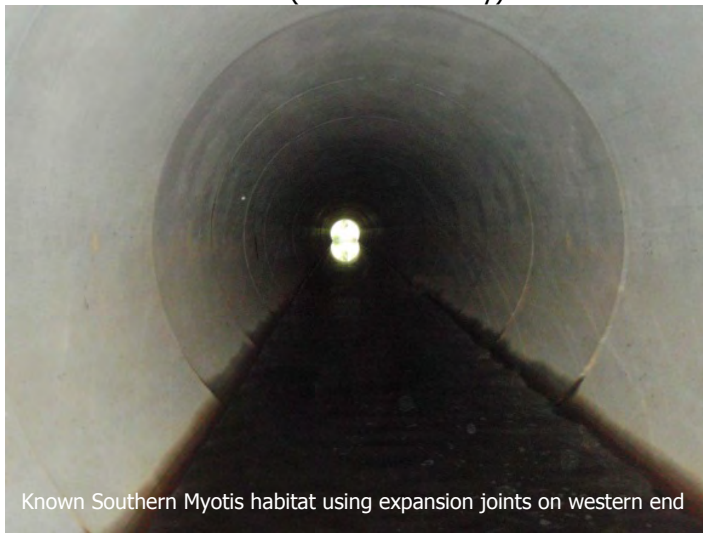
Seven Southern Myotis using exposed expansion joint							
			Little Bent-wing Bat	Low	Moderate	E1, E2	B, E1, E2	A (option 1), B, C, D, E1, E2, G1, G2
			Eastern Horseshoe Bat	Low	Moderate	E1, E2	B, E1, E2	A (option 1), B, C, D, E1, E2, G1, G2
599222 (Donnellyville)	 	Southern Myotis	-	Low	Moderate	E1, E2	B, D, E1, E2	A (option 1), B, C, D, E1, E2, G1, G2
 	Known Southern Myotis habitat within vertical weep/drainage holes							
	Vertical drainage/weep holes with earth cavities used by Southern Myotis							
			Little Bent-wing Bat	Low	Moderate	E1, E2	B, D, E1, E2	A (option 1), B, C, D, E1, E2, G1, G2

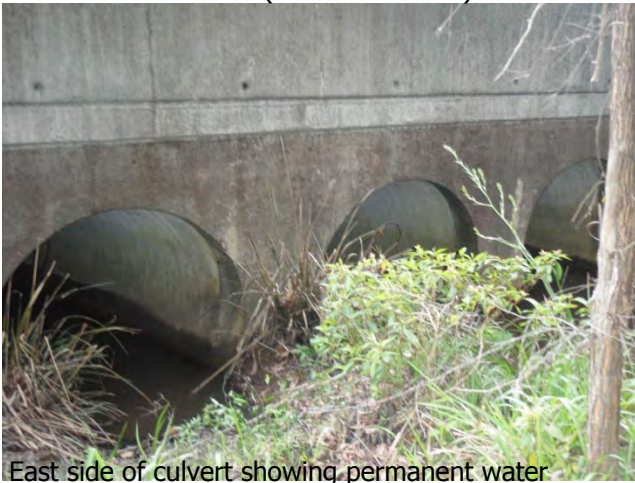
Structure	Roost Site	Species Recorded	Other Species to Consider	Breeding Site	Overwintering Site	Works 100-200 m from roost	Works Within 100 m	Works on the structure
<p>599306 (Dalhousie Creek)</p>

<p>East side of culvert showing permanent water</p>

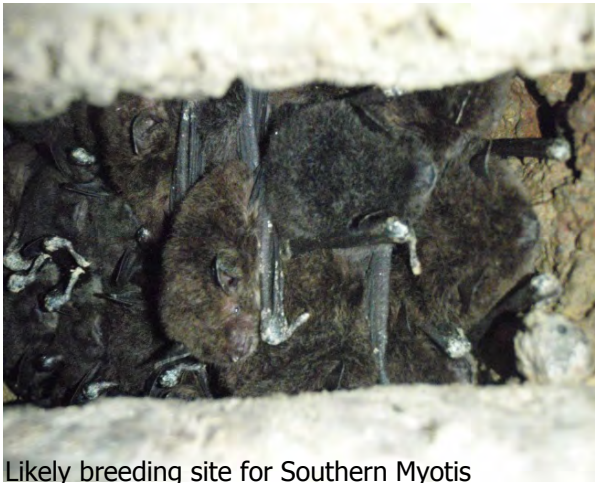
<p>Likely breeding site for Southern Myotis</p>	Southern Myotis	-	High	Moderate	A1, A2	na	na
Bridges								
<p>North Coast Railway Bridge (Nambucca Heads)</p>

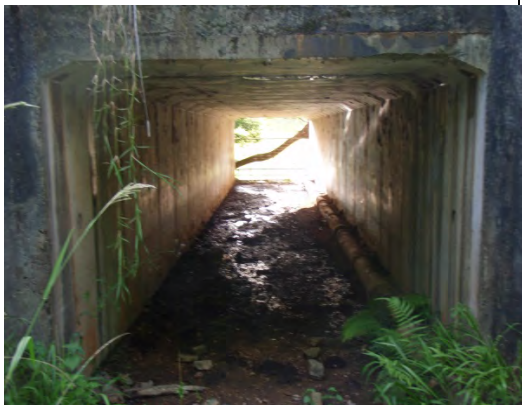
Structure	Roost Habitat	Species to Consider	Breeding Site	Overwintering	Works 100-200 m from roost	Works Within 100 m	Works on the structure
Warrell Creek to Nambucca Heads							
Culverts							
599228

No pic	Little Bent-wing Bat	Low	High	E1, E2, B	E1, E2, B, D	E1, E2, B, A, C, D, G1, G2
		Southern Myotis	Low (typically have water beneath – this is a dry passage culvert)	Moderate	E1, E2, B	E1, E2, B, D	E1, E2, B, A, C, D, G1, G2
		Eastern Horseshoe Bat	Low	Moderate	E1, E2, B	E1, E2, B, D	E1, E2, B, A, C, D, G1, G2
599229

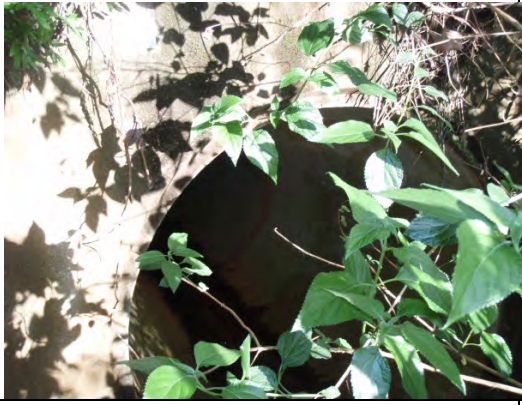
No pic	Little Bent-wing Bat	Low	Moderate	E1, E2, B	E1, E2, B, D	E1, E2, B, A, C, D, G1, G2
		Southern Myotis	Low (most likely towards the eastern end where water tends to pool in the culvert)	Moderate	E1, E2, B	E1, E2, B, D	E1, E2, B, A, C, D, G1, G2
		Eastern Horseshoe Bat	Low	Moderate	E1, E2, B	E1, E2, B, D	E1, E2, B, A, C, D, G1, G2
599237

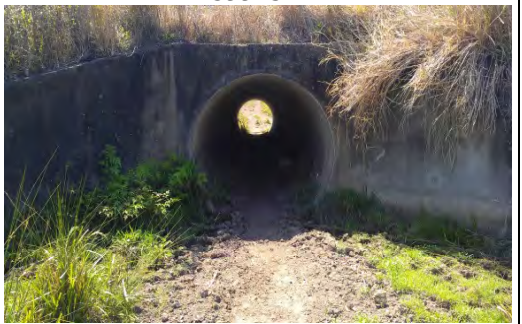
Little Bent-wing Bat	Low	High	E1, E2, B	E1, E2, B, D	E1, E2, B, A, C, D, G1, G2

Southern Myotis	Low (typically have water beneath – this is a dry passage culvert with high cattle use)	Moderate	E1, E2, B	E1, E2, B, D	E1, E2, B, A, C, D, G1, G2
		Eastern Horseshoe Bat	Low	Moderate	E1, E2, B	E1, E2, B, D	E1, E2, B, A, C, D, G1, G2

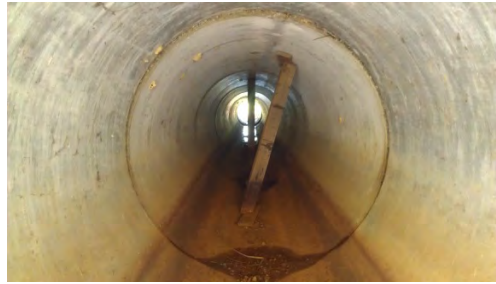
Structure	Roost Habitat	Species to Consider	Breeding Site	Overwintering	Works 100-200 m from roost	Works Within 100 m	
599238

No pic	Little Bent-wing Bat	Low	High	E1, E2, B	E1, E2, B, D	E1, E2, B, A, C, D, G1, G2
		Southern Myotis	Low (typically have water beneath – this is largely a dry passage culvert)	Moderate	E1, E2, B	E1, E2, B, D	E1, E2, B, A, C, D, G1, G2
		Eastern Horseshoe Bat	Low	Moderate	E1, E2, B	E1, E2, B, D	E1, E2, B, A, C, D, G1, G2
Bridges							
None identified							
Nambucca Heads to Urunga Culverts							
599265

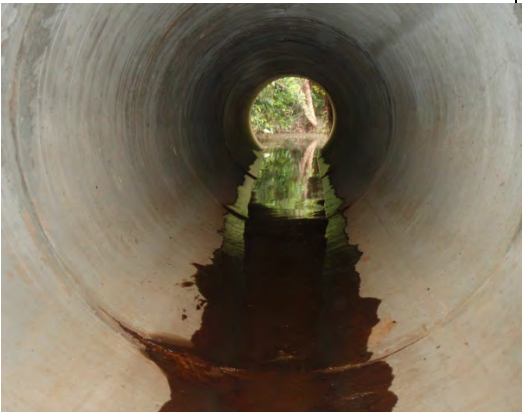
No pic	Little Bent-wing Bat	Very Low	Low	E1, E2, B	E1, E2, B, D	E1, E2, B, A, C, D, G1, G2
		Southern Myotis	Low (most likely towards the eastern end where water tends to pool in the culvert)	Moderate	E1, E2, B	E1, E2, B, D	E1, E2, B, A, C, D, G1, G2
		Eastern Horseshoe Bat	Very Low	Very Low	E1, E2, B	E1, E2, B, D	E1, E2, B, A, C, D, G1, G2
599272

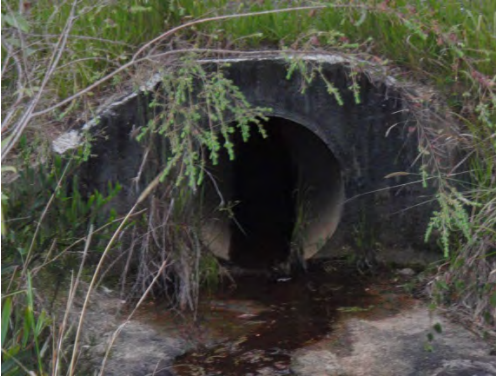
No pic	Little Bent-wing Bat	Very Low	Low	E1, E2, B	E1, E2, B, D	E1, E2, B, A, C, D, G1, G2

Southern Myotis	Low	Low	E1, E2, B	E1, E2, B, D	E1, E2, B, A, C, D, G1, G2
		Eastern Horseshoe Bat	Very Low	Low	E1, E2, B	E1, E2, B, D	E1, E2, B, A, C, D, G1, G2

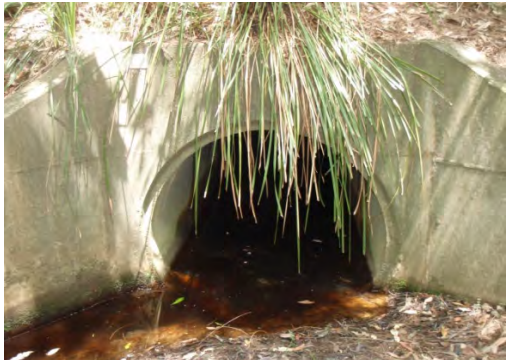
Structure	Roost Habitat	Species to Consider	Breeding Site	Overwintering	Works 200 m from roost	100-100 m	Works Within 100 m	Works on the structure
599274

No pic	Little Bent-wing Bat	Very Low	Low	E1, E2, B	E1, E2, B, D	E1, E2, B, A, C, D, G1, G2	
		Southern Myotis	Moderate	Moderate	E1, E2, B	E1, E2, B, D	E1, E2, B, A, C, D, G1, G2	
		Eastern Horseshoe Bat	Very Low	Low	E1, E2, B	E1, E2, B, D	E1, E2, B, A, C, D, G1, G2	
599276

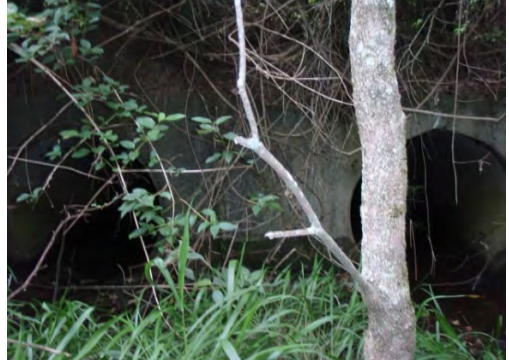
No pic	Little Bent-wing Bat	Very Low	Moderate	E1, E2, B	E1, E2, B, D	E1, E2, B, A, C, D, G1, G2	
		Southern Myotis	Moderate	Moderate	E1, E2, B	E1, E2, B, D	E1, E2, B, A, C, D, G1, G2	
		Eastern Horseshoe Bat	Low	Moderate	E1, E2, B	E1, E2, B, D	E1, E2, B, A, C, D, G1, G2	
599282

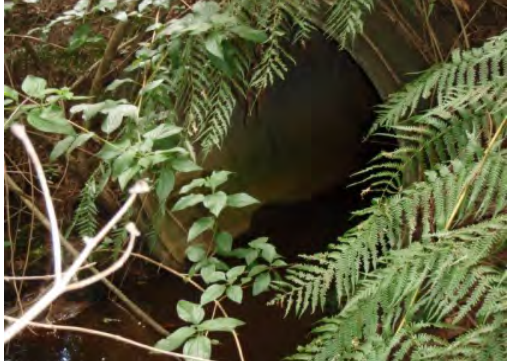
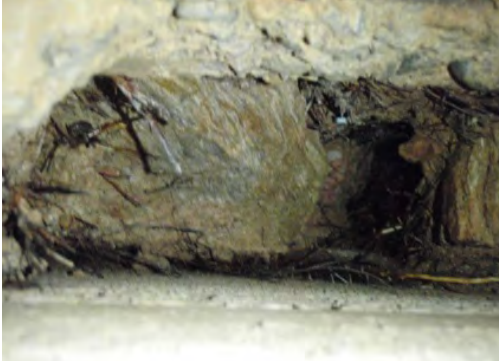
Little Bent-wing Bat	Very Low	Moderate	E1, E2, B	E1, E2, B, D	E1, E2, B, A, C, D, G1, G2	
		Southern Myotis	Moderate	Moderate	E1, E2, B	E1, E2, B, D	E1, E2, B, A, C, D, G1, G2	
		Eastern Horseshoe Bat	Low	Moderate	E1, E2, B	E1, E2, B, D	E1, E2, B, A, C, D, G1, G2

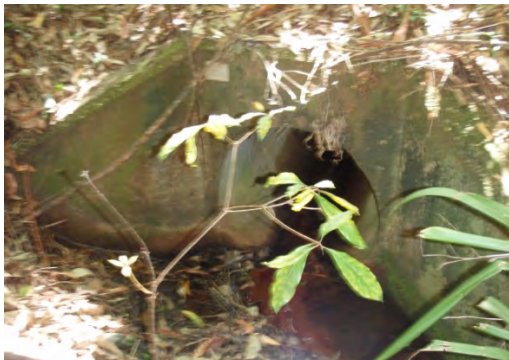
599291

No pic	Little Bent-wing Bat	Very Low	Low	E1, E2, B	E1, E2, B, D	E1, E2, B, A, C, D, G1, G2	
		Southern Myotis	Low	Moderate	E1, E2, B	E1, E2, B, D	E1, E2, B, A, C, D, G1, G2	
		Eastern Horseshoe Bat	Very Low	Low	E1, E2, B	E1, E2, B, D	E1, E2, B, A, C, D, G1, G2

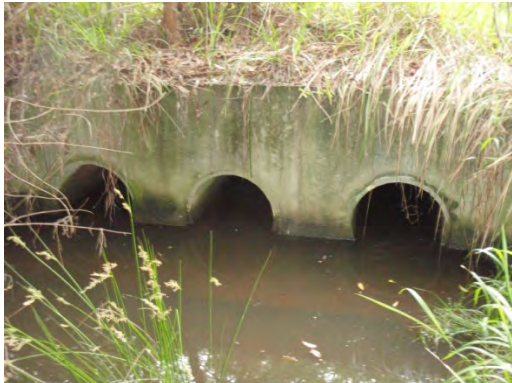
Structure	Roost Habitat	Species to Consider	Breeding Site	Overwintering	Works 100-200 m from roost	Works Within 100 m	Works on the structure
599302

No pic	Little Bent-wing Bat	Very Low	Low	E1, E2, B	E1, E2, B, D	E1, E2, B, A, C, D, G1, G2
		Southern Myotis	Very Low	Low	E1, E2, B	E1, E2, B, D	E1, E2, B, A, C, D, G1, G2
		Eastern Horseshoe Bat	Very Low	Low	E1, E2, B	E1, E2, B, D	E1, E2, B, A, C, D, G1, G2
599323

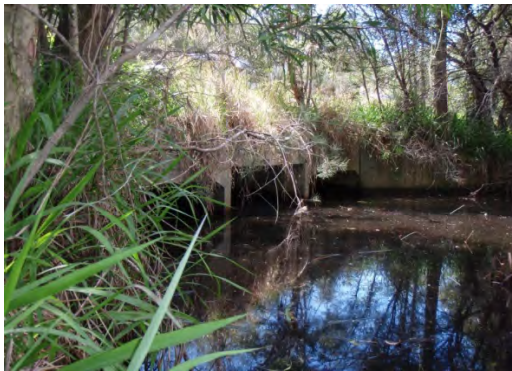
No pic	Little Bent-wing Bat	Very Low	Low	E1, E2, B	E1, E2, B, D	E1, E2, B, A, C, D, G1, G2
		Southern Myotis	Moderate	Moderate	E1, E2, B	E1, E2, B, D	E1, E2, B, A, C, D, G1, G2
		Eastern Horseshoe Bat	Very Low	Moderate	E1, E2, B	E1, E2, B, D	E1, E2, B, A, C, D, G1, G2
599325

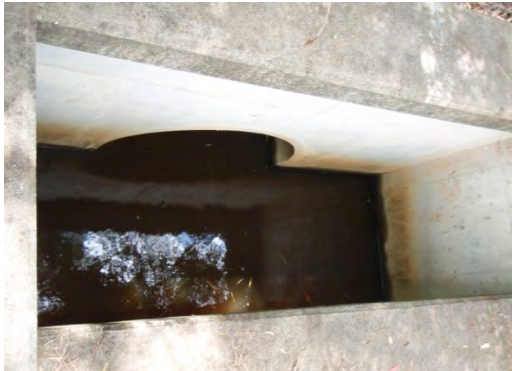
No pic	Little Bent-wing Bat	Very Low	Low	E1, E2, B	E1, E2, B, D	E1, E2, B, A, C, D, G1, G2
		Southern Myotis	Low	Moderate	E1, E2, B	E1, E2, B, D	E1, E2, B, A, C, D, G1, G2
		Eastern Horseshoe Bat	Very Low	Low	E1, E2, B	E1, E2, B, D	E1, E2, B, A, C, D, G1, G2

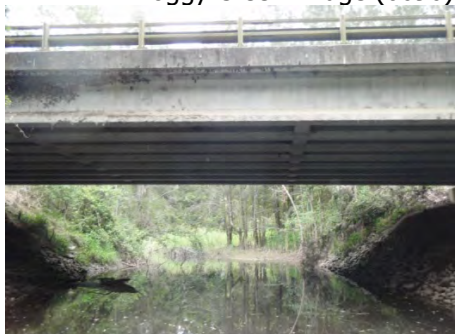
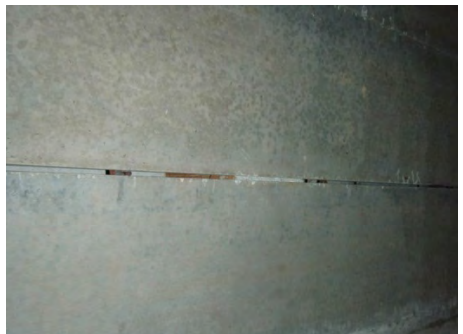
Bridges							
Boggy Creek Bridge (6696)

Little Bent-wing Bat	Very Low	Moderate	E1, E2, B	E1, E2, B, D	E1, E2, B, A, C, D, G1, G2
		Southern Myotis	Moderate	Moderate	E1, E2, B	E1, E2, B, D	E1, E2, B, A, C, D, G1, G2
		Eastern Horseshoe Bat	Very Low	Low	E1, E2, B	E1, E2, B, D	E1, E2, B, A, C, D, G1, G2
