Appendix B10.1

Tyndale Borrow Site Management Plan

Woolgoolga to Ballina (sections 3 to 11)

Pacific Highway Upgrade

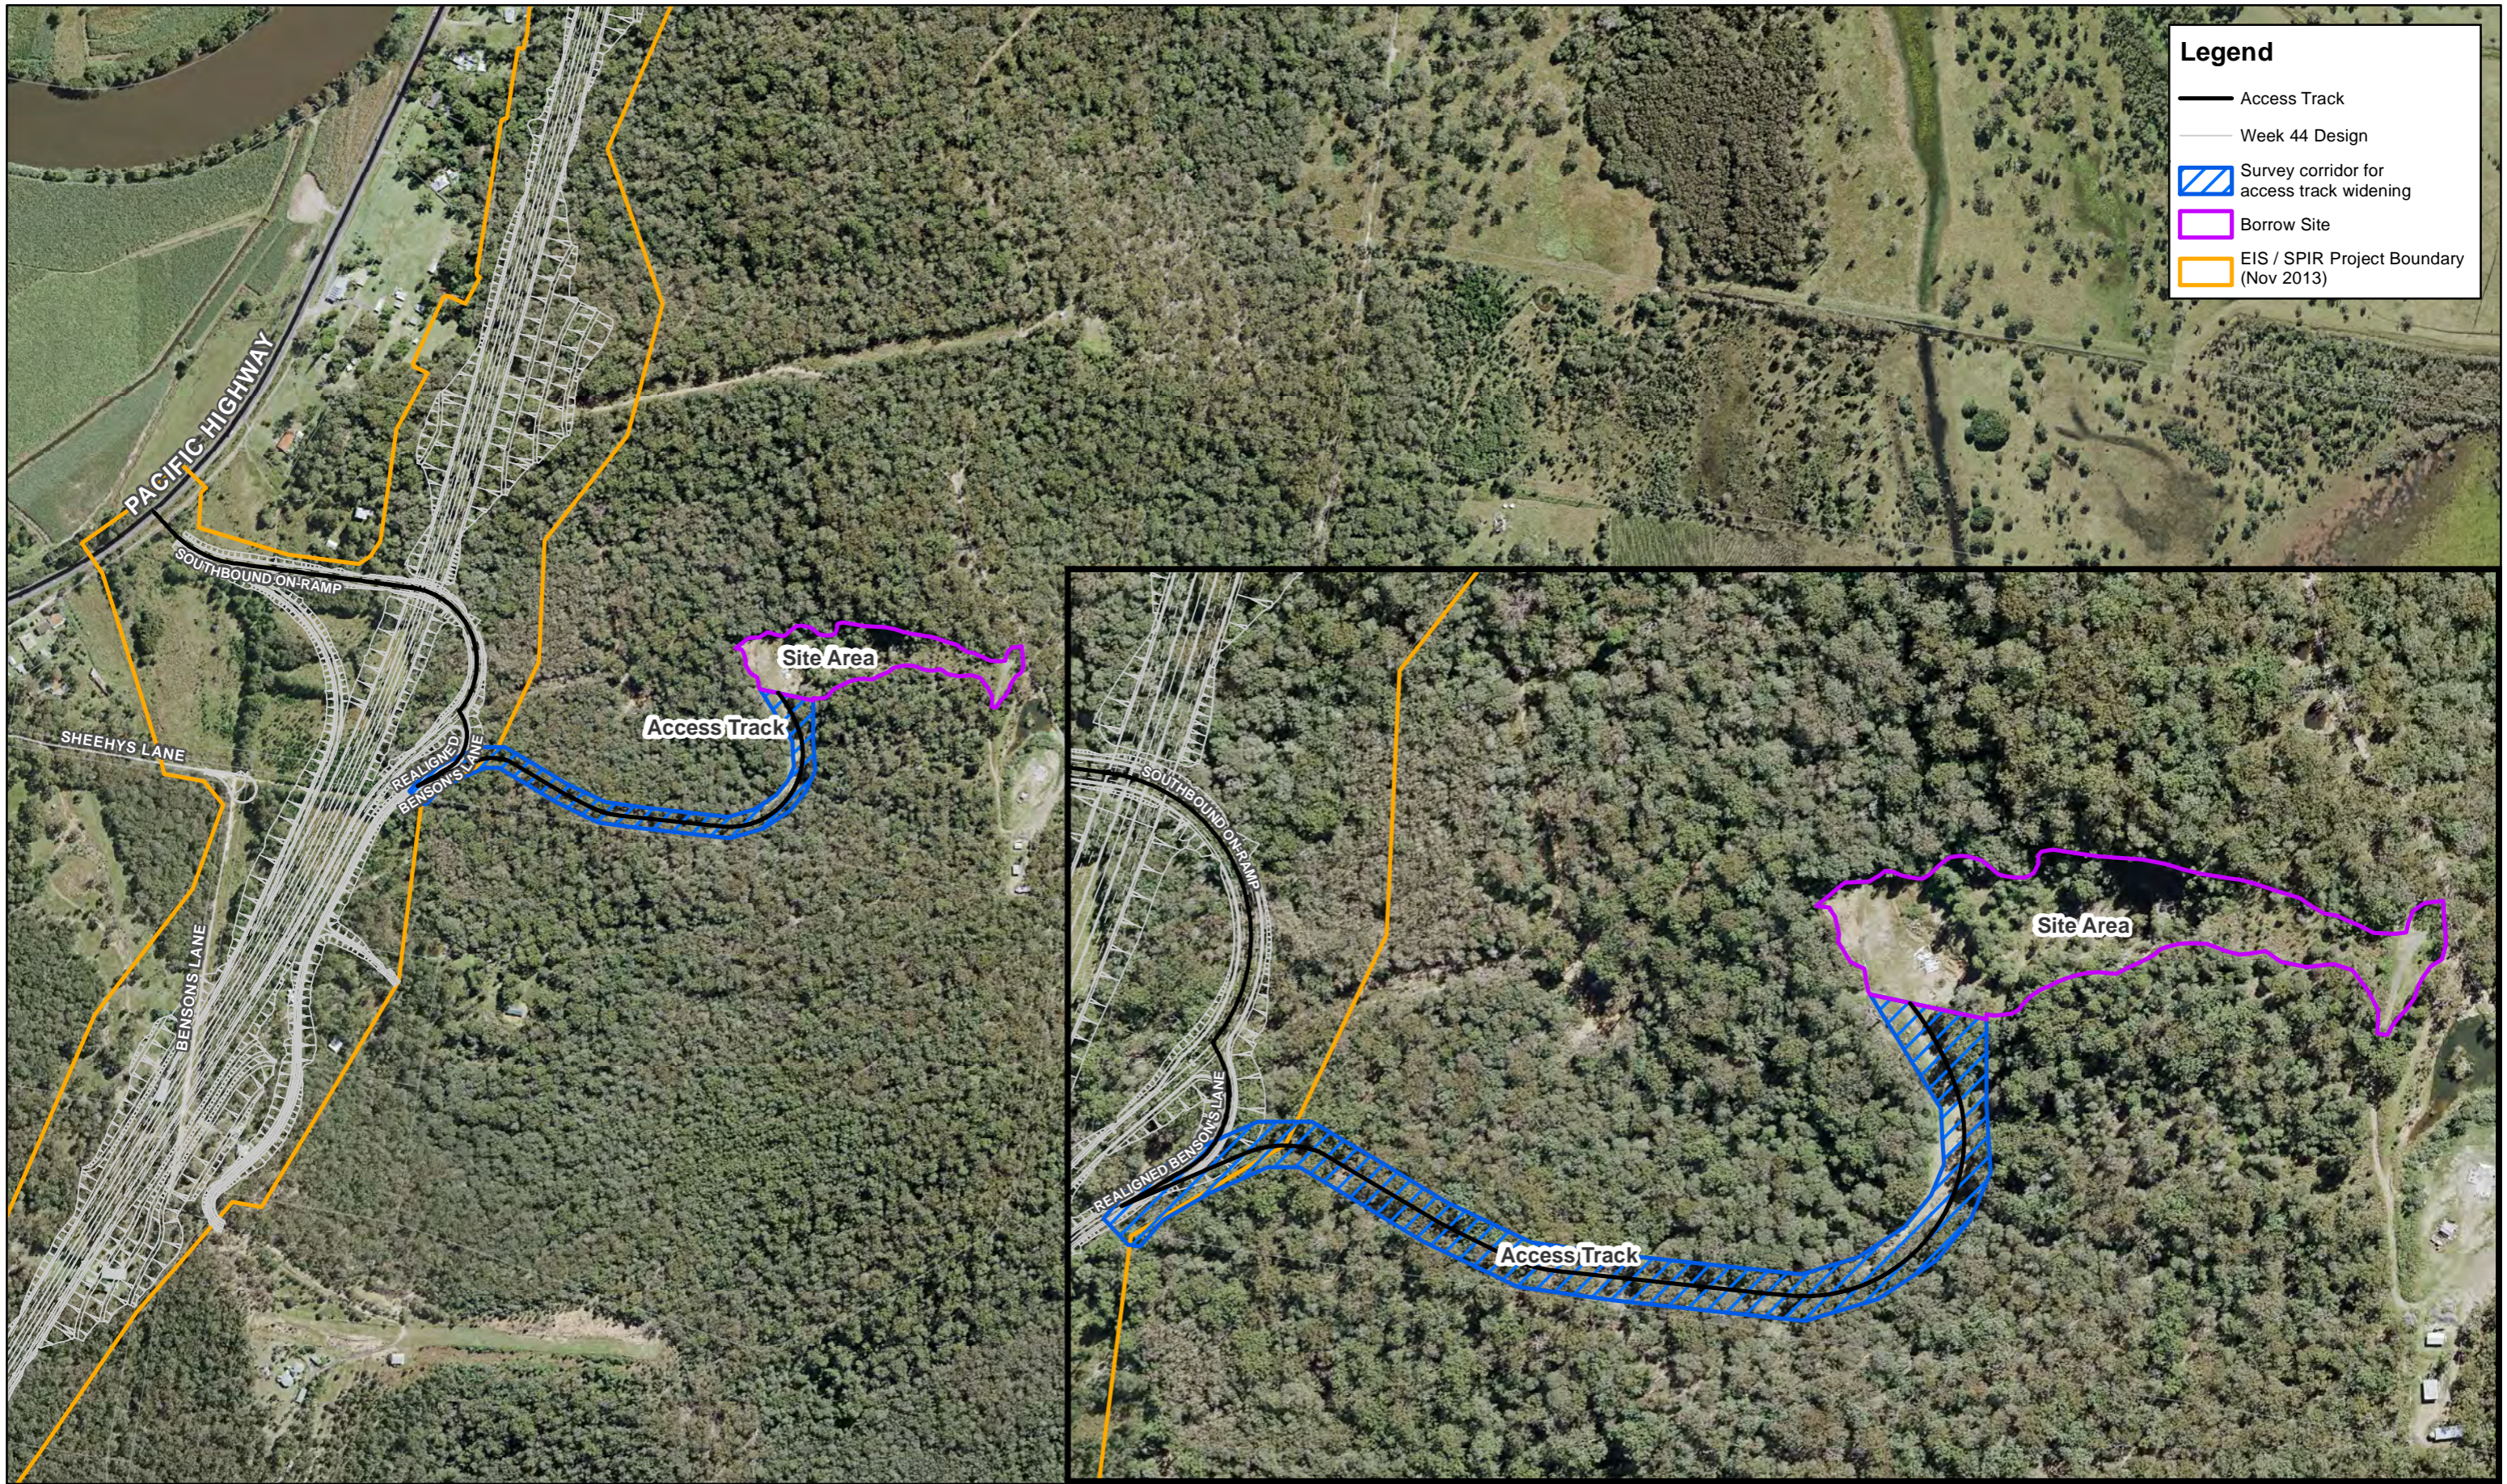
Figure 3-1
TYNDALE BORROW
SITE

Note: ecology surveys were carried out within the survey corridor to determine the location of threatened species and habitat trees to assist in the design for the widening of the access track. Only the required clearing within the survey corridor will occur.

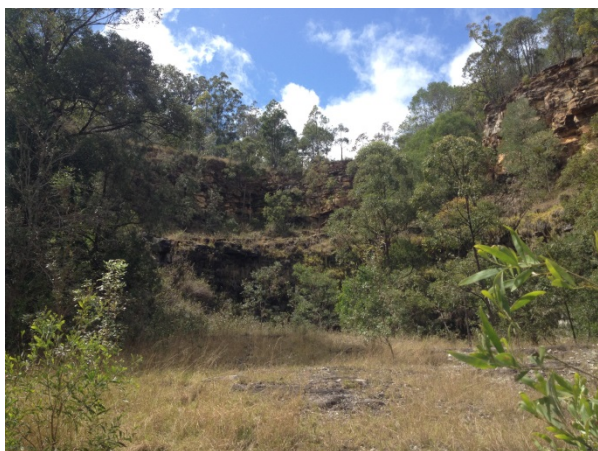
Plate 1 Early stage regrowth vegetation occurring within existing quarry footprint

Early stage regenerating vegetation comprises juvenile Tallowwood (*Eucalyptus microcorys*), Pink Bloodwood (*Corymbia gummifera*) and White Mahogany (*Eucalyptus acmenioides*) trees with regenerating *Acacia disparrima*. Areas of Blady Grass, introduced grasses and weeds such as Pink Flowering Lantana (*Lantana camara*) occur in association with early stage native regenerating vegetation. Examples of areas comprising early stage regeneration at the site are shown in **Plates 1** and **2** below.

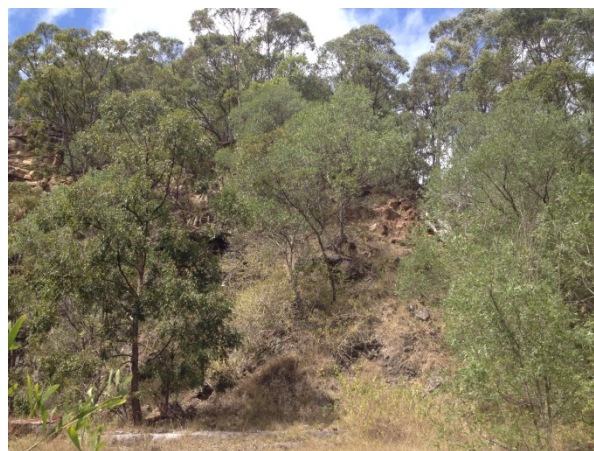
Plate 2 Regrowth Acacia and Tallowwood on existing quarry site

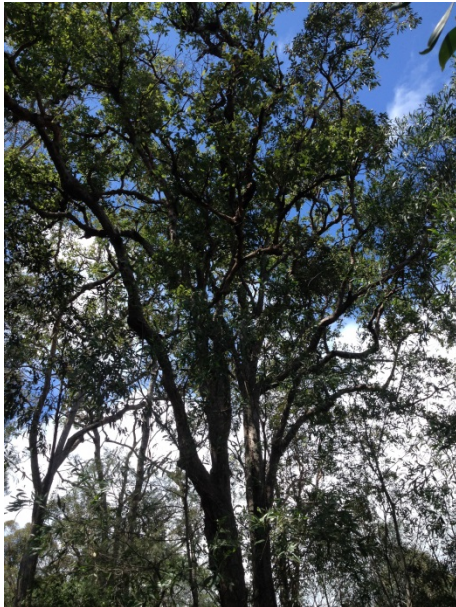
Plate 3 Potential threatened Sandstone Rough-barked Apple occurring at the site

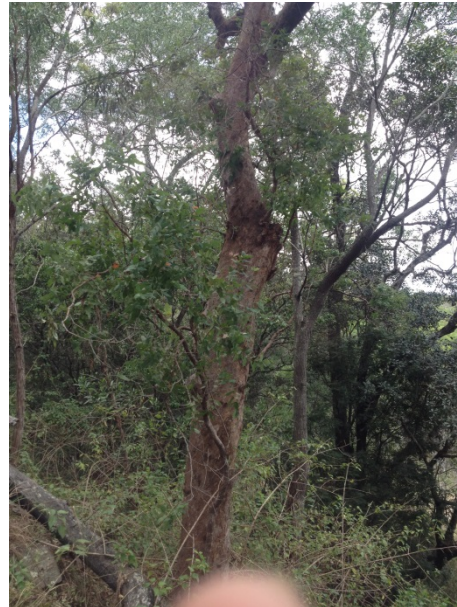
Plate 4 Example of more mature Pink Bloodwood Moist open Forest

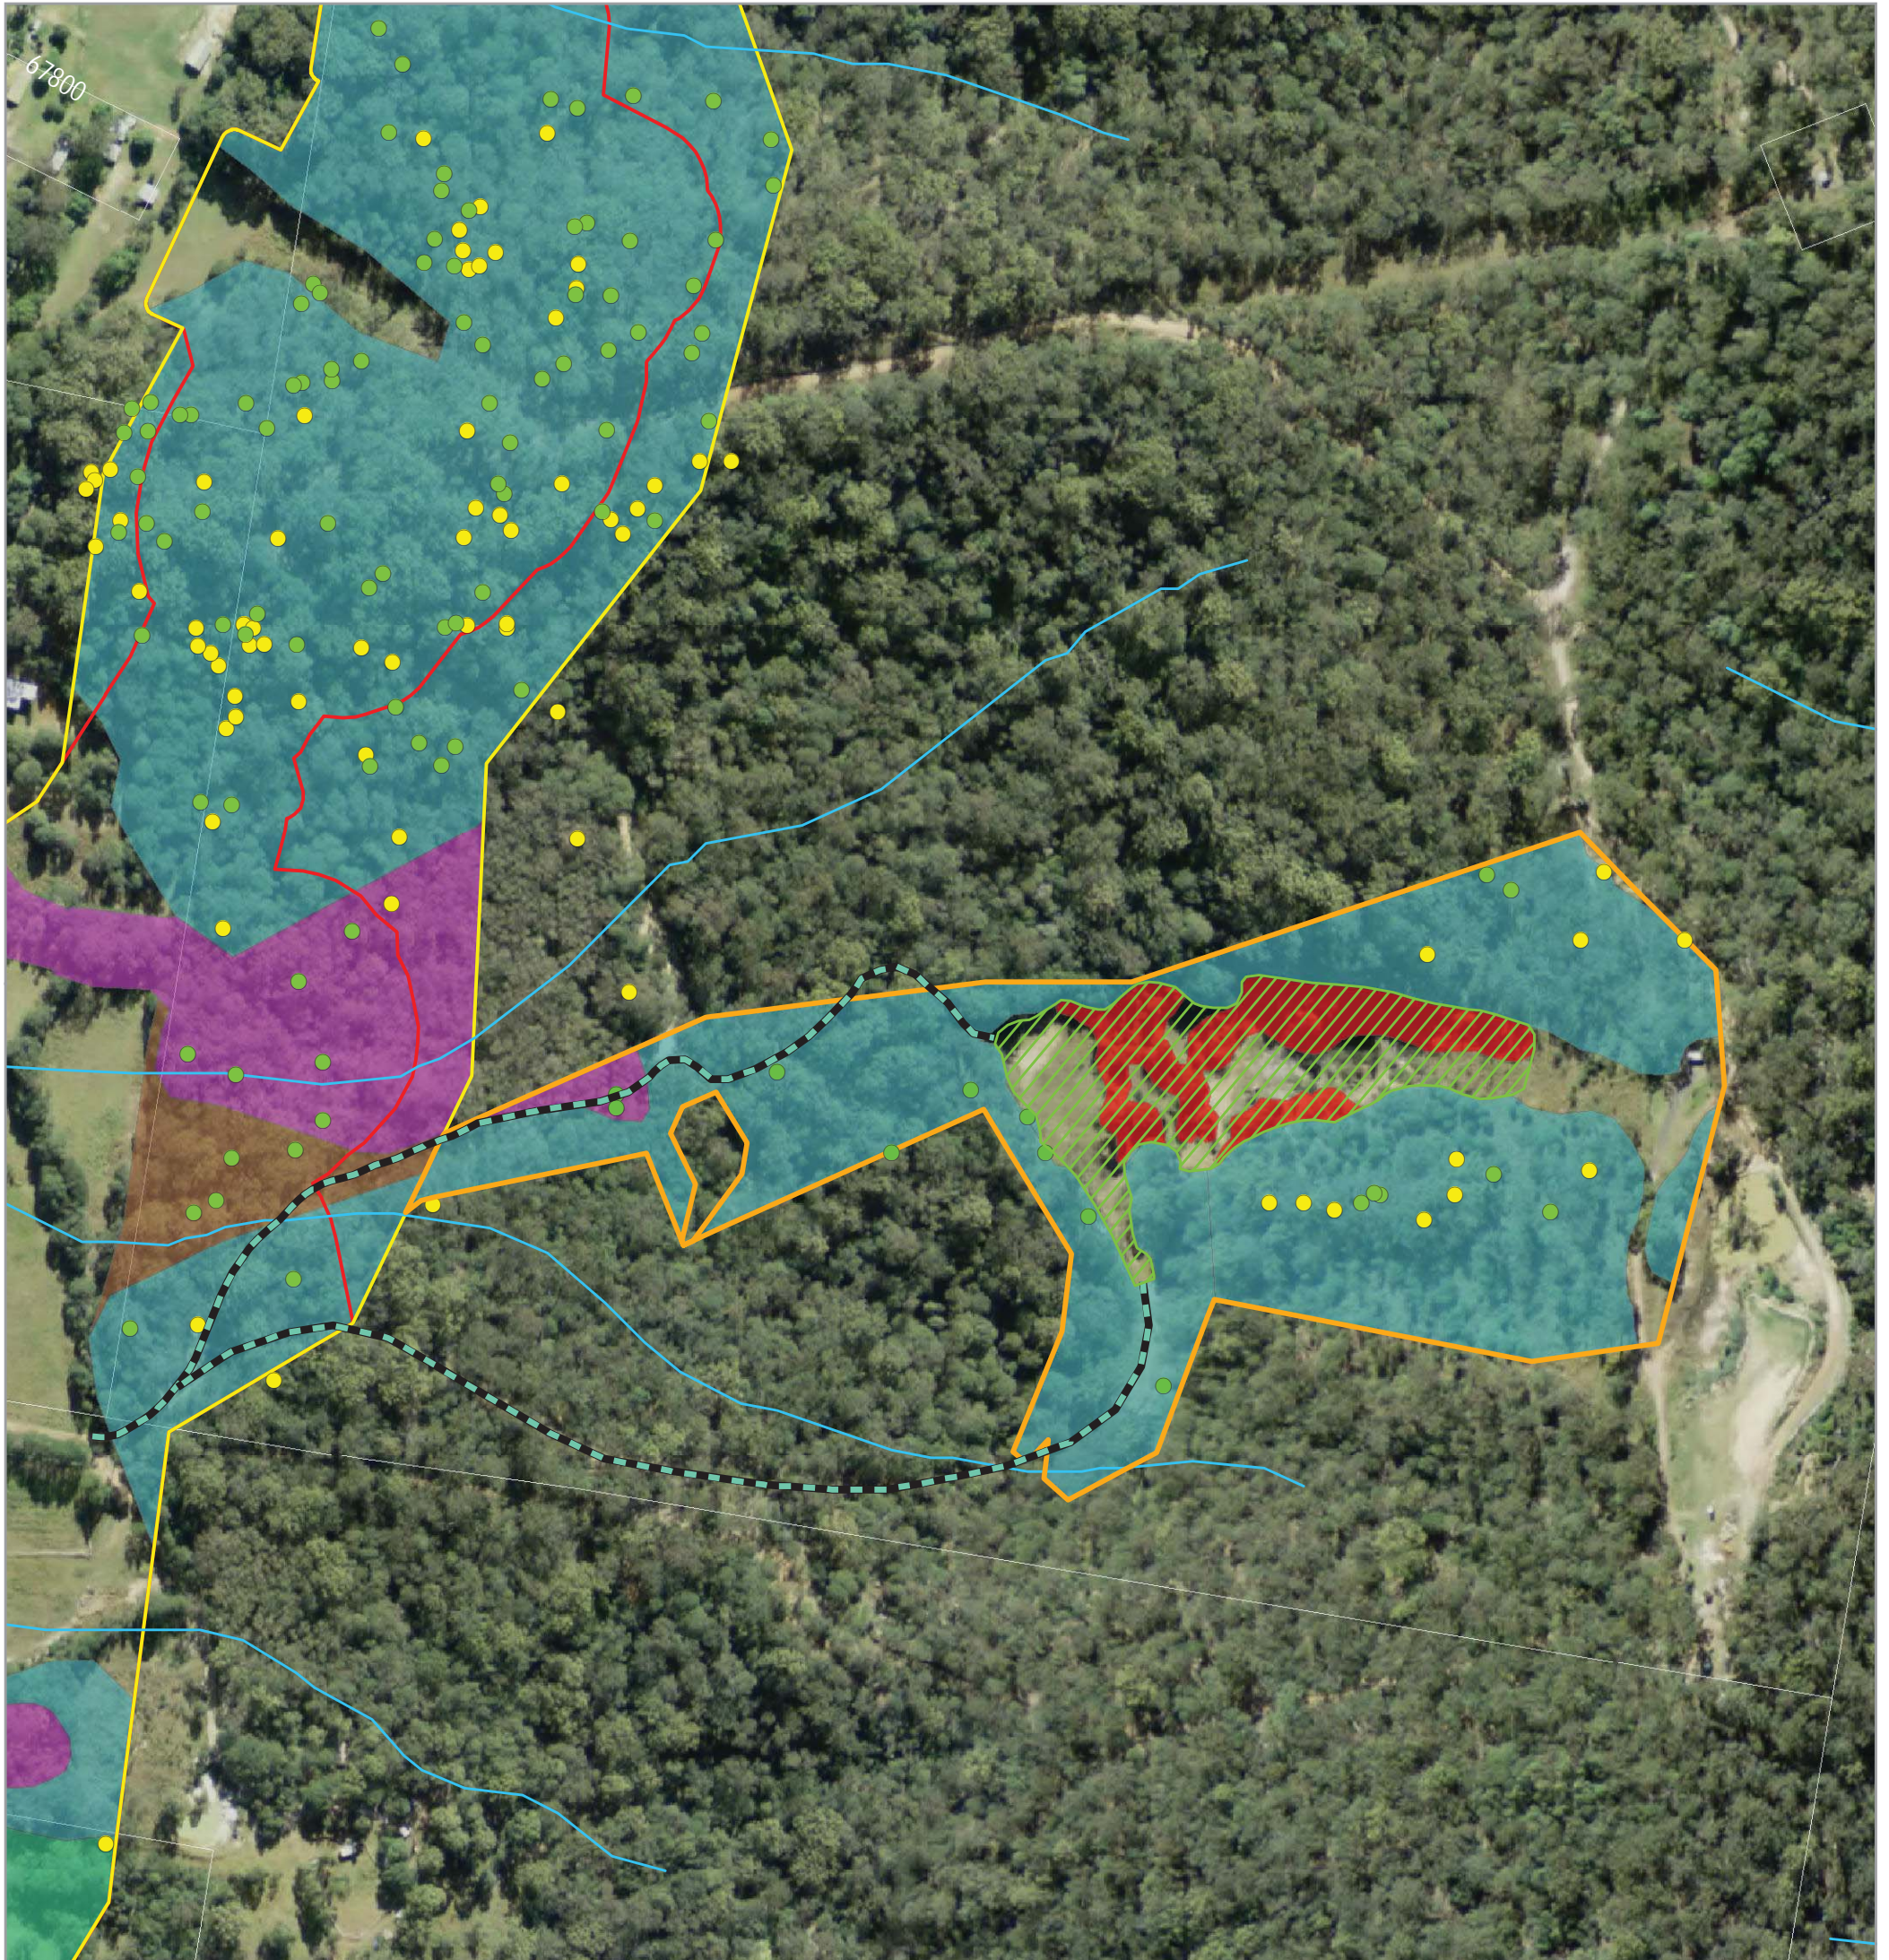
Ecological Constraints

- Habitat tree
- Angophora sp.
- Drainage line
- Tyndale borrow site access track
- Area of low ecological value
- Tyndale borrow site survey area
- EIS/SPIR clearing boundary
- Approved project boundary draft v5 20150610
- Angophora robur shrubby forest and woodland
- EEC - Paperbark swamp forest
- Pink Bloodwood - Tallowood moist open forest
- Re-growth Pink Bloodwood - Tallowood moist open forest
- EEC - Swamp Mahogany swamp forest

Vegetation mapping for the site is included as **Illustration 1**.

- Mature vegetation as defined as occurring outside the mapped polygon of low ecological value (refer to **Illustration 1**).
- Endangered Ecological Communities (EECs) as mapped in **Illustration 1**.
- Habitat trees.

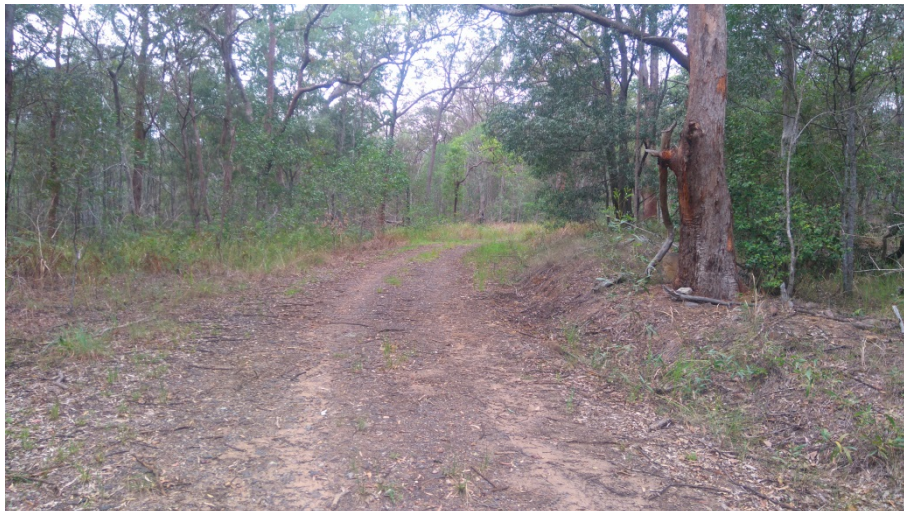
Plate 1 Typical view of existing access track proposed for widening and adjoining Pink Bloodwood-Tallowwood moist open forest

The vegetation adjoining the existing access road proposed for widening comprises the *Biometric* vegetation type: *Pink Bloodwood-Tallowwood moist open forest* (refer to **Illustration 1** and **Plate 1**). It is in moderate to good condition, with localised edge effects and varying density Lantana (*Lantana camara*) infestation. In total 0.822 ha of *Pink Bloodwood-Tallowwood moist open forest* occurs within the assessed access track widening footprint (*note: not all vegetation within the assessed footprint requires removal*).

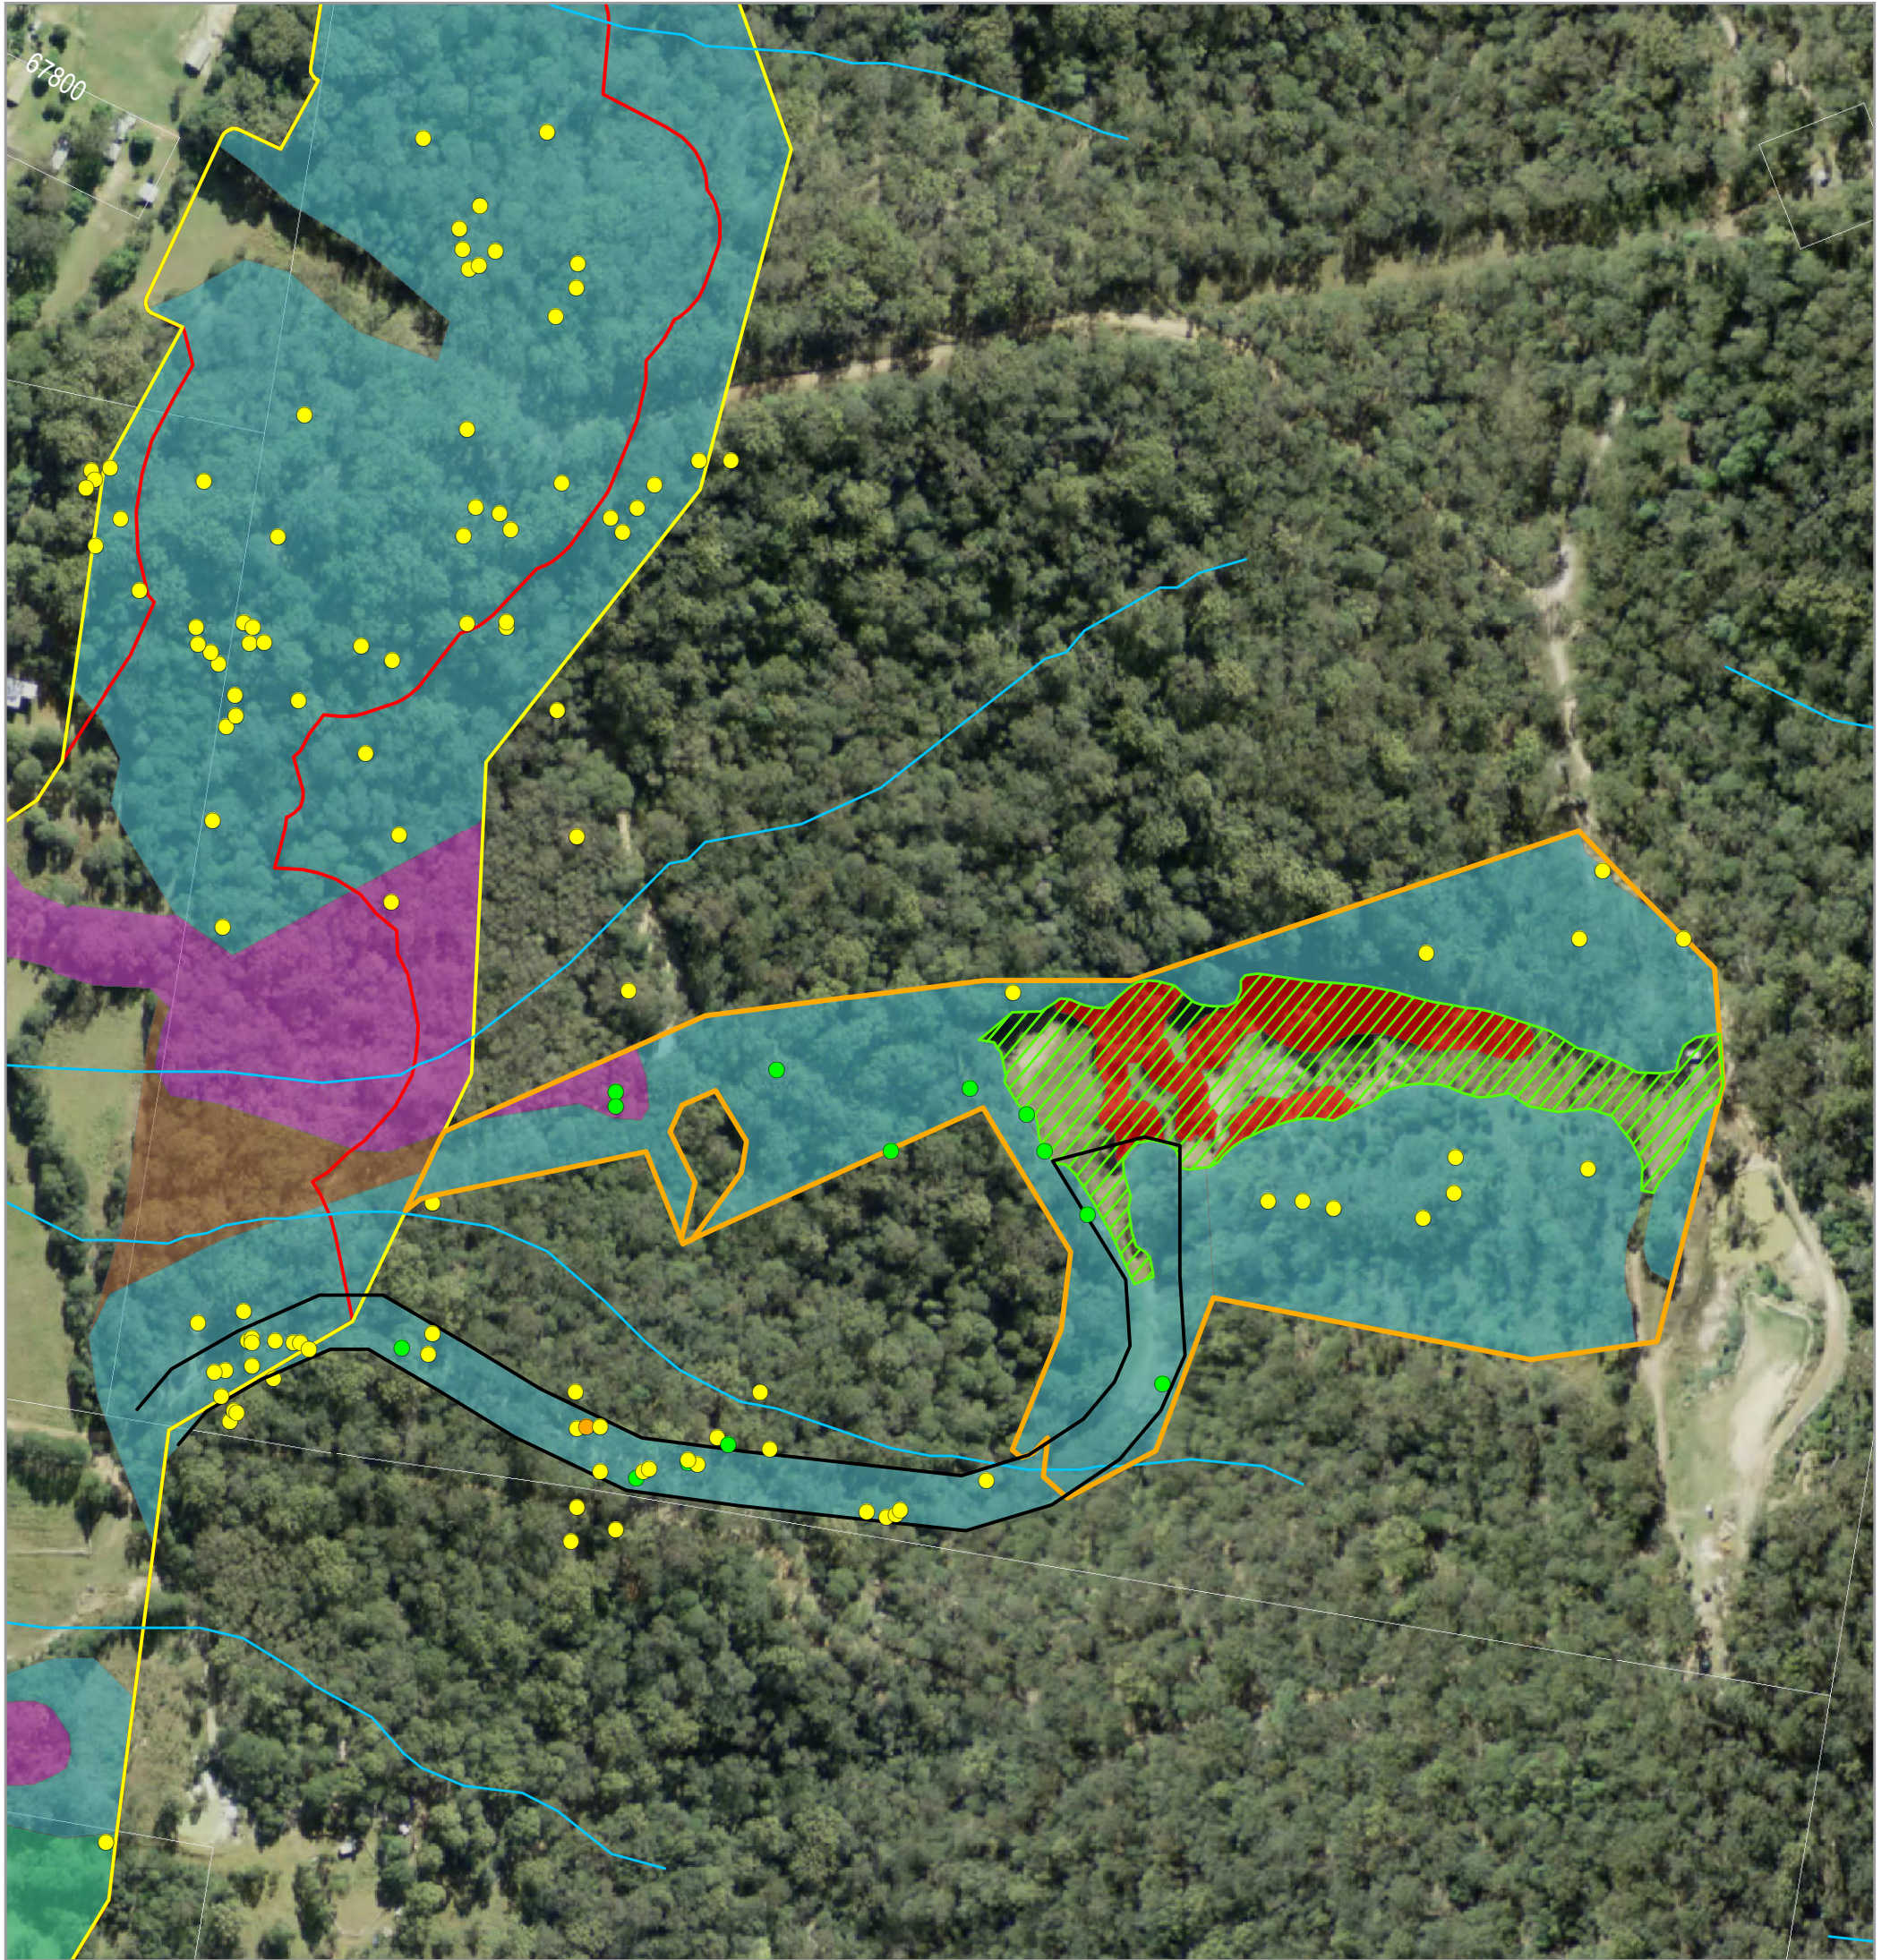
Borrow Site Access Road Constraints Mapping

LEGEND	
	Bush rock for retention or relocation
	Hollow-bearing tree
	Potential Angophora robur
	Drainage line
	Area of low ecological value
	Tyndale borrow site survey area
	EIS/SPIR clearing boundary
	ApprovedProjectBoundary_draft_v8_20151015
	Angophora robur shrubby forest and woodland
	EEC - Paperbark swamp forest
	Pink Bloodwood - Tallowood moist open forest
	Re-growth Pink Bloodwood - Tallowood moist open forest
	EEC - Swamp Mahogany swamp forest

Approximately 25 Sandstone Rough-barked Apple (*Angophora robur*) trees occur within the subject access track widening footprint (refer to **Illustration 1**). These trees are recommended for retention and are marked in the field with red and white flagging tape. No other threatened flora species were detected within the subject access track widening footprint.

- **Hollow-bearing trees:** Four hollow-bearing trees occur within the subject access track widening footprint (refer to **Illustration 1**). These trees have been marked in the field with white spray paint and red and white flagging tape. Hollow-bearing trees provide roosting/ denning/ nesting opportunities for a range of hollow-obligated fauna, including threatened species. These trees are recommended for retention.

- **Bush rock:** A small pile of sandstone bush rock occurs on the edge of the access track (refer to **Illustration 1**). It provides potential shelter and basking sites for reptiles and other small terrestrial fauna. The rocks are recommended for retention or relocation into adjacent retained habitat.

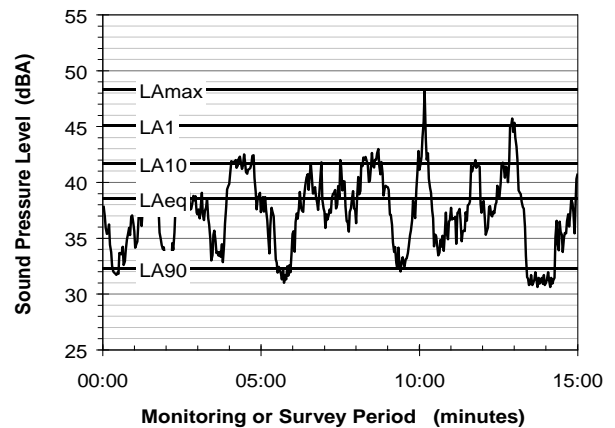
The following figure presents a hypothetical 15 minute noise survey, illustrating various common statistical indices of interest.

- LA1 The noise level exceeded for 1% of the 15 minute interval.
- LA10 The noise level exceeded for 10% of the 15 minute interval. This is commonly referred to as the average maximum noise level.
- LA90 The noise level exceeded for 90% of the sample period. This noise level is described as the average minimum background sound level (in the absence of the source under consideration), or simply the background level.
- LAeq The A-weighted equivalent noise level (basically the average noise level). It is defined as the steady sound level that contains the same amount of acoustical energy as the corresponding time-varying sound.

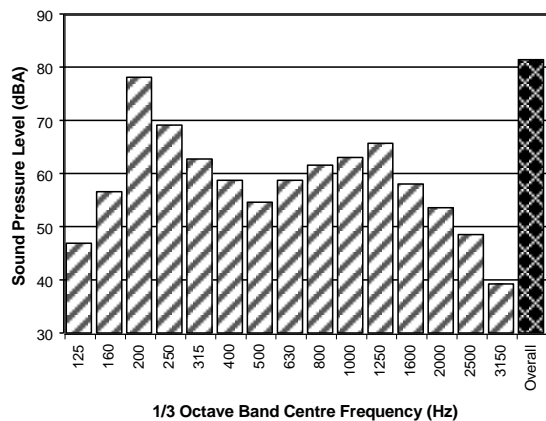
The following figure shows a 1/3 octave band frequency analysis where the noise is dominated by the 200 Hz band. Note that the indicated level of each individual band is less than the overall level, which is the logarithmic sum of the bands.

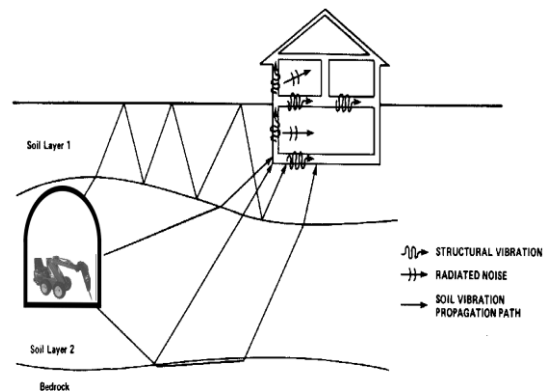
The following figure presents the various paths by which vibration and ground-borne noise may be transmitted between a source and receiver for construction activities occurring within a tunnel.

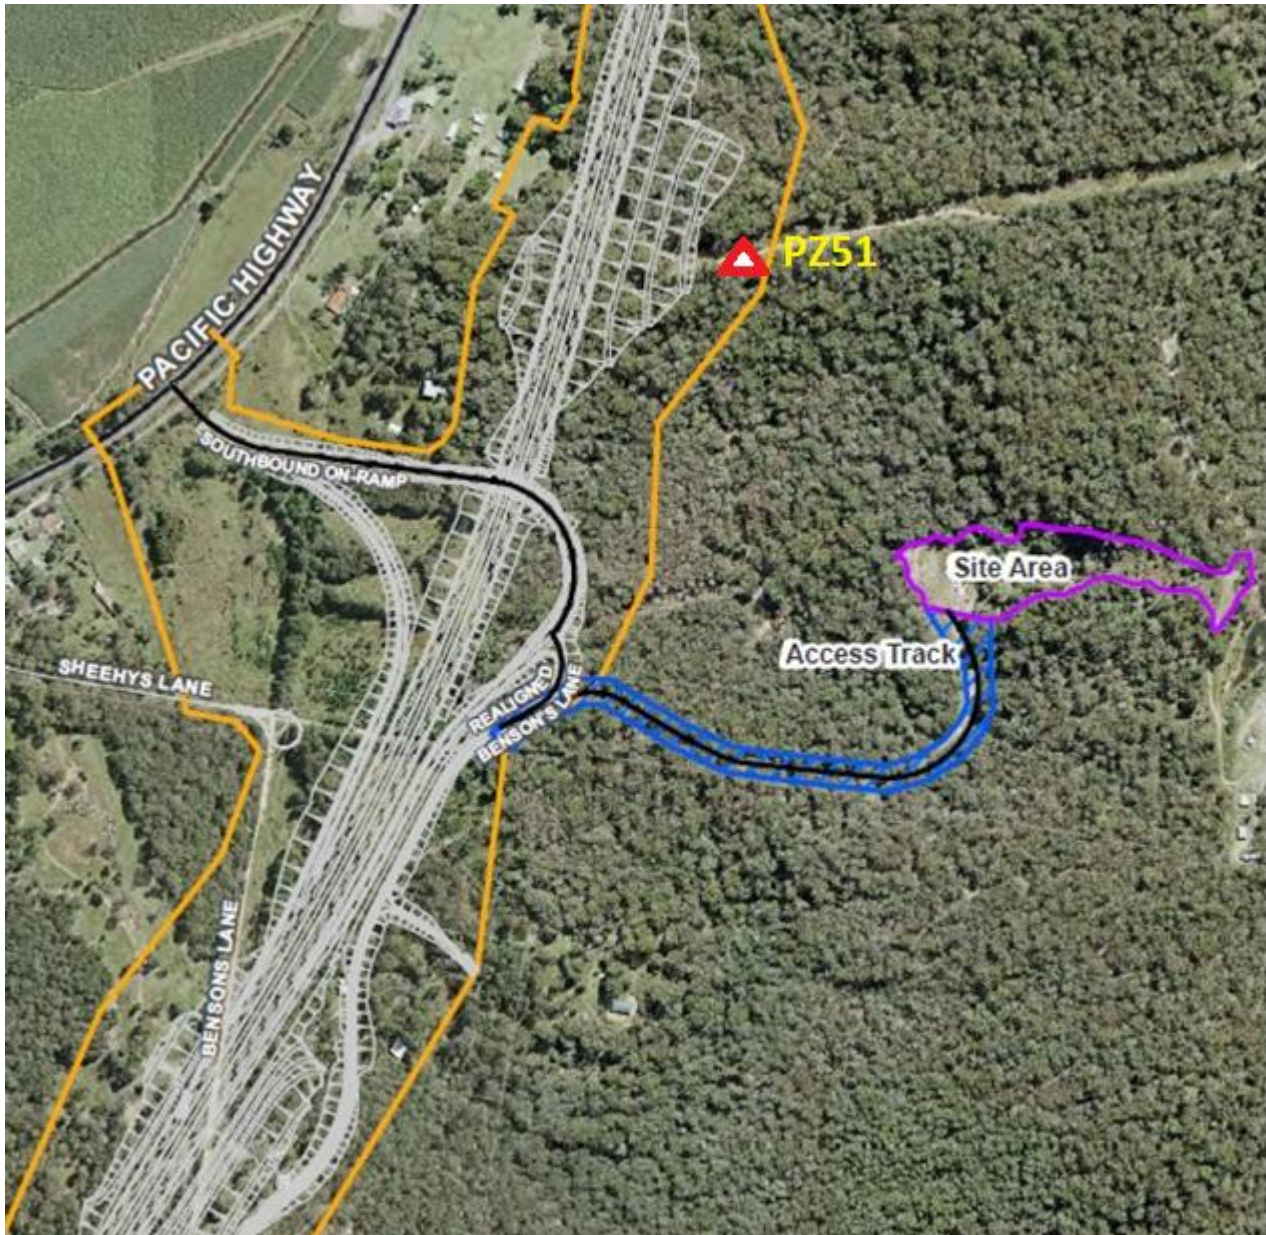
Figure 1 – Location of proposed Tyndale Borrow Site and closest project monitoring well site.

Figure 1 illustrates the location of the closest groundwater monitoring well, PZ51 (Cut C3-31 monitoring), and the Week 44 design. Figure 2 illustrates the borrow pit site layout. The subject

monitoring well was originally not within the footprint of the SPIR design. Due to significant design changes to the southbound on/off ramps, the design footprint has shifted east and conflicts with the position of the monitoring well.

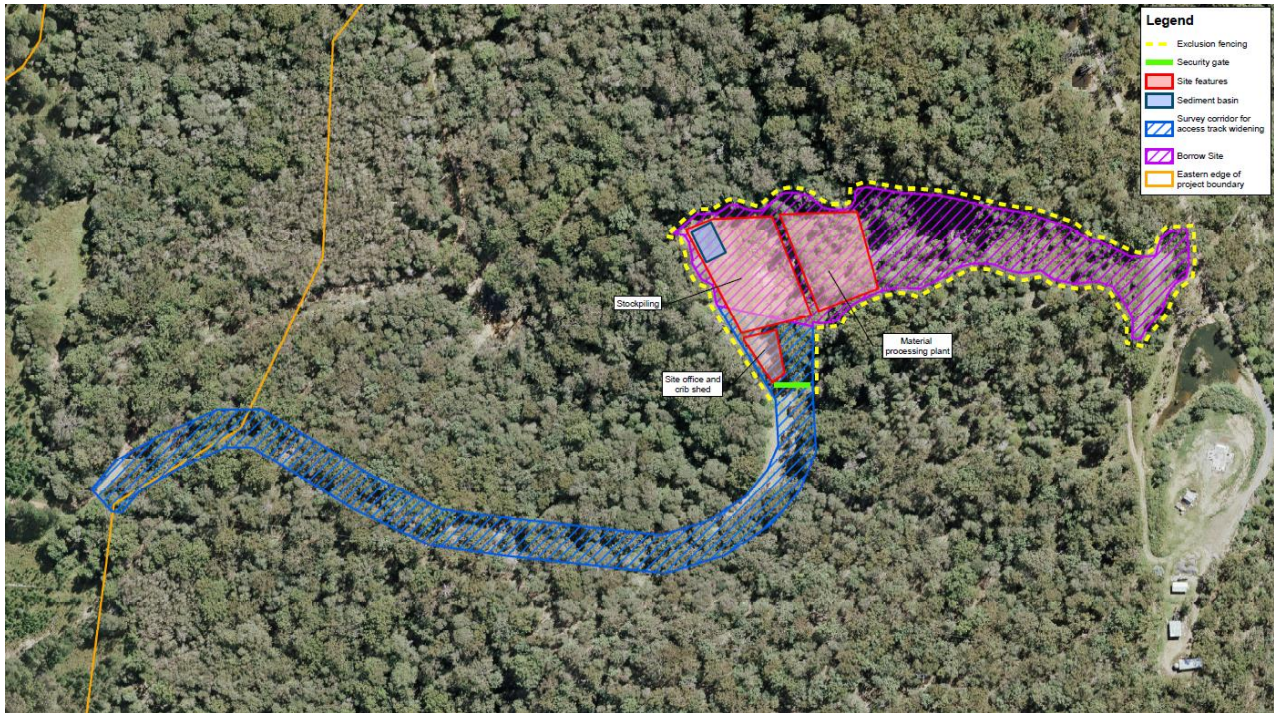
Figure 2 – Layout and extent of the proposed Tyndale Borrow Site

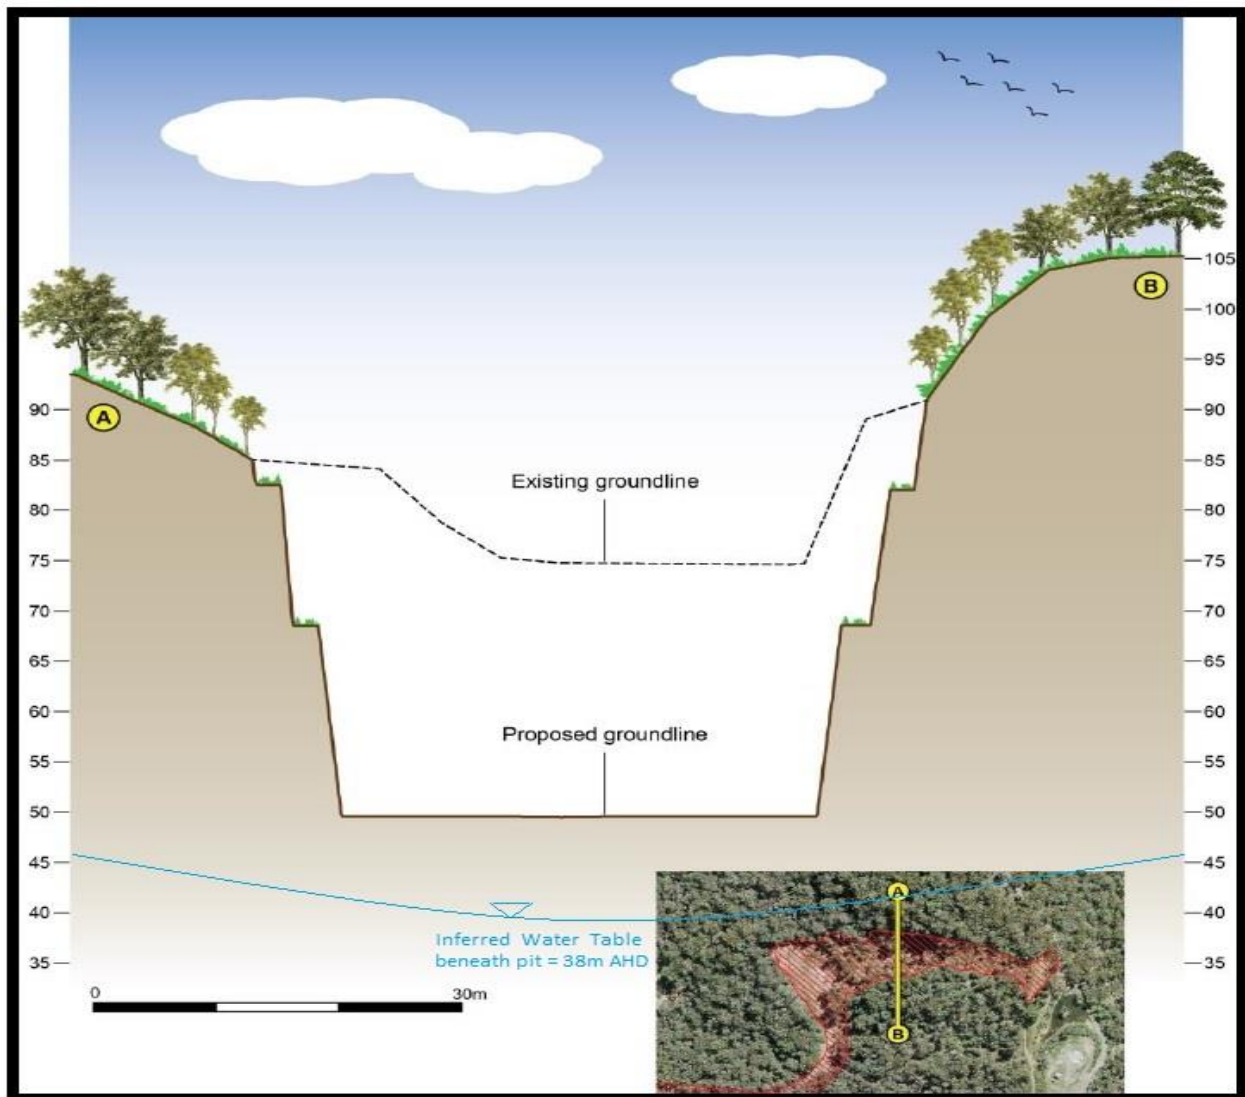
Figure 3 – Conceptual cross section of the proposed Tyndale Borrow Site showing the inferred regional water table level profile

The proposed excavation works to be carried out at the borrow site is not anticipated to intercept the deep bedrock groundwater table due to its elevation (as illustrated in Figure 3) within the KCS topography. That is, the floor of the final void will not penetrate the regional water table, and as such no regional impact from the works is foreseen.

The presence of the pit may enhance recharge to the regional groundwater system marginally, but this will be limited due to the low permeability of the bedrock mass, and mild mounding of the local groundwater table beneath the immediate footprint of the pit might occur. The limited mass flux of infiltrating rainfall water is unlikely to adversely impact the water quality of the regional groundwater for similar reasons. The limited density and tightness of the fracture flow pathways would effectively filter suspended solids (turbidity) related quarry activities, the primary source of pollutants associated with quarrying.

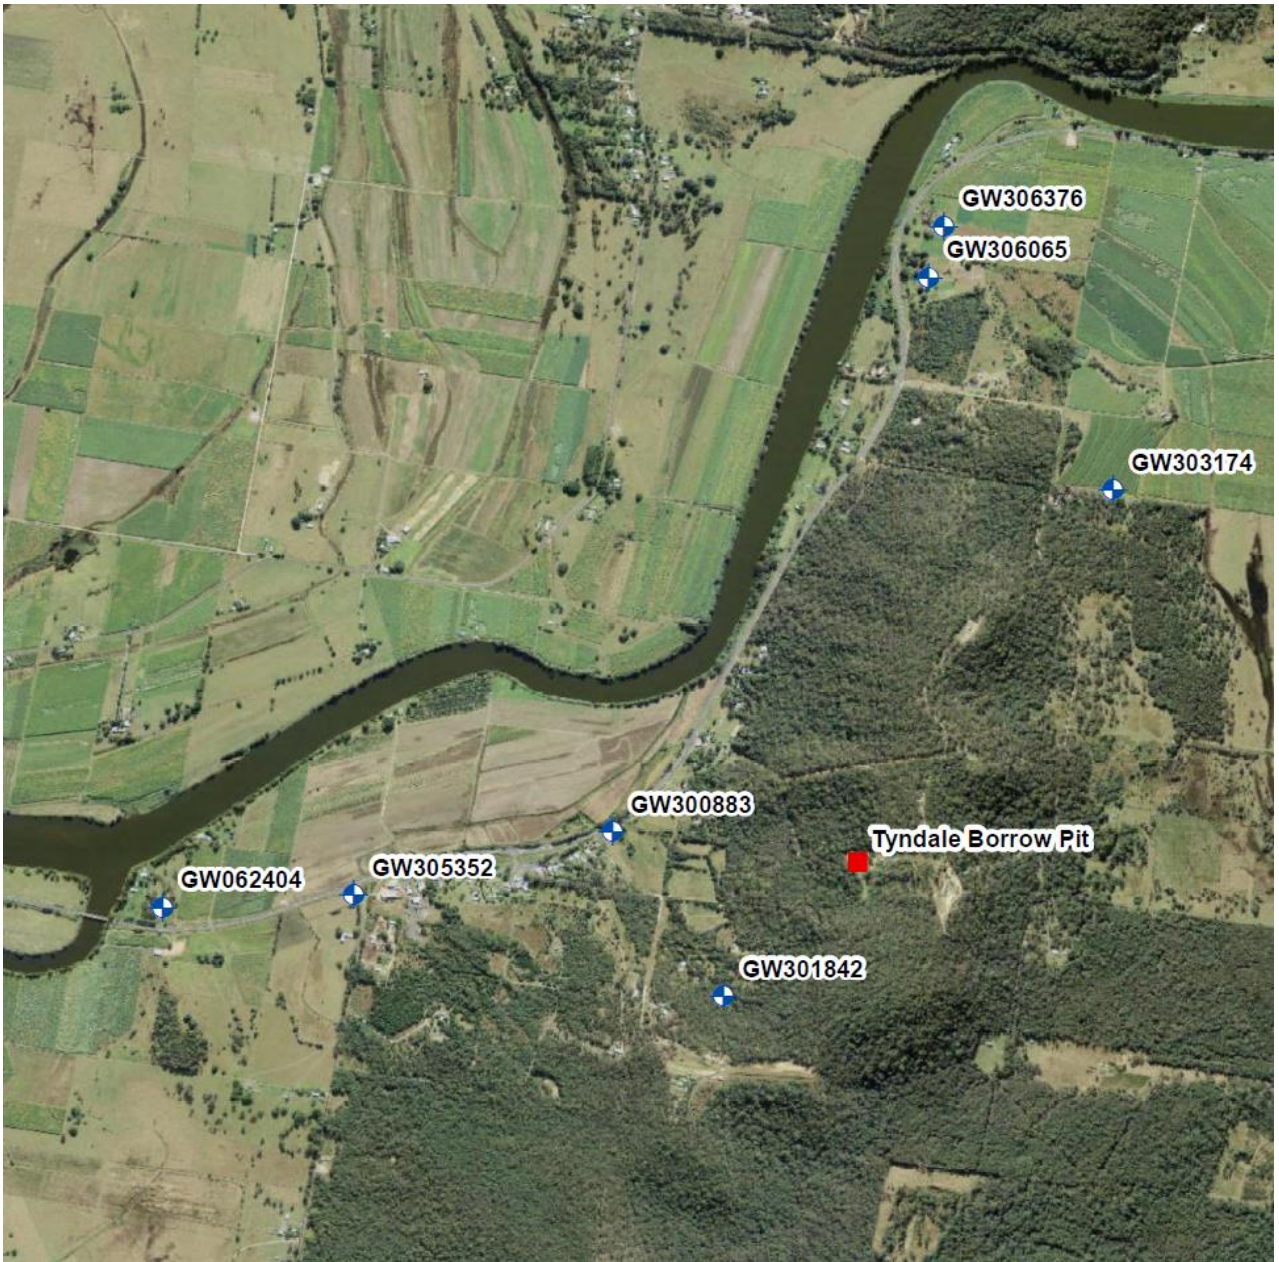
Figure B-1 – Location of existing water bore users within 2.5km of the borrow pit site

Note: Water bearing zones slotted.

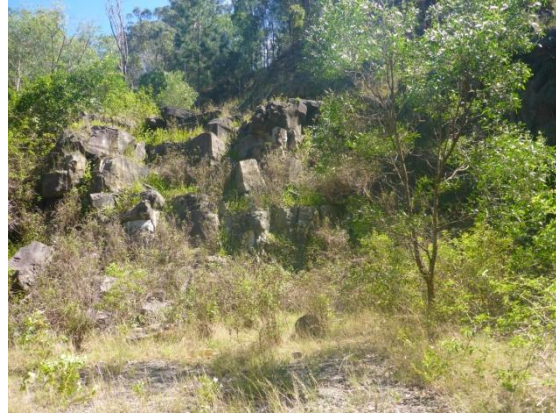
Plate 2: View E looking at the two tiers of the former quarry

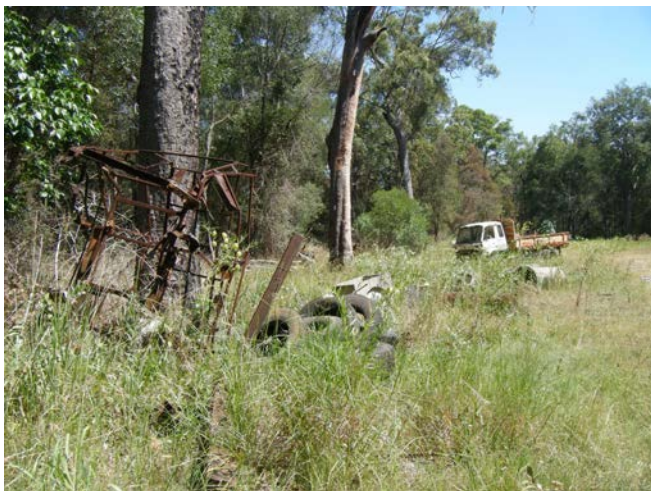
Figure 3.1 : View west showing the rubbish dumped in the clearing at the centre of A8 Tyndale/A6 Jacko's Quarry

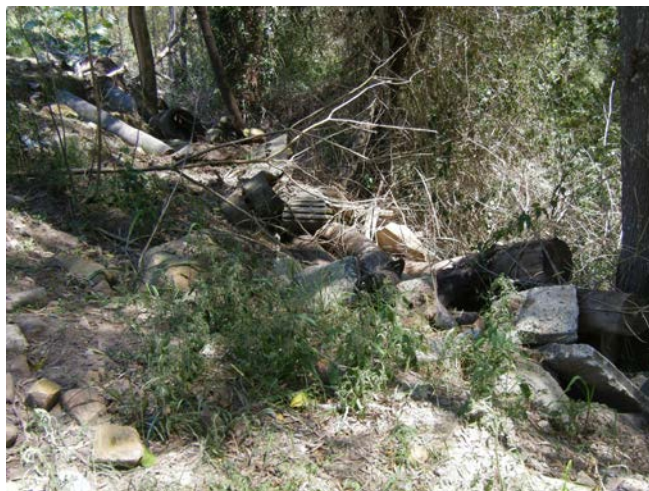
Figure 3.2 : View south showing the rubbish dumped at the clearing at the centre of A8 Tyndale/A6 Jacko's Quarry

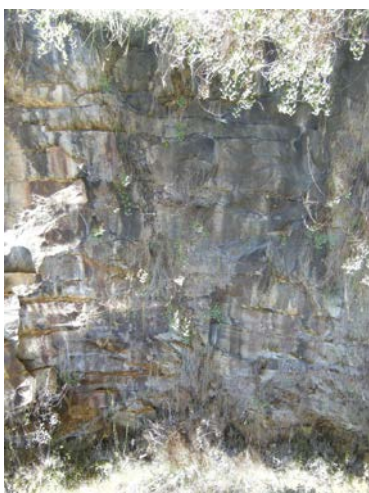
Figure 3.3 : View south-east showing the quarry wall in the north-eastern clearing of A8 Tyndale/A6 Jacko's Quarry

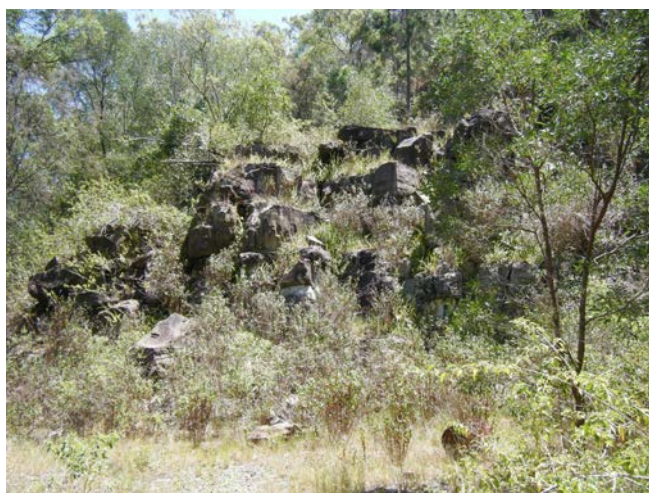
Figure 3.4 : View north-west showing the overgrown wall in the north-eastern clearing of A8 Tyndale/A6 Jacko's Quarry

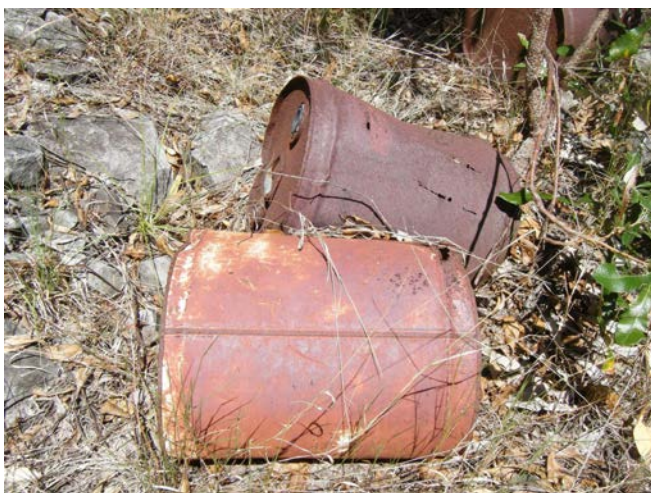
Figure 3.5 : Oil drums in the north-eastern clearing of A8 Tyndale/A6 Jacko's Quarry

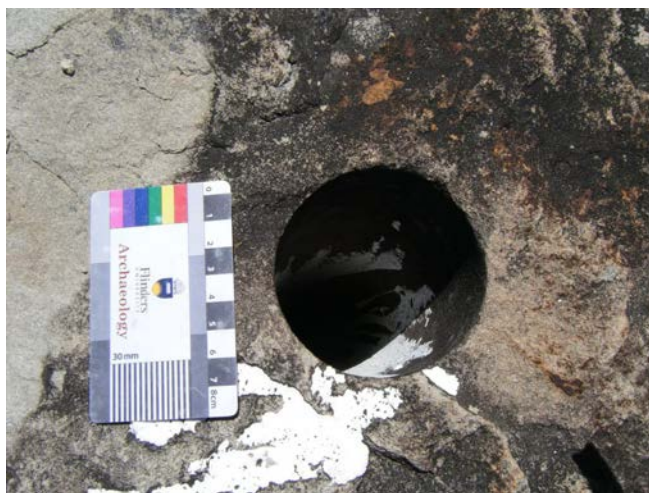
Figure 3.6 : Small circular hole in the rock surface in north-eastern clearing of A8 Tyndale/A6 Jacko's Quarry
