Appendix B10.1

Tyndale Borrow Site Management Plan

Woolgoolga to Ballina (sections 3 to 11)

Pacific Highway Upgrade

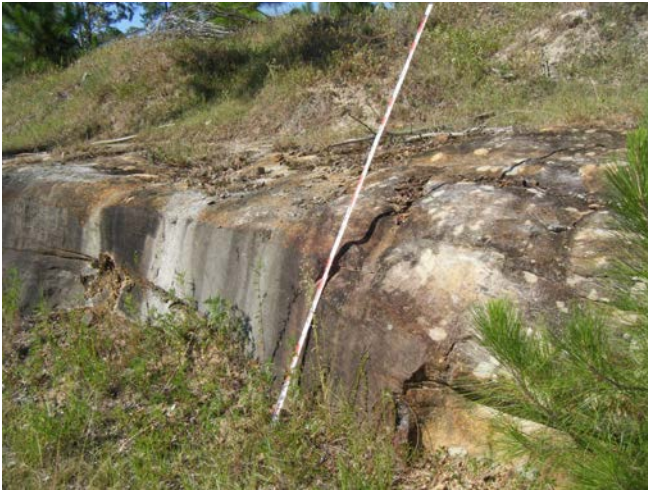
Figure 3.7 : View south towards natural rock terrace in cleared area of B6 Benson's Lane

B6 Benson's Lane ancillary area is located on the side of a hill. The hill is very steep with natural rock terraces on the north-eastern side. The hill slopes gently towards the road in the north. The treed area is very steeply inclined; with narrow, irregular, natural rock terraces present (Figure 3.7). There are also natural boulders present in the area. The cleared area is located on two wide terraces and has juvenile pine trees starting to grow on part of it (Figure 3.8). There is also rubbish dumped in piles around the site, including; broken concrete roof tiles (Figure 3.9), concrete pipes (Figure 3.10) and a large, corroded metal chain (Figure 3.11).

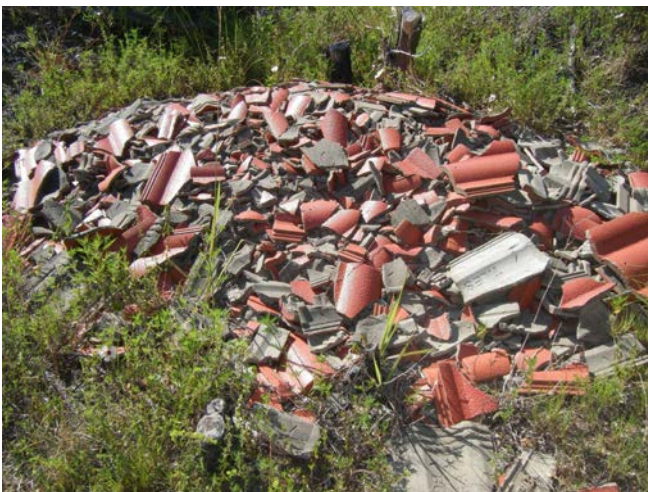
Figure 3.9 : View south-east towards a pile of broken cement roof tiles at B6 Benson's Lane

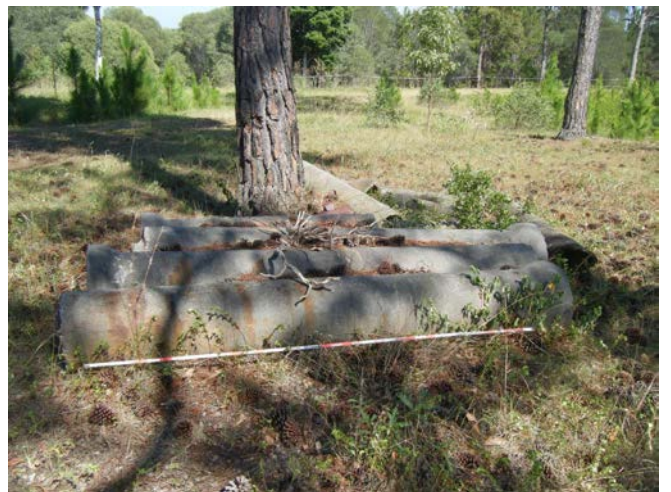
Figure 3.10 : View west showing the cement pipes at B6 Benson's Lane

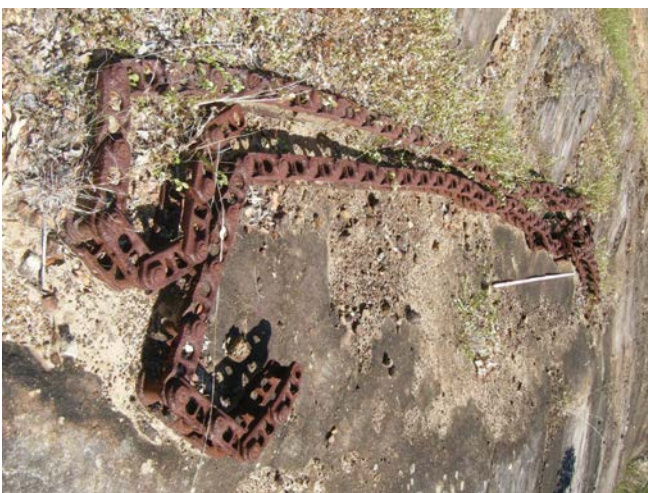
Figure 3.11 : View north showing the large, corroded metal chain at B6 Benson's Lane

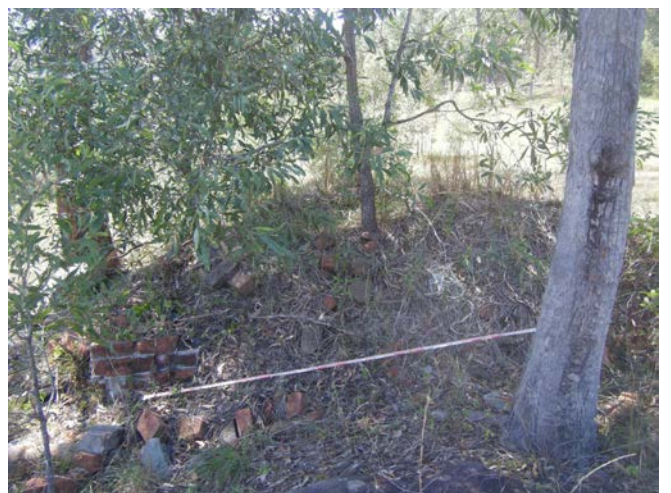
Figure 3.12 : View south-east showing the pile of bricks at B6 Benson's Lane

There is also a mounded area, approximately 4 m by 3 m in size, immediately to the south of the ancillary area, approximately 5 m outside the ancillary area boundary. The mound is made from bricks and leaf litter, with a young tree growing through the centre of it (Figure 3.12 and Figure 3.13). The bricks have a frog on one side – a small rectangle in the centre of the face. They are reasonably uniform in size and are composed of a red-orange material. The edges and corners of the bricks are slightly rounded. There is a group of bricks joined together with mortar (three courses high and three wide). Some of the other bricks have traces of mortar. The following artefacts were also identified on the mound:

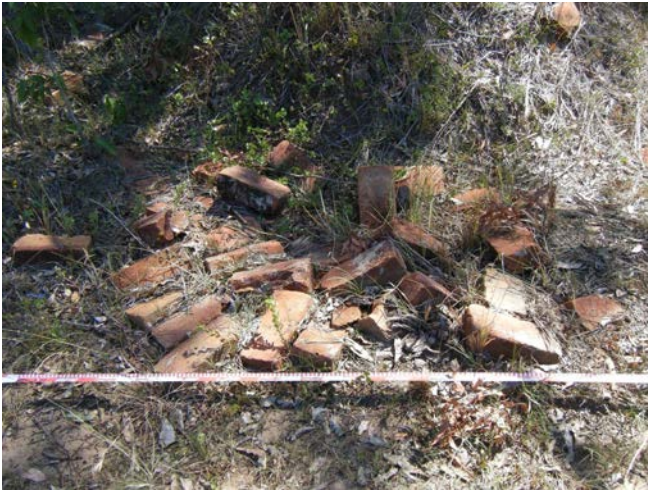
Figure 3.13 : Scatter of bricks immediately south of the pile of bricks at B6 Benson's Lane

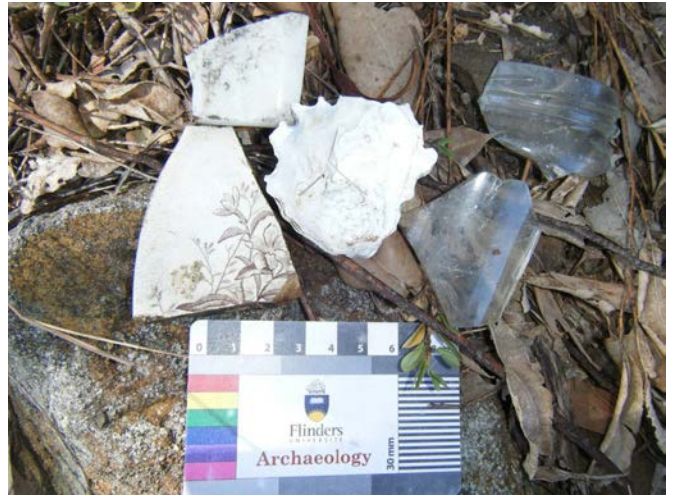
Figure 3.14 : Artefacts present in pile of bricks at B6 Benson's Lane

- Two pieces of clear glass (including a screw top rim piece) (Figure 3.14)
- Two pieces of white, earthenware ceramic (one with a transfer print floral pattern) (Figure 3.14)
- Half an oyster shell (Figure 3.14)
- A green, flat, metal circular object (possibly a container lid) (Figure 3.15).

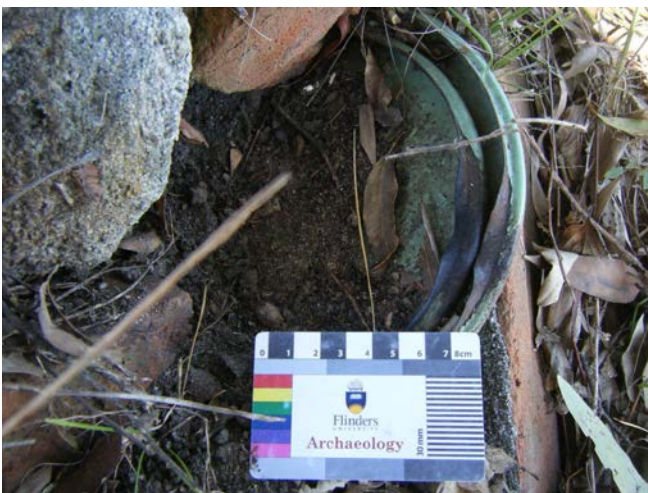
Figure 3.15 : Green metal circler object located in the pile of bricks at B6 Benson's Lane
