Appendix B10.4

Gibsons Borrow Site Management Plan

Woolgoolga to Ballina (sections 3 to 11)

Pacific Highway Upgrade

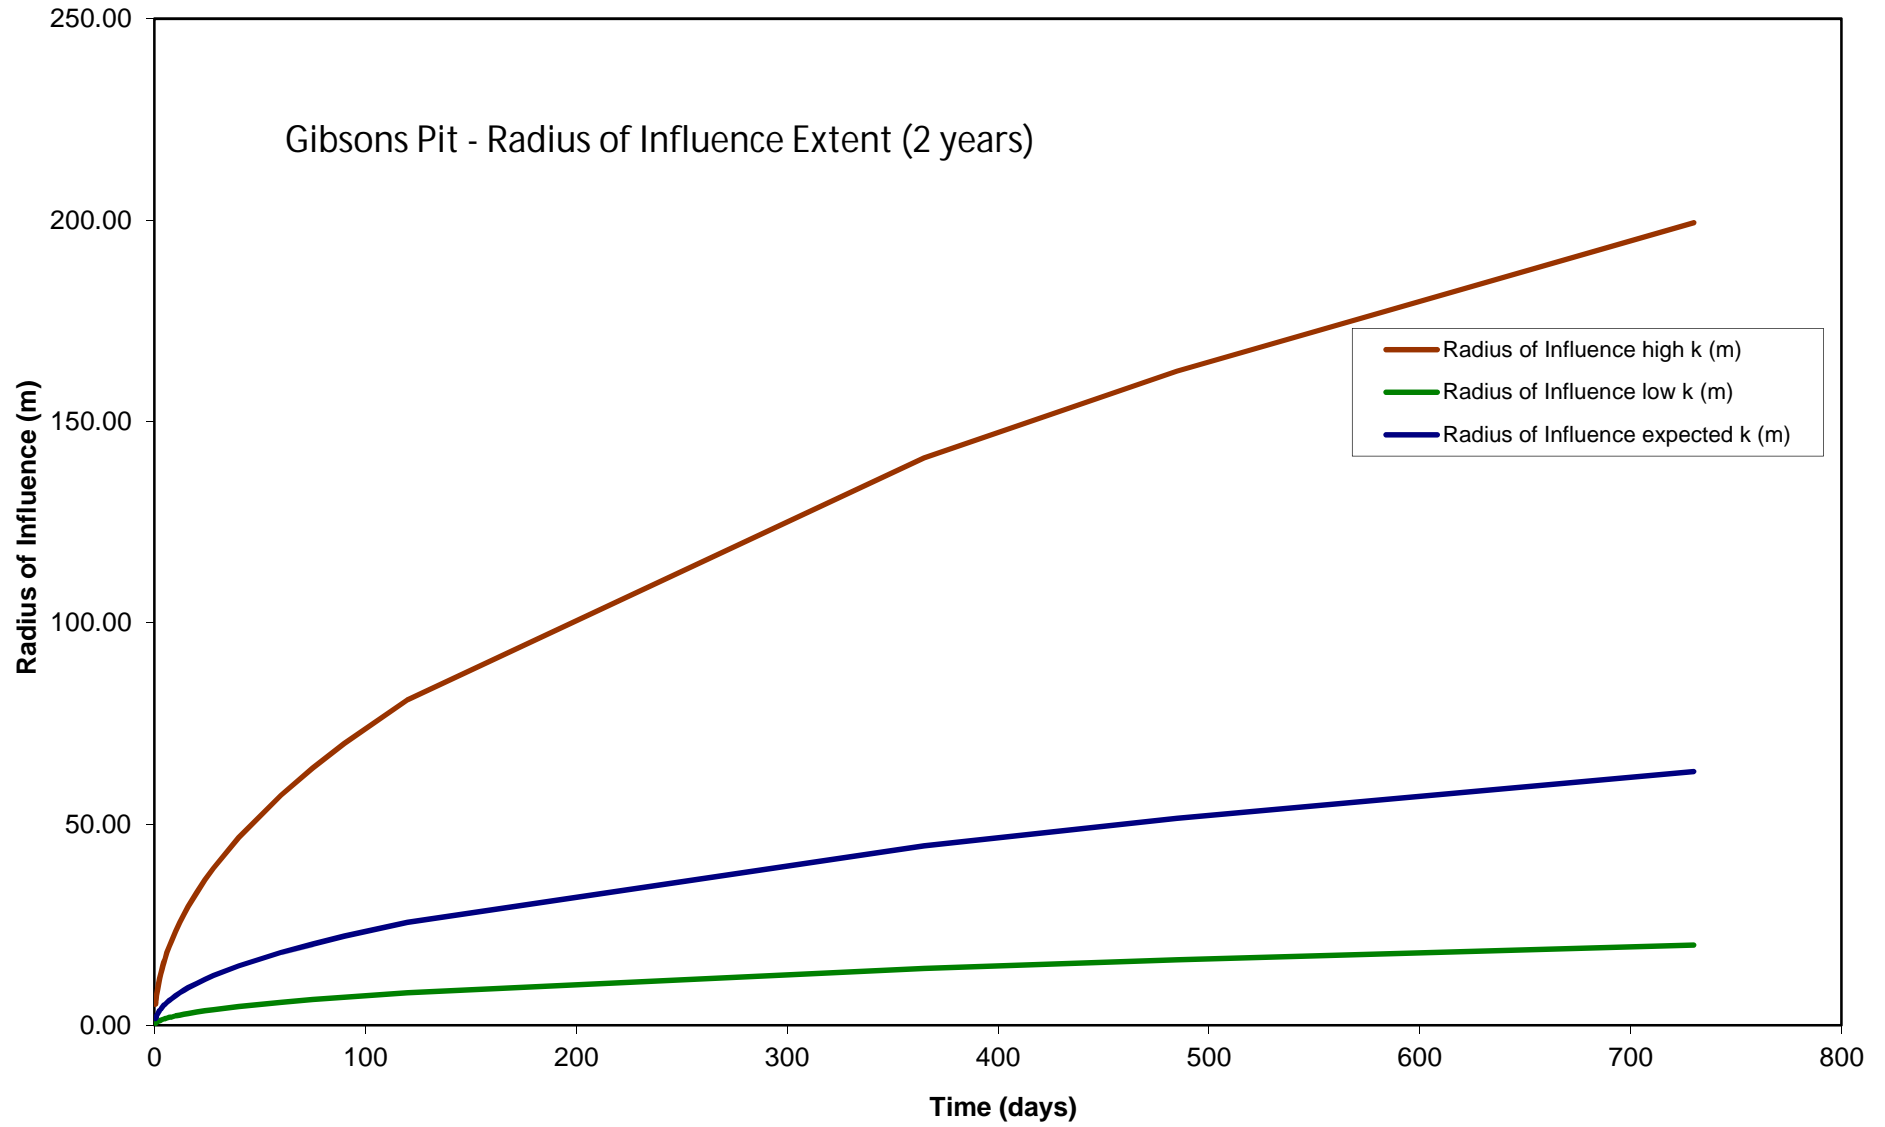
Gibsons Pit - Radius of Influence Extent (2 years)

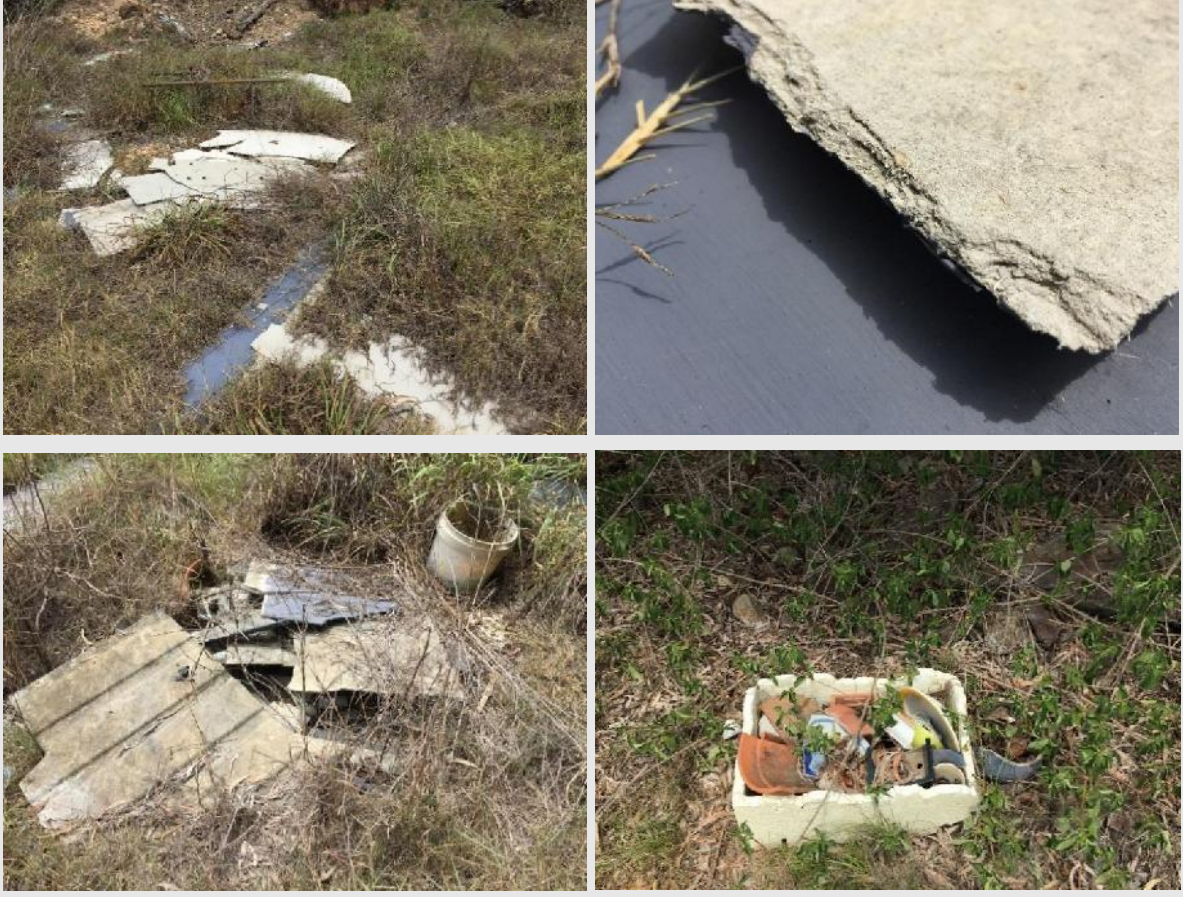
Typical example of stockpiled quarry material observed at Gibsons Quarry along Old Bagotville Road.	2

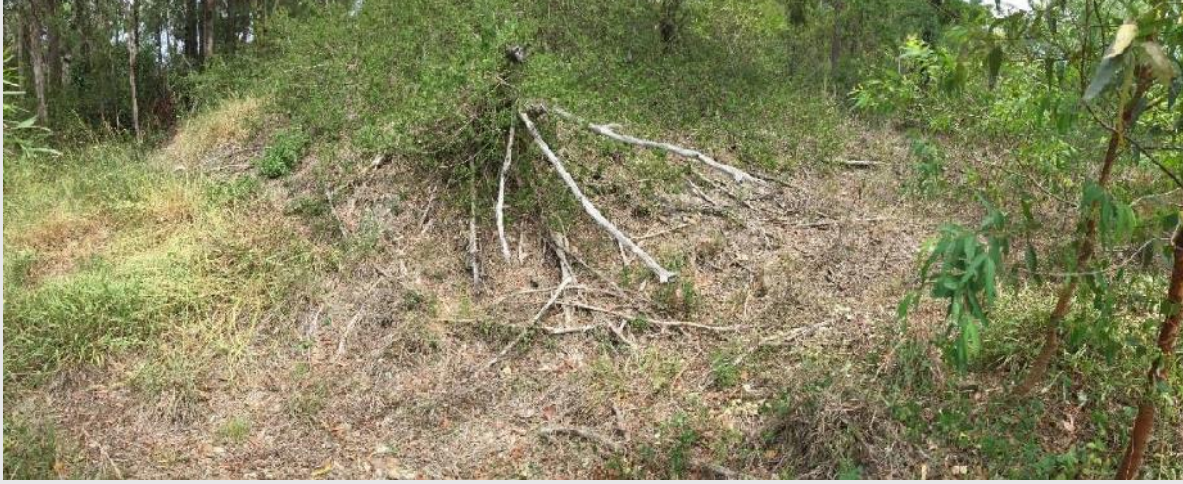
The centre of Gibsons Quarry, showing the cut faces and stockpiles in the background.	3a, 3b

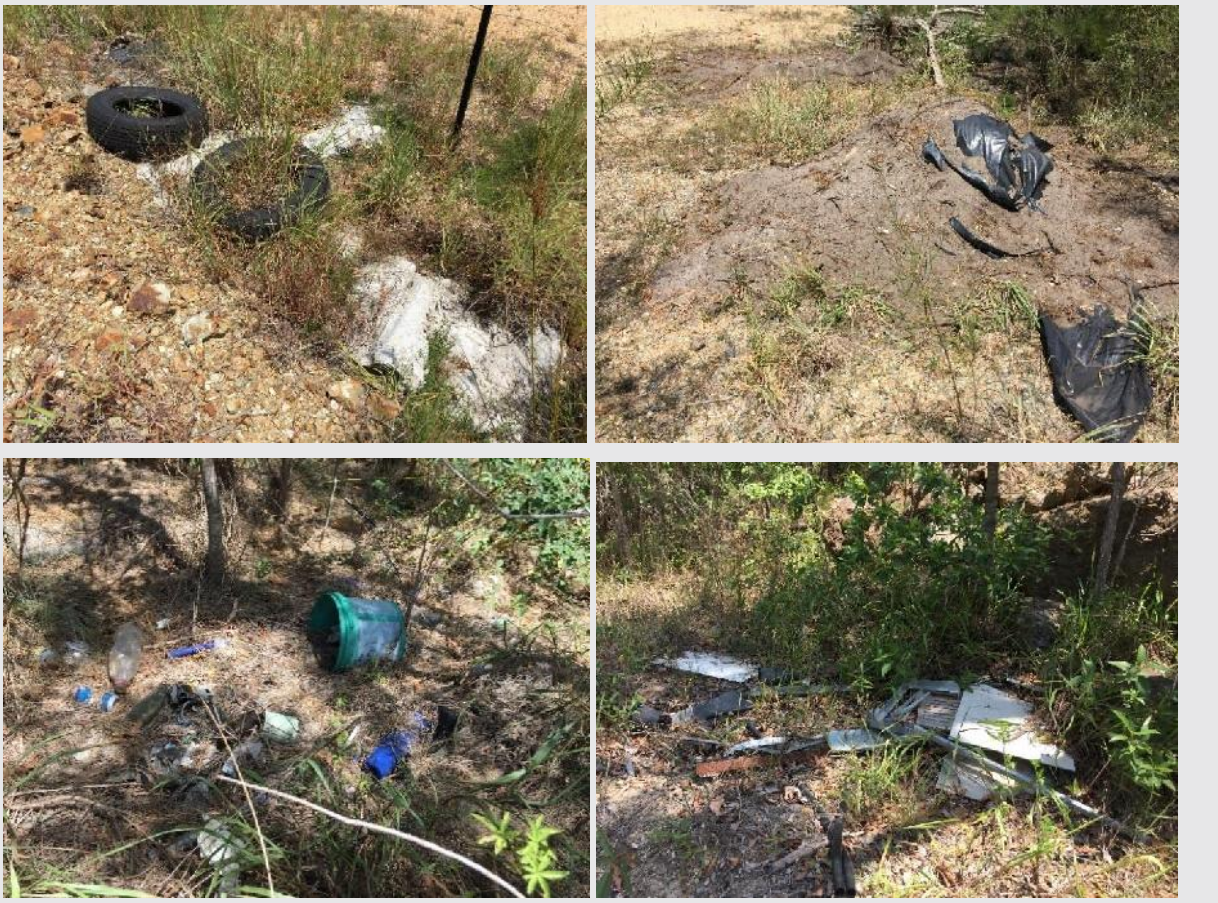
<p>Dumped fibro, potentially ACM located on the southern boundary of Gibsons Quarry.</p>	<p>7</p>

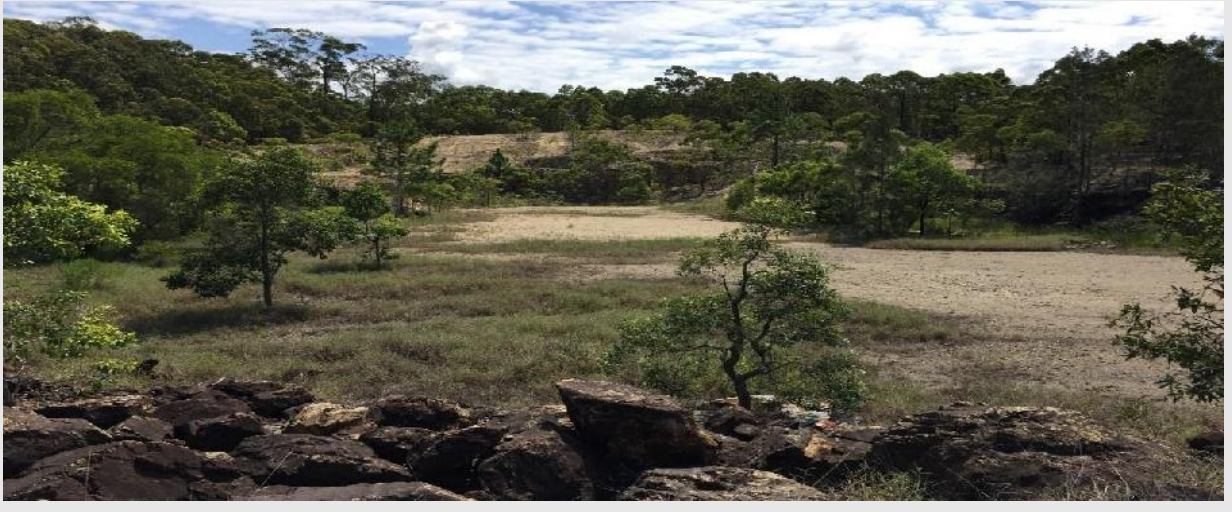
Rock stockpiles were located near the entrance of Jali Quarry, along with rusted drums and metal.	20

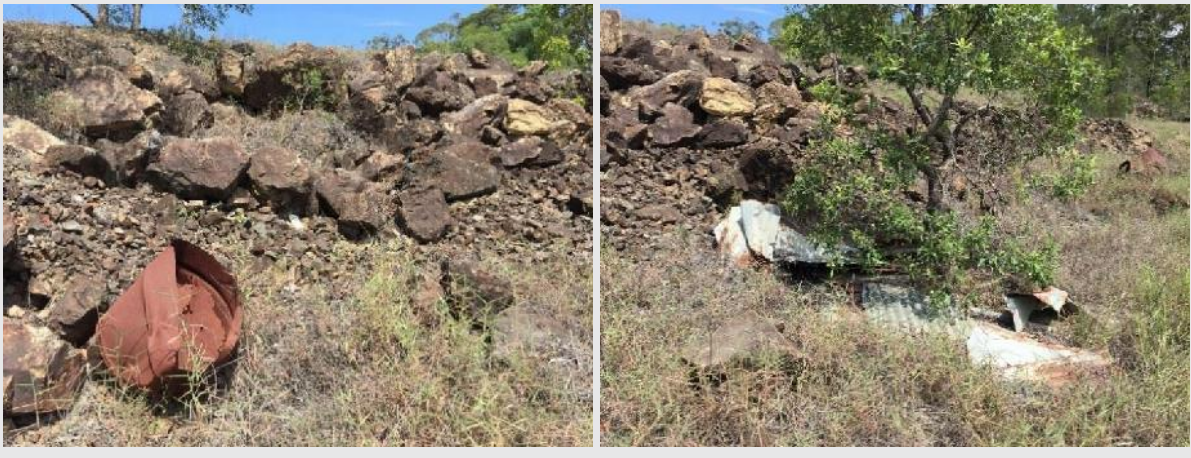
Marshy areas were located in the central and northern portions of Jali Quarry, indicating that the area has not been used for quarrying operations in some time. The vegetation appeared healthy.	21, 22	 
Numerous stockpiles of excavated material were located along the northern and southern portions of Jali Quarry. No evidence of contamination was observed.	23a, 23b, 23c, 23d

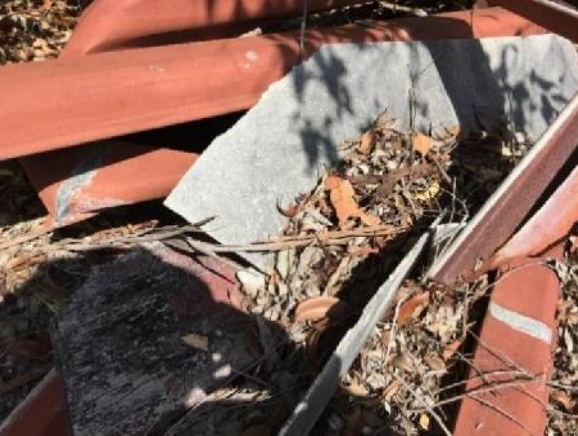
A stockpile containing metal and fibro (potential ACM) was located in the western portion of Jali Quarry.	24
