Microbat Management Plan Sections 3 to 11

**Woolgoolga to Ballina Pacific Highway
upgrade**

April 2015

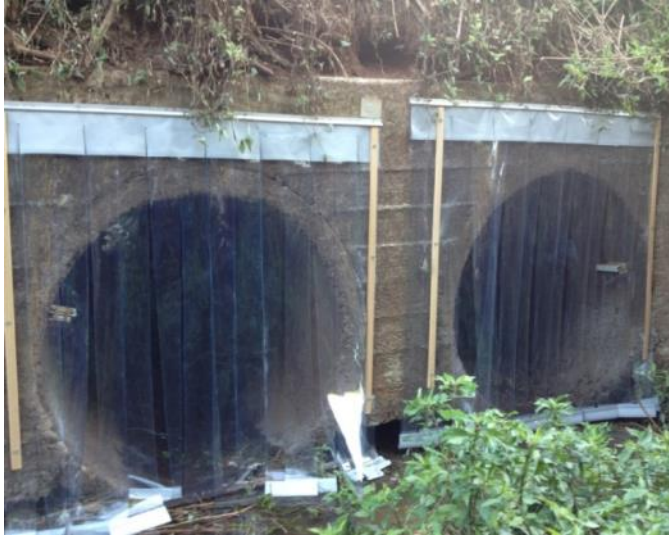
Plate 3.1 Plastic sheeting at Binna Burra
(Source: V Silver)

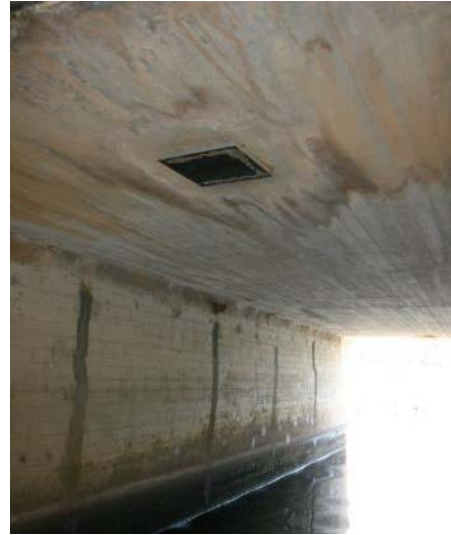
Plate 3.2 Plywood blocking a lift hole at Halfway Creek culvert (Source: V Silver)

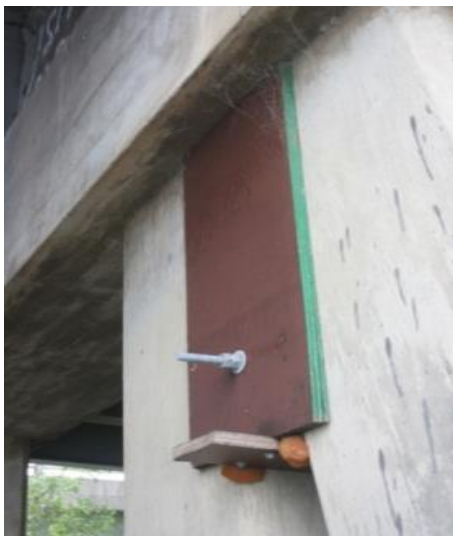
Plate 3.3 Plywood, liquid nails and expandable foam beneath Mororo Bridge
(Source: D Andrighetto)

Plywood screwed into the concrete is an effective way of excluding bats from large gaps or those that are along a straight surface such as within a RCBC or bridge (refer to **Plate 3.3**). Plywood needs to be marine grade or form ply which have smooth surfaces preventing microbats from holding on and do not warp following inundation by water. This method can be used in conjunction with gap filler and is best utilised in areas where the size of the gap exceeds the working limit of the gap filler (refer to **Plate 3.4**). Securing the plywood with adhesive (ie. liquid nails) has been found to be ineffective due to the weight of the plywood and the time needed for the adhesive to set.

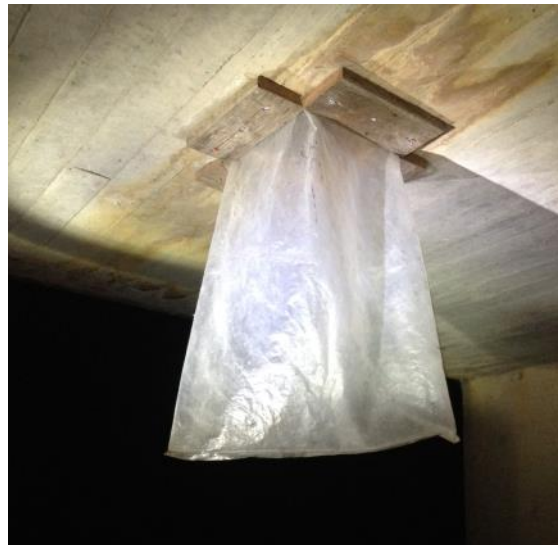
Plate 3.4 One way flap secured with timber at Halfway Creek culvert Source: V Silver)

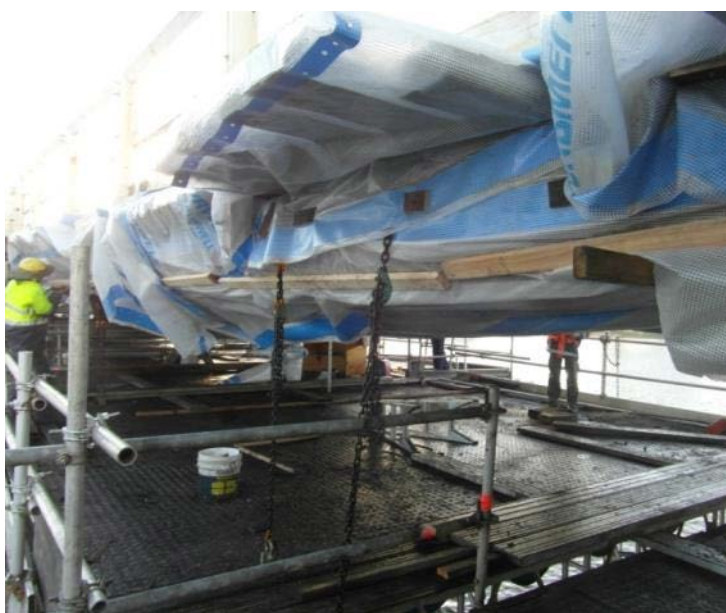
Plate 3.5 Exclusion Option – Plastic wrap bridge (Source: A Lloyd)

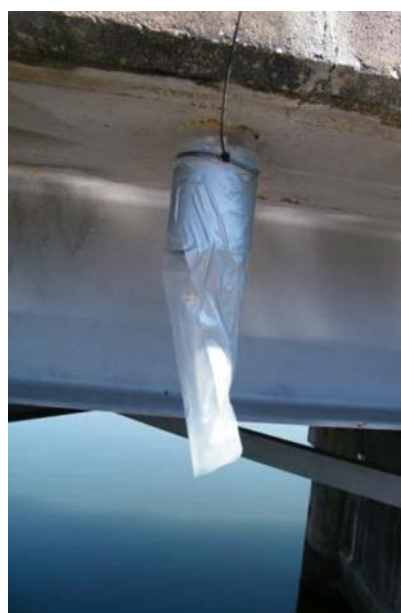
Plate 3.6 Exclusion – Plastic over scuppers (Source: D Andrighetto)

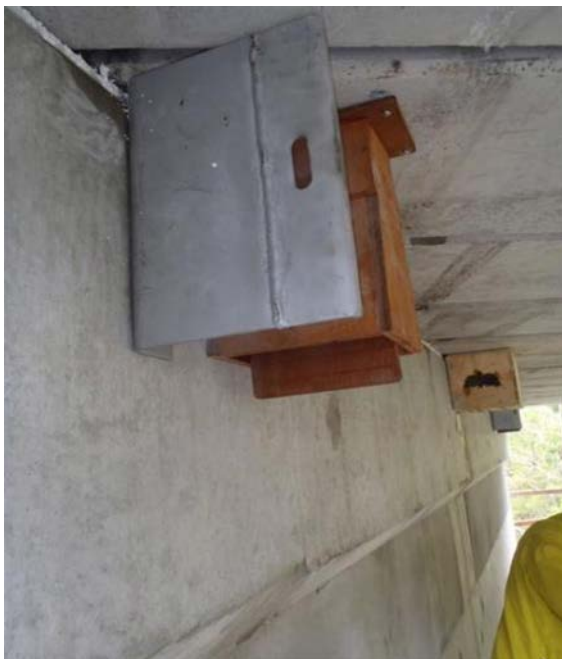
Plate 3.7 Bat boxes with bash plate beneath Myott Bridge (Source: A Lloyd)

- Hanging four-chambered bat boxes with bash plate to deflect any debris and reduce damage during a flood event (refer to **Plates 3.8**);
- Light weight concrete blocks (Hebel) with holes drilled to create cavities (refer to **Plates 3.10** and **3.11**); and
- Lattice style bat boxes (refer to **Plates 3.12** and **3.13**).

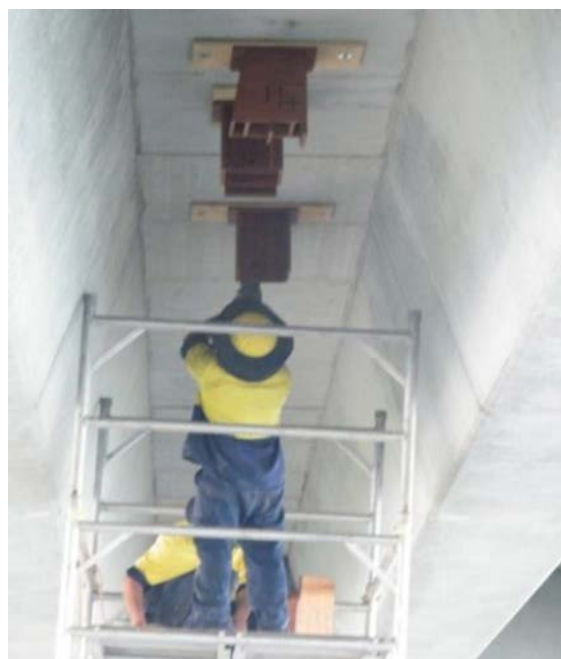
Plate 3.8 Installation of bat boxes beneath Mororo Bridge (Source: D Andrighetto)

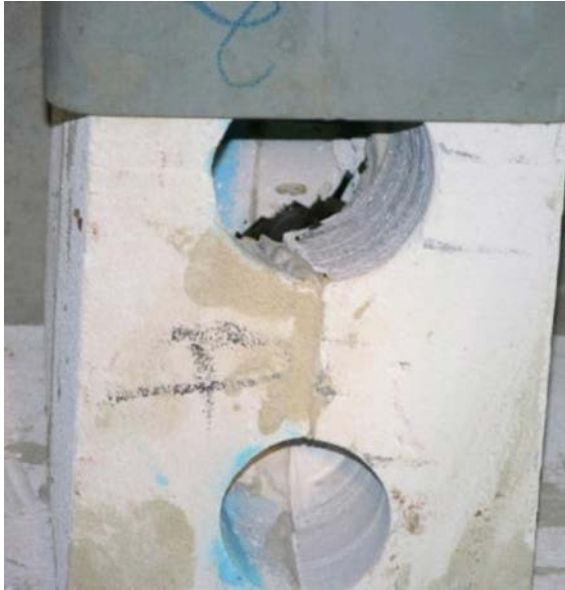
Plate 3.9 Lightweight concrete blocks with drill holes, microbat visible in chamber (Source: N Williams)

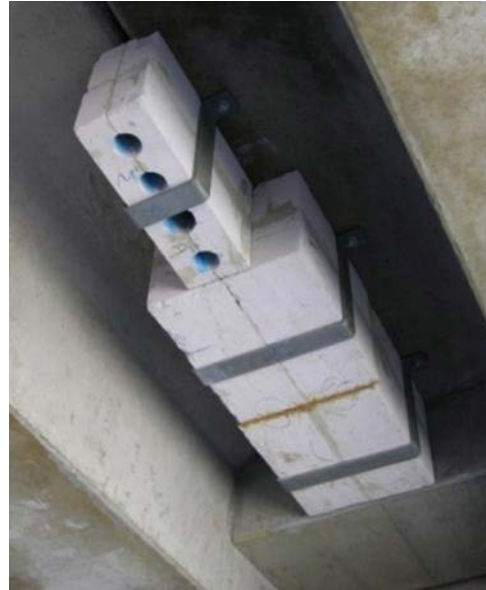
Plate 3.10 Lightweight concrete beneath bridge (Source: N Williams)

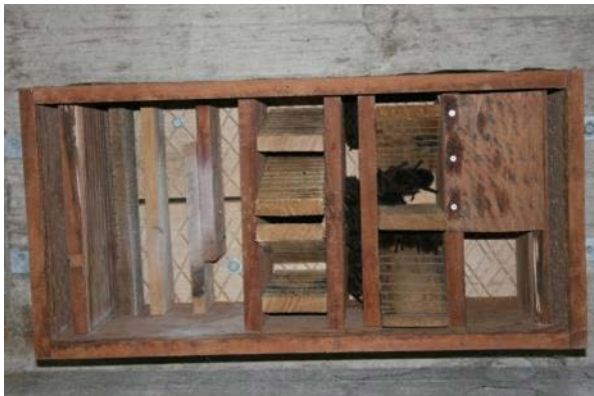
Plate 3.11 Lattice style bat box beneath Halfway Creek Bridge occupied by Large-footed Myotis (Source: V Silver)

Based on previous observations of microbat behaviour, lattice style boxes are recommended as they can allow for larger colonies and therefore increased ability to thermoregulate and breed.

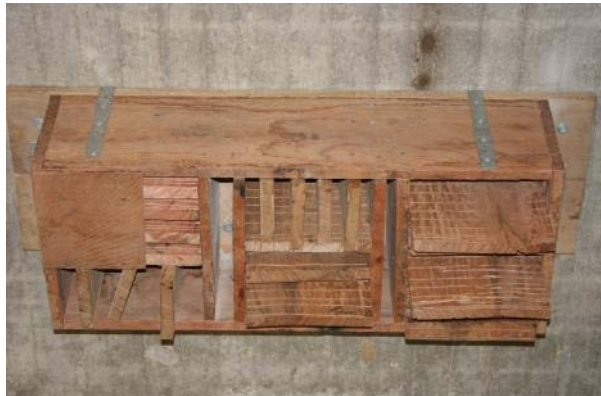
Plate 3.12 Lattice style bat box under Halfway Creek Bridge (Source: V Silver)

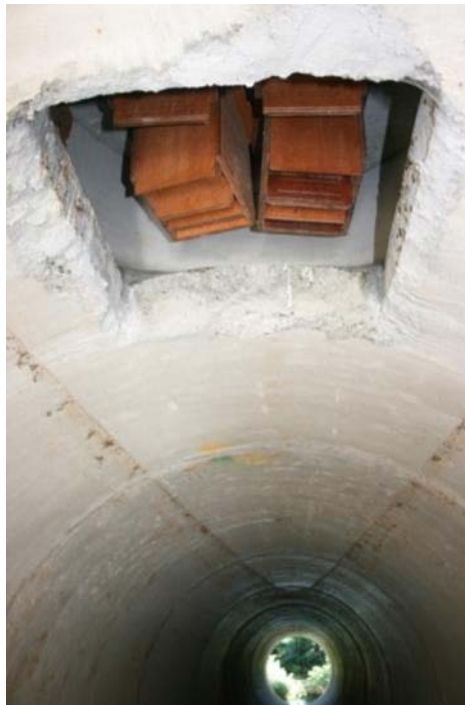
Plate 3.13 Recessed chamber with bat boxes (Source: V Silver)

A recessed chamber in the form of a manufactured man hole would provide bats with a well-insulated replacement cavity that would provide a safe roosting location. Recessed chambers are only recommended within CPCs, due to structural reinforcing being compromised within the obvert of a RCBC. The recessed chamber would be located approximately one third of the way through the culvert at the outlet end (as pools of water are often present at the outlet rather than inlet). The CPC would have a pre-fabricated hole the size of the man hole (chamber) and would be fitted with four-chambered hanging bat boxes (refer to **Plate 3.14**).
