Nest Box Management Plan (Section 6)

Woolgoolga to Ballina Pacific Highway upgrade

September 2014

Woolgoolga to Ballina Pacific Highway Upgrade Section 6- Nest Box Management Plan

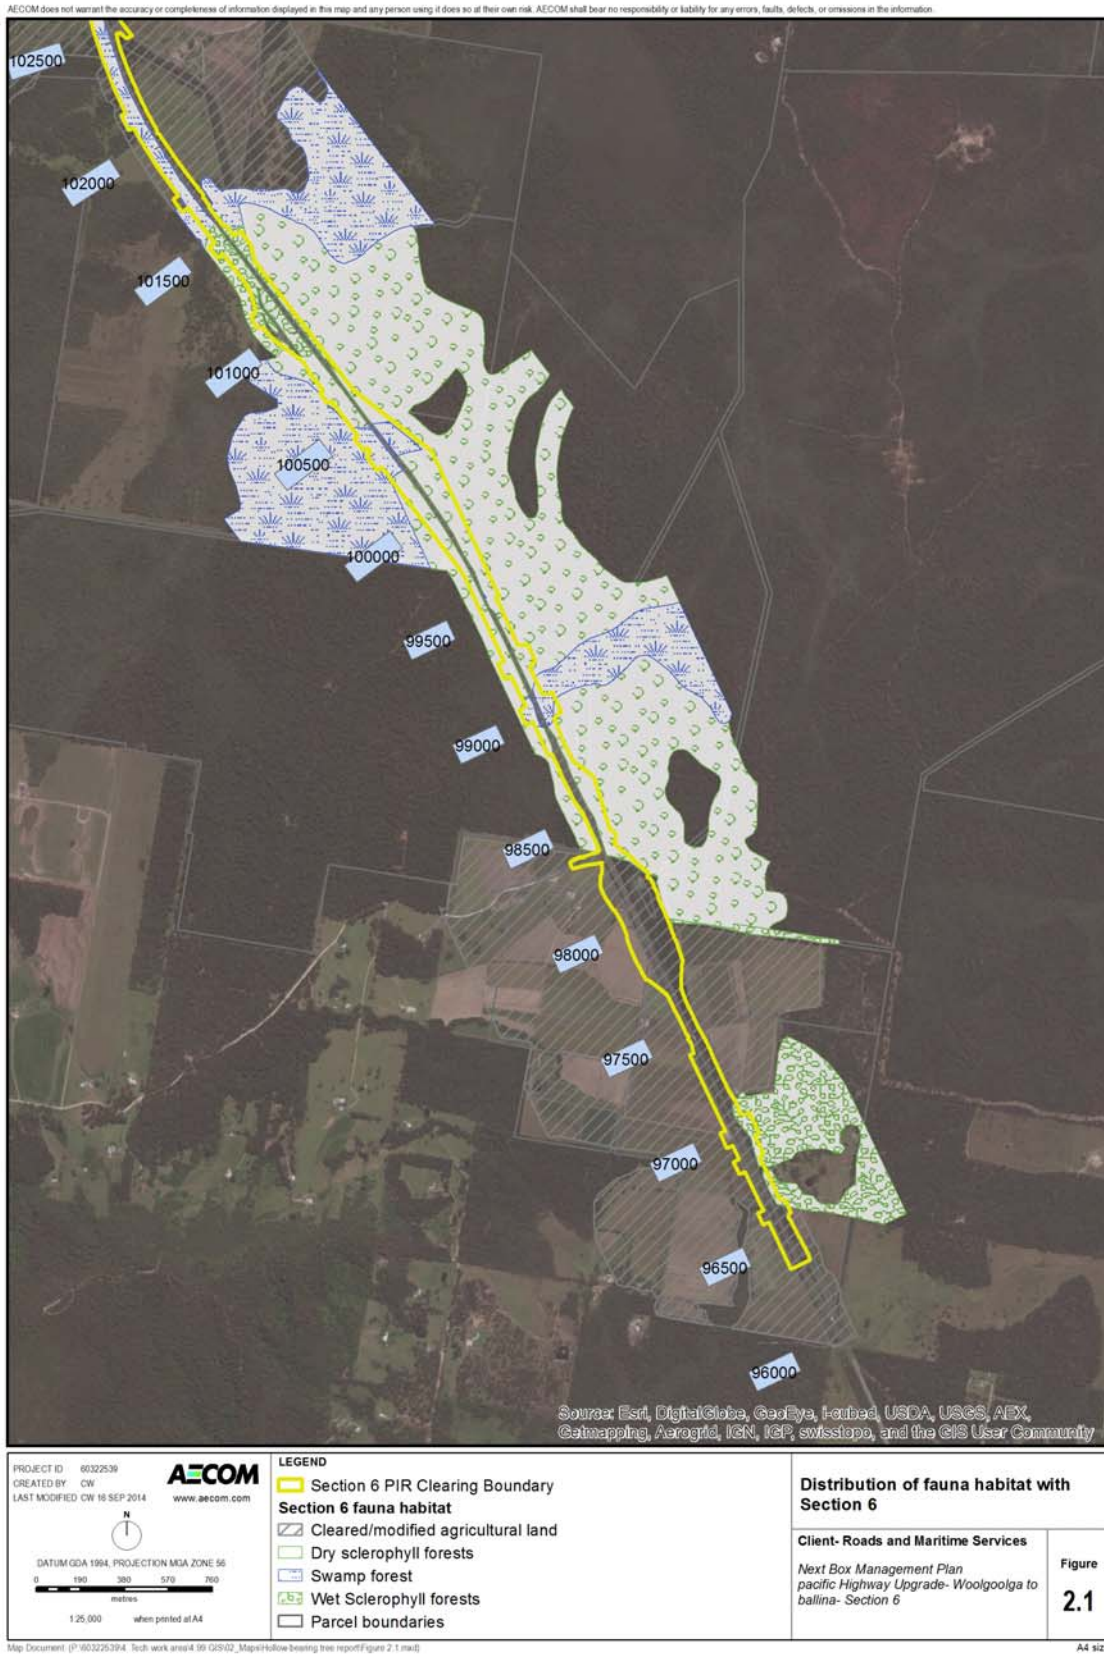
Figure 2-Distribution of fauna habitat within Section 6

Cleared or intensively modified habitat exists within Section 6, and whilst important roosting and breeding habitat such as hollow-bearing trees are scarce, this land does still provide useful habitat for a range of fauna species. Within Section 6, cleared land is often dominated by crops, typically sugar cane or exists as a grazing land dominated by introduced pasture grasses. These habitats provide useful foraging opportunities for microbats, particularly if farms dams are present, and for owl and reptile species that may frequent the fields in search of prey species. Figure 2, overleaf shows the distribution of fauna habitat within Section 6.

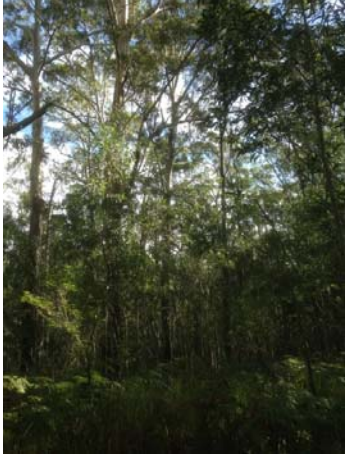
Zone	Chainages	Side of Carriageway	Tenure	Notes	Photo
1	96500-98499	East	NSWPWS	Bunjalung National Park. Tall, mature Eucalyptus with easy access for installation. Low density of existing hollow resources. Grey Gum – Grey Ironbark open forest of the Clarence lowlands of the North Coast.

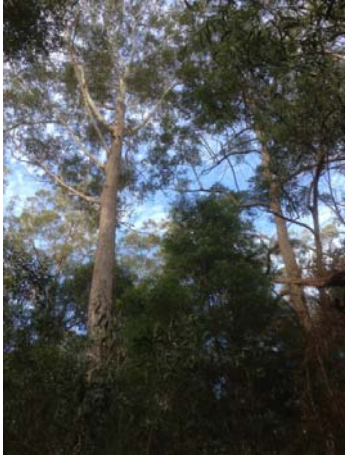
2	98500-100499	East and west	SFNSW	Mororo State Forest- Ideal receptor sites exist on both sides of the alignment. Many tall Blackbutt in good condition. Blackbutt – bloodwood dry heathy open forest on sandstones of the northern North Coast.

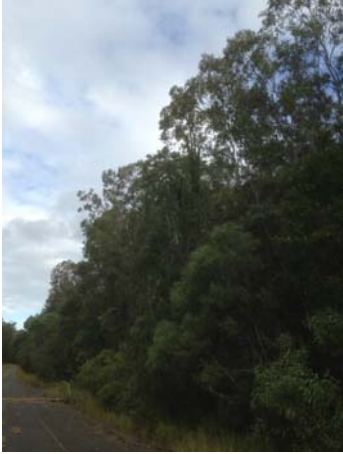
Zone	Chainages	Side of Carriageway	Tenure	Notes	Photo
3	100500-102499	East and West	Private and SFNSW	East side of alignment is Mororo state forest (DP751394). West side is privately owned- landholder would be willing to discuss next box placement (DP836263).. Good access for installation on both sides of the alignment.

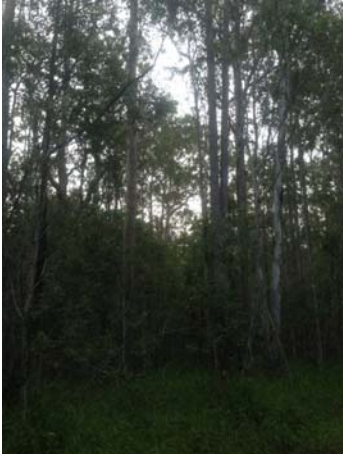
4	102500-104499	West and between carriageways	Private and RMS	West side of alignment is good receptor site. Privately owned but landowner permitted access (DP1186280). No discussion was held with landowner regarding installing nest boxes on the property, Between north and south carriageways may be suitable for bird and/or glider box. Good access to receptor sites via Pine Road extension

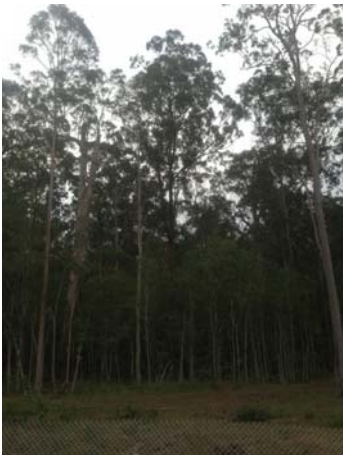
5	104500-105499	West	SFNSW	Bunjalong crown reserve- good receptor sites west of alignment. Mature forest red gum. Easy access for installation Private property access was denied on the eastern side of the alignment between chainages 104000 & 105470.
