Roads &
Maritime

Nest Box Management Plan (Sections 4 & 5)

Woolgoolga to Ballina Pacific Highway upgrade

October 2014

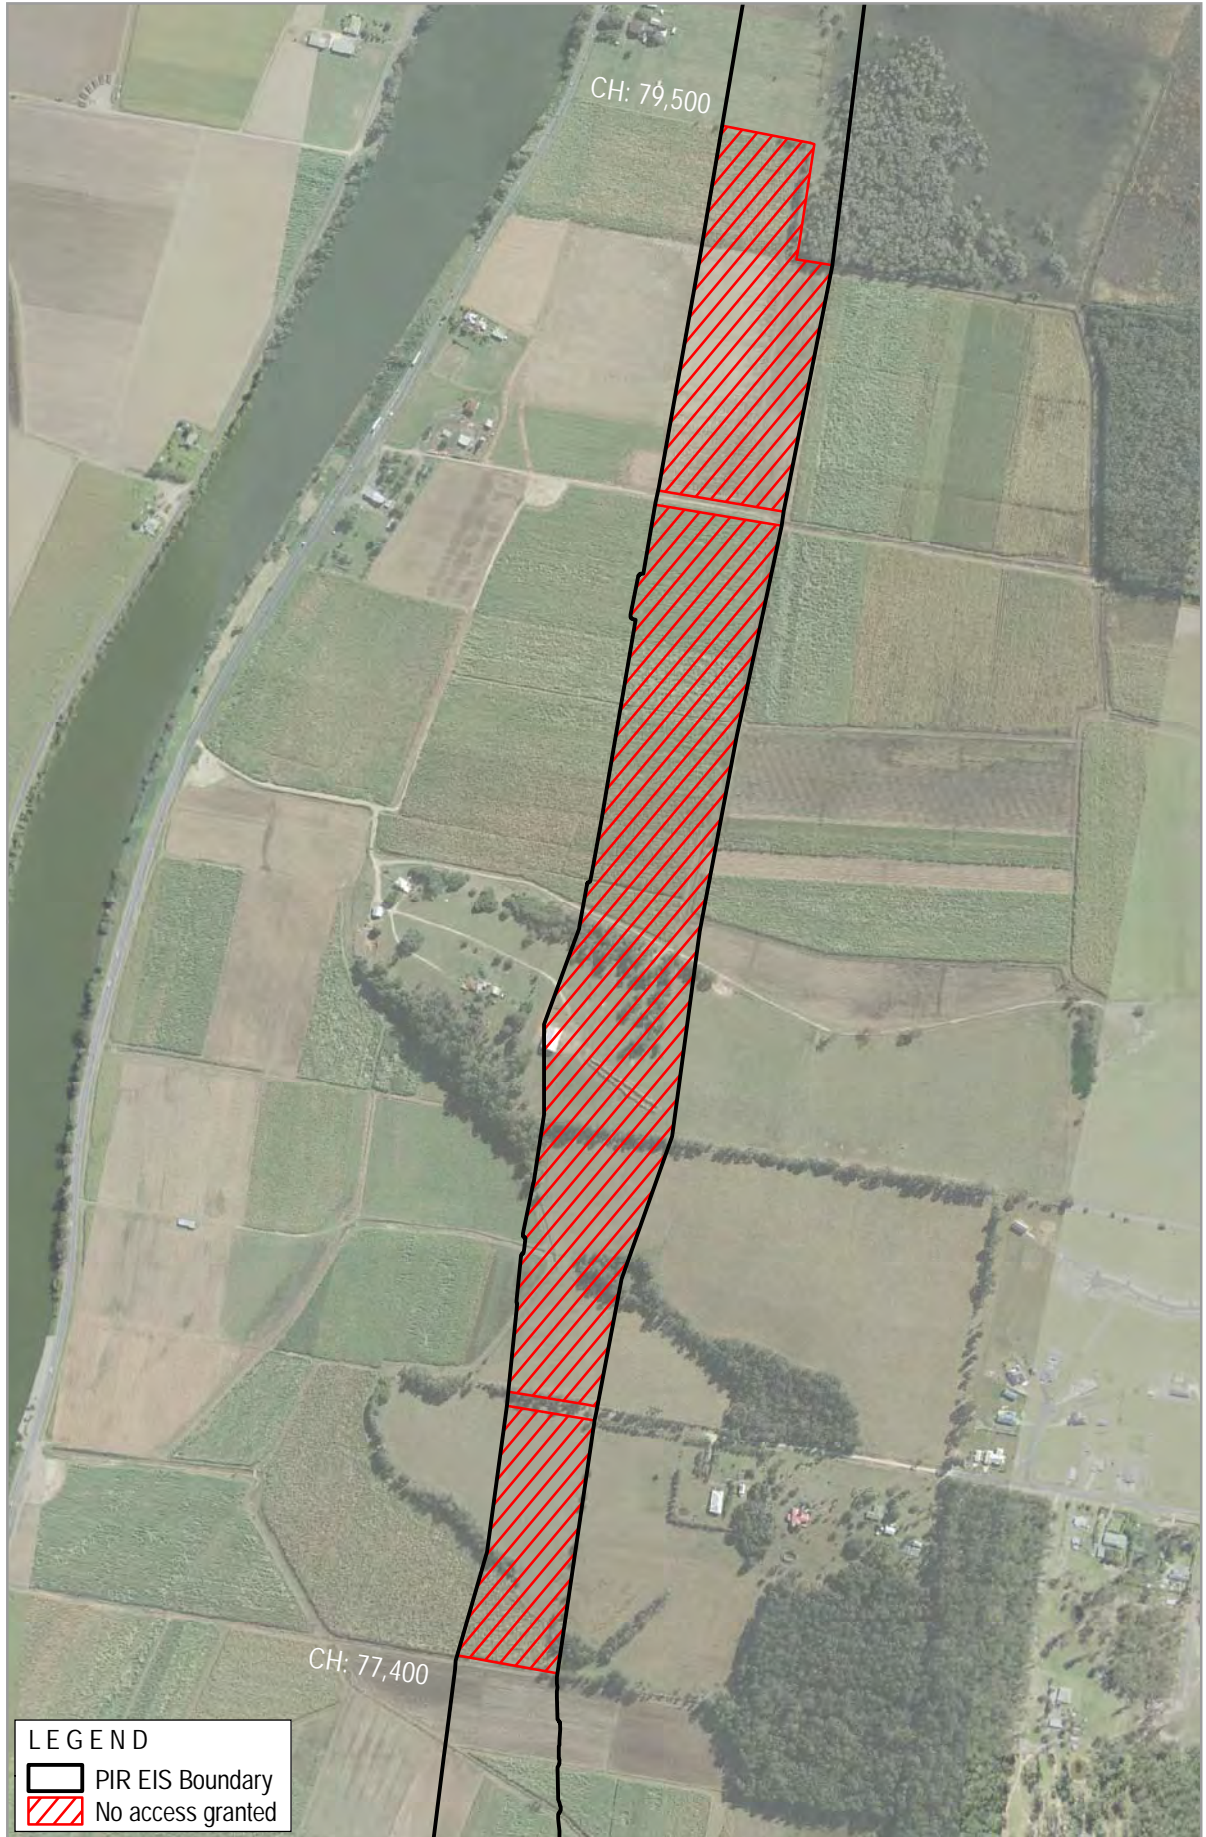
Illustration 2.3

Due to private property access limitations a number of areas were unable to be accessed at the time of survey. These areas are shown in **Illustrations 2.1 to 2.6**. While most of these areas were within areas currently under cultivation for Sugar Cane a number of areas contain areas of native vegetation, the most notable of these being in the vicinity of Iluka Road.

Areas of the Project Site Not Accessed (Map 3)

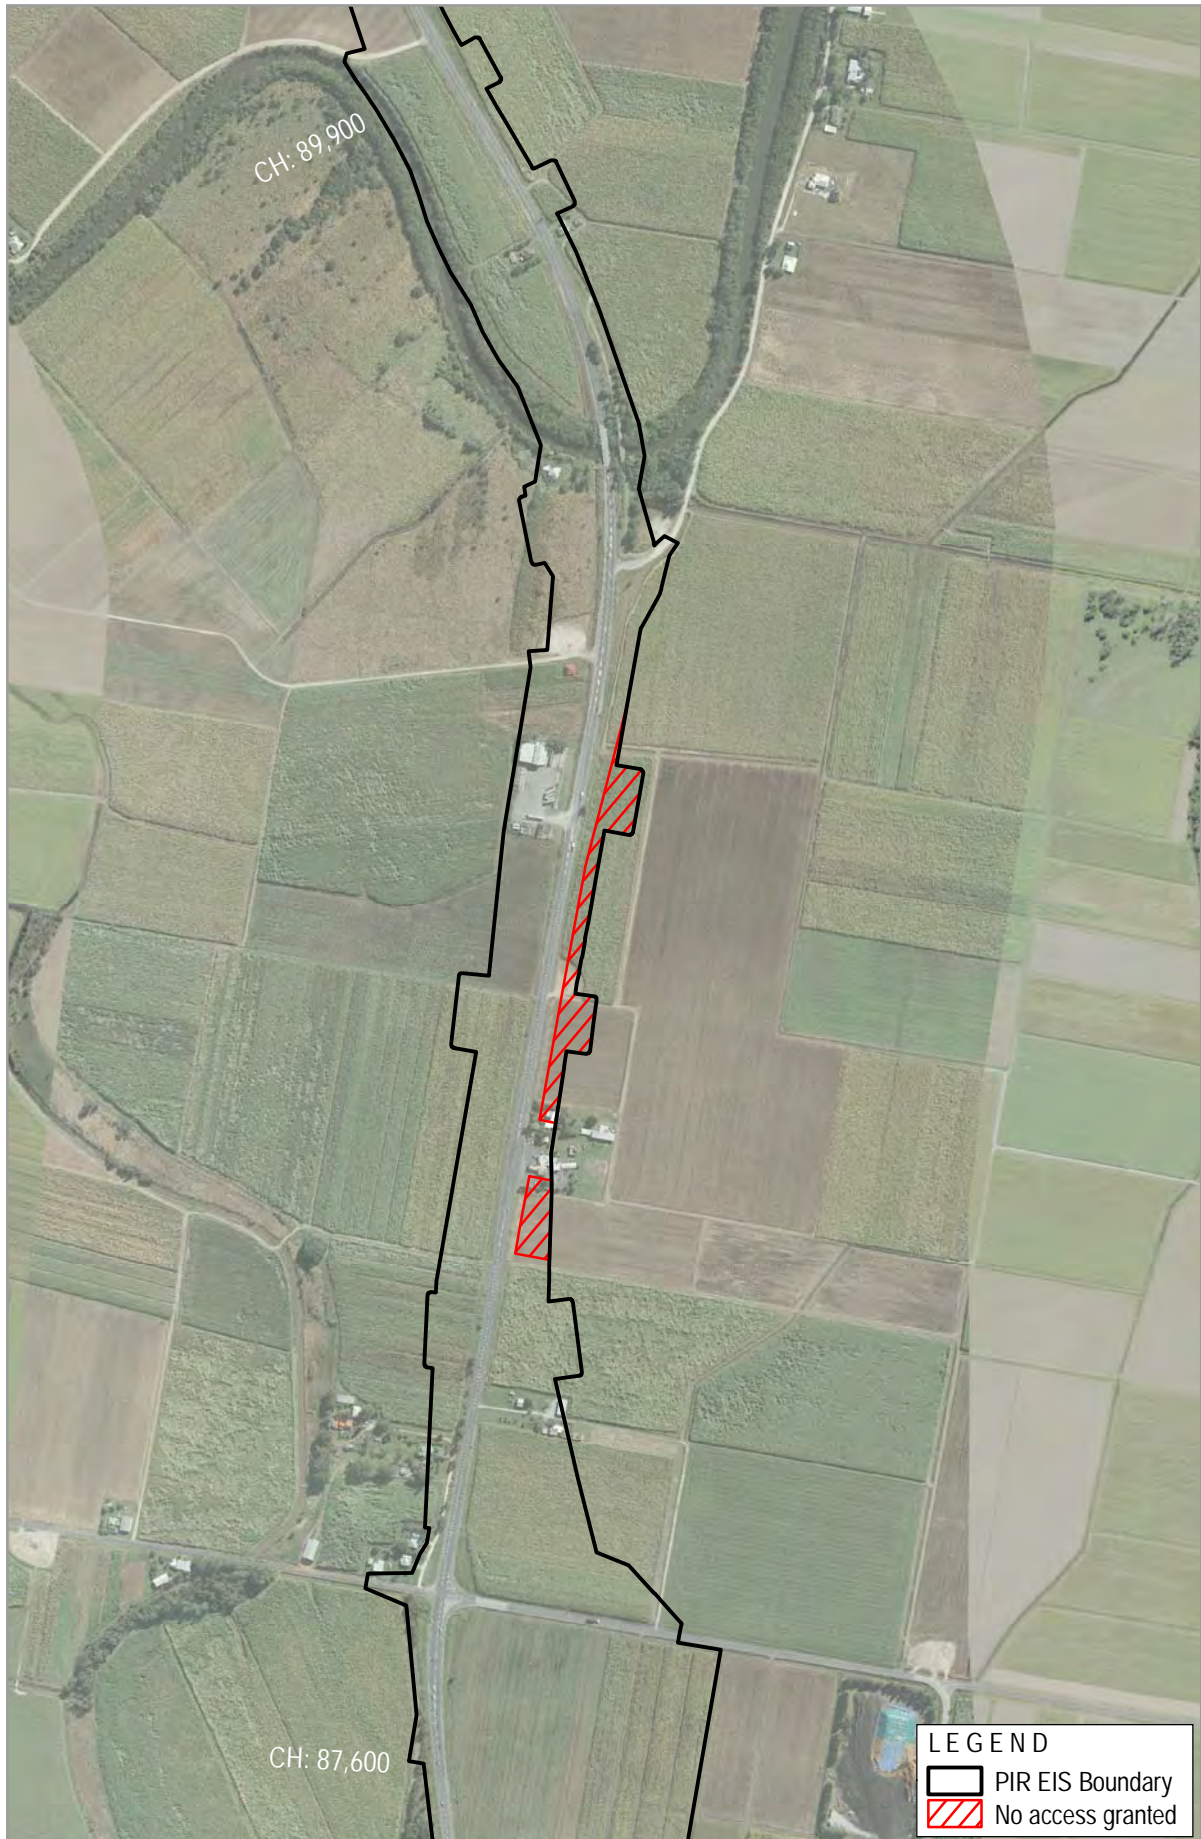
Illustration 2.5

Areas of the Project Site Not Accessed (Map 5)

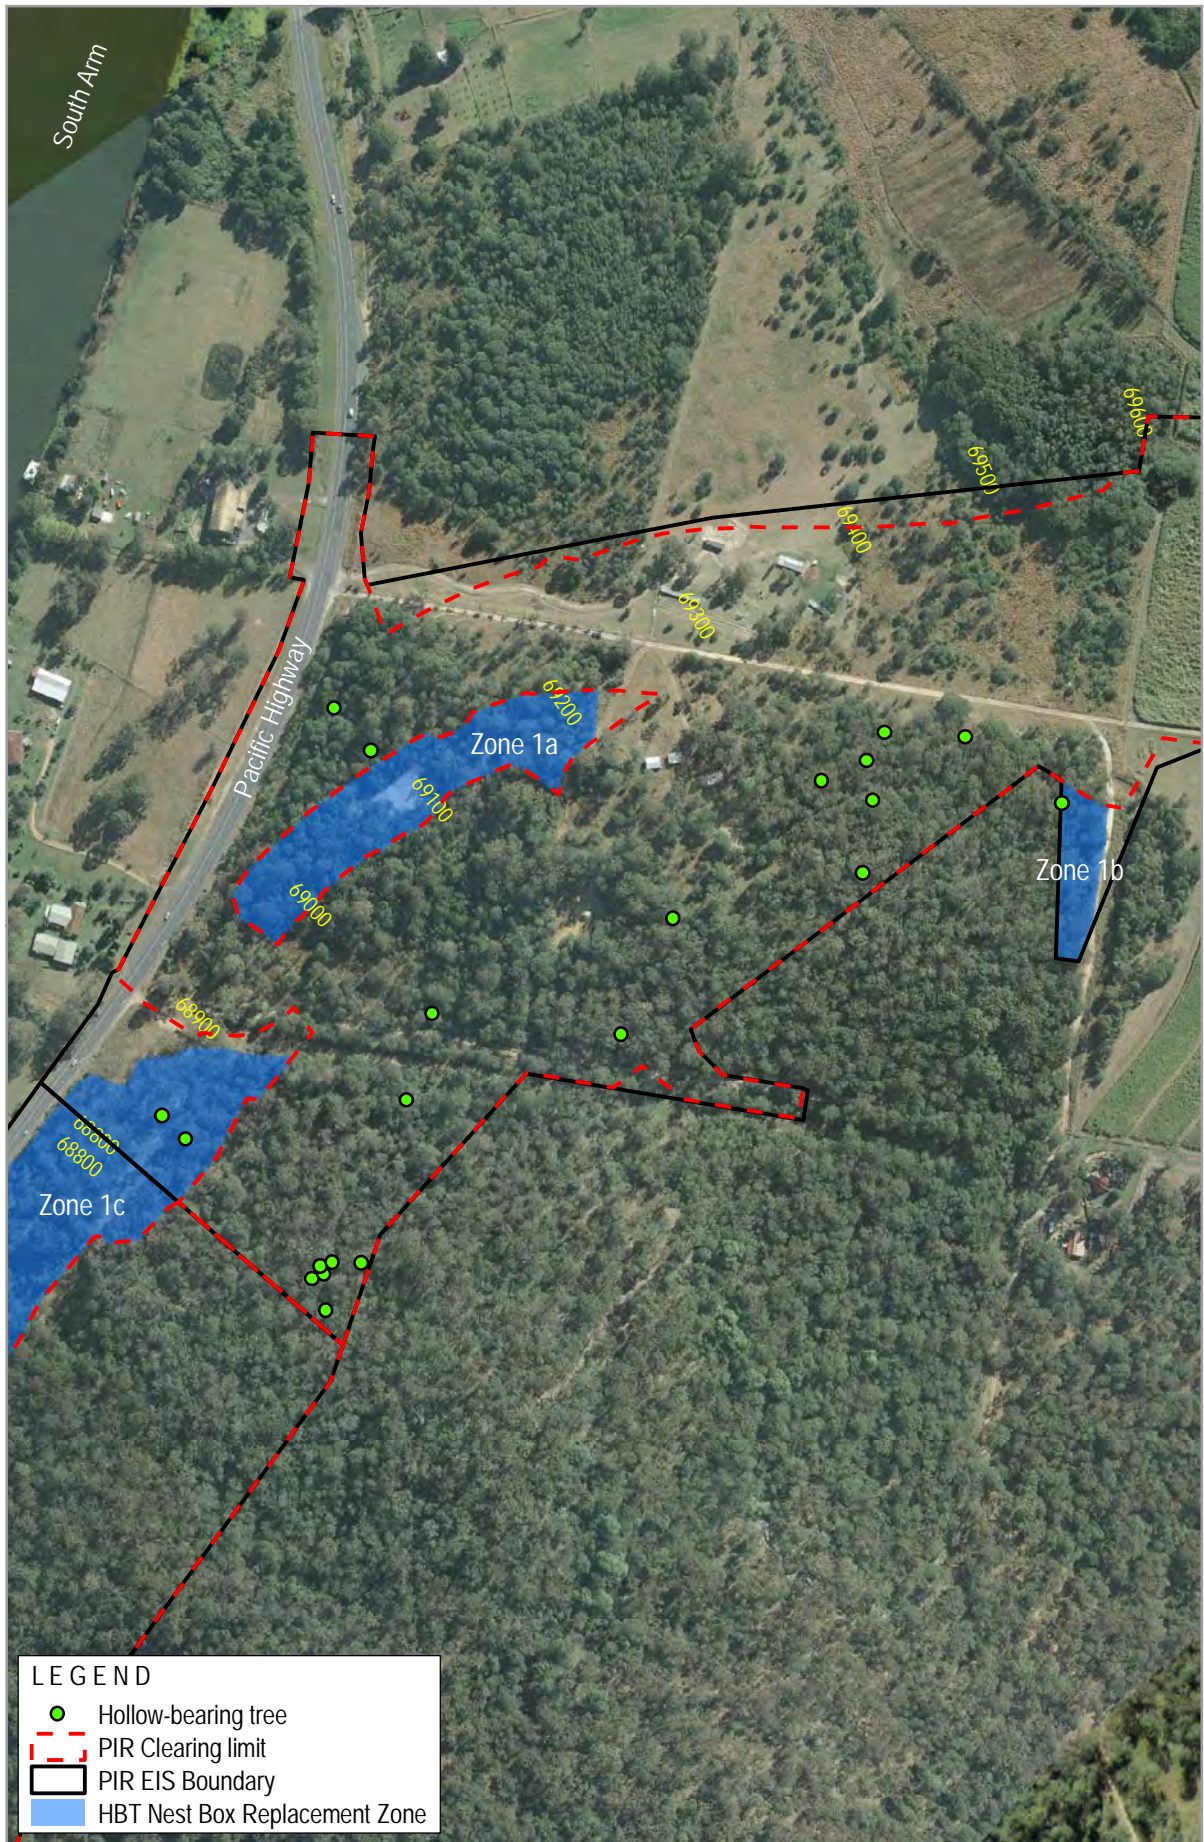
HBT data primarily indicated five areas within the project boundary where HBTs are to be cleared. It is considered appropriate that nest box replacement zones be focused on each of these areas. Other areas where HBTs were located comprised isolated paddock trees with some hollows in mostly cleared areas representing generally low quality fauna habitat. Replacement nest box zones are shown in **Illustrations 4.1 to 4.5**. Some zones have been divided into a number of smaller areas to provide a spread of nest boxes along or either side of the alignment. Nest boxes will be installed in appropriate trees within each zone as prescribed in the sections below.

Location of Replacement Nestbox Zones (Zone 1)

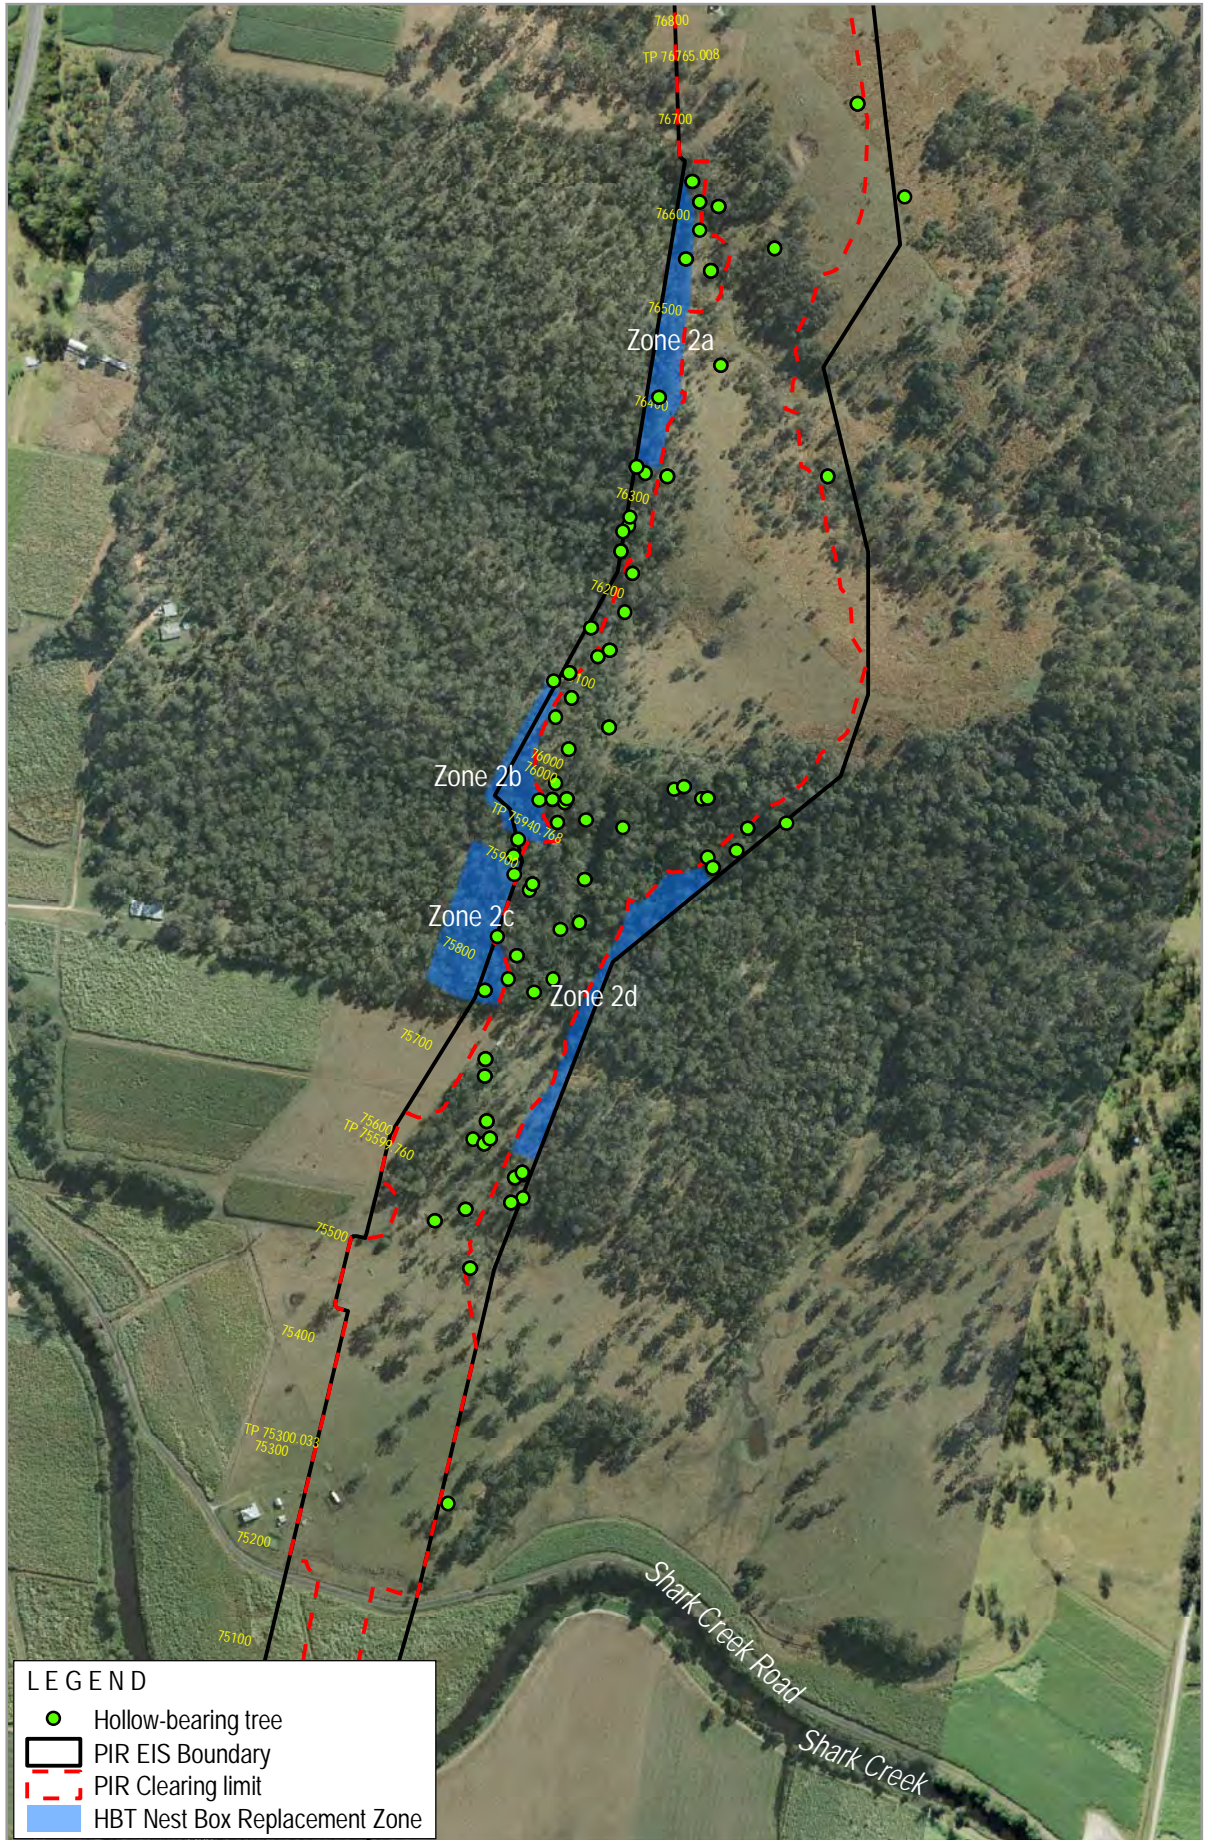
Illustration 4.2

The lack of State Forests, National Parks and Flora Reserves associated with Sections 4 and 5 of the W2B project poses challenges in ensuring land tenure challenges for replacement nest box zones. Where possible these zones have been located within RMS owned land (outside the clearing limits). A number of land owners in the vicinity of Tyndale and Greens Hill were approached to include parts of private property as part of nest box replacement zones. Permission was obtained to utilise private land in the Greens Hill area and parts of nest box replacement zone 2 have been configured to incorporate this land.

Location of Replacement Nestbox Zones (Zone 2)

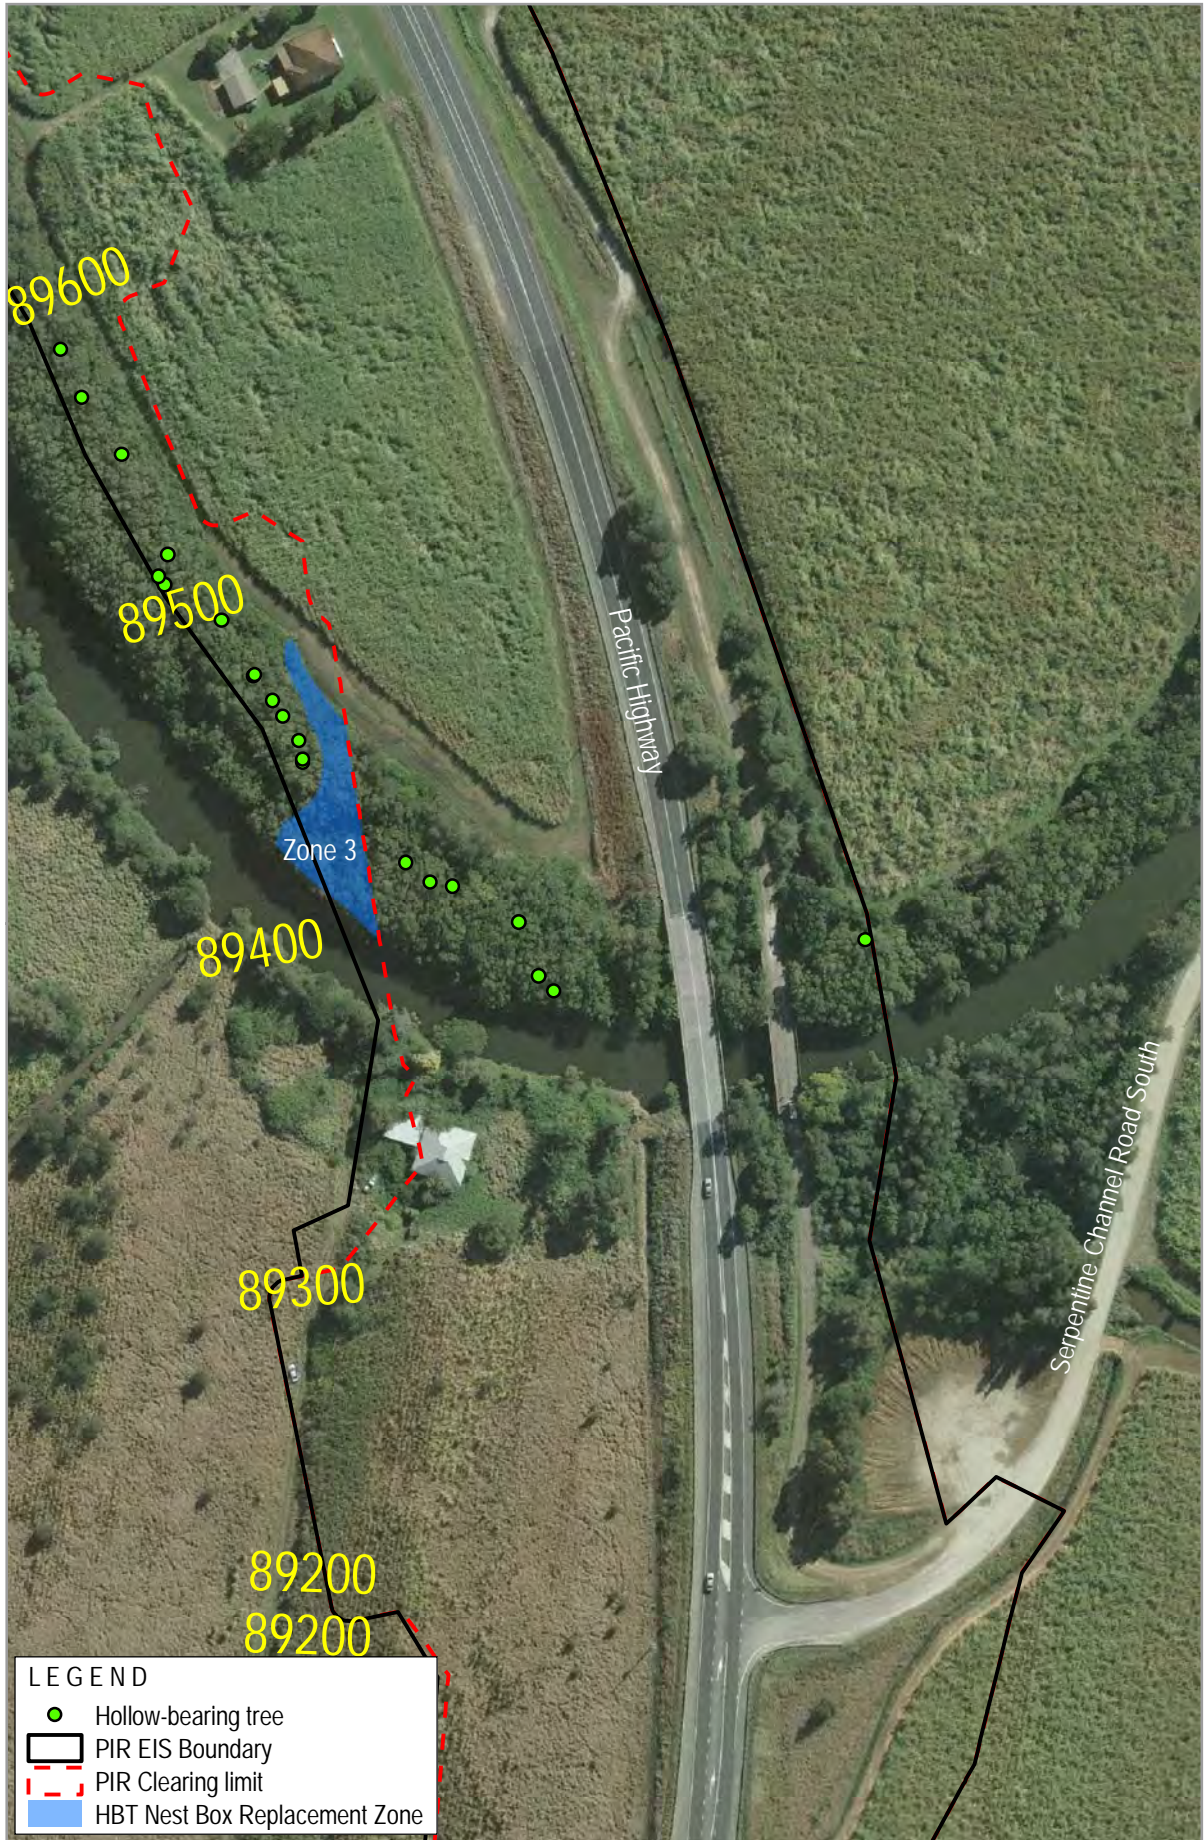
Location of Replacement Nestbox Zones (Zone 3)

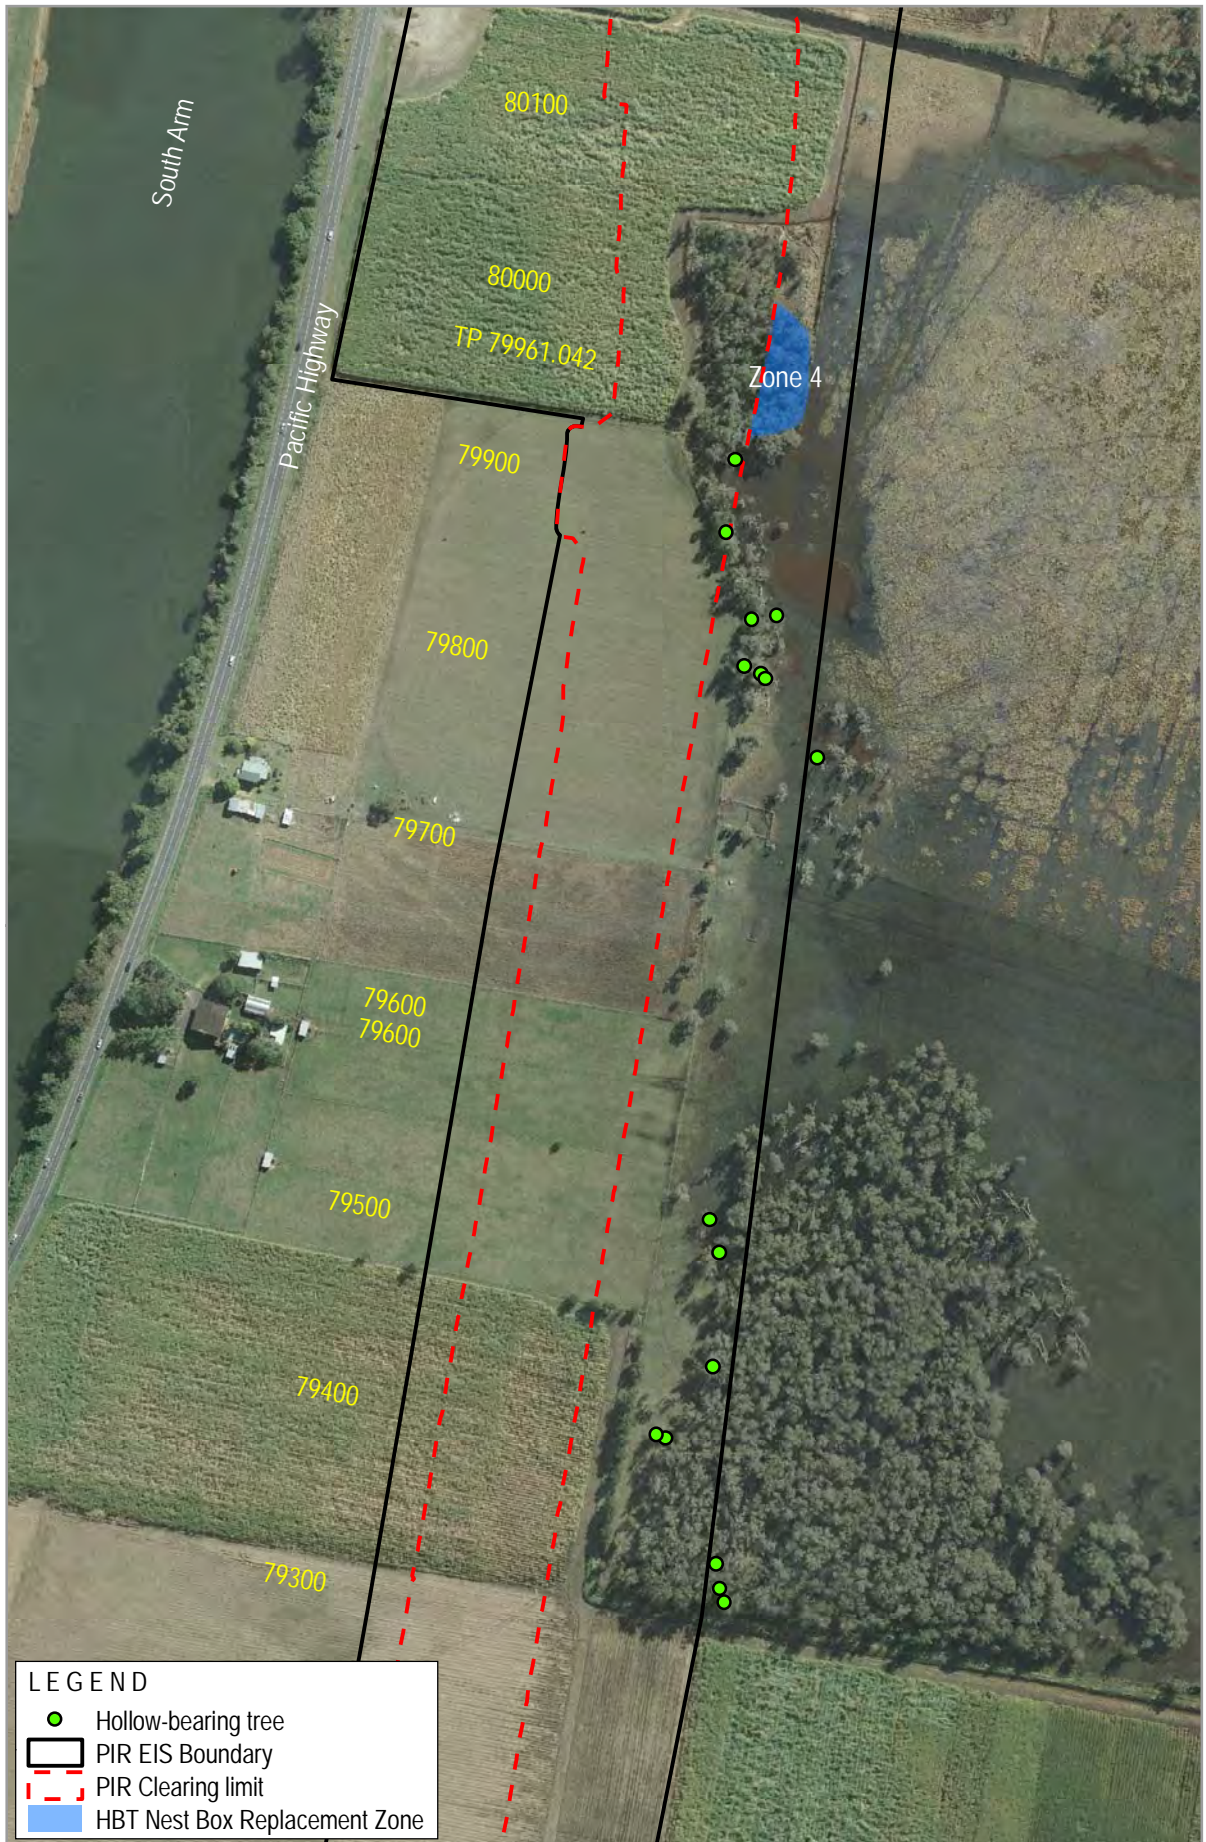
Location of Replacement Nest Box Zones (Zone 4)

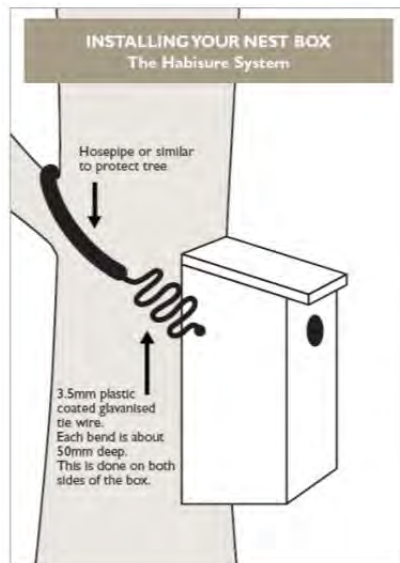
Illustration 4.6 The Habisure System of Nest Box Attachment (Franks and Franks, 2006)

The recommended attachment method for nest boxes is the Habisure system (refer to **Illustration 4.6**) which allows for at least one metre growth in the diameter of the host tree before adjustment is required. Bolting or screwing nest boxes to trees is not recommended due to increased damage to trees and a comparatively short lifespan.

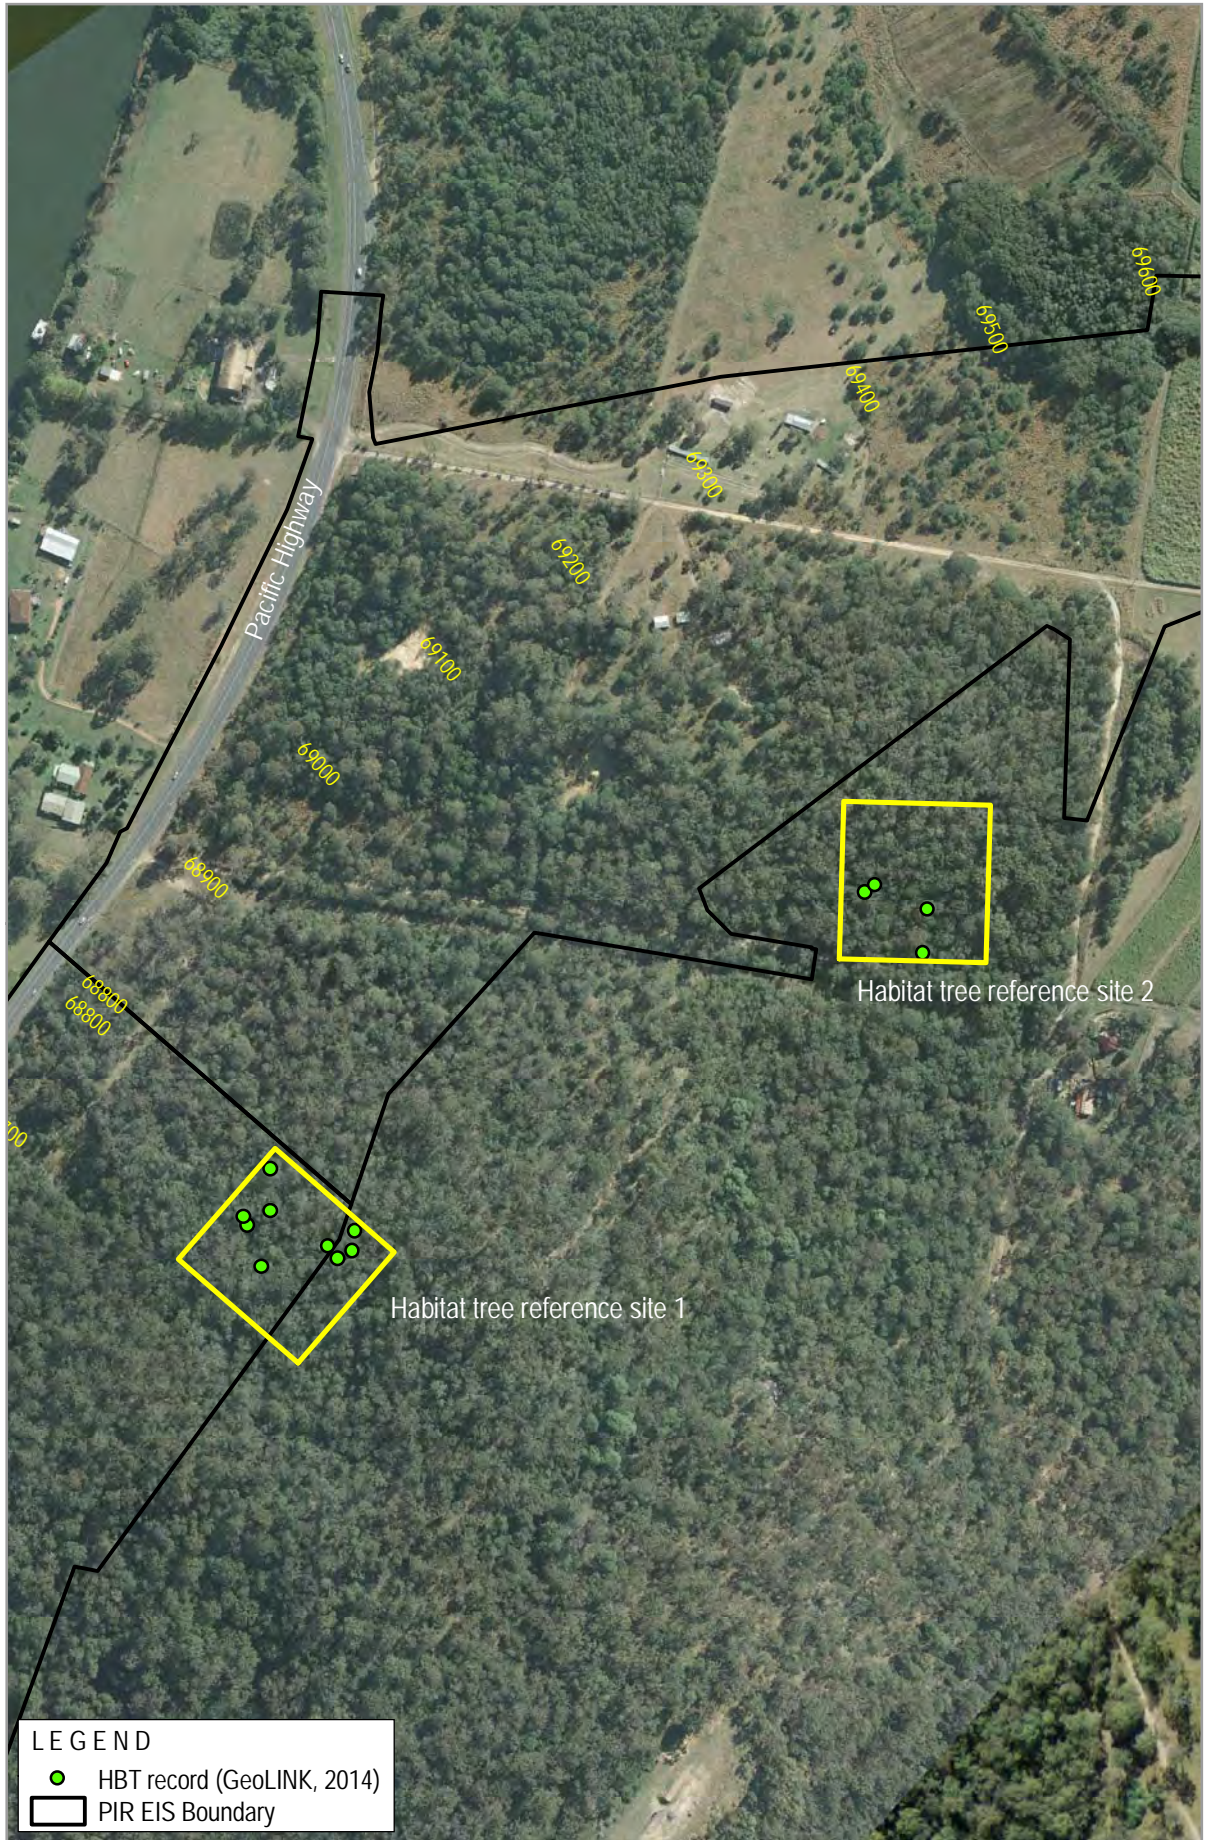
In line with the methodology used by Lewis (2013), 10 one hectare reference sites were established outside of the project boundary. The location of these reference sites was generally selected to coincide with areas of HBTs occurring within the clearing footprint and was aimed at providing more context on the type and availability of hollow resources within the general areas where HBTs are to be removed. The location of these reference sites is shown in **Appendix A**. The location of all HBTs and data outlined in **Section 2.1.1** was recorded for each reference site.

Location of Hollow-bearing Tree Reference Sites (Map 1)
