3. Study Area Characteristics

3.2 Existing Highway Corridor and Alignment

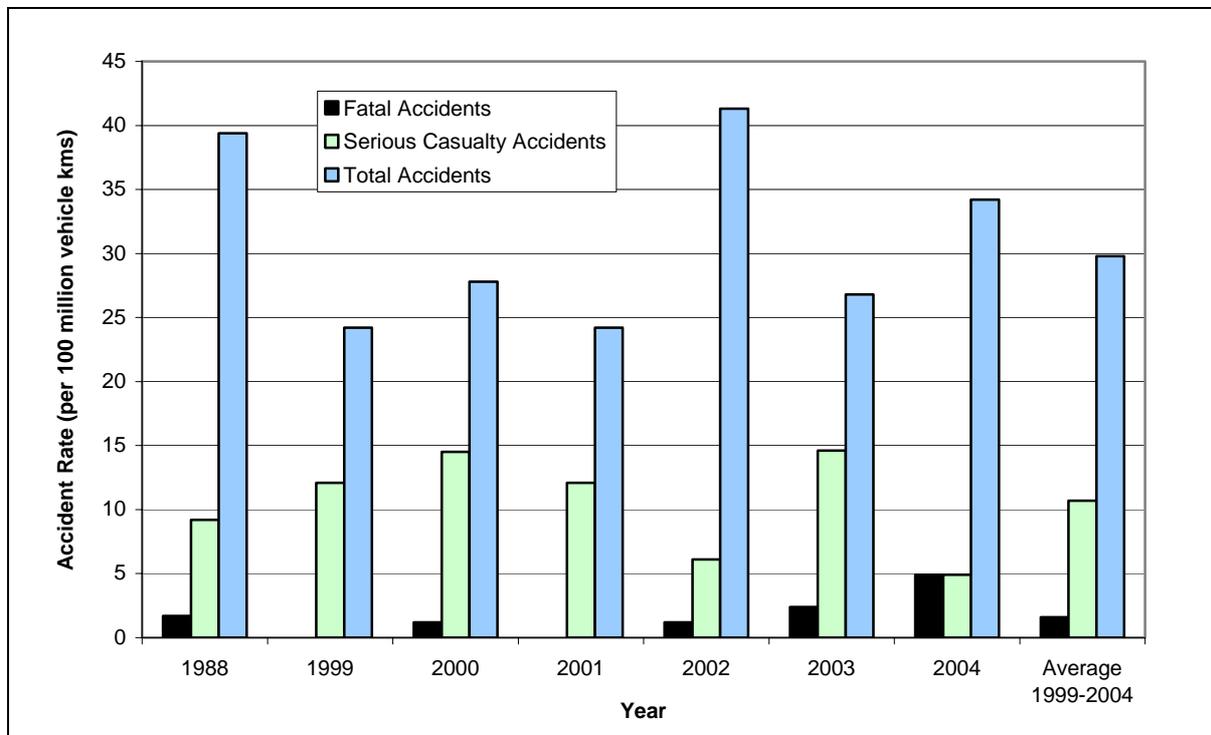
Figure 3.4 Crash Rate Per 100 Million Vehicle Kilometres

Note: The 1988 rates have been modified from the RTA Road Design Guide based on the overall reduction in crashes between 1988 and 2004 (approximately 71%).

Comparing the current crash rates against those in the RTA Road Design Guide indicate that the crash rates are less than what was encountered during 1988. Current crash rates are approximately 78% of those encountered during the late 1980's as shown on Figure 3.4. As a result this indicates that fatal crashes over this section of the highway are consistent with what would be expected, although serious casualty accidents are higher.

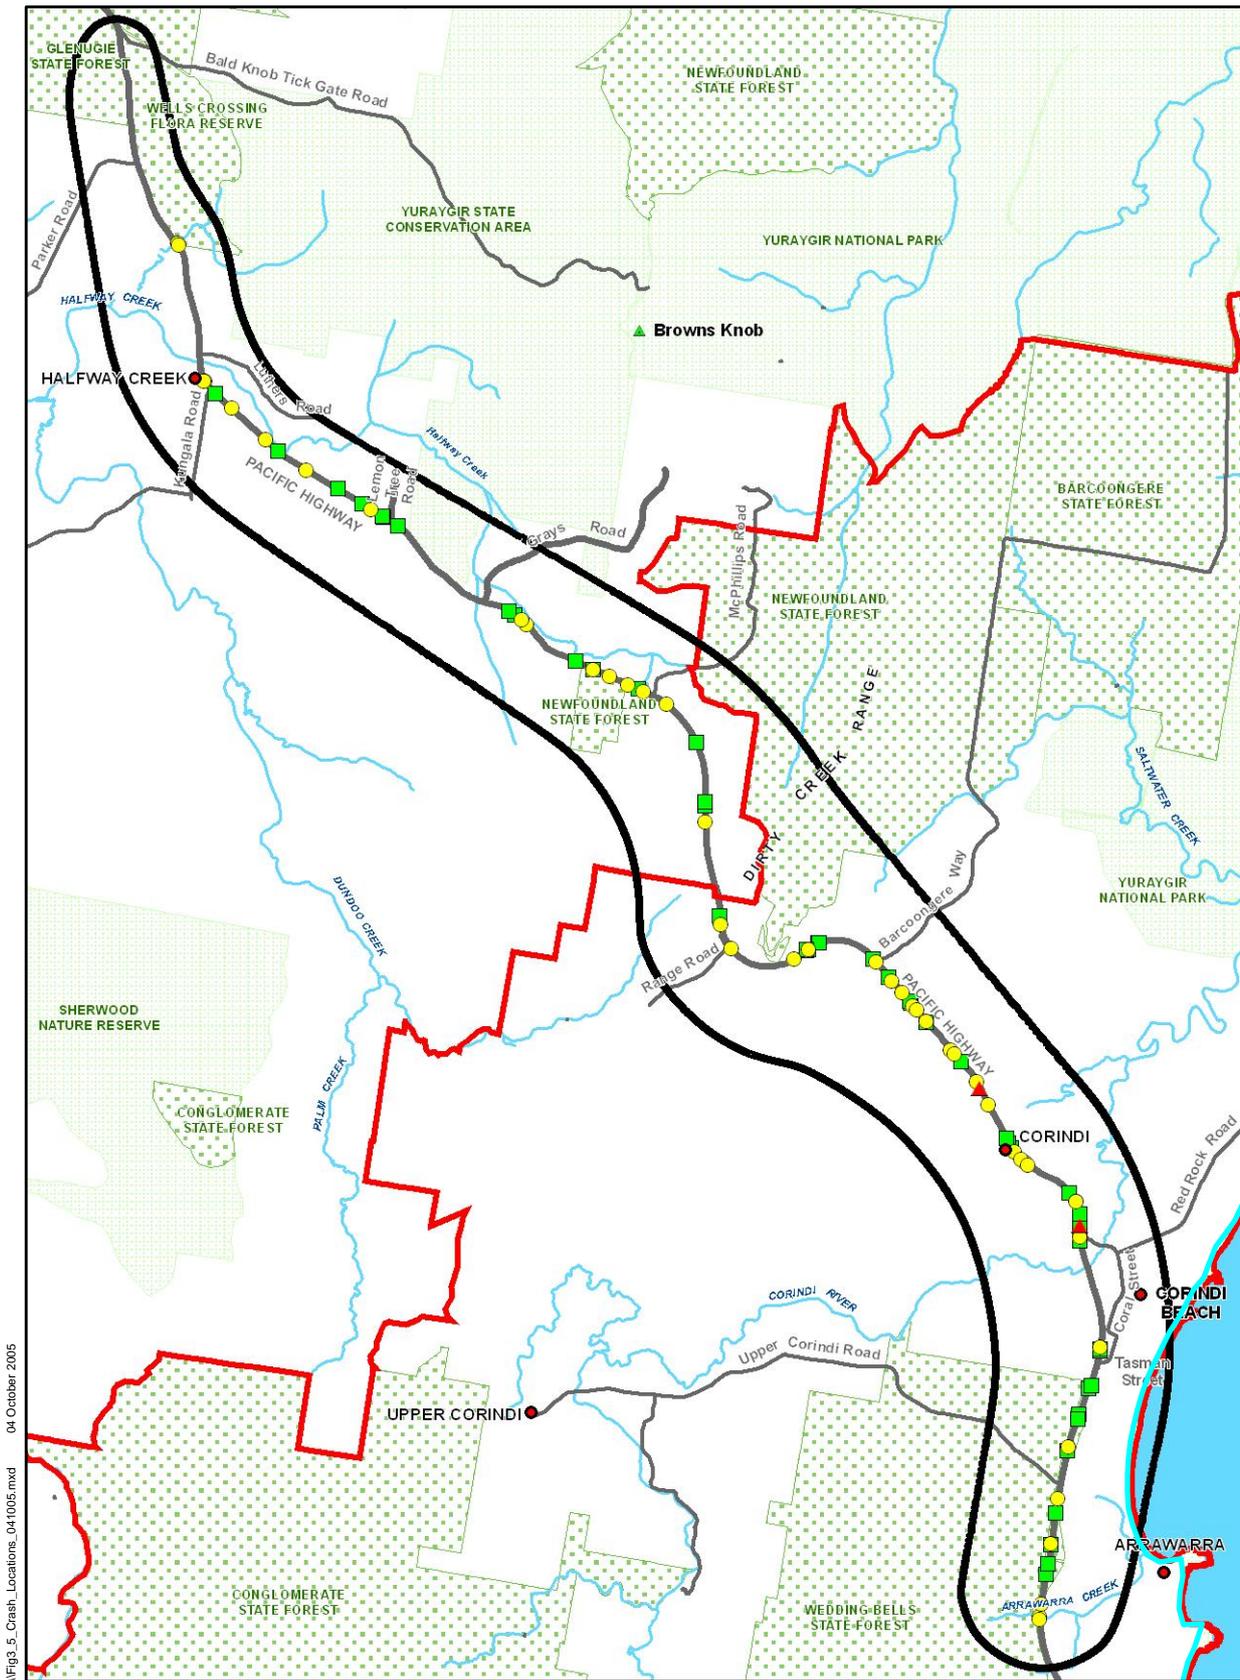
\Fig3_5_Crash_Locations_041005.mxd 04 October 2005

The categories of crashes highlighted in Figure 3.5 are described below:

- ▶ Fatality – a crash where there has been a fatality; and
- ▶ Serious Casualty Crash – a crash where an injury has resulted that required hospitalisation.
- ▶ Minor Crash – An accident where only minor injuries have been received and / or the vehicles involved were required to be removed.

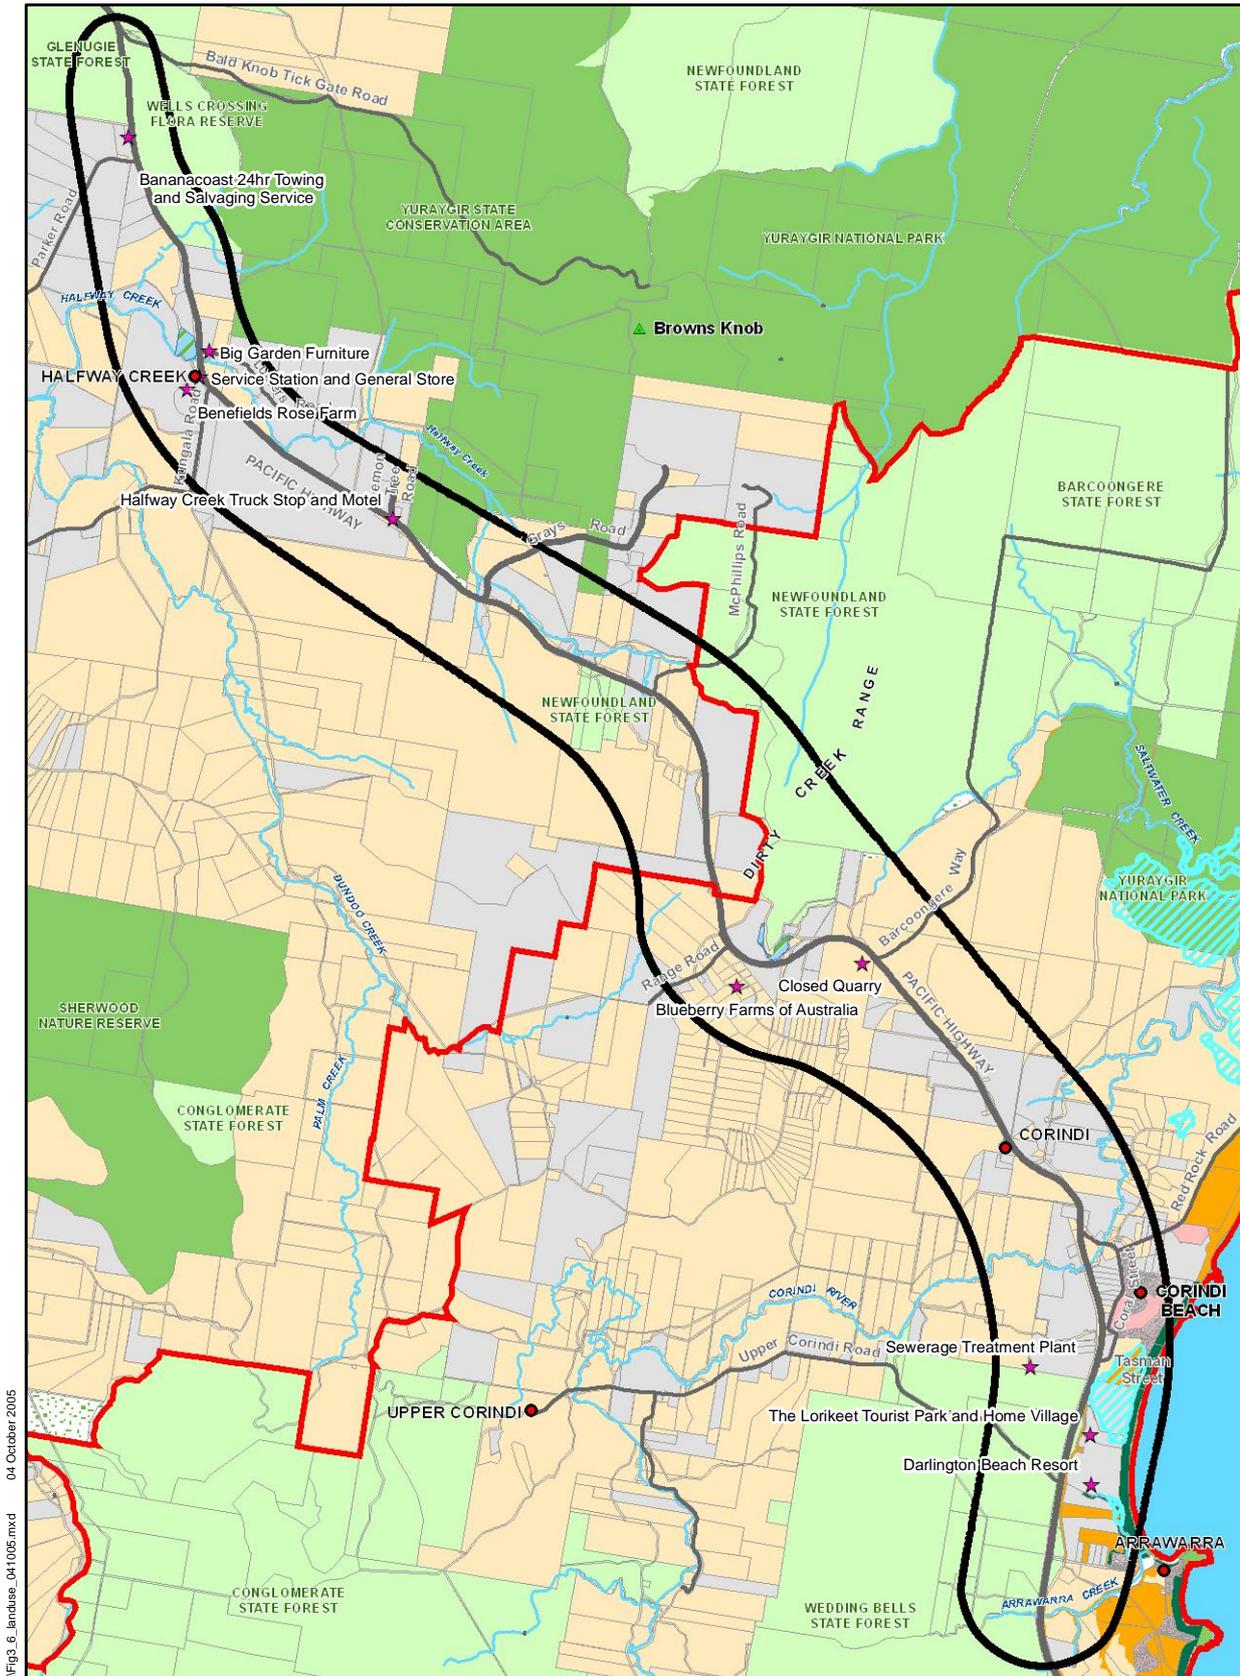
04 October 2005
\\F03_6_landuse_041005.mxd

- ▶ Residential – villages and small rural localities including Arrawarra, Corindi Beach, Corindi, and Halfway Creek;
- ▶ Rural – mainly grazing lands, small orchards, the rose farm on Kungala Road, and the extensive blueberry plantation at the top of Dirty Creek Range;
- ▶ Commercial enterprises – including service stations, caravan parks and miscellaneous businesses; and
- ▶ State forests and reserves – state forests (Wedding Bells State Forest, Newfoundland State Forest and Glenugie State Forest) and conservation areas (Yuraygir State Conservation Area and Wells Crossing Flora Reserve).

Existing land use is depicted in Figure 3.6.

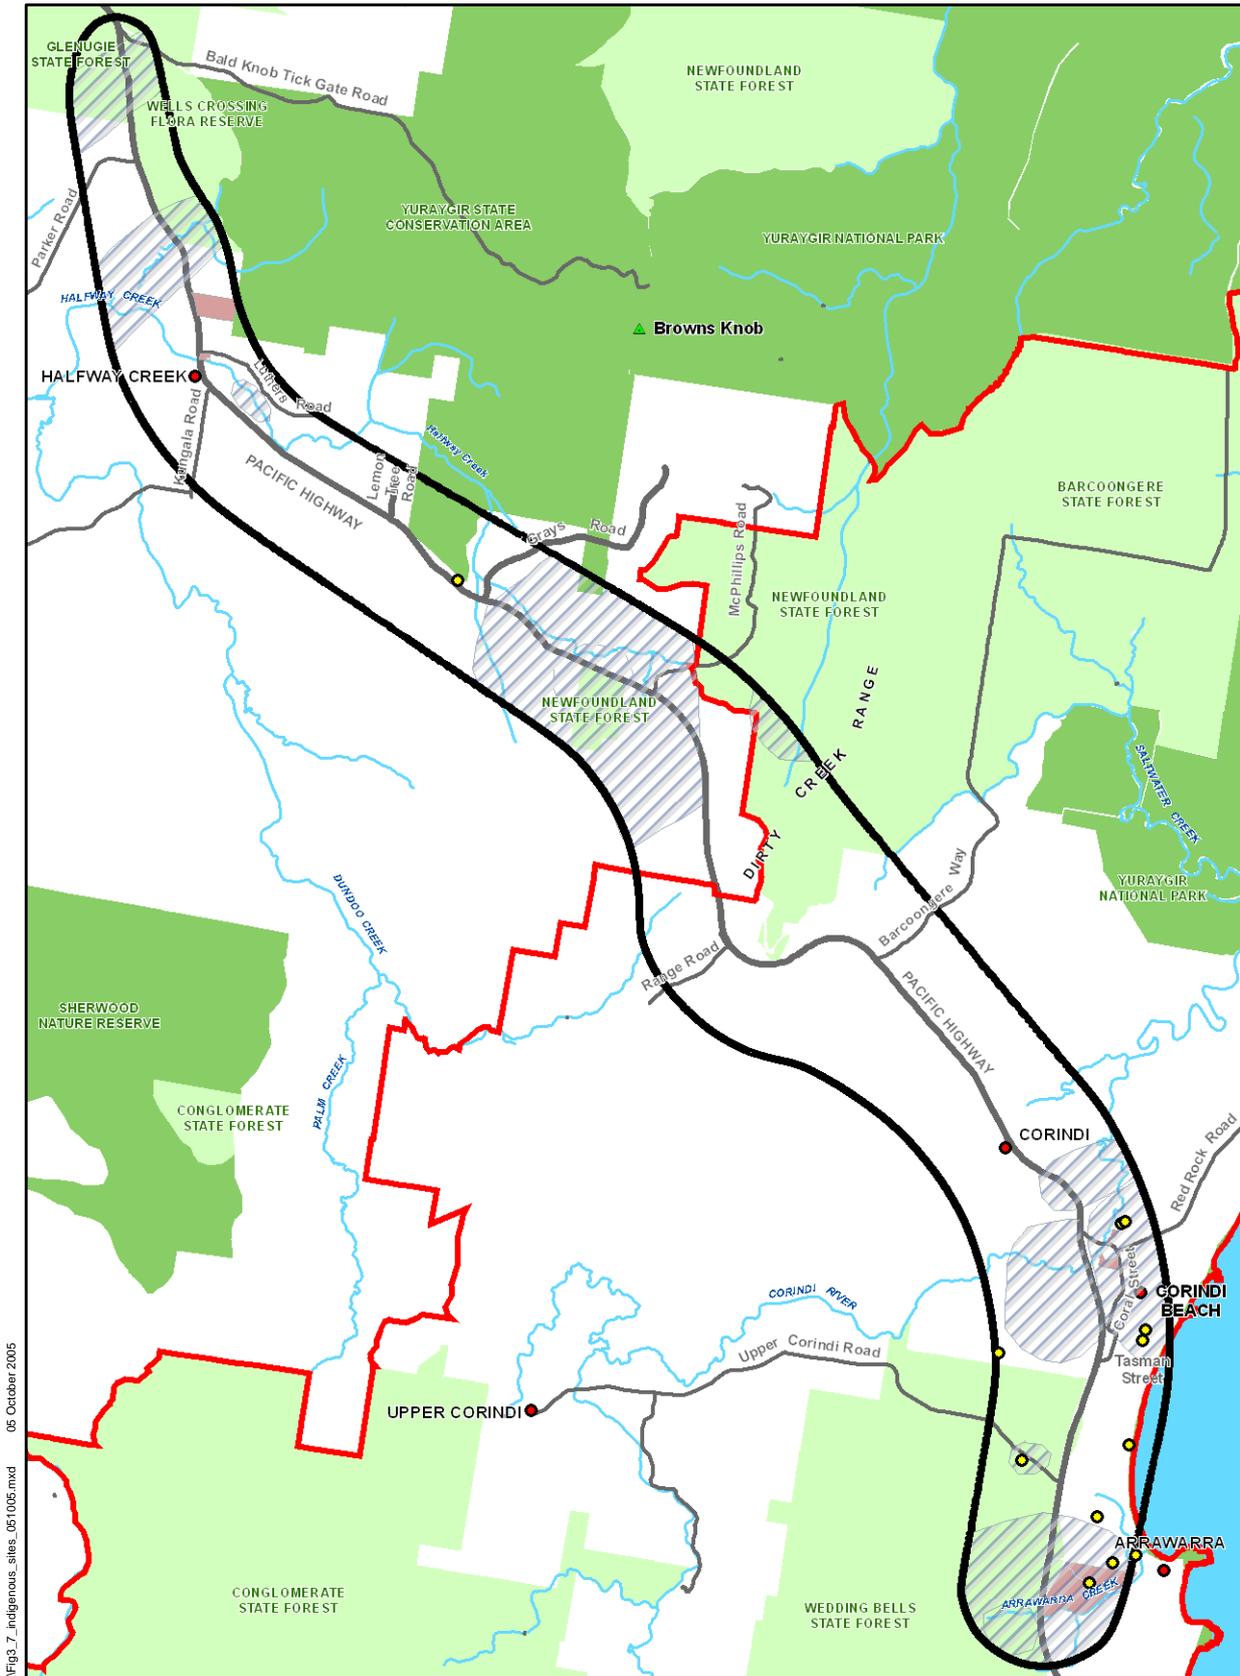
\\fig3_7_indigenous_sites_051006.mxd 05 October 2005

Sites of indigenous heritage significance within the study area are depicted on Figure 3.7.

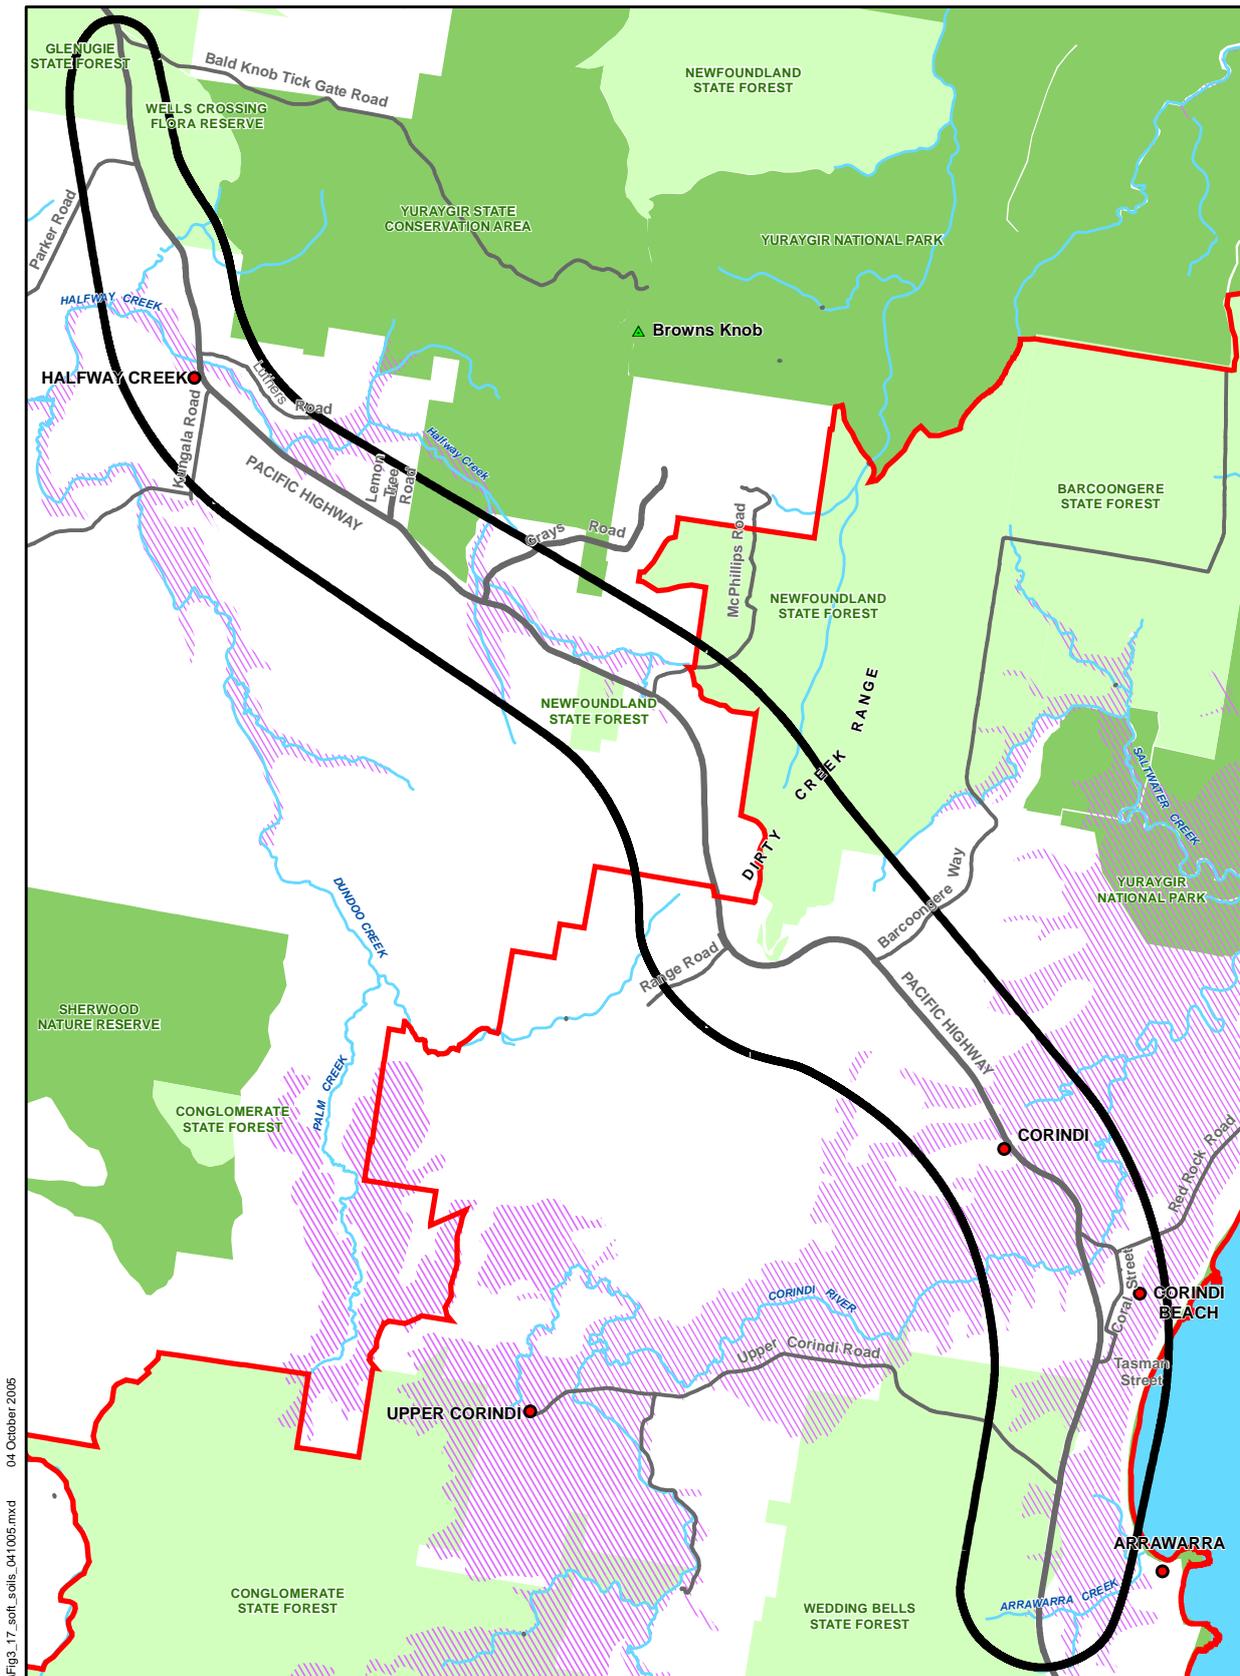
\\fig3_17_soft_soils_041005.mxd 04 October 2005

Preliminary subsurface investigations conducted within the Corindi floodplain found a relatively thin (1.5 metre) layer of soft soil north of Corindi River. Due to its small thickness and existing overburden pressure, limited settlement can be expected as a result of the construction of embankments. It is anticipated that specialist construction techniques can be avoided and hence such limited settlement could be accommodated in conventional embankment design.

Figure 3.17 shows the likely locations of soft soils and Figure 3.18 shows the likely location of acid sulphate producing soils.

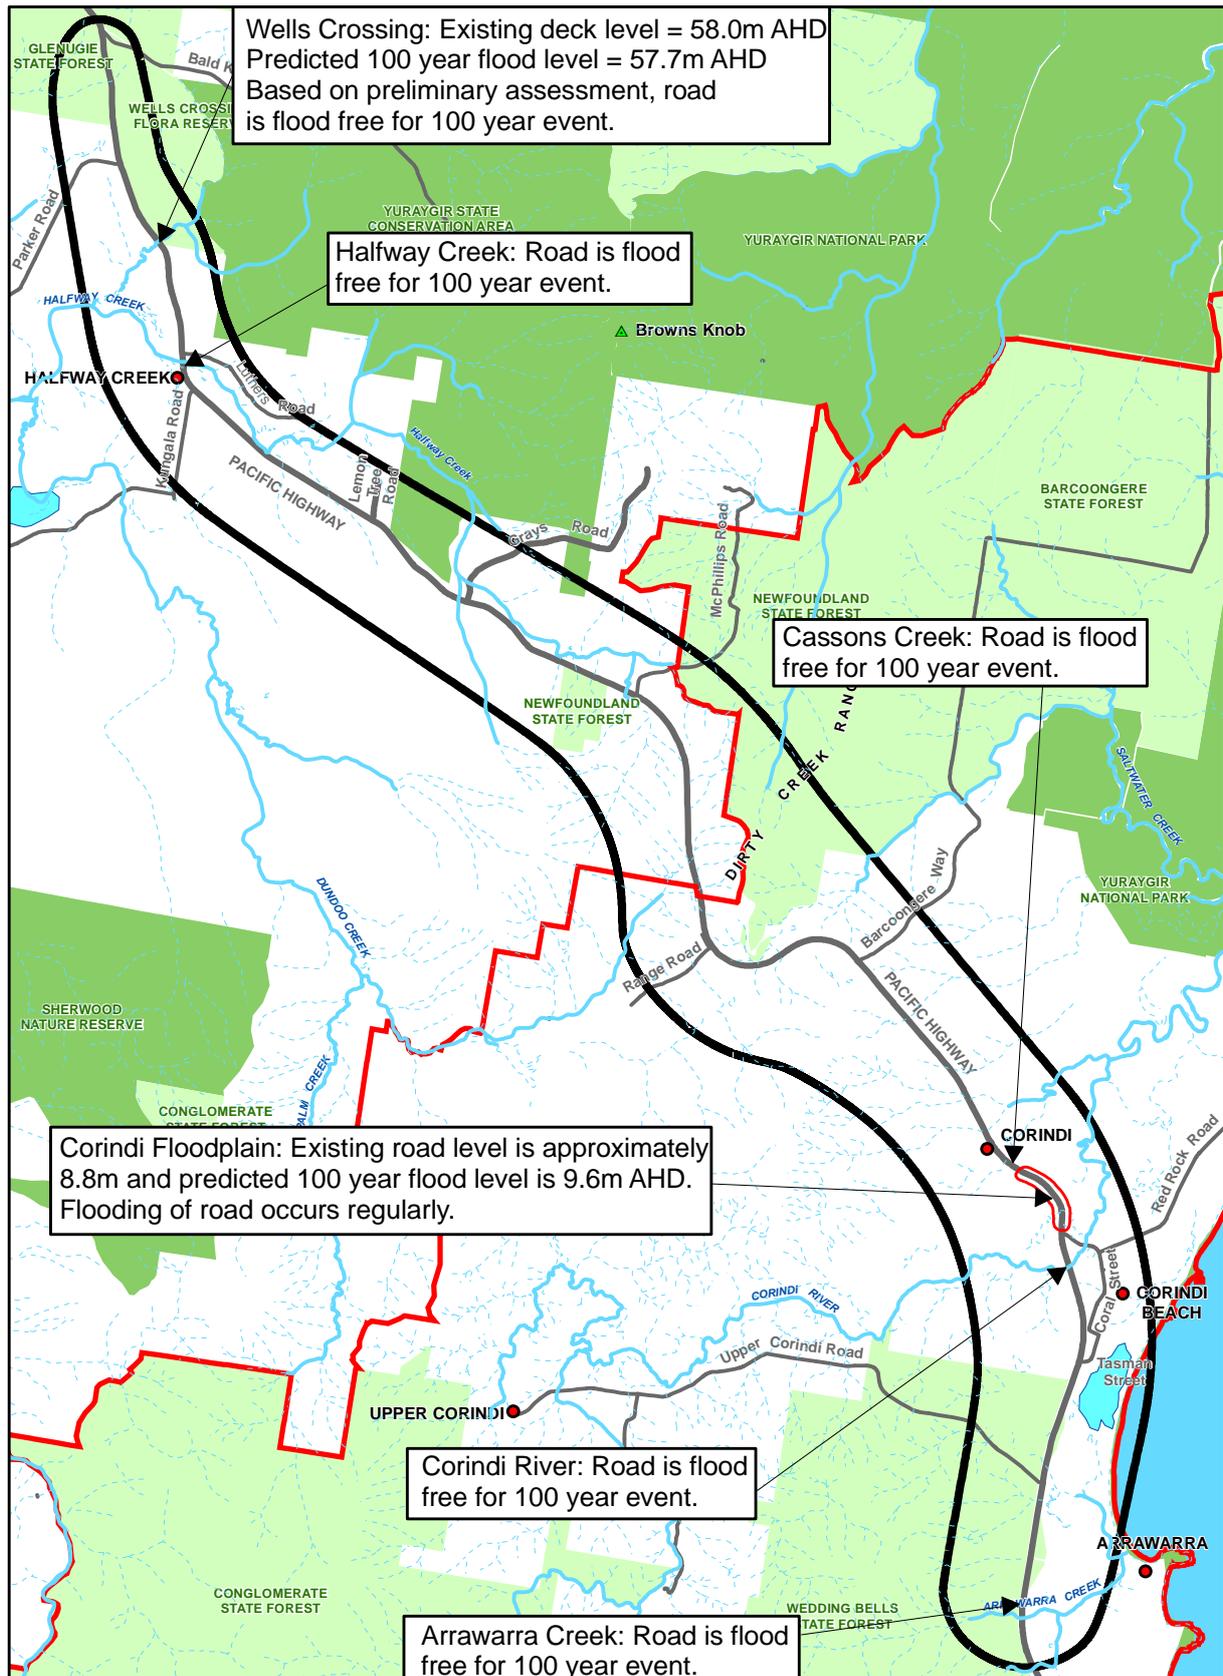
Figure 3.19 shows the watercourse in the study area, and the results of preliminary assessments of flooding at the bridges.

Location	Deck Level (m AHD)	Predicted 1% AEP Flood Level (m AHD)	Predicted 1% AEP Flood Free Condition	
			Deck	Soffit ⁽¹⁾
Arrawarra Creek	8.0	7.2	✓	x
Corindi River	11.6	9.8	✓	✓
Blackadder Gully	11.0	9.6	✓	✓
Cassons Creek	11.2	9.5	✓	✓
Halfway Creek	59.8	59.5	✓	x
Wells Crossing	58.0	57.7	✓	x

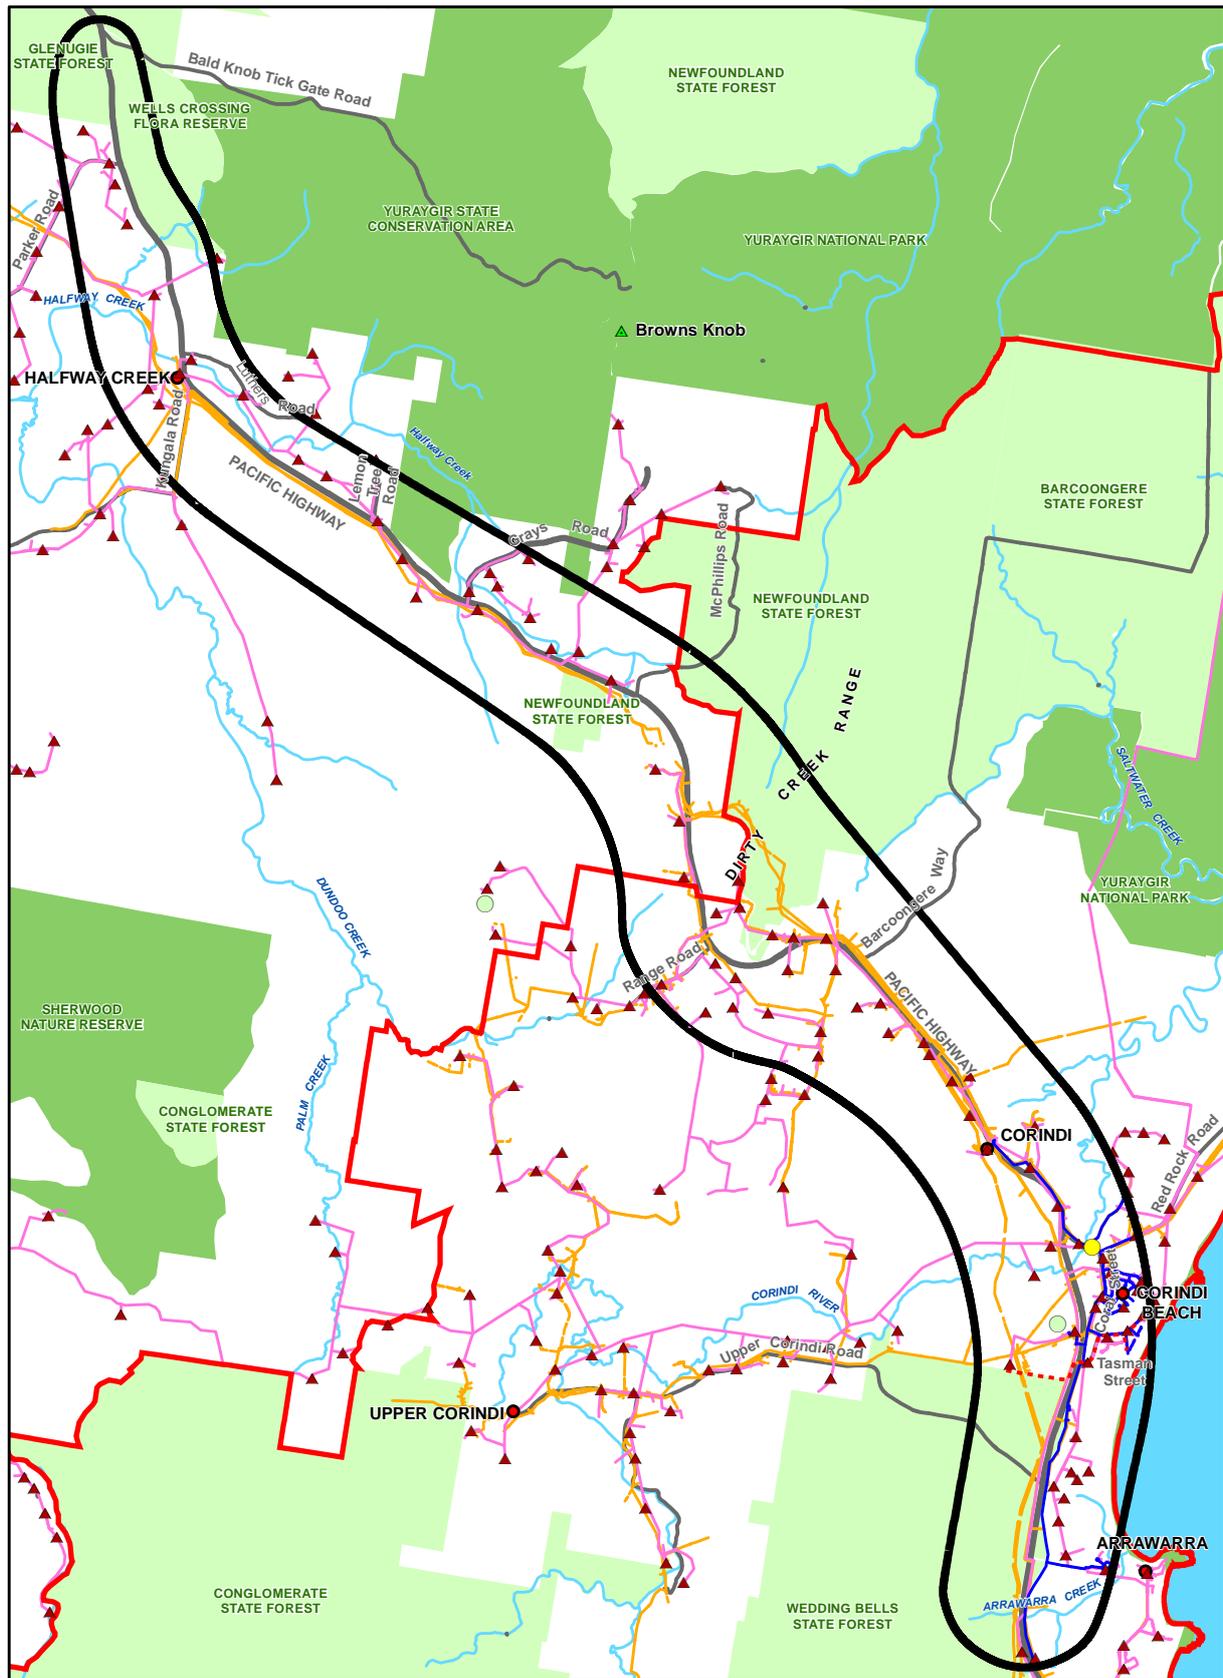
- ▶ Coffs Harbour City Council services Corindi Beach with a 150 mm diameter rising sewer main that crosses the Pacific Highway at Tasman Street; and
- ▶ Coffs Harbour City Council owns and operates a sewage treatment plant on Kangaroo Trail Road.

The public utilities within the study area are shown in Figure 3.20.
