# Fauna monitoring data

## Pacific Highway Upgrade

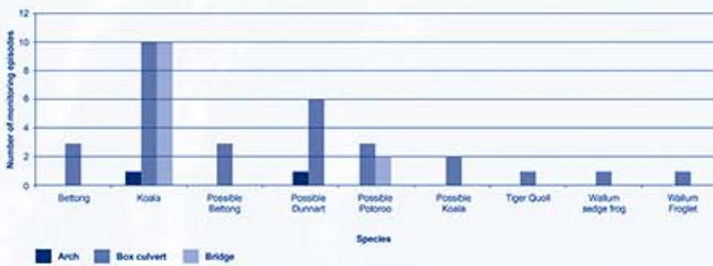
Threatened Species Recorded in Underpass Structures

The graph highlights the types of different threatened species recorded in various types of underpass structure. Monitoring carried out to date has not recorded any threatened species using pipe culverts, further research is ongoing in this area, particularly in relation to threatened frog species. The results only indicate a use of a structure by fauna rather than a record of the number of times a particular species used a structure.

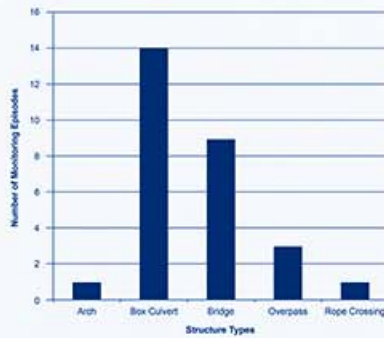
The graph shows frogs recorded within or using connectivity structures.

Frogs have been observed using 'stepping stones' within a culvert and tadpoles were also observed in the low-flow channels of combined underpass structures possibly indicating breeding activity.

The methods used to detect frogs included sand trays, pit traps and more recently motion sensor cameras. Not all records were able to confirm a complete passage, however, some data collection confirmed that frogs did make a complete passage in some culverts but it was not possible to classify to species level.

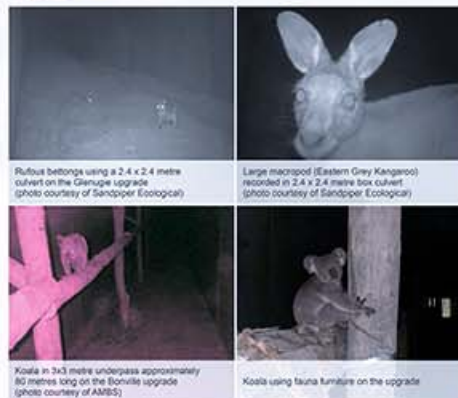
More recently, motion sensor cameras have been installed to monitor fauna usage. This provides visual identification of the different species using the structures and whether they complete a successful passage. Data has shown that the length of an underpass or culvert can influence the number of successful complete crossings. The typical length of culverts/underpasses monitored ranged from 40 to 55 metres. The length of culverts was not recorded for all monitoring episodes, however, the confirmed successful passages of koalas in culverts 1.2 metres high where generally less than 40 metres in length. Nonetheless data collected as part of the Australian Museum Business Services (AMBS) koala research at Bonville did record passage of koalas on culvert lengths exceeding 80 metres.

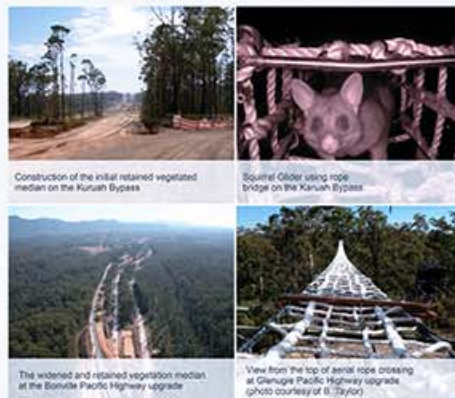
The Karuah Bypass was the first time that trees were used to create a retained median on the highway. However, the width of the median was too small to sustain the trees and they were later removed and replaced with rope bridges. Vegetated highway medians were later designed at about 20 metres wide to allow for adequate soil moisture depth and have been successfully implemented in subsequent upgrade projects, such as the Bonville upgrade.

Post-construction monitoring at Karuah has since shown that the threatened squirrel glider, common sugar gliders and possums have used the rope bridges installed in place of the vegetated median.

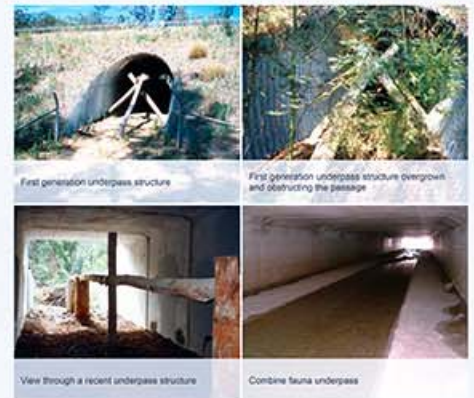
The first generation underpass structures along the Pacific Highway were built in the early 2000's. The cross support structure resulted in obstructing the fauna passage.

The more recent fauna underpass structures recognise the importance of a clear passage either side of the underpass and avoids the use of cross supports within the structure.

Combined underpasses are now regularly used which provides for fish and terrestrial fauna crossing. Installing culverts 200mm below bed level provides opportunity for fish passage.
