## Woolgoolga to Ballina Pacific Highway upgrade

Coastal Emu Monitoring Program  
Annual Report 2017

(Construction Phase Year 1)

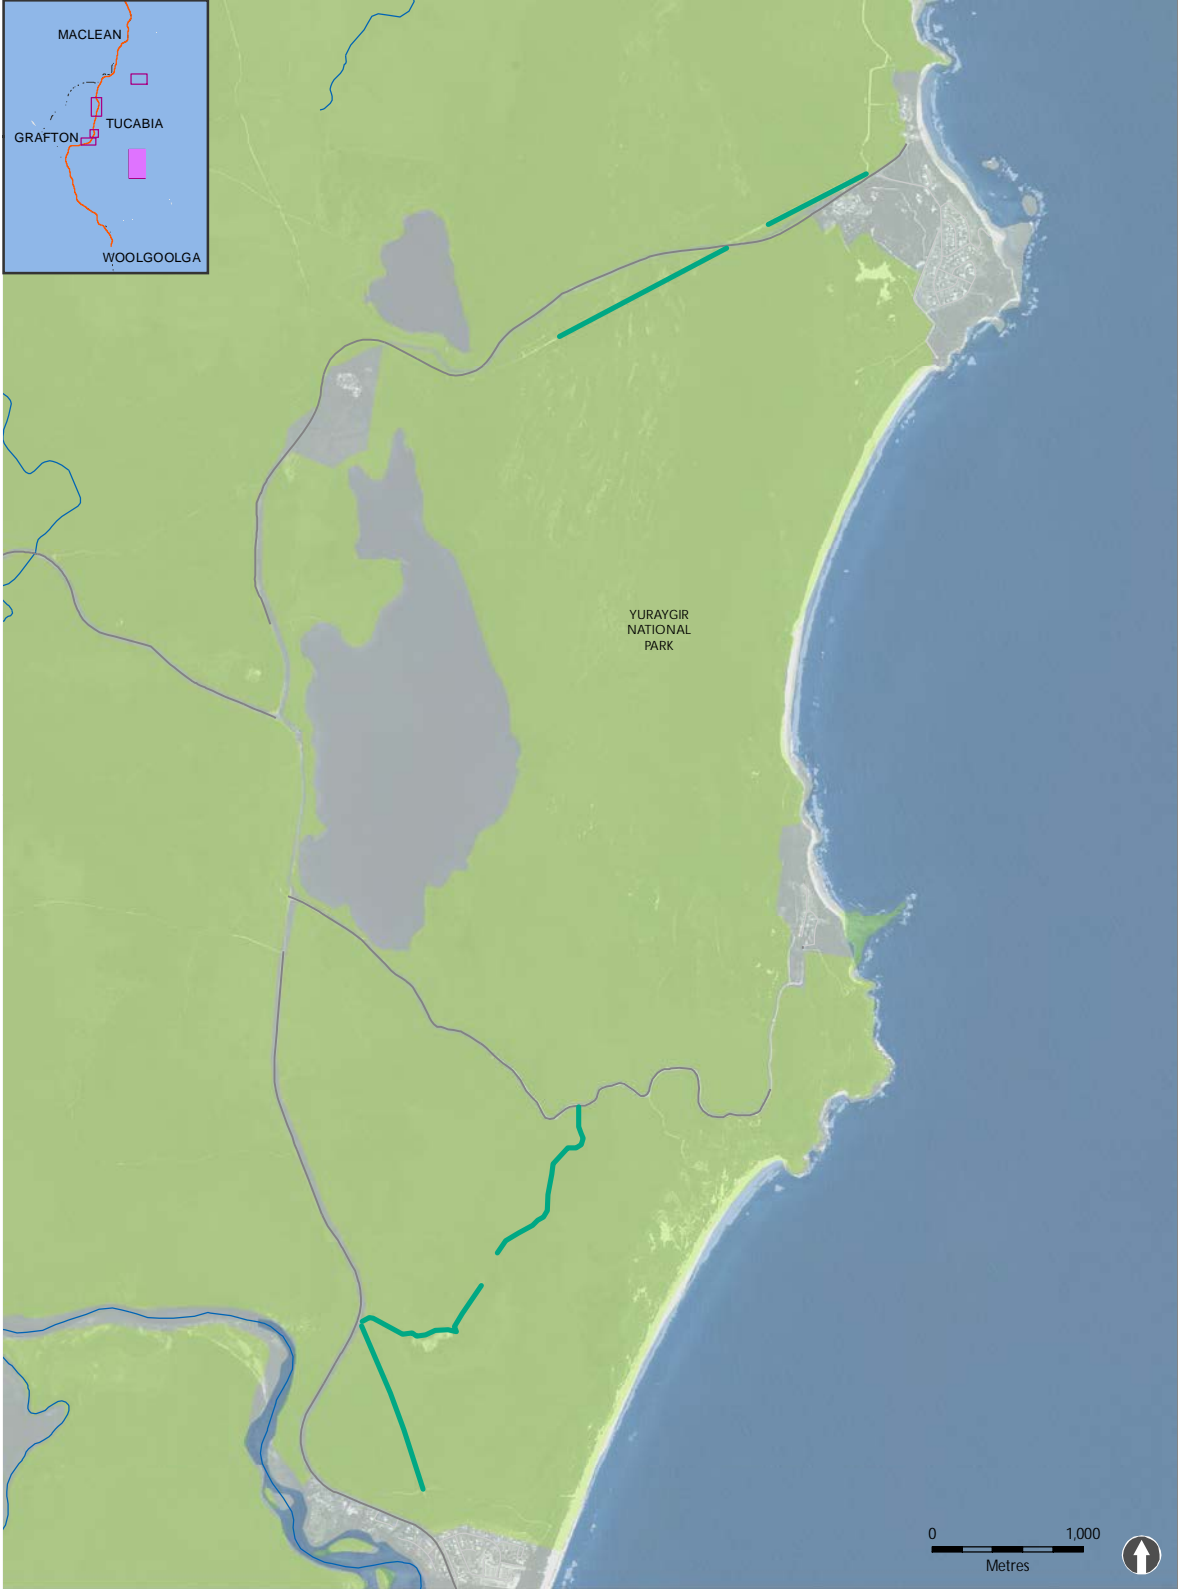
FIGURE 1 | Yuraygir South

- Highway upgrade
- Existing Pacific Highway
- Transect

The intent of the sampling regime was to compare emu presence over time within each of these study areas during the different project phases rather than a comparison between areas. This was achieved by sampling between 2 and 5 transects in each study area using transects that range between 800 and 2000 metres in length. In total 24.7 km of transects were sampled from 13 impact sites and 7 control sites (Table 1). Sites were stratified to sample a range of different habitat types including pastoral land, forest, riparian and wetland areas. The location of survey transects is shown in Figures 1-5.

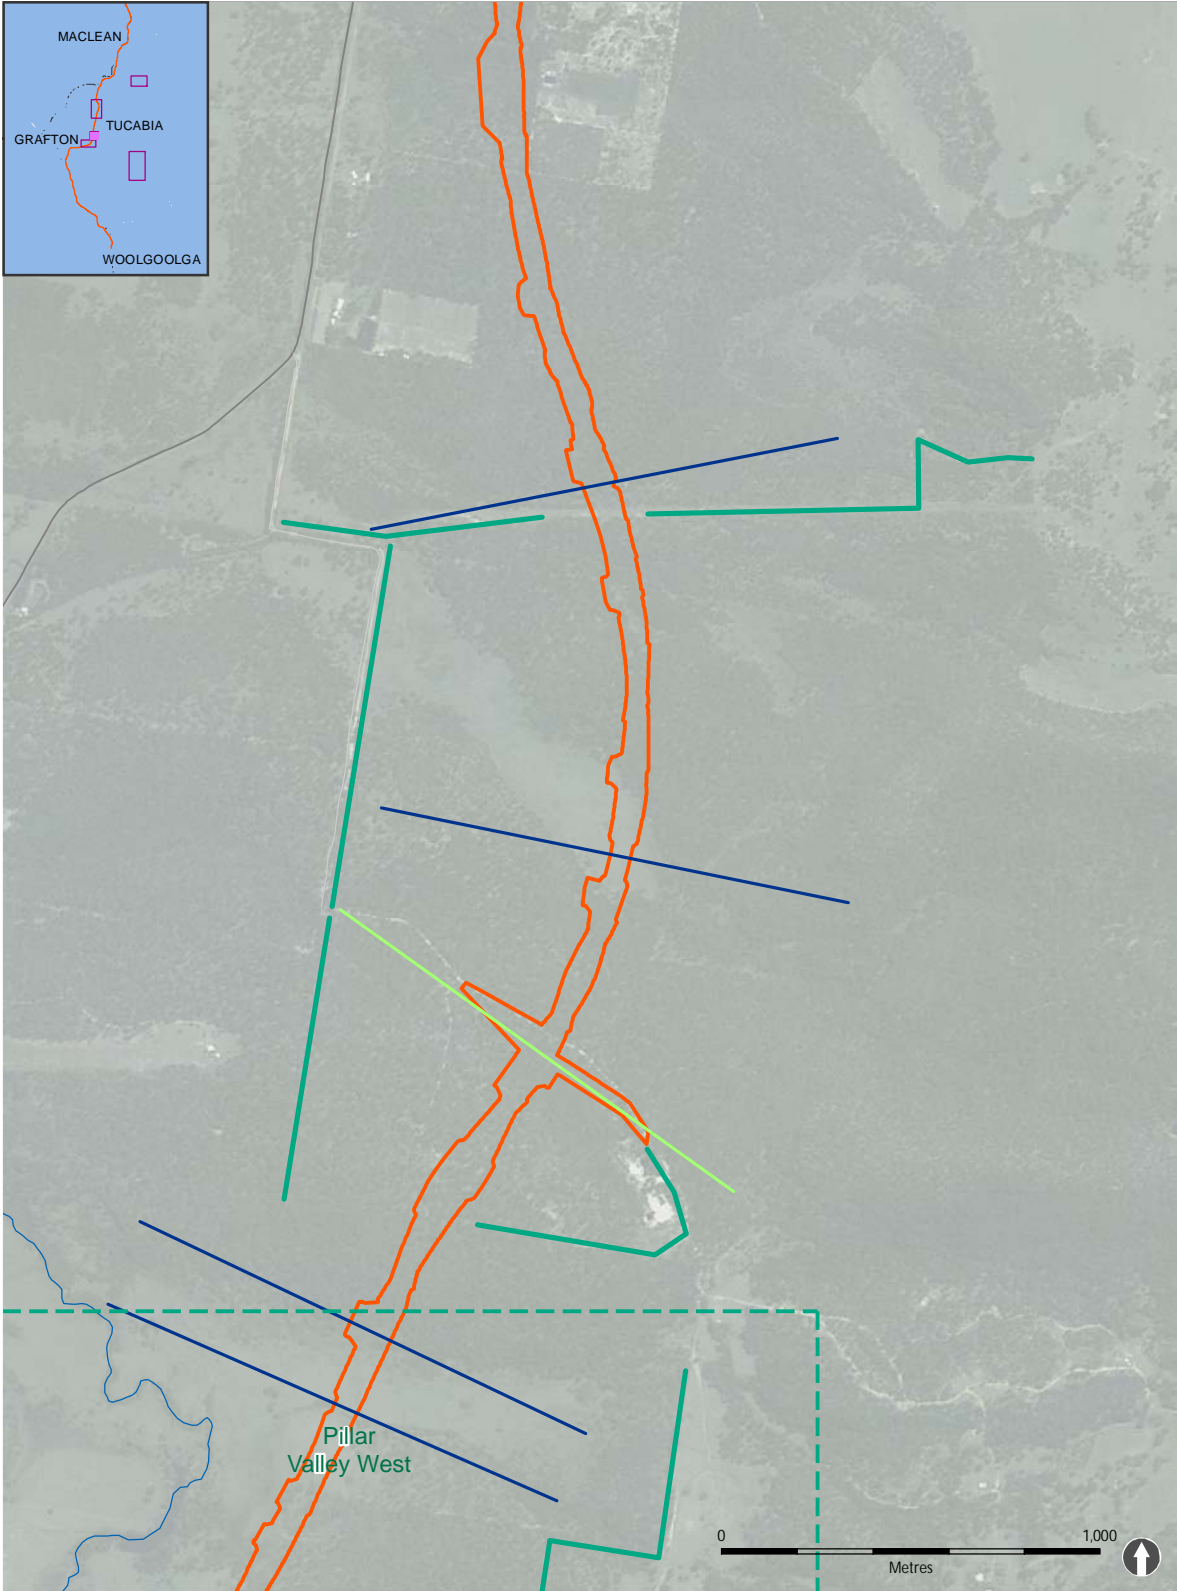
FIGURE 3 | Tucabia South

- Highway upgrade
- Existing Pacific Highway
- Transect
- Adjacent transect study site
- Combined Emu and Bridge Structure
- Incidental Emu Structure (road underpass)

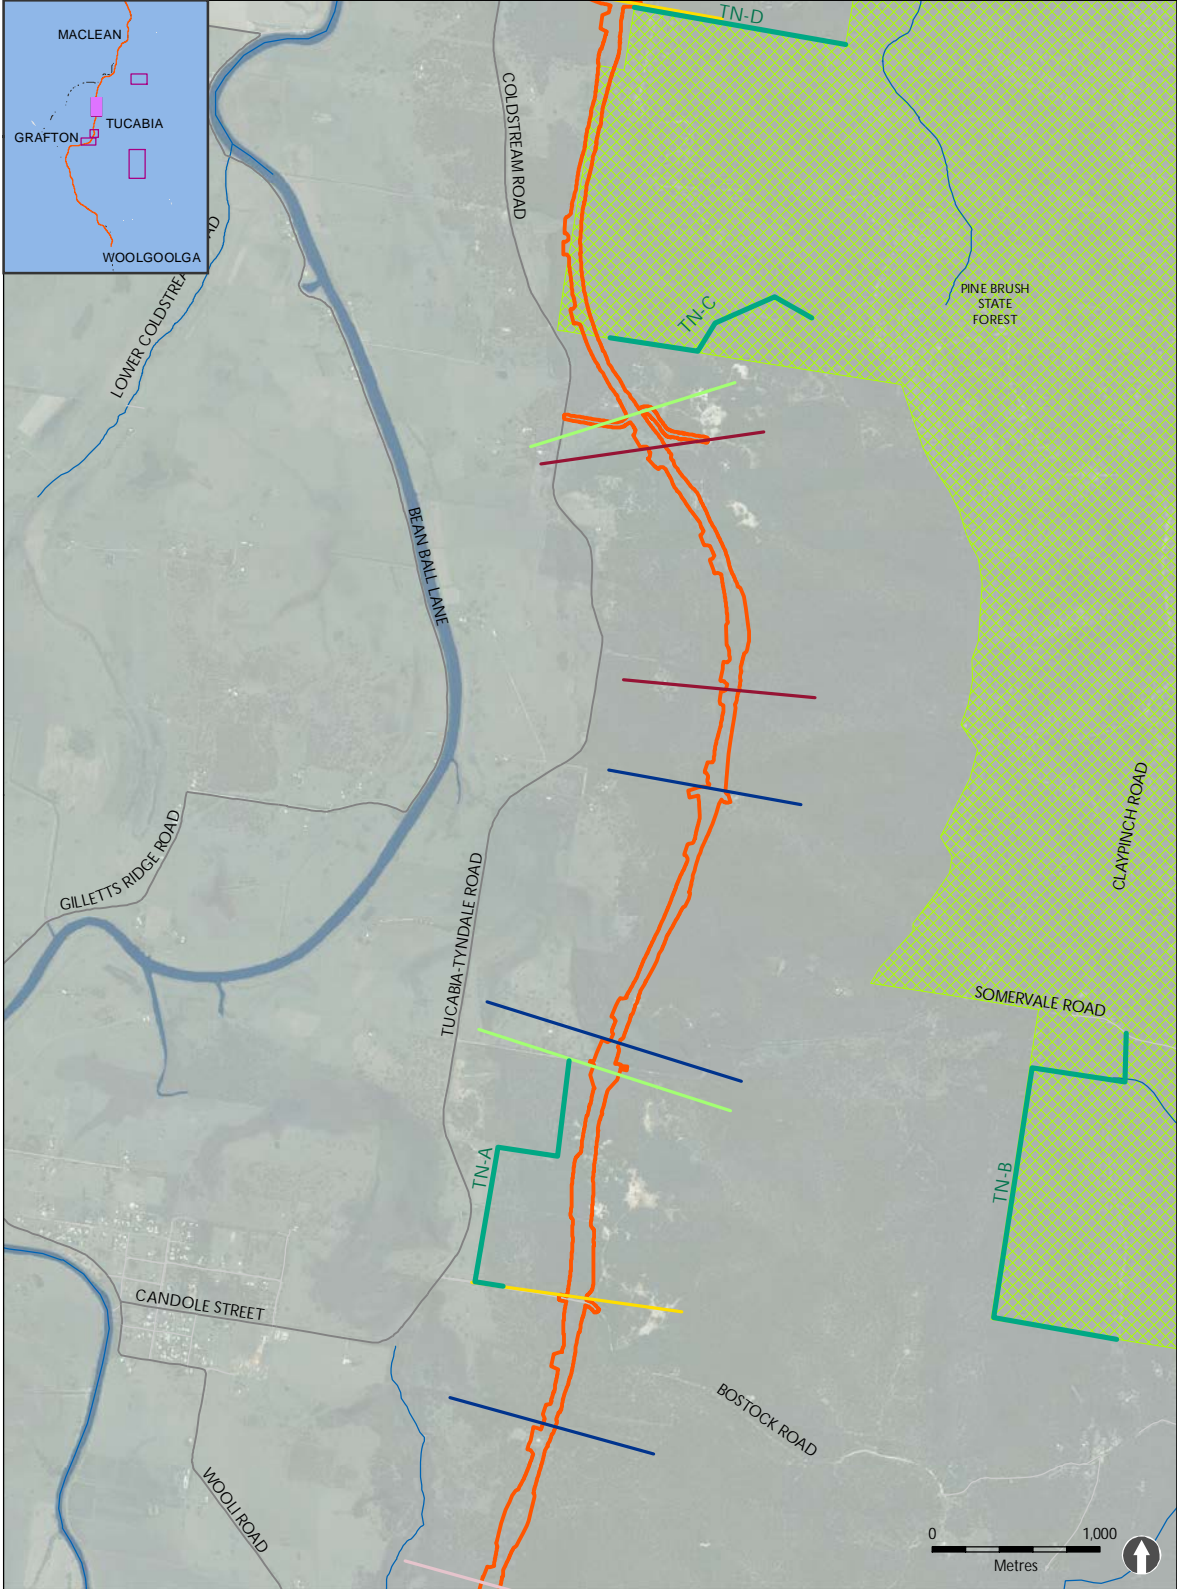
FIGURE 4 | Tucabia North

- Highway upgrade
- Existing Pacific Highway
- Transect
- Combined Emu and Bridge Structure
- Combined Emu and Drainage Structure
- Dedicated Emu Structure
- Incidental Emu Structure (road overpass)
- Incidental Emu Structure (road underpass)

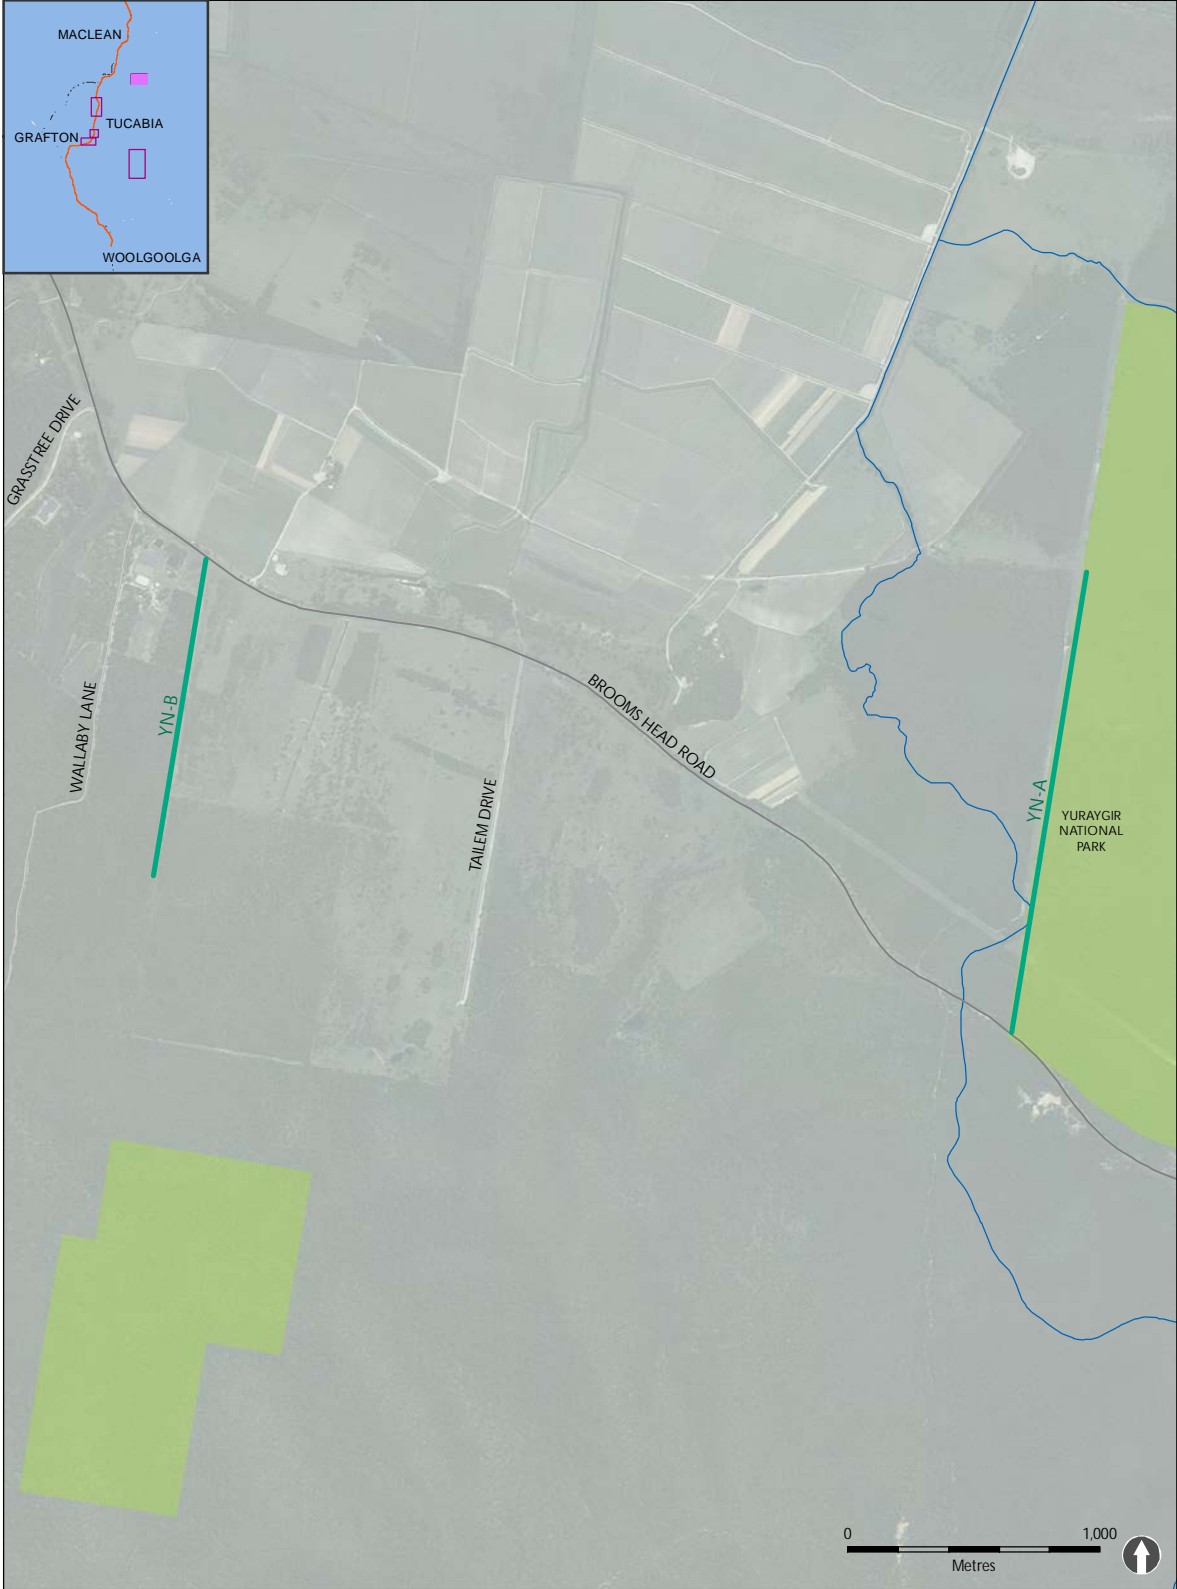
FIGURE 5 | Yuraygir North

- Highway upgrade
- Existing Pacific Highway
- Transect

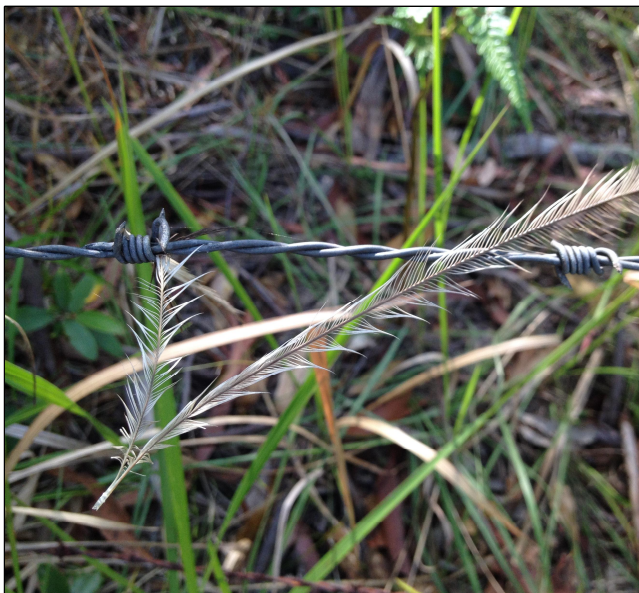
Plate 1. Example of recent emu feathers 'snagged' on barbed wire

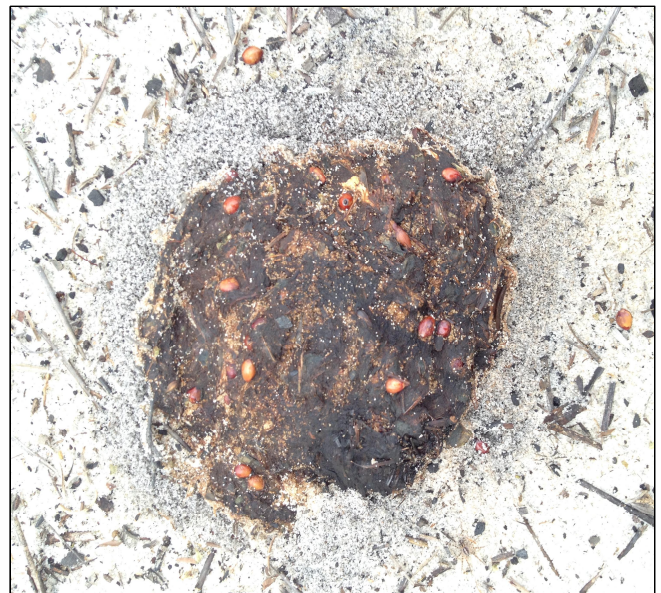
Plate 2. Emu dropping with *Gahnia sieberiana* seed

When encountered, the contents of scats were recorded and collected to be compared with reference plant material from each location to document dietary items. An updated list of plant species recorded in the diet of emus is maintained to inform the project revegetation and planting design, particular planting of emu food plants at crossing zones.

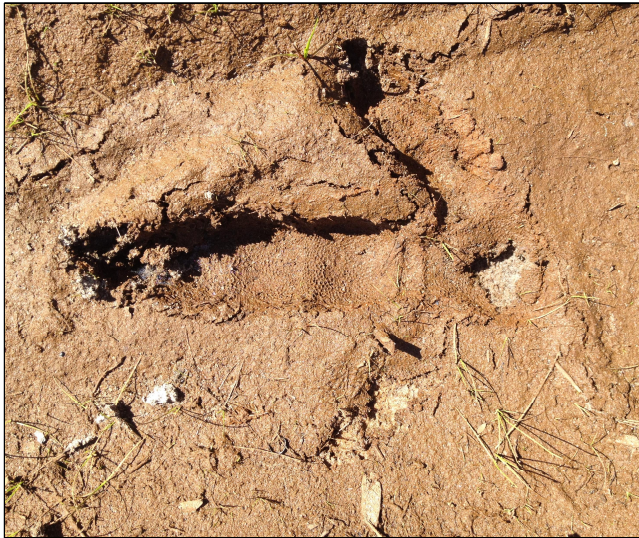
Plate 3. Example of muddy transect where emu tracks are apparent

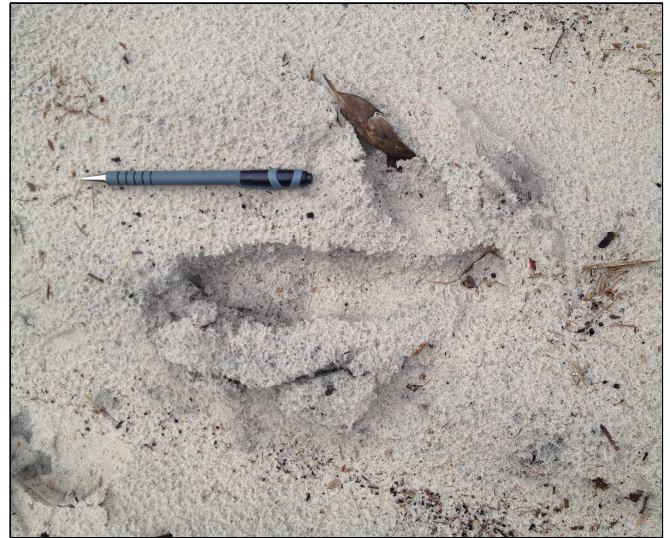
Plate 4. Example of sandy transect where emu tracks are apparent

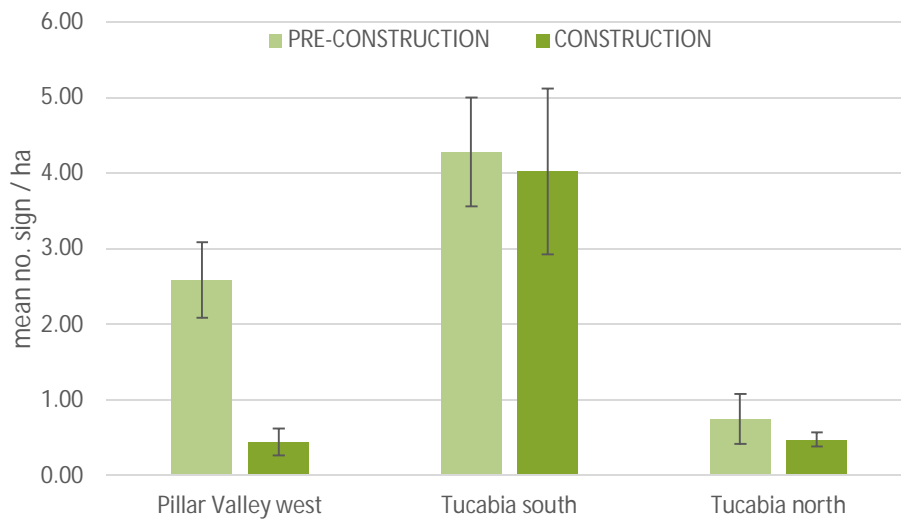
Figure 6: Mean density of emu sign (no./ ha) at impact sites comparing pre-construction (2014-16) and construction (2017)

Absolute densities of emu sign during the first year of construction were lower in all three impact study areas compared with the 3-year pre-construction period (Figure 6). In particular, there was a notable decline in emu activity from sites associated with Pillar Valley Creek and the Coldstream wetlands (Pillar Valley West). A similar pattern of decline in emu activity was also noted in the control areas, with a complete absence of emus recorded in the Yuraygir south control sites during construction (Figure 7).

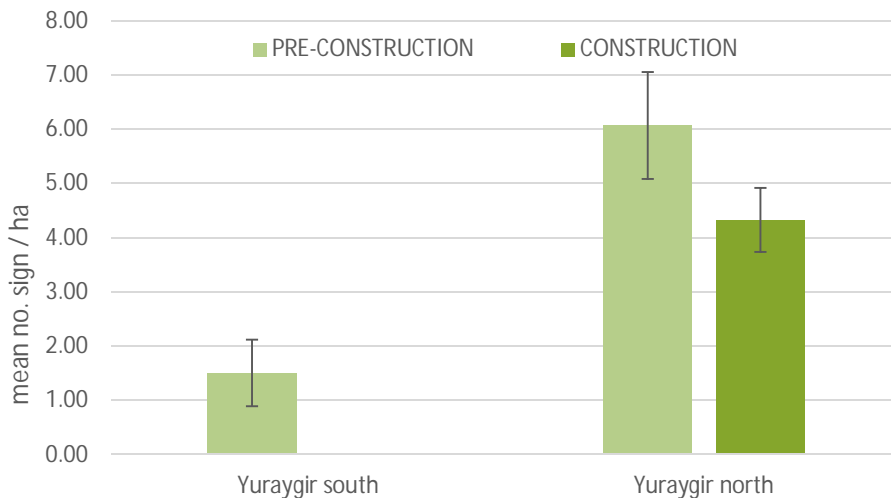
Figure 6 : Mean density of emu sign (no./ ha) at control sites comparing pre-construction (2014-16) and construction (2017)

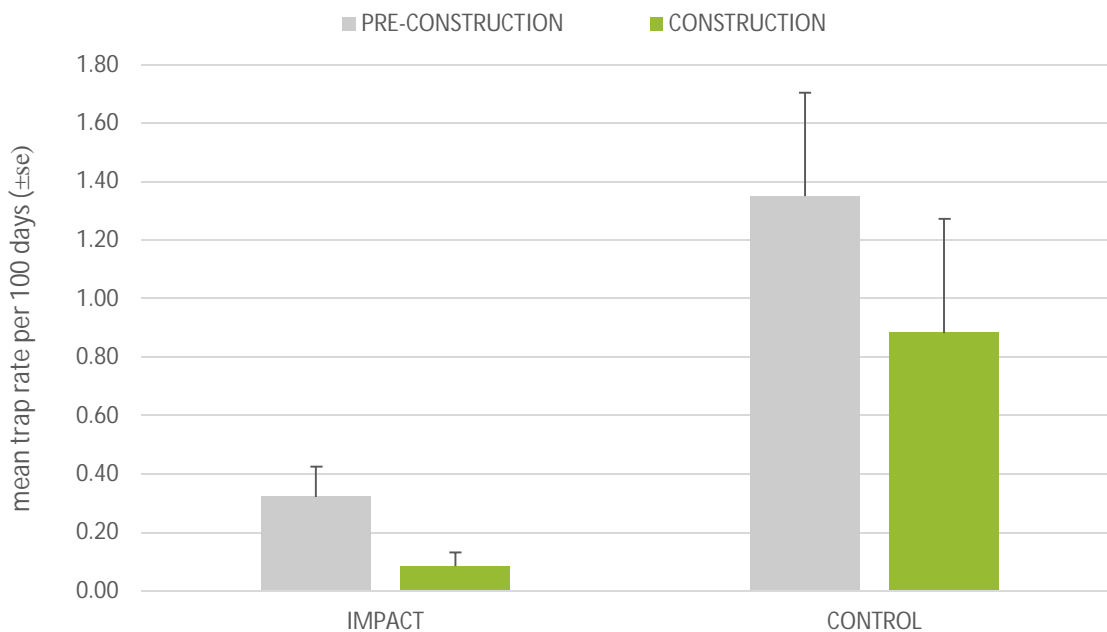
Figure 8: Mean camera trap rates (no. emus photographed per 100 trap days) at impact and control study areas for pre-construction period (2014-16) and construction period (2017)

Mean camera trap rates per study area are shown in Figure 8, these show an overall comparison of the pre-construction data (2014-2016) with the first year of construction (2017). There were no emu photos captured at Pillar Valley west or Yuraygir south during construction and this reflects the low density of emu sign and activity in these areas. An emu was photographed in Tucabia north for the first time during construction

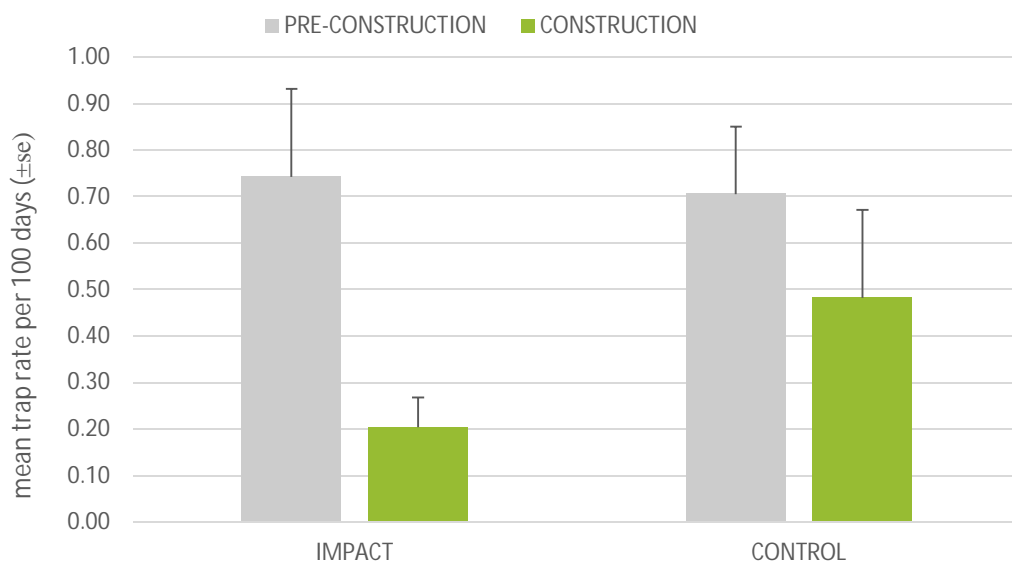
Figure 9: Mean camera trap rates (no. dogs photographed per 100 trap days) at impact and control study areas for pre-construction period (2014-16) and construction period (2017)

Trap rates of wild dogs were also recorded to monitor change in dog presence in emu study areas. Dogs were found to be present at all sites both during the pre-construction phase and construction phase, suggesting dogs and emus co-exist within impact and control areas. There was a large decrease in dog presence recorded at impact sites during the early phase of construction.

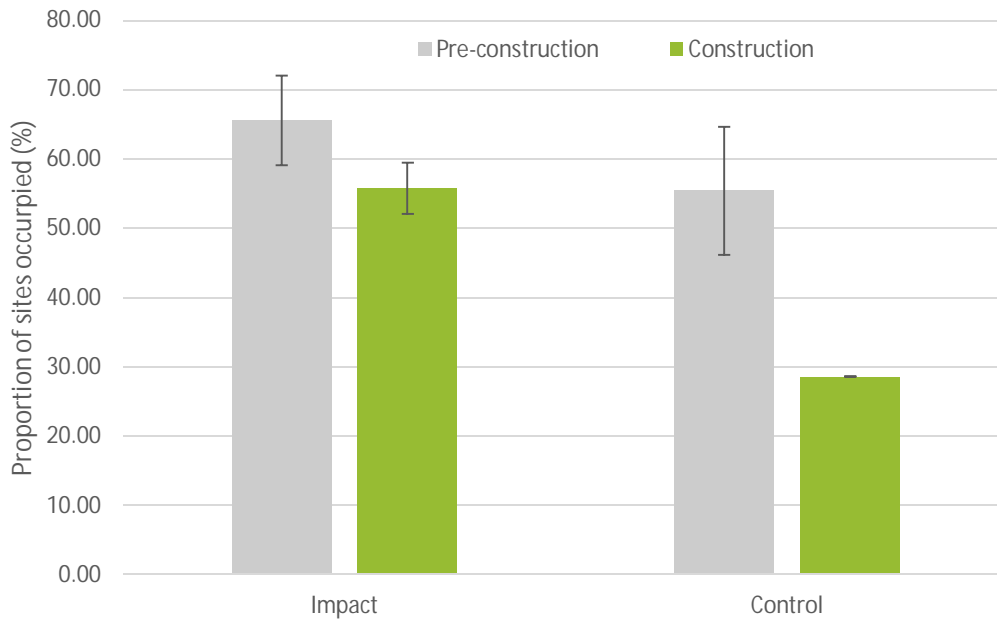
Figure 10. Mean occupation rates (±se) for impact and control sites comparing pre-construction (2014-16) with construction (2017)

Figure 10 compares the mean site occupation rate for the 13 pre-construction surveys (baseline) at impact and control sites and the mean rate from the 4 construction phase surveys. These two means were compared using an independent t- test with the dependent variable being occupation rate and the independent variable being time (pre-construction and construction). For the impact sites there has been a slight decrease in around 10 % occupation of survey sites however this change is not considered significant ( $P = 0.212$ ). There has been a significant decline in the number of control sites occupied ( $P = 0.013$ ). This decline was first noted in late 2015 during the pre-construction phase, associated with the absence of emu activity in the Yuraygir south control sites.

Table 9 shows the change in the number of impact and control sites occupied since the start of the monitoring program and illustrates that the mean decline shown in Figure 9 is a factor of the higher occupation rates in the first year of the program commencing in 2014 through the latter two pre-construction years (2015 and 2016). The data also shows an increase in the impact sites occupied in the first year of construction (2017).

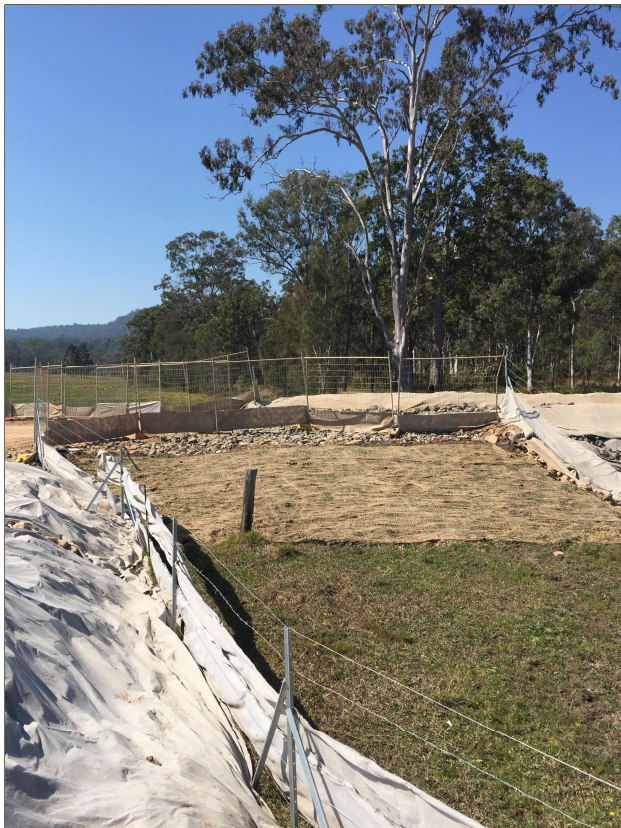
Plate 5. Emu crossing zone (race T5)

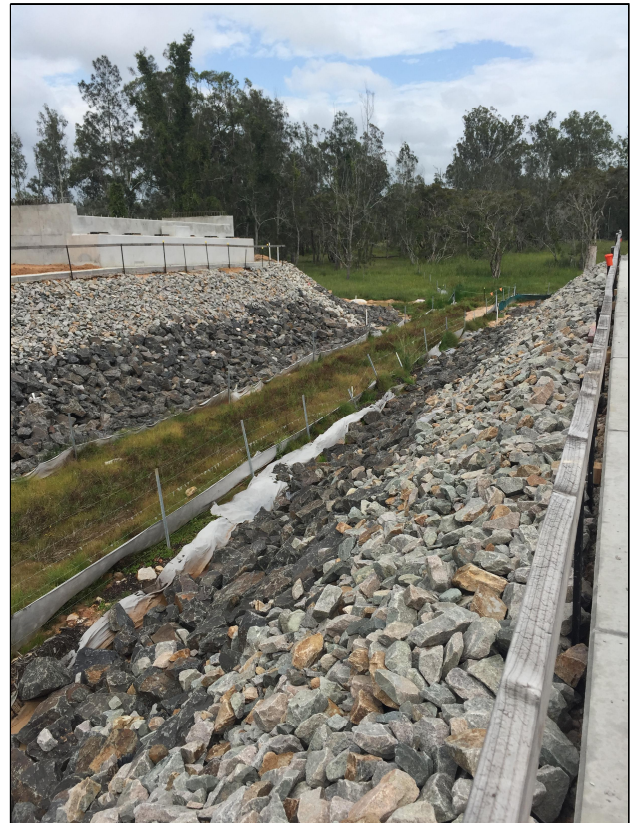
Plate 6. Emu crossing zone (race T4B)

One emu was photographed crossing race T4B. Other fauna found to be using the races included a dog (1 race), cattle (5 races) and kangaroos (3 races). Camera trap rates are not presented for emus because of the limited data and therefore cannot be compared with the pre-construction fence trial.

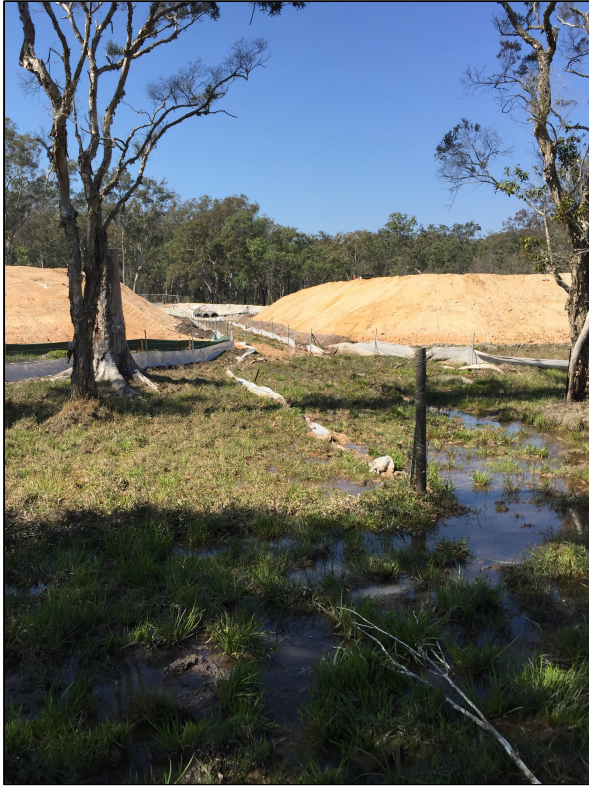
Plate 7. Emu crossing zone (T4A)

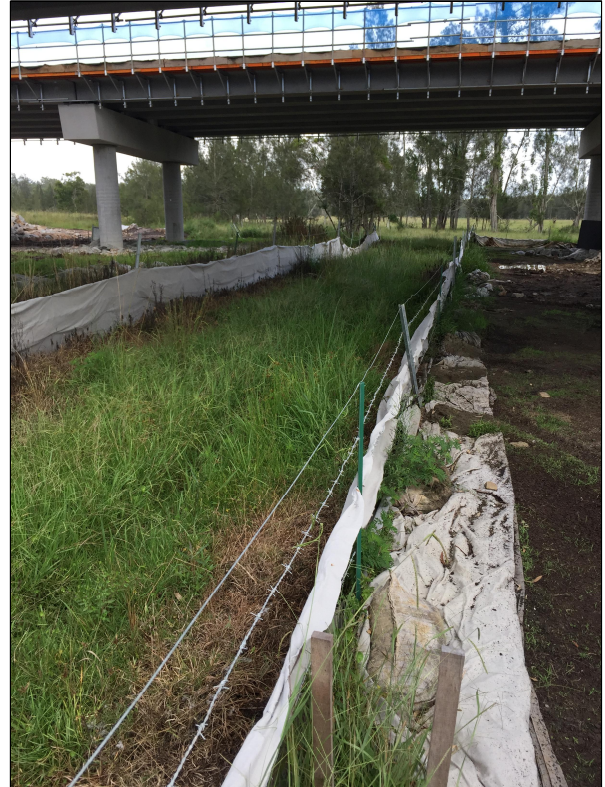
Plate 8. Emu crossing zone (race T9)

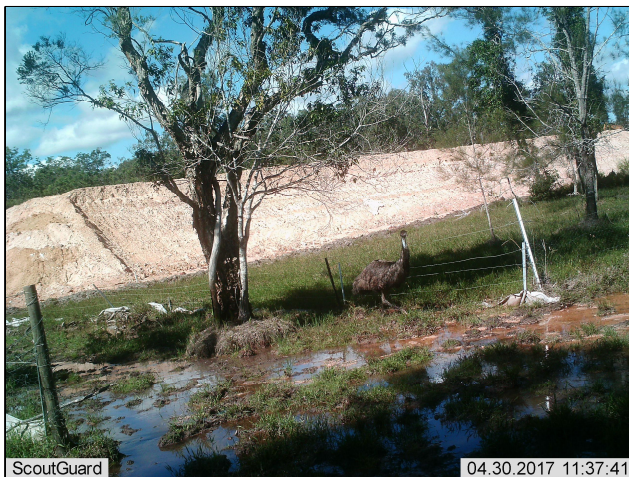
Plate 9. Image of adult emu crossing the fenced race (T4) during the early stage of construction

Of interest is the confirmed crossing of zone T4 which recorded the highest usage during the pre-construction fence trial. This may suggest that the emu has been educated to find the crossing zone. The recorded usage of the crossing zones during construction has been very low, particularly given the high usage of these zones during the pre-construction trial. This could mainly be attributed to the fact that the zones are closed 6 out of 7 week days (open Sunday only), and are open at night when emus are not active. Monitoring will continue through the second year of construction (2018). Considerable time and effort has been deployed into positioning cameras to avoid photographing construction vehicles and workers and this may improve emu detectability. Further to this, a number of modifications have been made to the entrance of the races to improve their functionality for emus and this is hoped to increase usage during 2018.

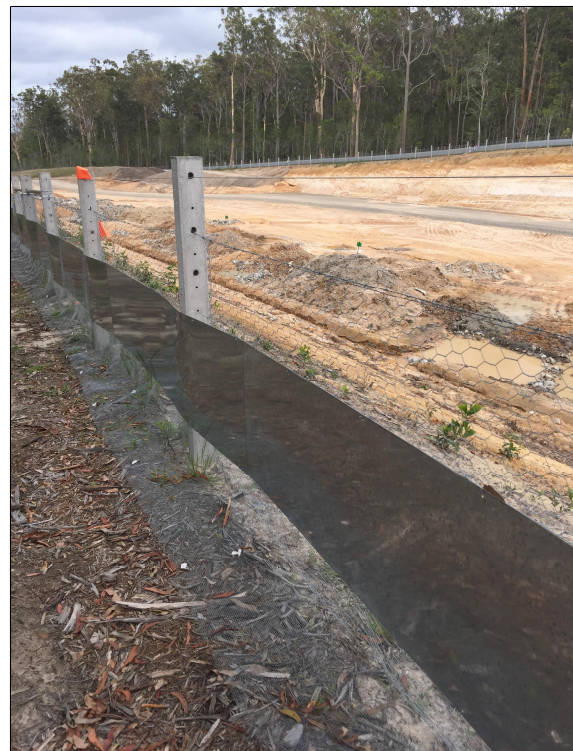
Plate 10. Permanent emu exclusion fence erected adjacent to crossing zone T9 on both sides of the highway

In addition to the maintenance of emu crossing zones, permanent emu exclusion fencing has been installed in elevated portions of Section 3 as per the requirements of the Emu Management Plan (refer Plate 10).

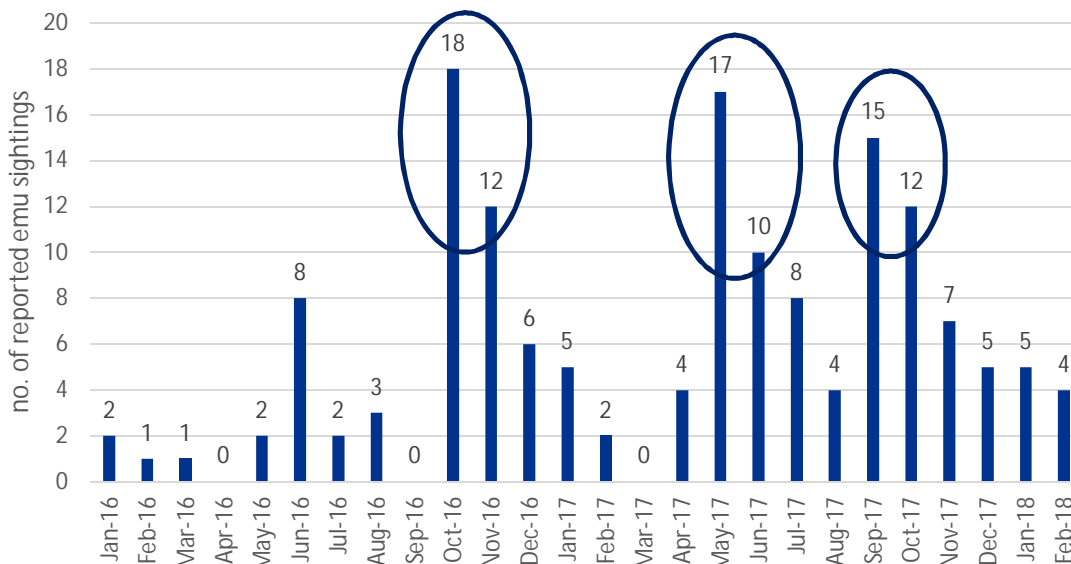
Figure 11. Number of reported emu sightings in Section 4 of the W2B upgrade during construction (Jan 2016 – February 2018)

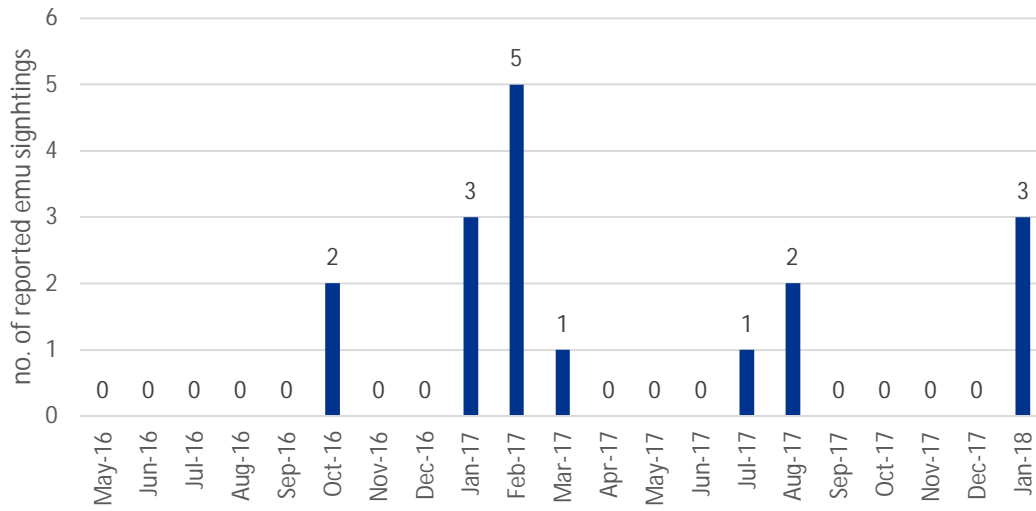
Figure 12. Number of reported emu sightings in Section 3 of the W2B upgrade during construction (Jan 2016 – February 2018)

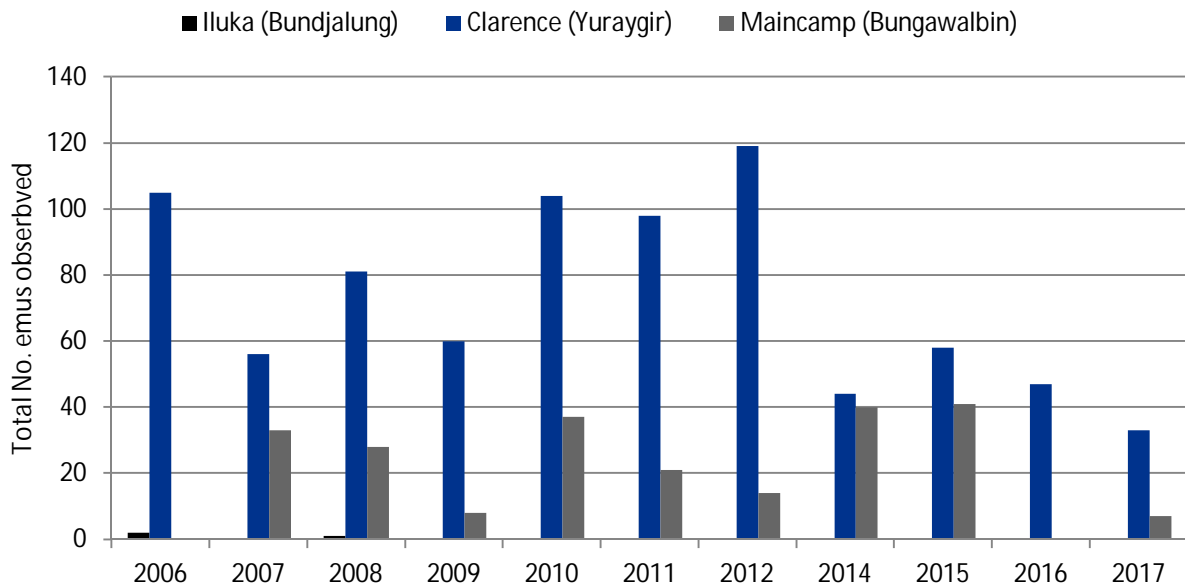
Figure 13: Relative population data collated from the annual coastal emu citizen survey (2006-2017 source: Office of Environment and Heritage)

Relative population data reported from the annual citizen survey of coastal emus is shown in **Figure 13** and has been divided into the three main sub-populations (Bundjalung, Yuraygir, and Bungawalbin). These data report the actual number of emus observed over the two-day survey and not individuals observed before or after the survey or sign data. The data is only intended to provide a relative abundance estimate and is not based on total counts. This is because the survey is largely restricted to road areas, the number of observers and hence survey effort varied from year to year and also emus are widespread and difficult to count.
